# MOUNT POLLEY MINING CORPORATION POST-EVENT ENVIRONMENTAL IMPACT ASSESSMENT REPORT – KEY FINDINGS REPORT

JUNE 5, 2015

Golder Associates Ltd.  
Suite 200 - 2920 Virtual Way,  
Vancouver, BC, V5M 0C4

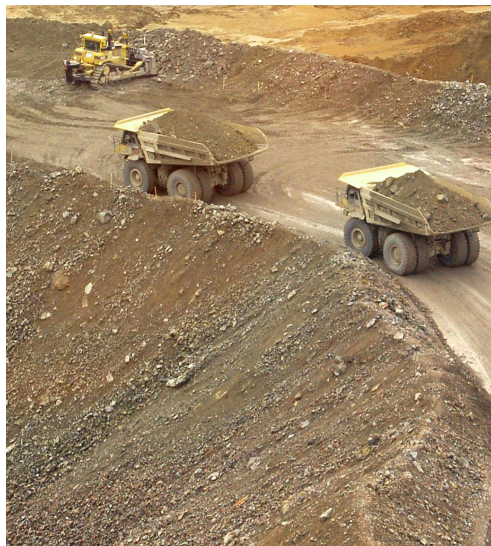
Haul trucks lined up to build a rock berm to hold back tailings in the TSF so that the breach could be repaired safely

- Stabilization of the tailings in the Tailings Storage Facility (TSF) by constructing two large rock berms inside the TSF. The rock berms functioned to stabilize the wet tailings on the inside of the TSF, preventing their mobilization into areas where people would need to go.
- Reducing the elevation of Polley Lake behind the Plug area to decrease pressure on the Plug and the possibility of rupture of the Plug. This was necessary to enable safe access into Hazeltnine Creek. A safety plan involving regular checks by geotechnical engineers, radio check-in and a “Hazeltnine Plug Spotter”, who monitored for early signs of Plug failure, was developed before access to Hazeltnine Creek was allowed.
- Stopping inputs from the TSF which continued to drain water and particulates. All drainage from the site water collection systems and breach outflow was collected as of September 4, 2014.

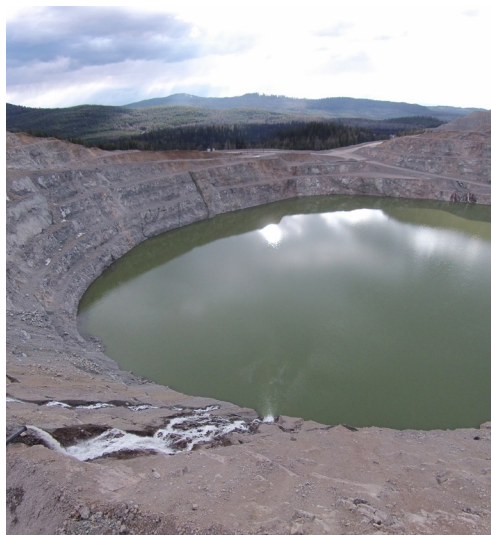
Mount Polley Mine diverted all site water collection systems to the Springer Pit

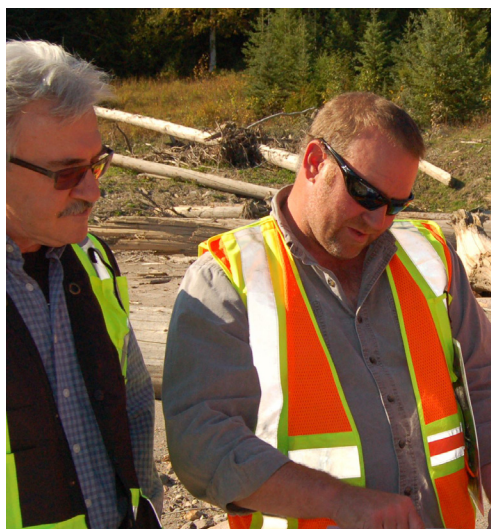
As soon as Hazeltnine Creek could be safely accessed, construction works to control erosion were initiated

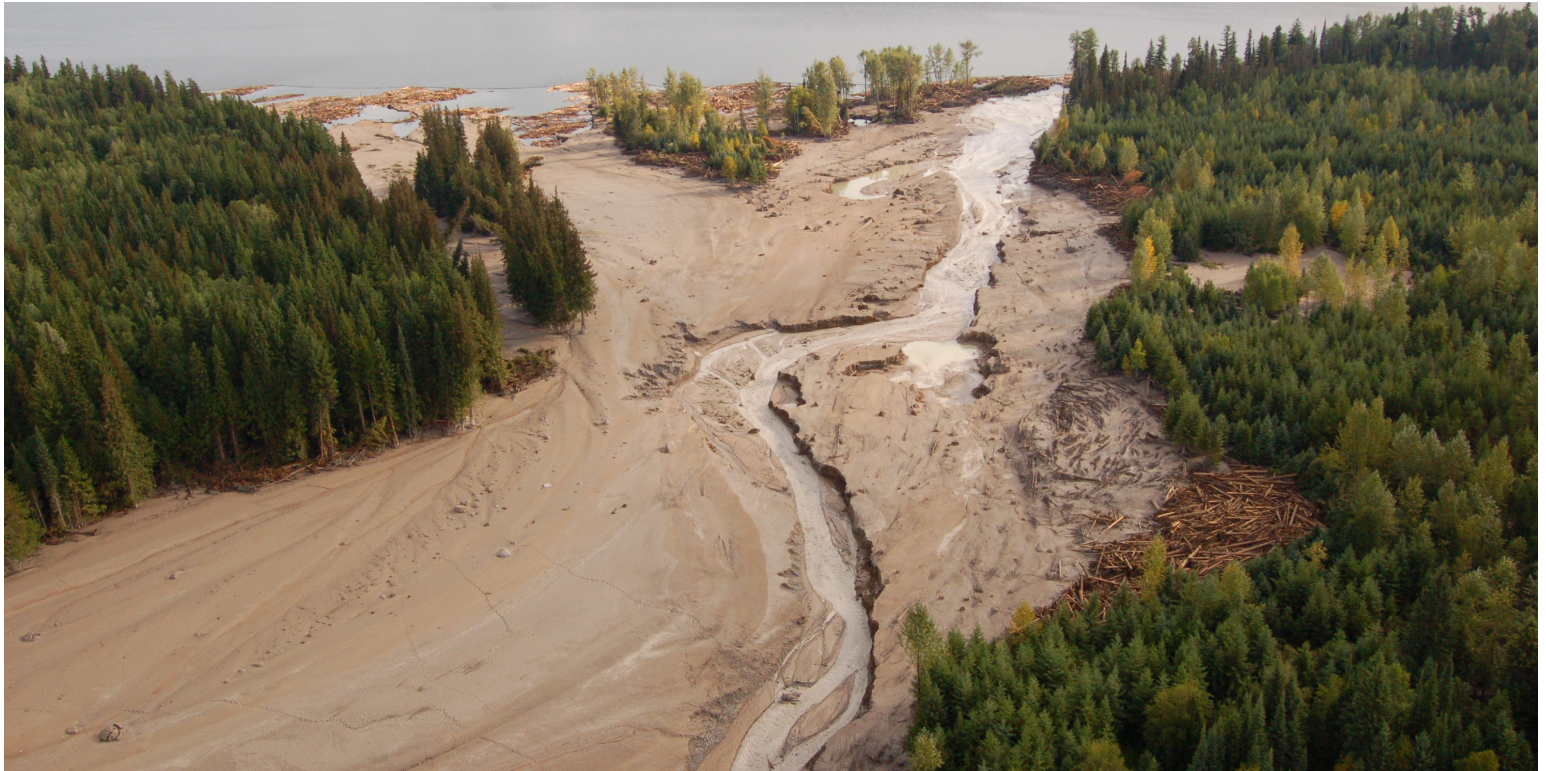
Lower Hazeltine Creek following the tailings dam failure (August, 2014) showing some of the physical changes that occurred

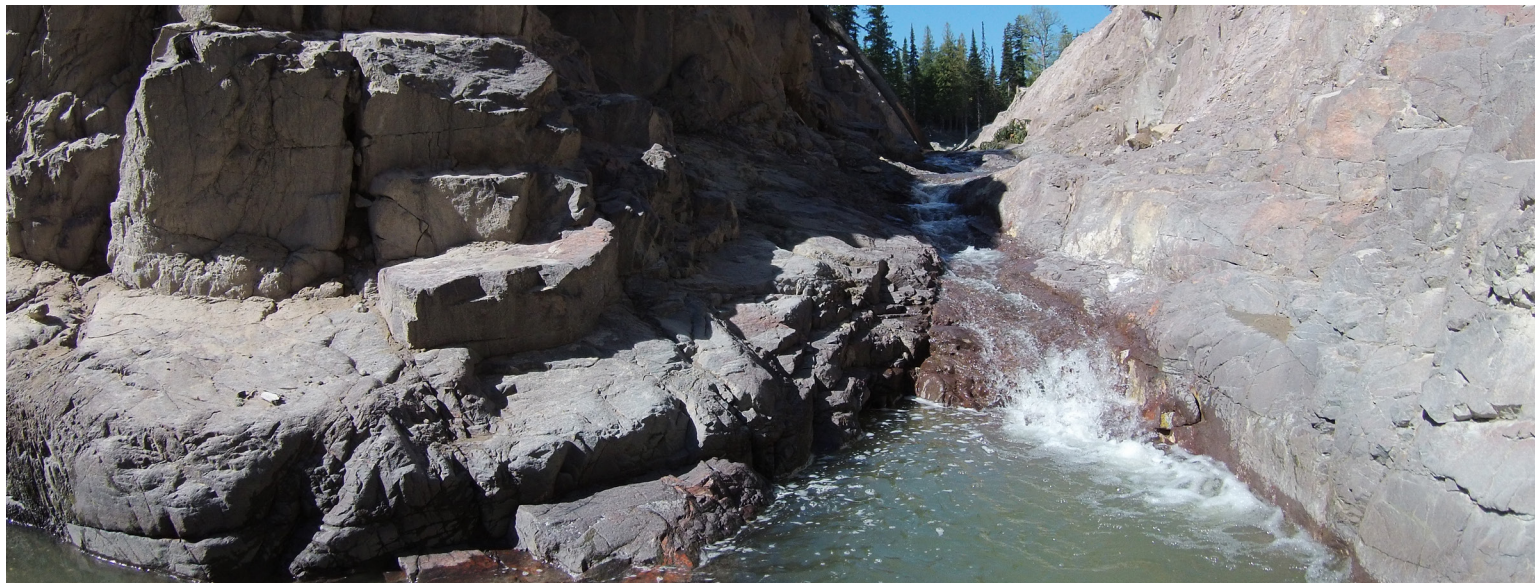
Hazeltine Creek Canyon showing exposed bedrock

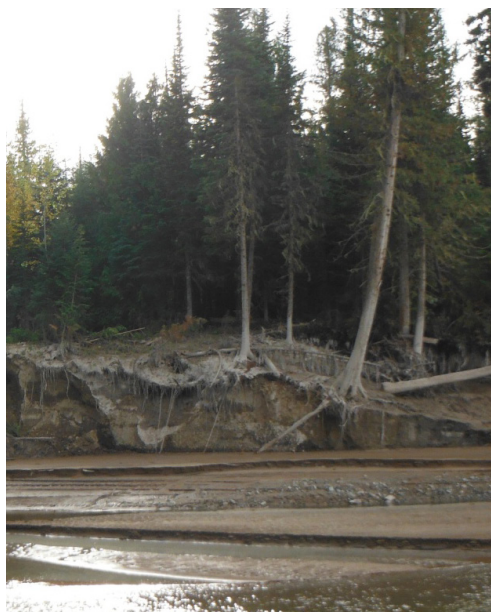
The slopes adjacent to the Hazeltine Creek channel became unstable within Upper Hazeltine Creek where a steep, quickly eroding zone developed. The tailings deposits in this area were thin and spatially heterogenous. Within the Hazeltine Creek Canyon, the channel bed was eroded down to bedrock with only limited tailings deposits. Within Lower Hazeltine Creek, the floodplain was eroded, and tailings and native material were deposited to variable depths ranging from 0.15 m to 1.5 m. The downstream-most 850 m of Edney Creek was affected by deposition

Slope instability and red tailings deposited within the Hazeltine Creek channel (September 22, 2014).

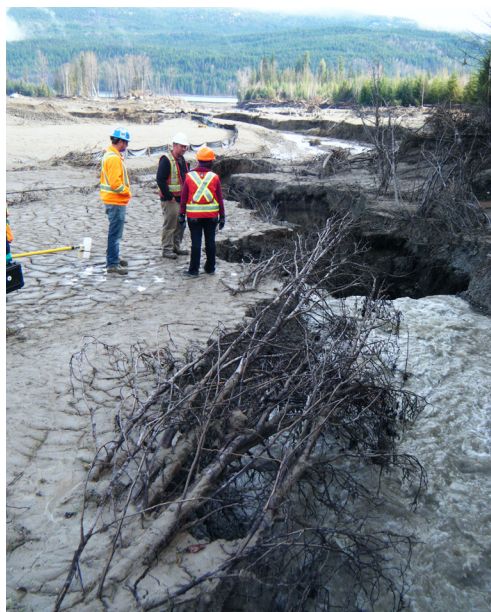
Hazeltine and Edney Creeks converge prior to discharge to Quesnel Lake. The mouth of Edney Creek was scoured during the debris flow to allow fish passage between Quesnel Lake and Edney Creek, a new channel was constructed.

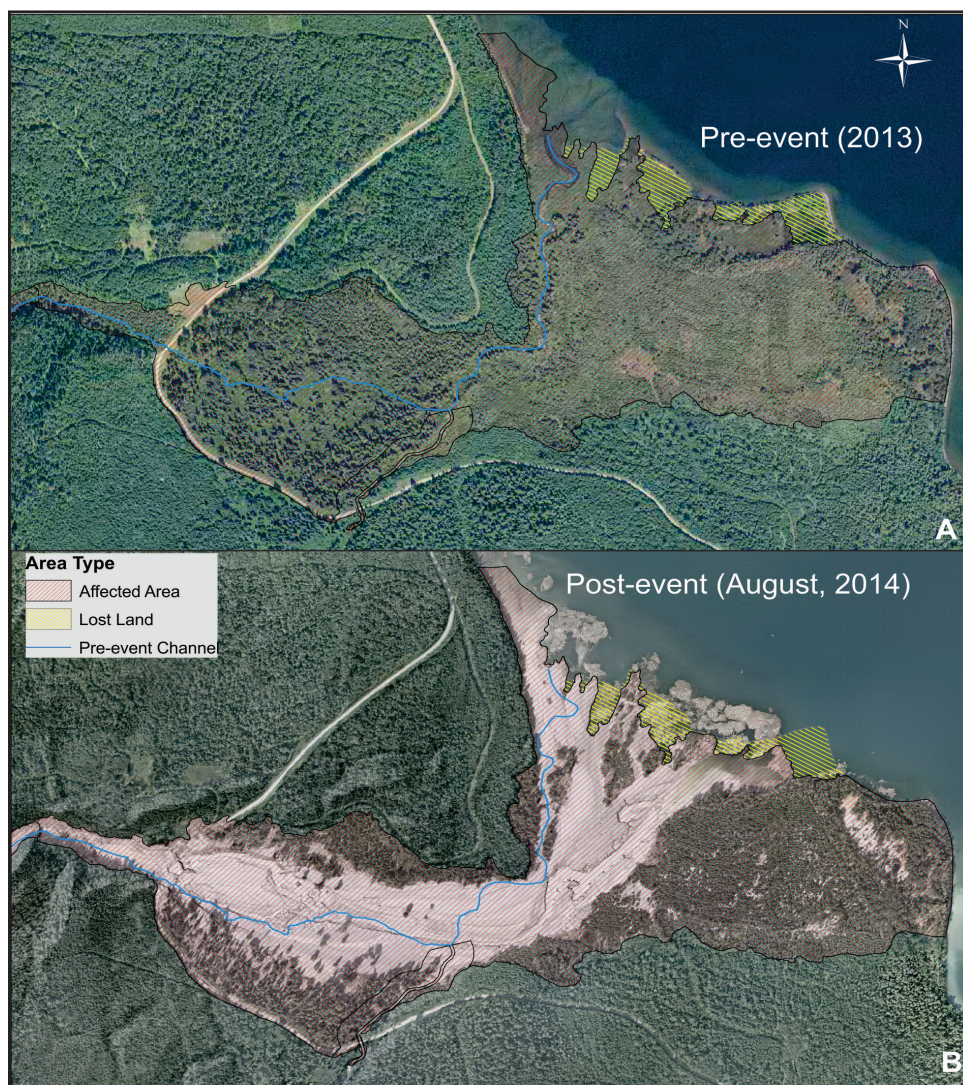
Figure 4: Pre- (A) and post-event (B) view of Hazeltine Creek delta

Water and tailings released from the dam failure created a debris flow that eroded the channel and floodplain of Hazeltine Creek. The area affected by the debris flow extends from the tailings dam downslope to Hazeltine Creek, upstream to Polley Lake and downstream to Quesnel Lake (Figure 4).

Following the dam failure, a thick deposit of tailings blocked the outlet of Polley Lake at the Plug area. Tailings deposits in this area near the dam failure location were the thickest, measuring > 3.5 m in some areas.

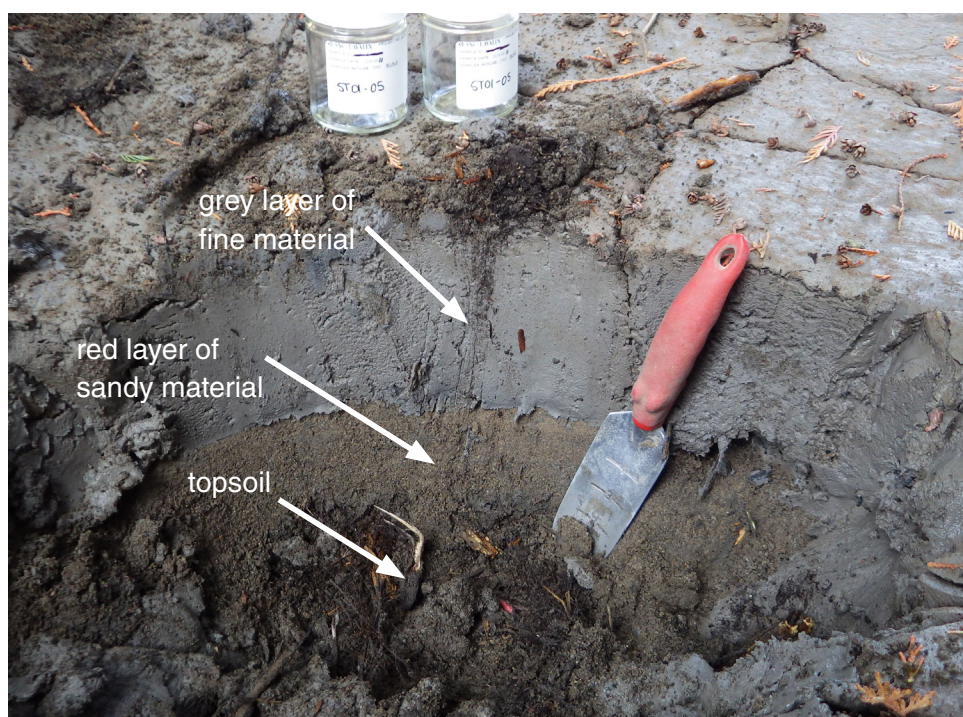
In some areas along Hazeltine Creek, the tailings settled in two layers over the native organic layer. The grey fine tailings settled out over the red-black sand. The concentrations of metals in the two layers were found to be similar.

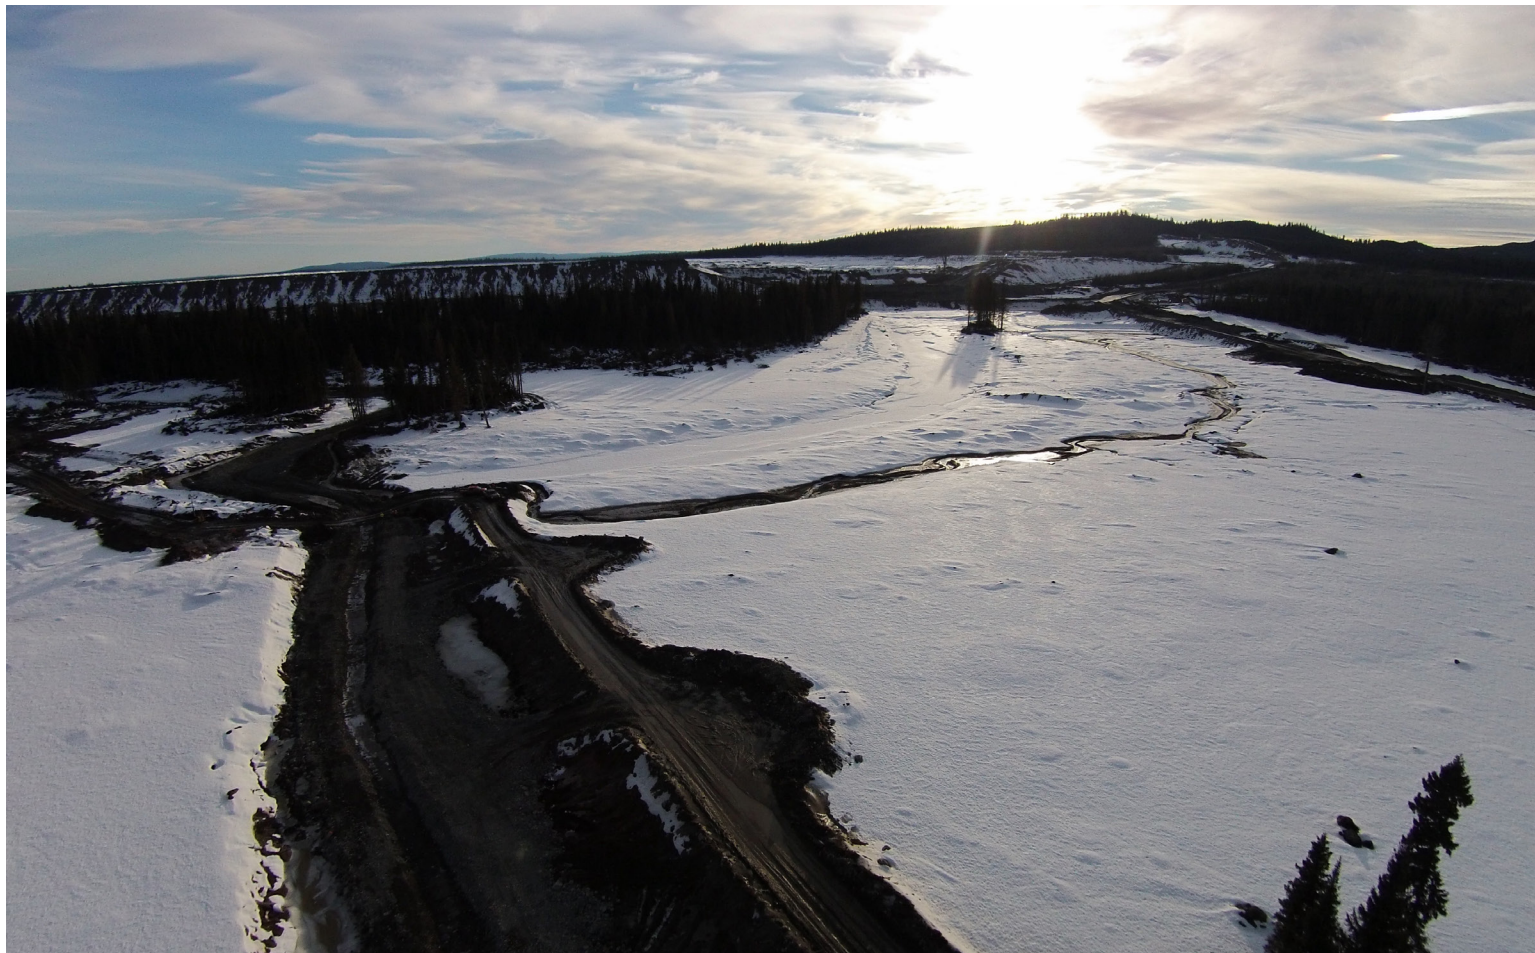
Reach 1 of Hazeltine Creek being constructed in the Polley Plug area

The physical conditions that were left immediately following the dam failure are no longer present. MPMC have been implementing their restoration and remediation strategy and have removed tailings and soil from Lower Hazeltine Creek, constructed the Hazeltine Creek bed, installed sedimentation ponds and corrected the connection between Edney Creek and Quesnel Lake to enable free movement of fish between these two aquatic habitats. The restoration work in these areas is ongoing and progress updates will be provided in the Long Term Human Health and Ecological Risk Assessment in Phase III of their Strategy.

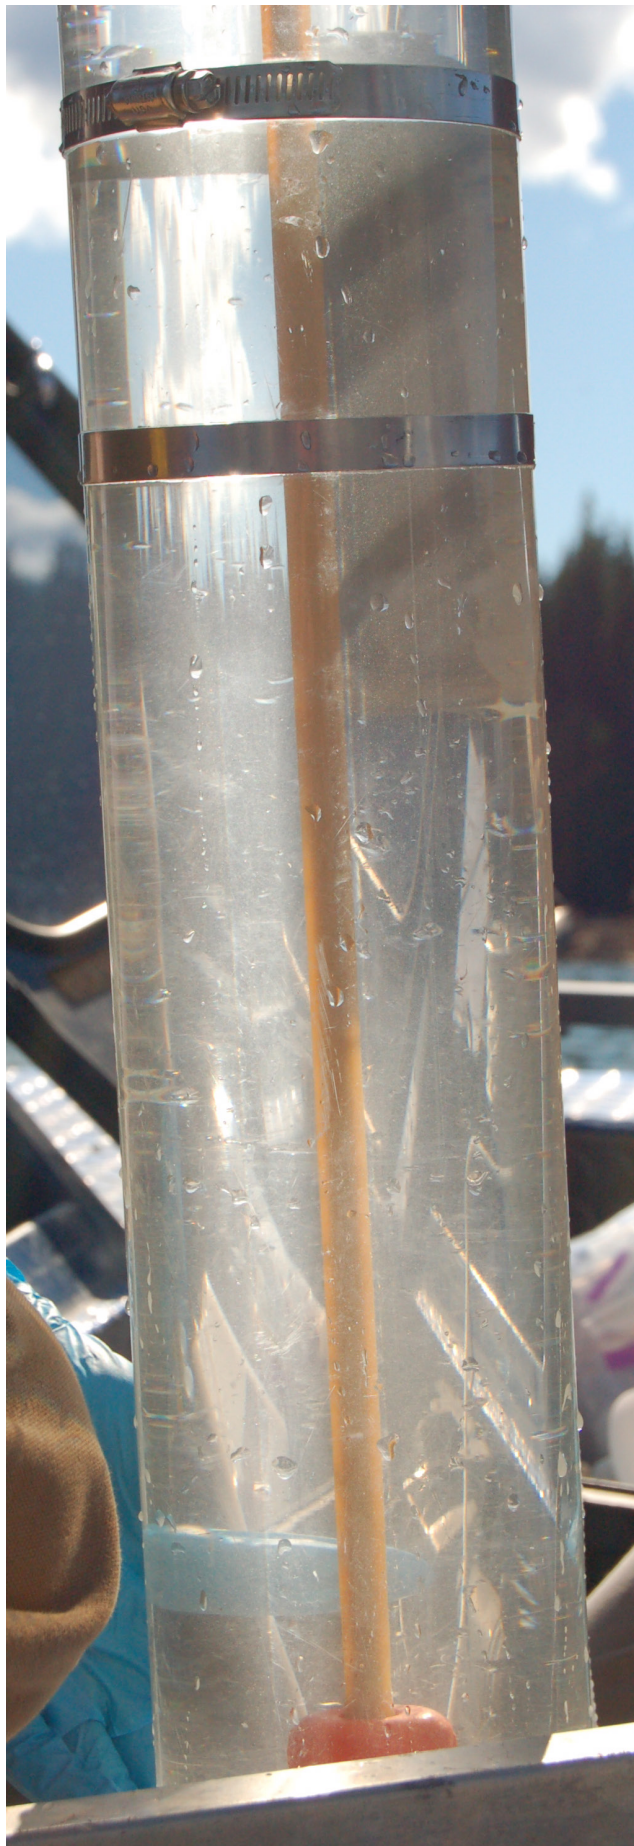
A sample of water collected from Quesnel Lake  
(September 4, 2014)

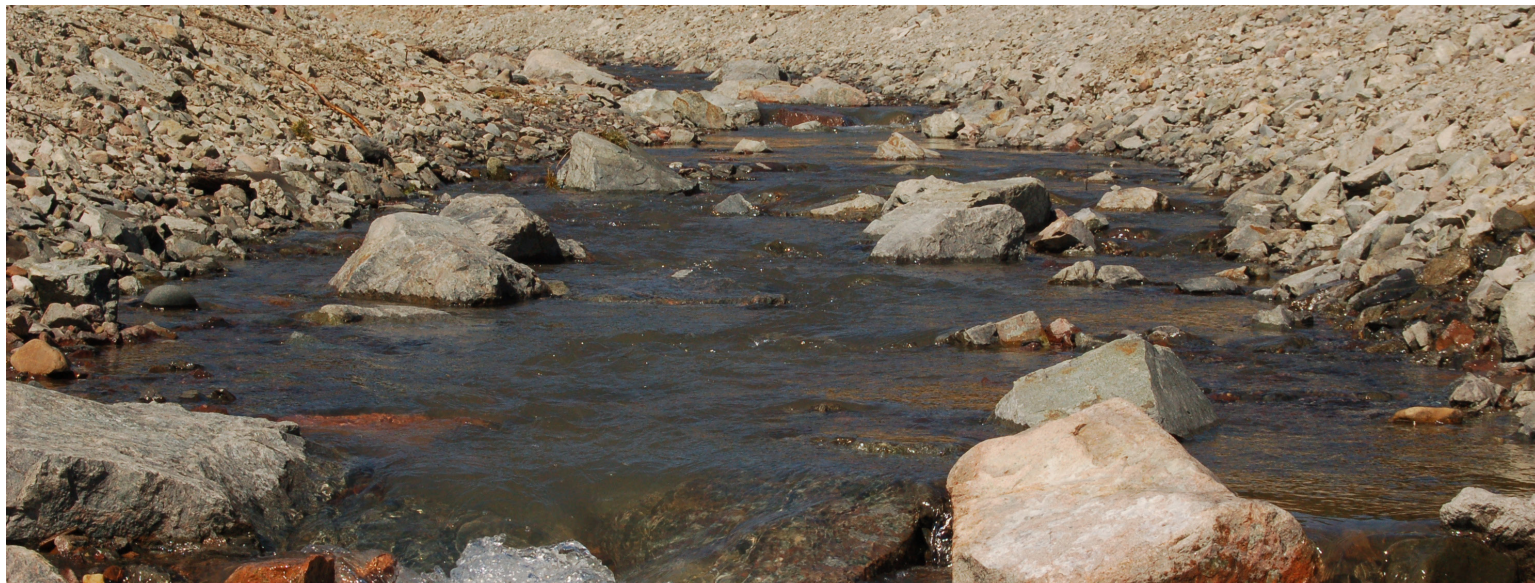
Lower Hazeltine Creek right after erosion control works in the channel had been completed. The water began to clear up quickly

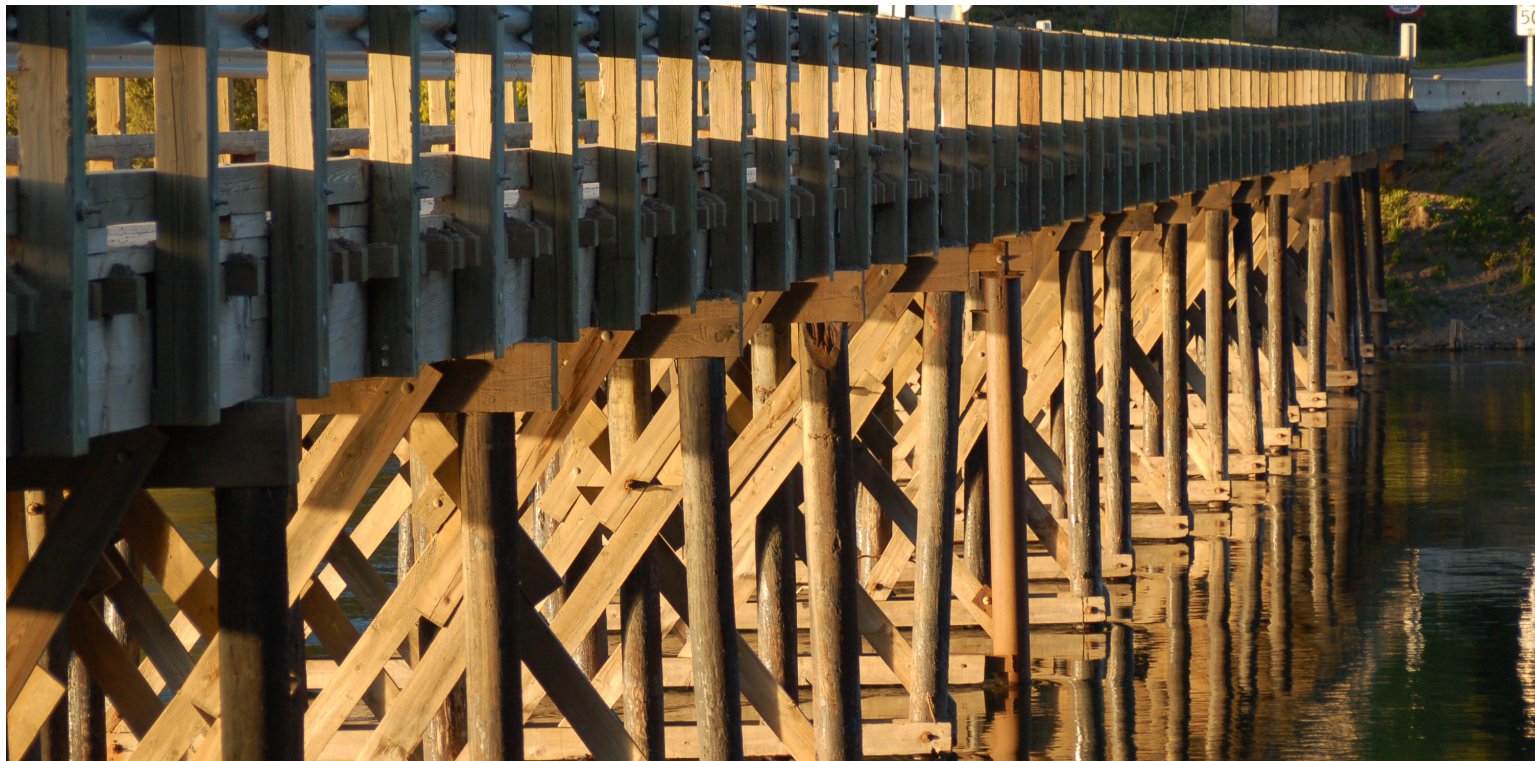
Turbidity of Quesnel Lake water flowing out at the Likely bridge on June 1, 2015 was 0.54 NTU. This water is in the range of background turbidities on record before the breach which ranged from 0.2 to 1.4 NTU

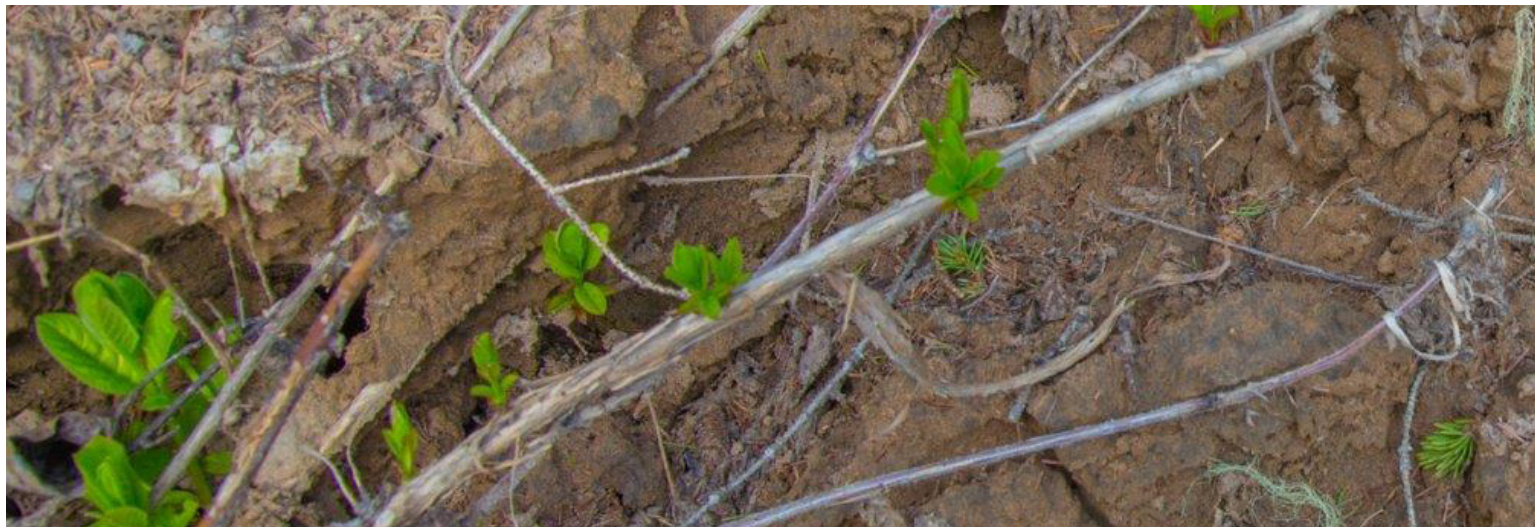
In the meantime, there were signs of new growth in some areas where tailings were deposited and willows planted as part of the Hazeltilde Creek restoration work have sprouted indicating that an adaptive succession has begun. The recovery of a healthy plant community will continue to be monitored.

New growth in the tailings impacted area along Hazeltine Creek - Apr 21, 2015.
