BC Ministry of Transportation and Infrastructure
Old Spences Bridge
2012 Inspection Report

2013 December 6

Our Ref: 2024-RPT-GEN-002-1

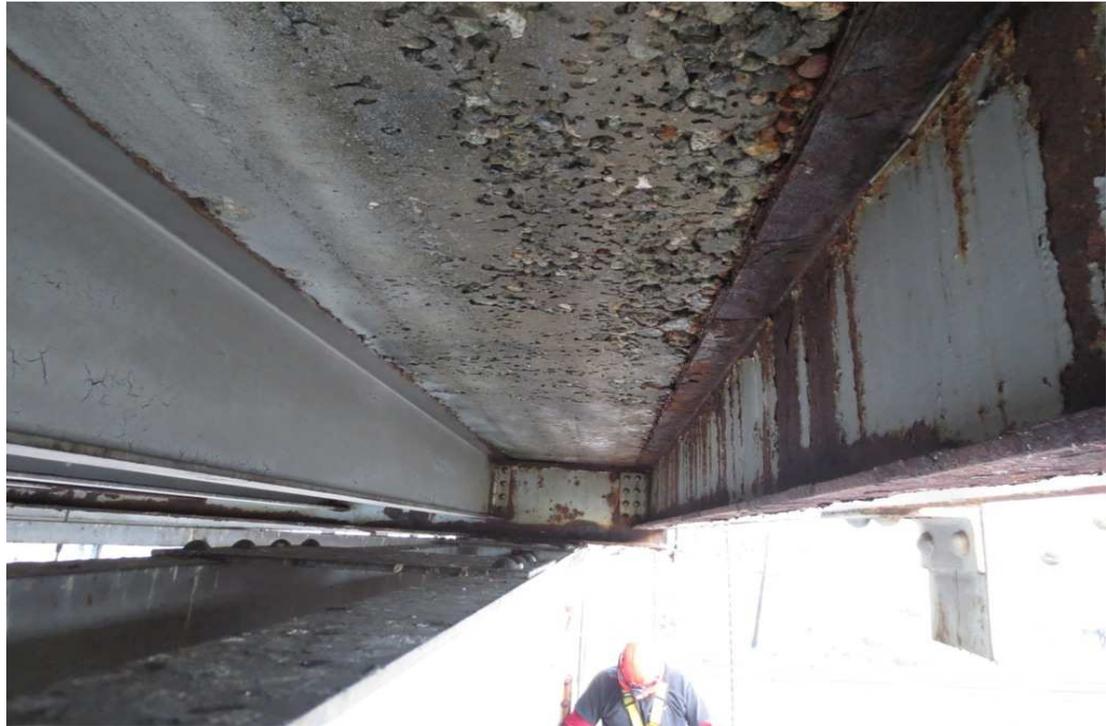
Figure 15: Variation in the Deterioration between a DS6 Interior Stringer and a DS7 Exterior Stringer (right) near FB10 in Span 4

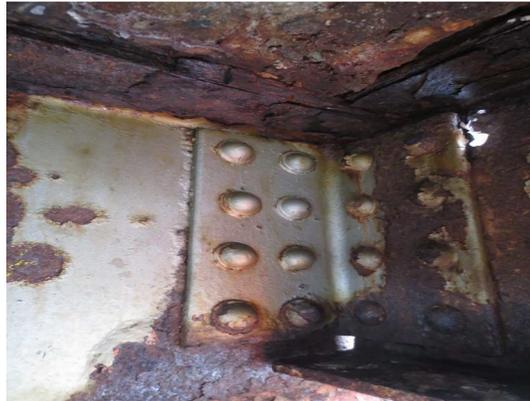
Numerous widespread areas of coating failure and surface corrosion were observed along many of the exterior stringers. As typical with all the stringers, the most notable deterioration was observed at the ends of the members; within approximately 100-200 mm (4-8") of the connection with the floorbeams. This deterioration has resulted in localized areas of section loss, including small perforations in the web on some members; refer to example shown in Figure 16 and Figure 17. Significant amounts of corrosion product build-up and associated section loss was also identified on the underside of the top flange and on the top and bottom surfaces of the bottom flange.

Figure 16: Inside Face of Exterior Deck Stringer DS7 at FB7 in Span 4

As outlined in the 2012 Updated Load Evaluation Report, the tolerable level of section loss is 50% of the web thickness over the entire web depth which is greater than the three locations identified and therefore repairs are not believed to be required prior to the end of 2013. However, if the bridge is to remain in service beyond the end of 2013 it is recommended that the stringers be repaired.

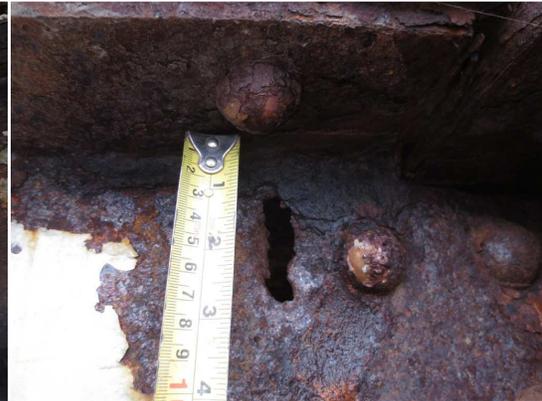
Figure 17: Outside Face of Exterior Deck Stringer DS7 at FB7 in Span 4

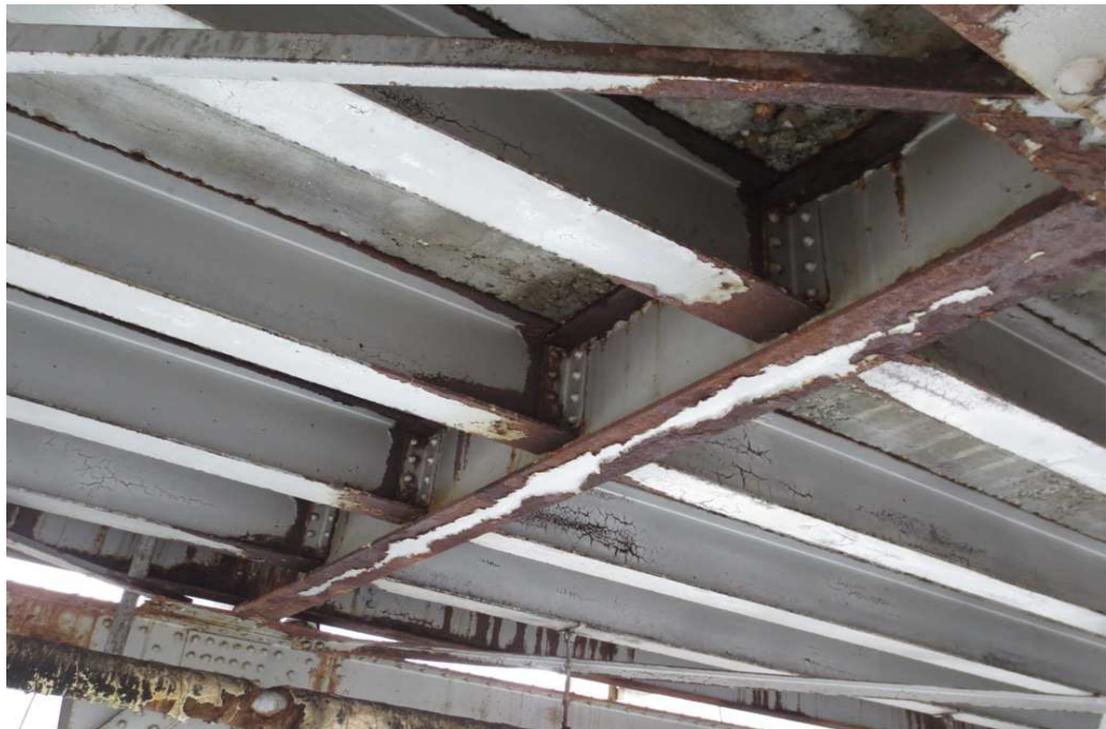
The majority of interior deck stringers were observed to have some coating failure and surface corrosion on the webs and flanges but are otherwise in good condition. Generally, the deterioration has occurred within approximately 100-200 mm (4-8") of the member ends at the connection with the floorbeams, as shown in Figure 18. This location specific deterioration is likely the result of water ingress from failed joint sealer in the deck above the floorbeams. The observed deterioration to the interior deck stringers was not advanced to the point of warranting immediate repairs.

Figure 18: Interior Deck Stringers at the South Face of Floorbeam 5 in Span 3, Exhibiting Minor Surface Deterioration at the Connections

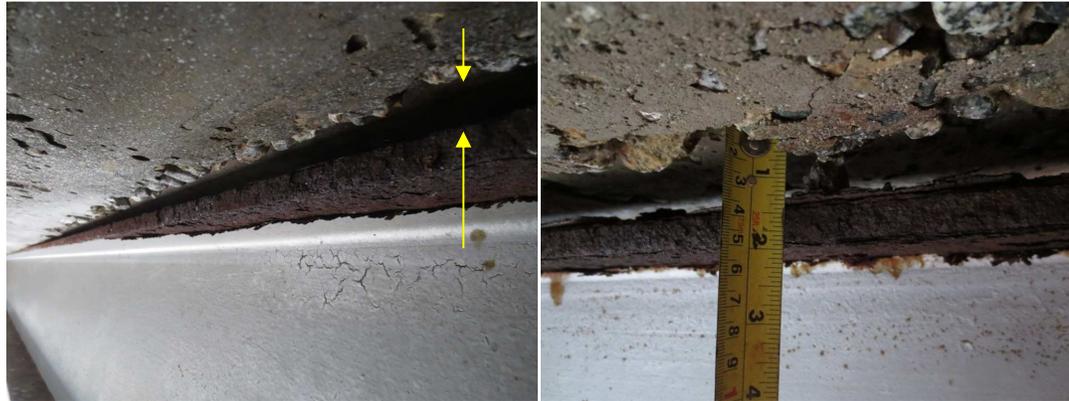
As noted in previous inspection reports, many of the deck stringers are no longer in contact with the underside of the concrete deck slab due to the formation of pack rust between the floorbeam top flange and the underside of the concrete deck. These expanding layers of corrosion have resulted in rust jacking of the deck such that there is a sizeable gap between the concrete deck and the longitudinal stringers in many locations (i.e. in several locations the deck is resting only on the floorbeams and not on the stringers), as shown in Figure 19 and Figure 20.

Figure 19: Gap above DS5 near FB10 in Span 4 **Figure 20: Gap above DS4 near FB2 in Span 2**

This effect reduces the dead load imposed on some stringers, while likely increasing it for those which remain in contact with the deck. This has also altered the behaviour of the concrete deck which was originally designed to span transversely, and is now having to span longitudinally; likely explaining some of the cracks on the top surface of the deck. This deficiency will have taken some time to fully develop and is not expected to become any greater an issue in the short term, therefore the rust jacking is not considered to be an immediate structural concern. However, it is recommended that grout be injected in the gaps between the deck and stringers in an effort to preserve the ride-ability and serviceability of the deck if the bridge is to remain in service beyond the end of 2013.

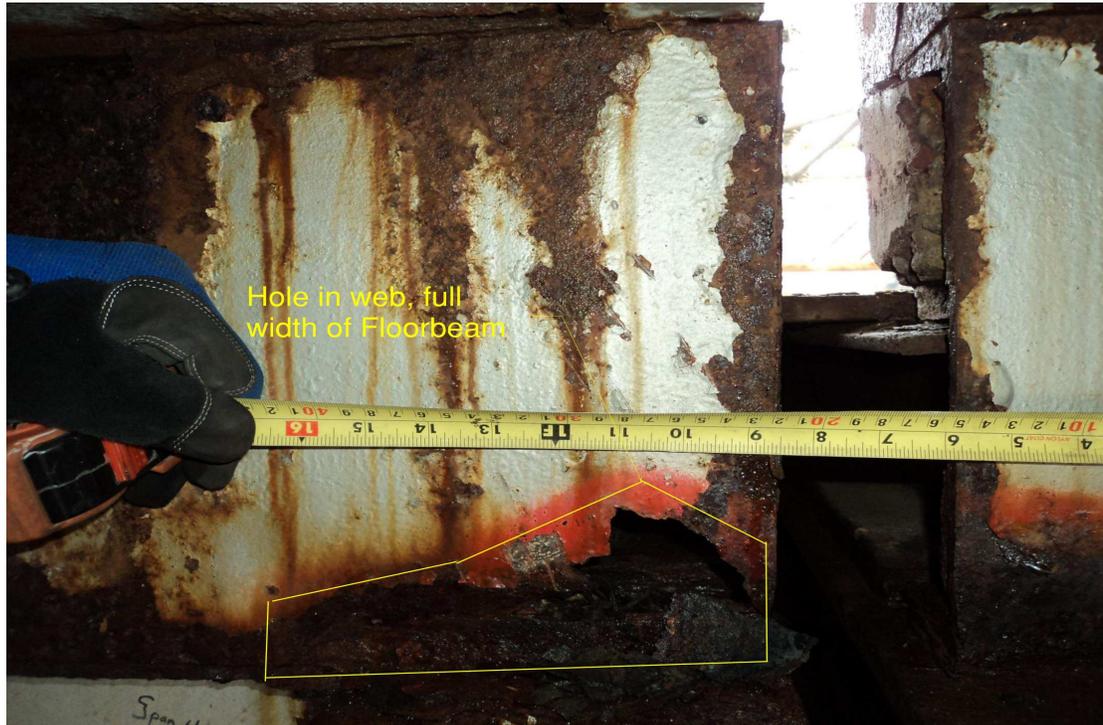
It was observed during the 2012 inspection that the sidewalk curb is cracked and spalled in numerous locations which is allowing water to run down on to SS3. The west side of the web of SS3 was typically observed to be covered in surface corrosion over large areas along its length with isolated areas of minor to moderate section loss identified in the web near mid-span. More significant areas of section loss and perforations in the web were observed in multiple SS3 stringers at the connection at the floorbeams, refer to Figure 21.

Figure 21: Typical Location of Perforations in the Sidewalk Stringer, as shown for SS3 at FB0 in Span 4

A summary of the condition of the sidewalk stringer ends that have notable deterioration is provided in Table 2. It is believed that Sidewalk Stringer SS3 is primarily a stay-in-place form and is not relied upon for carrying loads. Therefore the localised areas of section loss are not believed to be a concern at this time. Pack rust was also commonly observed between the bottom flange of SS3 and the top

flange of DS1. This pack rust has caused localized deformations in the top flange of DS1 but is not believed to be a concern. The SS3 stringer is supported along its length by DS1 and the localized section loss or local deformations are not considered to be an immediate structural concern in the short term. It is recommended that stringer SS3 be replaced at the same time as any planned rehabilitation of the deck stringers.

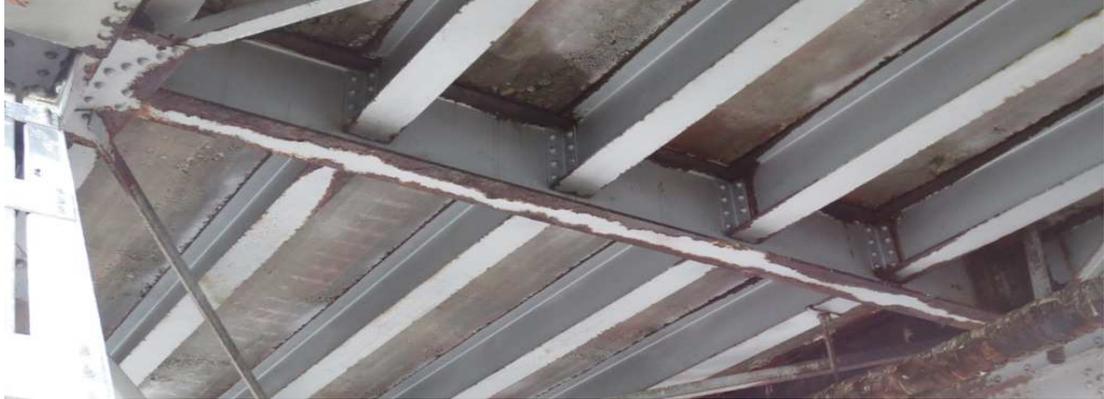
The inspection of the floorbeams throughout the truss spans of the Old Spences Bridge revealed that although the full length of the bottom flanges exhibit failure of the paint coating and surface corrosion on both the top and bottom faces, they were generally without significant deterioration in the form of section loss, refer to Figure 22. As such, the inspection findings can be focused on the condition of the top flange and the condition of the webs, which have the most significant deterioration.

Figure 22: North Face of Floorbeam 6 in Span 2; Typical Mid-Member Condition

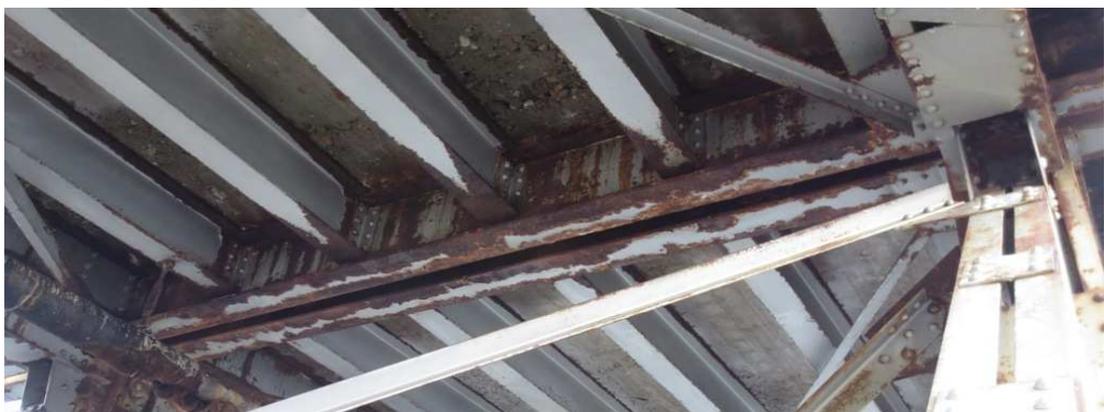
The deck joints located directly above each floorbeam are presumed to have leaked for many years, resulting in advanced deterioration of the top flange along the full length of the floorbeams, refer to Figure 23. This deterioration includes failure of the paint coating, moderate corrosion product on the underside of the top flange, and formation of pack rust on the top surface of the top flange, refer to Figure 24. As noted in Section 3.1.1.2, the accumulation of pack rust between the top flange and the underside of the concrete deck has resulted in rust jacking, which has lifted the concrete deck off of the stringers. While this jacking has resulted in the redistribution of forces and changes the demand on the concrete deck itself and some deck stringers, the floorbeams are required to support this load in either condition.

Figure 23: South face of Floorbeam 8 in Span 2; Most Extreme Mid-Member Condition (at Deck Joint)

During the 2012 Inspection, locations that were considered to be in a condition worse than 'typical' were cleaned to sound metal over a small area by removing all surrounding corrosion, and the flange thickness was measured to determine the extent of section loss. The measurement of the top flange thickness was made possible as a result of the rust jacking which has lifted the deck and exposed the top face of the top flange. The majority of the thickness measurements taken were between 10 and 12 mm. The most severe locations revealed that about 50% of the original thickness (8 mm) remains in a localized region. Given that the 2012 Updated Load Evaluation Report discussed an allowable loss in thickness of 48% to 52% across the entire width of the top flange it is believed that multiple floorbeams are approaching the permissible limits for section loss. If the bridge is to remain open beyond the end of 2013, it is recommended that these floorbeams be repaired.

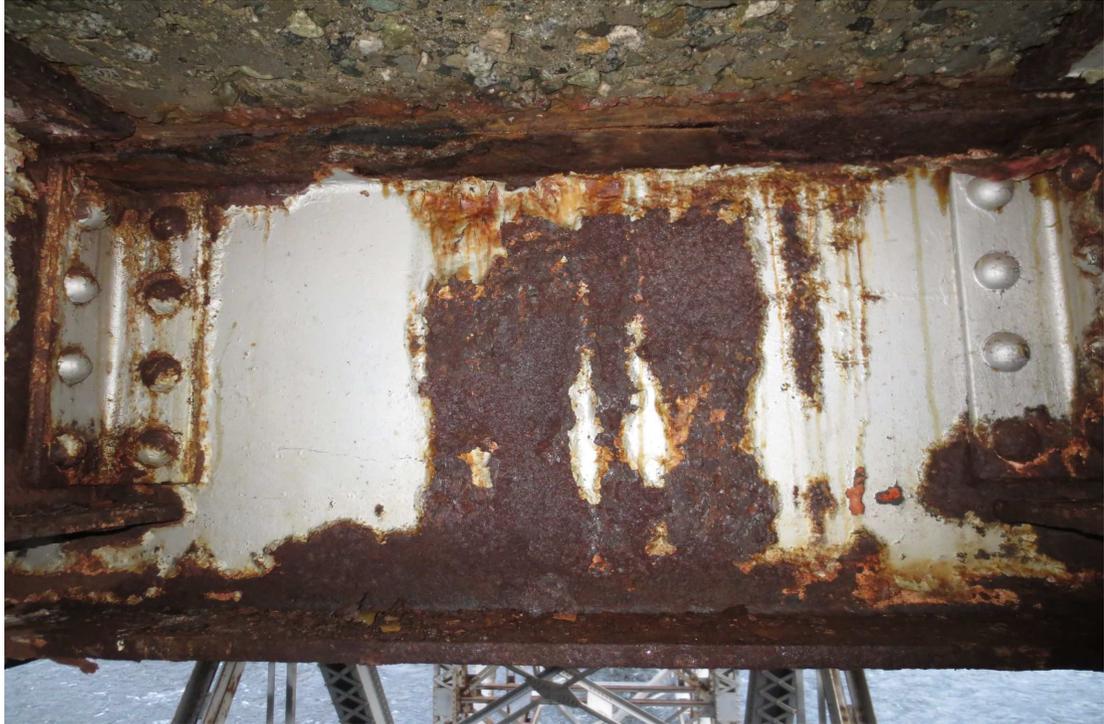
Figure 24: South Face of Floorbeam 8 between DS4 and DS5 in Span 3

In multiple isolated locations, the thickness of the pack rust on the top flange initially appeared to be equivalent to the thickness of the top flange, however, upon further investigation, it was discovered that the observed corrosion was in fact deterioration of a plate located on the top flange of several of the floorbeams. This top plate was not considered during B&T's load evaluation and the corrosion on the plate is not believed to be an immediate concern.

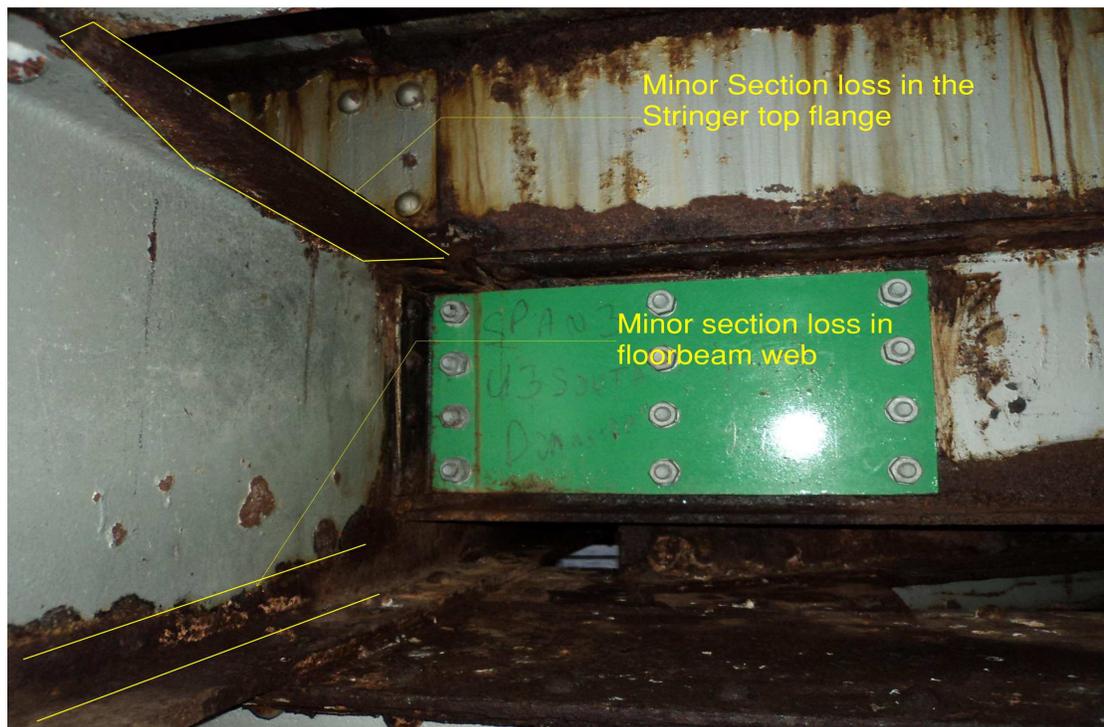
Areas of deterioration at the west end of the floorbeams were typically concentrated along the lower 50-100 mm of the web in the cantilever section where it is believed that water has migrated from leaking deck joints. The amount of section loss in these areas was typically 1-3 mm of thickness in the area of the web approximately 450 mm from the end, refer to Figure 25, which is well below the threshold value identified in B&T's evaluation.

Figure 25: Section Loss in the Flanges of FB2 above the West Truss in Span 3

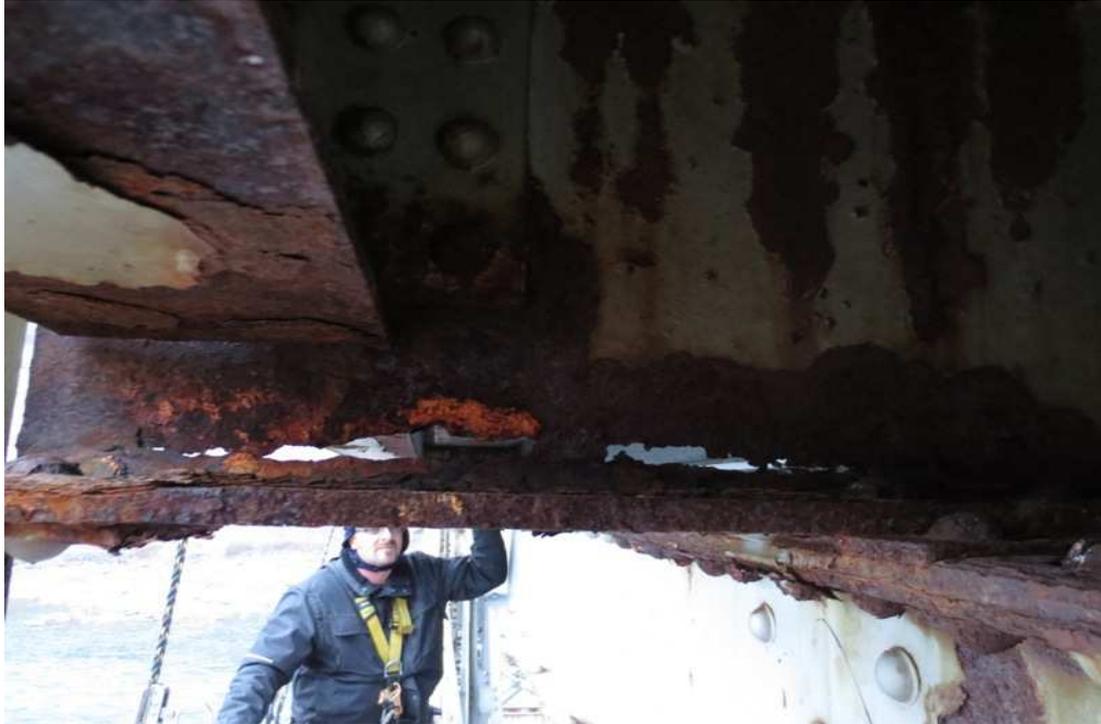
The section loss noted at Location Number 6 in Table 3 is shown below in Figure 26. At this location, the perforation and section loss extend to the top chord of the East Truss where there are significant shear requirements in the floorbeam and it is recommended that the floorbeams be repaired if the bridge is to remain open beyond the end of 2013.

Figure 26: Section Loss in the Web of the East End of FB4 in Span 4

The perforations observed in the webs of some of the floorbeams adjacent to the top chord reduce the shear capacity of the floorbeam and require more timely repair. While a failure of the floorbeam will not result in a collapse of the structure, it represents a safety concern for cars on the bridge and a potential serviceability issue. It is recommended that the floorbeams listed in Table 4 as well as floorbeam 4 in Span 4, refer to Table 3, be a prioritized repair if the bridge is to remain in service beyond the end of 2013.

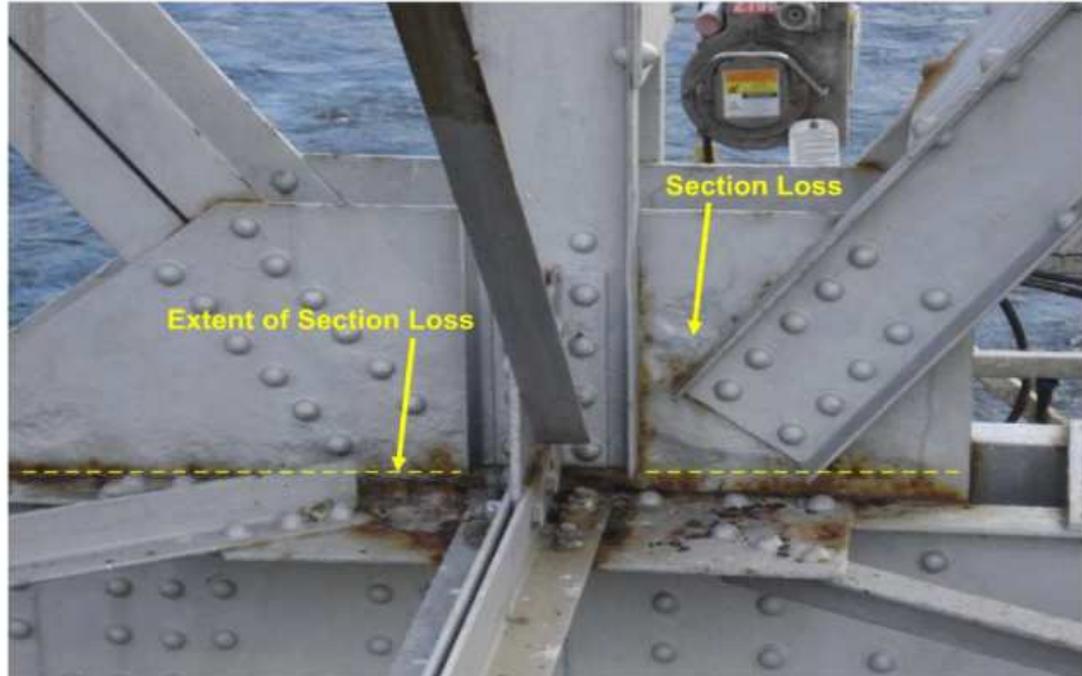
A corrosion pattern was identified at the even numbered bottom chord panel points in Spans 3 and 4. At these locations, the gusset plates connecting the vertical and diagonal members to the bottom chord were observed to have areas of section loss immediately above the level of the bottom chord top flange and in some locations extending up behind the Truss Diagonal, as seen in Figure 27. It is believed that the section loss was originally caused by the accumulation of moisture and debris in these locations, and perhaps the corrosion was not completely removed when repainted resulting in the continuation of deterioration and the corrosion staining observed today. In the majority of locations, the section loss was only noted on the interior gusset plate although areas of section loss were also noted in a small number of exterior gusset plates.

Figure 27: Typical Section Loss Observed along Bottom Chord Gusset Plates showing Extent to Section Loss above Level of the Top Flange and the Section Loss Extending up the Diagonal

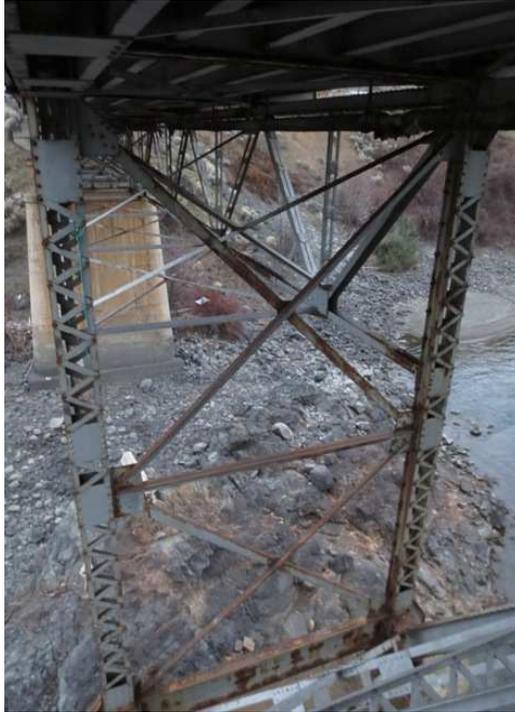
The vertical members in the truss spans were found to be generally in good condition with a small number of isolated areas of coating failure and surface corrosion observed.

Figure 28: General View of Vertical Members U0-L0 in Span 3

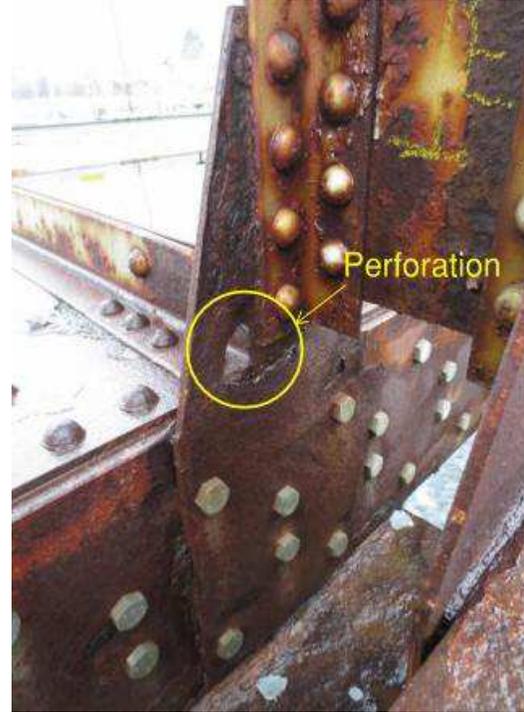
Figure 29: Perforation in Gusset Plate of L1E in Span 4

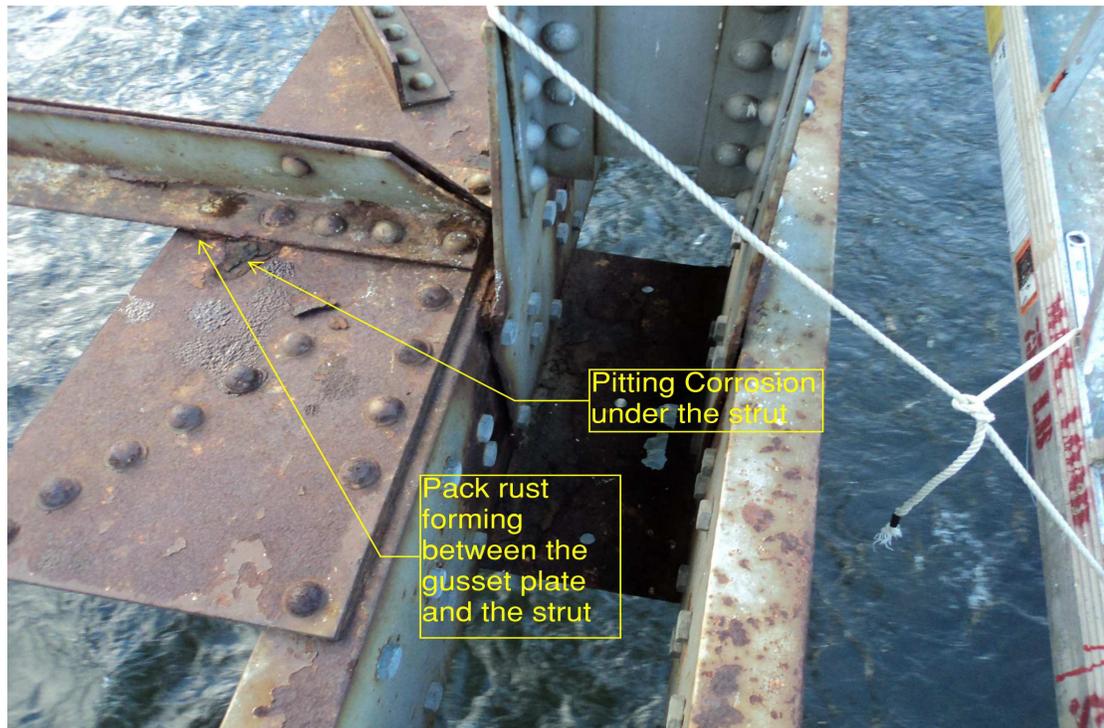
Figure 30: L9 Lateral Strut West Gusset Plate

4	Lateral Bracing between L9 and L10	The bracing has some isolated areas with surface corrosion.	No repairs recommended

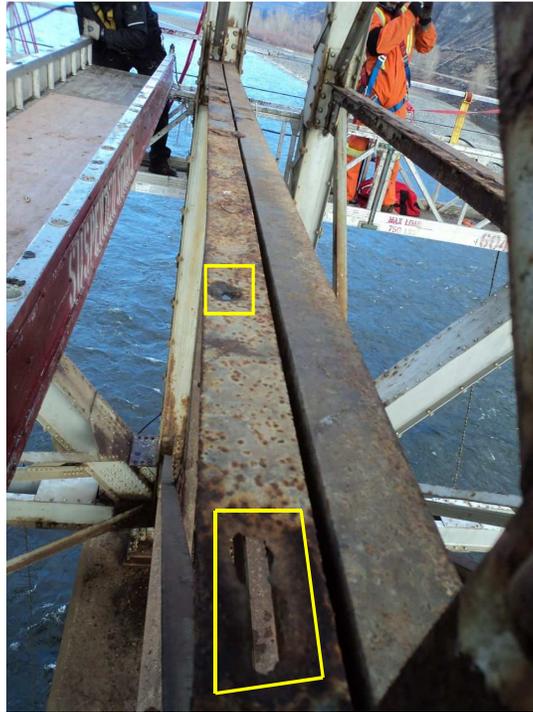
The general condition of the sway bracing members and gusset plates is fair, however many of the sway bracing members located directly below the deck joints were observed to be in poor condition. Coating failure and surface corrosion were widespread on both the members and gusset plates and numerous perforations were identified in both members and gusset plates, refer to Figure 31 and Figure 32. A list of locations where perforations were observed in the sway bracing members is included in Table 7.

Figure 31: Perforations in the Mid Height Strut Top Flange at PP0 in Span 4

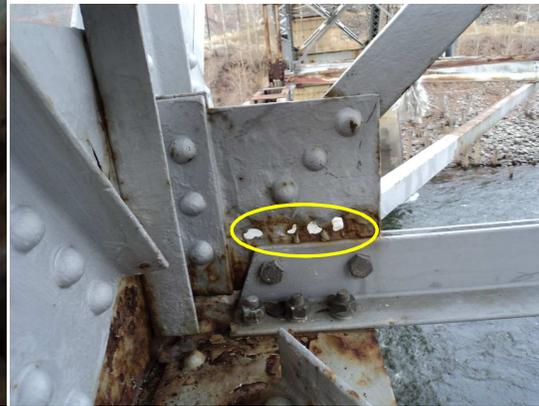
Figure 32: Lower Sway Bracing Gusset Plate at L6W, Span 4, with Four 20 mm Diameter Holes

- Replace the sway bracing gusset plate in Span 4; and,
- Repair the webs of three floorbeams in Span 4.

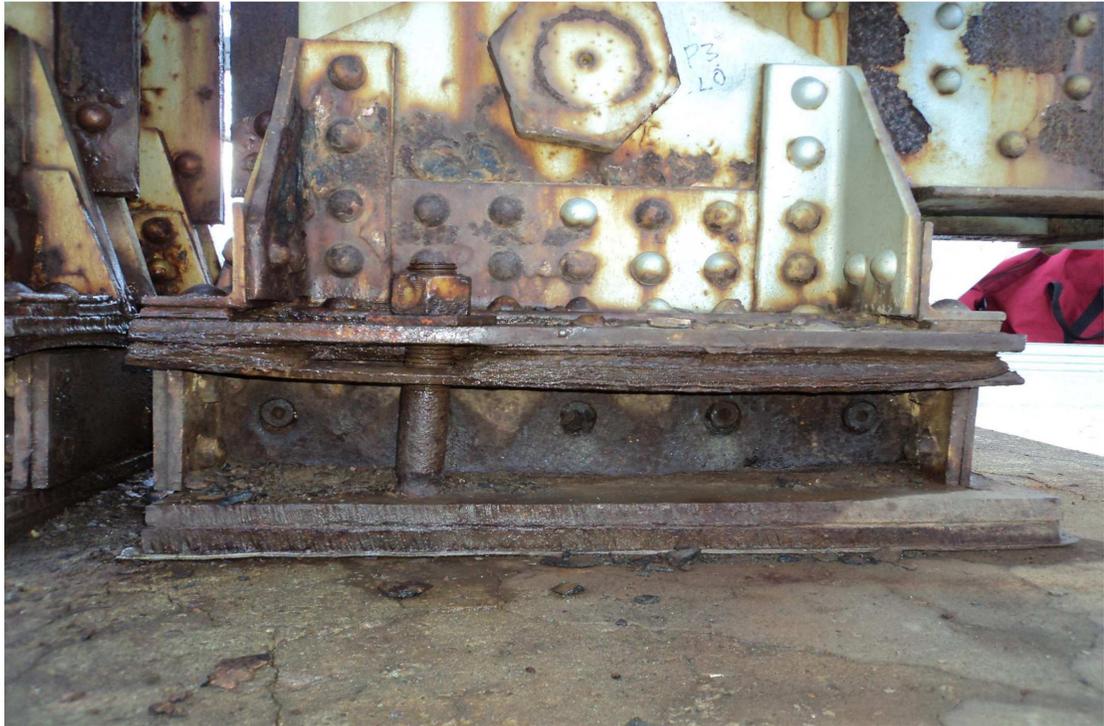
The roller bearings for the longer spans are located at Pier 3 and consist of a pin assembly located on top of a nest of five steel rollers, refer to Figure 33. Three anchor bolts, situated in slotted holes, connect the pin assembly to the bearing base plate and prevent uplift. The ends of the rollers are visible through holes in guide plates on either side of the bearings, although one of the rollers on the east side of the southwest bearing for Span 4 was found to have come out of the hole in the guide plate.

Figure 33: East Face of the West Bearing on Pier 3 for Span 4

All four of the roller bearing bases at Pier 3 (two for Span 3 and two for Span 4) were observed to be widely covered in surface corrosion and pack rust was identified between many of the plates in the bearing assemblies. No obvious signs of longitudinal movement were observed and there is a possibility that the bearings have seized, a theory supported by the undisturbed debris accumulations observed around the bearings. The washer beneath the northwest anchor bolt on the southwest bearing of Span 3 was found to be tight against the surface of the pin assembly bearing plate and this condition may restrict the ability of the bearing to move. The cracked top surface of Pier 3 may also suggest that the longitudinal movement of the bridge truss is being transferred into the pier.

For the short term, no repairs are recommended for the roller bearings at pier 3. However, if repairs are made to the concrete bridge piers it is recommended that the roller bearings be rehabilitated.

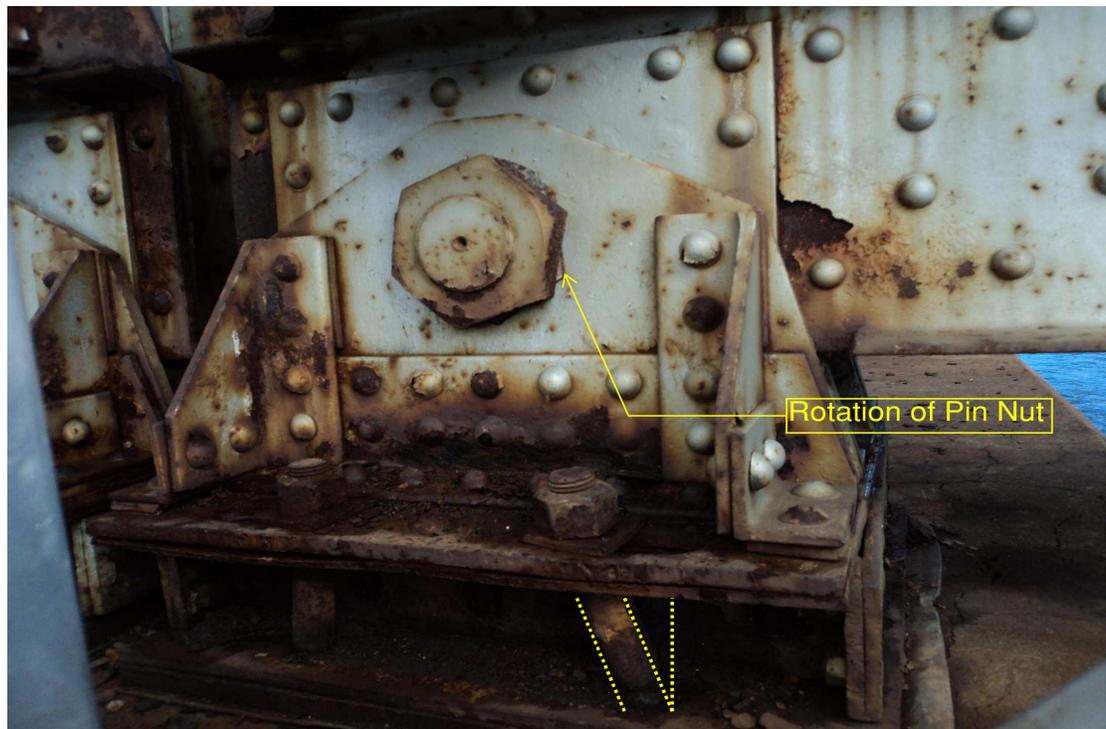
Figure 34: West Face of the West Bearing on Pier 3 for Span 3 - Rotation of the Nut Relative to the Truss Suggests Rotation

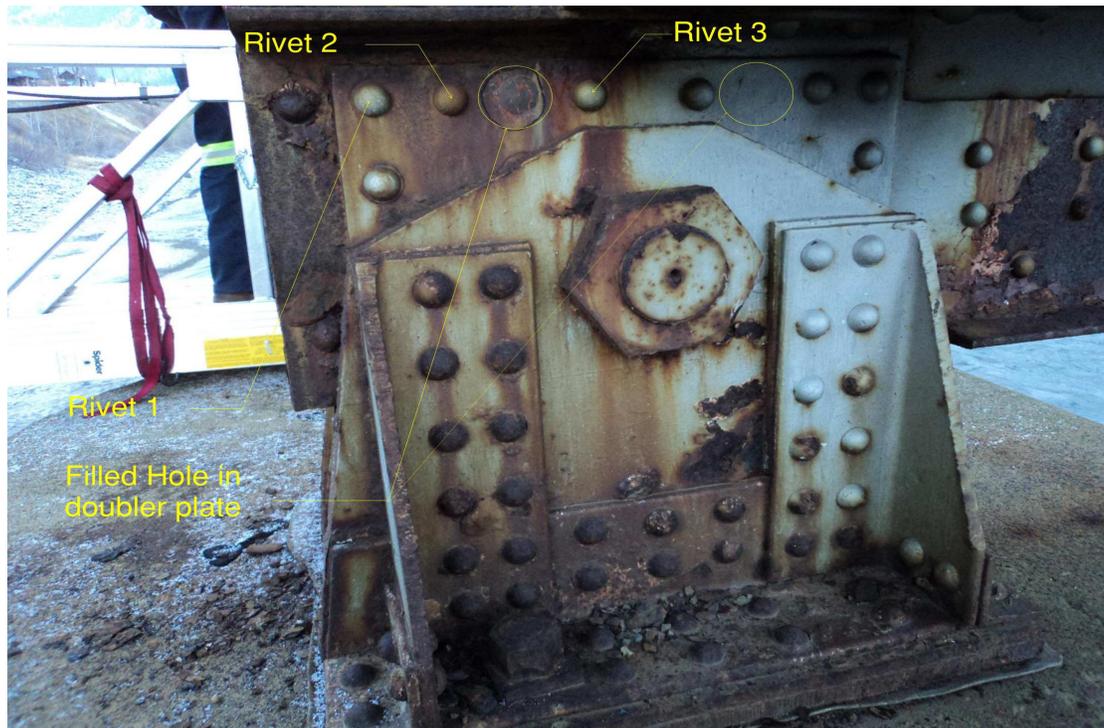
Although it appears that the bearings are seized from the 2012 Inspection, it is recommended that no repairs are required for short term use of the bridge as the flexibility of the substructure appears to be sufficient to accommodate the thermal movements of the structure. However, if repairs are made to the concrete piers, as discussed in Section 3.6, it is recommended that the roller bearings be rehabilitated to prevent the longitudinal forces being transferred into the superstructure.

Figure 35: East Face of the West Bearing at Pier 2 for Span 3
