**TRAFFIC OPERATION AND  
SAFETY REVIEW AT LEE  
ROAD AND HIGHWAY 19A  
PARKSVILLE, BC**

**INSURANCE CORPORATION OF BRITISH COLUMBIA  
MINISTRY OF TRANSPORTATION**

May 2007

H-08182.00

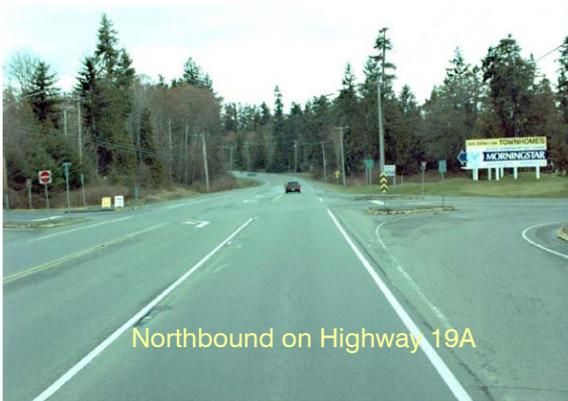
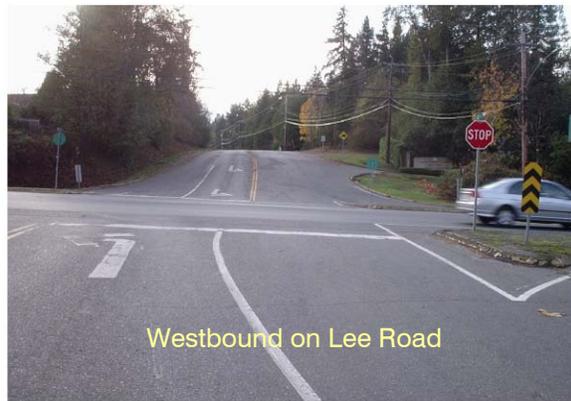
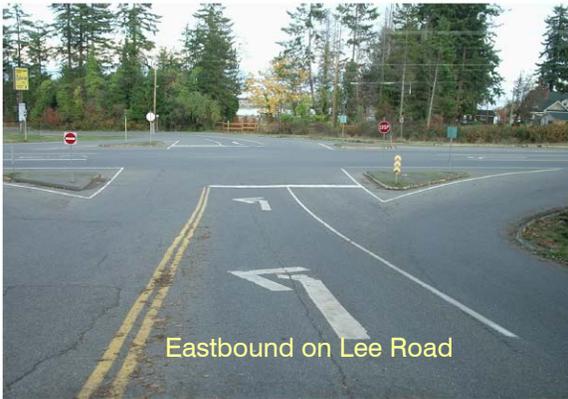
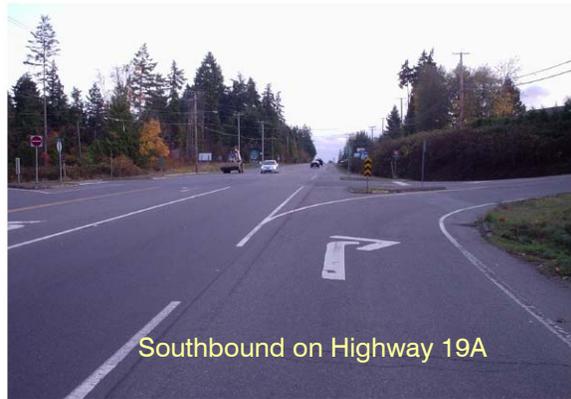
**FIGURE 2.1 PHOTOS OF THE STUDY INTERSECTION**

- Two lighting fixtures are provided at the study intersection with one at about midway of the right-turn deceleration lane on Highway 19A northbound and the other located distant from the ditch at the north-west corner of intersection. In general, the intersection provides low lighting conditions.

- A truck crossing / turning ahead sign is viewed on Lee Road when travelling to the west from the intersection.
- A curve ahead warning sign and an advisory speed sign of 60 kilometres per hour are provided on Highway 19A northbound and southbound for motorists to navigate the horizontal left-turn curve at about 100 metres north of the intersection.

- A large ferry guide sign is provided on Highway 19A southbound at about the beginning of the left-turn lane.
- Hazard markers to mark the start of the raised islands and no entry signs to warn the drivers from entering into the wrong traffic lanes are provided on all approaches to the intersection.

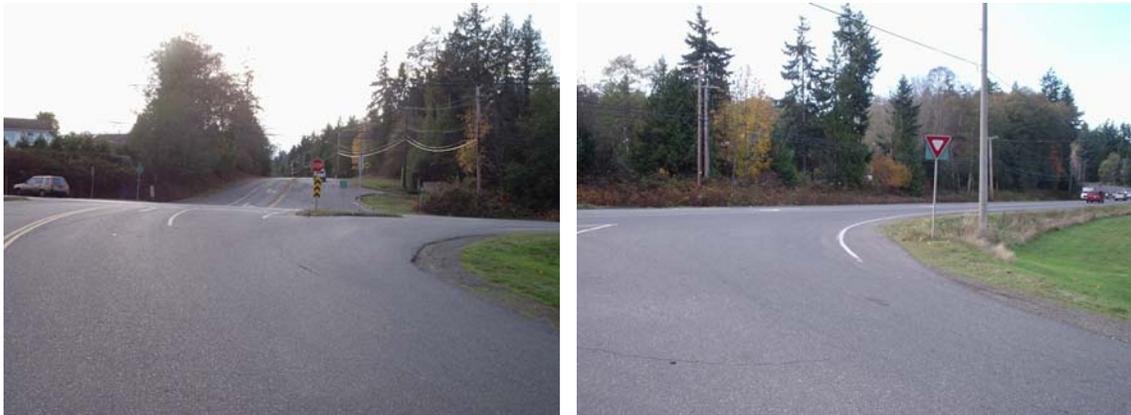
**FIGURE 2.3 APPROACHING HIGHWAY 19A FROM LEE ROAD WESTBOUND**

- The intersection and highway is generally visible when approaching uphill from the harbour on Lee Road westbound as shown in FIGURE 2.3.
- Vehicles from Lee Road westbound waiting at the stop line to merge into the mainstream highway traffic can be seen by approaching drivers in both northbound and southbound directions.
- The sightline distances, as shown in FIGURE 2.4, when looking south and north from the stop line on Lee Road westbound appeared to be adequate for drivers to enter or cross the highway with vehicles travelling at or near the posted speed limit. However, as is the case with many other intersections in the Province, if there are vehicles queuing in the left-turn lane on Highway 19A southbound or in the right-turn lane on Highway 19A northbound, the queues may block Lee Road drivers' views of through traffic approaching on the highway.

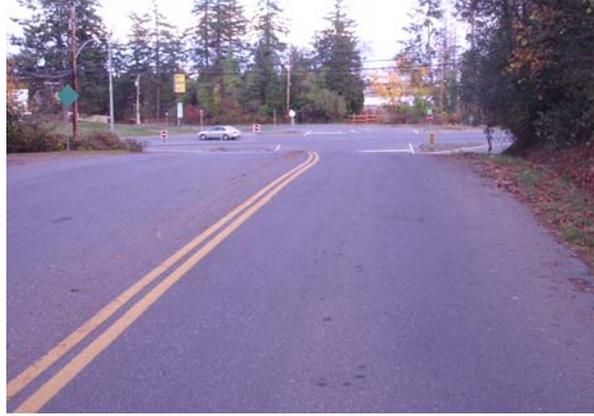
**FIGURE 2.5 APPROACHING HIGHWAY 19A FROM LEE ROAD EASTBOUND**

- Due to the downhill slope on Lee Road eastbound, the stop line and auxiliary lanes only become visible as vehicles get closer to the highway. The highway and the intersection are visible as drivers approach the intersection as shown in FIGURE 2.5.

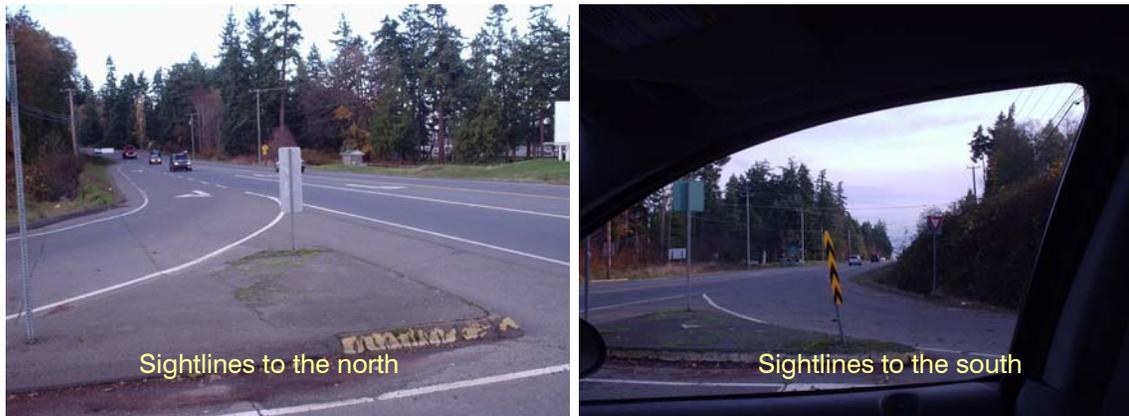
**FIGURE 2.6 SIGHTLINES FROM LEE ROAD EASTBOUND**

- The sightline distances when looking north and south from the stop line on Lee Road eastbound, as shown in FIGURE 2.6, are generally adequate for drivers to enter or cross the highway with vehicles travelling at or near the posted speed limit under good visibility conditions. However, sightlines to the north may become more critical when conditions are less than ideal as they are limited by the horizontal curvature and roadside vegetation. Also, as is the case with many other intersections in the Province, Lee Road drivers' views of through traffic approaching on the highway could be blocked by the left-turning queues on the northbound and right-turning vehicles on the southbound.

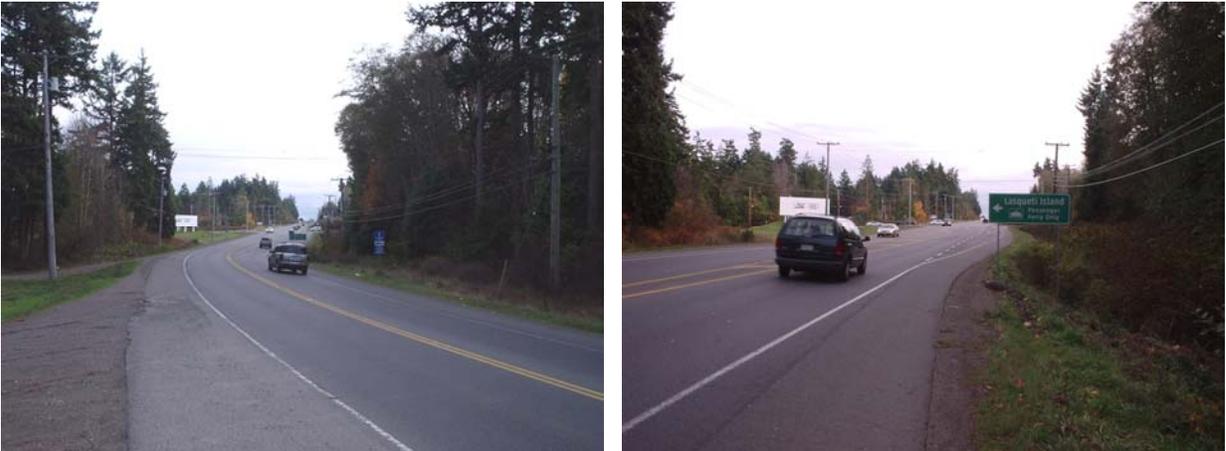
**FIGURE 2.7 APPROACHING THE INTERSECTION IN SOUTHBOUND DIRECTION**

- The intersection first appears in the field of vision as drivers approach the horizontal curve section on Highway 19A southbound, as shown in FIGURE 2.7.
- The ferry guide sign may momentarily obscure drivers' visibilities of vehicles coming out from Lee Road eastbound at certain approach positions.

- x. Provide animal crossing warning signs on all approaches;
- xi. Trim roadside vegetation; and
- xii. Relocate the large ferry guide sign on Highway 19A southbound further north or overhead in order to minimize the interference with the sight lines.

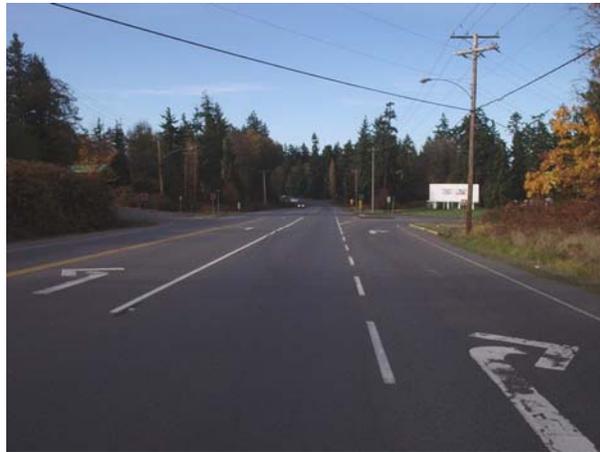
**FIGURE 2.8 APPROACHING THE INTERSECTION IN NORTHBOUND DIRECTION**

- Motorists when approaching the intersection in northbound direction, as shown in FIGURE 2.8, have good and unobstructed visibility of the intersection and vehicles coming out from Lee Road. However, the right-turn deceleration lane which leads to a sharp turn onto Lee Road is not clearly discernable.

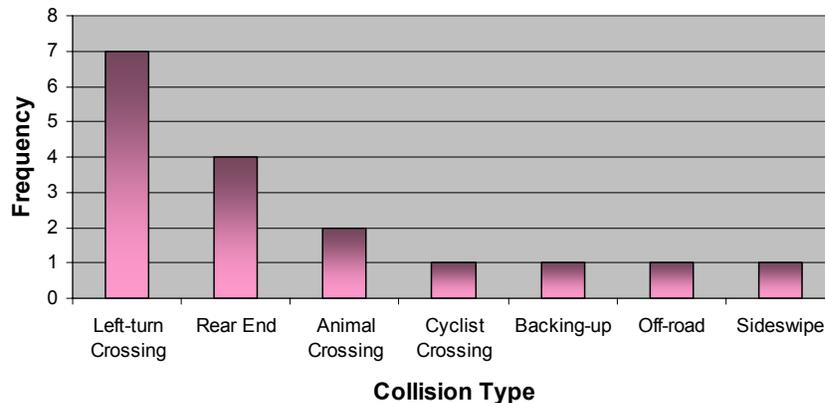
**FIGURE 3.1 DISTRIBUTION OF COLLISION TYPE**

As can be seen from FIGURE 3.1, left-turn crossing collisions were dominant (7 out of 17) at the study intersection followed by rear-end collisions (4 out of 17). Most of these left-turn crossing and rear-end collisions are related to vehicles exiting from the French Creek Boat Harbour on Lee Road westbound. Other collision claims involved animals and a cyclist crossing in the vicinity of the study intersection, backing-up for a sweeper truck when making a right-turn onto Lee Road, losing control of vehicle due to the icy road condition, and sideswiping when pulling out from side of the highway.

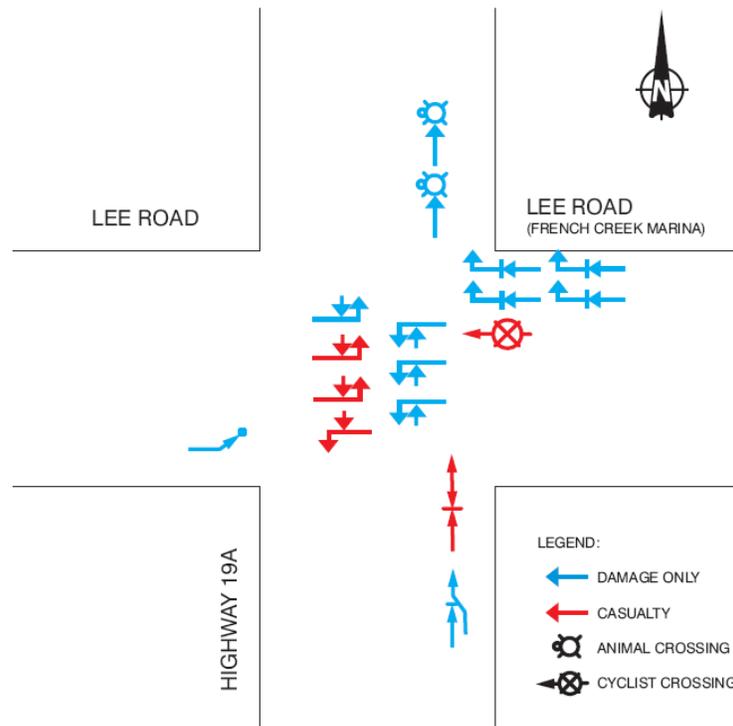
FIGURE 3.3 SPATIAL DISTRIBUTIONS OF COLLISIONS

The reported 17 collisions at the study intersection during the study period were plotted spatially and are shown in FIGURE 3.3. However, some of the incident descriptions as contained within the given set of ICBC claim records are vague and incomplete; hence, some logical assumptions on the approaches, orientations, and types of collisions were made by Opus Hamilton in plotting out the data.
