BC DAM SAFETY ANNUAL REPORT

2012/2013

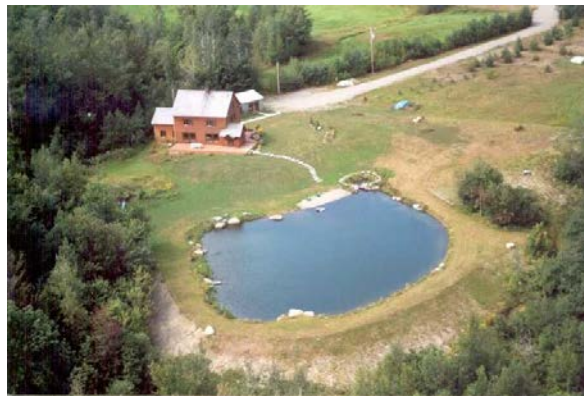
3. *Consistent oversight and regulation of all water related structures (Recommendation #11)*: With the expansion in the oil and gas industry in northeastern BC, dugouts are proliferating. Water is being stored in dugouts to be sold later to gas mining companies for fracking purposes. These structures are not currently licensed. The Ministry of Environment together with MFLNRO are currently developing policy around dugouts for the storage of water. These dugouts may have dam-like properties which can be a dam safety issue (Figure 1).

Figure 1: A dugout pond which has a dammed slope on one side.

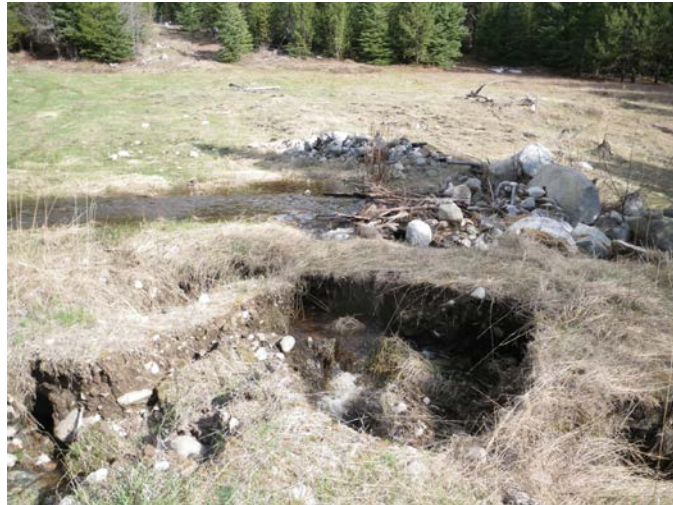
1. *North Nine Mile Creek dams:* On May 10, 2012, three unauthorized dams previously discovered on March 29, 2012 on private property were visited by MFLNRO staff. The first dam had impounded approximately 1000 m³ of water and had large sinkholes on the dam crest (Figure 8).

Figure 8: Large sinkholes on crest of one North Nine Mile Creek dam.

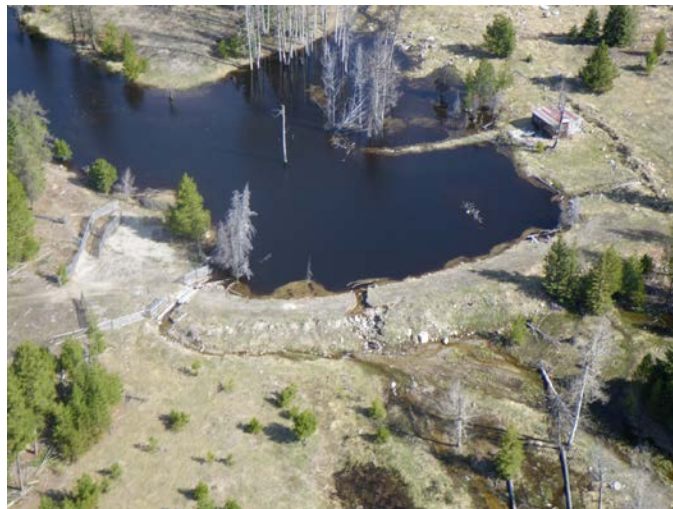
The second dam impounded 10,000 m³ of water and had a large breach recently created at the centre of the dam crest as a result of internal erosion due to gopher activity (Figure 9).

Figure 9: Aerial view of a large breach on another North Nine Mile Creek dam.

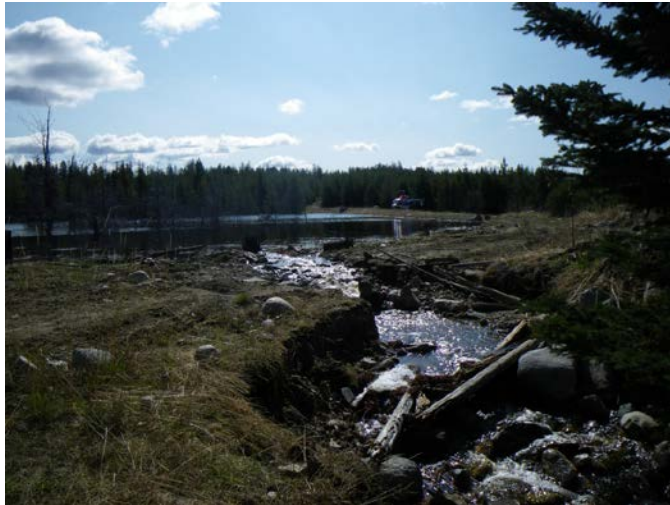
The third dam, the largest of the three, was overtopped in 5 locations but the breach was clearly evident on the western end where erosion of the abutment had also occurred (Figure 10). Heavy rains and above average temperatures exacerbated erosion conditions leading to partial breaches of the three dams. Immediate action was taken on the second dam with the construction of a relief spillway and continued excavation of the breach on the western end of the third dam. On May 15, 2013, a controlled breach was performed on the second dam when the water level behind the dam was low enough. As a safety measure, the owner was also directed to maintain another foot of freeboard by lowering the reservoir level behind the third dam.

Figure 10: Breach of the western end of the third North Nine Mile Creek dam.

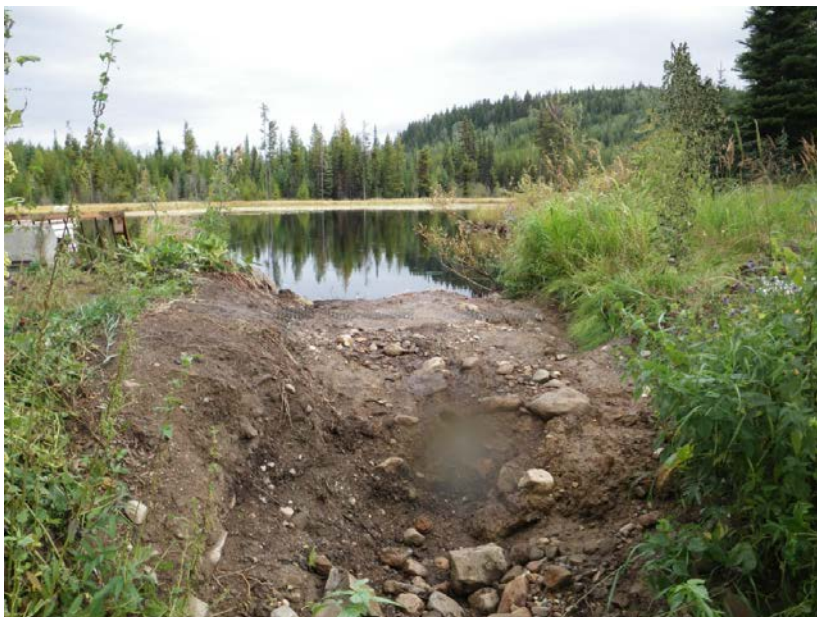
2. Knox Lake and Weddell Lake dams - During the audit of these dams located east of Kelowna near McCulloch Reservoir on September 10, 2012 by staff, these earthfilled structures were discovered to have been breached (Figures 11 and 12). Freeboard was inadequate for both dams. To stop the breach from progressing due to overtopping, a tarp was initially used by the dam owner to cover the breach. MFLNRO are following up with the dam owner on an alternative strategy to deal with the dam.

Figure 11: Partial breach of Knox Lake.

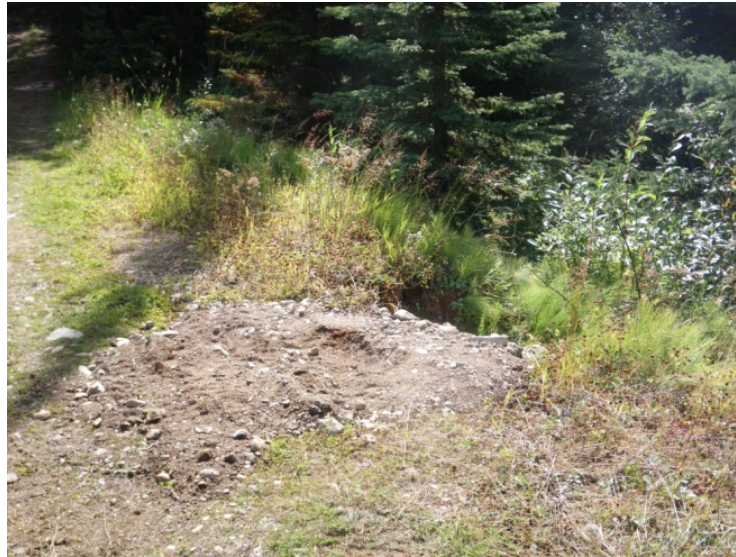
Figure 12: Evidence of overtopping on crest of Weddell Lake dam

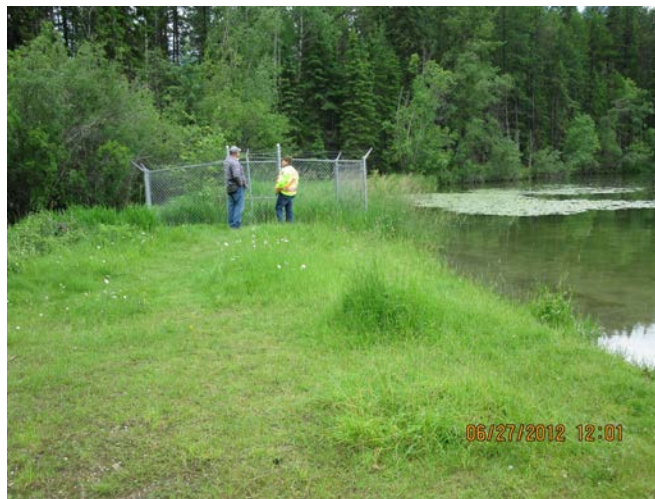
2. *Tie Lake Dam:* On June 27, 2012, MFLNRO, Ministry of Transportation and Infrastructure (MOTI) and Regional District of East Kootenay staff visited Tie Lake dam and the dikes near Jaffray as the reservoir had only 5" (12cm) of freeboard and the water level was rising (Figure 13). MFLNRO staff recommended appropriate monitoring frequency, techniques to apply to prevent wave erosion, and clearance of debris and vegetation in culverts downstream of the dam. The Regional District was informed that emergency and evacuation plans were needed to assist emergency response personnel and the residents in the immediate area and beyond in case the Tie Lake Road be overtopped, and flooding occur downstream in residential areas. MFLRNO advised that a professional engineer was needed to assess the safety of the dam especially the lack of freeboard and spillway capacity.

Figure 13: High water level of the Tie Lake reservoir

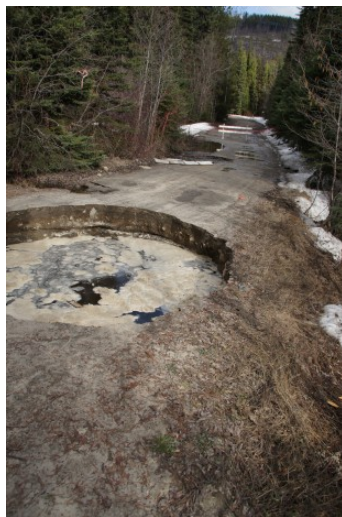
2. *Chute Lake Dam*: On April 27, 2012, due to heavy rainfall from the previous day, reservoir inflows exceeded the capacity of 4 culverts on the Elinor Forest Service Road located just 10m downstream of the dam which is located south of Kelowna. This resulted in the road impounding water from the reservoir to an approximate height of 0.6m above the dam. Significant internal erosion of the road and creation of sinkholes in the road threatened to cause a sudden release of 200 acre-feet of water into Ratnip and Chute Creek, which placed numerous downstream properties at risk (Figure 14). Twenty four hour monitoring of site conditions and ultimately removal of a section of Elinor road defused the situation. This is considered a 'no dam incident' because at issue were the Forest Service Road culverts and the road itself, not the dam.

Figure 14: Sinkhole in Elinor Forest Service Road.

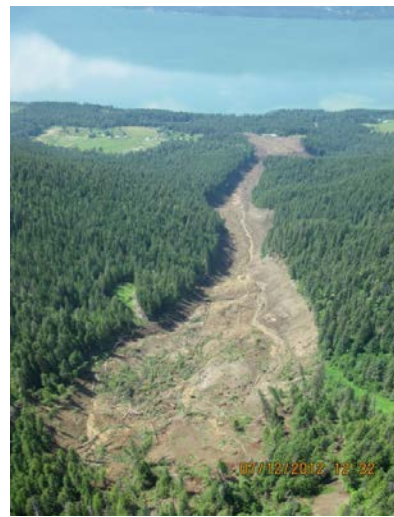
4. *Johnson's Landing*: On July 12, 2012, initial reports suggested that torrents bringing down large boulders on Gar Creek near Johnson's Landing was due to the failure of a dam. Regional MFLNRO staff from the Nelson office inspected the site and verified that the dam was located on a different stream and was not the cause of the torrent. The debris torrent was a landslide (Figure 15).

Figure 15: Landslide near Johnsons Landing.
