Bedrock Geology of the South Island Aggregates Stebbings Road Quarry

Kirk Hancock, B.Sc., P.Geo.
BC Geological Survey – Energy, Mines and Natural Gas
Province of British Columbia

30 October, 2012

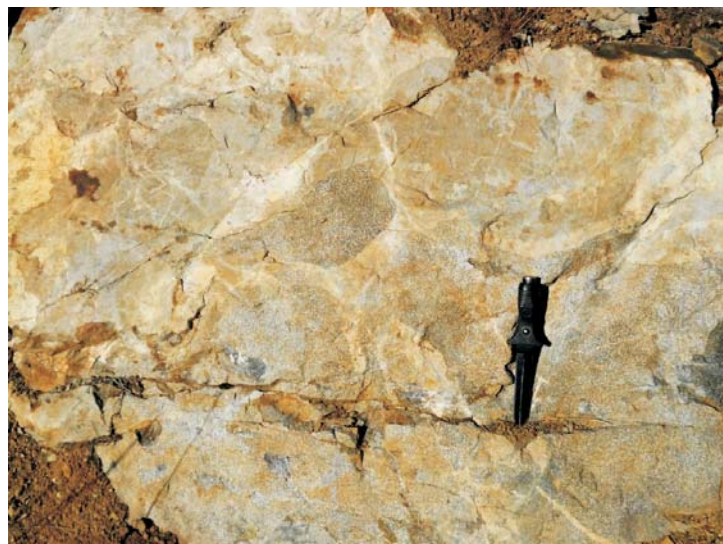
Photo 1:

Showing the variable texture of Wark Gneiss complex. Note contrasting coarse and fine grained material. Knife is 30 cm long.

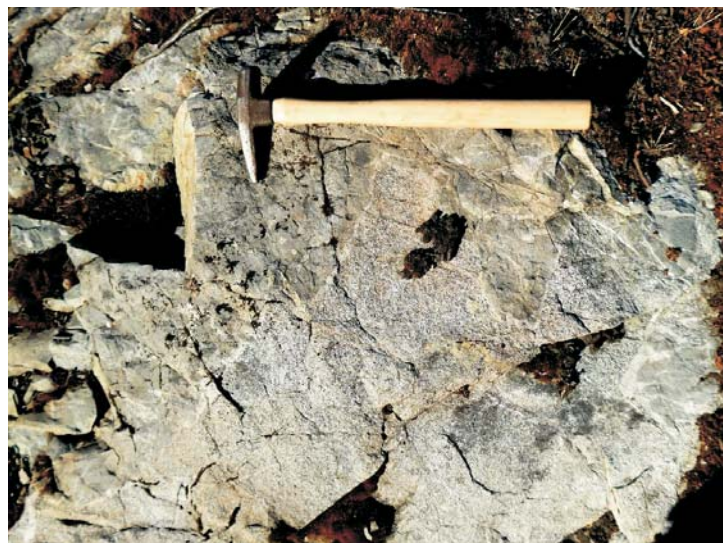
Photo 2:

Showing blocky weathering along fracture planes [upper left corner of image] plus compositional segregation [right of image].

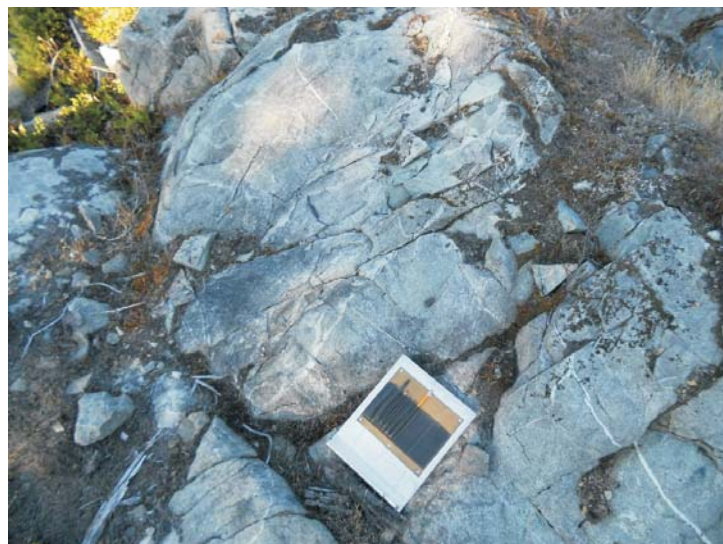
Photo 3:

Showing a typical weathered outcrop of massive gneiss with veinlets, fracture planes and compositional variation.

Outside of the active quarry, fractures are difficult to see. Generally, weathered surfaces show a thin tracery of lines that criss-cross each other (Photo 3). Spacing of sub-parallel fracture lines is typically on the 10 cm scale. However, when struck the rock does not necessarily break along the visible lines, leaving jagged faces. Weathering has accented the lines of fracture and some outcrops show blocky breakage that mimics the fracture pattern (Photo 2). Elsewhere, mostly at the southeast corner of the property, some glacial plucking of down-ice faces along fracture planes is present, though again, is poorly developed.

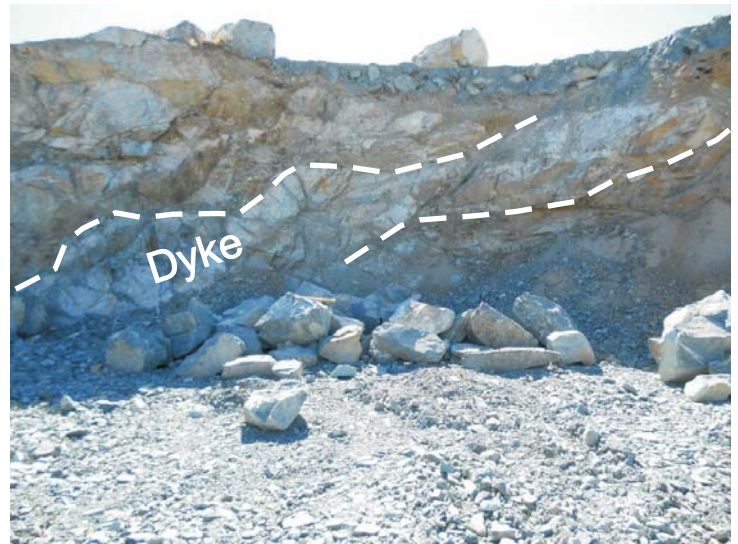
Photo 4:

The pale green diorite forms dykes that cross cut the gabbro and dark green diorite. A shallowly-dipping ($120^{\circ}/20^{\circ}$) one metre thick dyke is exposed in the south pit face (Photo 4). Adjacent to the dyke, a relatively wide (5-20 cm) baked contact is developed in the host. At the contact with host diorite / gabbro, a broken zone of biotite/chlorite/hornblende, 5 – 20 centimetres wide is present. The edge of the dyke has numerous thin fingers extending into the host rock, and the amount of apparent alteration increases adjacent to these fingers.

Showing low angle dyke [outlined] in gabbro host. Face is approximately 8 metres high.

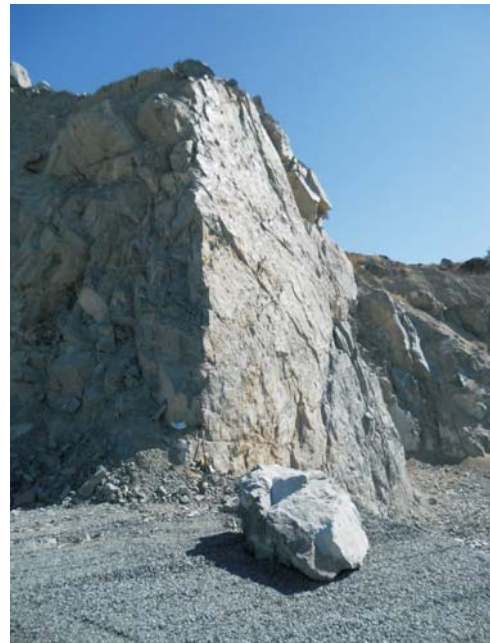
Photo 5:

Rocks in the quarry break along fractures over limited distances when struck with a hammer. Large faces created by blasting are developed only along chlorite-filled fractures (Photo 5); otherwise, the rock breaks across fracture lines. Similarly, examination of blast rock indicates breakage across sparse filled fractures and numerous faces where the rock has broken across fracture planes. Anecdotal evidence from SIA staff supports the observation that the rock is both hard to break and does so in a mostly irregular pattern. Hence rock breakage appears to be only minimally controlled by fractures.

Showing large blast face and fracturing

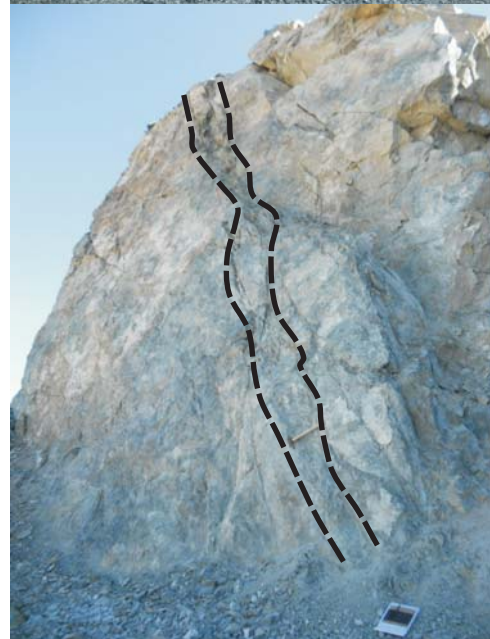
Photo 6:

A northeast-trending, moderately dipping ($055^\circ/68^\circ\text{SE}$) brittle shear zone, 30-50 cm wide is exposed along the pit face at Station 5 (Photo 6). It consists of an anastomosing network of fractures separating broken rock fragments that are set in a clay matrix and partially cemented by

Blast face with brittle shear zone outlined. Hammer for scale, across shear.

calcite. The material within the shear zone is broken and there is evidence of open spaces, but the open volume was not quantified.

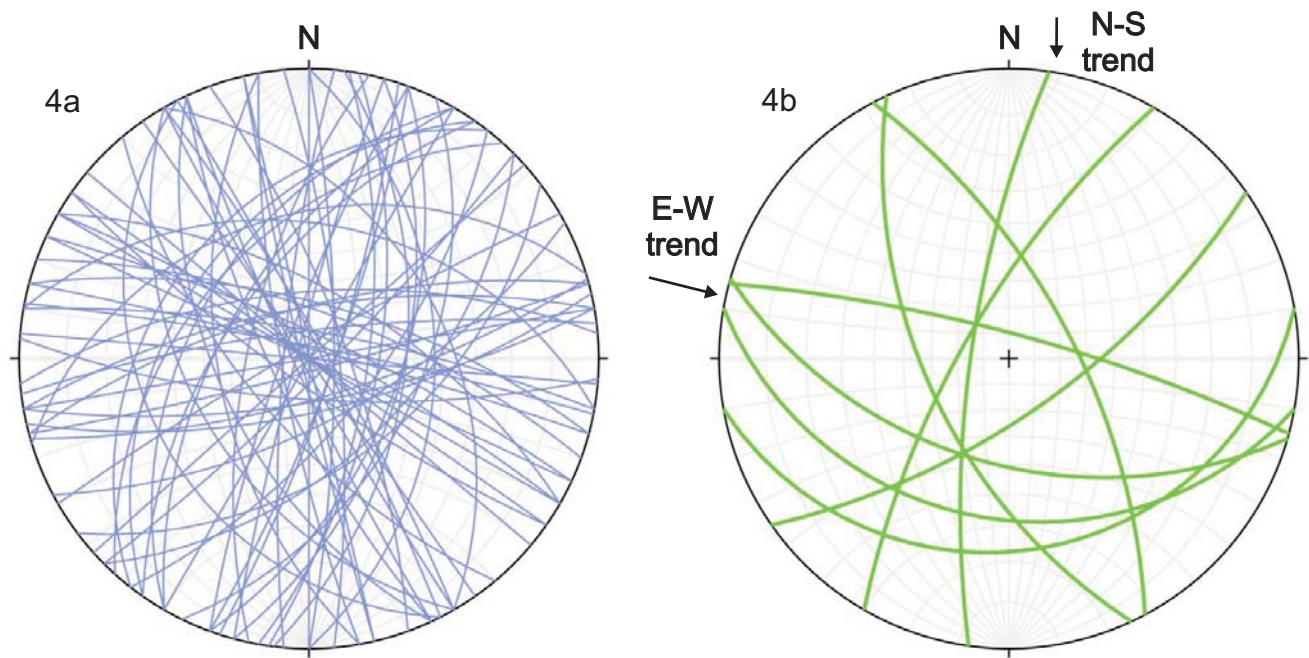
Figure 4: Stereonets showing fracture planes.
4a) "tight" fractures. 4b) "filled" fractures.

Measurements of tight fractures failed to indicate preferred orientations (Fig 4a). Combining sparse data of filled fractures and fractures with slickensides, suggests a vague pattern (Fig. 4b) with a roughly east-west group and a more north-south group. The general high dispersion of fracture orientations is consistent with a massive, intrusion-like bedrock body that has experienced multiple episodes of deformation over geological time.

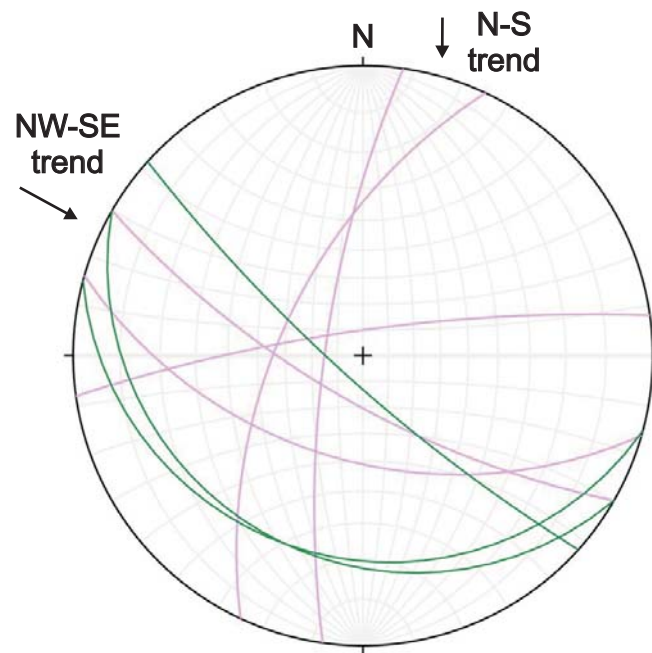
Figure 5: Stereonet showing dyke and vein planes.
Green planes - dykes. Pink planes - veins.

Dykes and veins suggest two groups of trends: one west-northwest/east-southeast and the other north/south (Fig. 5). The west-northwest trend may reflect the regional structural trend of the gabbro block that the SIA quarry sits within. However, the number of measurements is inadequate to draw definitive conclusions.

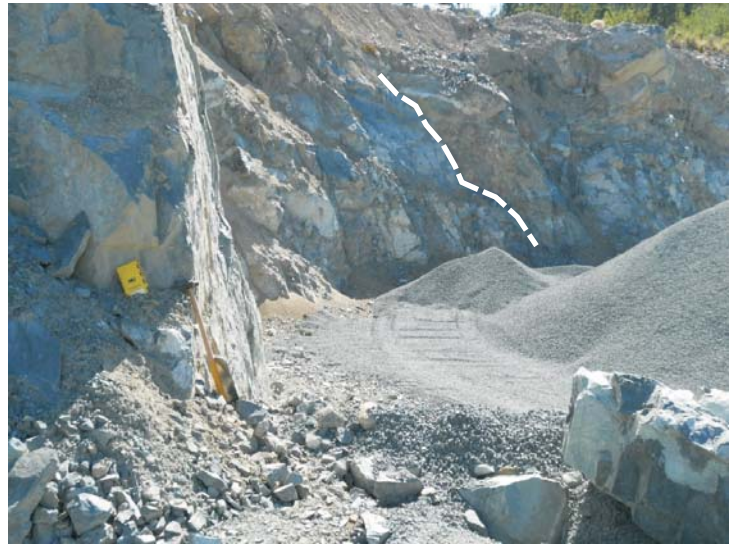
Photo 7:

There appears to be one, marginally preferred, fracture orientation of 190°/85°W. Along the south wall of the quarry, rock breaks preferentially along these surfaces. Spacing is on a one to two metre scale (Photo 7). Secondary fracture orientations show some breakage but are moderately to poorly developed. Fracture faces tend to be curvi-planar over several metres.

Showing fracture series in quarry. Oriented at approximately $190^{\circ}/85^{\circ}\text{W}$ and spaced at 1 - 2 metres. Note the curvi-planar fracture surfaces: white line traces one such surface.

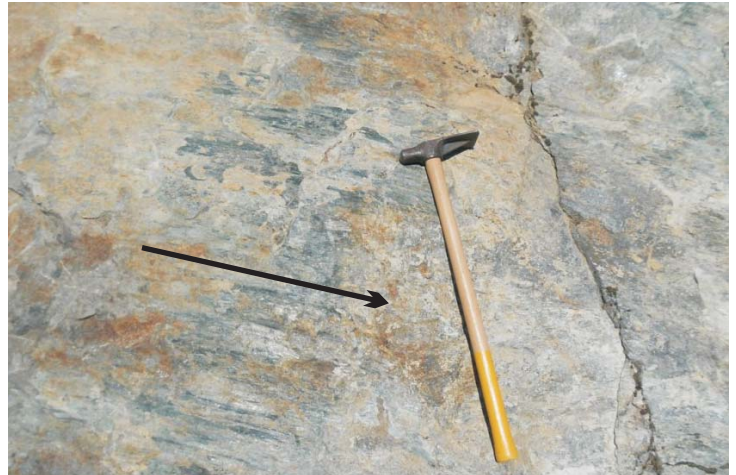
Photo 8:

Filled fractures are uncommon, and are generally 1 - 3 mm across. In the field, chlorite, epidote and quartz were identified as fracture fills; petrographic analysis identified sericite and calcite. Some fractures display chlorite (\pm quartz, calcite, and sericite) slickensides indicating displacement along the fracture surface (Photo 8). Iron oxide on fracture faces seems to diminish with depth, consistent with recent weathering.

Showing near vertical fracture face with slickensides indicating lateral motion (black arrow). Hammer for scale, handle is 30" long.

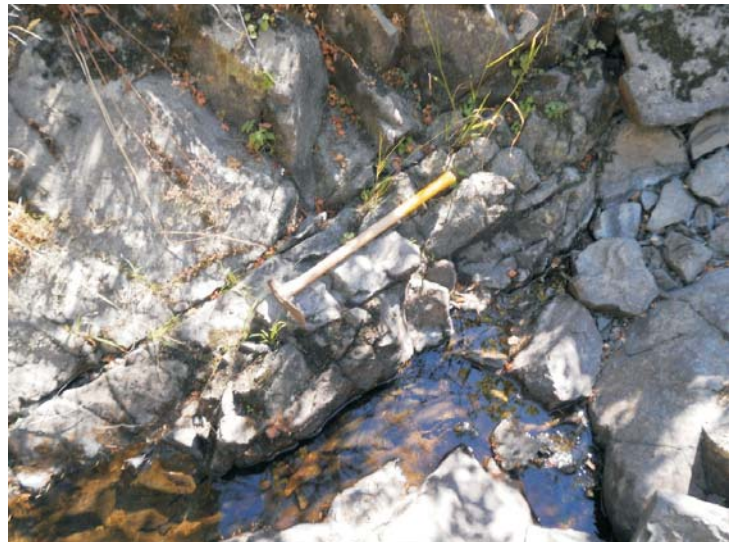
Photo 9:

During the site investigation no water was observed in any fractures. Although Shawnigan Creek was observed to be flowing with water, fractures in adjacent bedrock were dry (Photo 9). Furthermore, a series of bench tests were performed on rock samples from the quarry (Hoog and Weiher, 2011). Repeated wetting/drying and freeze/thaw tests determined that the rock does not absorb water and does not spall due to freezing.

Shawnigan Creek at SIA bridge crossing. Showing fractures in creek parallel to hammer and flowing water. Hammer for scale, handle is 30" long.
