Project: 2087

RE: Cobble Hill Holdings Ltd. 460 Stebbings Road-Winter Liner Inspection November 19, 2018

Islander Engineering Ltd. (IEL) has been retained by ALLTERRA Construction Ltd. to provide a pre-winter liner inspection for the 2018 season for Cobble Hill Holding Ltd. 460 Stebbings Road (the "Site"). IEL staff conducted a thorough inspection **of the Site's Permanent Encapsulation Area (PEA)** on November 19, 2018.

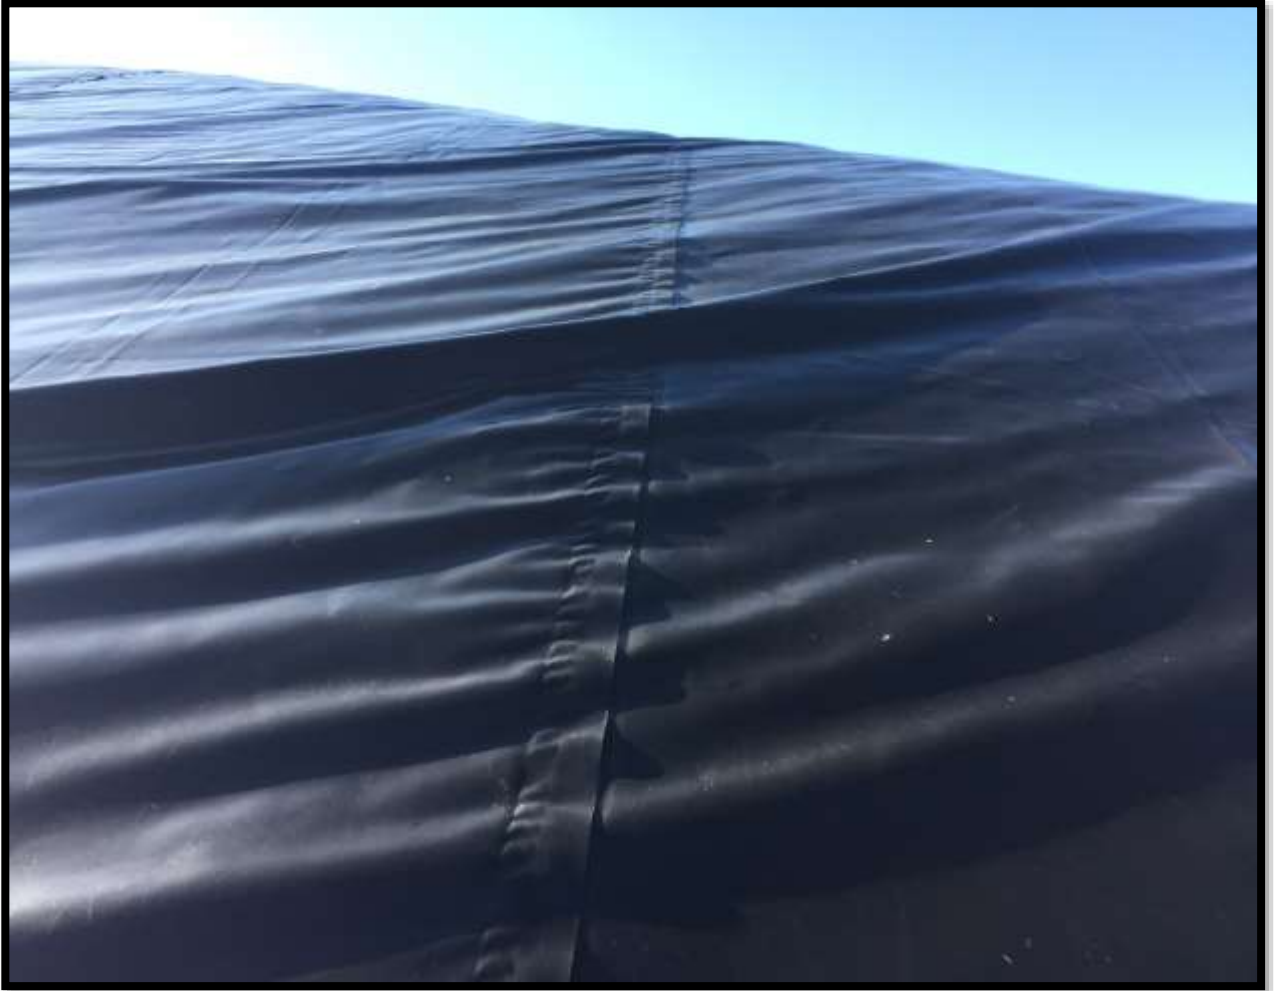
The entire liner system, including the surface and faces, were inspected for signs of stretching and heat degradation caused by UV radiation. The liner system appeared smooth throughout showing no signs of warping or stretching on all faces. Small folds were noted to exist on North and East faces that have likely accommodated small movements of the liner during its installation (Photo 1). To investigate the likelihood of stretching as a cause of these small folds, IEL removed tires and geotextile membranes that lay overtop the liner system in the surface water ditch systems. This is the most likely area where stretching would occur as ditches are weighted down by tires and sand bags.

**Photo 1 – PEA North Face Liner Folds**

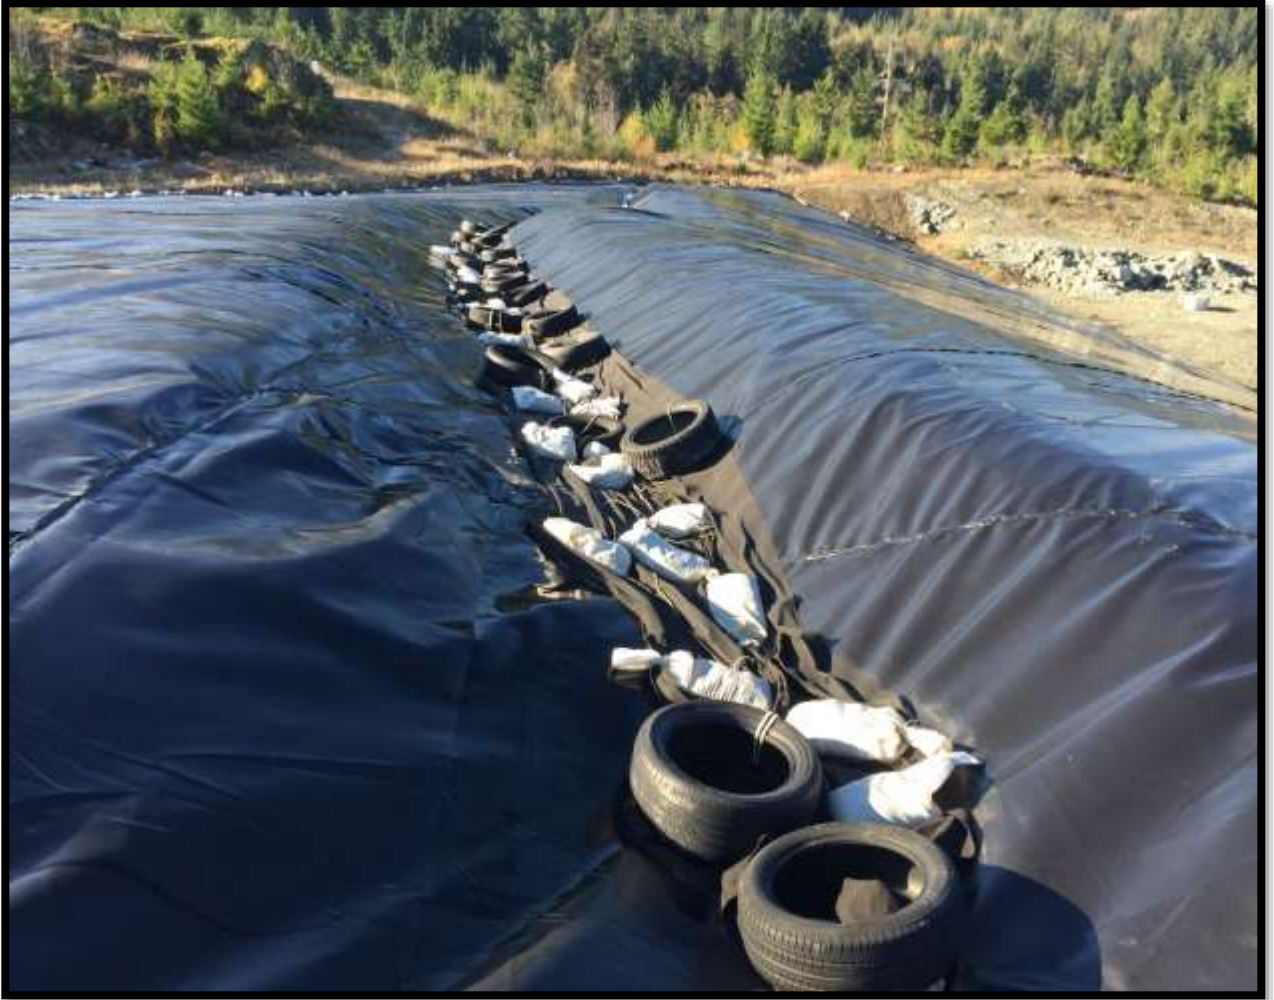
Ditches were observed as lined with tires and sand bags placed upon geotextile fabric followed by the PEA liner underneath. Tires, sandbags, and fabric were removed to show no signs of tearing, stretching, or warping (Photos 2 and 3).

Photo 2 – PEA East-West Surface Ditch System

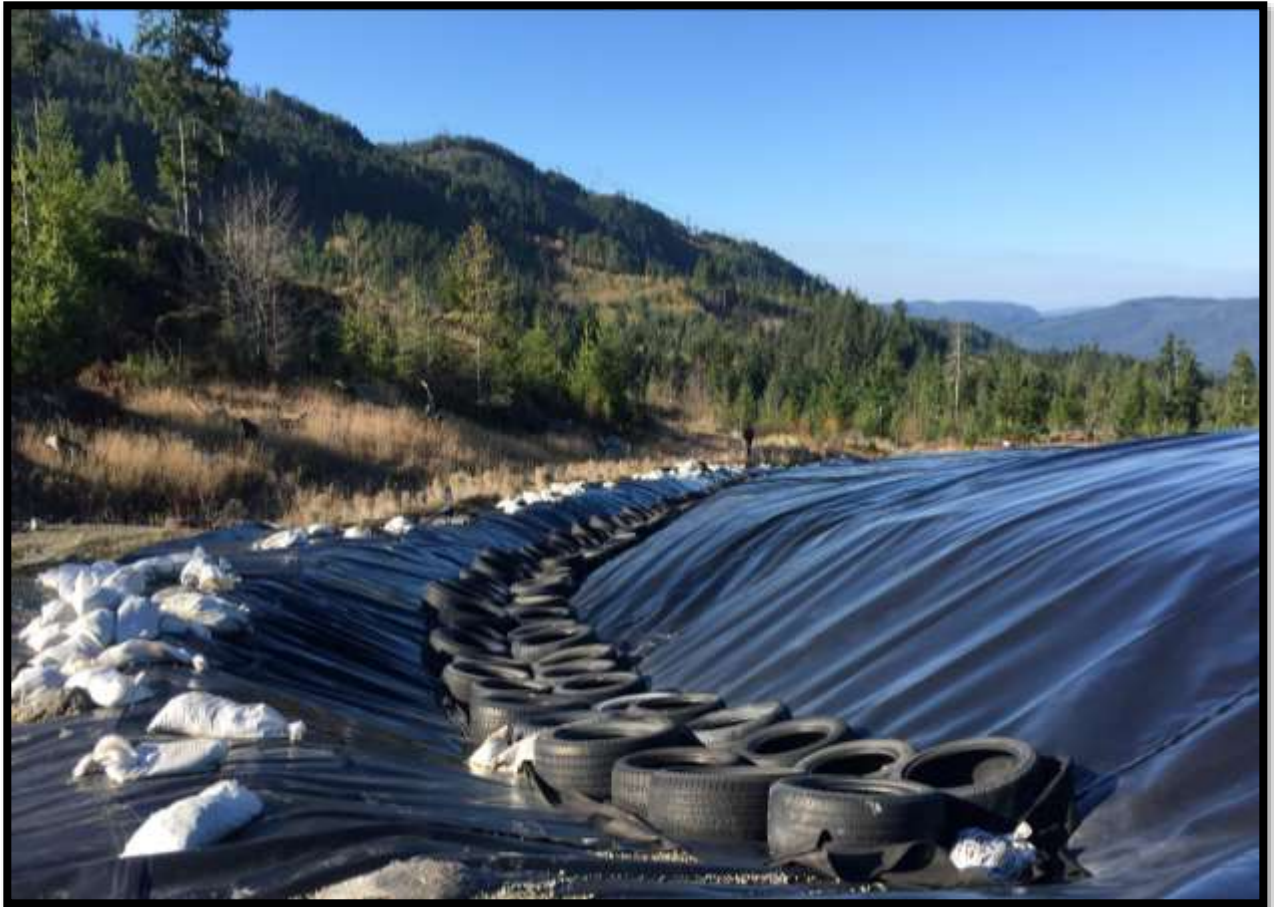
Photo 3 – PEA North-South Surface Ditch System

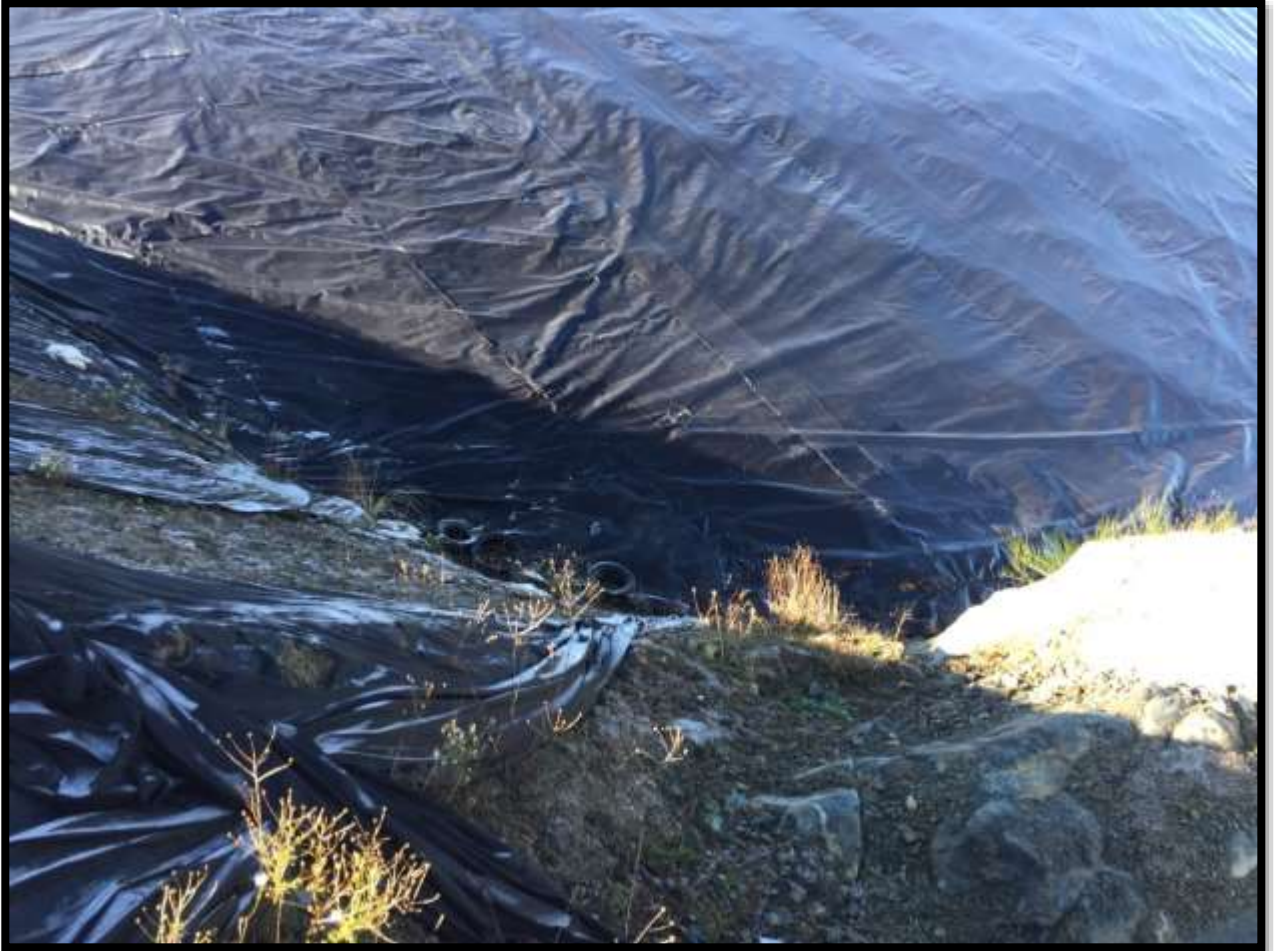
Evidence of wildlife in the forms of hoof prints, feces, bird nesting, burrowing, were devoid on the entire PEA including surface and faces (Photo 4, 5, 6). There were no signs of wildlife markings including punctures or nesting on the liner itself, however, wildlife marking can be shown to track **along the North and South toes in the ditch systems located outside the PEA's footprint** (Photo 7).

Photo 4 – PEA East Face- Evidence of Wildlife is devoid on the liner system

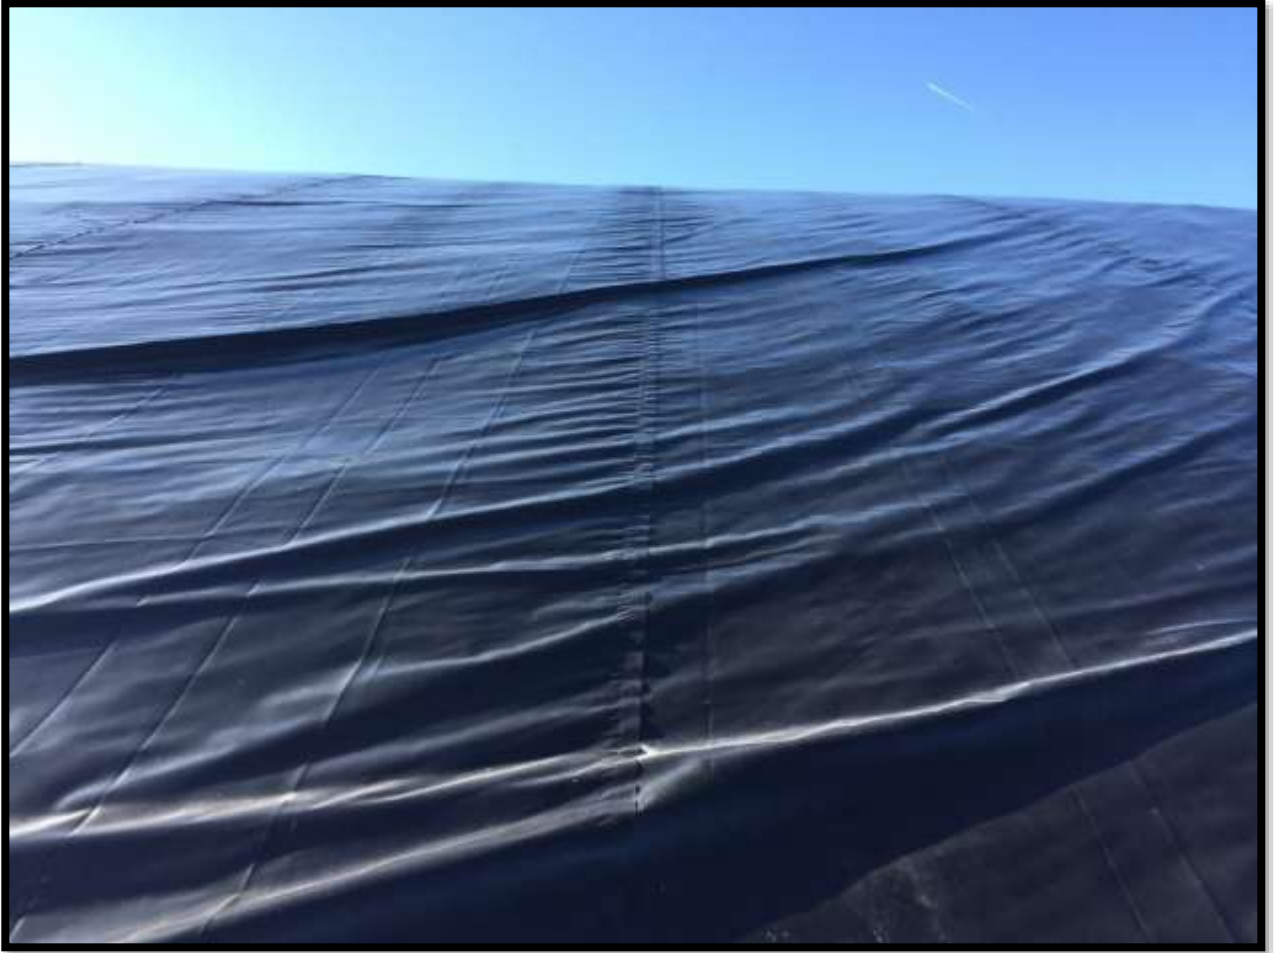
Photo 5 – PEA North Face- Evidence of Wildlife is devoid on the liner system

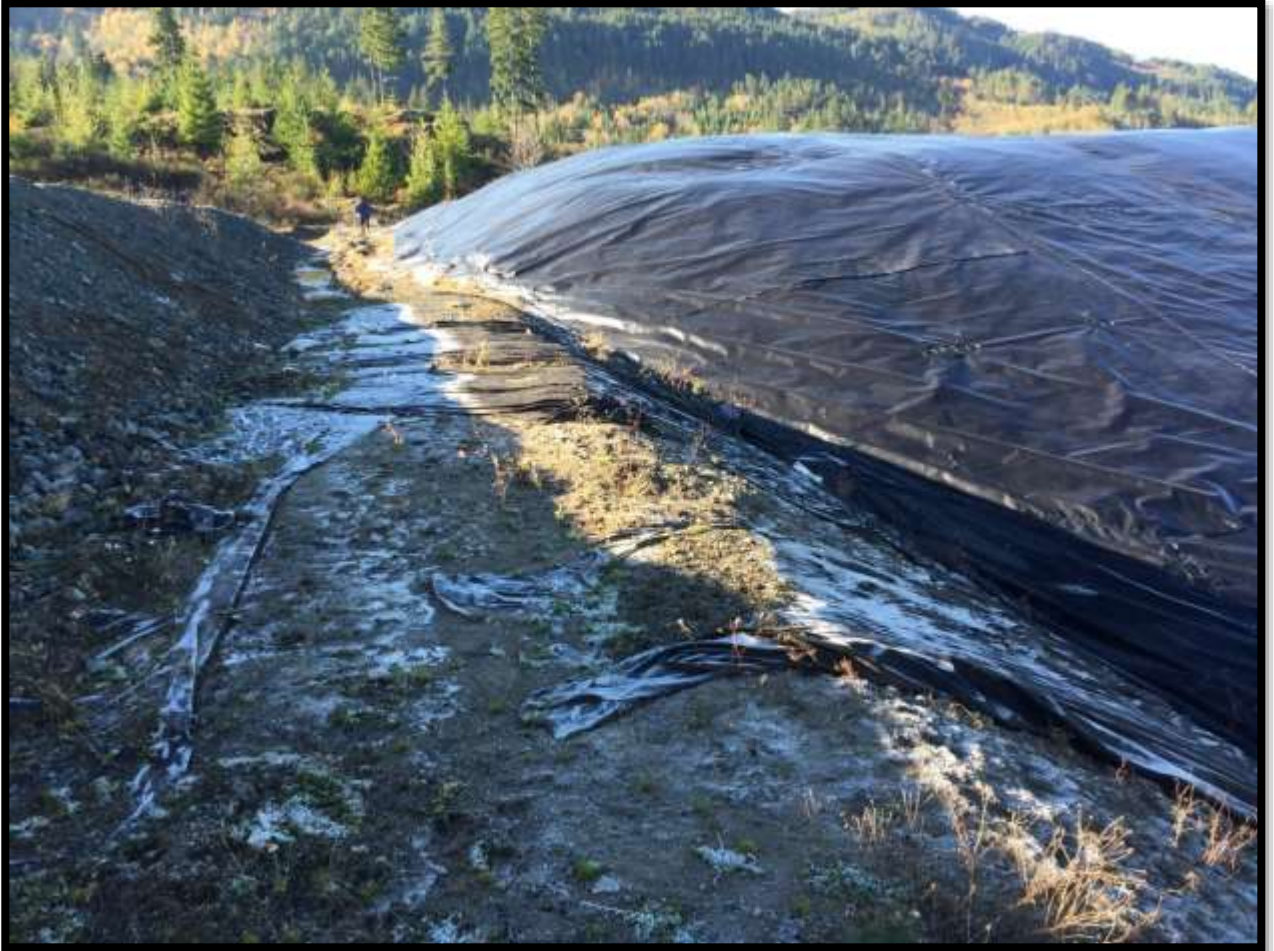
Photo 6 – PEA South-East Surface- Evidence of Wildlife is devoid on the liner system

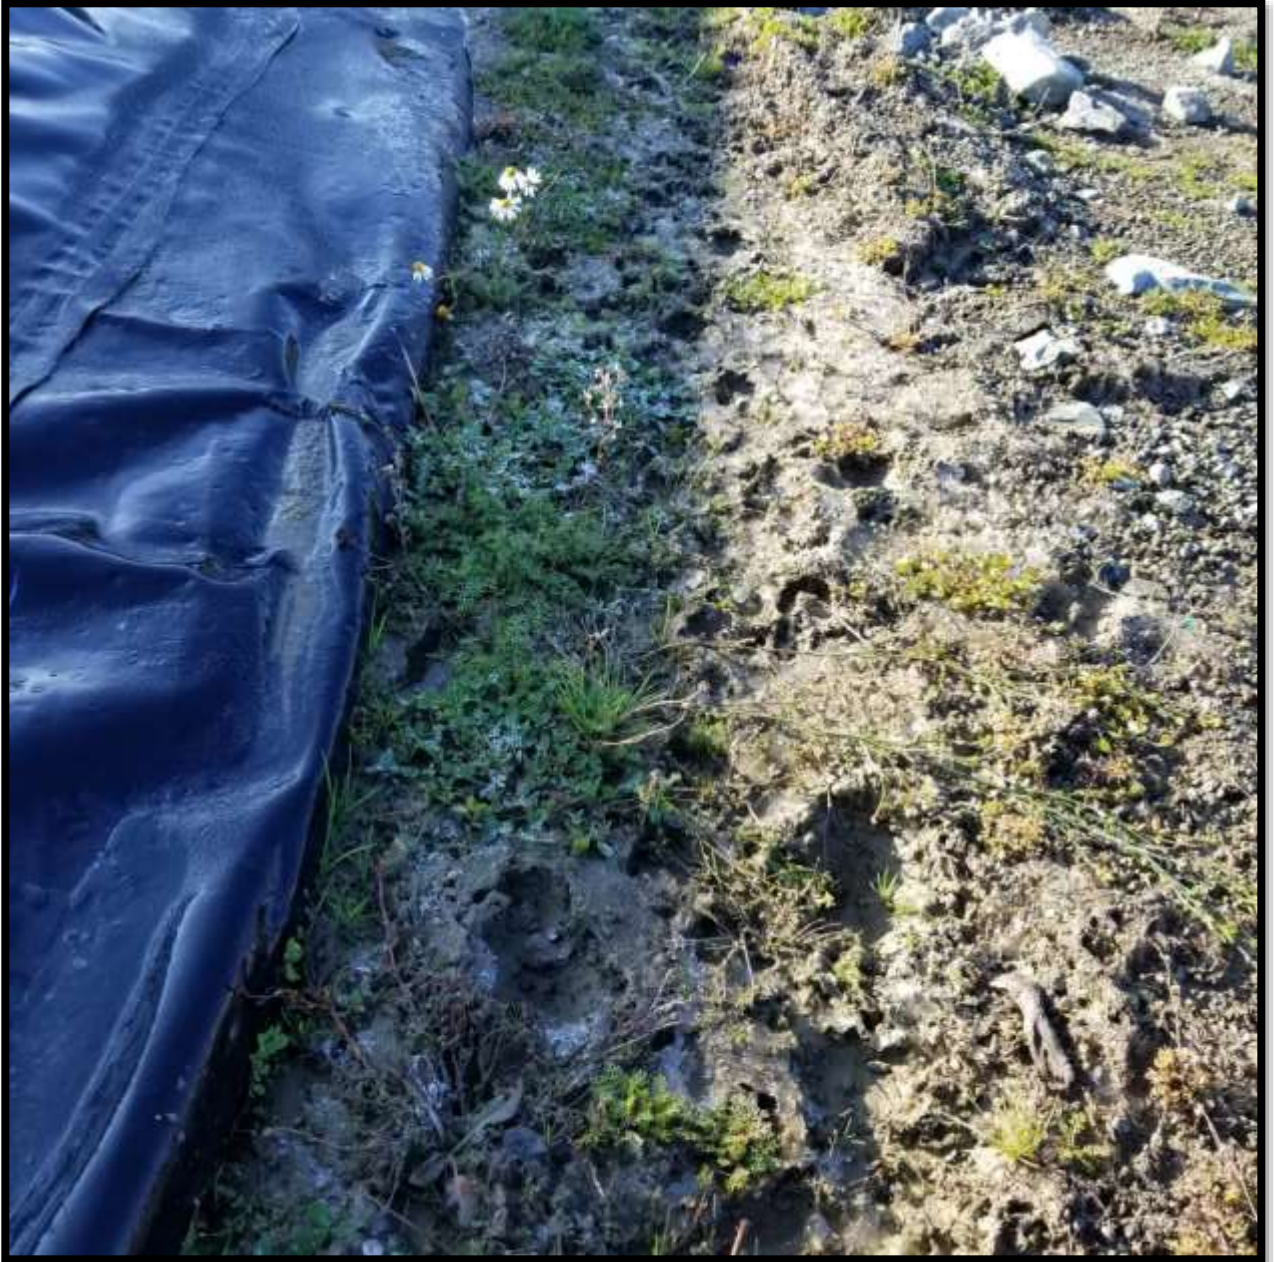
Photo 7 – Wildlife track marks outside of the PEA-Base of north toe

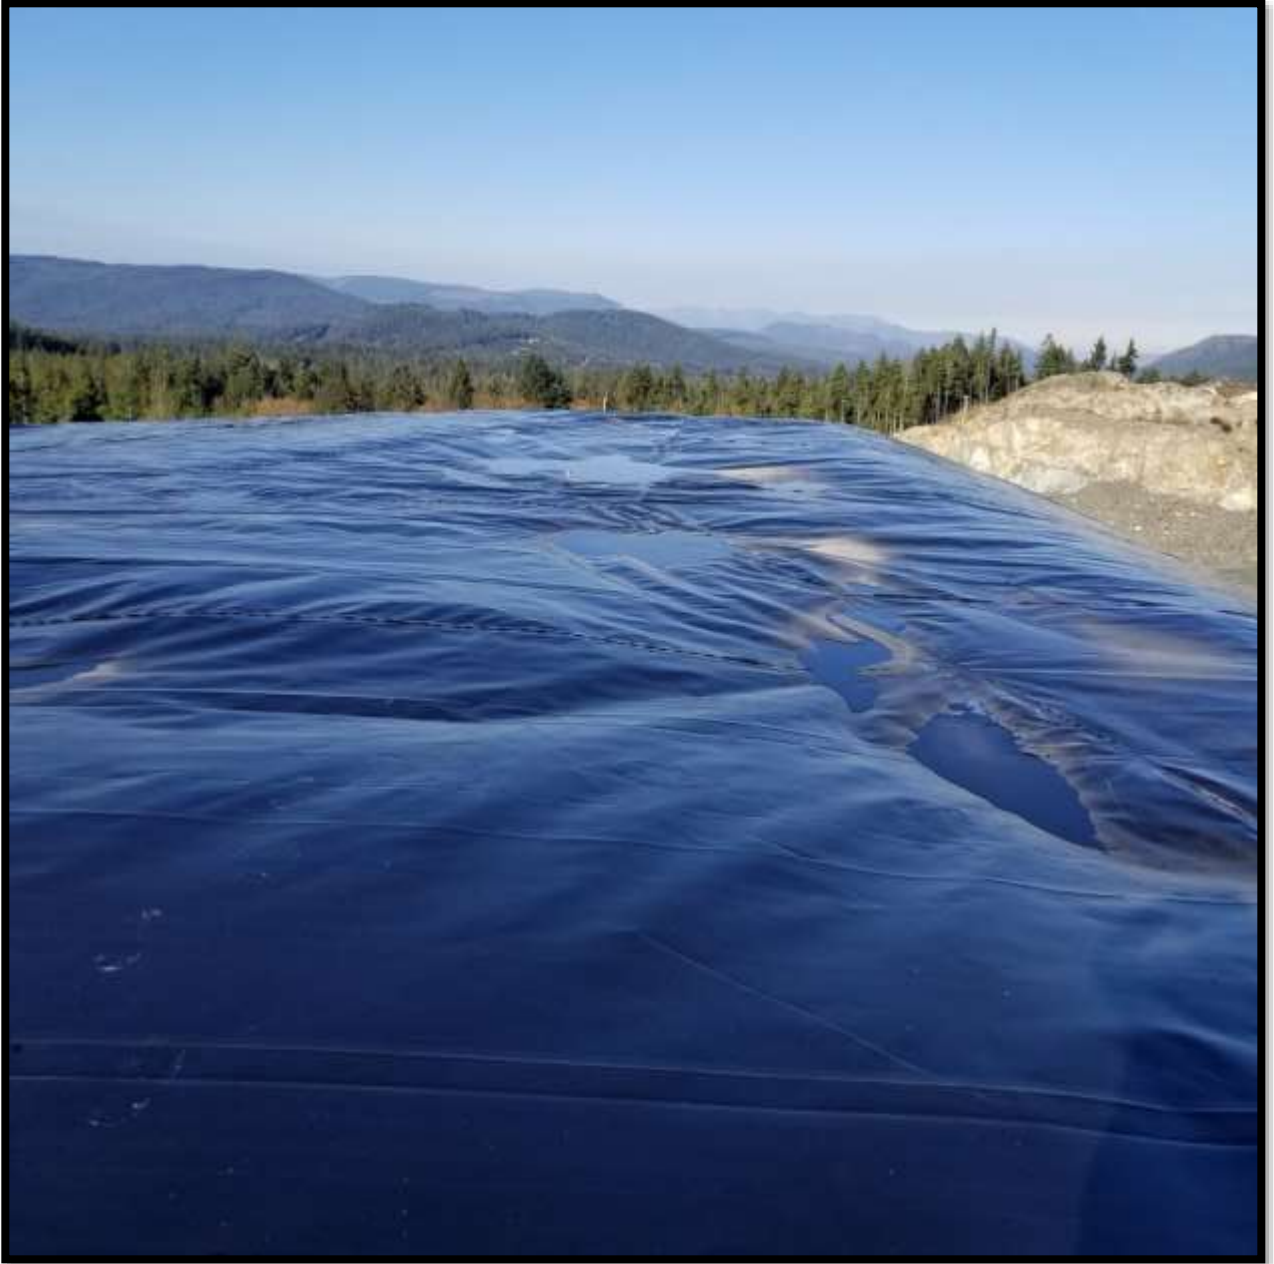
The surface contours and ditch systems of the PEA appear to promote adequate drainage of surface waters from the PEA with minimal surface pooling observed (Photo 8). Signs of abrasion are devoid on the liner itself including PEA surface ditch works. Erosion caused by PEA surface water to ditch works designed to transfer water from the south east corner to the southwest corner and onto the surrounding property is not evident (Photo 9), however, there are small signs of minimal erosion to the quarry most noticeably at the toe of the NW corner (Photo 10).

**Photo 8 – Minimal ponding of surface waters is observed**

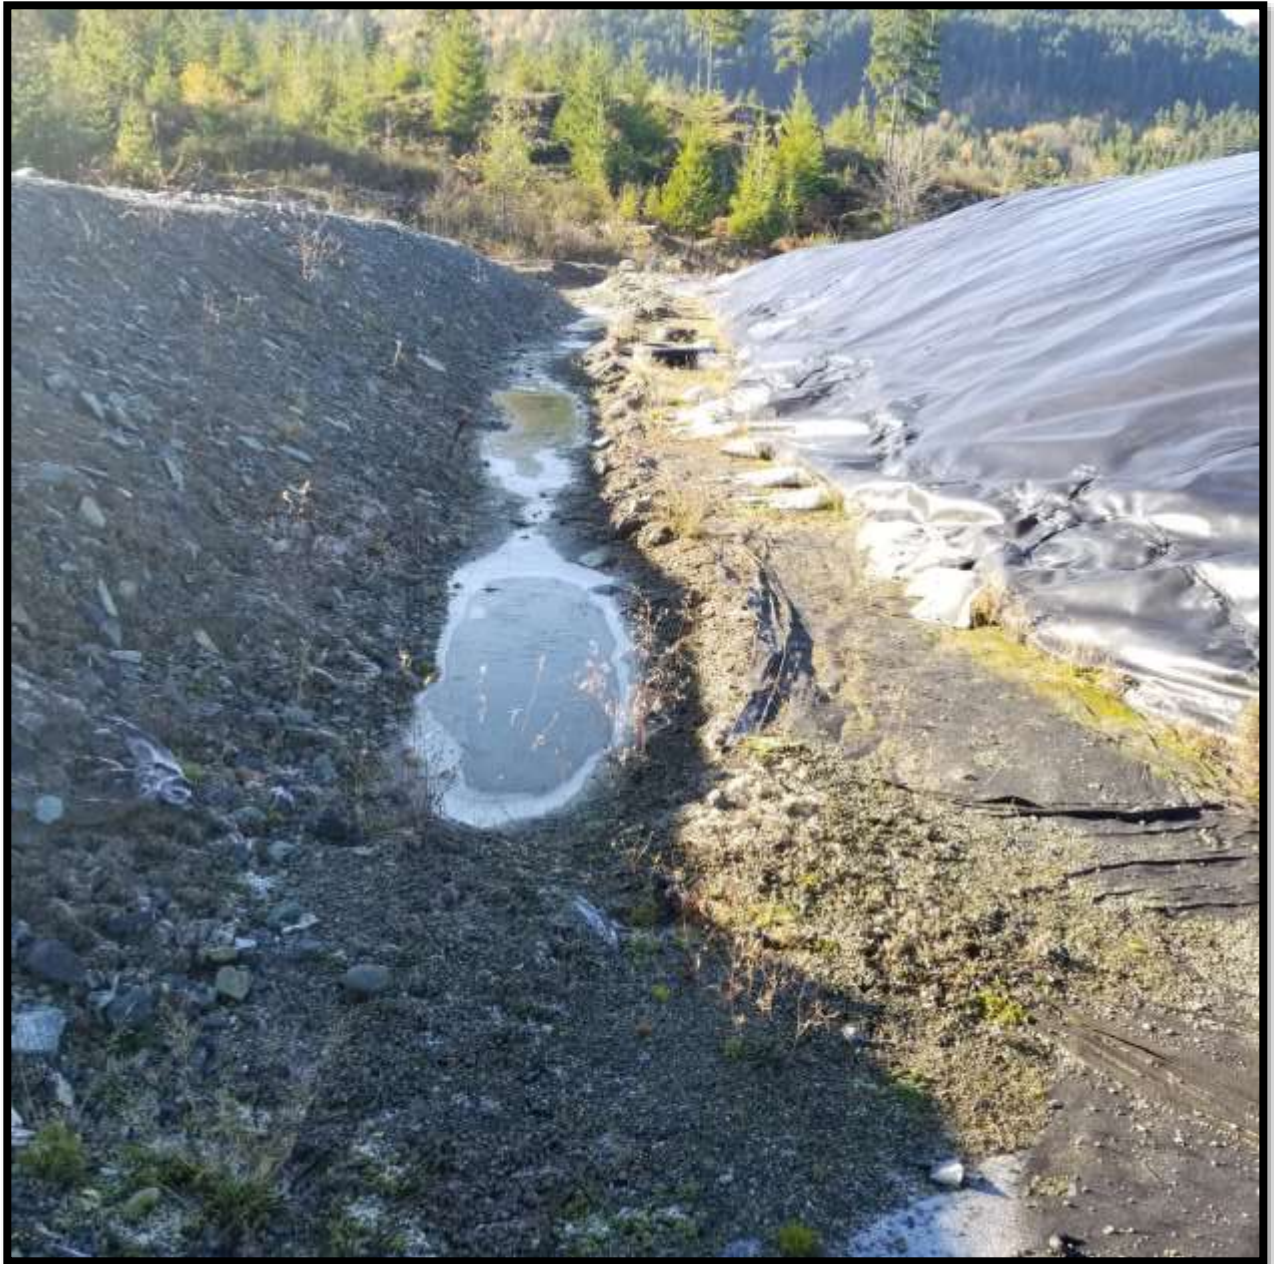
Photo 9 – South ditch erosion is not present

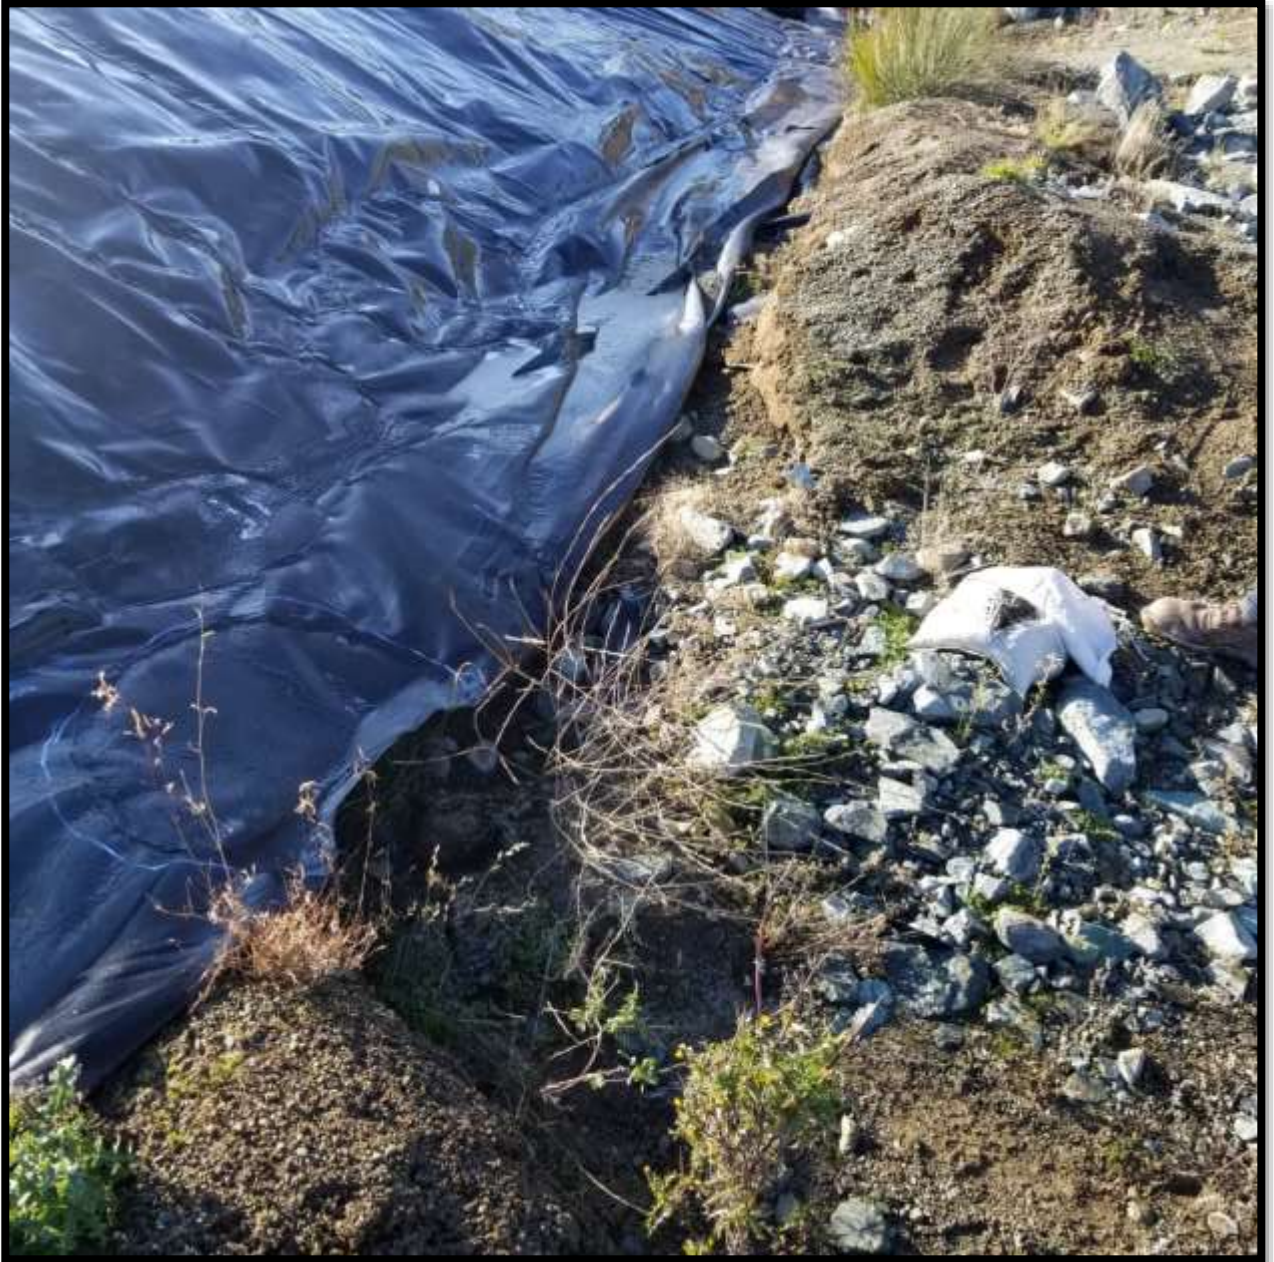
Photo 10 – Slight erosion of the quarry is noted at the NW toe-the liner is fully sealed at this location

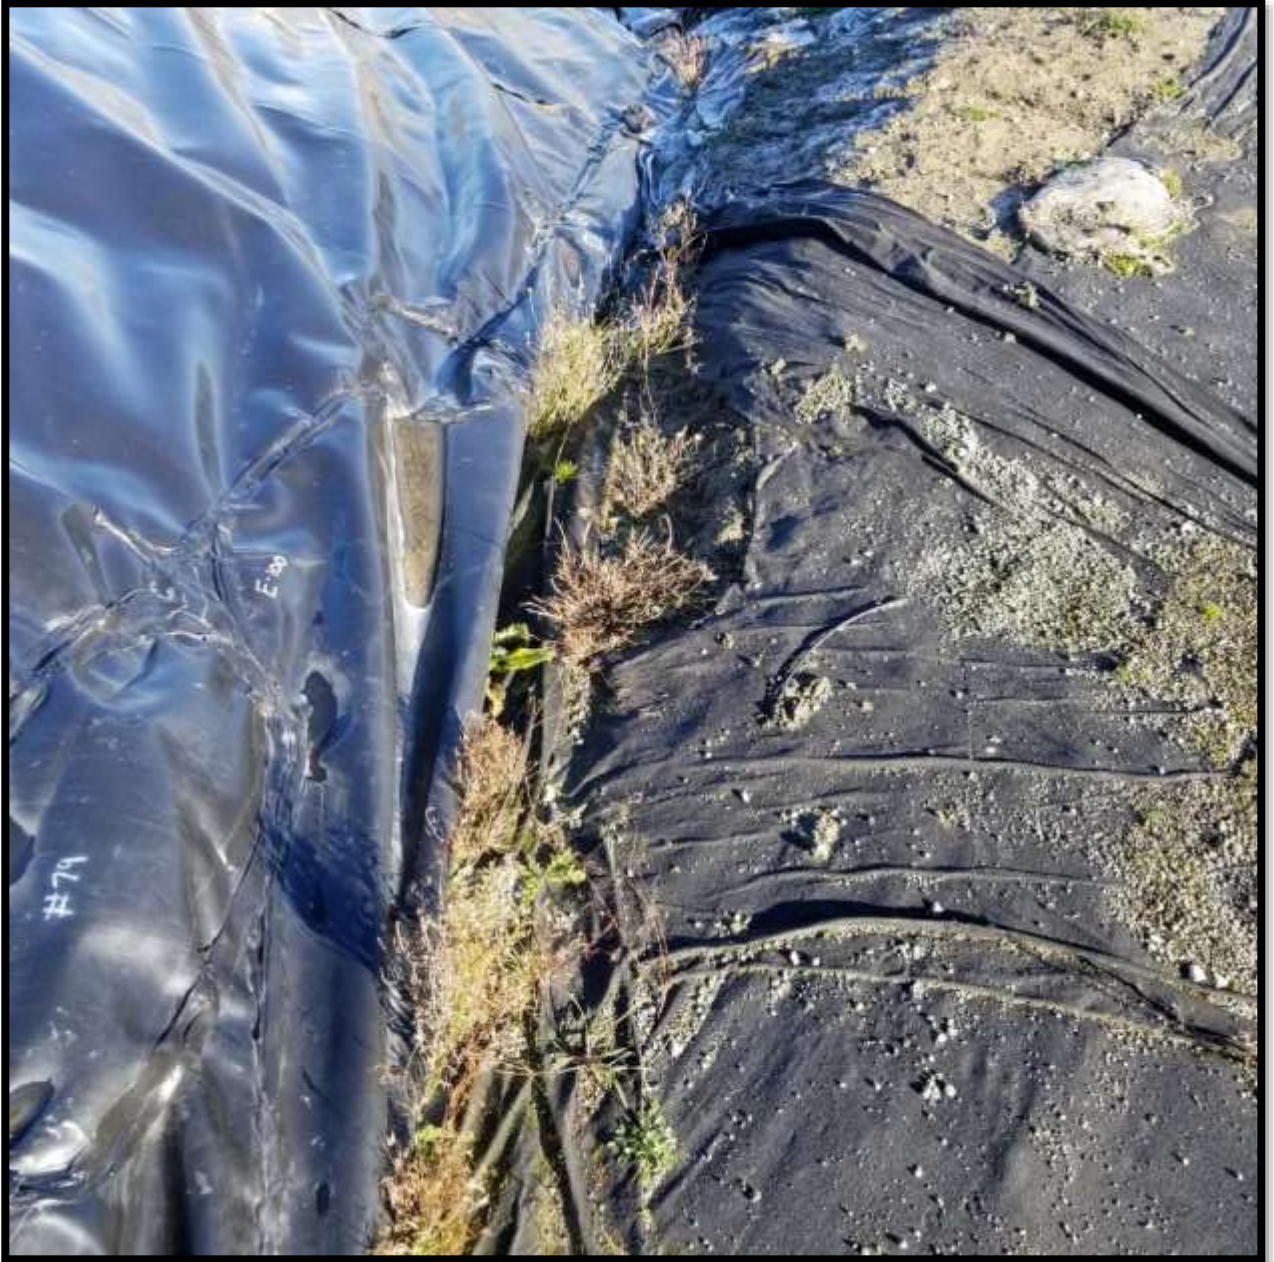
small weeds, small shrubs appear within surface water ditch works along the outer quarry perimeter of the PEA (Photo 11, 12, 13).

Photo 11 – Grasses, weeds, small shrubs are present along the PEA perimeter-SE crest

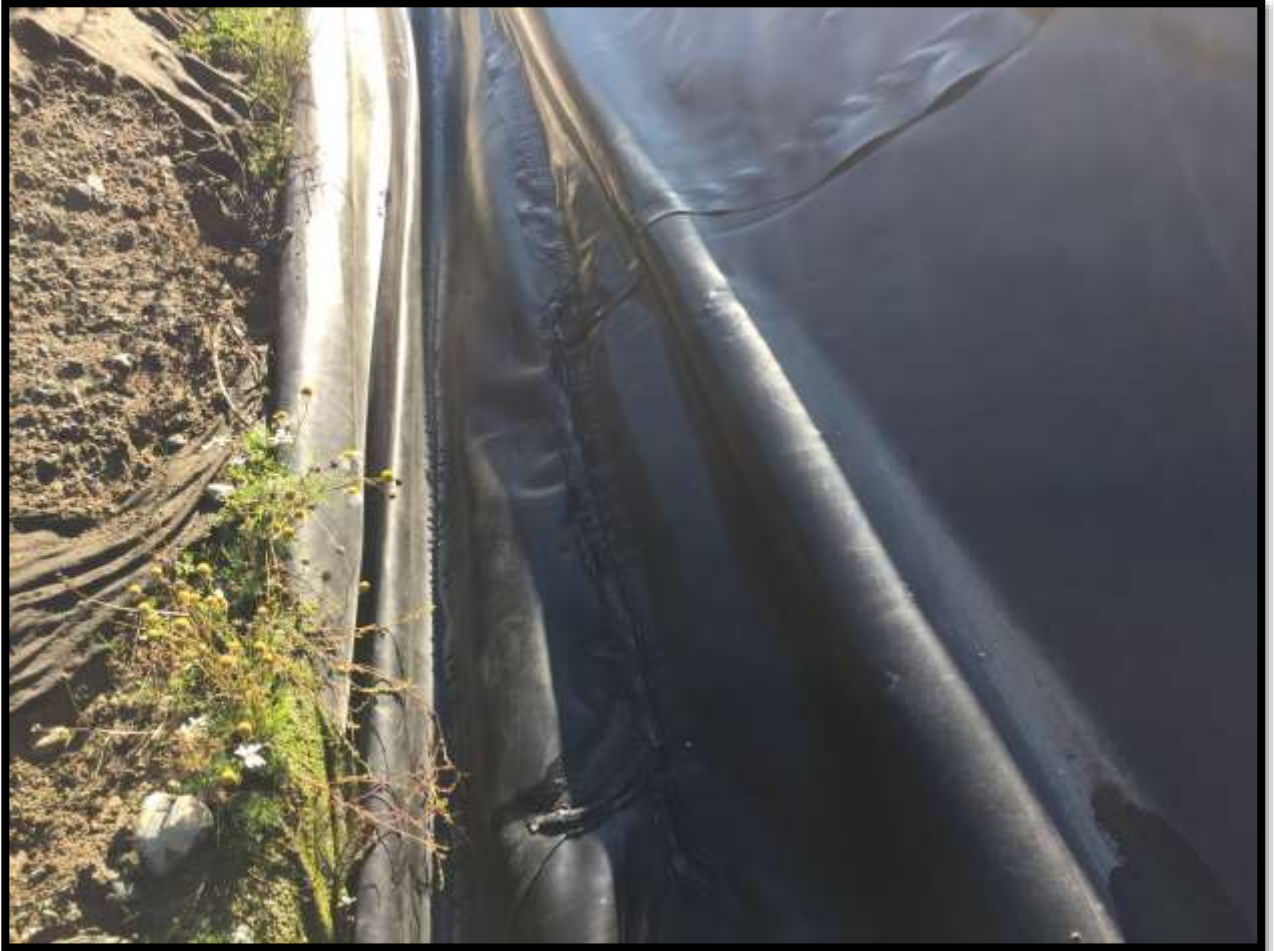
Photo 12 – Grasses, weeds, small shrubs are present along the PEA perimeter

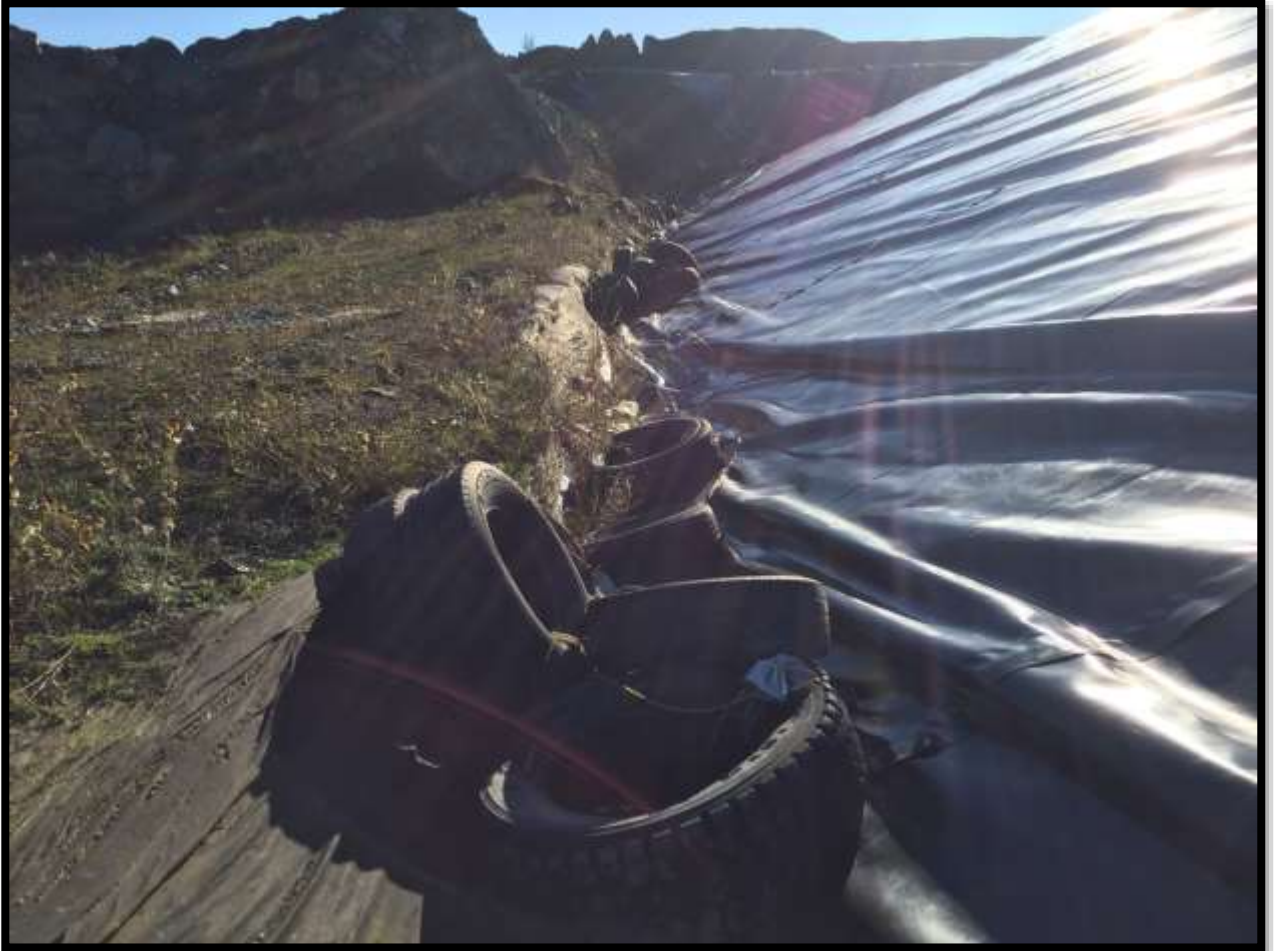
Photo 13 – Grasses, weeds, small shrubs are present along the PEA perimeter

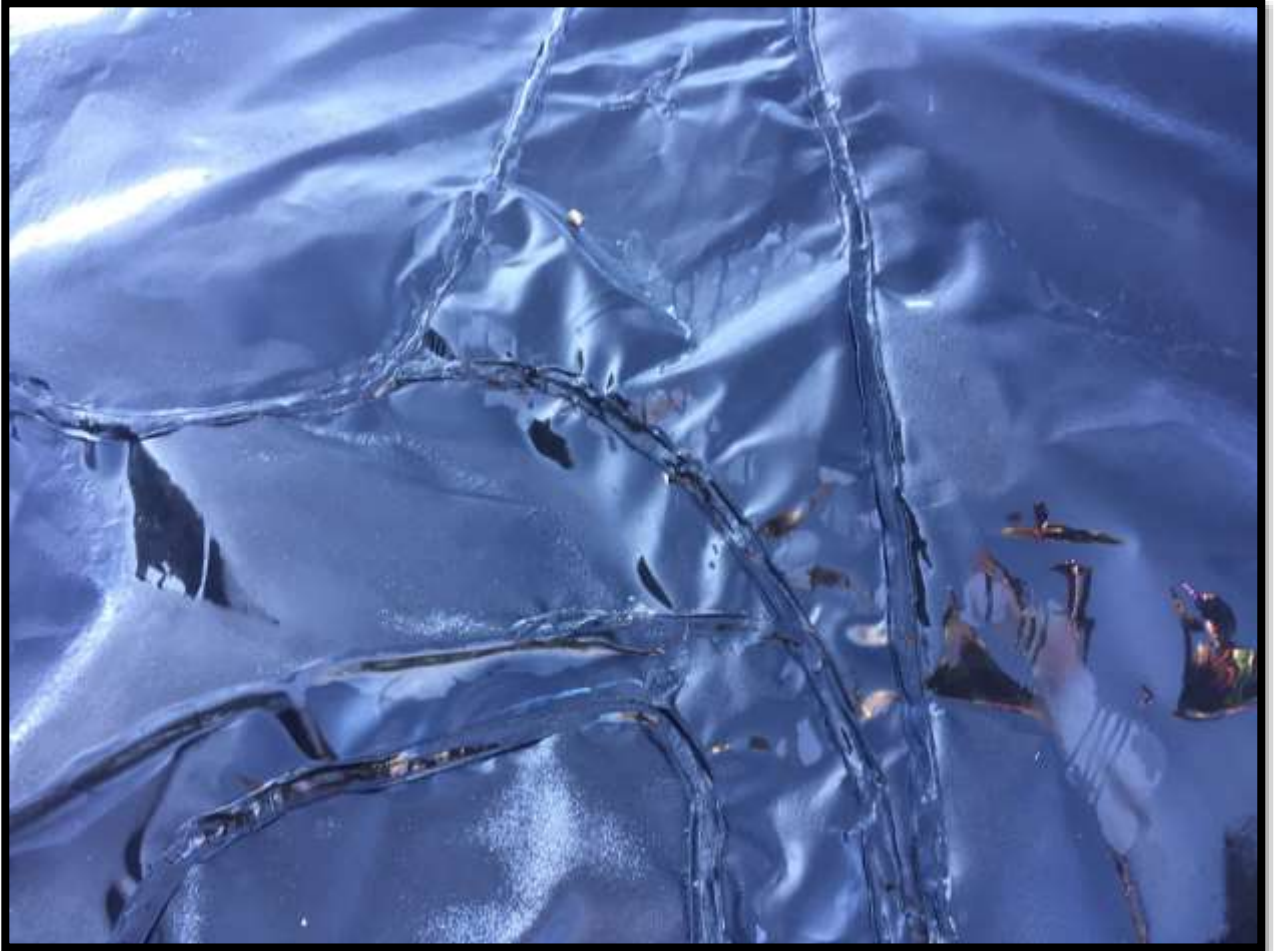
Seams were inspected throughout the PEA including those welded during the minor construction works during the fall of 2017. Original seams welded by the liner manufacturer were also inspected including others that could be visually detected. Seams show no sign of degradation (Photo 14, 15, 16, 17, 18). Extrusion welds were observed to hold strong with no observable deterioration. Additionally, water was devoid within the liner system itself i.e. there was no pooling within the liner system at all toes along the perimeter.

Photo 14 – Liner seams show no signs of deterioration

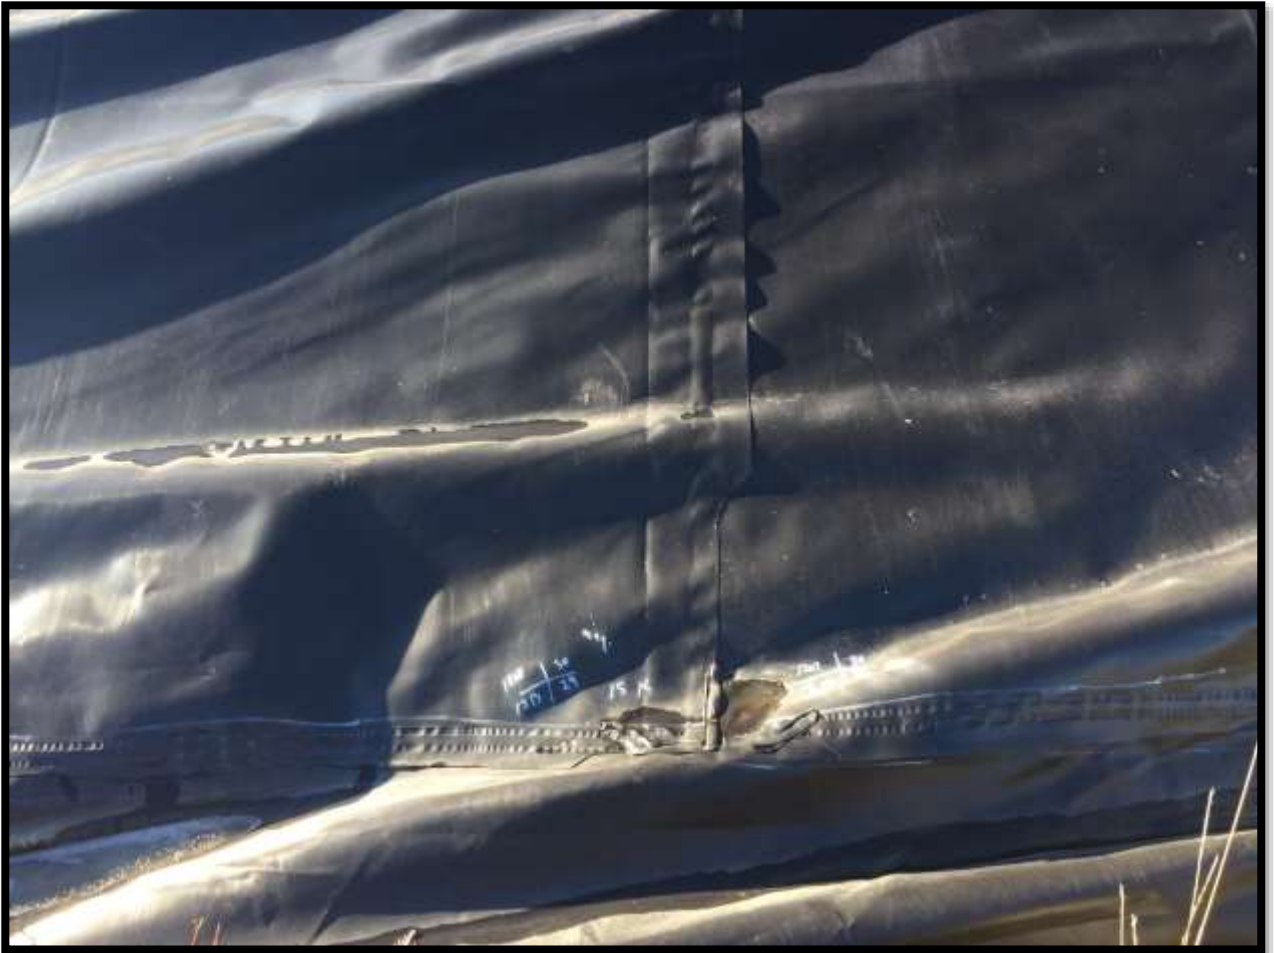
Photo 15 – Liner seams show no signs of deterioration

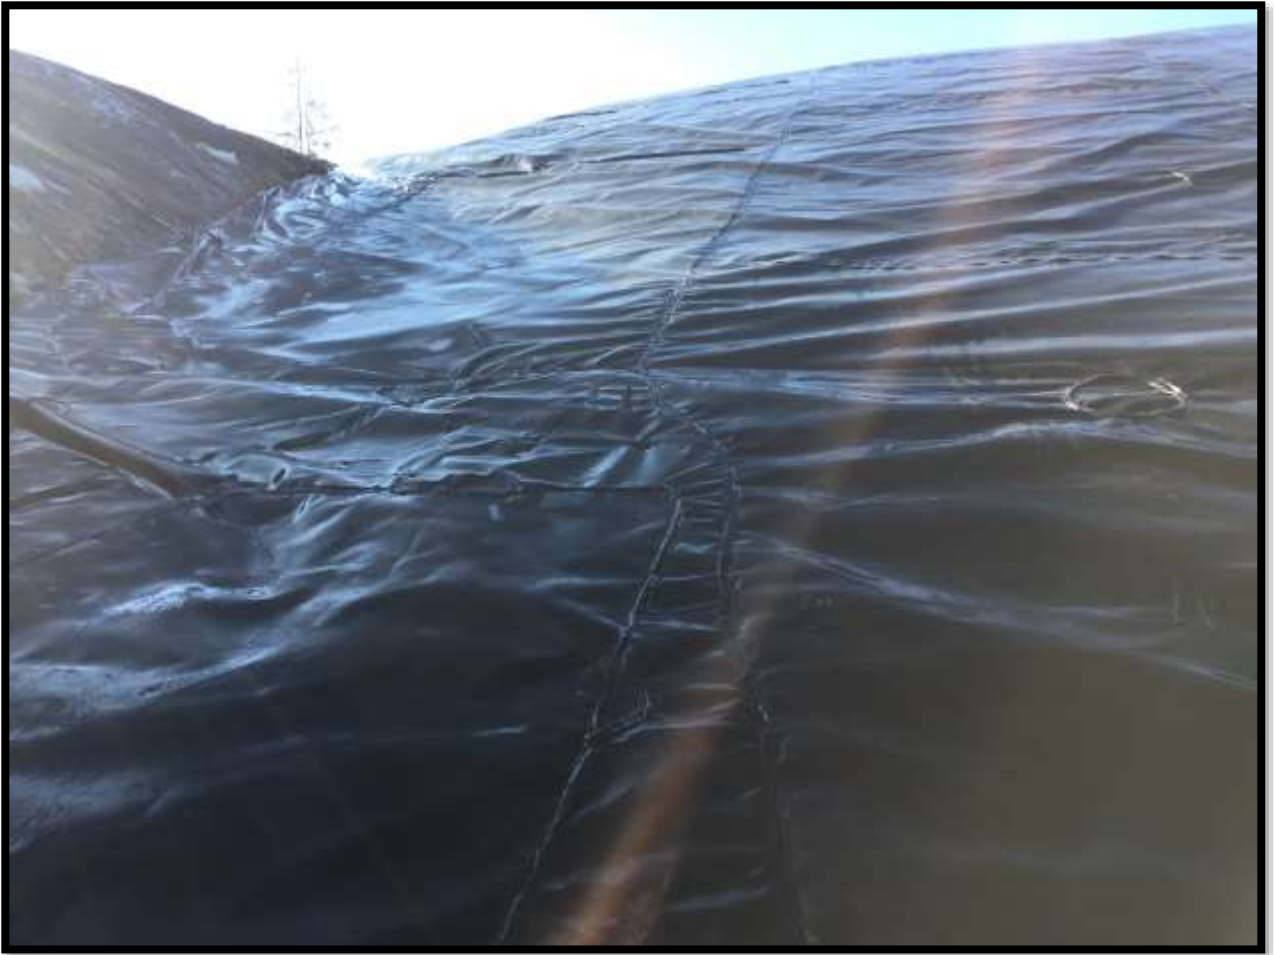
Photo 16 – Liner seams show no signs of deterioration
