Project: 2087

RE: Cobble Hill Holdings Ltd. 460 Stebbings Road-Winter Liner Inspection November 19, 2018

Islander Engineering Ltd. (IEL) has been retained by ALLTERRA Construction Ltd. to provide a pre-winter liner inspection for the 2018 season for Cobble Hill Holding Ltd. 460 Stebbings Road (the "Site"). IEL staff conducted a thorough inspection **of the Site's Permanent Encapsulation Area (PEA)** on November 19, 2018.

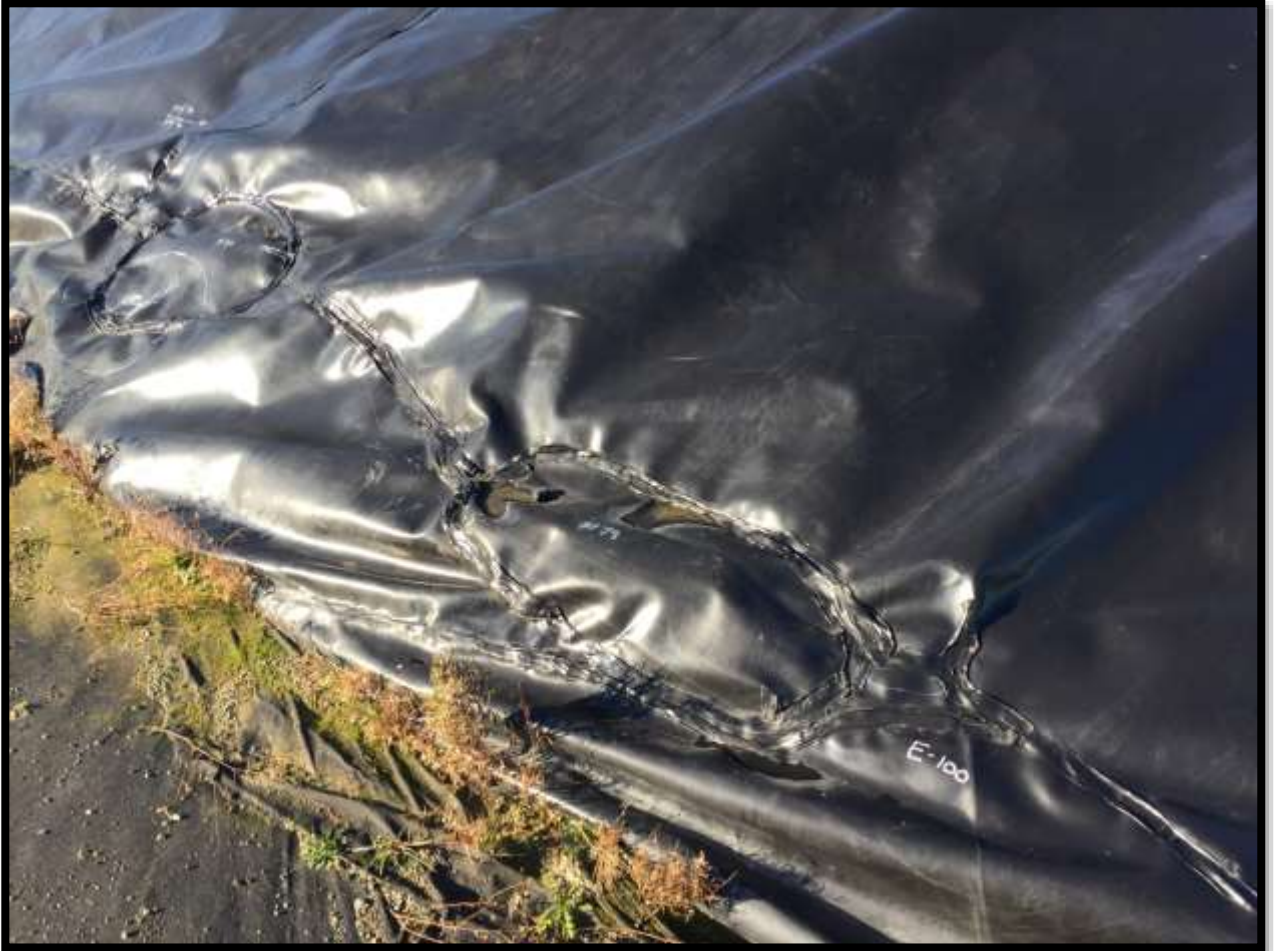
Seams were inspected throughout the PEA including those welded during the minor construction works during the fall of 2017. Original seams welded by the liner manufacturer were also inspected including others that could be visually detected. Seams show no sign of degradation (Photo 14, 15, 16, 17, 18). Extrusion welds were observed to hold strong with no observable deterioration. Additionally, water was devoid within the liner system itself i.e. there was no pooling within the liner system at all toes along the perimeter.

Photo 17 – Liner seams show no signs of deterioration

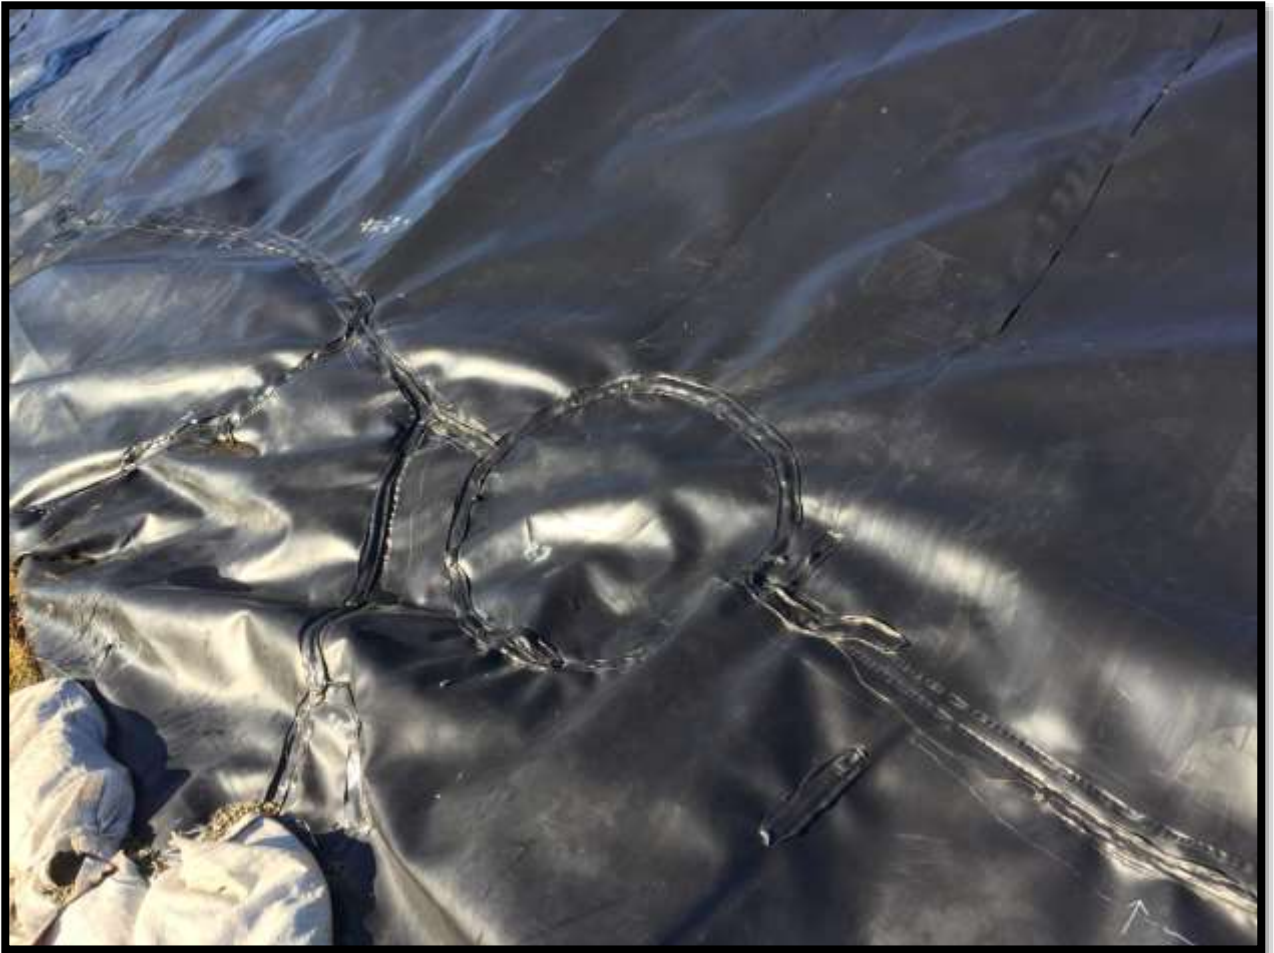
Photo 18 – Liner seams show no signs of deterioration

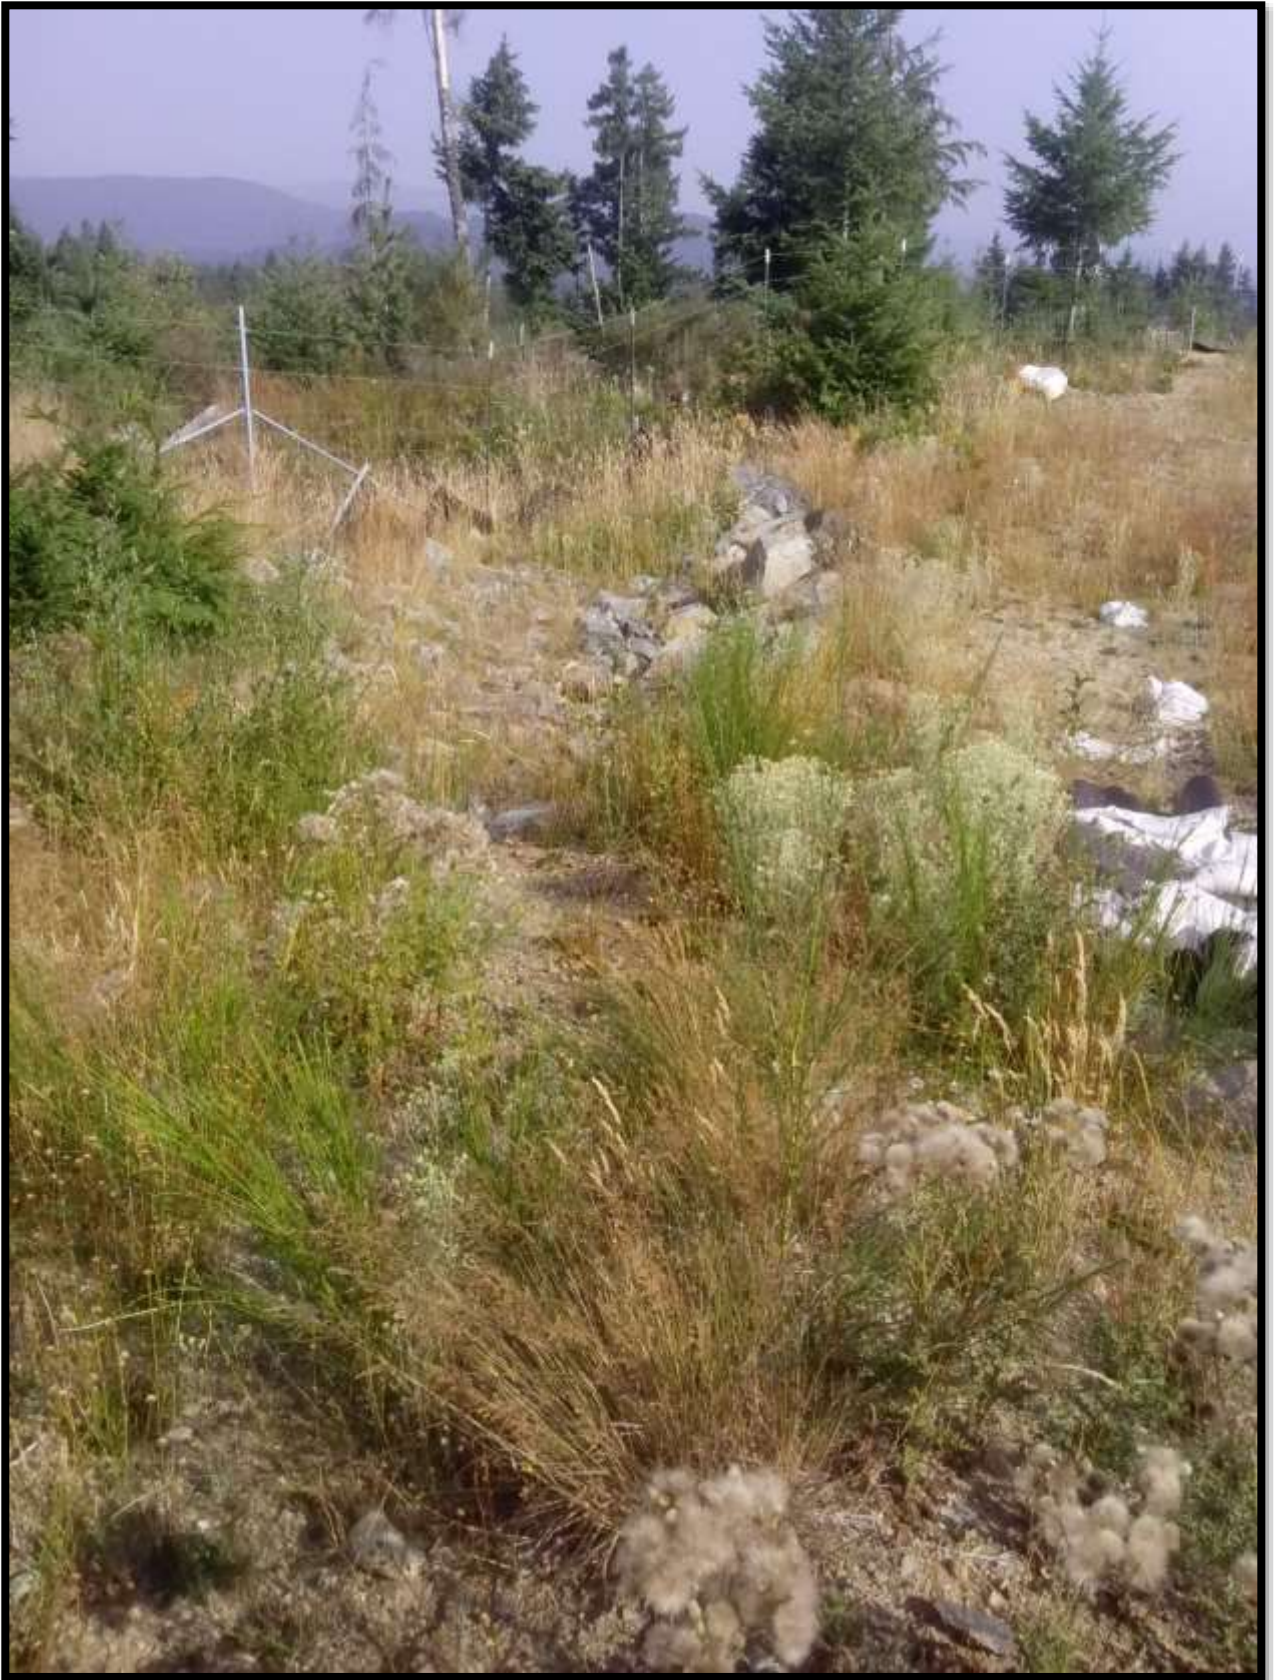
Photo 19 – Monitoring site SHA-SW-2

Monitoring sites are maintained well. Surface water stations SHA-SW-2 and SHA-SW-1 are shown **in Photo's 19 and 20 respectively** and show natural foliage. The leachate/leak detection enclosure and piping system is shown in Photo 21. IEL did not observe any soil discoloration or vegetative stress surrounding the closure. Monitoring wells are encased in metal housing and show no signs of deterioration.
