## **BI-WEEKLY STATUS REPORT**

### **Cobble Hill Landfill Closure**

<b>PROJECT # : PRJ18074</b>	<b>File #:</b> 18074- BWR-75
<b>REPORT #:</b> 75	<b>Date:</b> August 30, 2020
<b>SHA REPRESENTATIVES:</b> Dr. Tony Sperling, P.Eng. Scott Garthwaite Carly Wolfe, EIT	<b>Owner:</b> Cobble Hill Holdings Ltd.  <b>Contractor:</b> Allterra Construction Ltd.

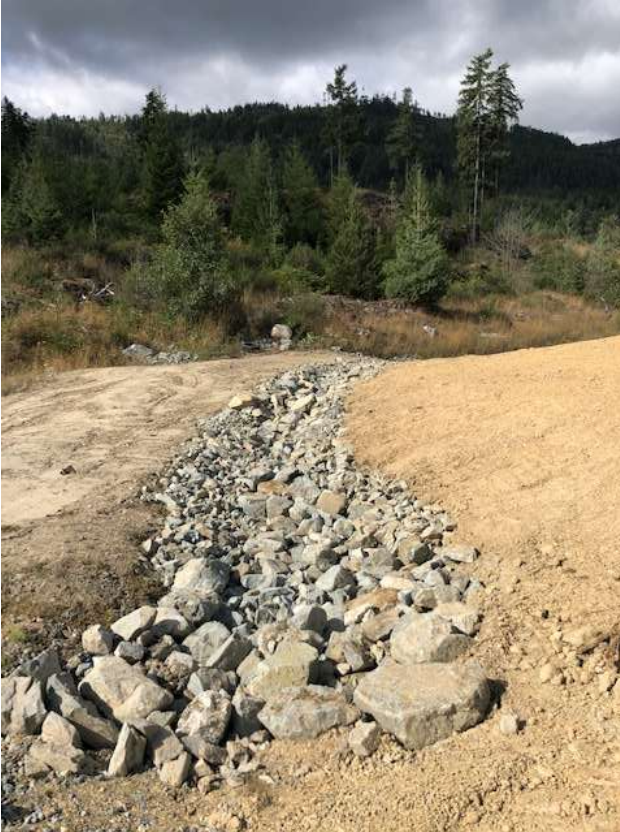
**Picture #1 (left) : South ditch with more rip rap added to cover all geotextile**

- Trim geotextile around south and west ditches and smooth the soil in that area.
  - Shape cobble into a “V” shape in the west ditch.
  - Shape the north slope at a 5H:1V.

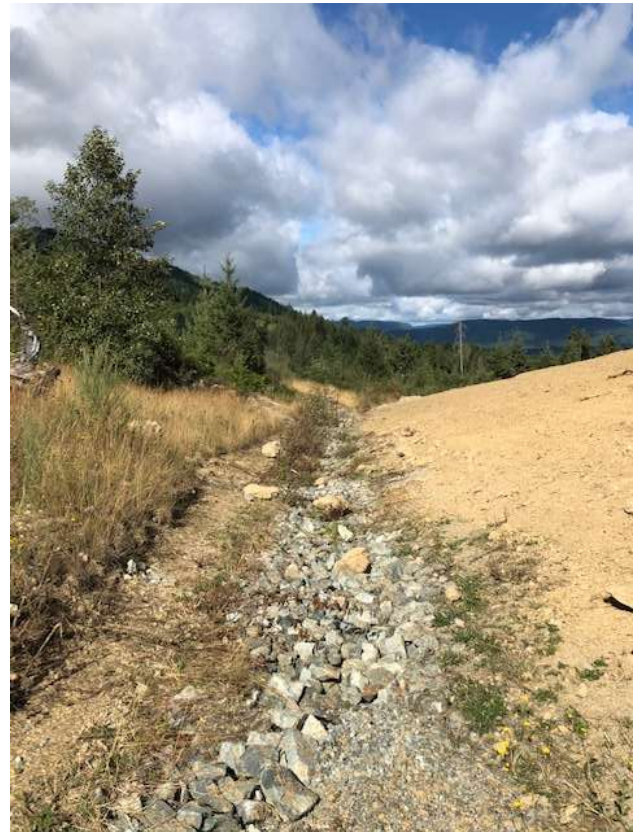
**Picture #2 (right) : West ditch with extra geotextile removed**

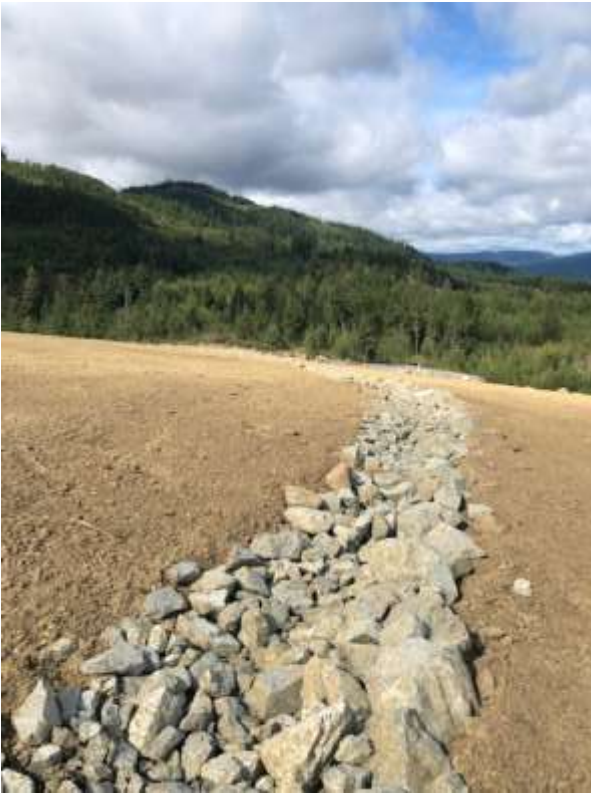
**Picture #3 (left): Intermediate ditch complete**

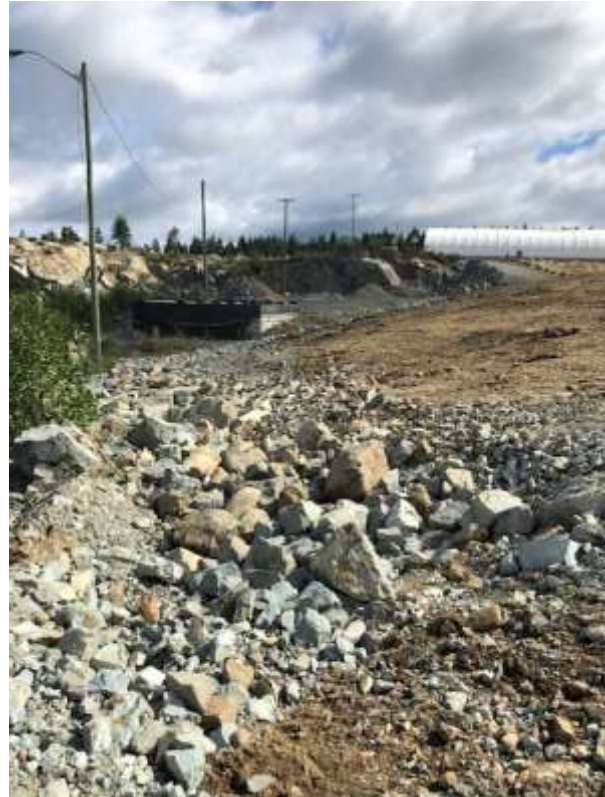
**Picture #4 (right): Berms knocked down and sloped to match cover**

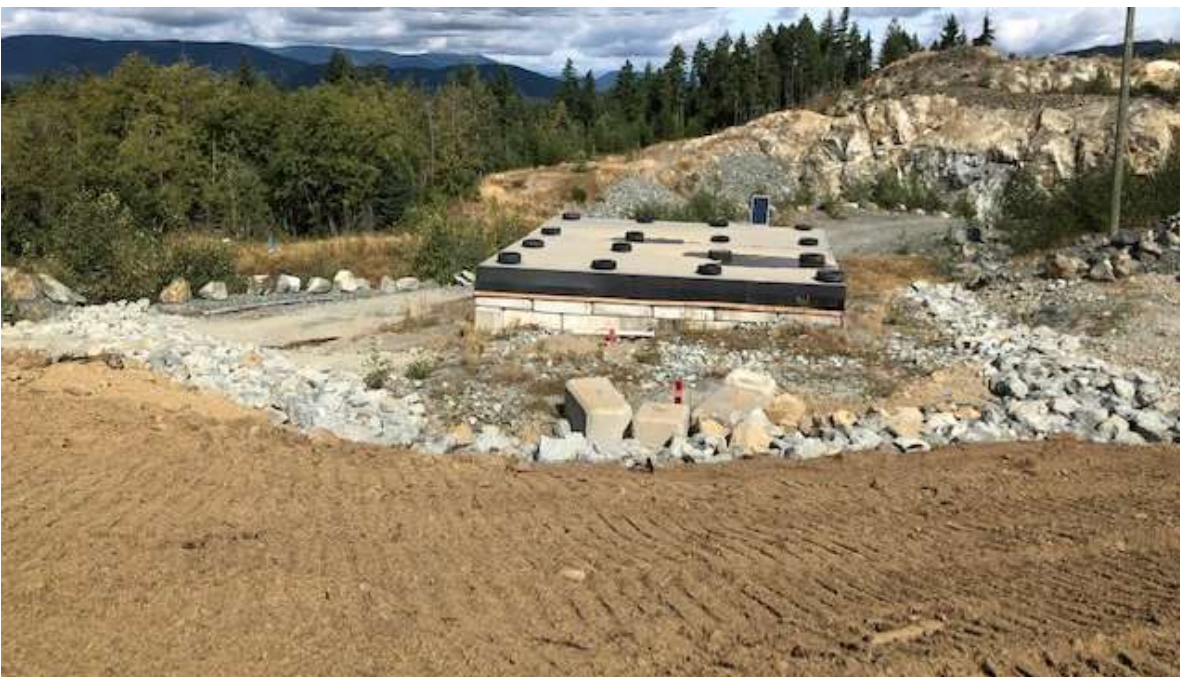
**Picture #5: Toe ditches complete at north slope**

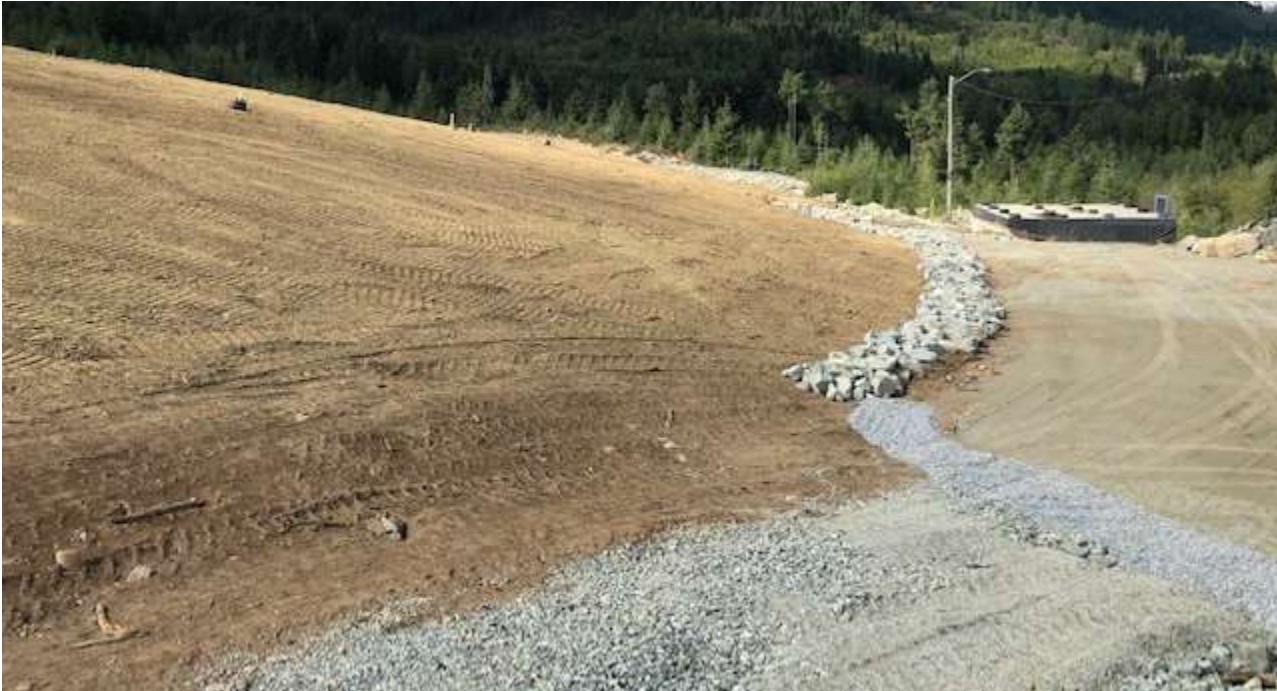
**Picture #6: North slope toe extended to achieve 5H:1V slope.**

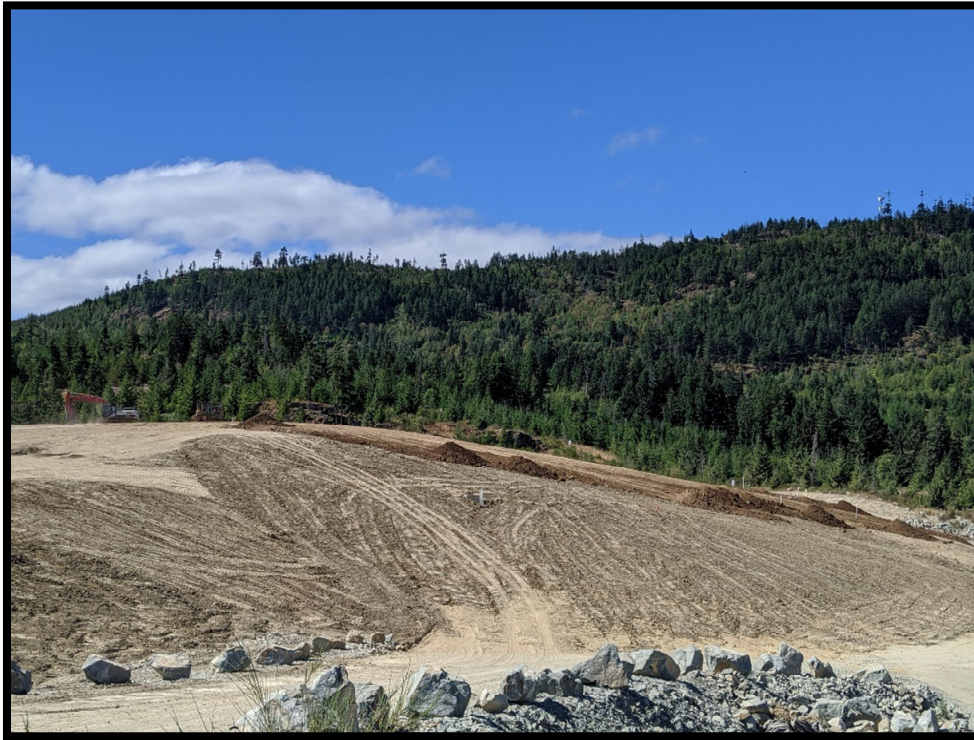
**Picture # 1:** Site overview looking southwest towards topsoil placement along the north and western sides of the PEA. Two rock trucks hauled material throughout the day to various locations to be graded out with an excavator, and bulldozer.

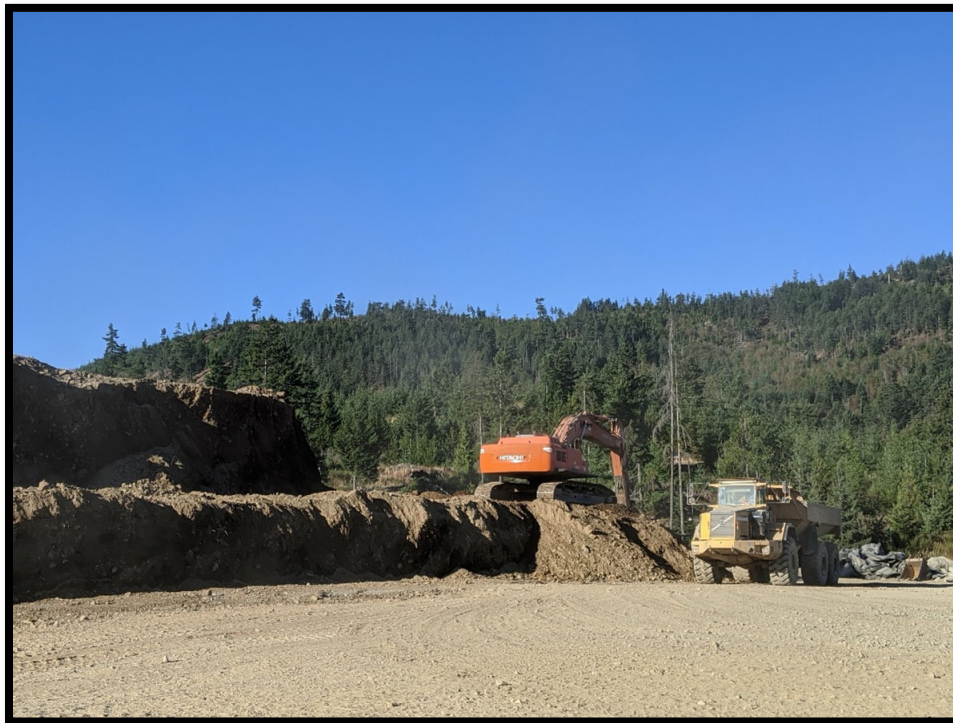
**Picture # 2:** Previously stockpiled topsoil material being loaded on to a rock truck. Larger rocks or unsuitable debris were removed from the topsoil prior to being loaded on to the rock trucks.

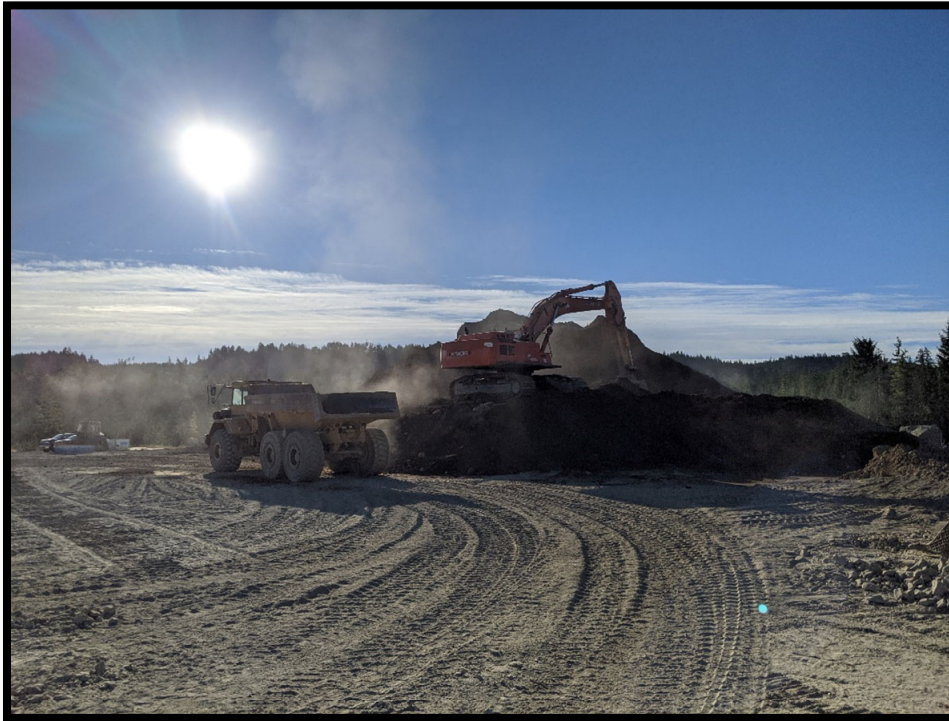
**Picture # 3:** Looking southeast towards an excavator loading a rock truck with stockpiled top soil material.

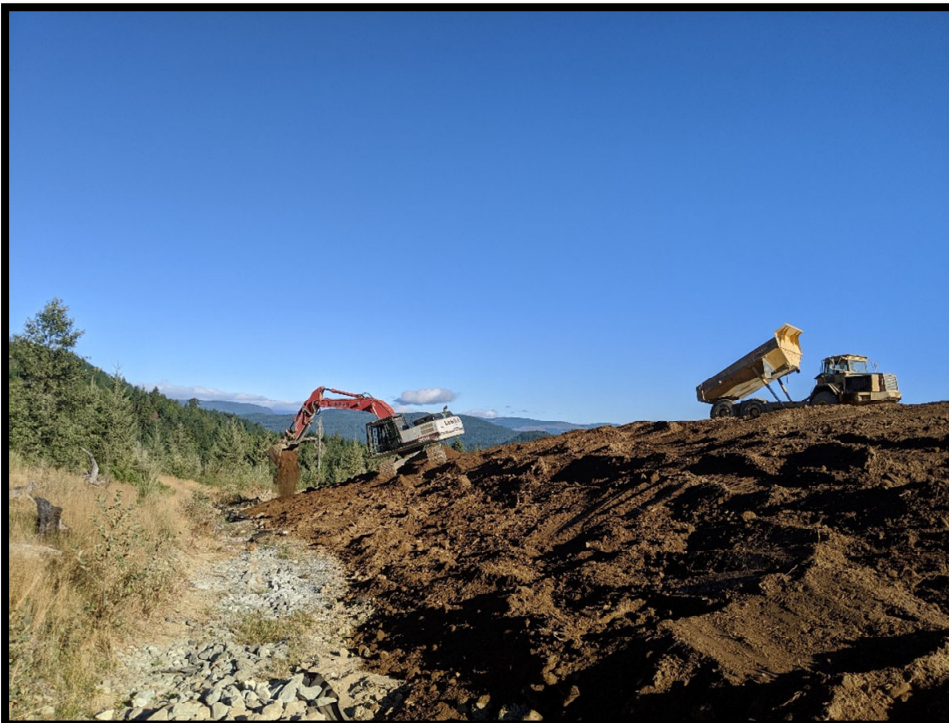
**Picture # 4:** Looking north along the western slope of the PEA towards topsoil being placed and graded.

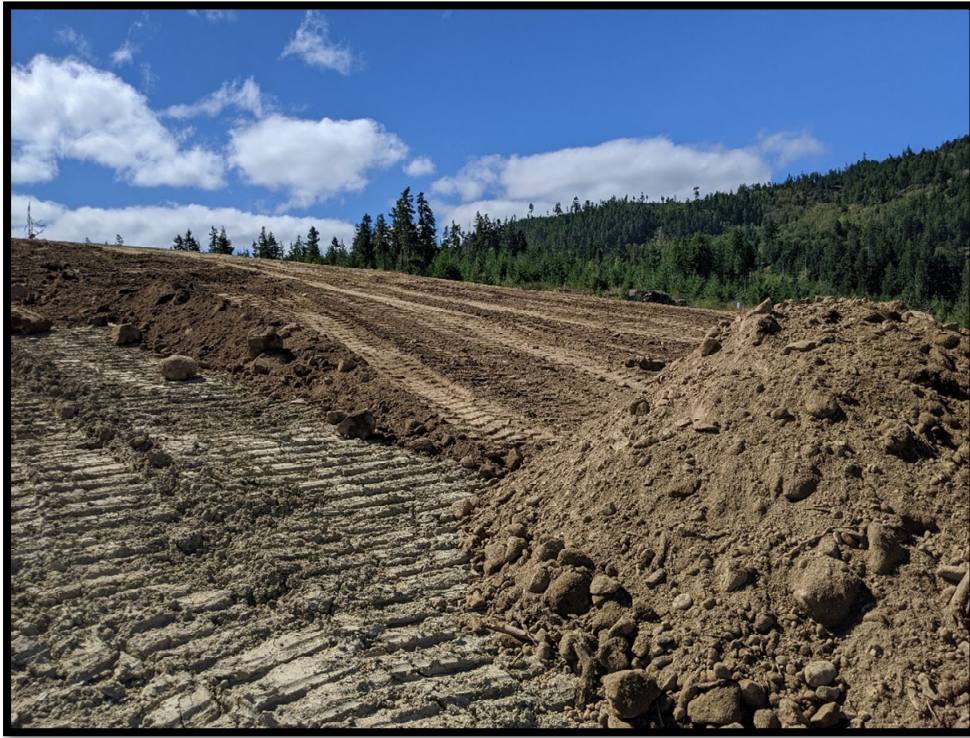
**Picture # 5:** Bulked in topsoil placed on the north side of the PEA prior to grading and track-packing.

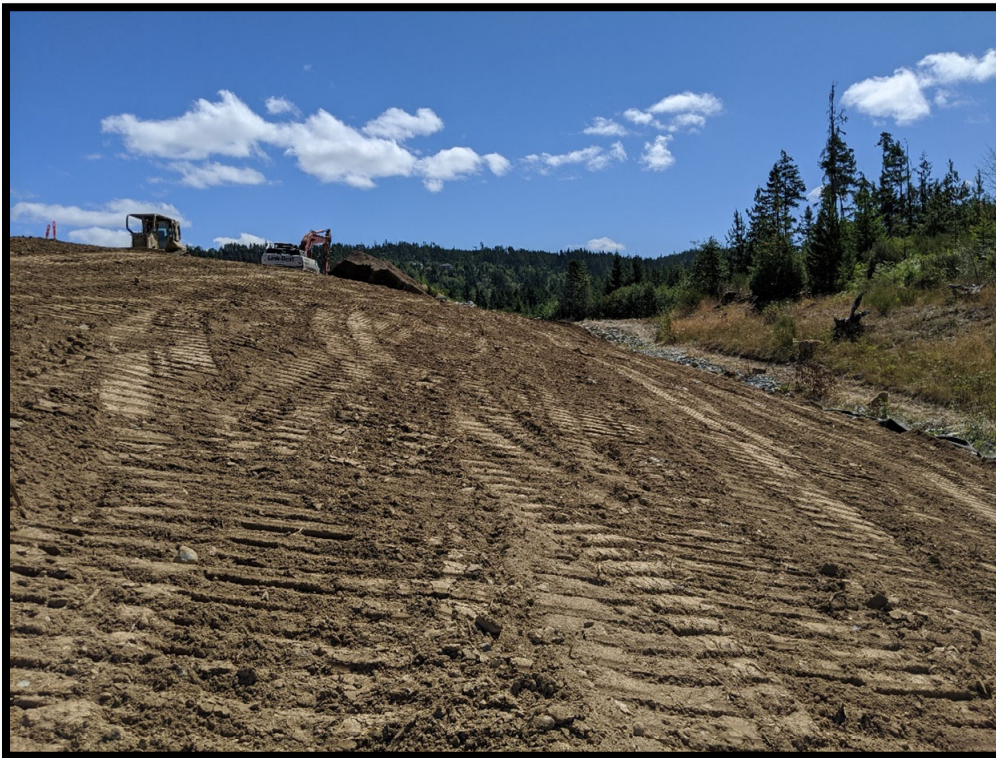
**Picture # 6:** Placed, graded and track-packed topsoil along the west side of the PEA. View is to the south.

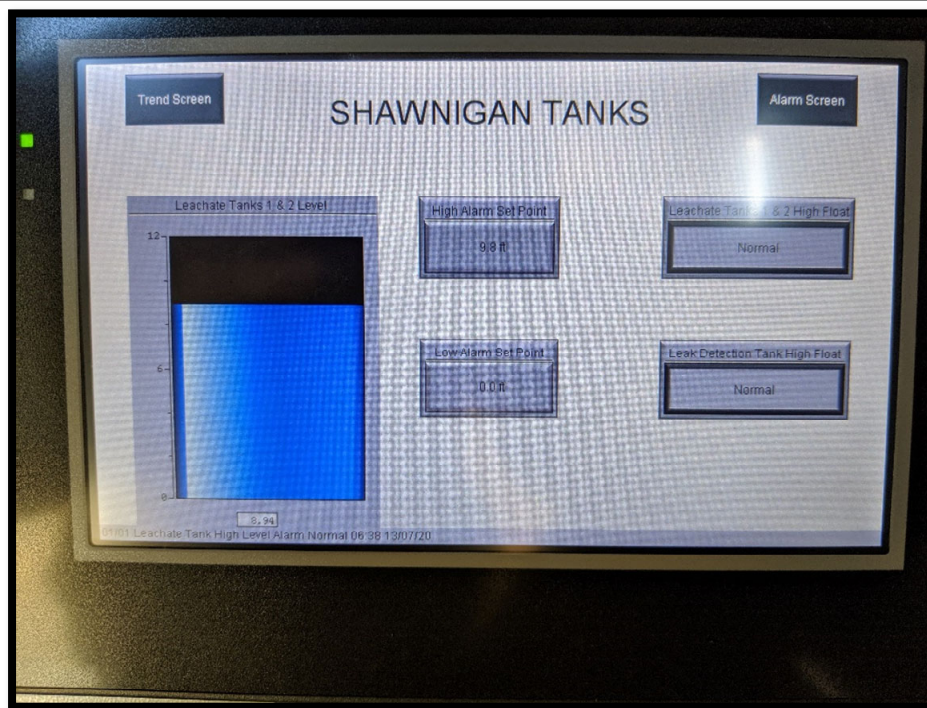
**Picture # 7:** Leachate display – 8.94 ft per tank.

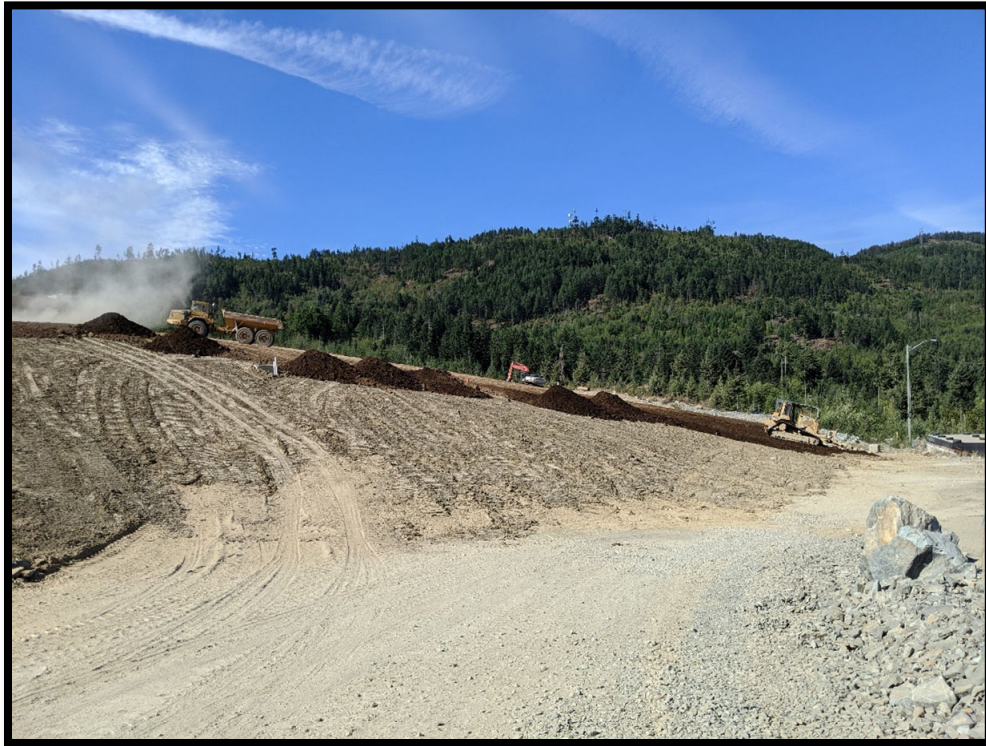
**Picture # 1:** Site overview looking southwest towards topsoil placement along the north and eastern sides of the PEA. Two rock trucks continued to haul material throughout the day to be graded out with a bulldozer.

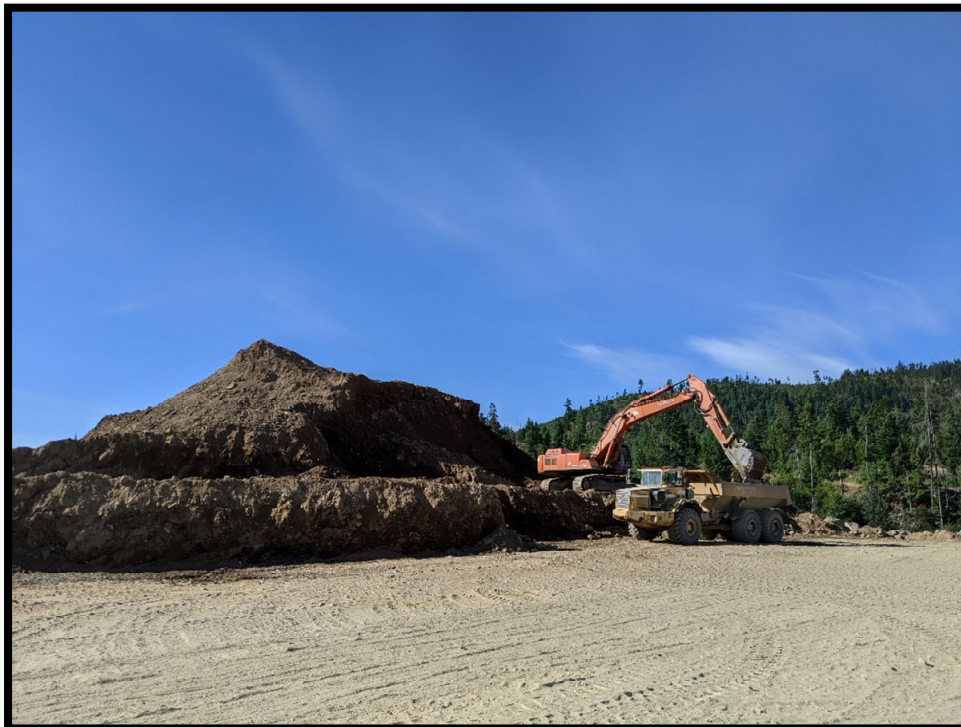
**Picture # 2:** Previously stockpiled topsoil material being loaded on to a rock truck for transport.

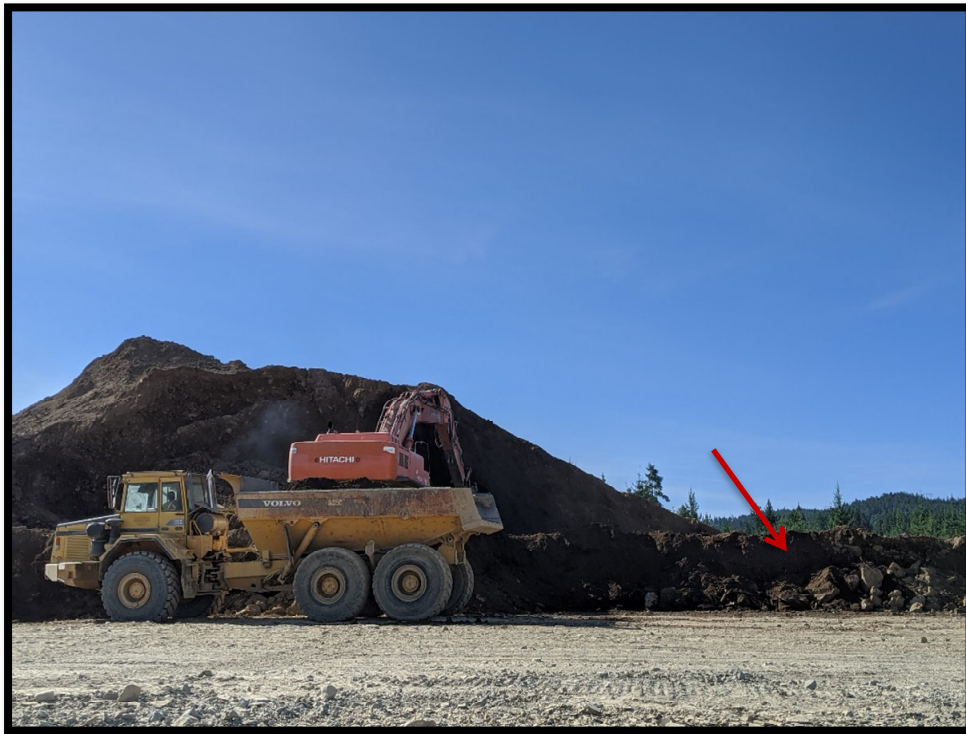
**Picture # 3:** Larger rocks were sorted out of the topsoil material (red arrow) prior to loading into the rock trucks for material transportation.

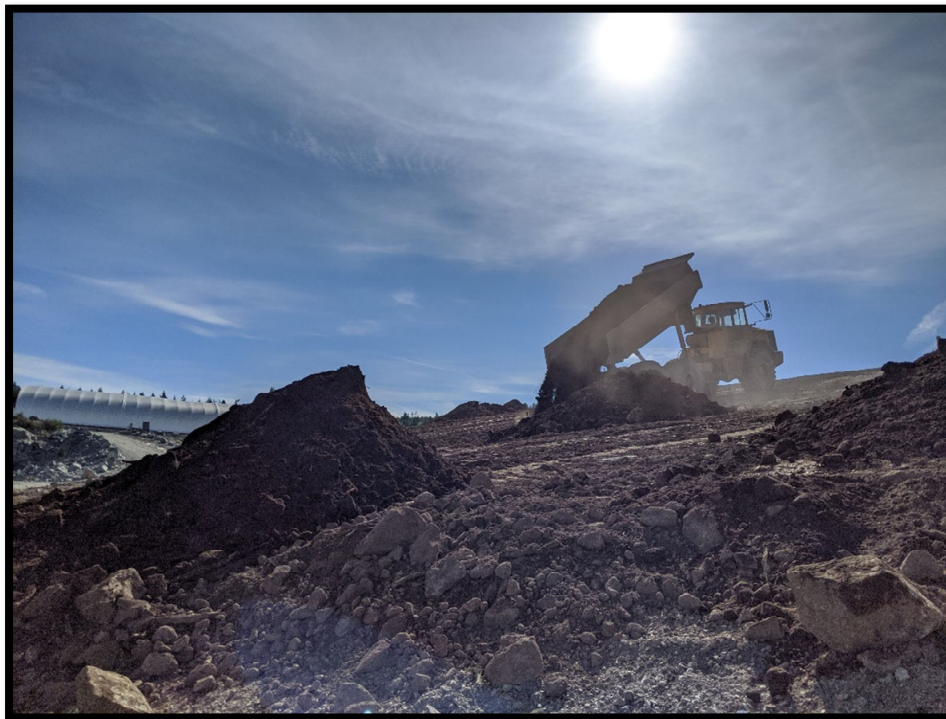
**Picture # 4:** Looking east along the north side of the PEA towards topsoil material being bulked in prior to being graded out via bulldozer.

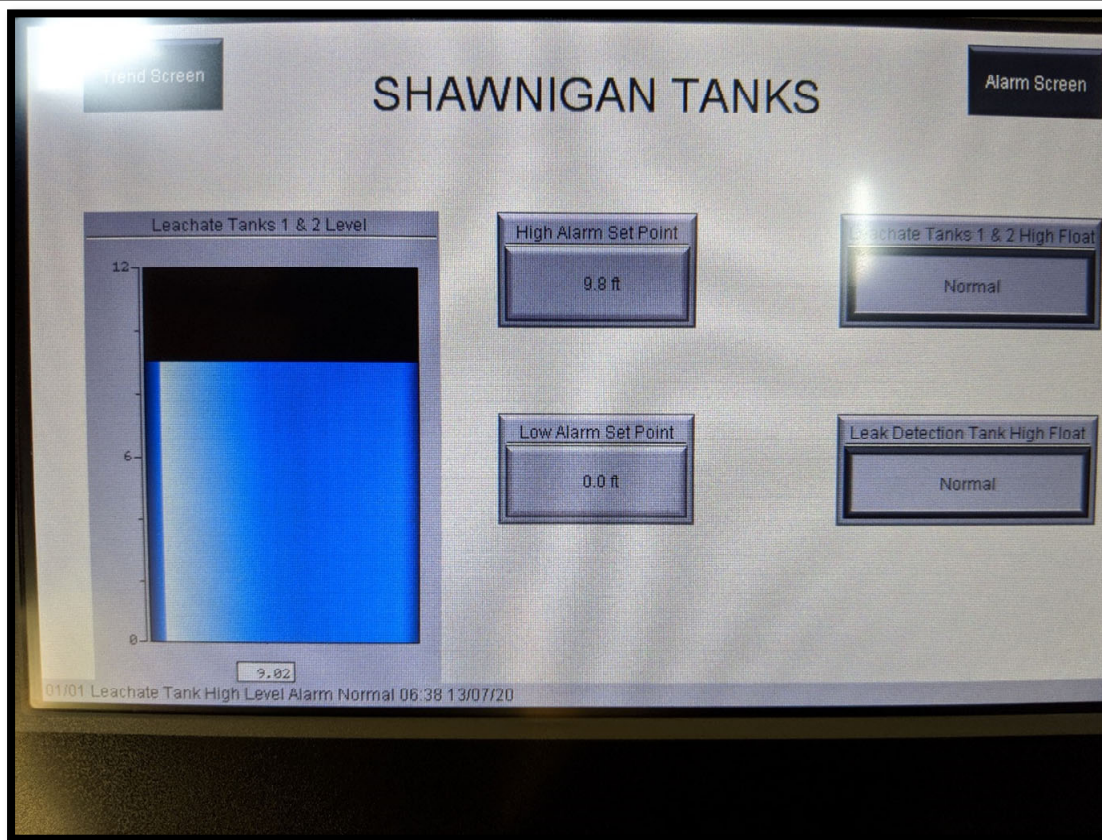
**Picture # 5:** Leachate display – 9.02 ft per tank.

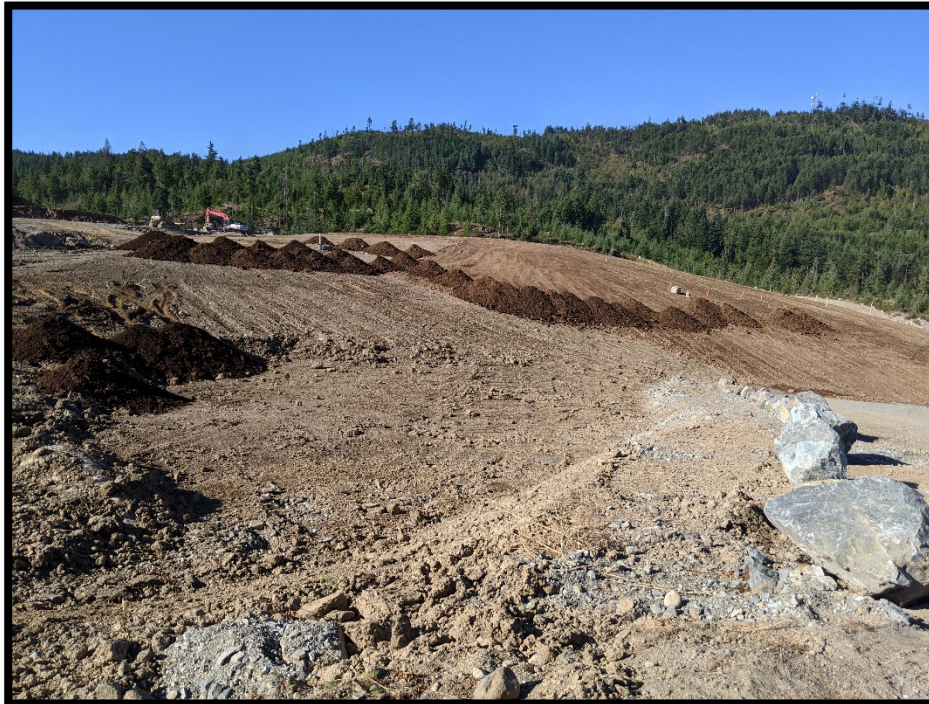
**Picture # 1:** Looking towards PEA from quarry entrance road – Contractor is moving previously stockpiled topsoil onto the PEA to increase thickness of cap, improve drainage and build out 5:1 slope.

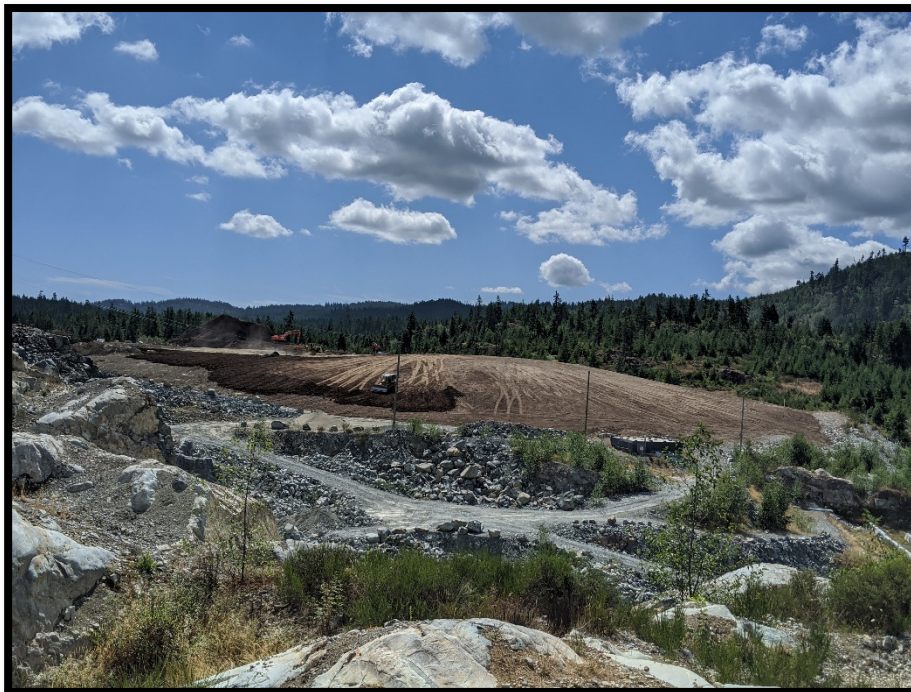
**Picture # 2:** Overview of PEA, looking south. Dozer is spreading soils down PEA slope.

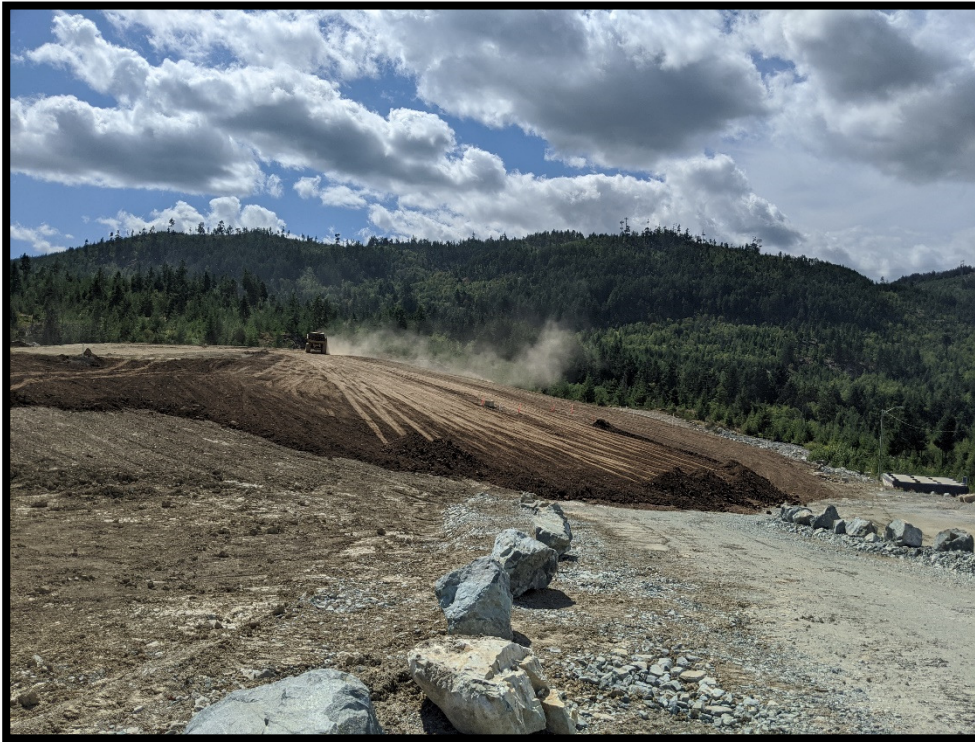
**Picture # 3:** View of PEA from quarry entrance road. Materials dumped onto PEA earlier in the day have been spread with dozer.

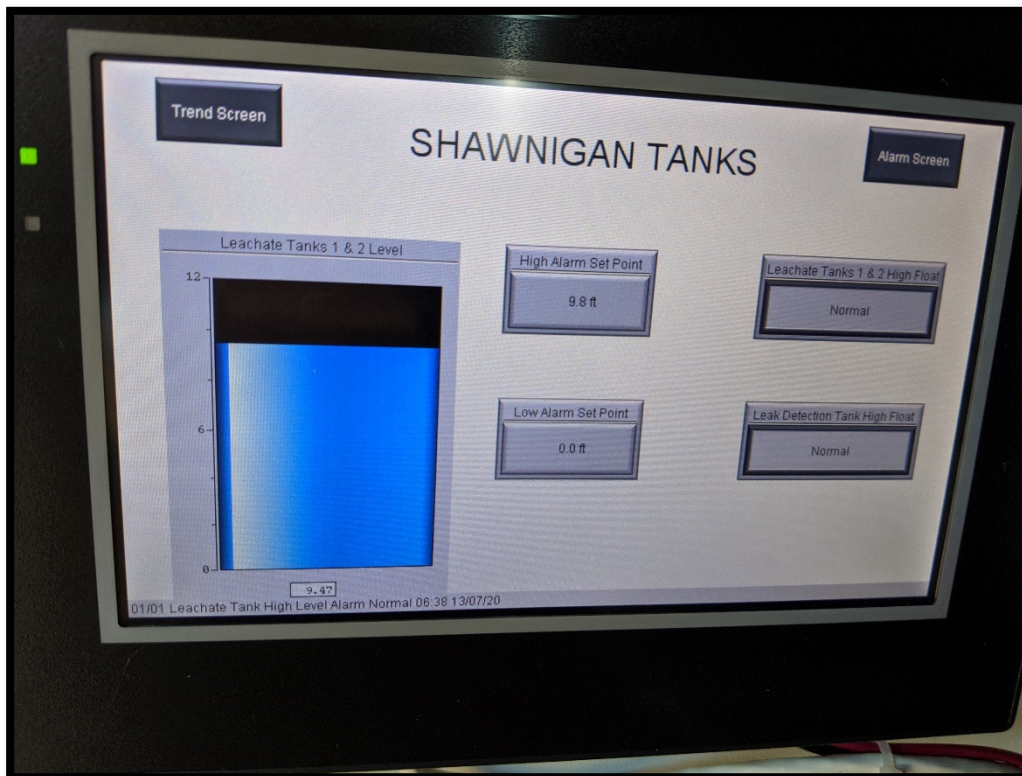
**Picture # 4:** Leachate display – 9.47 ft per tank.

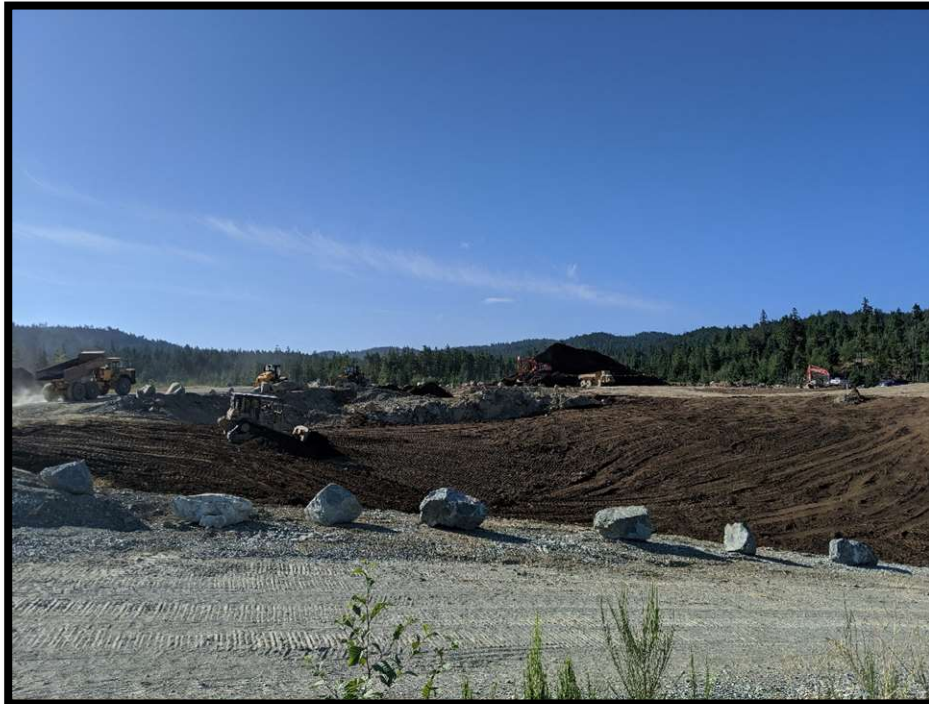
**Picture # 1:** Looking south towards topsoil material being graded out along the south side of the leachate facility access road. The final lift of PEA topsoil is expected to begin placement tomorrow and will be assisted by an on-site surveyor to provide spot elevations. Hydroseed placement is scheduled for Thursday August 27, 2020.

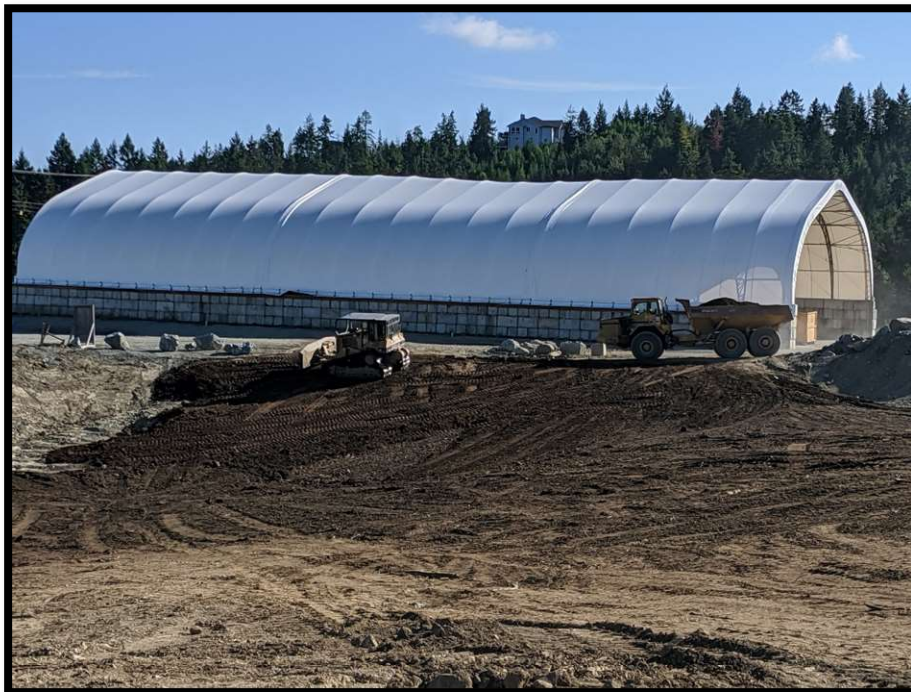
**Picture # 2:** Looking east towards topsoil material being graded out along the south side of the leachate facility access road.

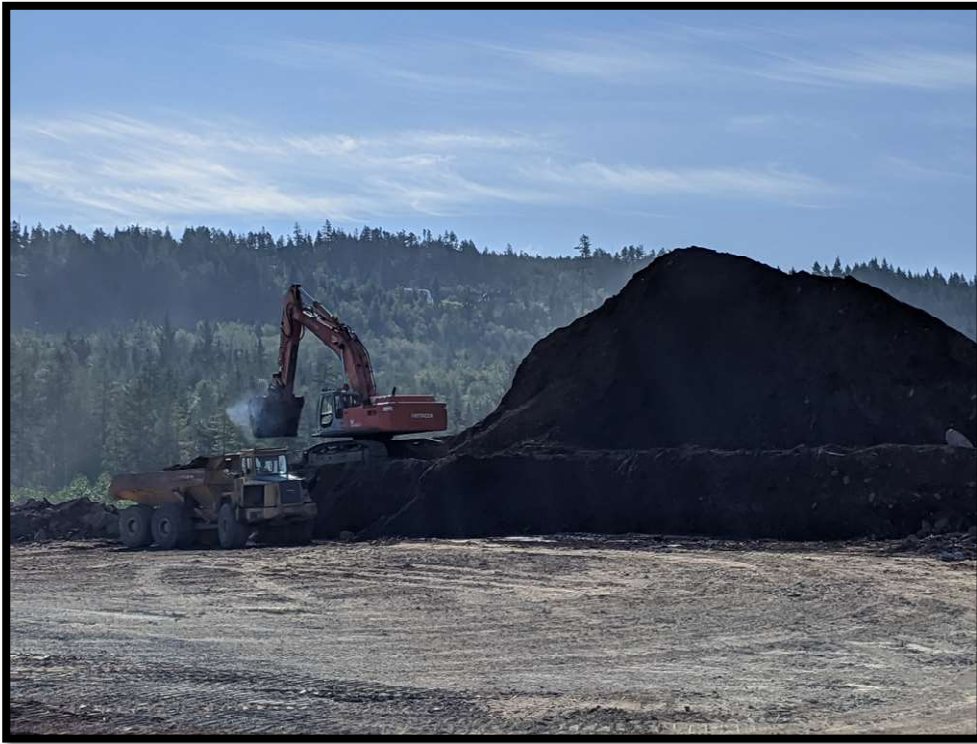
**Picture # 3:** Stockpiled topsoil material being loaded onto a rock truck to on-site transportation.

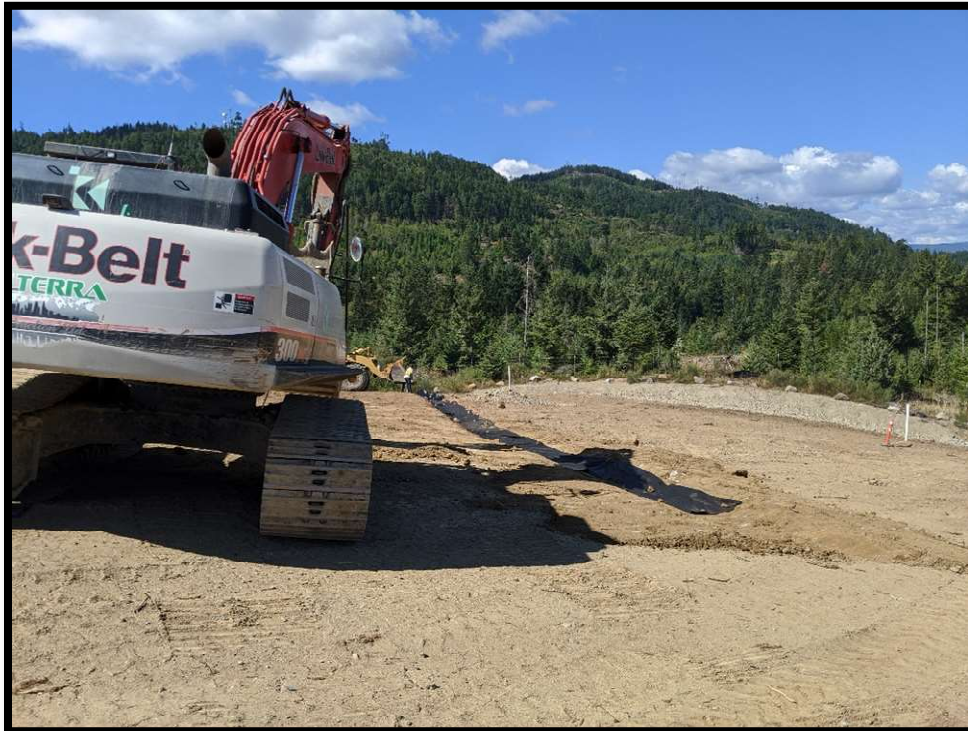
**Picture # 4:** Looking west along the north slope of the PEA towards the contractor installing a drainage control ditch. Geofabric was placed along the ditch prior to placing clear crush material. Drainage ditches are expected to be completed by tomorrow.

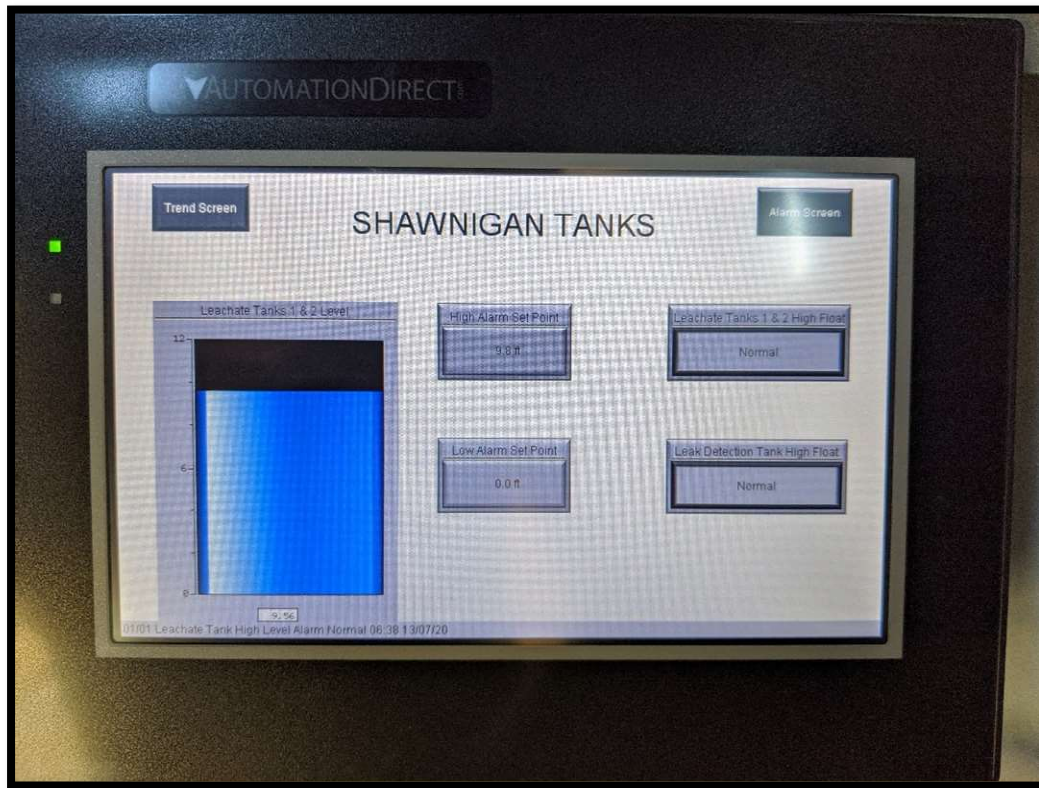
**Picture # 5:** Leachate display – 9.56 ft per tank.

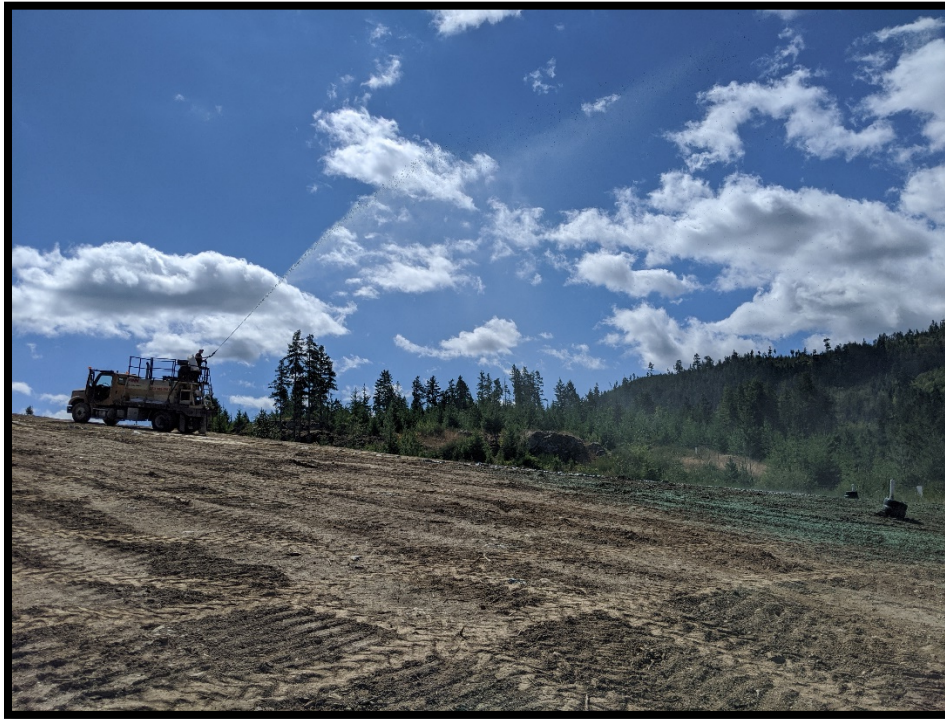
**Picture # 1:** Hydroseed contractor was on site for the duration of the day hydroseeding the previously placed topsoil over the PEA. View is to the southwest.

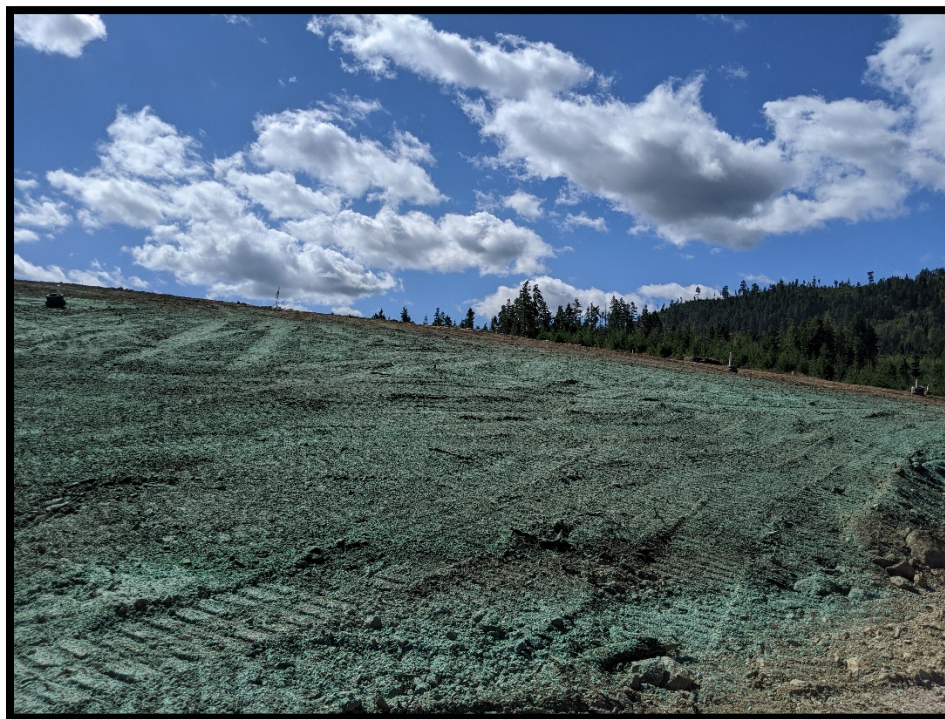
**Picture # 2:** Looking southwest from the northern toe of the PEA towards placed hydroseed.

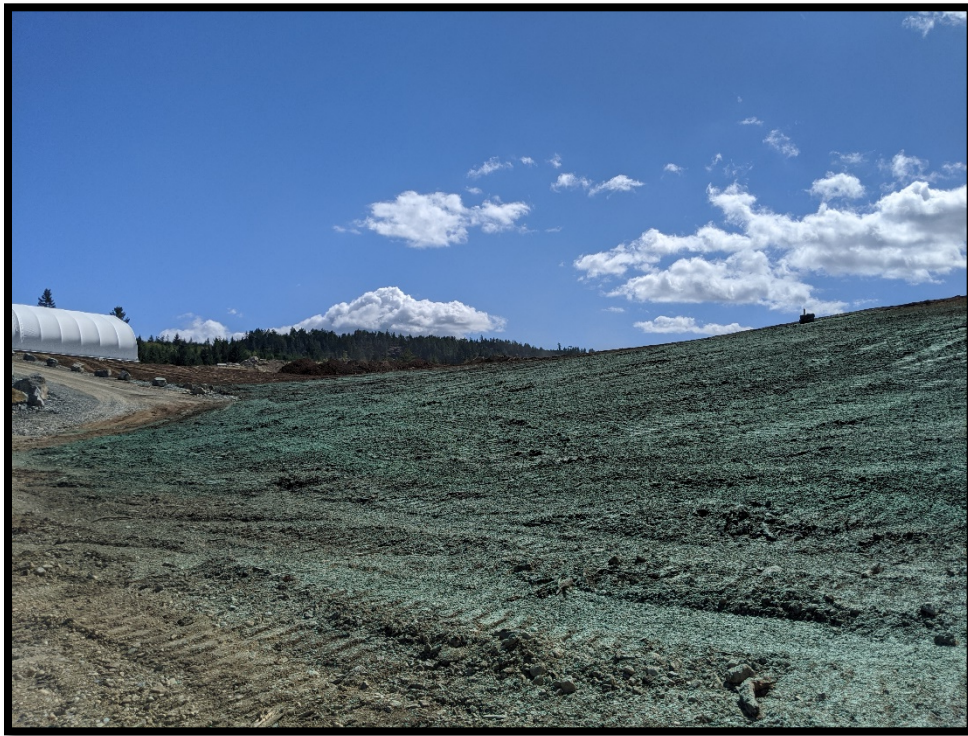
**Picture # 3:** Looking southeast from the northern toe of the PEA towards placed hydroseed.

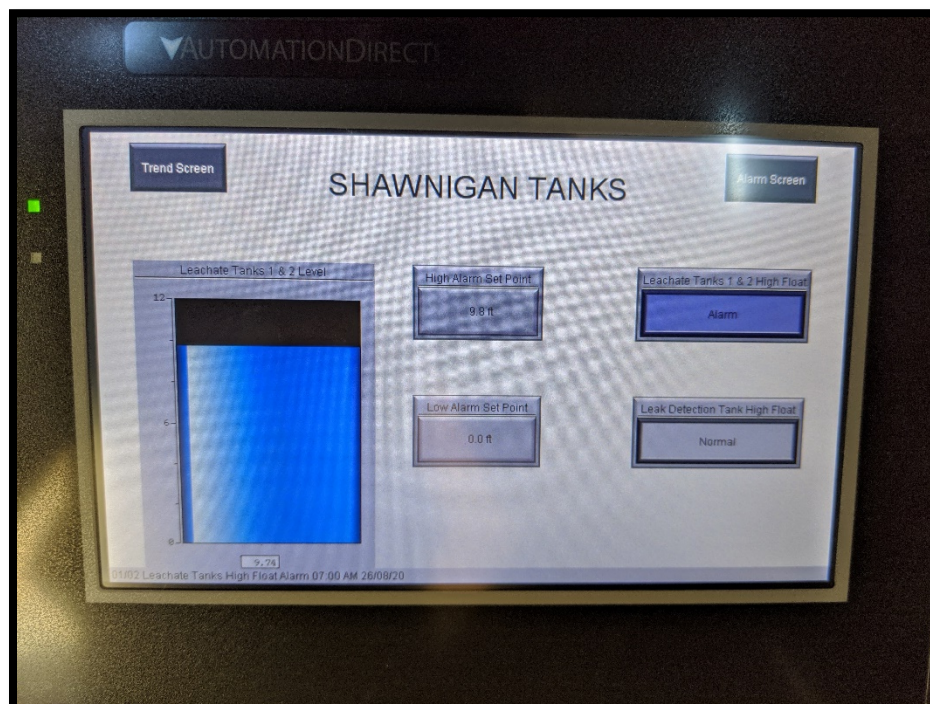
**Picture # 4:** Leachate display – 9.74 ft per tank.

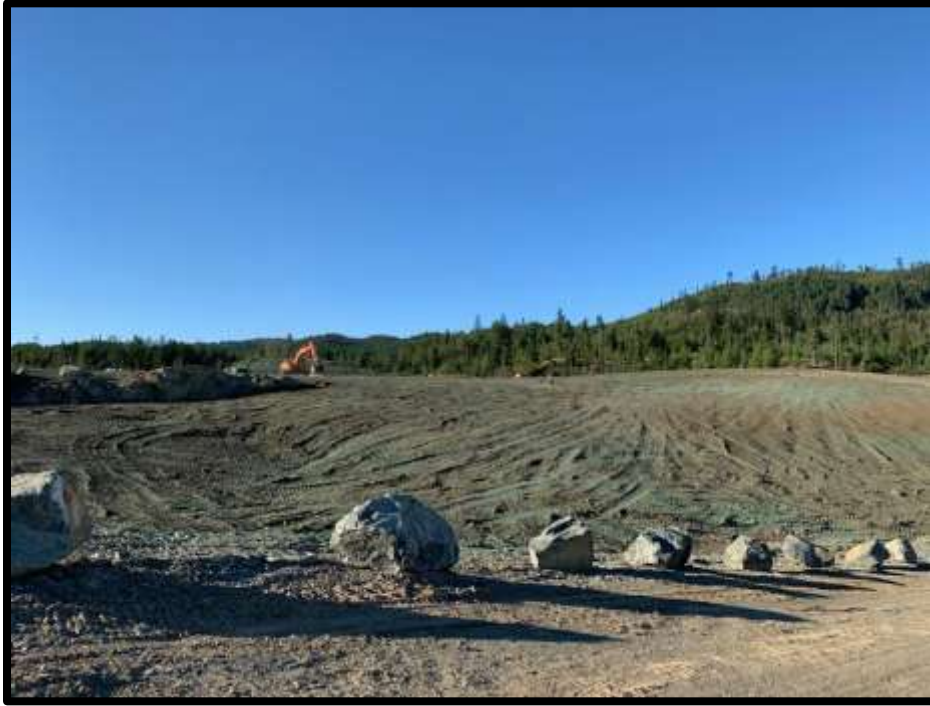
**Picture # 1:** Looking south towards hydroseeded PEA and rip rap that has been placed to delineate the edge of the road.
