## **BI-WEEKLY STATUS REPORT**

### **Cobble Hill Landfill Closure**

<b>PROJECT # : PRJ18074</b>	<b>File #:</b> 18074- BWR-75
<b>REPORT #:</b> 75	<b>Date:</b> August 30, 2020
<b>SHA REPRESENTATIVES:</b> Dr. Tony Sperling, P.Eng. Scott Garthwaite Carly Wolfe, EIT	<b>Owner:</b> Cobble Hill Holdings Ltd.  <b>Contractor:</b> Allterra Construction Ltd.

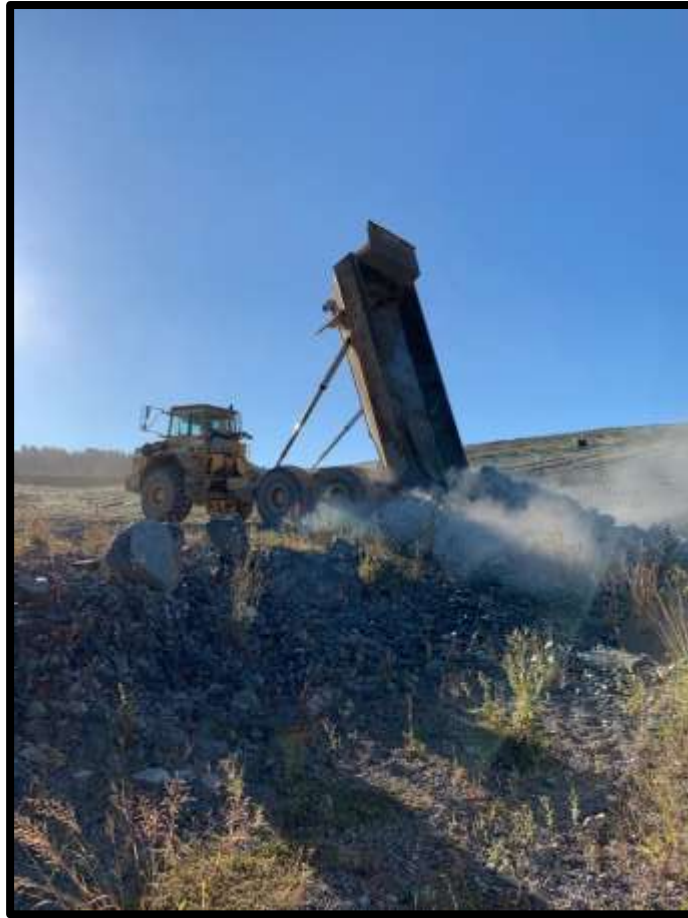
**Picture # 2:** Rock truck dumping rip rap to be placed along the toe of the PEA on the north end.

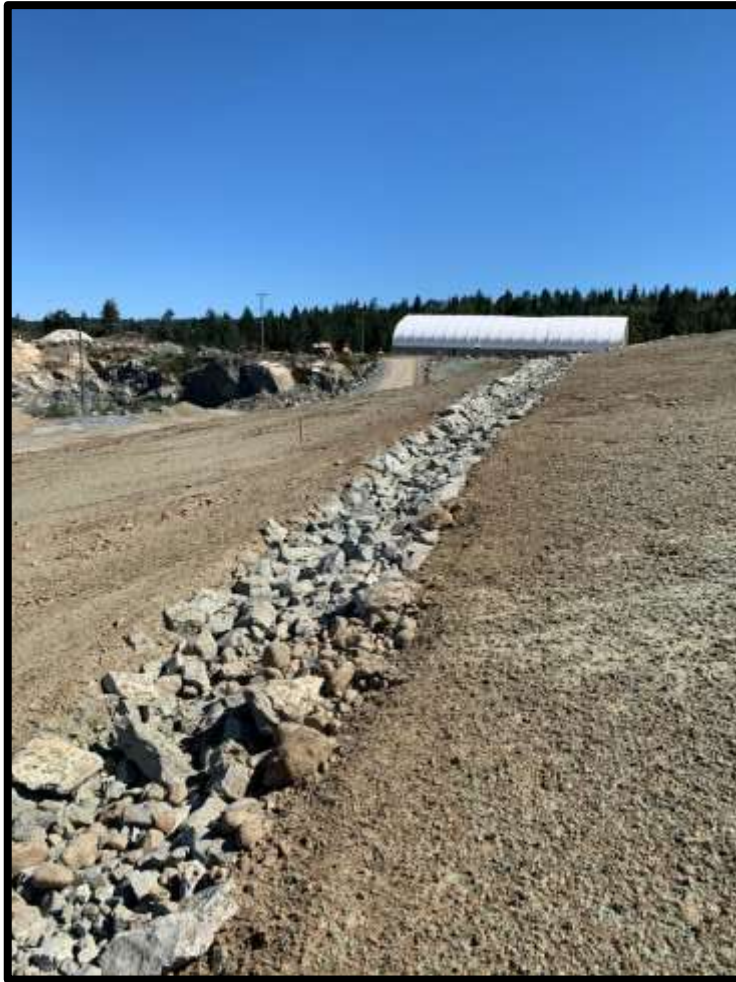
**Picture # 3:** Looking east along a drainage ditch that runs along the 5:1 slope of the PEA.

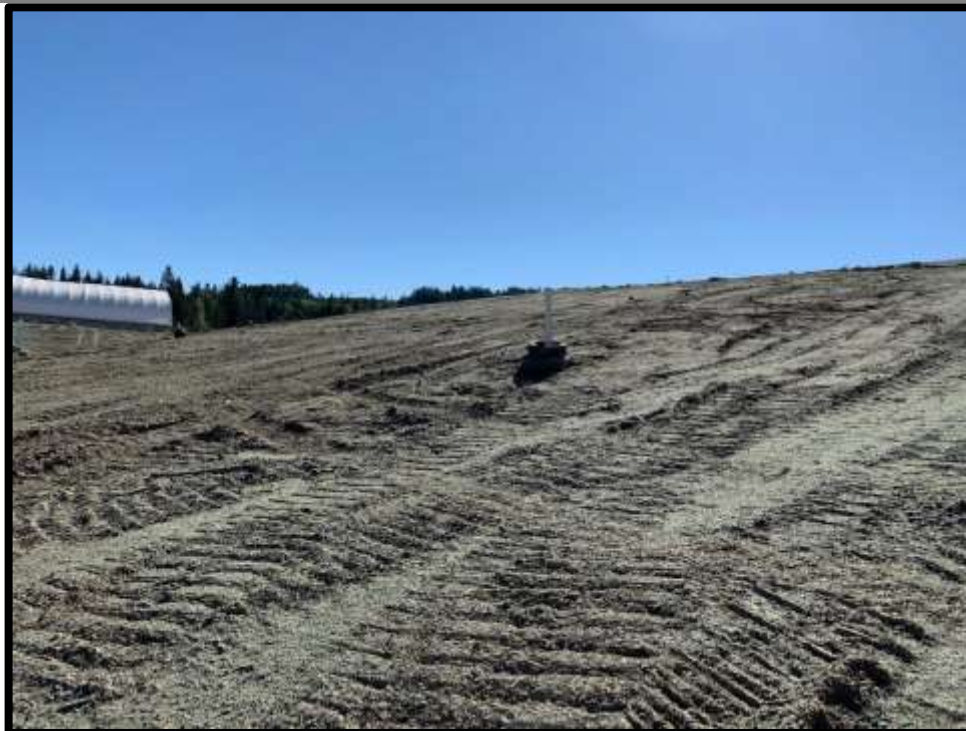
**Picture # 4:** Looking southeast, the PEA has been smoothed out and hydroseeding completed. Tires can be seen protecting the cleanouts and monitoring wells.

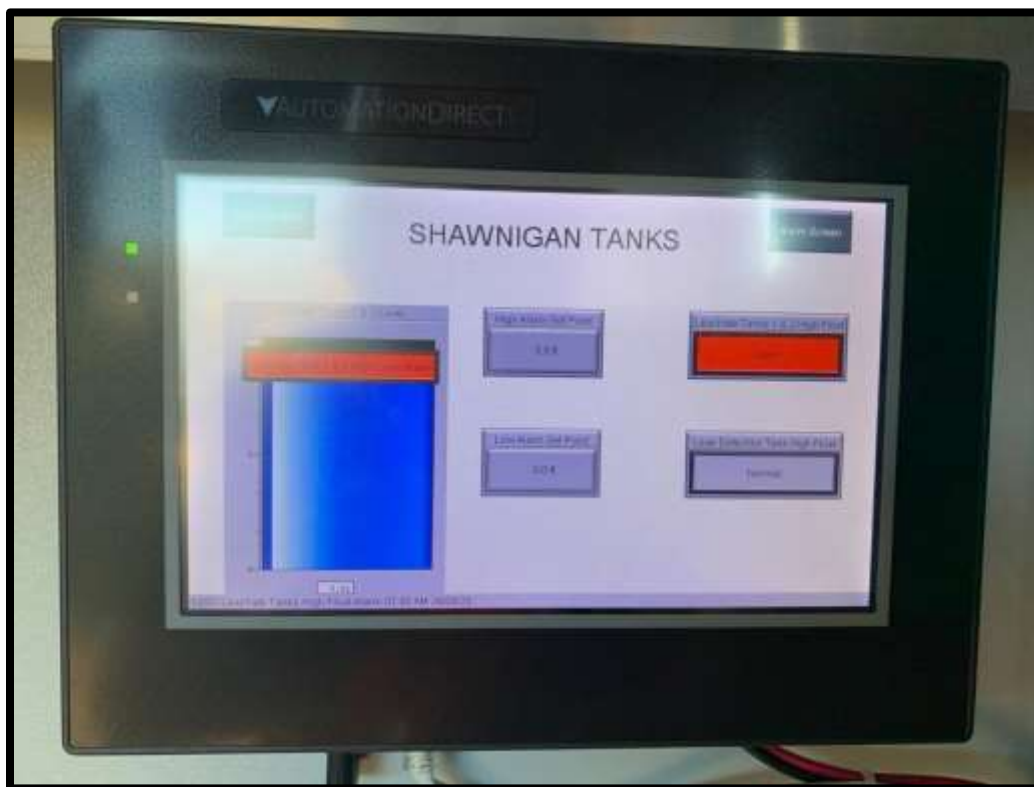
**Picture # 5:** Leachate display – 9.81 ft per tank.
