| FIELD REVIEW REPORT | | DATE: February 28, 2020 | ISLANDER PROJECT No.: 2087 |
| REPORT No: 63 | STAGE OF CONSTRUCTION: Landfill Closure | WEATHER: Rain 9°C | PAGE: 1 OF 4 |
| PROJECT: Cobble Hill Landfill Closure Construction | | | |

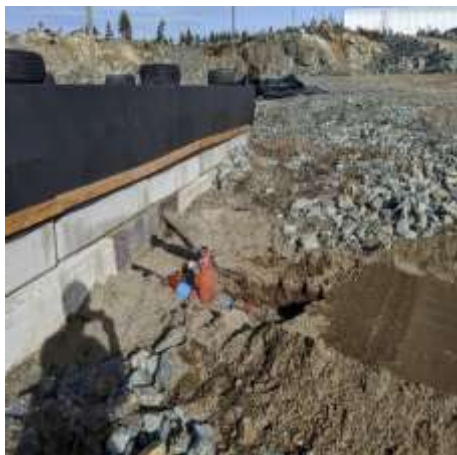
Leachate and Leak Detection Facility – Looking East -
Completed valve relocation

- Installation of a new valve on the leachate collection pipe directly in front of the collection tank building occurred this reporting period.
- *The results of inspections, repairs, quality controls and testing, in accordance with the quality management plan referenced in condition 5 of this approval;*
