Re: Third Party Review – Quesnel-Hydraulic Road/Slide

# Independent Review of Feasibility of Temporary Access Quesnel-Hydraulic Road landslide

*Quesnel, BC*

20397030-001-R-Rev0

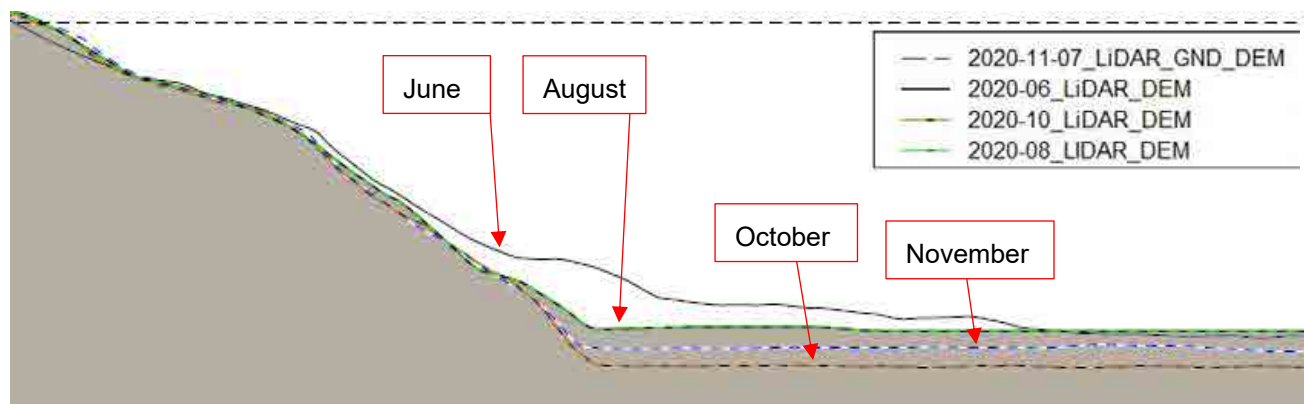
**Figure 1: Toe Erosion by Quesnel River**

Figure 1 shows the main landslide debris as present in June 2020 and then becoming eroded over the summer and fall of 2020. The slide debris/river bank is eroded about 10 m horizontally and up to 2 m or more vertically.

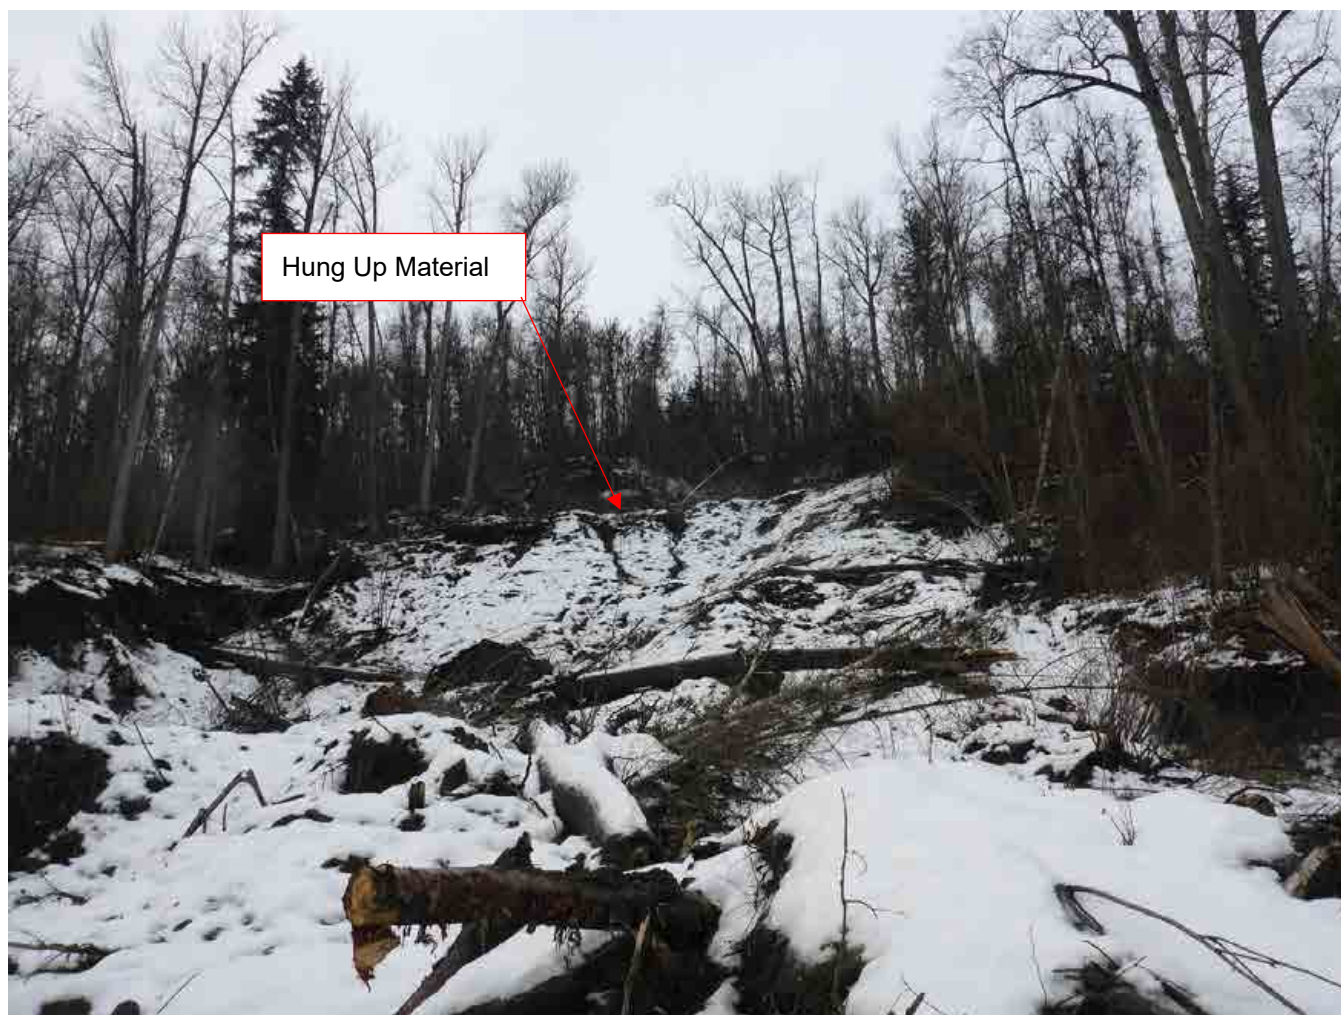
Photo 1: Slide B Looking Upslope at Hung up Material

Slide B on MoTI Figure 1 was observed in Photo 1 to have displaced a significant amount of debris into the Quesnel River as shown on Photo 2. Water with grey silt was observed flowing over the slide debris. Some saturated, very soft zones with sand and silt were noted, making travel over the debris difficult. Rounds of wood had been placed over the slide debris in spots indicating that the ground is/was very soft.

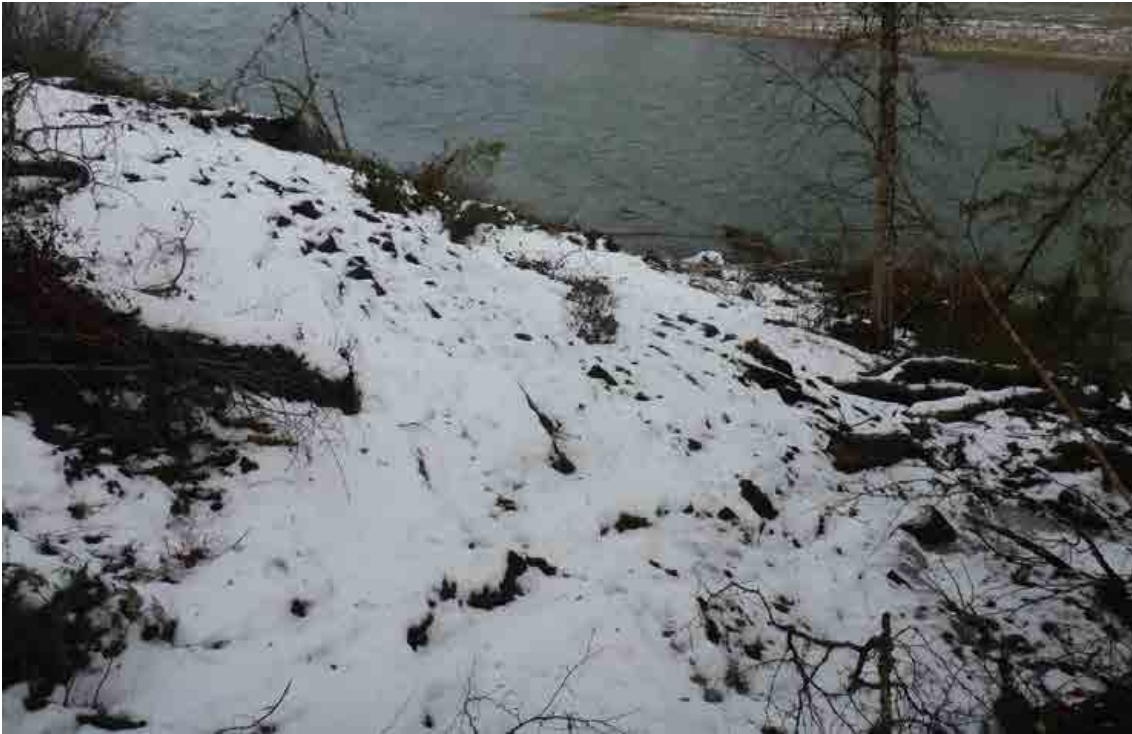
**Photo 3: Shows the Toe of Slide E**

Slide E has grown and merged with Slide C, Slide D and the larger Slide F. Photo 3 shows the toe of Slide E in the Quesnel River. Soils exposed within the flank of Slide E appeared to be compact silty, clayey sand with some gravel.

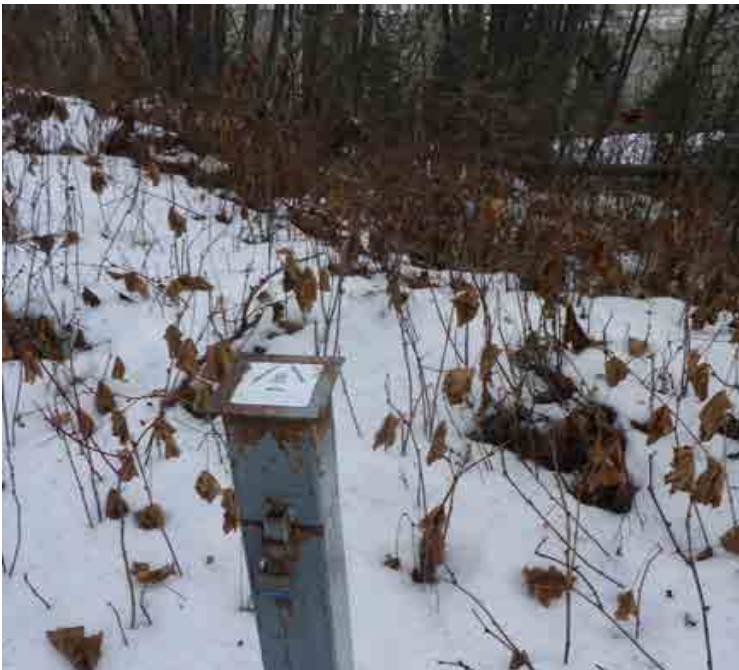
**Photo 4: TH03-4 Looking Downslope**

Golder traversed to the area of TH03-4 with installed slope inclinometer and piezometer as shown in Photo 4 below. It is understood that TH03-4 is located between Slide B and Slide E and may be within Slide F. However, the exact lateral extent of Slide F is not known.

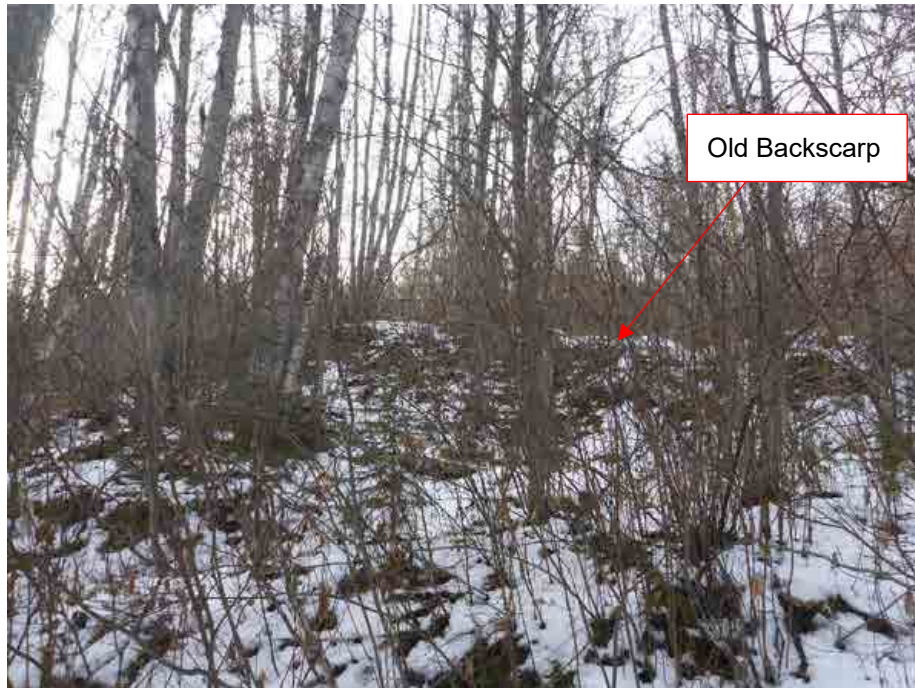
**Photo 5: Old Backscarp of Slide F**

This old backscarp, understood to be the remnant of Slide F, may have been part of the mapping completed by MoTI (2020). Numerous old trails and drainage ditches were observed on the slope. It is possible that these old trails and drainage ditches follow old backscarps due to their orientation. These old trails and drainage ditches are assumed to be part of the historical works described by GeoNorth. Golder observed a wet area with some water ponded above slide B as shown in Photo 6 and Photo 7 which may be the location observed in Golder's air photo review.

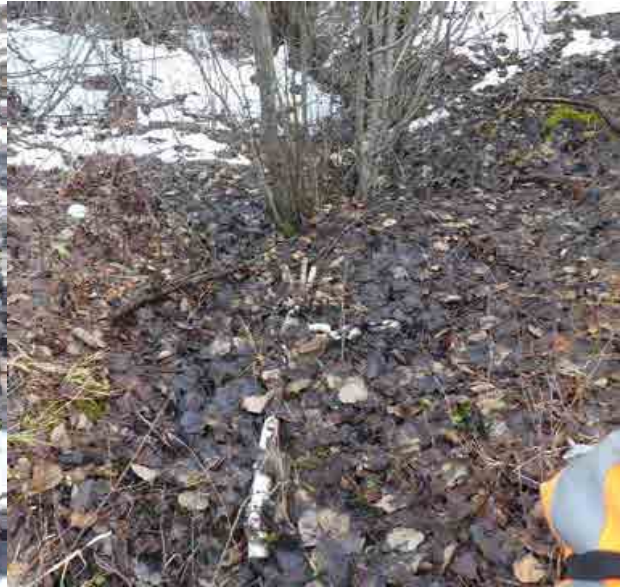
**Photo 7: Water on Slope**

The water may have originated from melt upslope or be seepage and funnelled into a slight swale as shown in Photo 7.

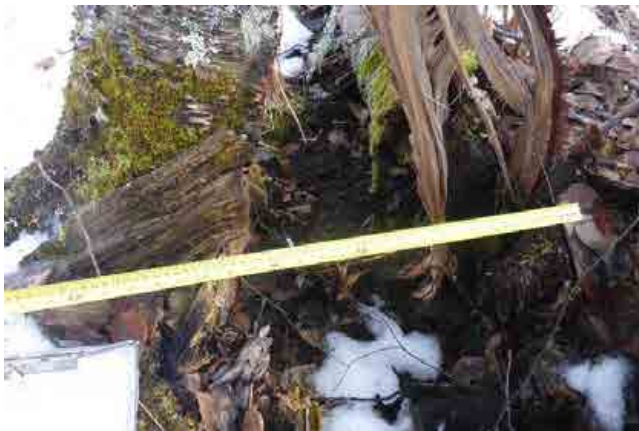
**Photo 8: 0.4 m Split Tree**

Golder traversed to the area between Slide A and Slide B and observed trees split and cracked with between 0.4 m to 0.8 m of displacement observed in the split trees as shown in Photo 8 and Photo 9.

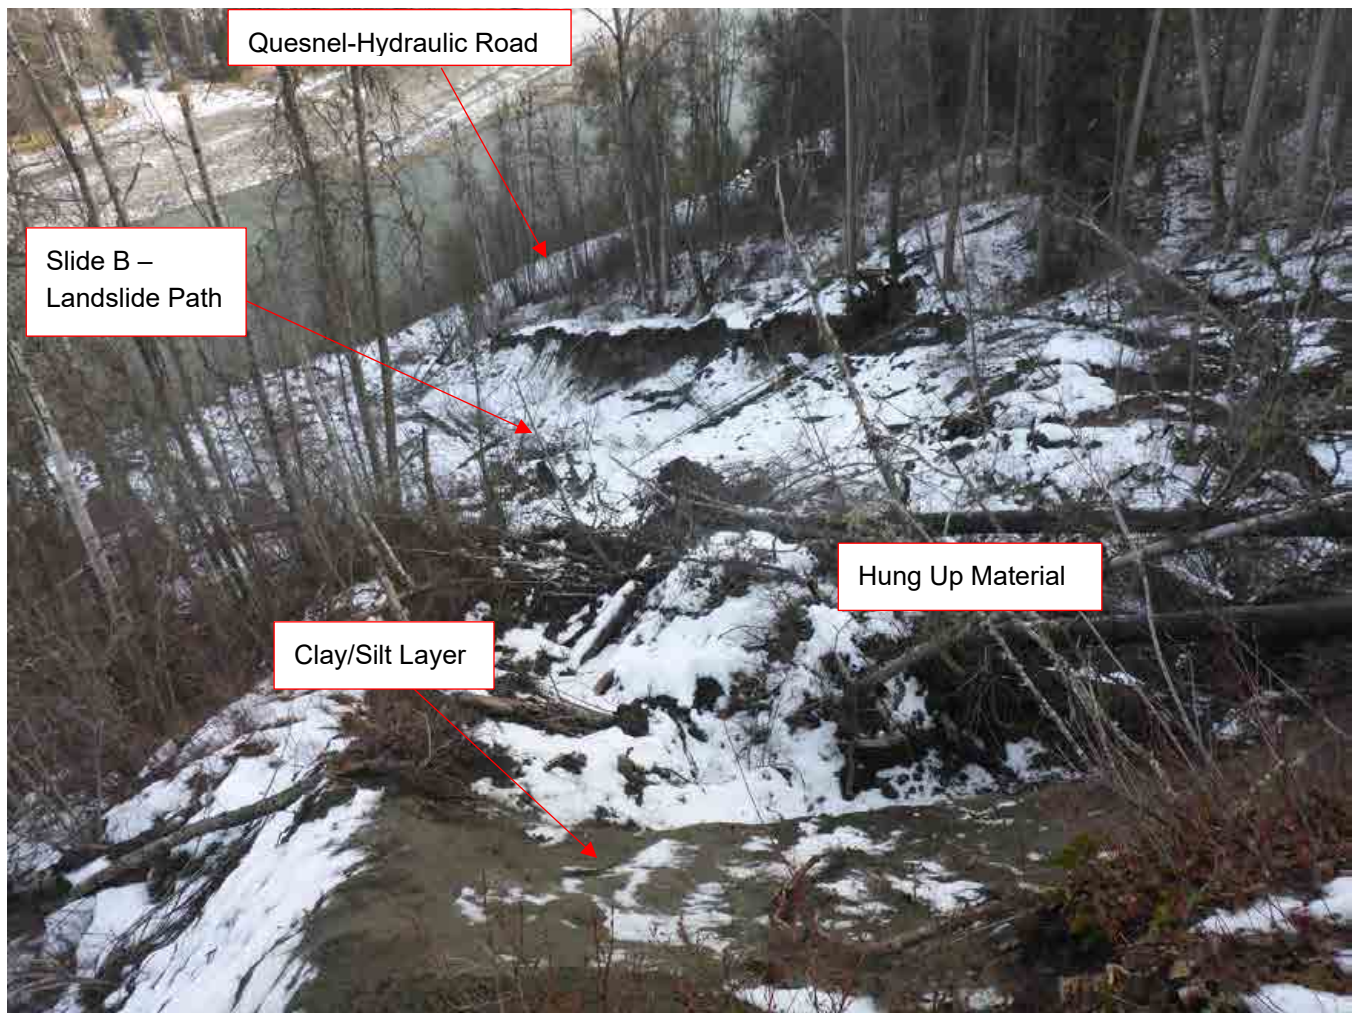
From the area between Slide A and Slide B, the landslide paths were observed and the top of the “hung up material” observed in Photo 1 and shown on MoTI Figure 1. The “hung up material” was estimated to be approximately 8 m to 10 m below the main backscarp as shown in Photo 10. The soils observed above this “hung up material” appeared to be clay/silt overlain by sand. The clay/silt appeared to have some water on it and ice was observed within the sand indicating that likely water is flowing at the interface between the clay/silt and sand.

Photo 10: Slide B: Looking Downslope at Block of Debris and Possible Clay Layer
