**RE: Compliance with permit PR-105809**

Attached is the report for the inspection that was conducted at 460 Stebbings Road on November 14, 2015.

Ministry of Environment  
**Inspection Record**

Authorization: PR-105809	Cobble Hill Holdings Ltd. (BC0754588)
CVIS IR #:	November 14, 2015 Site Inspection Photos

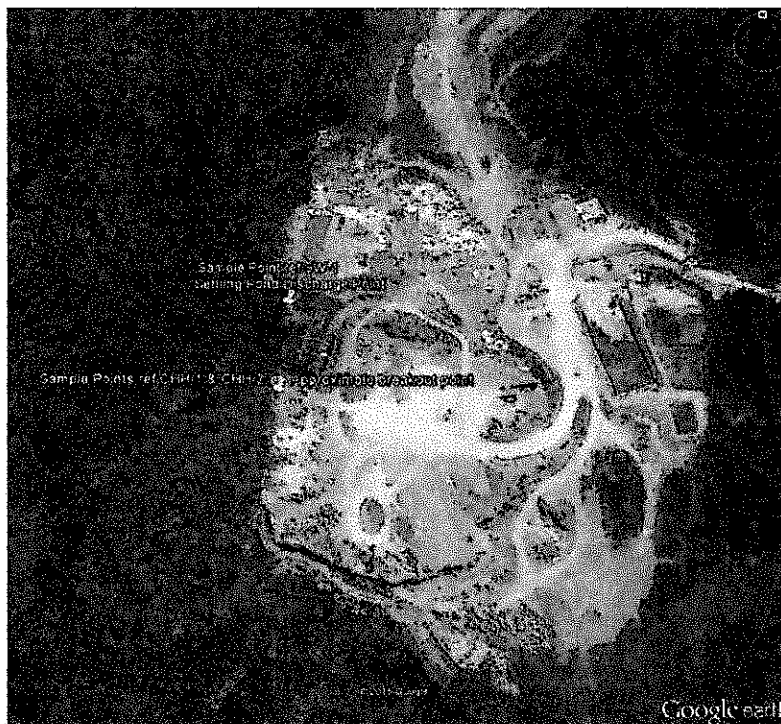
Photo 1

Site Map  
with  
approx.  
sample  
points for  
reference

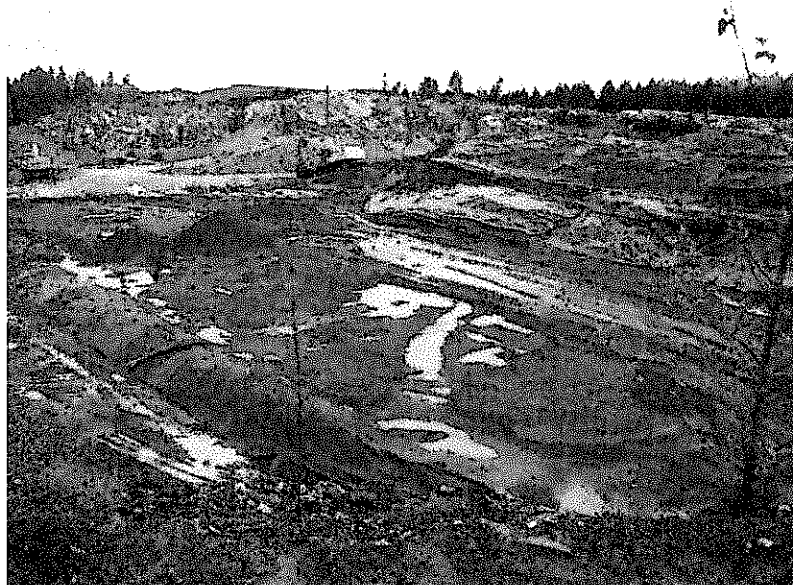
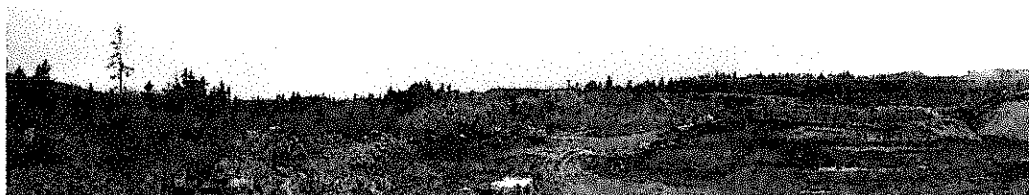
Photo 2

Contained  
landfill area  
and 180°  
view of site  
looking  
north (Nov  
14)

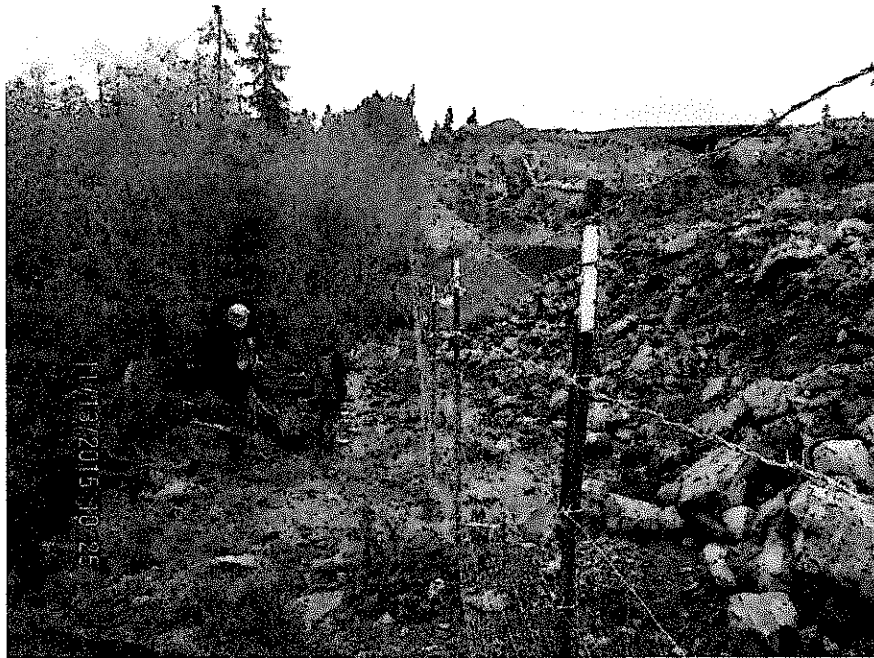
Photo 3

Westside perimeter surface runoff collection and diversion ditches as shown on Figure A were not complete and in operation while discharging.

CVRD  
Bylaw  
photo from  
Nov 13  
a.m., prior  
to channel  
diversion  
looking  
north

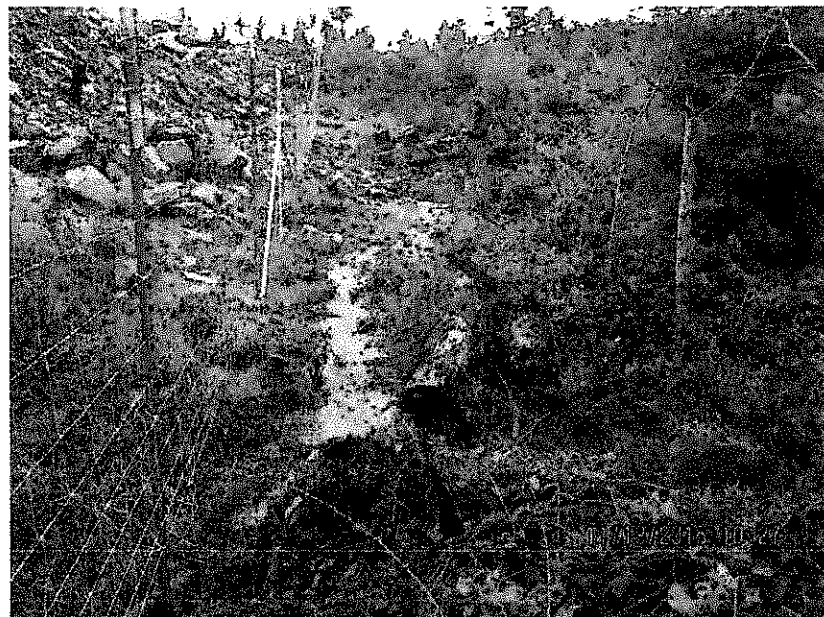
Photo 4

CVRD  
Bylaw  
photo from  
Nov 13  
a.m., prior  
to channel  
diversion  
looking  
south

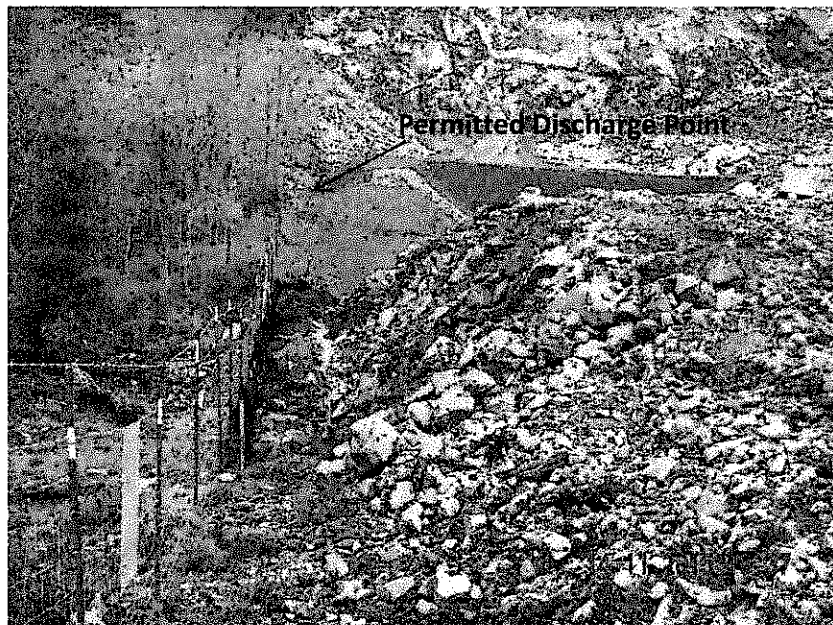
Photo 5

The water management system did not divert and channel the seepage from the toe of the disturbed earth and rock pile at the west boundary effectively to the settling pond at a time of high precipitation, i.e. works were not maintained in good working order in contravention with section 2.12 of the permit and in accordance with the Environmental Procedures Manual, Rev 1.0 (July 2015) sections 7.2 and 7.8. In further contravention of section 2.12, the permittee did not immediately notify the Director upon discovery of the water leaving the property boundary. Director was first notified by CVRD bylaw officer Nino Morano on the morning of the event. Permittee was cooperative and thoroughly responsive and took appropriate remedial action as required. Emergency procedures were followed as prescribed by the ERP.

Site of  
seepage.  
Ditching  
and silt  
fencing  
installed  
Nov 13

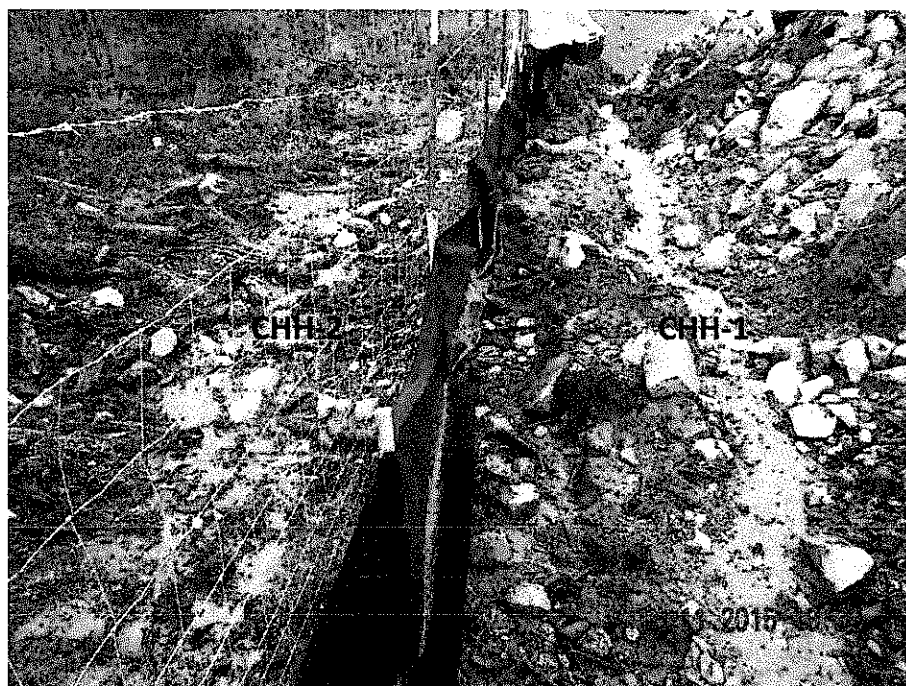
Photo 6

Nov 14 Sample  
sites on either  
side of western  
perimeter fence  
(CHH-1 – inside  
perimeter; CHH-2  
– outside  
perimeter)

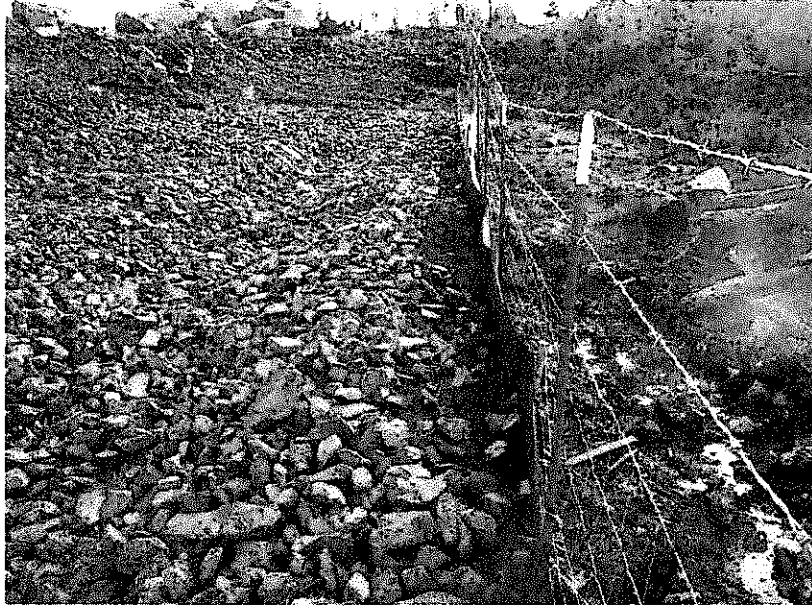
Photo 7

Nov 17 photo shows perimeter ditching lengthened, widened, lined with geotextile, and covered with clear crushed rock.

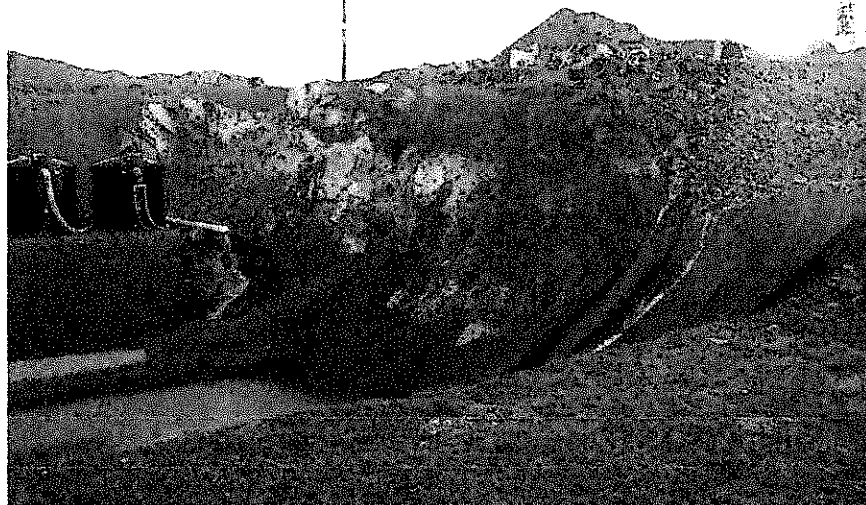
Photo 8

Nov 17 perimeter ditching channeling to settling pond

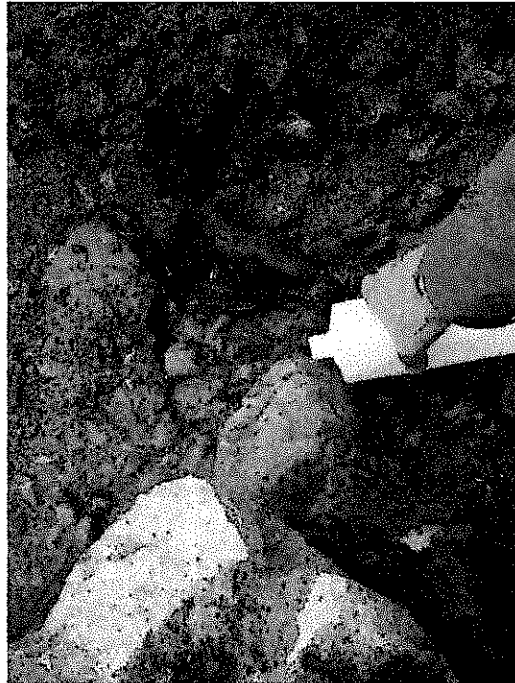
Photo 7

Sample CHH-1  
inside west  
perimeter fence  
(Nov 14)

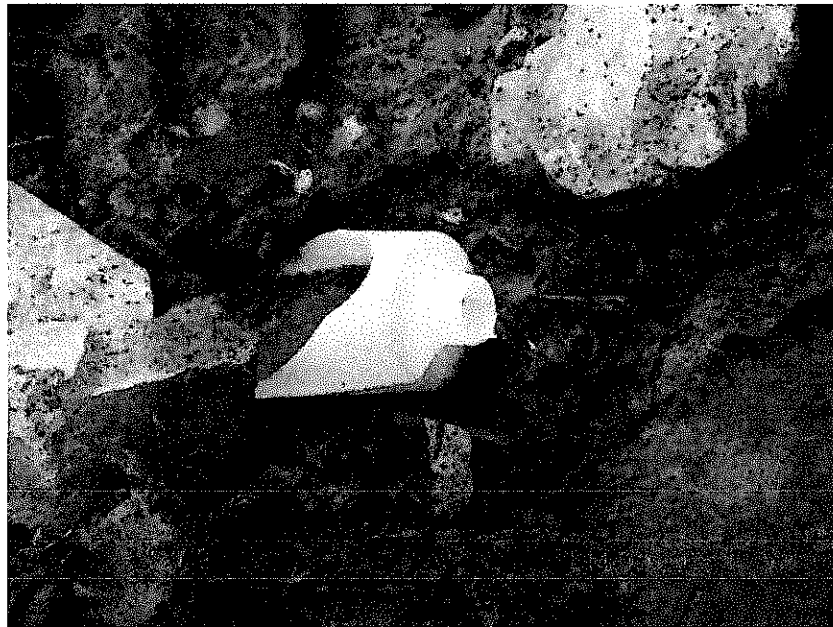
Photo 8

CHH-2 sample  
site, outer  
perimeter. Note  
spout fashioned  
from lab bottle  
to allow sufficient  
flow volume and  
depth to sample  
from trickle (Nov  
14)

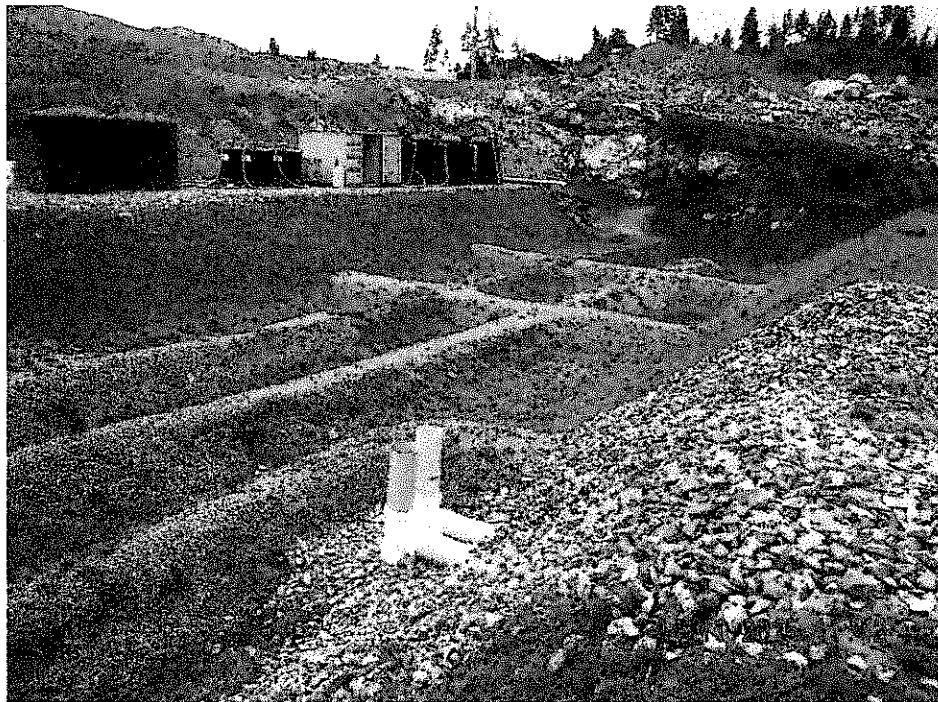
Photo 9

Settling pond on Nov 14. Note no significant standing water. Pond was discharging through outlet on the day previous to the inspection (Nov 13) during periods of high precipitation

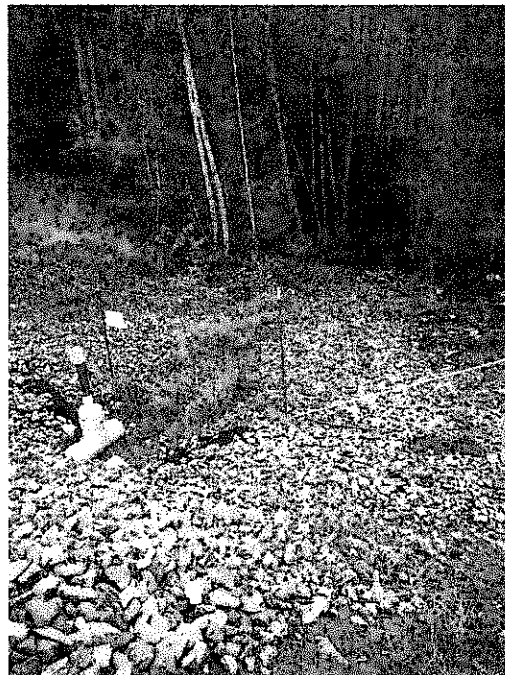
Photo 10

No flow from discharge point at time of inspection (Nov 14)

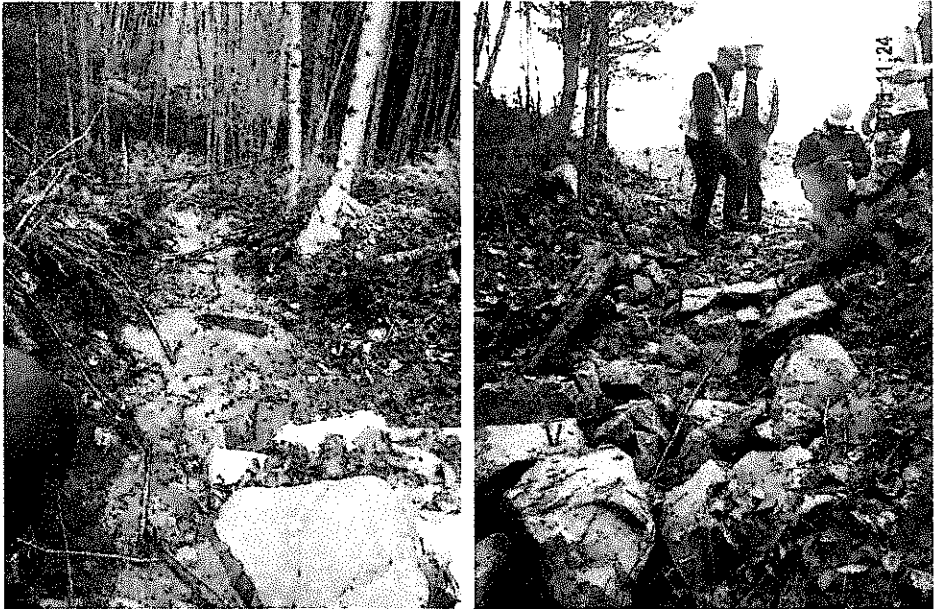
Photo 11

Nov 14 Sample site at ephemeral stream breakout point, approximately 15 m downstream of settling pond surface discharge point (Sample named SW-1)
