APPENDIX D

Shawnigan Research Group (SRG) Information Submissions
May 31, June 08, June 13 & June 21, 2017

The Contaminated Soil Waste Landfill Site Is Leaking

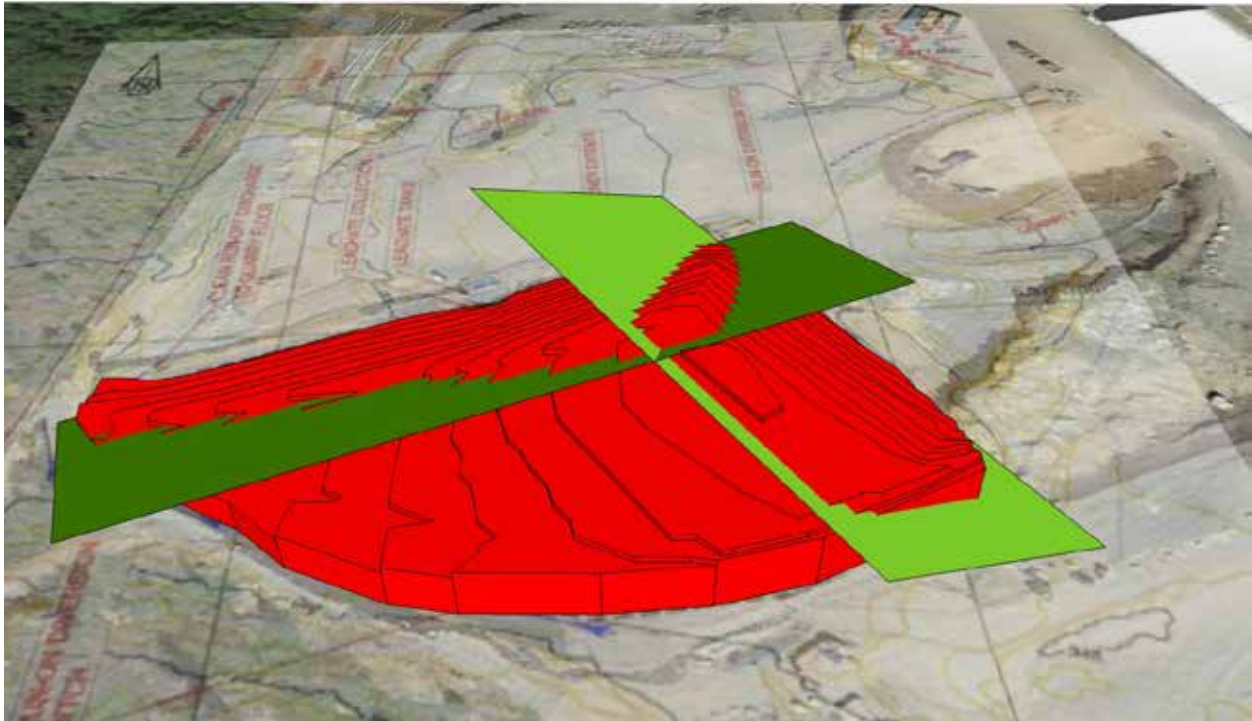
Fig 6

The map from the companies, Fig 1 above, claims that the slope on the upper left, the northwest facing slope, is 3H:1V, and that the slope to the upper right, the northeast facing slope, is 2.5H:1V. In fact, neither slope meets the requirement for final contours.

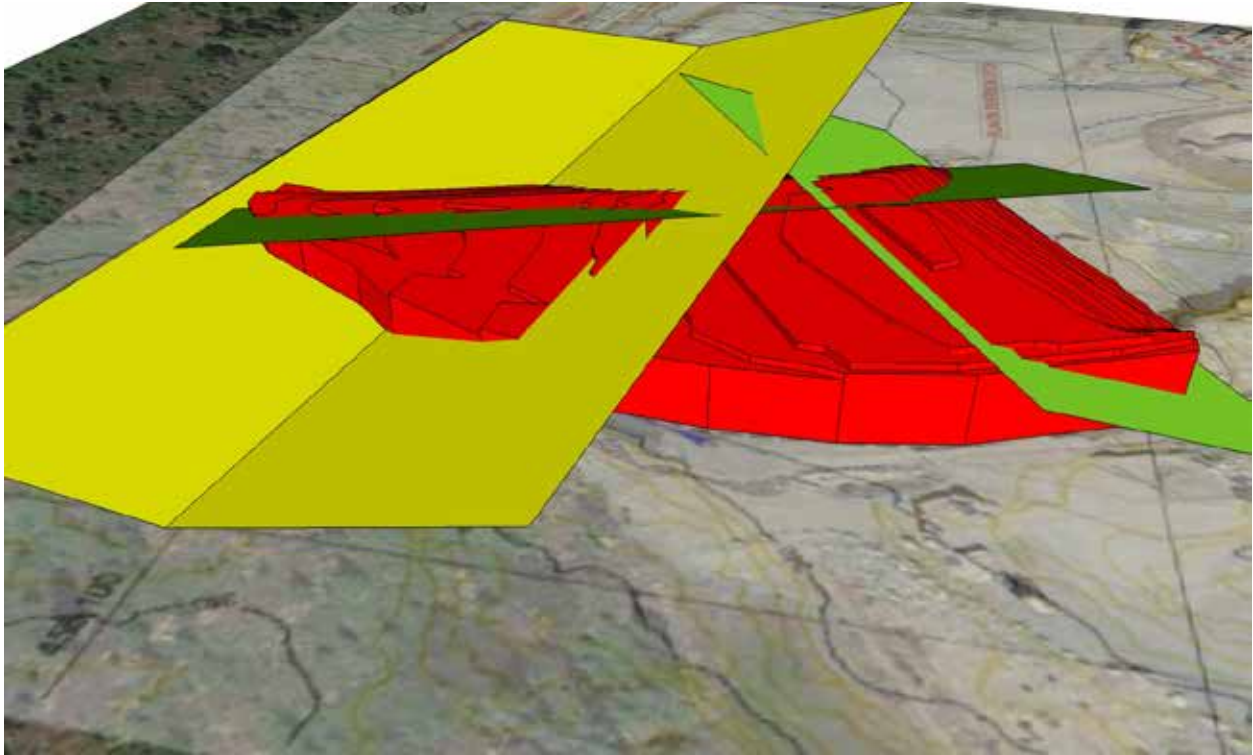
Fig 8

Here the new west face of the waste pile is shown. Allowing for the 50 m buffer zone and the 3H:1V slope of the new west face, all the current waste above the yellow face must be removed in order for the remaining waste to meet the LCMSW standard.

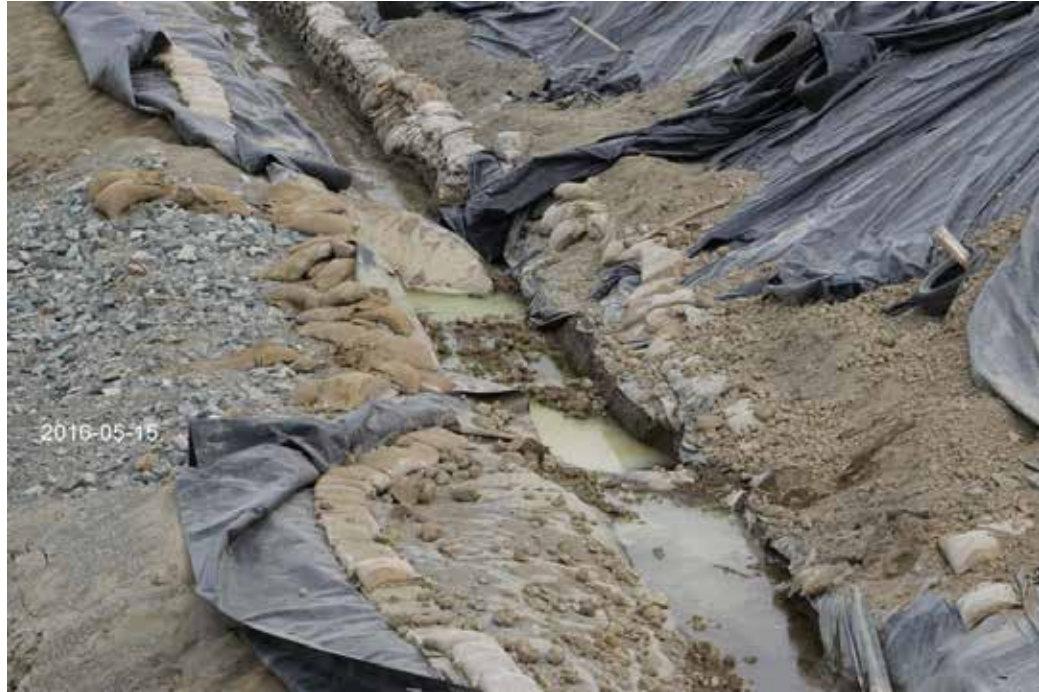
IMAGE 1: Leachate collecting in the trench at the edge of PEA-1B 6 weeks after the winter rains had stopped.

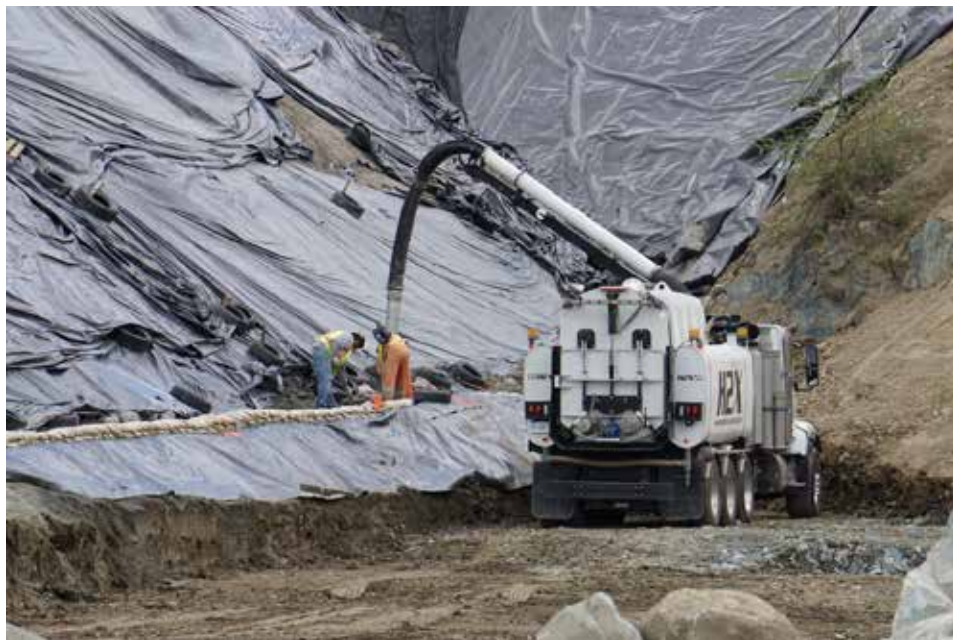
IMAGE 2: The solution when the leachate collection system is overwhelmed by the supersaturated contaminated soil is to suck up the leachate using a hydrovac.

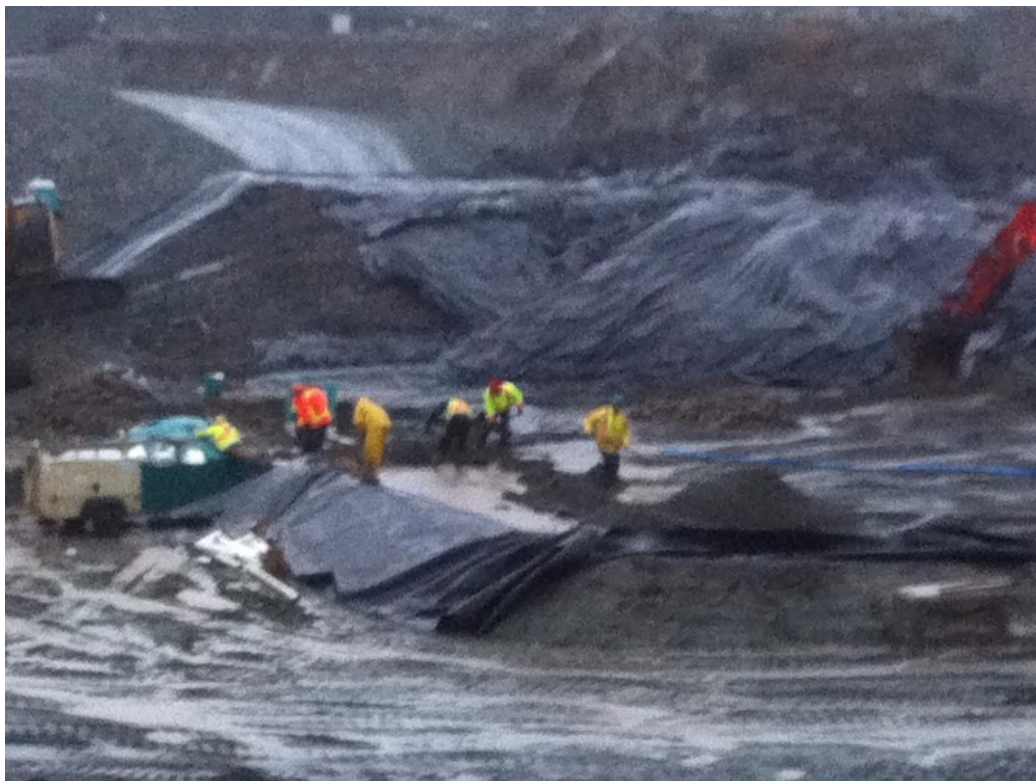
IMAGE 3: Photo taken November 17, 2015 during the installation of the base liner of PEA 1B.

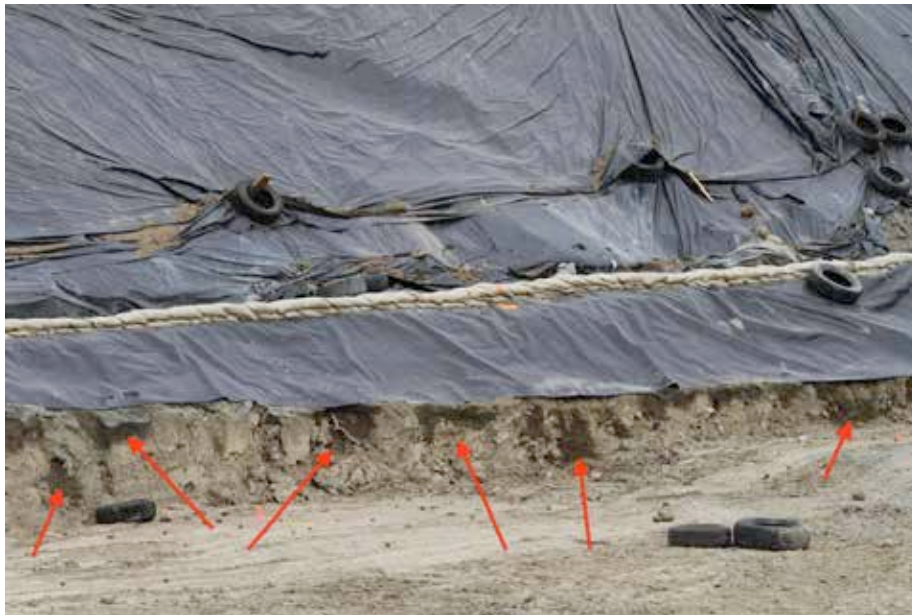
There was considerable sloppiness in the construction of the base liner of the PEA that ensured that liner failure occurred almost immediately following placement of contaminated soils. The best documented was the construction of PEA 1C; however, we do have one photograph documenting the installation of PEA 1B during the very wet month of November 2015 (Image 3). Welding of seams under such wet conditions is very problematical. Indeed, the westerly berm of PEA 1B shows moisture leaking below the level of the base liner in the first week of May 2016, five weeks since there had been any significant rainfall (Image 4).

IMAGE 4: Photograph taken the first week of May, 2016 after 5 weeks of a dry spell. The westerly face of PEA 1B is shown with wet areas below the base liner covering the berm. The only possible source of this wetness is the contaminated soil landfill site.

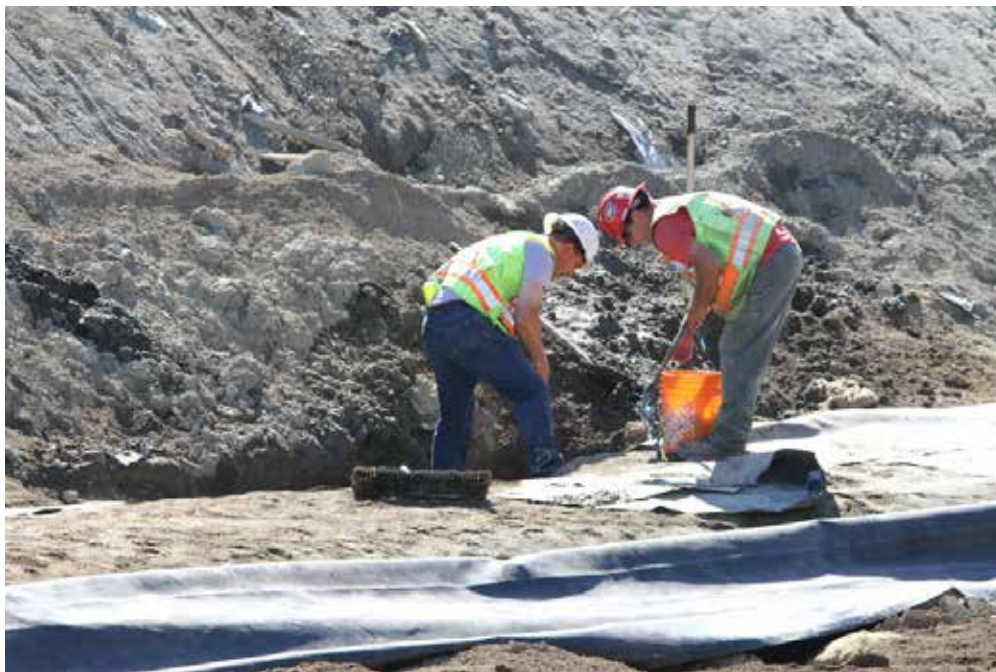
- 1) Problems linking the base liner of PEA 1C with the base liner of PEA 1B because of moisture problems (Image 5). This was difficult to document since the operators very often had an excavator blocking our view of this clean-up operation. Since this was a dry summer the only source of the moisture was PEA 1B and it is questionable whether the welding was properly done.

IMAGE 5: Because of moisture problems there was difficulty in welding the base liner of PEA 1C with the base liner of PEA 1B. Note the very moist contaminated soil that had to be scooped off the base liner and thrown against the wall of PEA 1B.

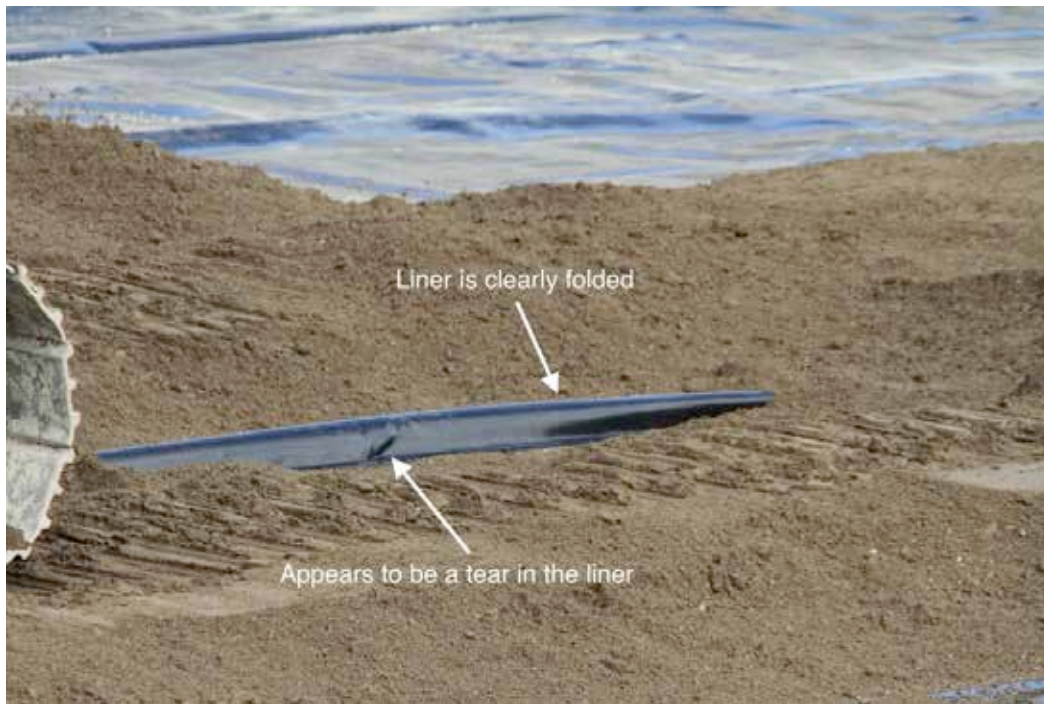
- 2) During the deposition of a sand blanket onto the base liner of PEA 1C, folds were present and the excavator tracks appeared to have caused gouges in the base liner (Images 6, 7 & 8). Cracks were also present in the liner fold (Image 9). At times an excavator dragged the base liner over rip-rap, accounting for some of the gouges and cracks that were present in the base liner – note video entitled “The Professionals”. For further details see ‘Problematical Aspects of SIRM’s Landfill Liner. Part 1’.

IMAGE 6: Note the base liner fold and an apparent gouge possibly formed by excavator track – see IMAGES 5 & 6.

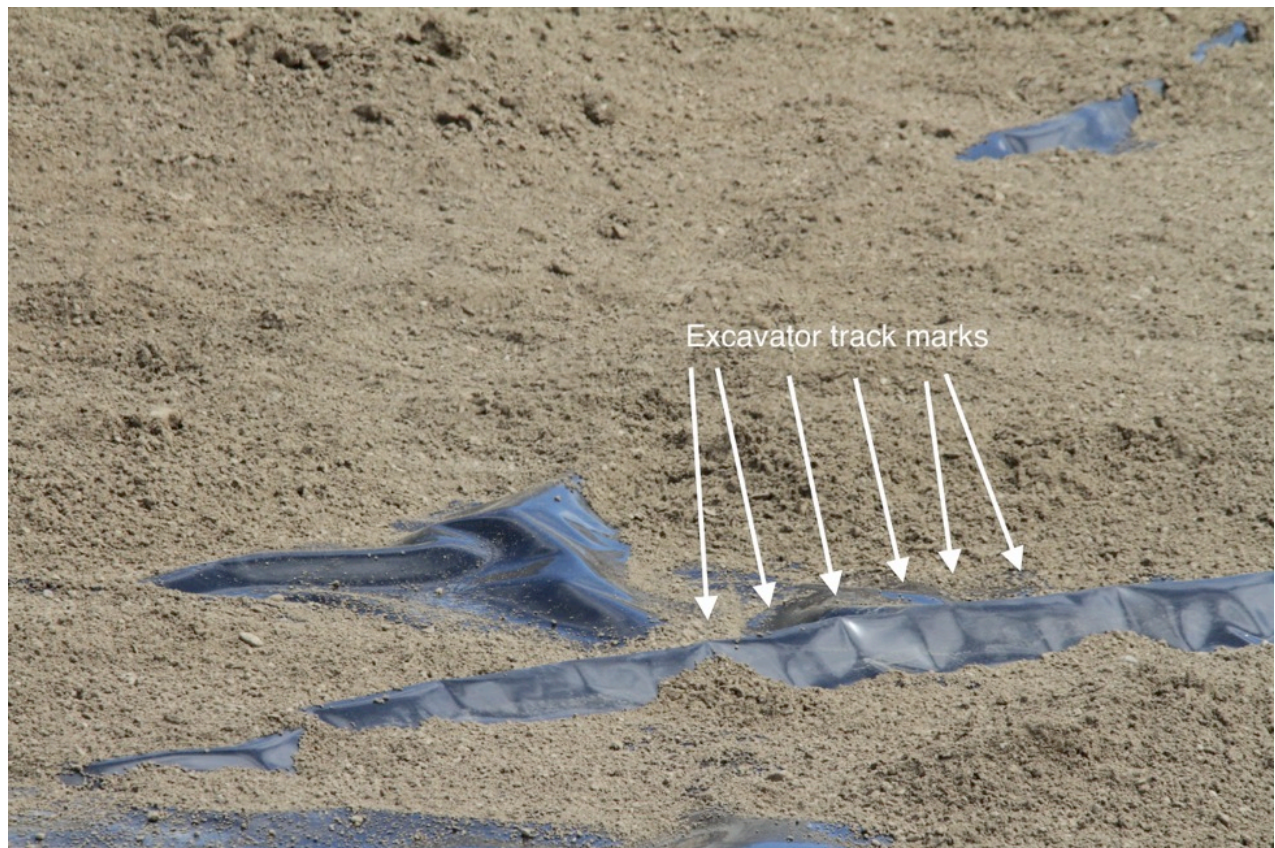
IMAGE 7: Excavator track marks on base liner of PEA 1C.

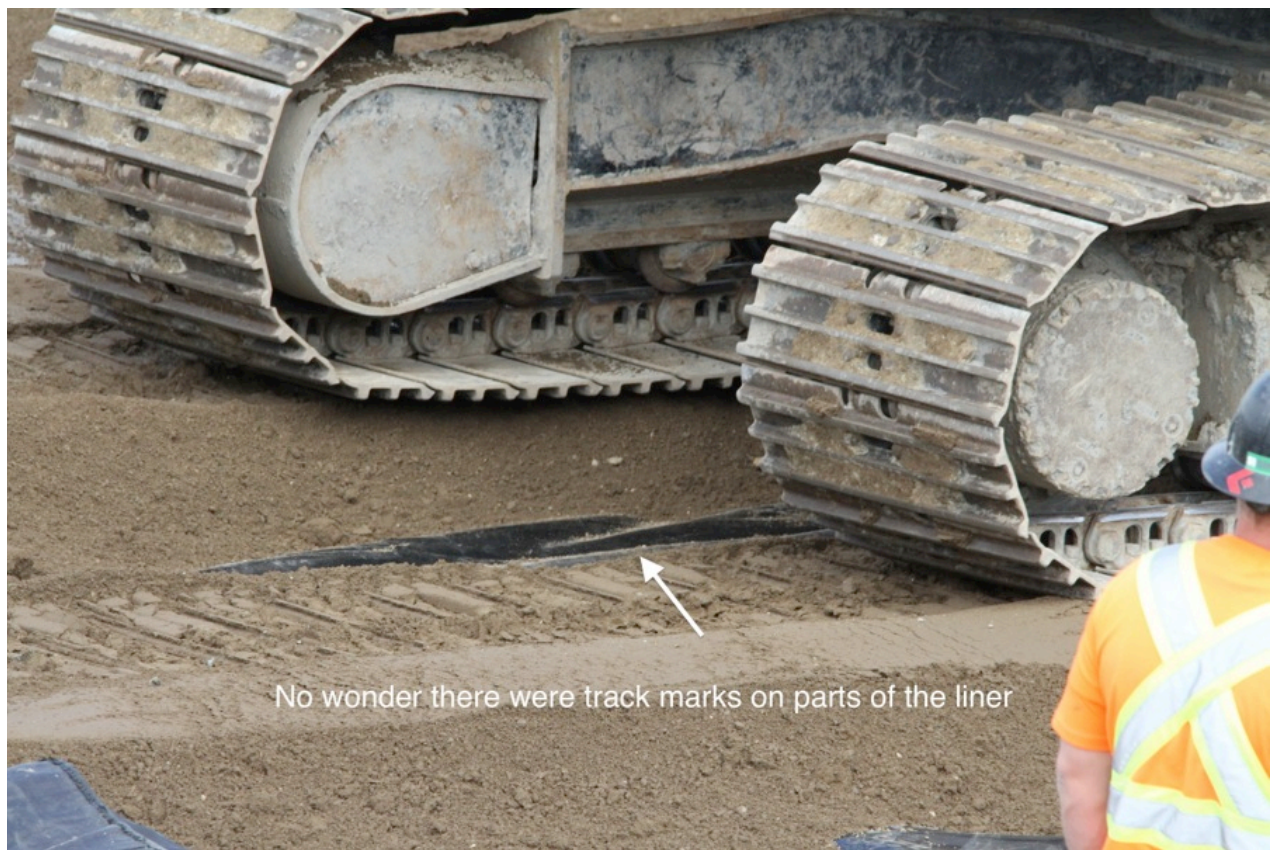
IMAGE 8: Note how close this excavator track is to the base liner of PEA 1C.

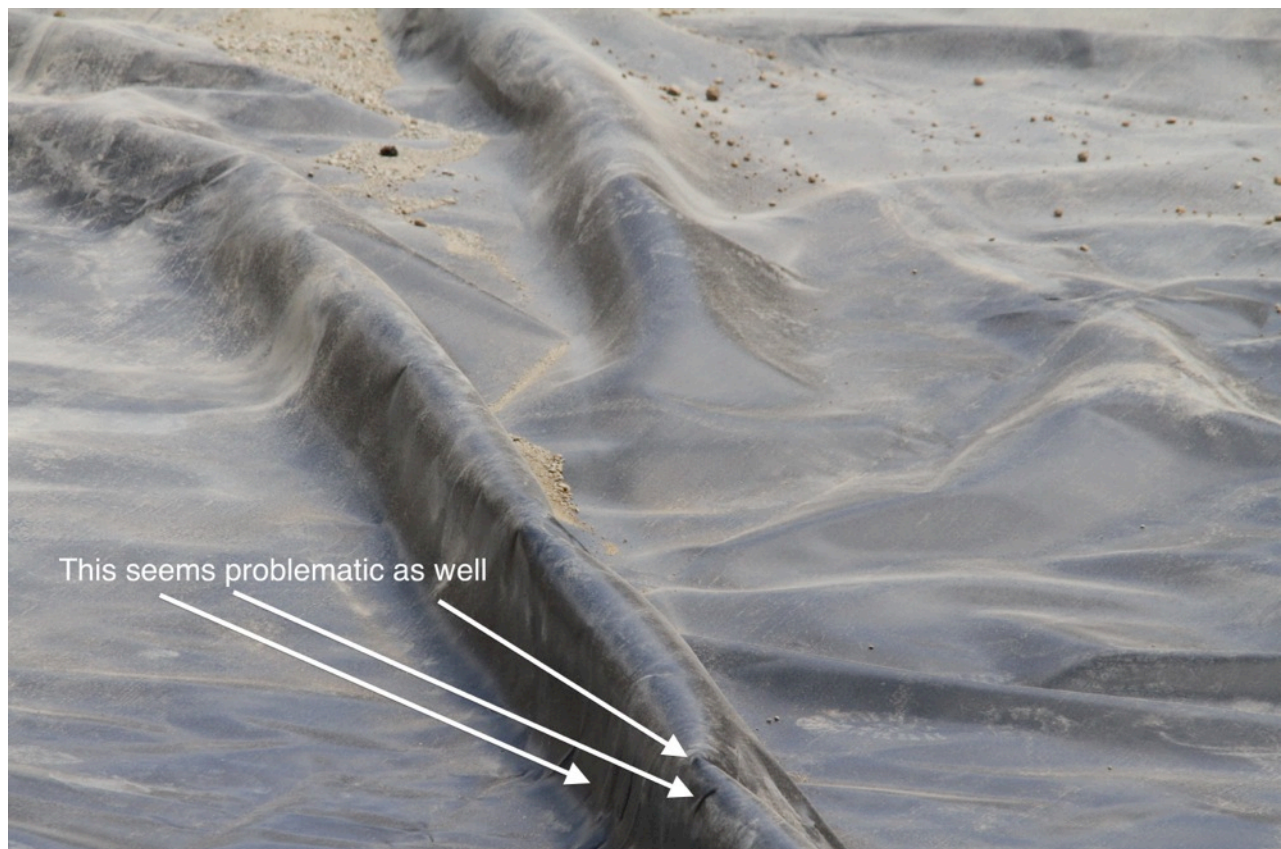
IMAGE 9: Cracks in base liner fold of PEA 1C.

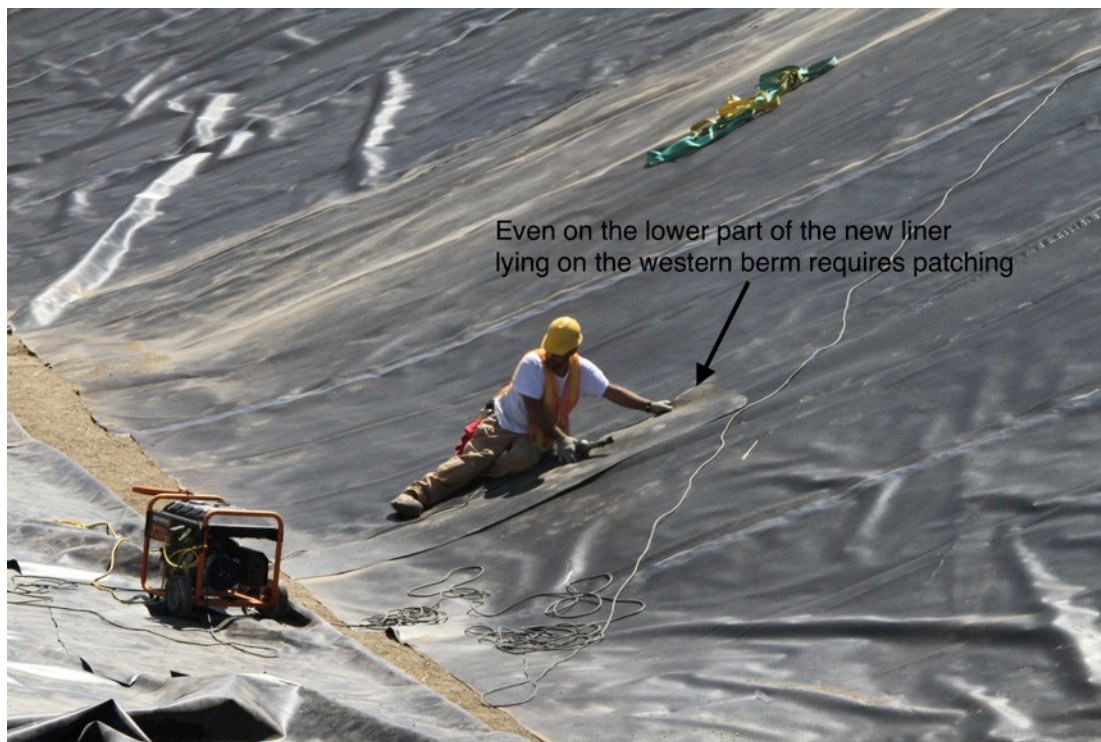
- 3) Because of errors such as the above and because of miscalculations of liner segment sizes multiple patches were required to complete the base liner. Each patch increased leakiness of the liner. Image 10 is but one example of the multiple patches used. For more details see ‘Problematical Aspects of SIRM’s Landfill Liner. Part 2’ for more details.

IMAGE 10: One example of a patch required to cover a large gap. Note also the gap between the floor liner and the berm liner that requires patching. An error, one of many, was made in calculating the size of the berm liner.

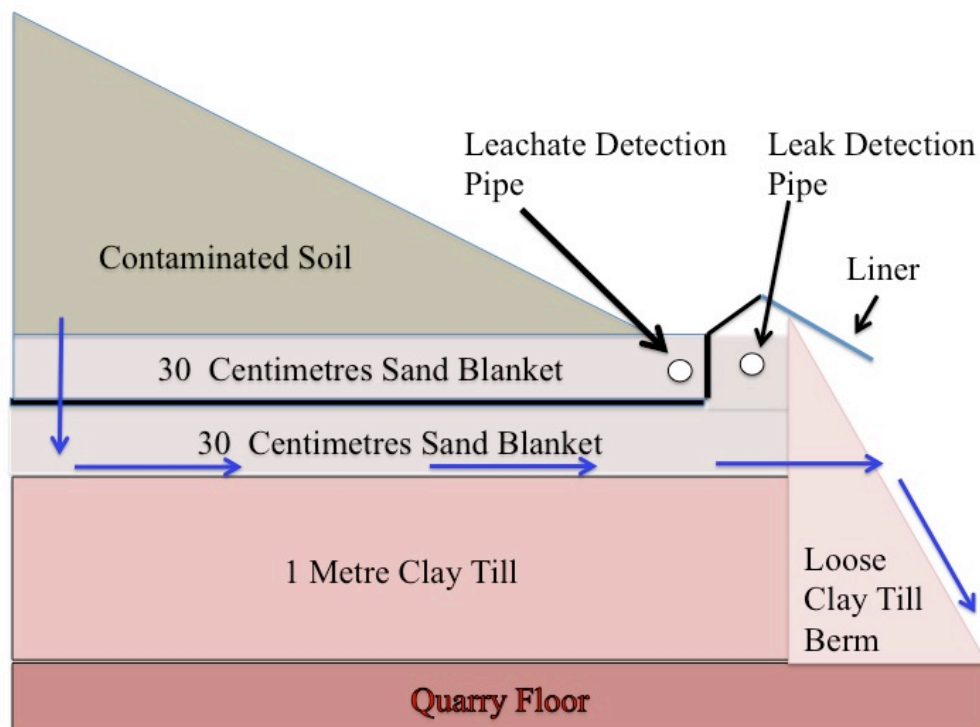
- 4) The Leak Collection System was designed not to detect leaks. SIRM’s design is shown in Image 11. The fault in the design is that the leak collection perforated pipe that is within the sand blanket below the base liner is located in an elevation above the landfill floor (Images 11 & 12 illustrate this). This requires that water must flow uphill to enter the leak detection piping. The more likely alternate route is for leaks to move laterally through the loose till berm and onto and into the mine floor (see Image 4). More details can be found in the document entitled “.SIRM’s Non-Functional Leak Detection System’.

IMAGE 11: The so-called “leak detection system” designed by SIRM. The leaks would have to go **uphill** through sand and coarse crushed rock to enter the leak detection pipe. The simplest route for leaks is to flow through the

sand blanket below the liner and through the loose clay till berm and from there the leak makes its way ultimately to the Ephemeral Stream. This is the source of the wet patches seen in IMAGE 4.

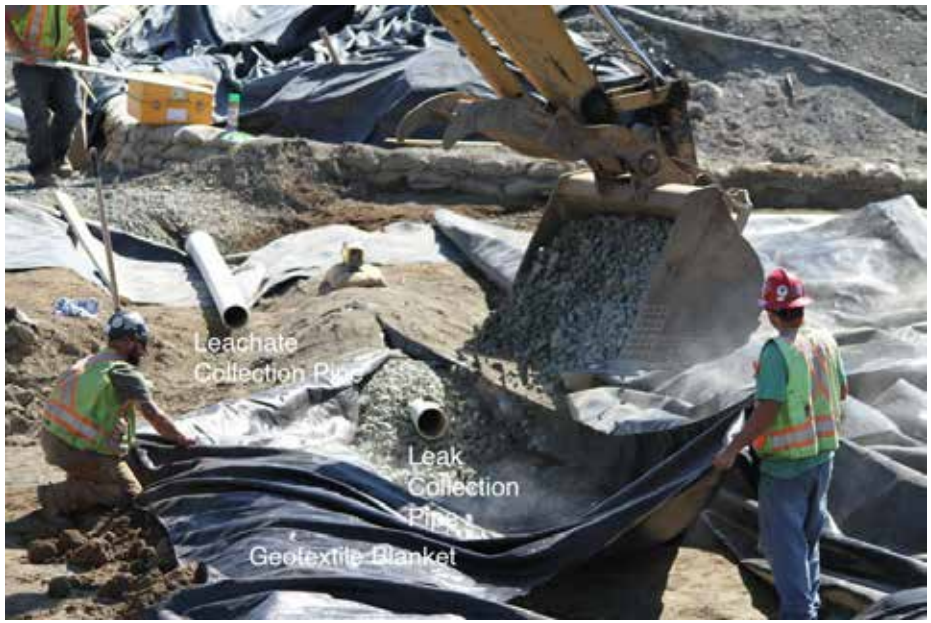
IMAGE 12: Early stage of installation of the leak collection and leachate collection pipes in PEA 1C. The worker on the right is standing on the PEA 1C floor. It can be seen that the leak collection pipe is well above the floor of PEA 1C.

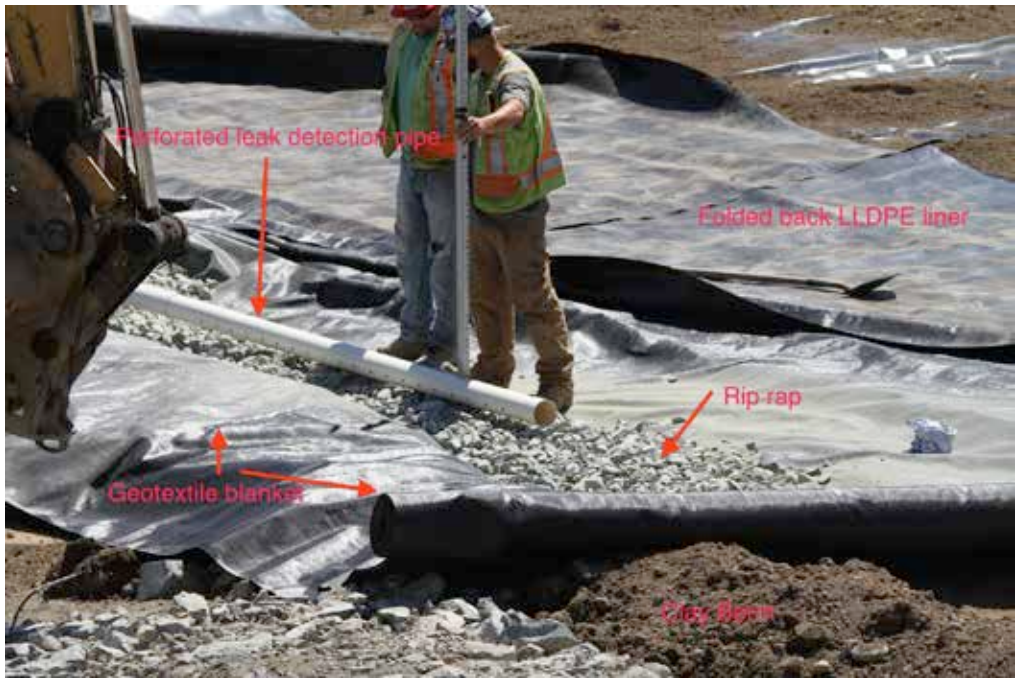
IMAGE 13: This photo shows a later stage in the installation of the leak collection pipe. One can appreciate that the leak collection pipe is higher than the floor of the landfill site.

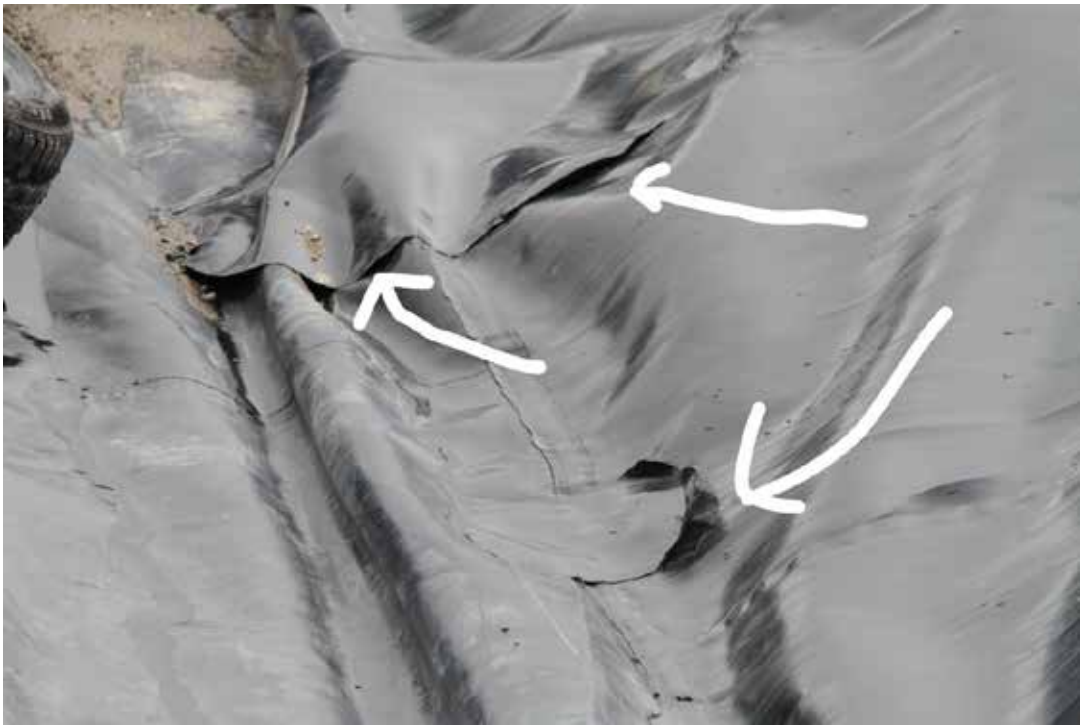
- 5) The Cover Liner (which is not 40 mil as stated but is actually 35 ml) also has multiple patches, many of which are coming loose (for example, see Image 14). This seam opening of the cover liner is yet another of the shoddiness of the construction of PEA 1.

IMAGE 14: A few examples of cover liner seams opening. These welds were performed in the wet season and it is no surprise so many seams are opening.

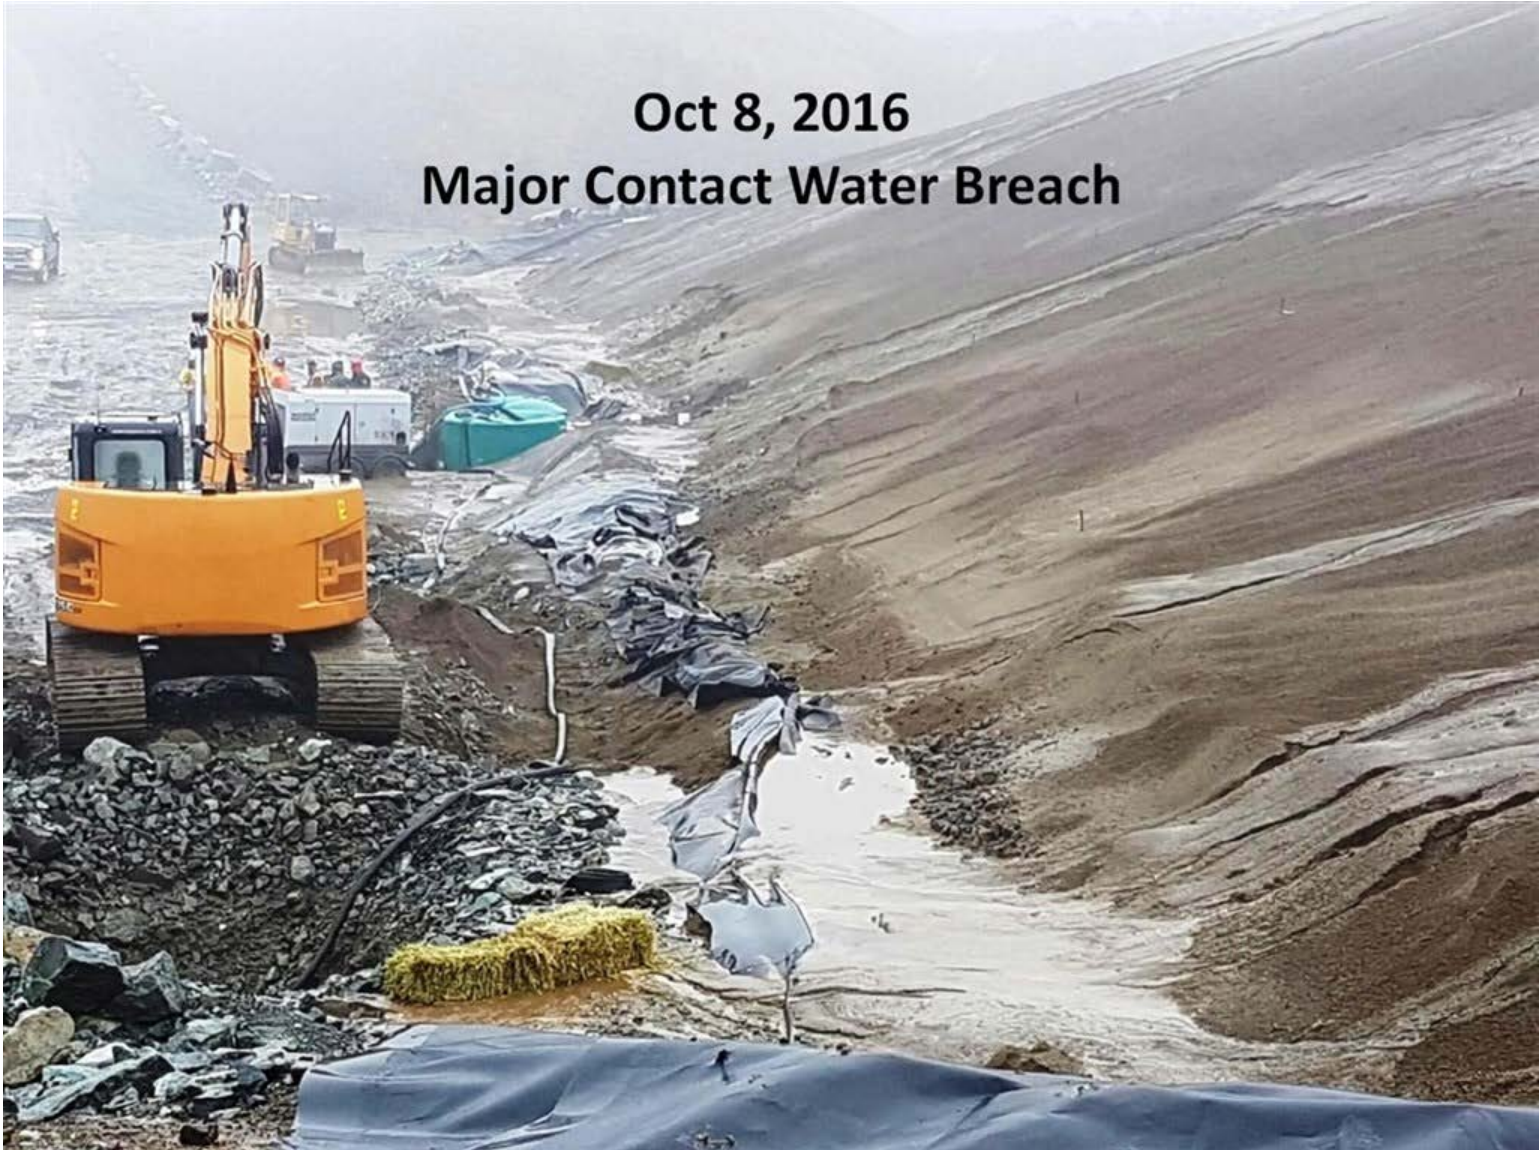
2016-10-08 Contact Water Breach

Oct 8, 2016
Major Contact Water Breach

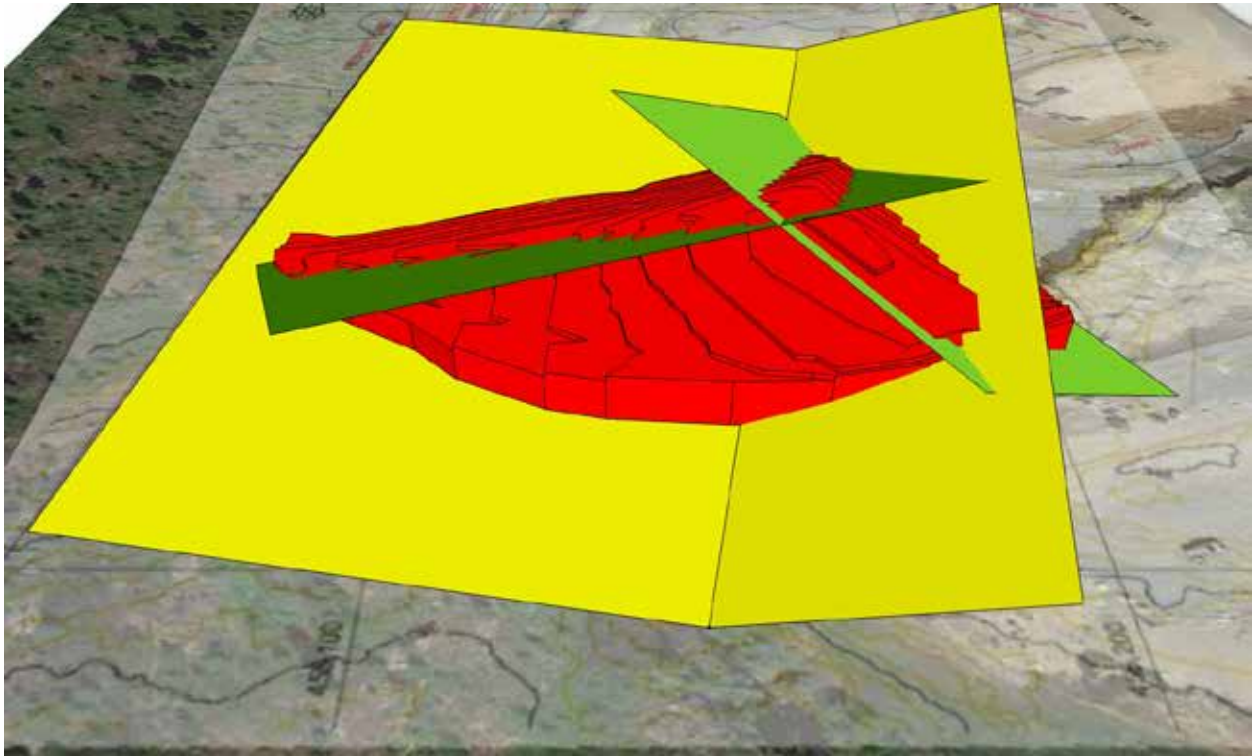
The google earth/sketchup model of the landfill (in red) and the buffer required from the CVRD regional park (in yellow) with appropriate slope on the west face, shows that almost the entire landfill sits in the buffer zone and hence violates the LCMSW.

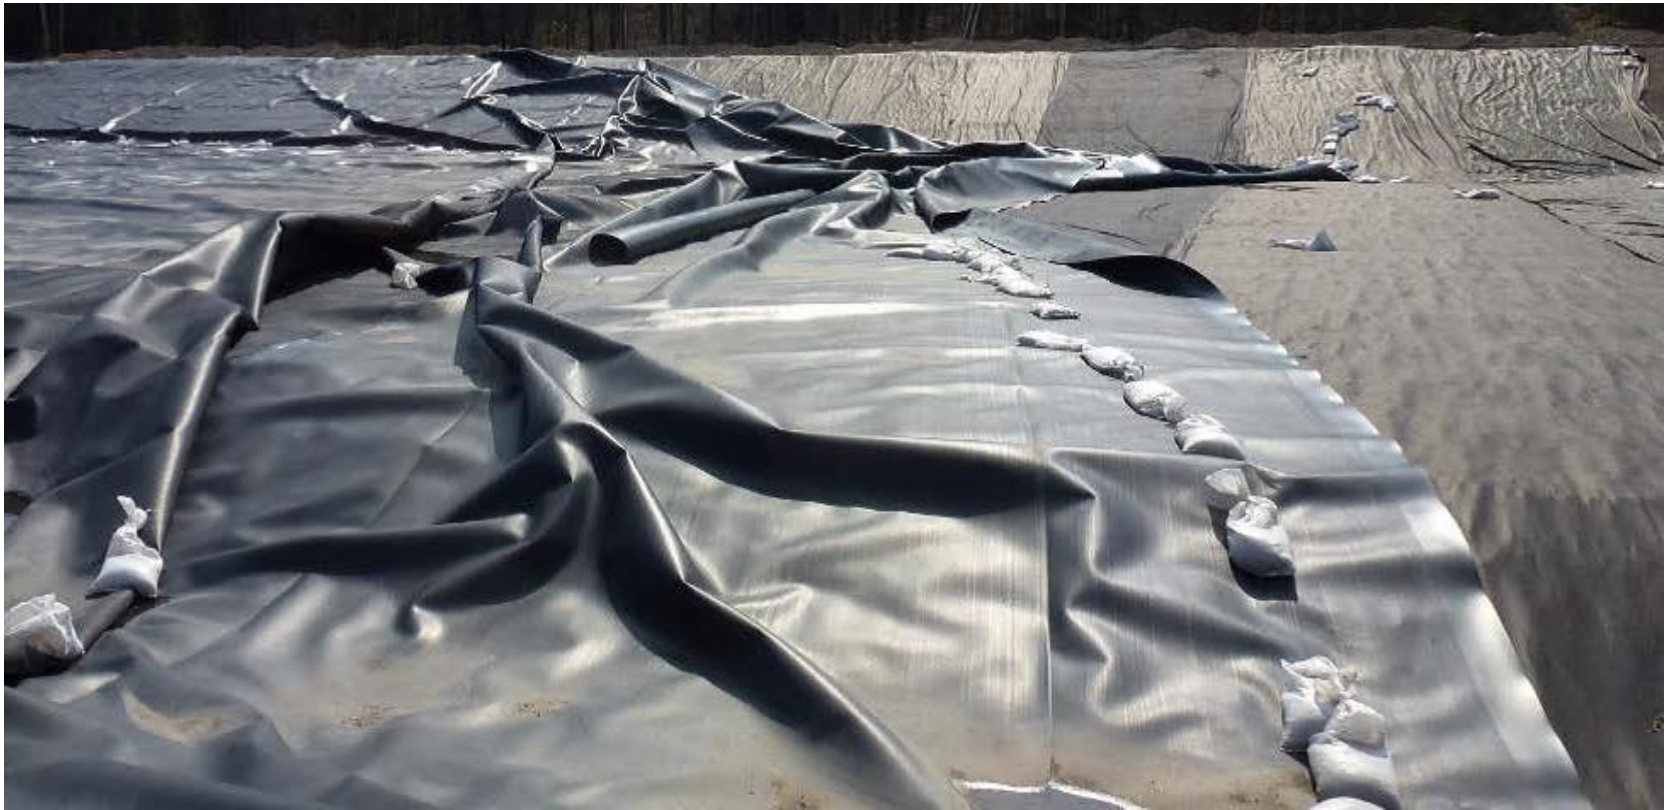
“Once up-lifted and folded the geomembrane is compromised and cannot be re-used.”

The images below show a portion of the base liner for Cell-1C which was uplifted and folded.

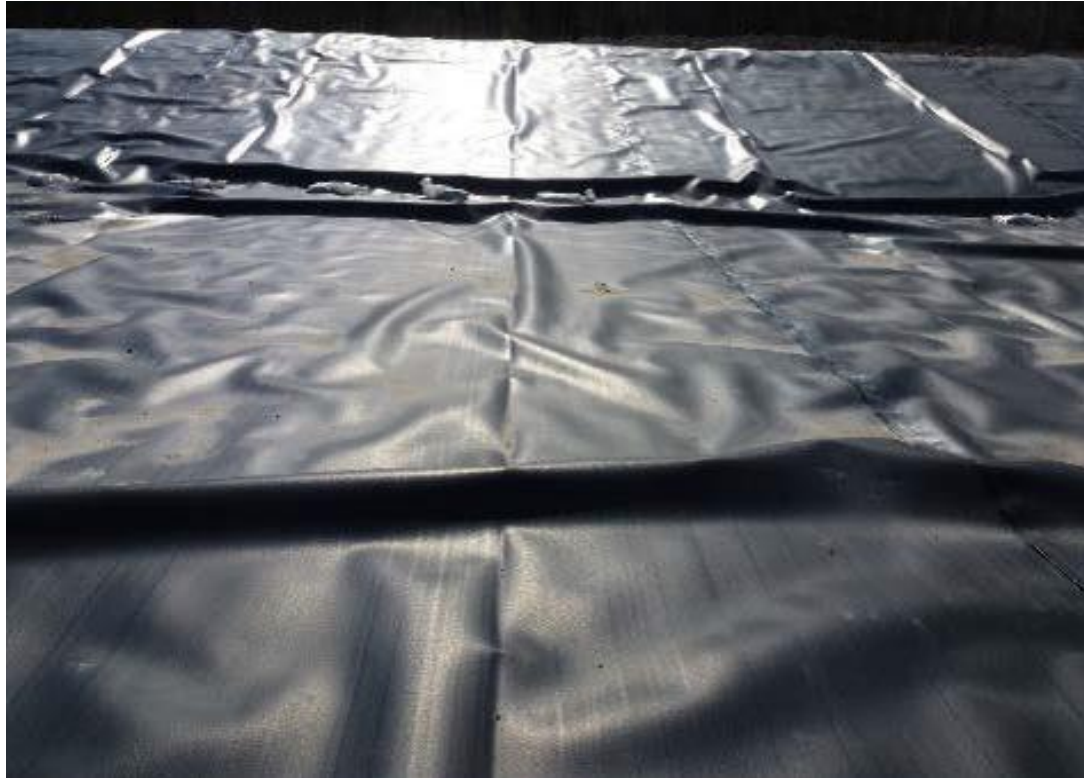
“Common problems associated with the installation include covering the geomembrane liner when there are too many wrinkles present”

The image below shows the base liner for Cell-1C being covered with many wrinkles.
