# **Ministry of Energy and Mines**

## **Mount Polley Tailings Dam Failure**

### ***A Summary of Opinions in Support of CIM Investigation***

**Mount Polley Tailings Dam Failure**  
**A Summary of Opinions in Support of CIM Investigation**

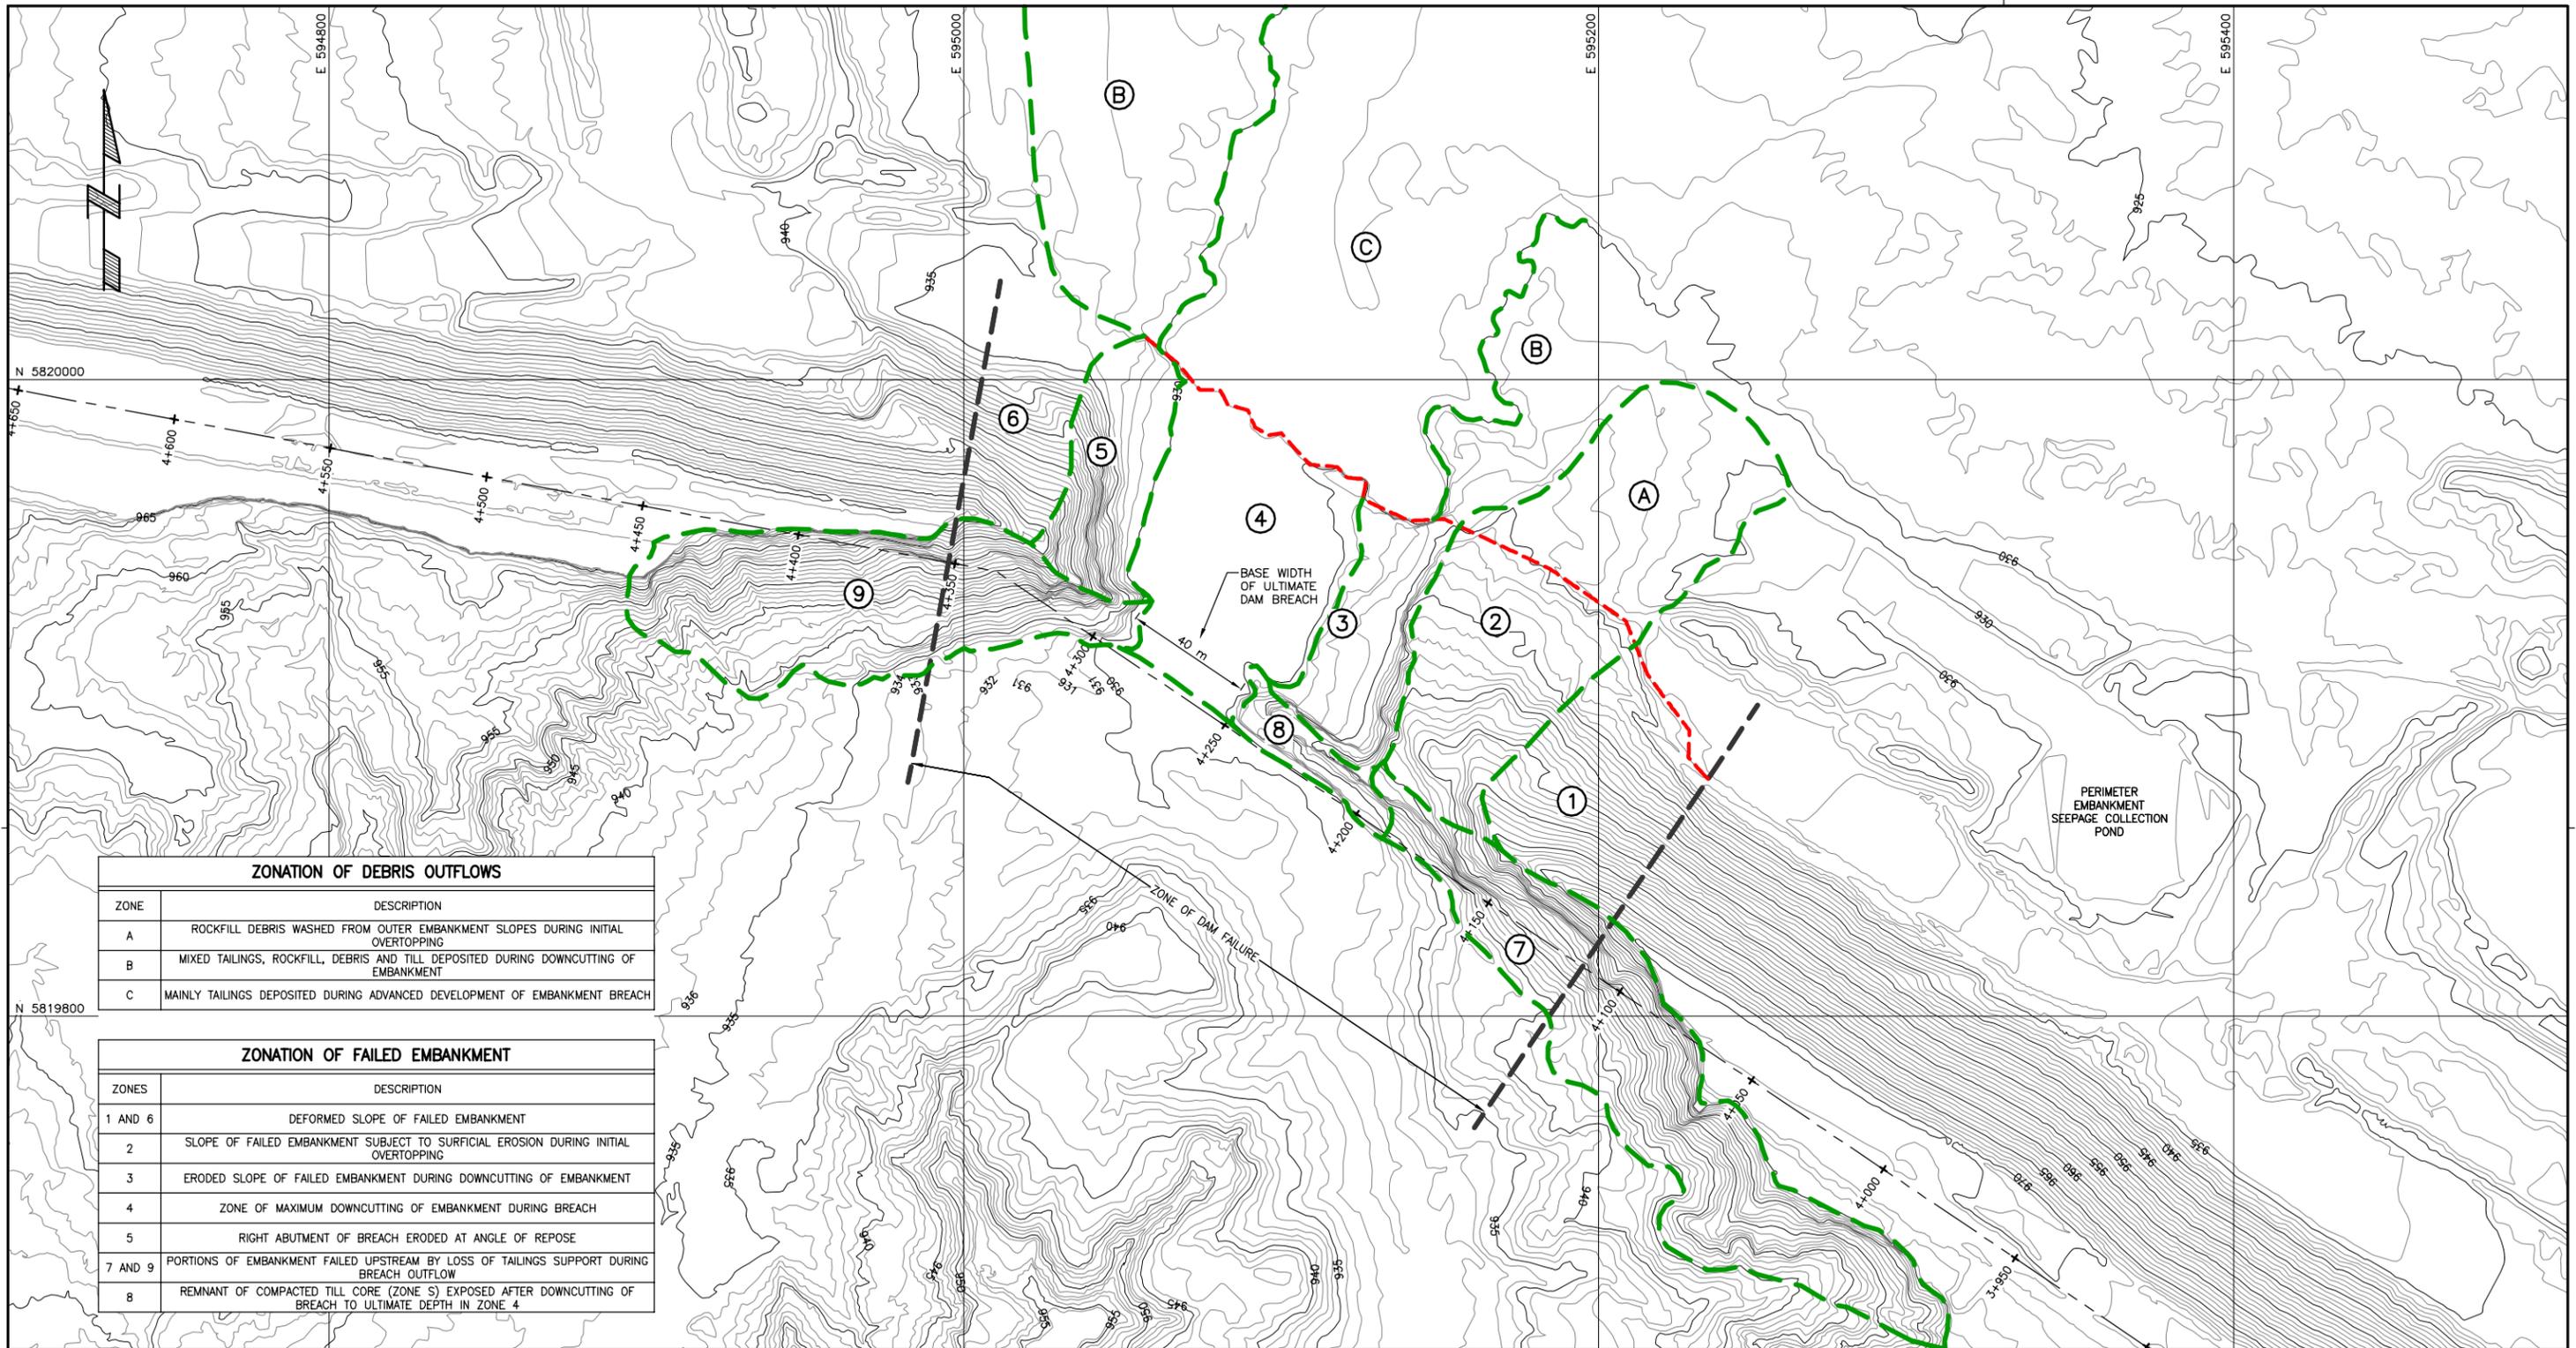
ZONATION OF DEBRIS OUTFLOWS	
ZONE	DESCRIPTION
A	ROCKFILL DEBRIS WASHED FROM OUTER EMBANKMENT SLOPES DURING INITIAL OVERTOPPING
B	MIXED TAILINGS, ROCKFILL, DEBRIS AND TILL DEPOSITED DURING DOWNCUTTING OF EMBANKMENT
C	MAINLY TAILINGS DEPOSITED DURING ADVANCED DEVELOPMENT OF EMBANKMENT BREACH

ZONATION OF FAILED EMBANKMENT	
ZONES	DESCRIPTION
1 AND 6	DEFORMED SLOPE OF FAILED EMBANKMENT
2	SLOPE OF FAILED EMBANKMENT SUBJECT TO SURFICIAL EROSION DURING INITIAL OVERTOPPING
3	ERODED SLOPE OF FAILED EMBANKMENT DURING DOWNCUTTING OF EMBANKMENT
4	ZONE OF MAXIMUM DOWNCUTTING OF EMBANKMENT DURING BREACH
5	RIGHT ABUTMENT OF BREACH ERODED AT ANGLE OF REPOSE
7 AND 9	PORTIONS OF EMBANKMENT FAILED UPSTREAM BY LOSS OF TAILINGS SUPPORT DURING BREACH OUTFLOW
8	REMNANT OF COMPACTED TILL CORE (ZONE 5) EXPOSED AFTER DOWNCUTTING OF BREACH TO ULTIMATE DEPTH IN ZONE 4

- SET OUT LINE FOR TAILINGS EMBANKMENT
- - - - - LIMIT OF CRACKING AND UPTHURST GROUND AT EMBANKMENT TOE

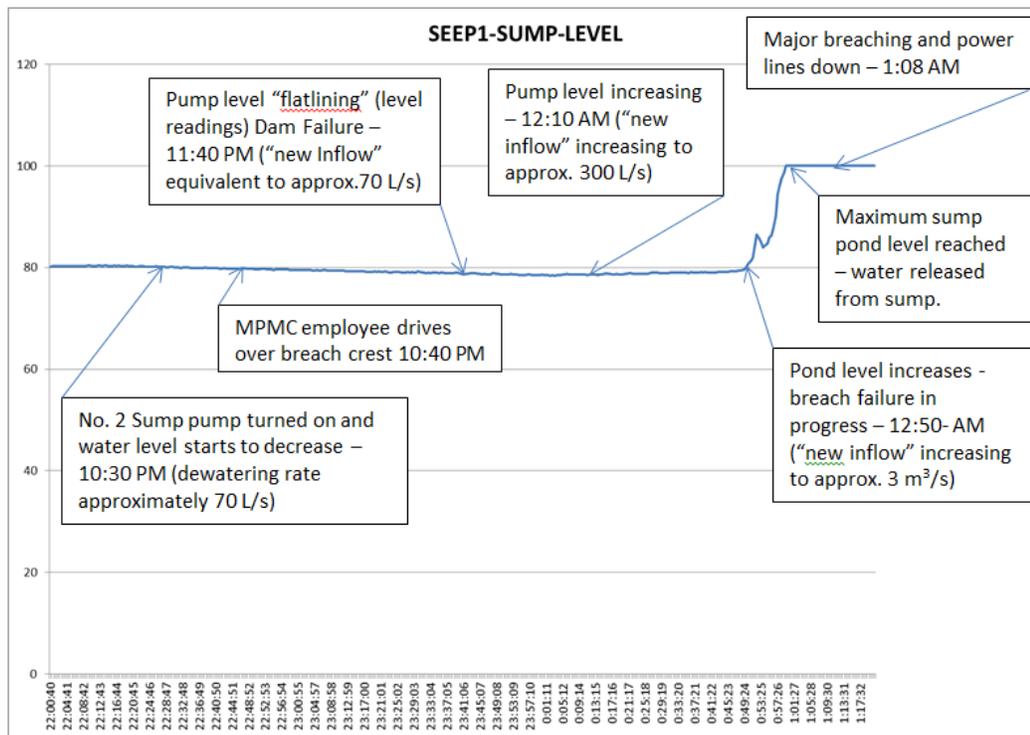
**Figure 2.1 Perimeter Sump Water Level Record**

Witness observations were helpful in establishing the potential time line of the failure event and providing water level records (obtained from the Mill Control room and shown on Figure 2.1) for the Perimeter Sump station. The timeline is summarized as follows:

sump water level was exceeded. The rapid rise suggests that the dam had breached further.
1:08 AM	Time reported by a number of staff as to when the power went out, which is near the time of the rapid rise in the sump water level. The power going out appears to be the result of the dam failure inundating the power lines located approximately 300 m downstream of the breach.

1:40 AM to 2:10 AM	Staff went to the TSF to check the power lines and reclaim water lines and realized that failure of the dam was in progress.
2:20 AM	Emergency calls started being made to all potential parties and the dam area was being cordoned off.

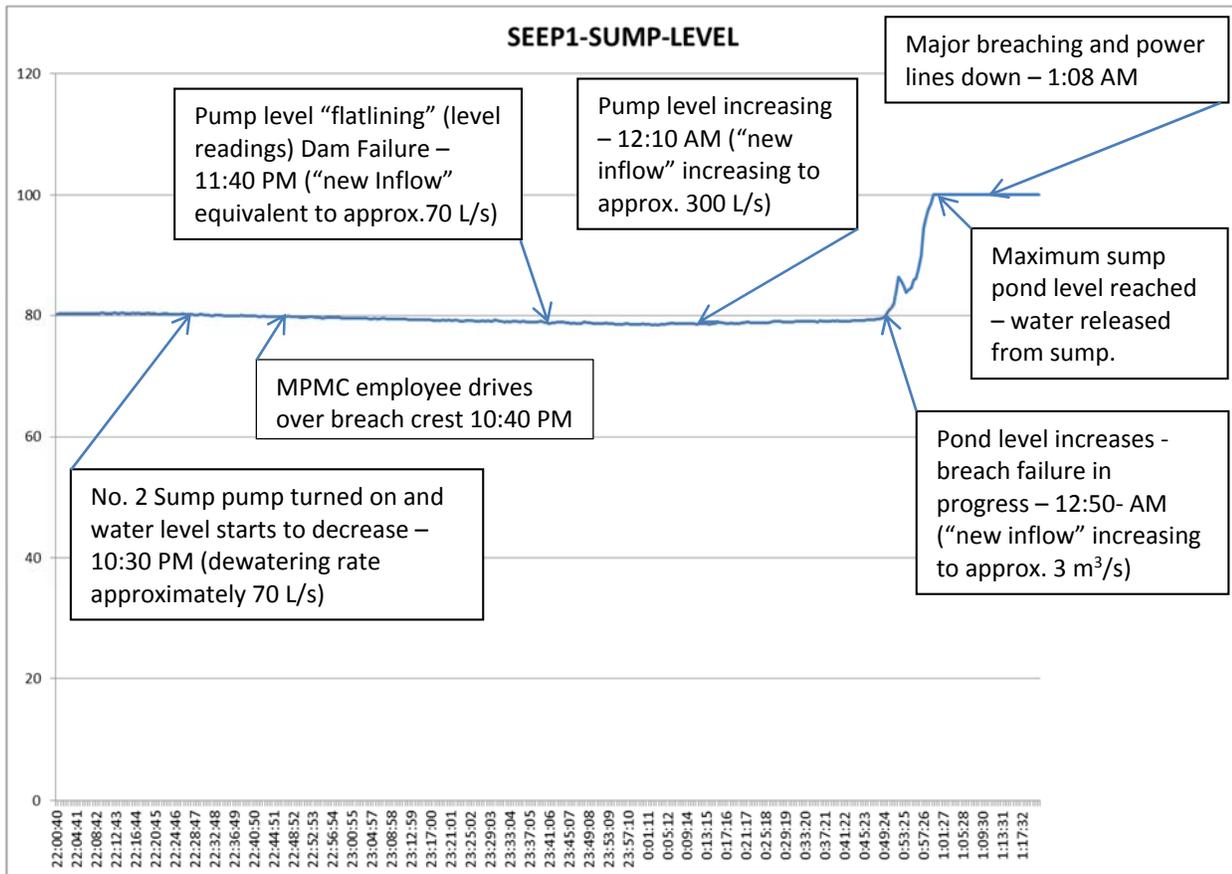
**Figure 5.1 Perimeter Sump Water Level Record and Breach Observations**

MEM interviewed the MPMC Electrician, [REDACTED], on September 12, 2014 and questioned him on the timing of the events. [REDACTED] also provided a print out of the pump instrumentation record that documents the times. Figure 5.1 is a printout of the instrumented pump level record, along with observations provided from the MEM interview. KCB have estimated the flows based on the approximate pump capacity and storage capacity of the PE SCP.

IRP (2015) had a different time sequence than presented in Figure 5.1 and the main discrepancies in the Panel version and the MEM version is that the Panel’s time for the pump being turned on and the employee driving past the dam is approximately 1 hour later; i.e. the MPMC electrician turned on the pump at 10:30 PM and drove across the dam at approximately 10:40 PM.
