Ministry of Environment
Inspection Record

Inspection Number: 30547		Inspection Status: FINAL	
EP System: <u>AMS</u>		Inspection Date: 2016-10-12	
EP System Number: 105809		EP System Status: <u>Active</u>	
Region: West Coast		Office: <u>Nanaimo</u>	
Trigger: <u>Incident</u>		Incidents of Non-Compliance Observed: <u>Yes</u>	
Non-Compliance Decision Matrix Level: <u>Level 2</u>		Non-Compliance Decision Matrix Category: <u>Category C</u>	
Inspector Name(s): Laura Hunse		CPIX: <u>Over 2 = High</u>	
Audit: []		Total Non-Compliance(s): 4	
Regulated Party: COBBLE HILL HOLDINGS LTD. (BC0754588)			
Regulated Party Contact(s): Marty Block (CHH director), Todd Mizuik (SIRM)			
Legal Address: South Island Aggregates Ltd. PO Box 282 Malahat BC V0R 2L0			
Phone No: (250)743-0811		Fax No: (250) 743-3338	
Contact Email: <u>marty.sia@shaw.ca</u>			
Location Description or Site Address: 460 Stebbings Road, Shawnigan Lake			
Latitude: 48.5505194 N		Longitude: 123.6074055 W

Authorization: 105809	Cobble Hill Holdings BC 0754588
CVIS IR #: 30547	Oct. 8 and 9, 2016 Site Inspection Photos

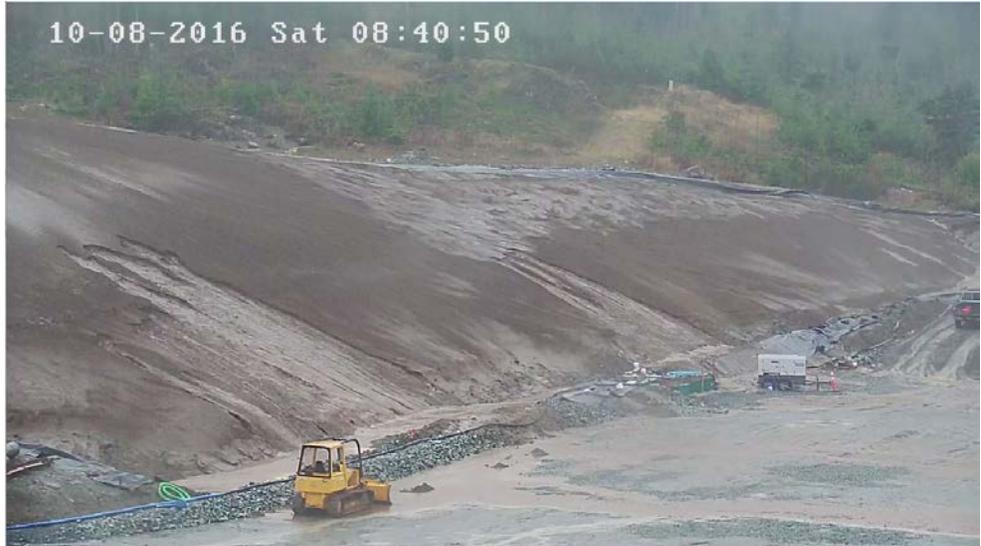
Photo 1

-- as sand and water eroded down the contaminated soil slopes, it created berms which prevented this contact water from entering the runoff containment system properly

Oct 8 2016,
0840h, landfill
with eroded
sides, site photo
submitted by
SIRM

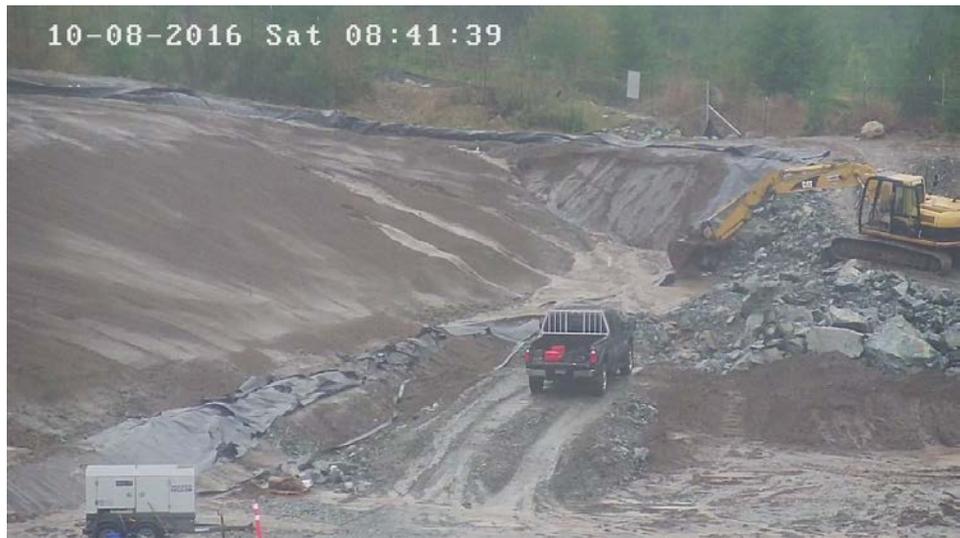
Photo 2

Oct. 8, 2016,
0841h, landfill
with eroded
sides, site photo
submitted by
SIRM

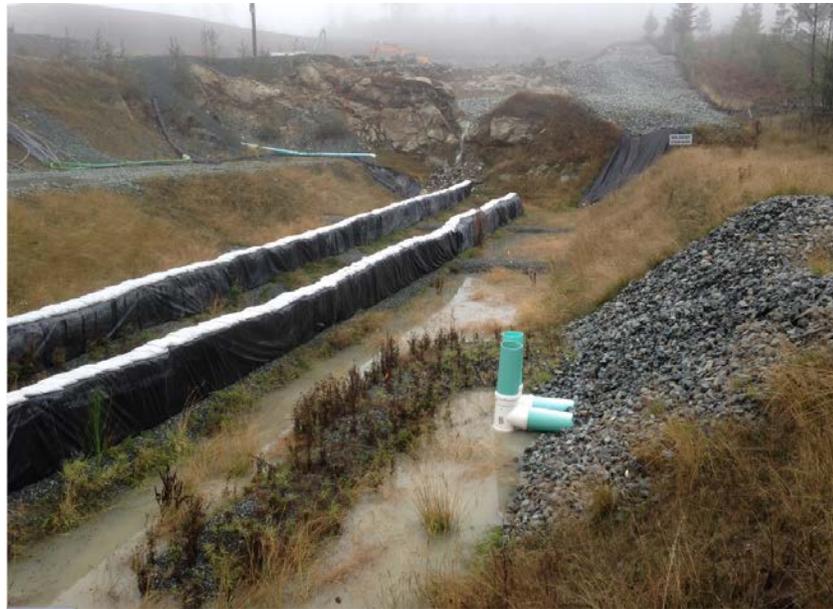
Photo 3

Oct. 9, 2016,
approx. 1400h,
settling pond no
longer
discharging from
pipe

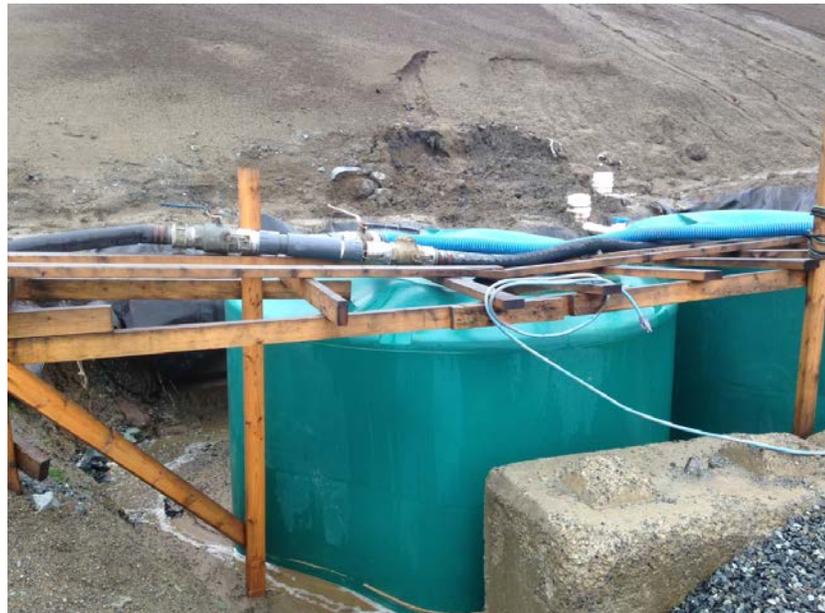
Photo 4

Oct 9, 2016,
approx. 1400h,
contact water
collection area
prior to pumping
to containment
pond
