April 28, 2017

***Re: Balfour Osprey 2000 Gear Oil Spill - Summary of SCAT Assessment - April 26, 2017***

**Survey Date:** April 26, 2017. 9:00 – 12:30

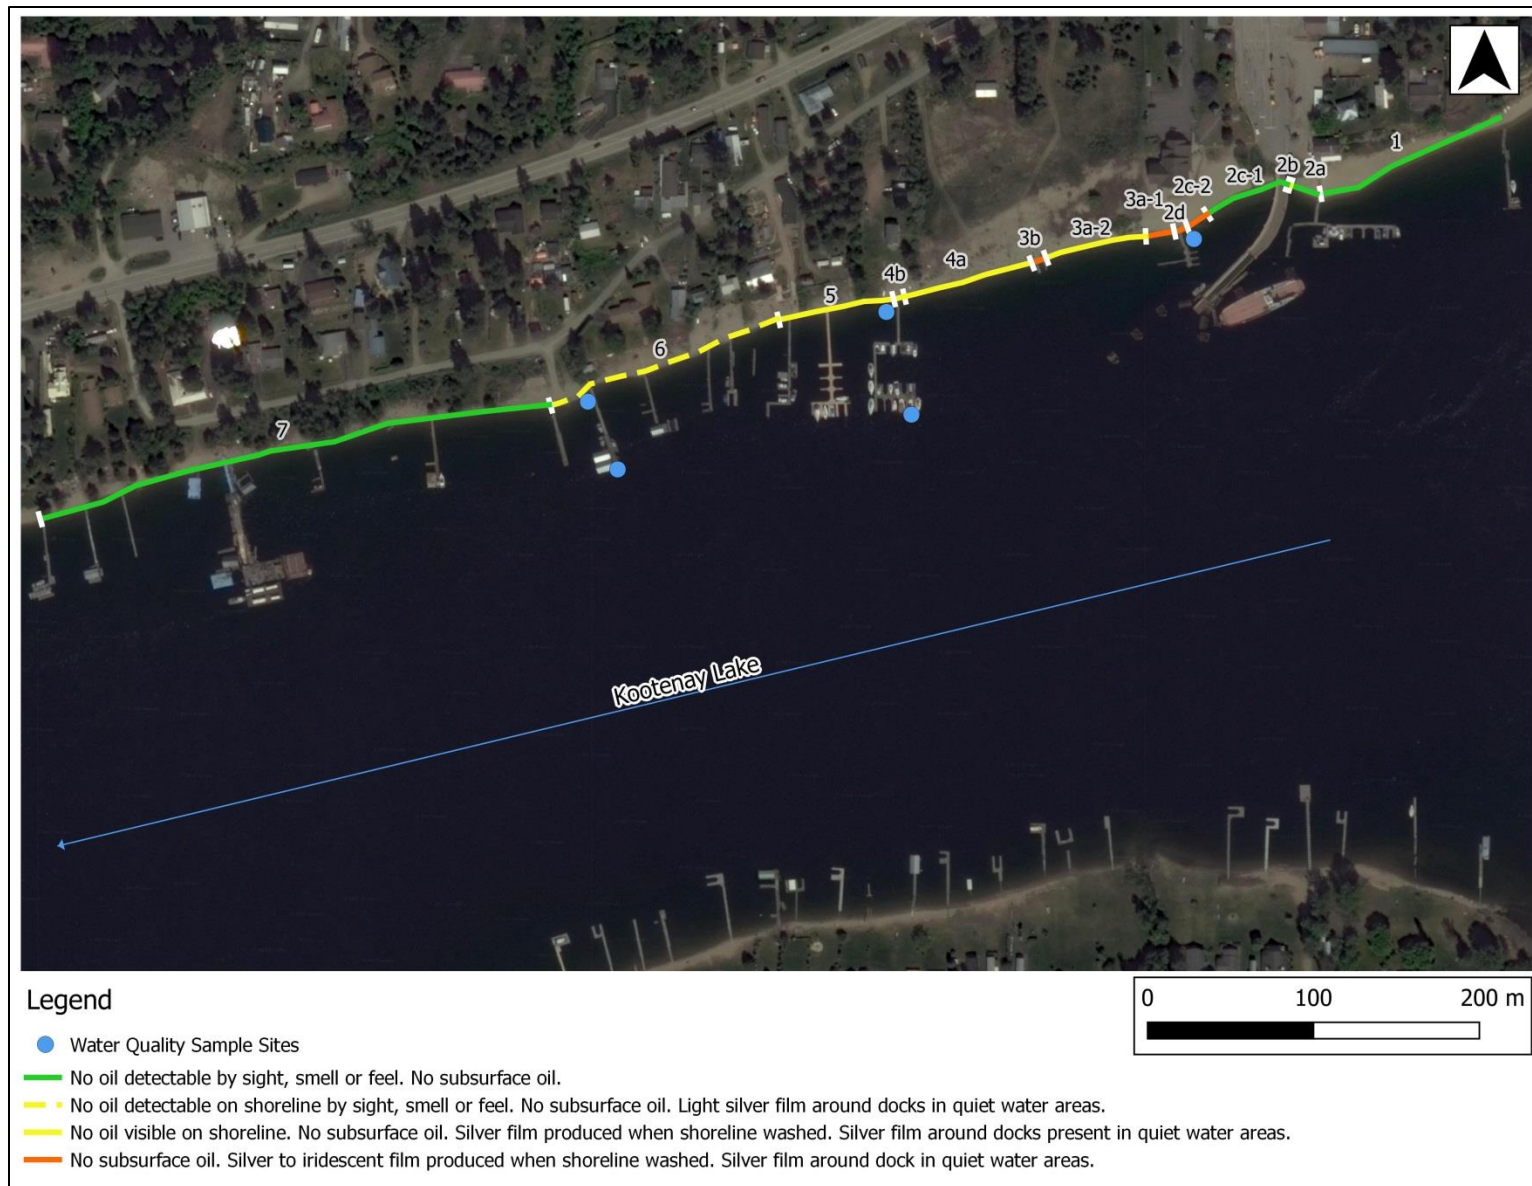
Figure 1. Map of sub-sections and assessment result summary.

<b>*Sub Section ID</b>	<b>Length (m)</b>	<b>Comments</b>
1	120	Upstream. No oil detectable by sight, smell or feel. No subsurface oil. No impacted wildlife observed.
2a	15	No oil detectable by sight, smell or feel. No subsurface oil. No impacted wildlife observed.
2b	2	Under ferry ramp beside upstream pier. No oil visible on shoreline. No subsurface oil. Very small amount of silver film produced when shoreline washed. No ambient smell. No impacted wildlife observed.
2c-1	61	No oil detectable by sight, smell or feel. No subsurface oil. No impacted wildlife observed.
2c-2	12	Starts ~15 m upstream of Dock 'n' Duck dock. Silver to iridescent film on standing water located above water line. Oil film visible on < 1 % (trace) of beach immediately (1 - 2 m) above water line. No subsurface oil. Silver film produced when shoreline washed. Slight ambient smell. Odor when sand brought to nose. No impacted wildlife observed.

2d	5	Either side of Dock 'n' Duck dock. Silver to iridescent film on standing water located immediately above water line. Oil film visible on < 1 % (trace) of beach immediately (1 - 2 m) above water line. No subsurface oil. Silver to iridescent film produced when shoreline washed. Slight ambient smell. Odor when sand brought to nose. No impacted wildlife observed.
3a-1	64	Downstream of Dock 'n' Duck dock. Silver to iridescent film on standing water located immediately above water line. Oil film visible on < 1 % (trace) of beach immediately (1 - 2 m) above water line. No subsurface oil. Silver to iridescent film produced when shoreline washed. Slight ambient smell. Odor when sand brought to nose. No impacted wildlife observed.
3a-2	15	No oil visible on shoreline. No subsurface oil. Silver film produced when shoreline washed. No ambient smell. No impacted wildlife observed.
3b	11	Either side of two old small docks. No oil visible on shoreline. No subsurface oil. Silver to iridescent film produced when shoreline washed. Silver film around dock. No ambient smell. Slight odor when handfuls of sand brought to nose. No impacted wildlife observed.

4a	75	No oil visible on shoreline. No subsurface oil. Silver to iridescent film on up to 1 m of lake water adjacent to shore. Silver film produced when shoreline washed. No ambient smell. No impacted wildlife observed.
4b	10	Either side of first Marina dock. No oil visible on shoreline. No subsurface oil. Silver film produced when shoreline washed. Silver film around dock and most boat slips. No ambient smell. No impacted wildlife observed.
5	70	No oil visible on shoreline. No subsurface oil. Silver film produced when shoreline washed. Light silver film around docks in quiet areas. No ambient smell. No impacted wildlife observed.
6	150	No oil detectable on shoreline by sight, smell or feel. Light silver film around docks in quiet areas. No impacted wildlife observed.
7	315	No oil detectable by sight, smell or feel. No subsurface oil. No impacted wildlife observed.

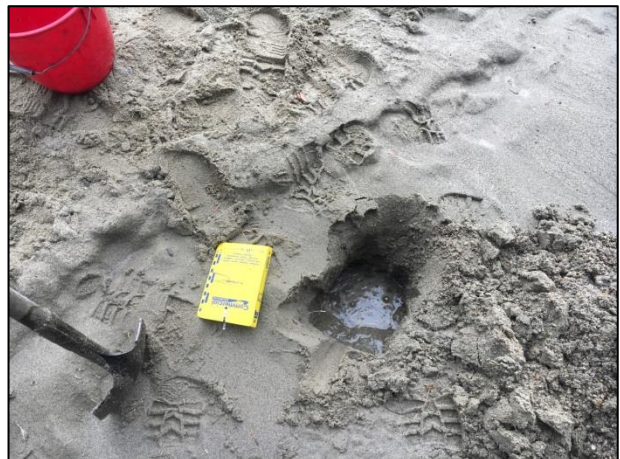
Photo 4. Section 2b (under ferry ramp) – Pit – No subsurface oil.

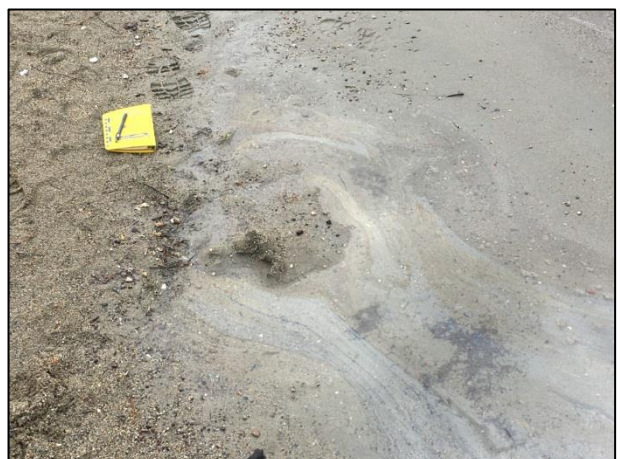
Photo 6. Section 2c – 2 - Silver to iridescent film on standing water located immediately above water line.

- Silver to iridescent film observed in quiet water areas around docks in Subsections 2d and 3b.
- Shoreline
  - Oil film visible on small patches (< 1 %) of beach immediately (1 - 2 m) above water line in Sections 2c-2 to 3a-1 (combined length of ~80 m).

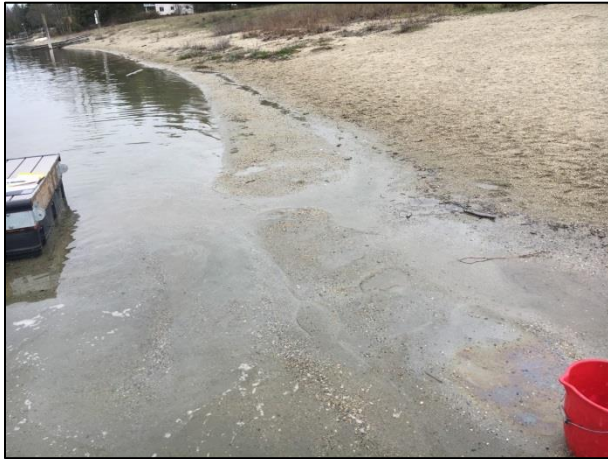
Photo 7. Section 2d – Silver to iridescent film on standing water and portions of shoreline above water line.

- Washing the shoreline within 1 – 2 m of water level generates silver to iridescent film within Sub-sections 2d, 3a-1, 3b (combined length of 80 m).

2. Temporary relocation of docks in sub-section 3b to increase lake water circulation to shoreline area.
3. Remobilizing oil in Sections 2d, 3a-1, 3b by raking.

- Remobilization of product in these areas will result in some reductions in product concentrations if wind and/or current directs floating product downstream.

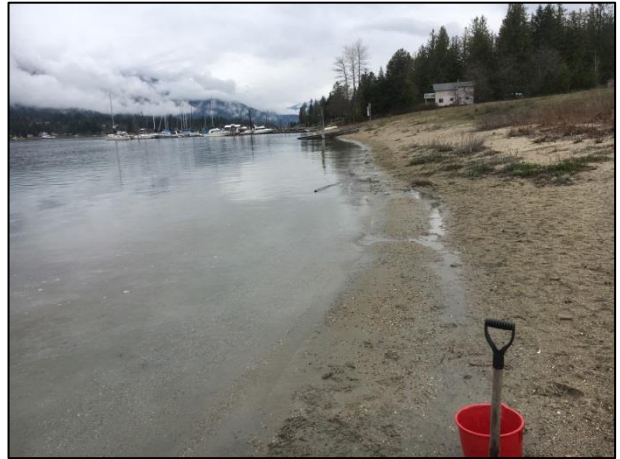
Photo 8. Section 3a – 1 - Silver to iridescent film on standing water immediately above water line.

- Water
  - Silver to iridescent film on standing water located above water line in Sections 2c-2 to 3a-1 (combined length of ~80 m).
  - Silver to iridescent film on up to 1 m of lake water adjacent to shore in Section 4a (~75 m).

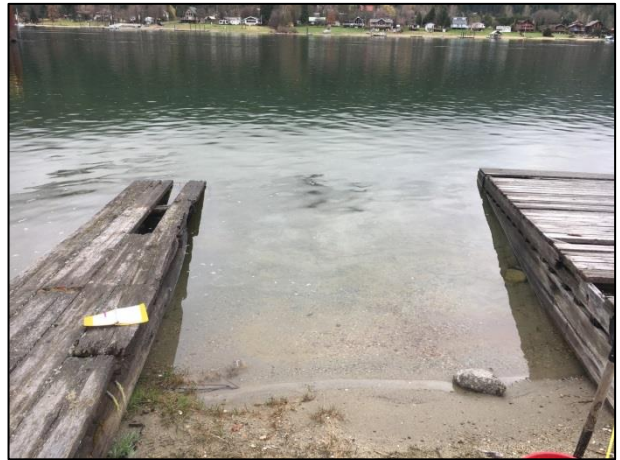
Photo 10. Section 3b – Silver to iridescent film in quiet water areas between and either side small docks.

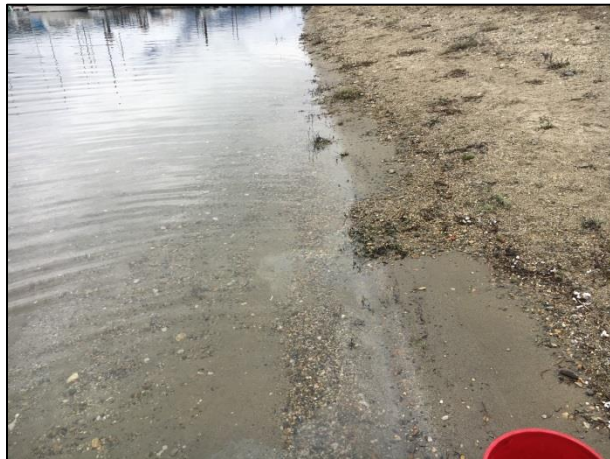
Photo 11. Section 4a – Silver to iridescent film on up to 1 m of lake water adjacent to shore.

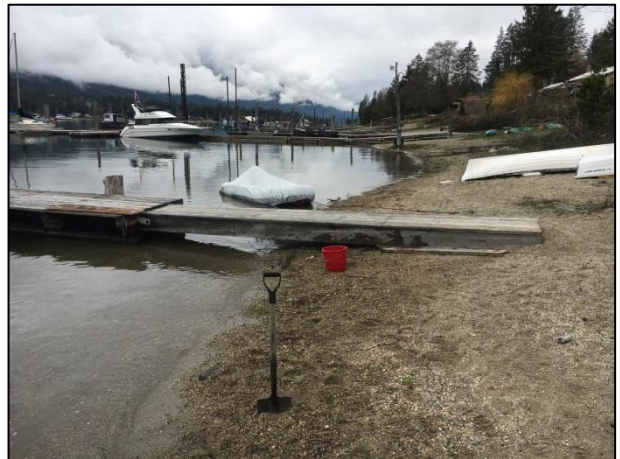
Photo 12. Section 4b – Silver film in quiet water areas around dock.

- Silver film from product observed on water surface next to docks and boat slips in Sections 4 – 6. Product present in quiet water areas where water does not flow through structures.

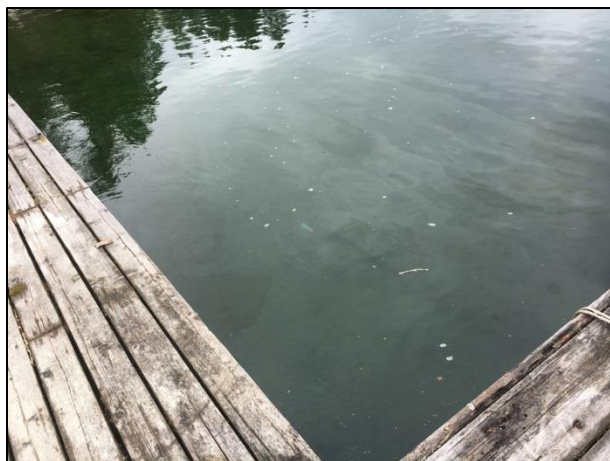
Photo 13. Section 4b –Light silver film present in quiet areas around marina dock and boat slips
