Ministry of Transportation and Infrastructure
Malahat Highway No. 1 Safety Review
Proposed Highway Improvements

R.F. Binnie & Associates Ltd.
205 – 4946 Canada Way,
Burnaby, BC
Tel: 604-420-1721
Fax: 604-420-4743
Email: eballarin@binnie.com
#11-107N-04
Date of Issue: March 27, 2012

1.0 EXECUTIVE SUMMARY

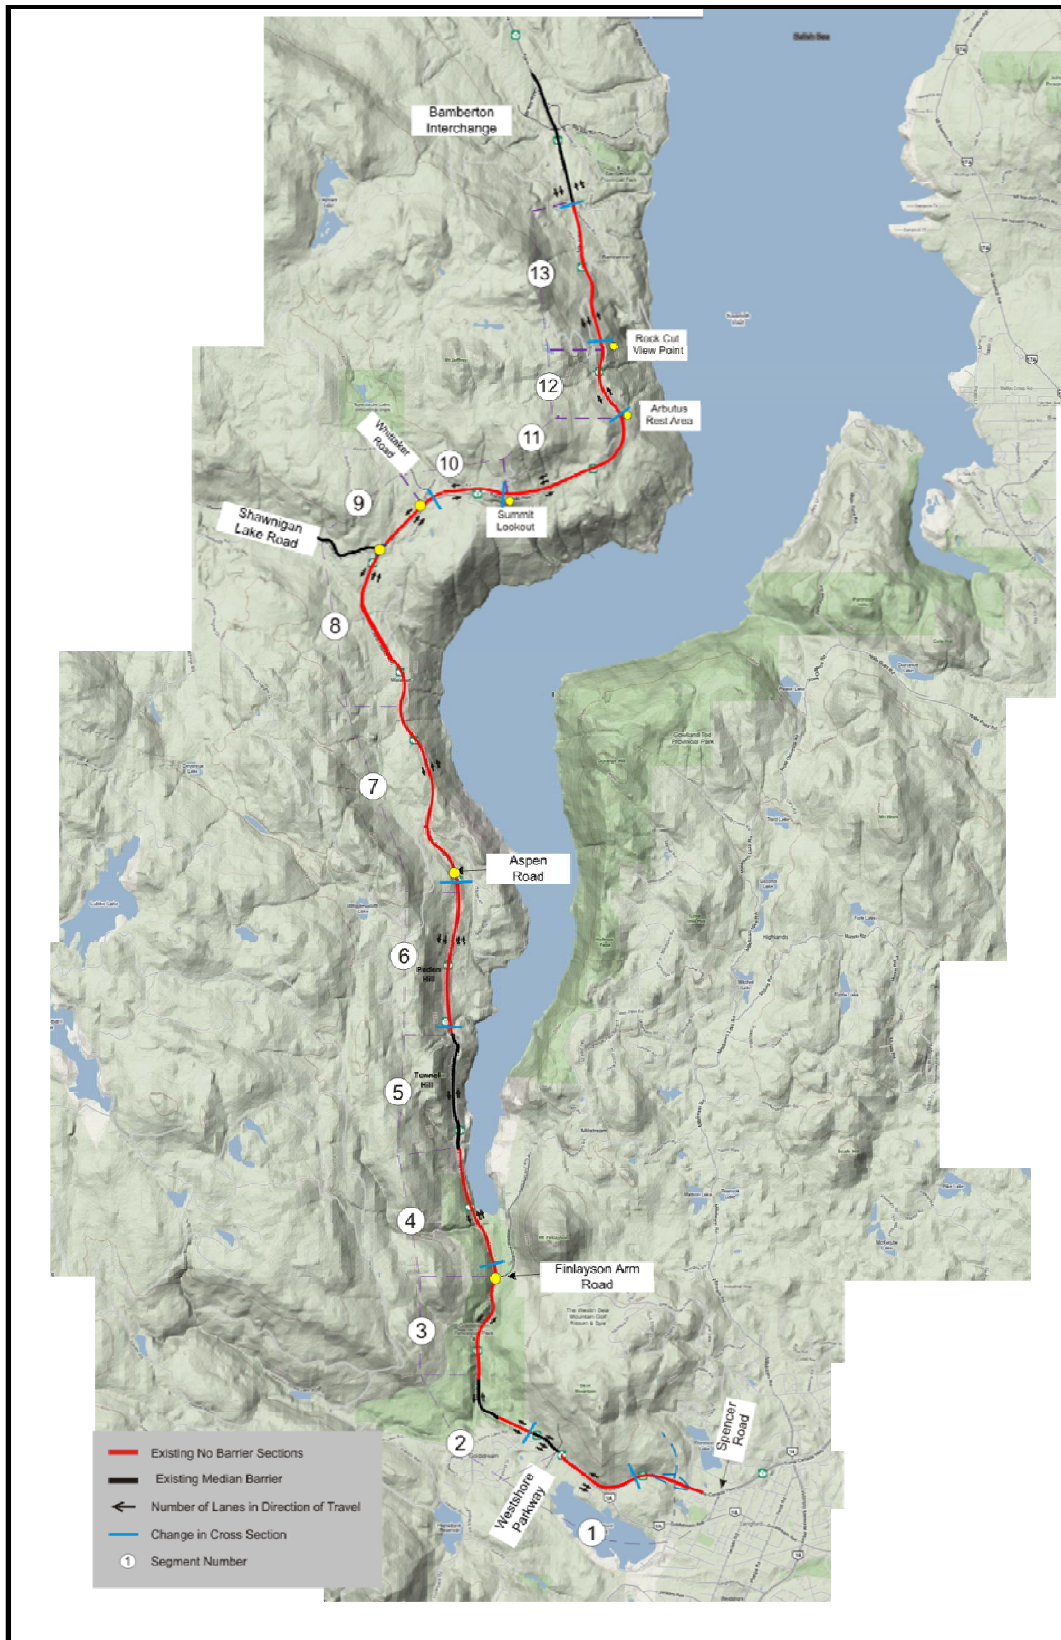
Figure 2: Existing conditions along review corridor

For the purpose of this safety review report, the Highway No. 1 corridor was divided into 13 segments as listed below and shown in **Figure 2**. Segment 1 (Spencer Road to West Shore Parkway) is not considered part of the Malahat however it was still included as part of this review because it is the only remaining undivided section of Highway No. 1 south of the West Shore Parkway. Segment's 2 to 13 contain the Malahat section of Highway No. 1 which begins at the West Shore Parkway intersection in the south and ends at the Bamberton Overpass in the north.

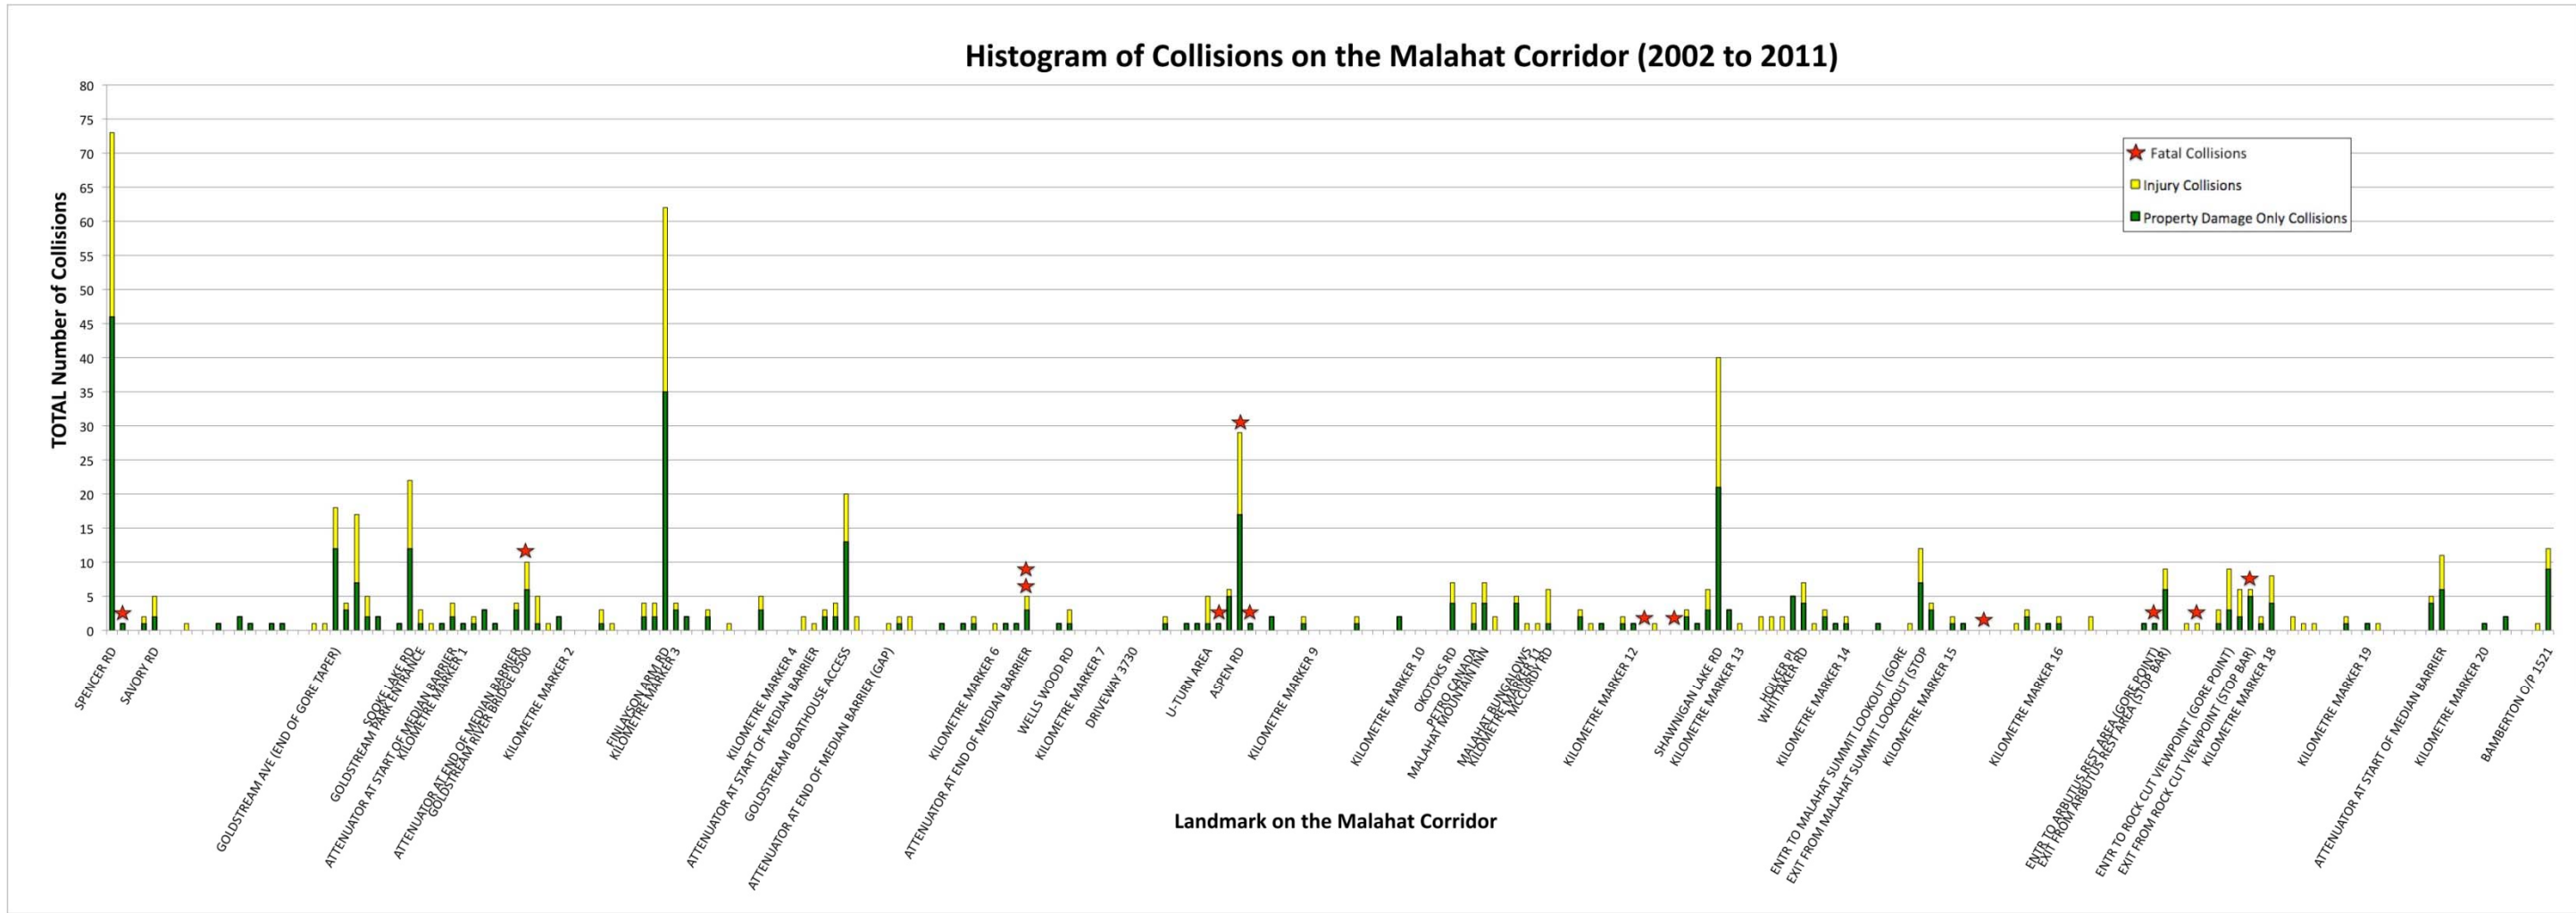
Appendix B: HISTOGRAM OF COLLISIONS ALONG THE MALAHAT CORRIDOR

A histogram of the collisions that have occurred on the Malahat corridor from 2002 to 2011 can be found in **Appendix B**.
