Ministry of Environment
Inspection Record

EP System: <u>AMS</u>	Inspection Status: <u>FINAL</u>
System Number: <u>105809</u>	Inspection No: <u>24405</u>
EP System Status: <u>Active</u>	Inspection Date: <u>2015-12-02</u>
Region: <u>West Coast</u>	Office: <u>Nanaimo</u>
Trigger: <u>Unplanned</u>	Incidents of Non-Compliance Observed: <u>No</u>
Non-Compliance Decision Matrix Level: <u>Level 0</u>	Non-Compliance Decision Matrix Category: <u>Category 0</u>
Inspector Name(s): <u>Laura Hunse</u>	Risk Ranking: <u>Over 2 = High</u>
Audit: <u></u>	Total Non-Compliance(s): <u>0</u>
Regulated Party: <u>Cobble Hill Holdings (BC0754588)</u>	
Regulated Party Contact(s): <u>Marty Block (CHH director), Pete Craig (SIRM operations)</u>	
Mailing Address: <u>Cobble Hill Holdings Ltd. (BC0754588)</u> <u>c/o Herald Street Law</u> <u>101 - 536 Herald Street</u> <u>Victoria BC V8W S61</u>	
Phone No: <u>(250)743-0811</u>	Fax No: <u></u>
Contact Email: <u>marty.sia@shaw.ca</u>

Location Description or Site Address: <u>460 Stebbings Road, Shawnigan Lake</u>	
Latitude: <u>48.5511</u> <u>N</u>	Longitude: <u>123.6066</u> <u>W</u>
Receiving Environment(s): <u>Groundwater, Land & Surfacewater</u>

Authorization:

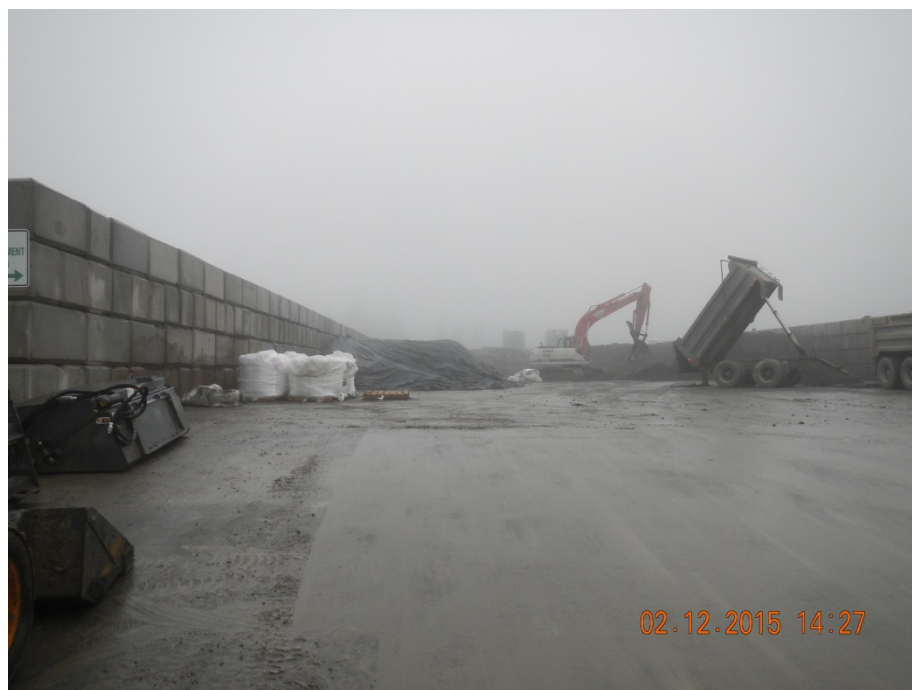
Photo 1

Soil management area was mostly empty and further sandbagging and lining was added to the outer perimeter. The small amount of soil in it was covered as required.

Soil management
area (SMA)nearly
empty

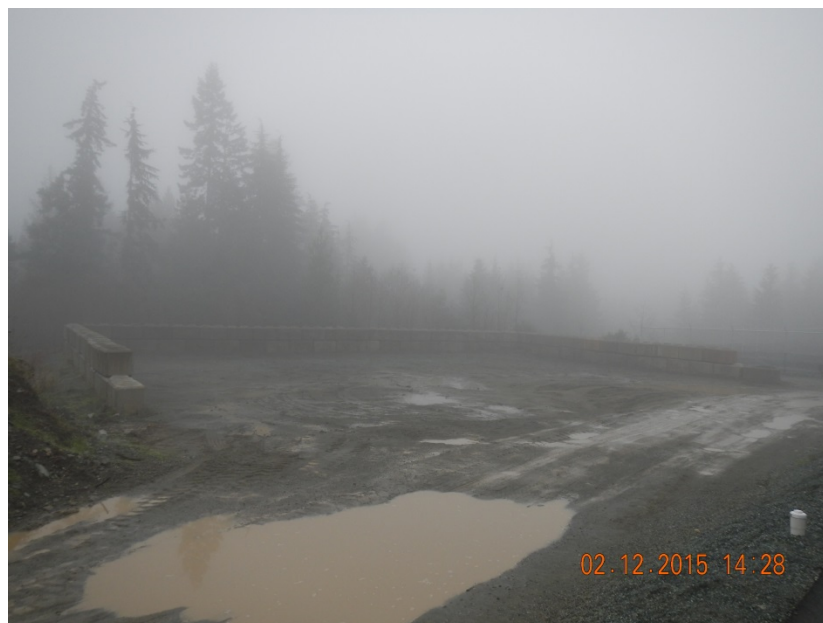
Photo 2

The perc soil pile (regulated by land remediation) has now been removed to the landfill and was required to meet standard waste acceptance procedure prior to acceptance at the landfill.

Site of former
perc soils, now
removed to
landfill

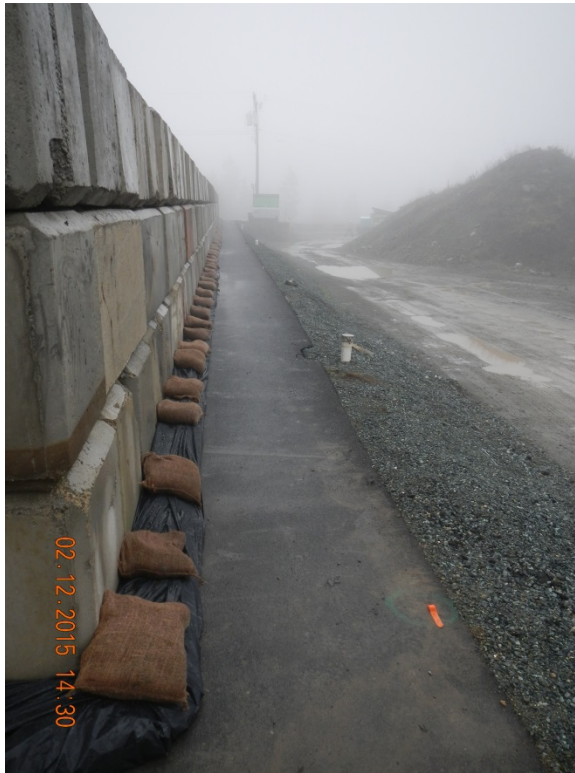
Photo 3

SMA perimeter

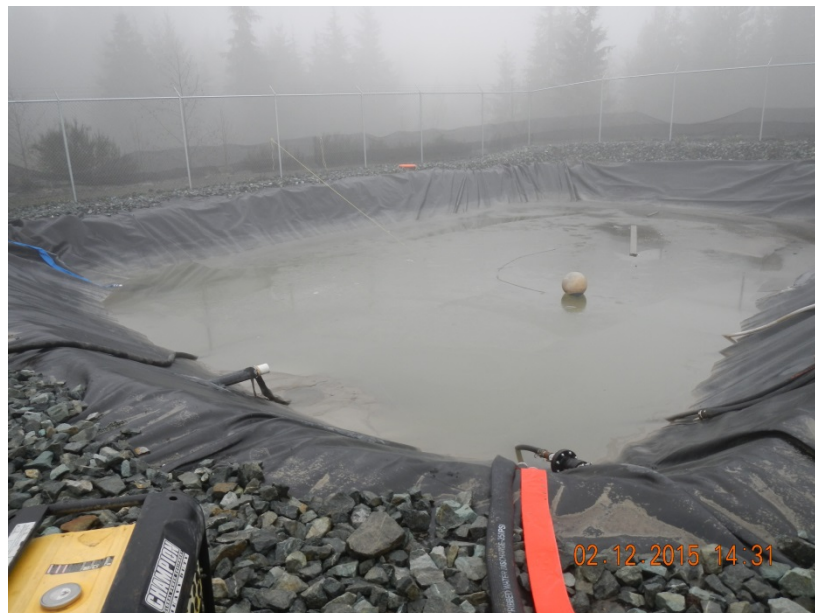
Photo 4

The holding pond (pre-treatment) was very low at the time. Much of the piping has now been twinned for redundancy; further redundancy planning is in progress. 52000 gallons of storage in tanks is on standby if necessary.

Pre-treatment
holding pond.
Note twinning of
pipes to
treatment plant
for redundancy

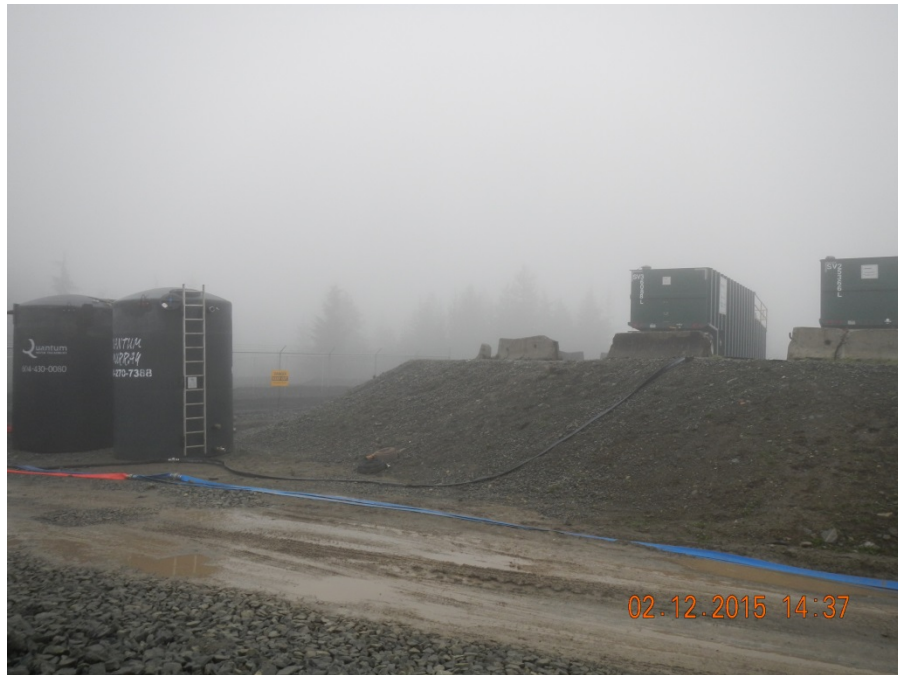
Photo 5

Additional 52000 gallons standby storage space (2 x 5000, 2 x 21000)

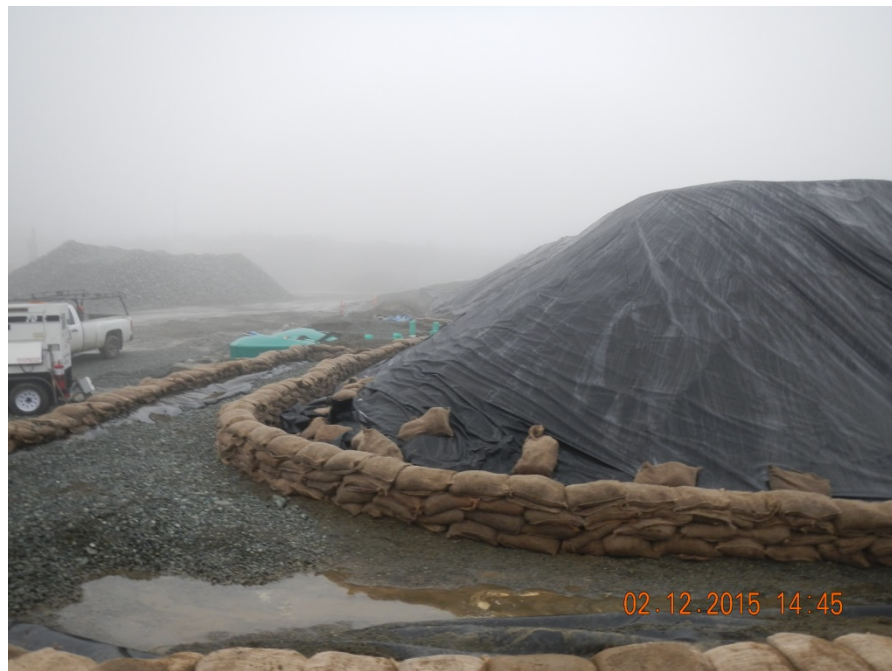
Photo 6

The PEA was further shored up at the perimeters and tidy. Only the active area was not covered by poly at the time of inspection.

Further reinforcement of Permanent Encapsulation Area (PEA). This corner includes the recently accepted former perc soil

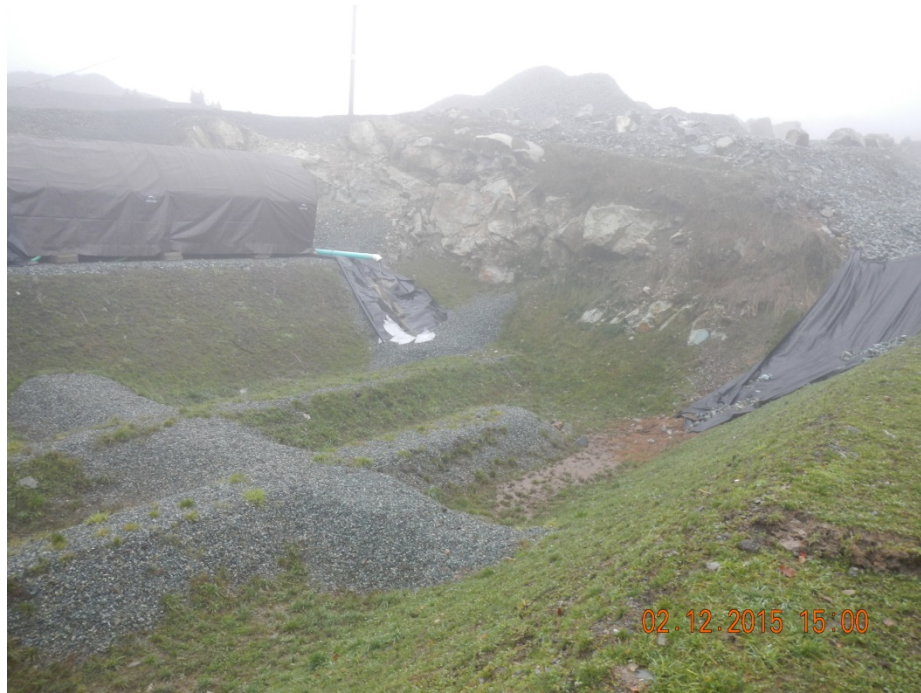
Photo 7

The settling pond was empty.

Sedimentation
Pond

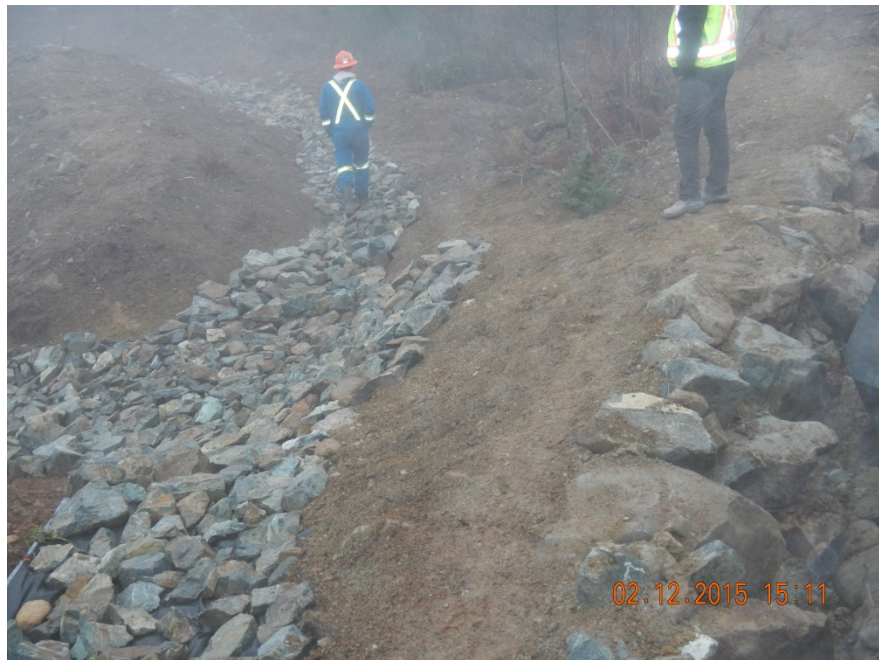
Photo 8

The ditching south of the active pit which collects the overland flow from the untouched vegetation has also been landscaped to inhibit the flow of the storm flow from leaving the site. Swales were enhanced with depth and riprap to inhibit solids.

Southwest
perimeter swale
and stormwater
redirect

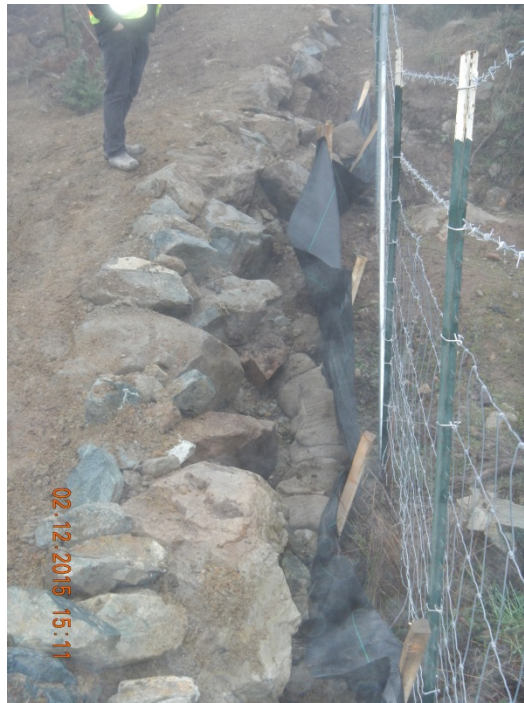
Photo 9

Southwest
perimeter swale
and stormwater
redirect
