Re: Balfour Osprey 2000 Gear Oil Spill - Summary of SCAT Assessment - April 20, 2017

Survey Date: April 20, 2017. 9:00 – 12:30

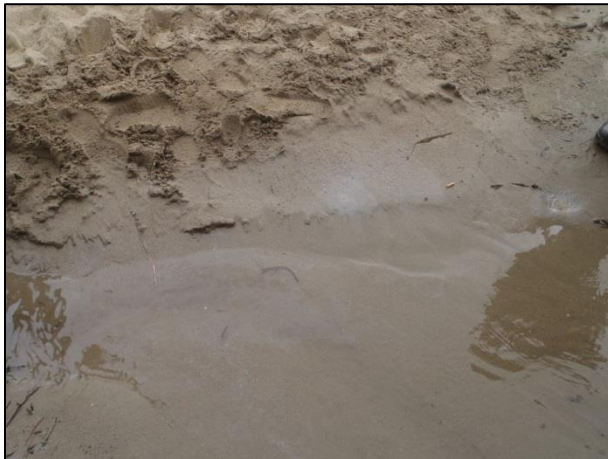
Photo 3. Section 2a - Silver film when shoreline washed.

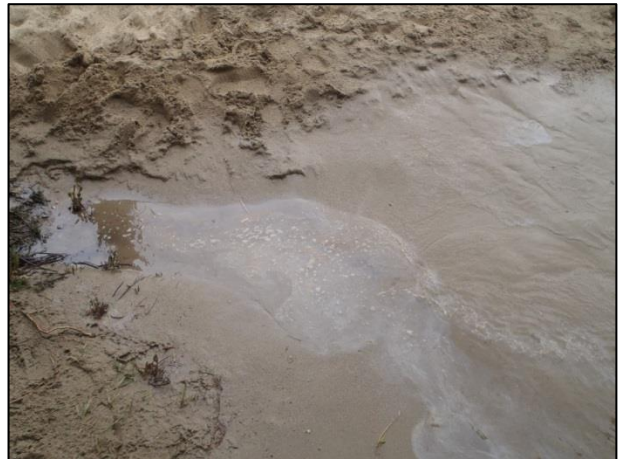
Photo 4. Section 2b (under ferry ramp) – silver to iridescent film observed when shoreline washed.

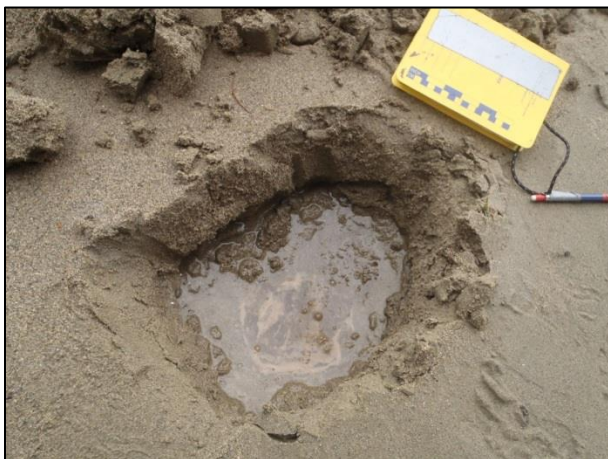
Photo 5. Section 2b – pit – no film or subsurface oil present

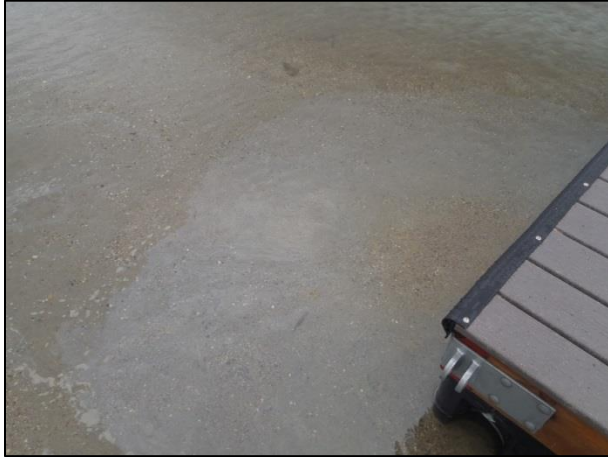
Photo 7. Section 2d – silver to iridescent film on downstream side of Dock 'n' Duck dock after washing of shoreline.

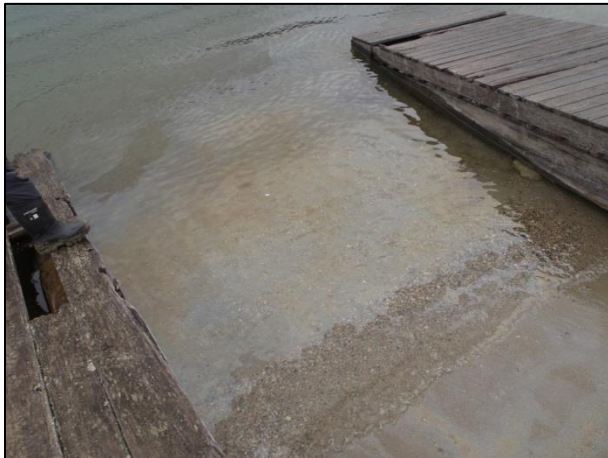
Photo 9. Section 3b – silver to iridescent film observed in quiet area between small docks at downstream end of section

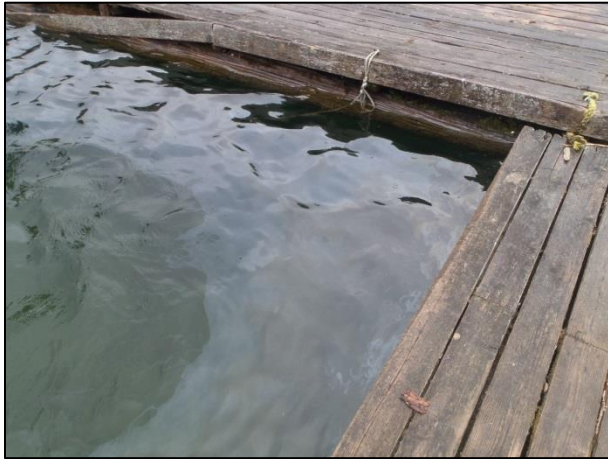
Photo 11. Section 4b –silver film present in quiet areas around marina dock and boat slips

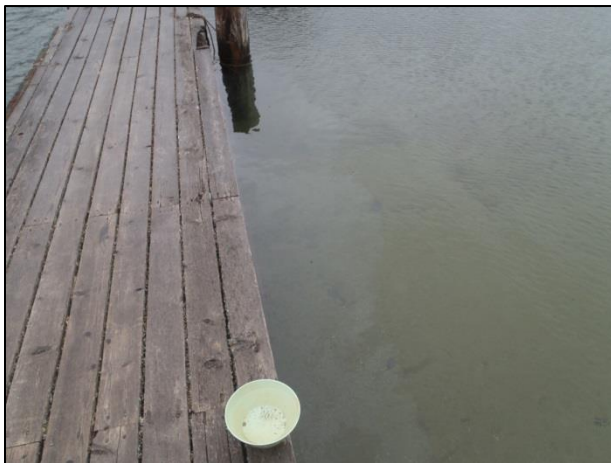
Photo 13. Section 5 – Light silver film around docks in quiet areas

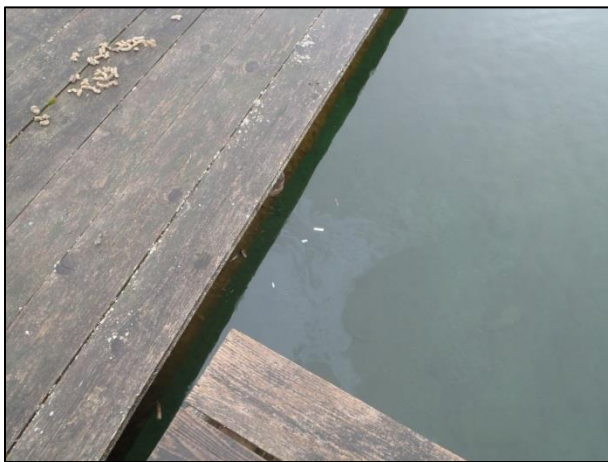
Photo 15. Section 6 - Light silver film around docks in quiet areas
