MINISTRY OF TRANSPORT AND INFRASTRUCTURE

ISLAND RAIL CORRIDOR CONDITION ASSESSMENT

TRACK CONDITION ASSESSMENT

MARCH 13, 2020

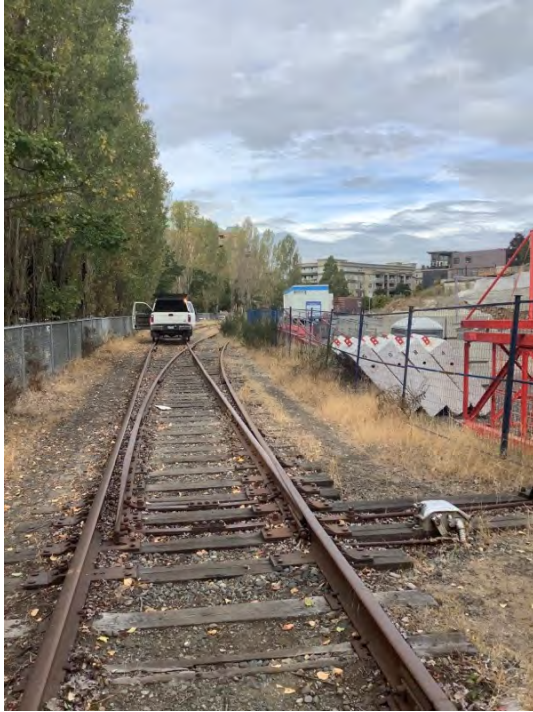
Figure 6: Turnout Mile 0.37 General Condition

No condition assessment of any of the mainline turnouts between Victoria and Langford were undertaken during the site investigation. However, the southern Victoria siding turnout was photographed and logged for reference (Figure 6). It is believed that the 5 turnouts between Victoria and Langford are in a generally fair condition, based upon the overall turnout condition of the Victoria subdivision and hi-rail assessment..

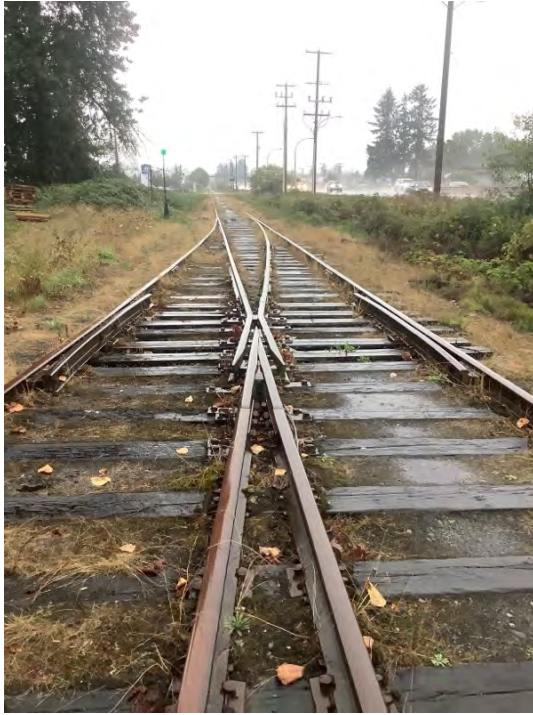
Figure 9: Turnout Mile 38.20 General Condition

During a site inspection one turnout condition assessment was undertaken. The 85lb turnout was observed to be in a fair condition with some components of the turnout in poor condition. The ballast and ties were shown to be in poor condition while the rail, frog and anchors were in fair condition with approximately 9mm of rail head loss noted in the inspection. While not all of the 3 mainline turnouts were inspected out on site, it is observed from the hi-rail that the other 2 turnouts are in a similar condition. Figure 9 shows the typical condition of the turnouts between Langford and Duncan

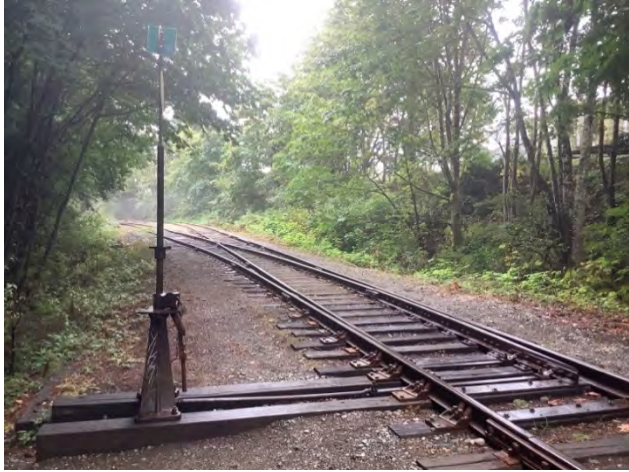
Figure 12: Turnout Mile 70.07 General Condition

During a site inspection one turnout was noted for reference at the northern wye turnout to Wellcox yard. A condition inspection was not undertaken as the 100lb turnout was noted to be in a fair condition. Current operations and maintenance procedures show that the turnout is in a fair working condition. While not all the 7 mainline turnouts were inspected while out on site, it is observed from the hi-rail that the other turnouts are in a fair condition, similar to the rest of the Victoria subdivision. Figure 12 shows the typical condition of the turnouts between Duncan and Nanaimo.

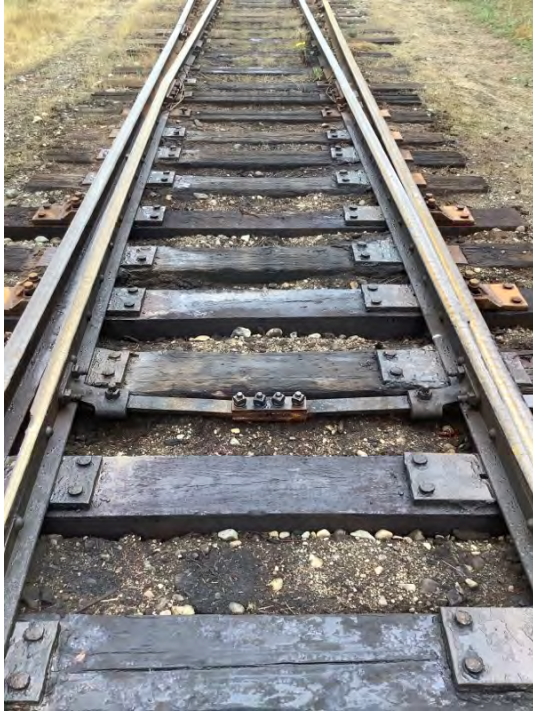
During a site inspection one turnout condition assessment was undertaken and one turnout was visually reviewed and logged. Both 85lb turnouts was observed to be in a generally fair condition with some segments of the turnout considered to be poor. The ballast and ties were noted to be in poor condition while the rail, frog and anchors noted to be in fair condition with no head loss measured on site. While not all the 9 mainline turnouts were inspected while out on site, it is observed from the hi-rail that the other turnouts are in a similar condition.

Figure 15 shows the typical condition of the turnouts between Nanaimo and Parksville.

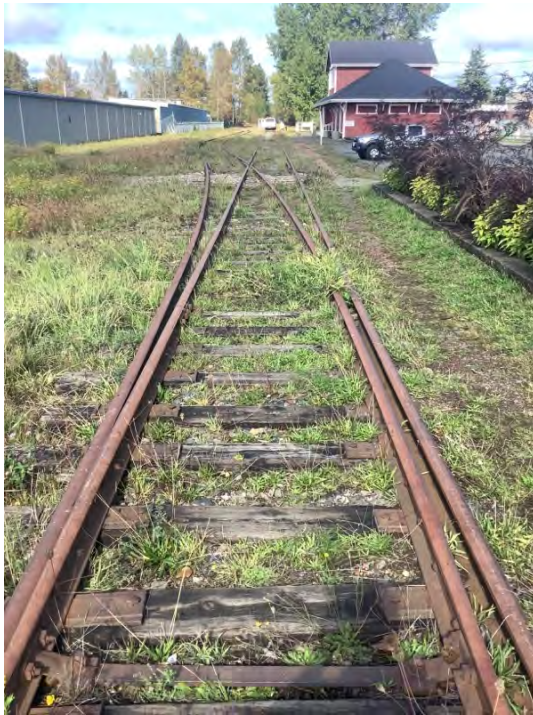
During a site inspection one turnout condition assessment was undertaken at Courtenay station. The 85lb turnout was observed to be in a fair condition with some components of the turnout considered to be poor. The ballast and ties were deemed to be in poor condition while the rail, frog and anchors deemed to be in fair condition with approximately 7-8mm of rail head loss, with a maximum of 11 noted on the through rail. While not all 7 mainline turnouts were inspected while out on site, it is observed from the hi-rail that the other turnouts are in a similar condition.

Figure 18 shows the typical condition of the turnouts between Parksville and Courtenay.

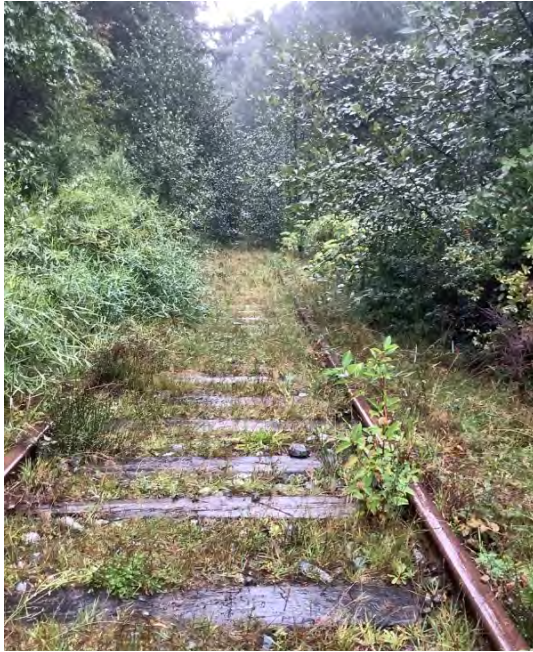
Figure 19: Parksville to Port Alberni - Typical Road Bed

be in a fair condition. The fair condition is located in Port Alberni town center or at the interface with Victoria subdivision.

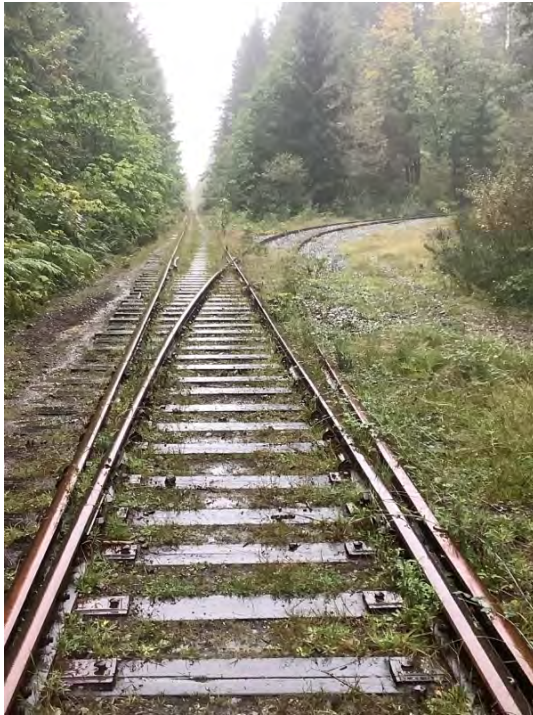
Figure 21: Turnout Mile 34.40 (Port Alberni)
general photo

During a site inspection three turnout condition assessments were undertaken along the subdivision. All 85lb turnouts was observed to be in a generally fair condition with some parts of the turnout considered to be poor. The ballast was noted to mainly in poor condition while the rail, frog and anchors noted to be in fair condition with approximately 9mm of rail head loss, with a maximum of 11mm noted on the through and closure rails. While not all 5 mainline turnouts were inspected while out on site, it is observed from a walking inspection, that the other turnouts are in a similar condition. Figure 21 shows the typical condition of the turnouts between Nanaimo and Parksville.

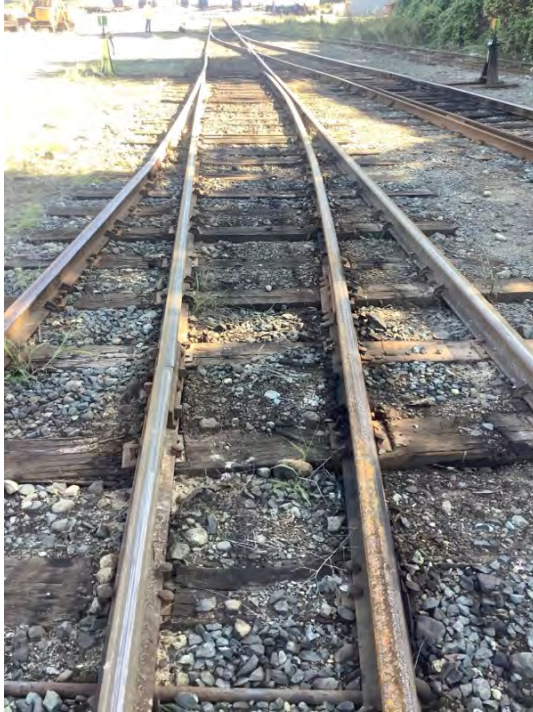
Figure 24: Turnout Wellcox Yard. General Photo

During a walking site inspection of the yard only one of the 34 turnouts had a condition assessment undertaken. The 85lb turnout was observed to be in a generally fair condition with some components of the turnout considered to be poor. The ballast, ties and anchors were deemed to mainly in poor condition while the rail and frog deemed to be in fair condition with approximately 11mm of rail head loss, with a maximum of 12mm noted on the and closure rails. While not all 34 yard turnouts were inspected while out on site, it is observed from a walking inspection, that the other turnouts are in a similar condition.

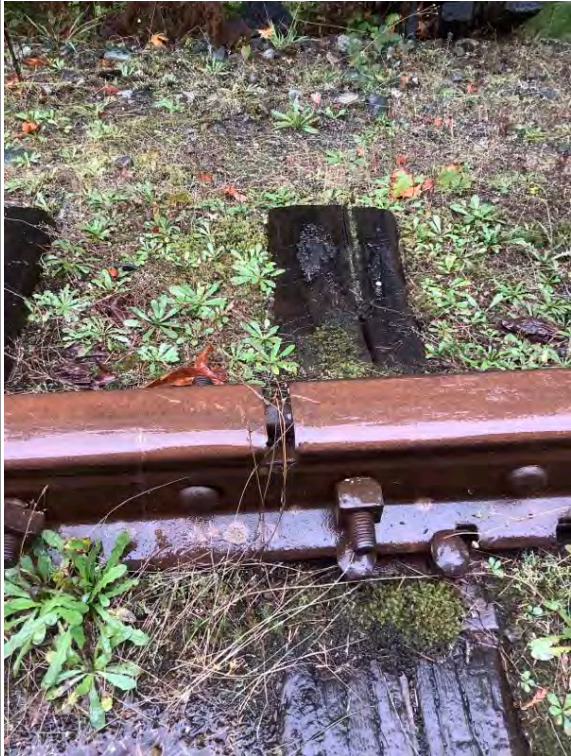
<p>Joint gap</p>

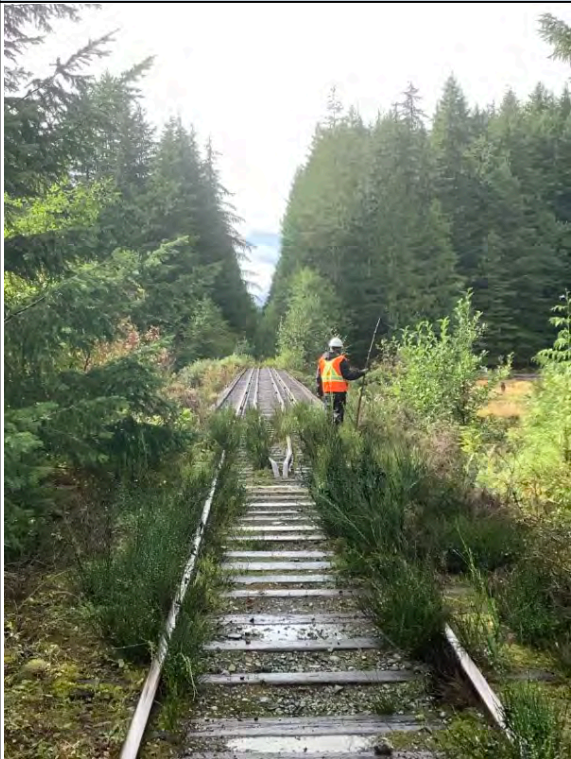
Summit lake bridge
