Ministry of Environment
Inspection Record

EP System: <u>AMS</u>	Inspection Status: <u>FINAL</u>
System Number: <u>105809</u>	Inspection No: <u>27734</u>
EP System Status: <u>Active</u>	Inspection Date: <u>2016-08-03</u>
Region: <u>West Coast</u>	Office: <u>Nanaimo</u>
Trigger: <u>Planned</u>	Incidents of Non-Compliance Observed: <u>No</u>
Non-Compliance Decision Matrix Level: <u>Level 0</u>	Non-Compliance Decision Matrix Category: <u>Category 0</u>
Inspector Name(s): <u>Laura Hunse</u>	CPIX: <u>Over 2 = High</u>
Audit: <u></u>	Total Non-Compliance(s): <u>0</u>
Regulated Party: <u>COBBLE HILL HOLDINGS LTD. (BC0754588)</u>	
Regulated Party Contact(s): <u>Marty Block (CHH director), Todd Mizuik (SIRM)</u>	
Mailing Address: <u>South Island Aggregates Ltd. PO Box 282 Malahat BC V0R 2L0</u>	
Phone No: <u>(250)743-0811</u>	Fax No: <u>(250) 743-3338</u>
Contact Email: <u>marty.sia@shaw.ca</u>	
Location Description or Site Address: <u>460 Stebbings Road, Shawnigan Lake</u>

Authorization: 105809	Client Name: Cobble Hill Holdings
CVIS IR #: 27734	August 3, 2016 Site Inspection Photos

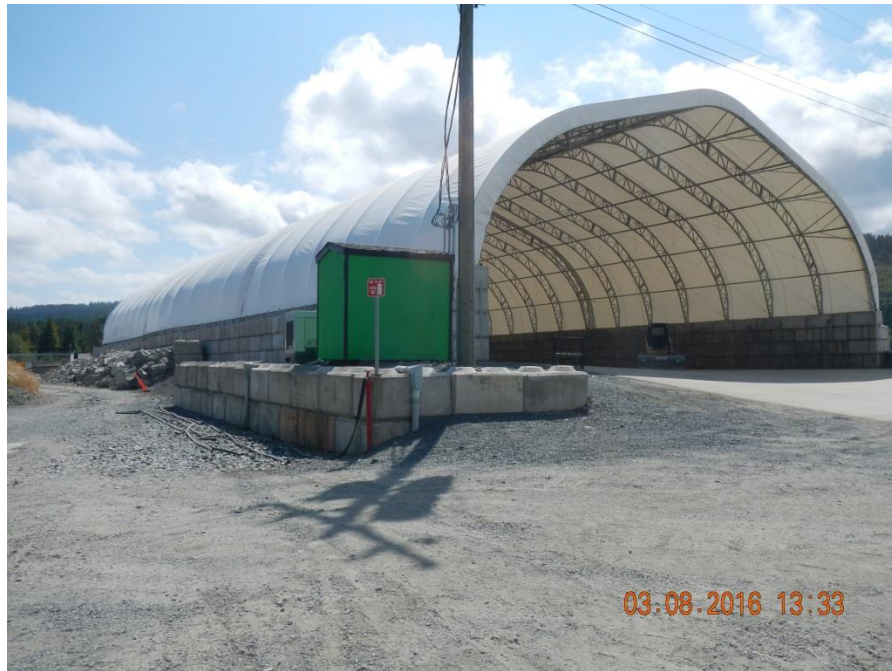
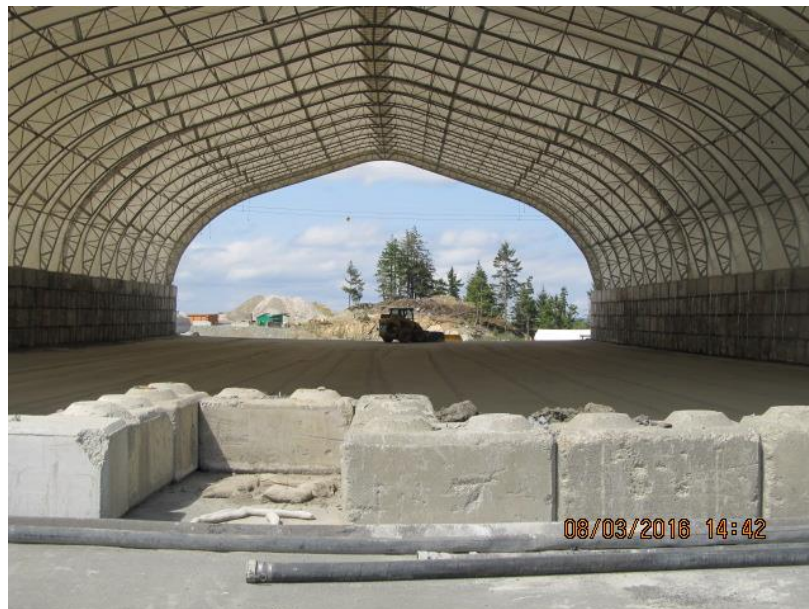
Requirement Type:	Requirement Description:	Details/Findings:	Compliance:
Operations	<p>SMA AUTHORIZED WORKS</p> <p>1.1.4 The authorized works as defined under Subsections 1.2.1, 1.3.1, 1.4.5 and 1.5.4 must be complete and in operation while discharging.</p> <p>1.2.1 The authorized works are a lined asphalt paved soil management and bioremediation treatment area of approximately 1800 m2, temporary soil holding area (as described under</p>	<p>The authorized works are complete and in operation and located as per updated site map as included with 2016 Q2 report p. 20. See photos 1 and 2.</p>	In

Requirement Type:	Requirement Description:	Details/Findings:	Compliance:
<u>Operations</u>	<p>WEATHER PROTECTION</p> <p>2.7 A permanent roof must be placed over, cover, and prevent precipitation from entering the soil management and bio-remediation treatment area including the temporary soil holding area (as described under subsection 2.3), referred to in subsection 1.2.1. The Permittee must cover the active landfill areas completely from</p>	<p>SMA permanent roof is in place and no soil was stored outside or inside the covered area at time of inspection. See additional comments for further discussion. See photos 1 and 2.</p>	<u>In</u>

Soil Management
Area (SMA)

SMA

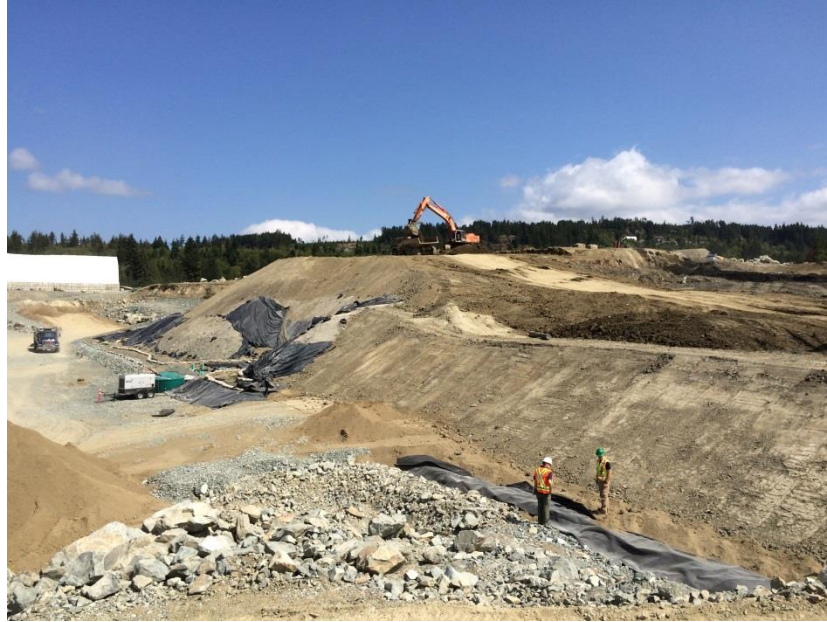
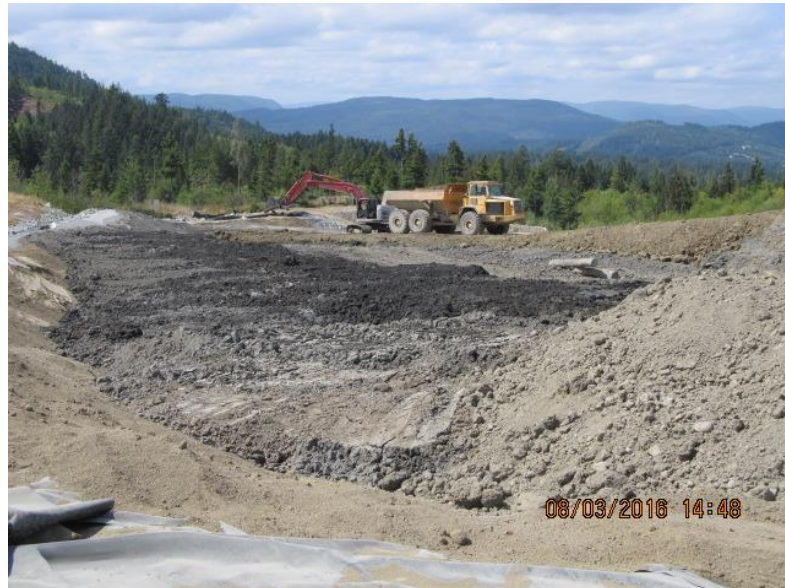
Subsection 2.3), biocell, berm, primary and secondary containment detection and inspection sumps and associated cleanout ports, catch basins, groundwater monitoring wells (as described under Subsection 3.3), management works and related appurtenances approximately located as shown on Figure A.		
Requirement Type:	Requirement Description:	Details/Findings:	Compliance:
<u>Operations</u>	<p>LANDFILL AUTHORIZED WORKS</p> <p>1.1.4 The authorized works as defined under Subsections 1.2.1, 1.3.1, 1.4.5 and 1.5.4 must be complete and in operation while discharging.</p> <p>1.3.1 The authorized works are a landfill, engineered lined landfill cells, perimeter ditches, erosion and sedimentation control infrastructure, primary and secondary containment detection and inspection sumps and associated cleanout ports, catch basins, groundwater monitoring wells, management works and related appurtenances approximately located as shown on Figure A.</p>	The authorized works are complete and in operation and located as per updated site map as included with 2016 Q2 report p. 20. See photos 3 and 4.	<u>In</u>

Southwest of
Landfill looking
northeast

Landfill southeast
corner looking
northwest

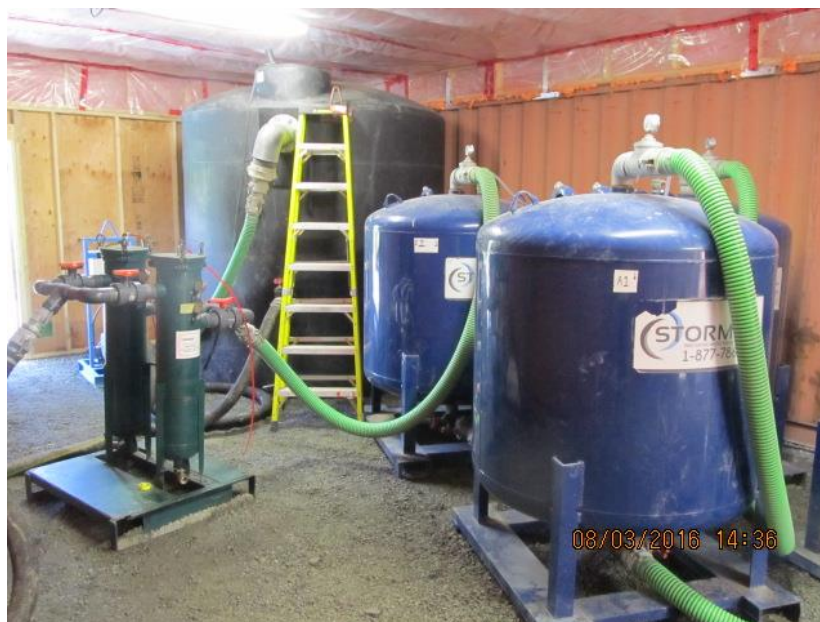
Photo 5

Requirement Type:	Requirement Description:	Details/Findings:	Compliance:
<u>Operations</u>	<p>WTS AUTHORIZED WORKS</p> <p>1.1.4 The authorized works as defined under Subsections 1.2.1, 1.3.1, 1.4.5 and 1.5.4 must be complete and in operation while discharging.</p> <p>1.4.5 The authorized works are surface runoff collection and diversion ditches associated with the WTS, WTS (including pH control and flocculent injection</p>	The authorized works are complete and in operation and located as per updated site map as included with 2016 Q2 report p. 20. See photos 5 and 6.	<u>In</u>

Water Treatment
System (WTS)

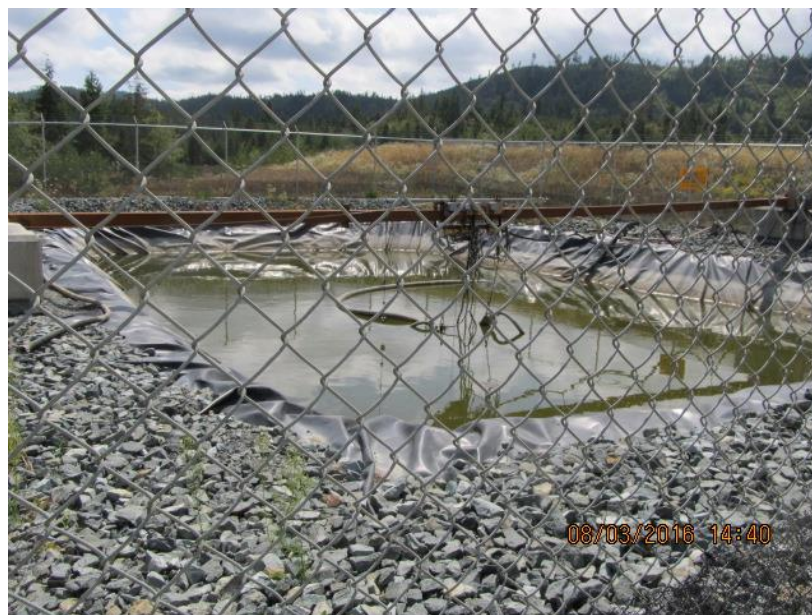
Photo 6

Containment
Pond

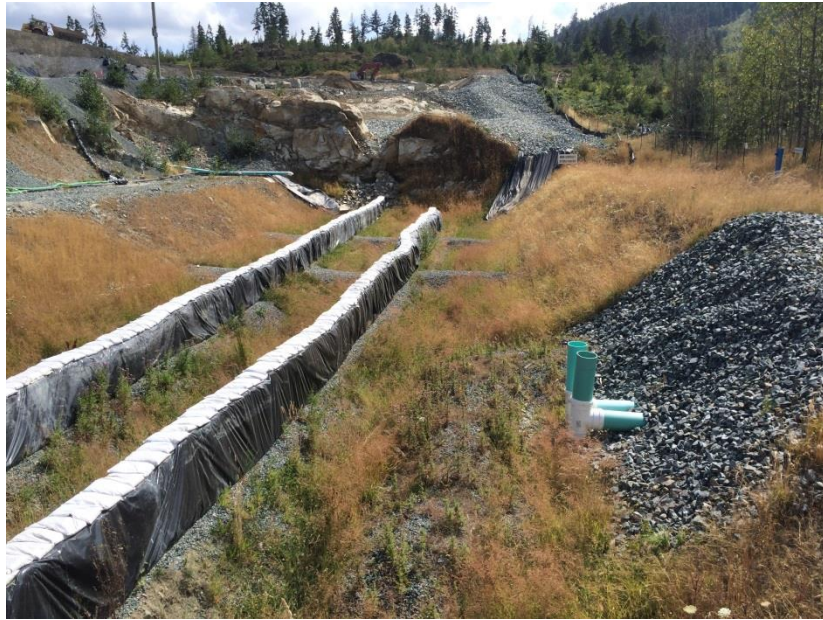
Photo 7

<p>system, settling tank, bag and activated carbon filters), leachate and leak detection reservoirs, flow measurement device, monitoring and sampling equipment, reservoirs and related appurtenances approximately located as shown on Figure A.</p> <p>1.4.6 The authorized works must be complete and in operation while discharging.</p>		
Requirement Type:	Requirement Description:	Details/Findings:	Compliance:
<u>Operations</u>	<p>SETTLING POND AUTHORIZED WORKS</p> <p>1.1.4 The authorized works as defined under Subsections 1.2.1, 1.3.1, 1.4.5 and 1.5.4 must be complete and in operation while discharging.</p> <p>1.5.4 The authorized works are surface runoff collection and diversion ditches, leachate, surface runoff and leak detection control reservoirs, one surface settling pond, flow measurement device, monitoring and sampling equipment, emergency overflow and related appurtenances approximately located as shown on Figure A.</p>	<p>The authorized works are complete and in operation and located as per updated site map as included with 2016 Q2 report p. 20. See photo 7.</p>	<u>In</u>

Settling pond
looking south.

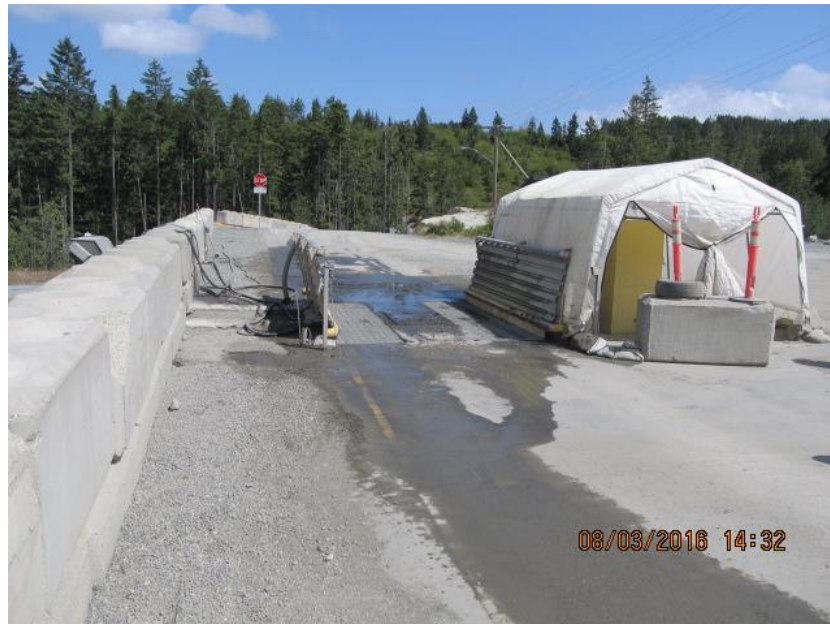
Photo 8

Wheel Rinsing
facilities

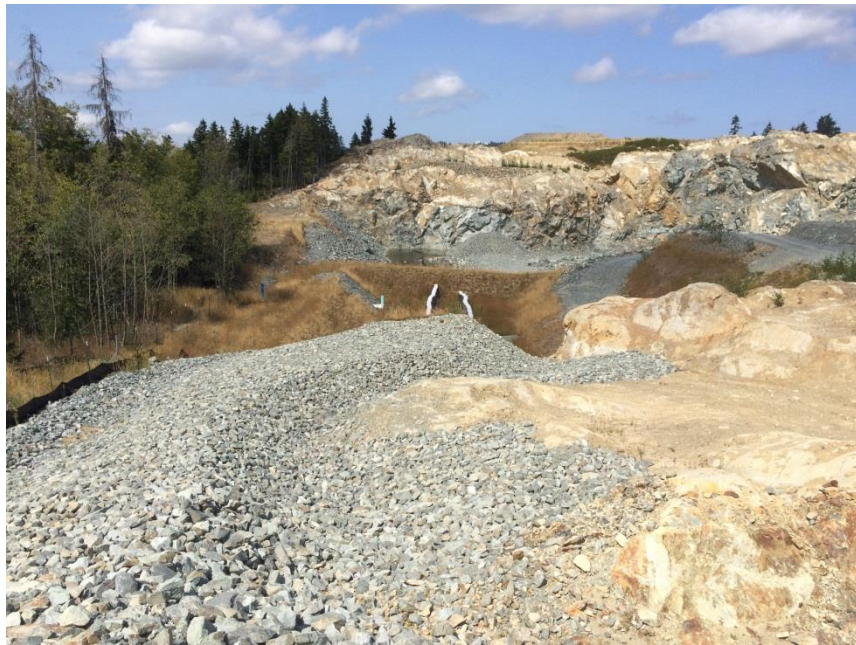
Photo 10

November to April when not actively worked on and provide sufficient weather protection and containment for nutrients stored at the site for the protection of human health and the environment.		
Requirement Type:	Requirement Description:	Details/Findings:	Compliance:
<u>Operations</u>	<p>WHEEL RINSING</p> <p>2.7.1 Before soil transport vehicles leave the site, their wheels must be rinsed to remove all soil and waste. Soil and waste must be managed in accordance with the permit. Rinse water must be directed to the leachate and leak detection reservoir(s). These requirements must be included in the Environmental Procedures Manual.</p>	Wheel rinsing facilities are in place, vehicle wheels and truck beds are rinsed and soil and waste dealt with in accordance with the permit. See photo 8.	<u>In</u>
Requirement Type:	Requirement Description:	Details/Findings:	Compliance:
<u>Operations</u>	<p>EROSION AND SEDIMENTATION CONTROL</p> <p>2.8 The Permittee must ensure erosion and sedimentation control measures are implemented with the soil management and treatment area and the landfill area, to limit sediment releases to the settling pond, the water treatment system and to the receiving waters. Storm water runoff must be diverted away from the soil management and treatment area and all active landfill areas at all times. Erosion and sedimentation controls must be developed and implemented according to industry best management practices and consider the Aggregate Operators Best Management Practices Handbook prepared by the Ministry of Energy and Mines.</p>	Ongoing and progressing erosion and sedimentation control measures including vegetation and diversion tactics were evident at the site visit. See photos 9 and 10.	<u>In</u>

Final west ditch, which now diverts non-contact flow in a manner which does not short-circuit settling time.

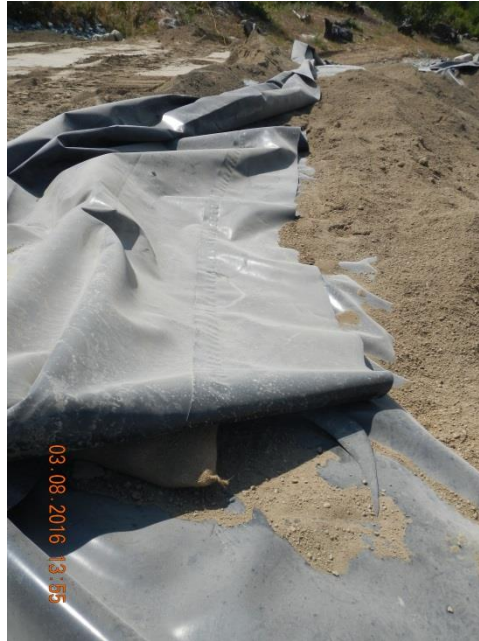
Photo 11

tracks on the liner in a photo submitted by the public appears to be a factory weld. Actual excavator track damage on surplus liner was also viewed at the site and would cause significant damage (see photos 11 - 14).

Factory welded
seam

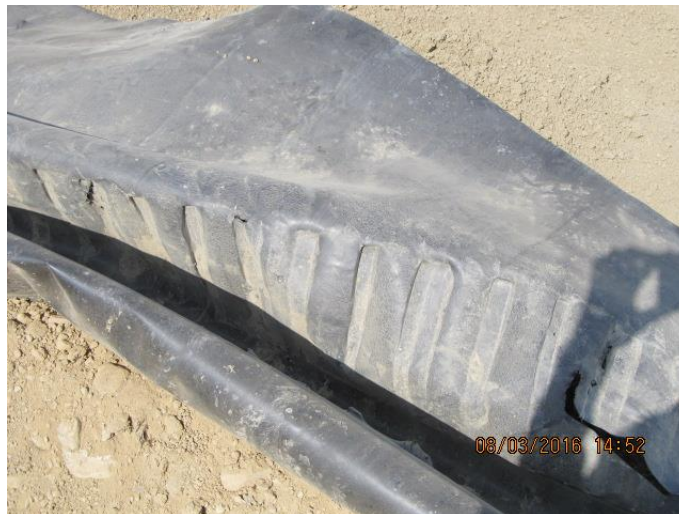
Photo 12

Excavator tracks
on excess liner

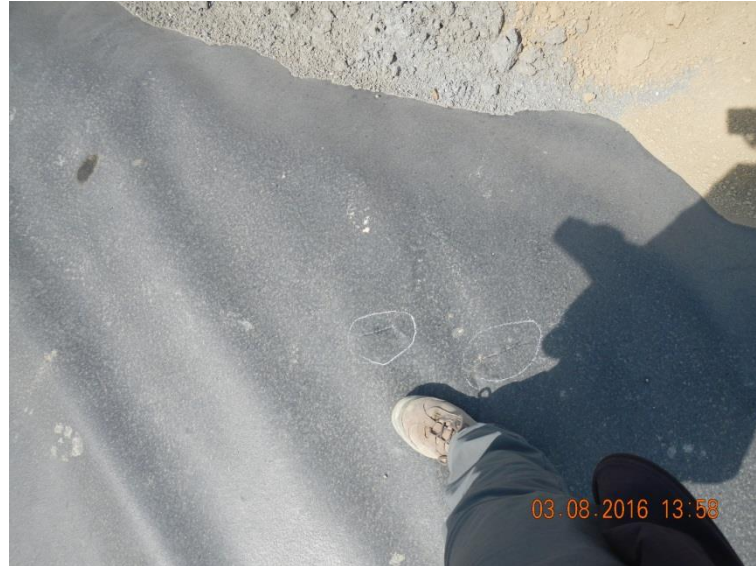
Photo 13

Regarding construction of Permanent Encapsulation Area (PEA) extension and installation concerns: Actual construction may deviate slightly from submitted plan/specs and generic cross-sections and discretion of the professionals in the field is acknowledged. As-Built plans/specs for PEA Cell 1C are on file at MOE; SIRM will submit accurate As-Built cross-section details for PEA Cells 1A, 1B and 1C, certified by a QP, including all details (e.g. leak detection works, all layers, anchor trenches, etc.). Regular inspections are made as part of the liner installation process, and welds and patches are applied as necessary. What looks to be excavation

In the installation process, any suspect areas on the liner are marked for further action

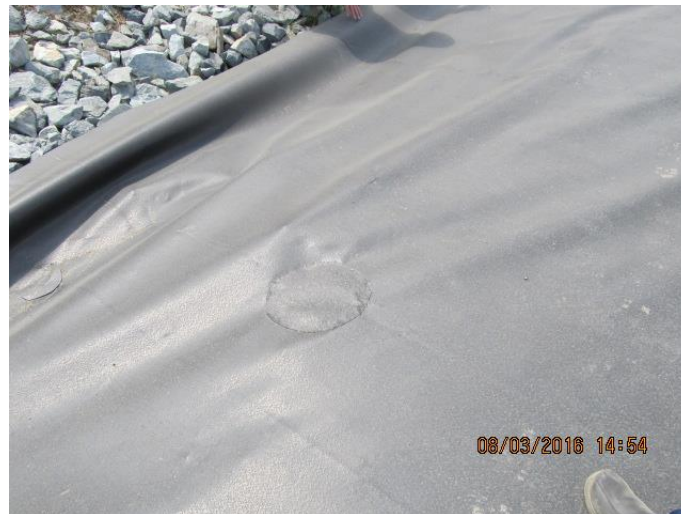
Photo 14

Typical hand-welded patch on liner

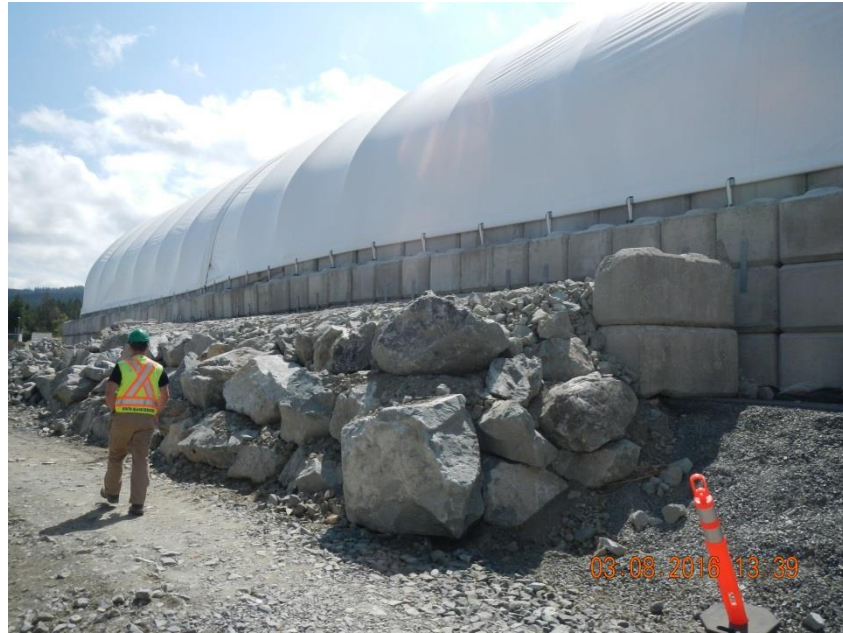
Photo 15

Regarding the SMA -- structural concerns: repairs to the structure were viewed at the inspection. Results of sediment sample at point of concern did not exceed CSR Schedule 7 Col II levels except in the case of chromium which tested at below original background levels found in quarry rock testing by Golder in 2013. The wetting of the soil shown in photos submitted by the public near the SMA structural buckling appears to be a result of runoff from the roof of the SMA in that area as opposed to sourcing from beneath the wall (see photos 15 and 16). A QP has signed off on the structural safety. SIRM will provide a copy of the QP certified plans/specs for the cover.

Reinforced outer
wall of SMA

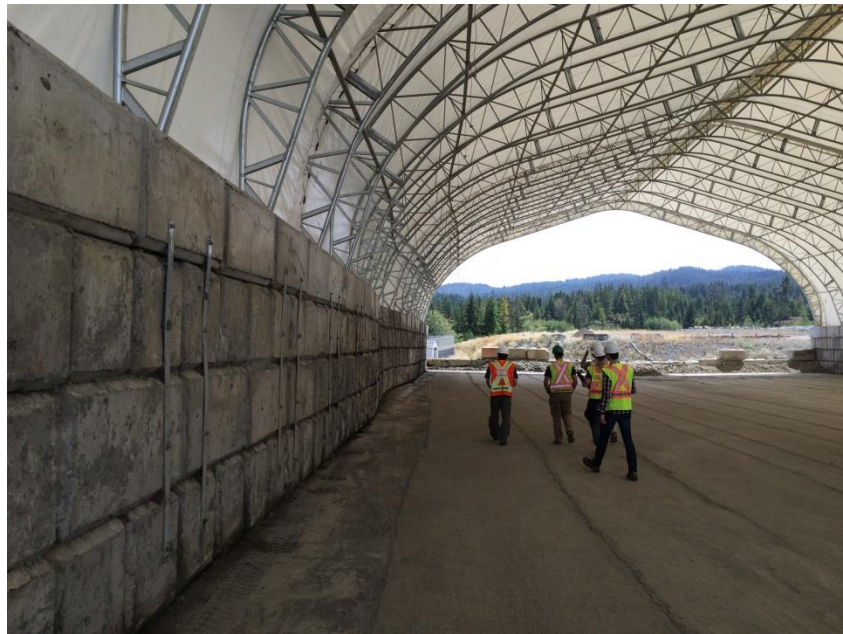
Photo 16

Internal view of
reinforced area
of SMA
