From: spomo1701@outlook.com
Sent: Monday, April 2, 2018 8:29 PM
To: Environmental Compliance ENV:EX; marty@chholdings.ca
Subject: SPO MO1701-Status Update March 30, 2018
Attachments: March 30, 2018 CHH Progress Report.pdf

FIELD REVIEW REPORT		DATE: March 27, 2018	ISLANDER PROJECT No.: 2087
REPORT No: 17	STAGE OF CONSTRUCTION: Landfill Closure	WEATHER: Rain & cloudy	PAGE: 1 of 3
PROJECT: Cobble Hill Landfill 2017 Minor Construction Works			
TO: CHH	ATTENTION: Marty Block		
CC:

The field review included the inspection of the following items included in the detailed summary of works section of the *Cobble Hill Landfill — 2017 Minor Construction Works, Detailed Construction Plan (Sperling Hansen Associates, September 13, 2017)*:

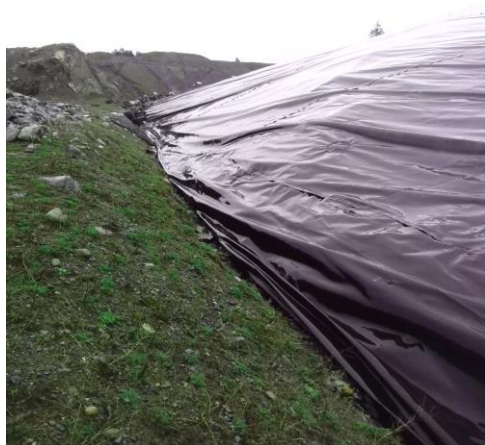
PEA – liner near NE corner

- **PEA**
 - Liner appears to be in good condition, with no noticeable changes since the date of our last inspection
- **Leachate and Leak Detention facility**
 - Total leachate collected: = 5.59 m³
 - Total leachate stored = 52.53 m³
 - Total leachate transported = 0 m³
- **Soil Management Area (SMA)**
 - All works are in good condition and no noticeable changes since the date of our last inspection
- **Contact Water Containment Pond**
 - All works are in good condition and no noticeable changes since the date of our last inspection
- **cut-off ditch upland of PEA**
 - All works are in good condition, ditch still performing well.
