Report Date:September 28, 2017 File:7982

Report Number:067359

Re: Notice Letter, Permit 7982, Tenerife Fish Processing - Port Edward, Effluent

Authorization: 7982	Client Name: Tenerife Packing Company Ltd.
NRIS IR#: 67359	Site Inspection Photos: September 20 <sup>th</sup> , 2017

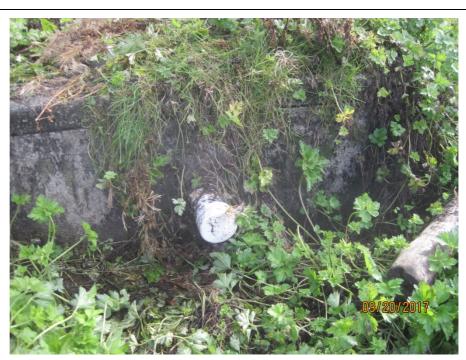
was issued, and that no discharge has passed through the modified outfall pipe since last inspection conducted on September 22nd, 2016. A photograph taken by the Officers during the September 20th, 2017 site inspection shows that the outflow from the septic tank is cut and capped with vegetation flattened down around it, a 3 inch PVC pipe that extends from the ground has been cut and capped (see attached Photo 1). A modified outfall pipe that connects directly to the floor drain and sump within the fish processing building runs along the boat launch to below the high water mark, no sign of discharge was evident at the time of inspection (see attached Photos 2 and 3).  The Officers then inspected the fish processing building. The salmon cutting machine for fix processing has been removed, and the building is currently being used for storage. Mr. Johnson stated that no fish processing has occurred at the Site since the Order was issued and that the sinks and washroom are not currently being used. A floor drain and sump that connects to the modified outflow pipe showed no signs of recent use (see Photo 4). Mr. Johnson stated that he wants to comply with the Order and take the necessary actions to resume fish processing.		owner and operator. The time frame assessed within this inspection report is from

Photo 1 – Capped septic tank outflow pipe. Capped PVC pipe extending into ground under vegetation.

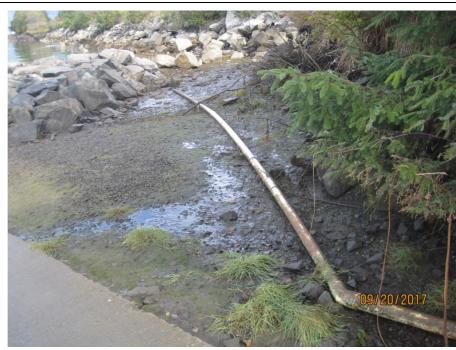
Photo 2 –
Modified septic
outfall pipe
extending down
the boat launch
and ending below
the high tide
level.

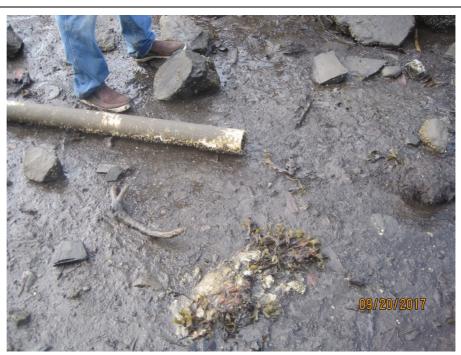
Photo 3 – End of modified outfall pipe, no sign of discharge visible

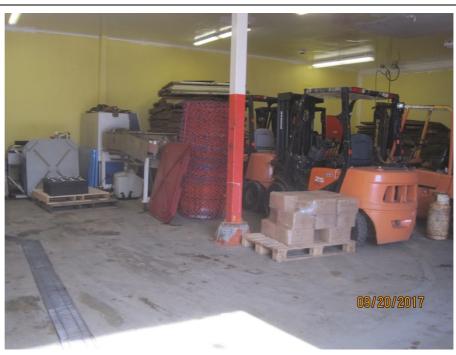
Compliance: Not Applicable		Johnson stated that no fish processing has occurred at the Site since the Order was issued, and that the sinks and washroom are not currently being used. A floor drain and sump that connects to the modified outflow pipe showed no signs of recent use (see Photo 4). Mr. Johnson stated that he wants to comply with the Order and take the necessary actions to
	Compliance:

Photo 4 – Floor drainage ditch that was previously utilized to collect excess fish processing water.
