BI-WEEKLY STATUS REPORT

Cobble Hill Landfill Closure

PROJECT # : PRJ18074	File #: 18074- BWR-71
REPORT #: 73	Date: July 30, 2020
SHA REPRESENTATIVES: Dr. Tony Sperling, P.Eng. Scott Garthwaite Carly Wolfe, EIT	Owner: Cobble Hill Holdings Ltd. Contractor: Allterra Construction Ltd.

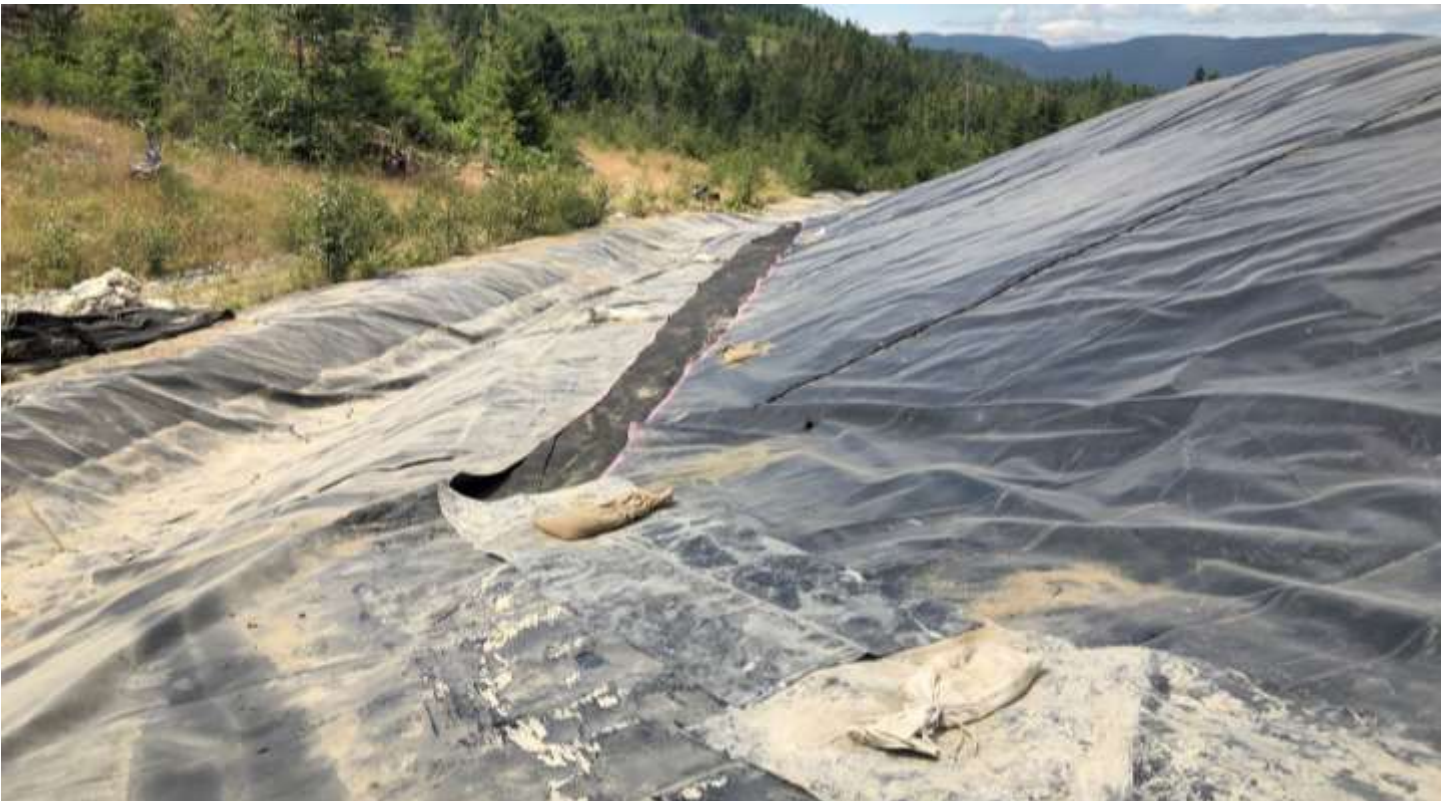
Picture # 4: Strip requiring patching on east side of PEA.

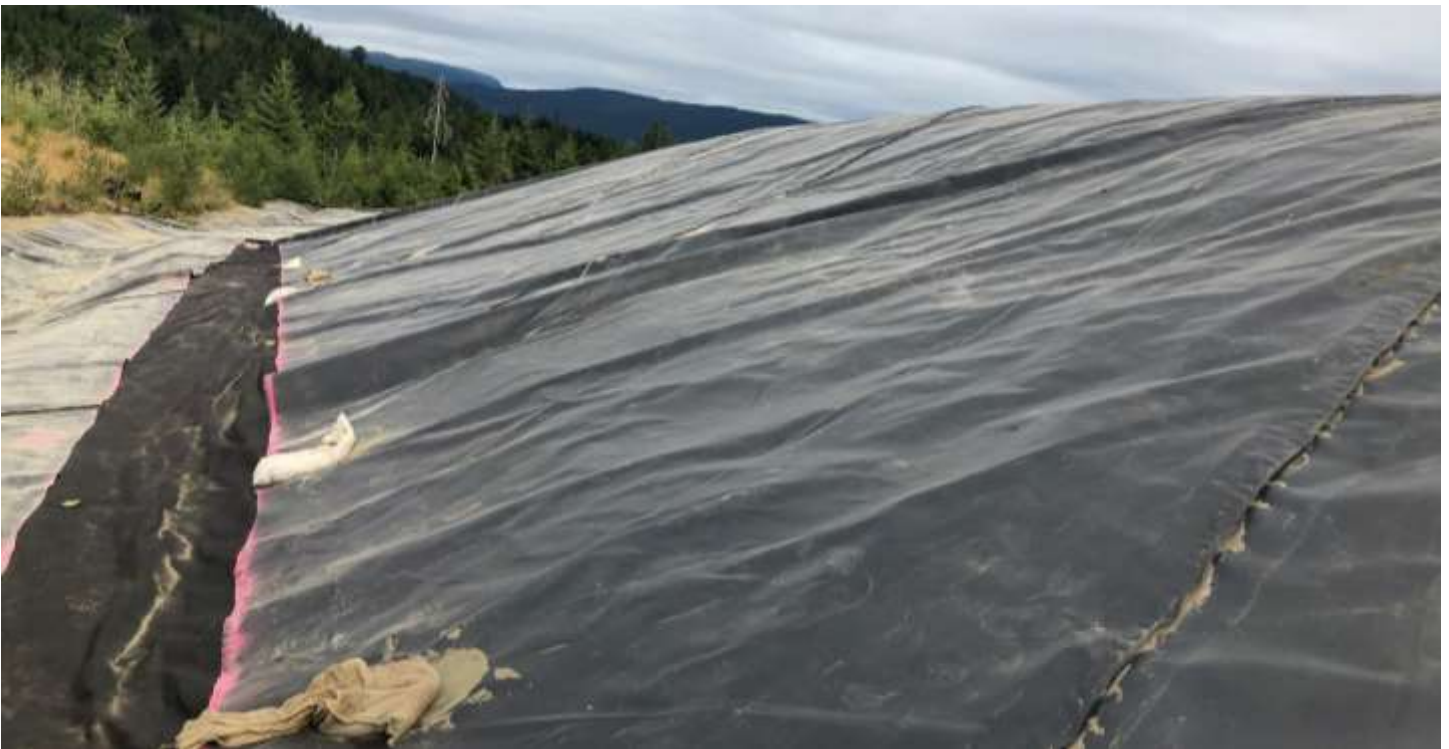
Picture # 10: Wrinkles in geomembrane at south side of PEA.

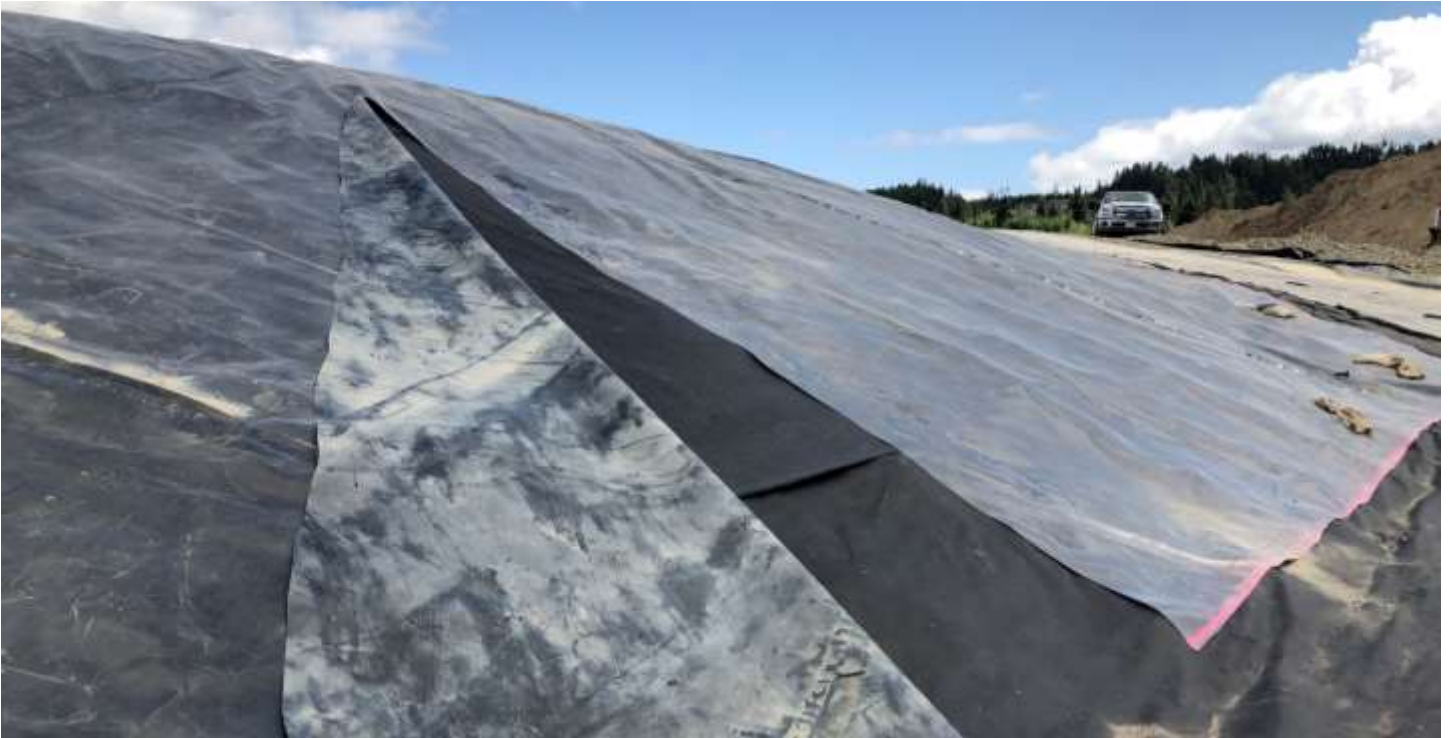
Picture # 11: The wrinkles in the geomembrane were cut so that the geomembrane could be welded such that the geomembrane would lie flat.

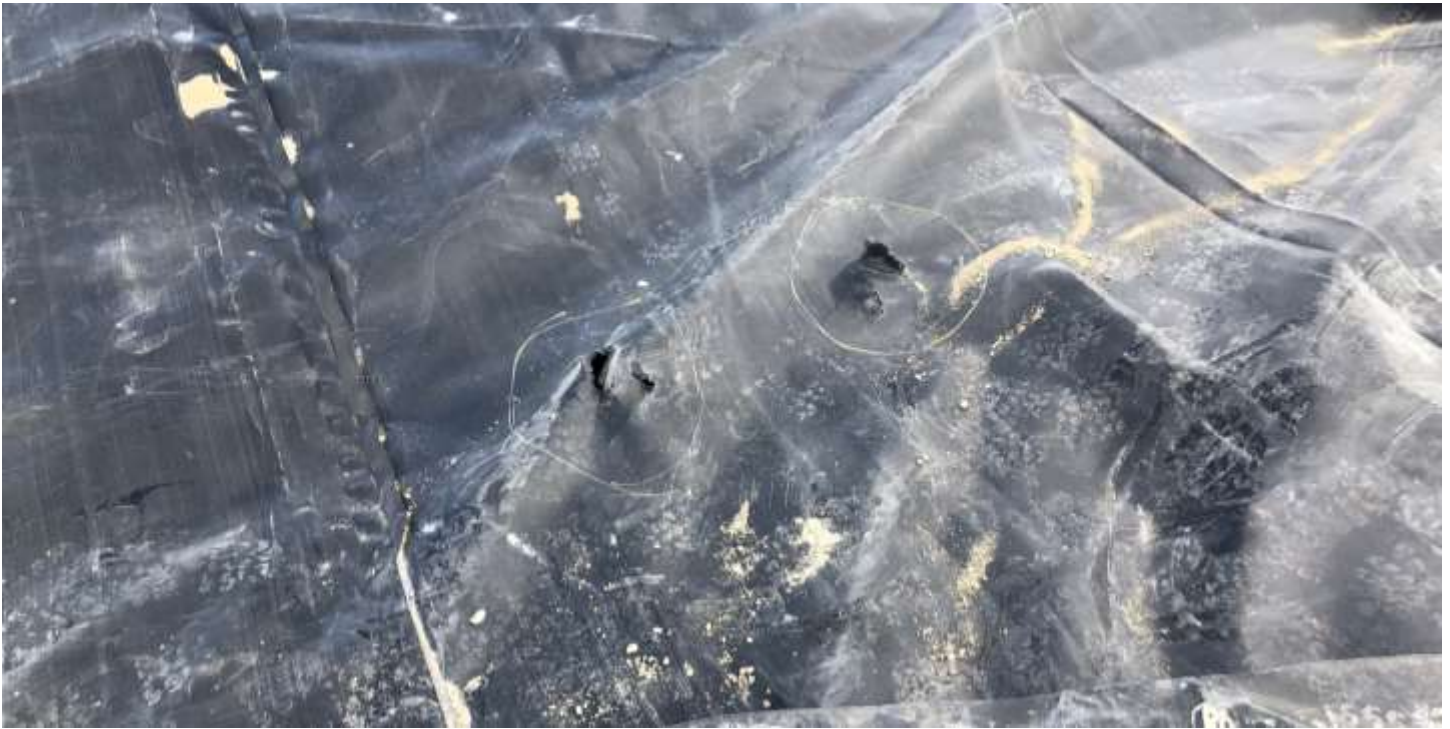
Picture # 5: Example of geomembrane damage requiring repair

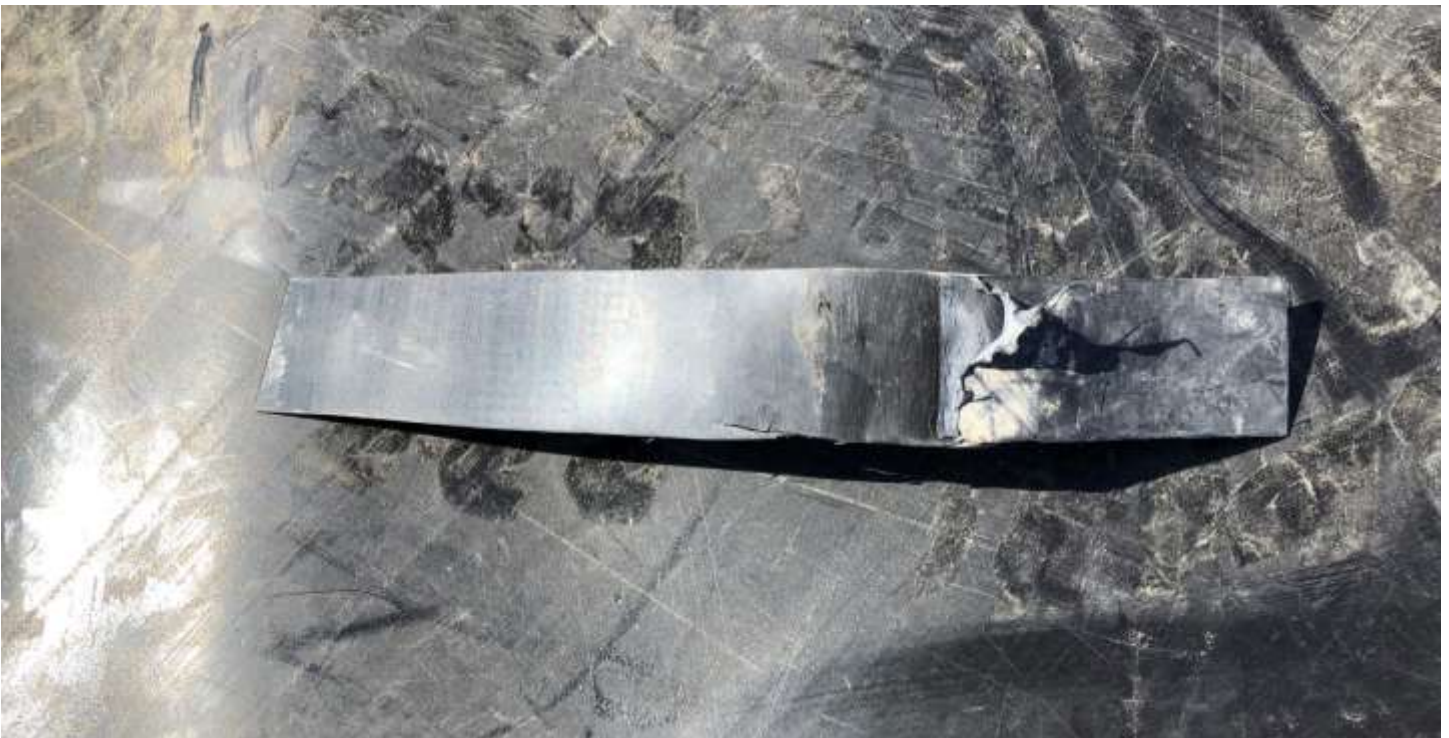
Picture # 6: Example of failed extrusion weld. WTL re-qualified the extrusion welder and re-sampled.

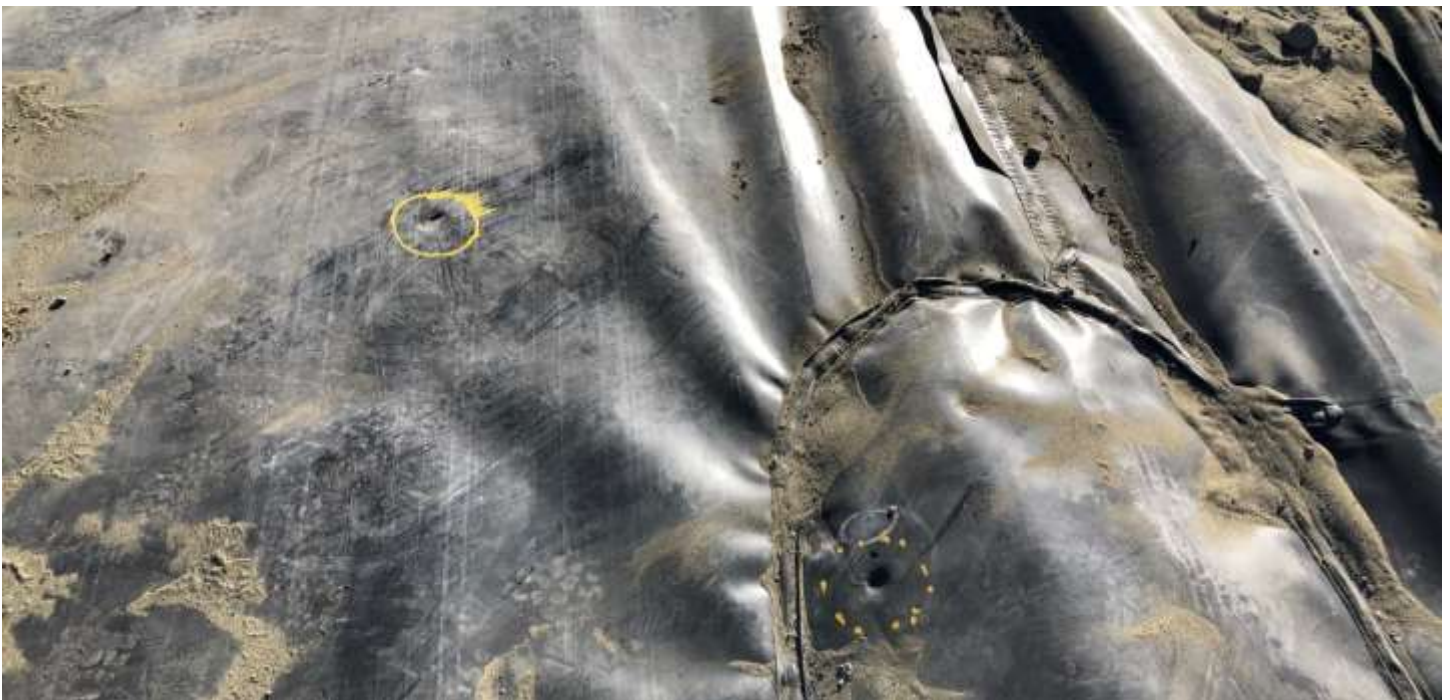
Picture # 4: Examples of geomembrane damage marked for repair

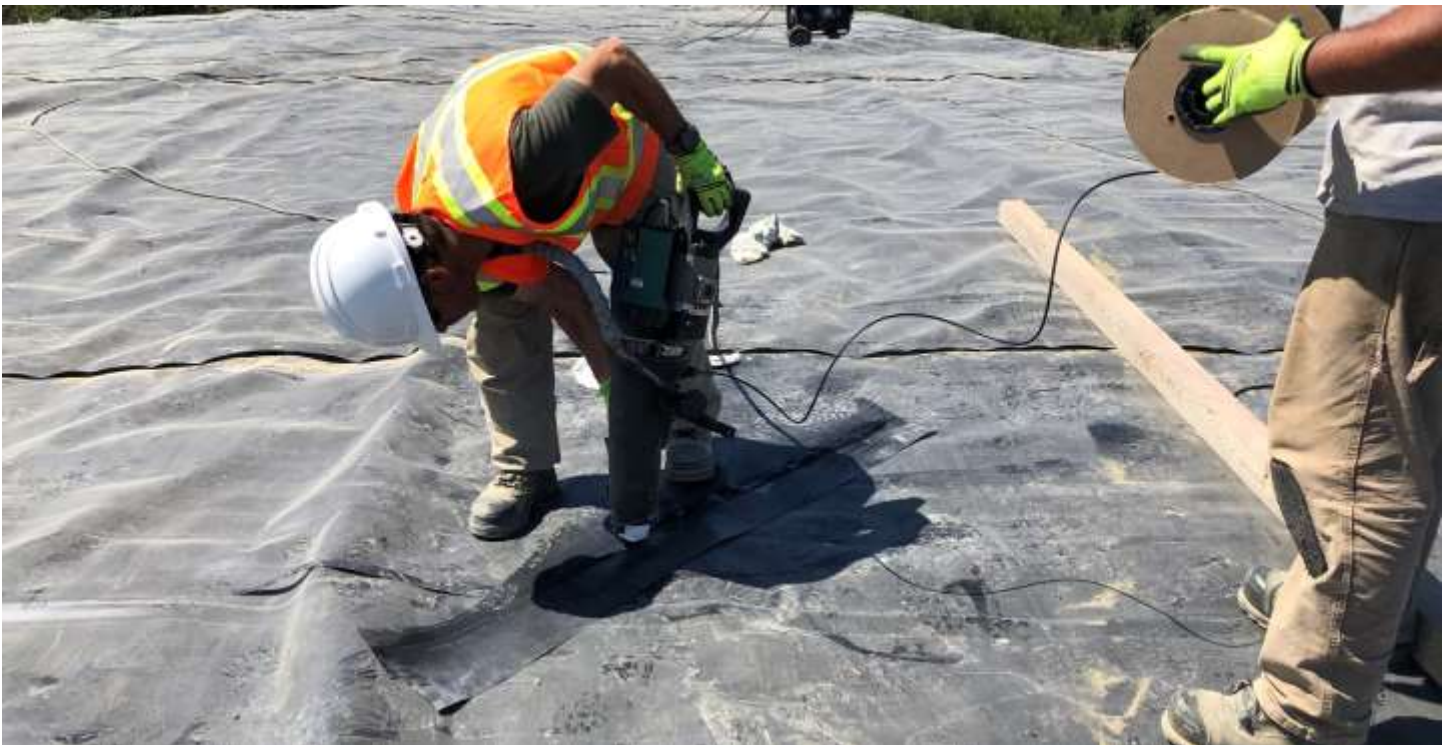
Picture #8: WTL re-qualifying the extrusion welder in the afternoon due to high outdoor temperatures.

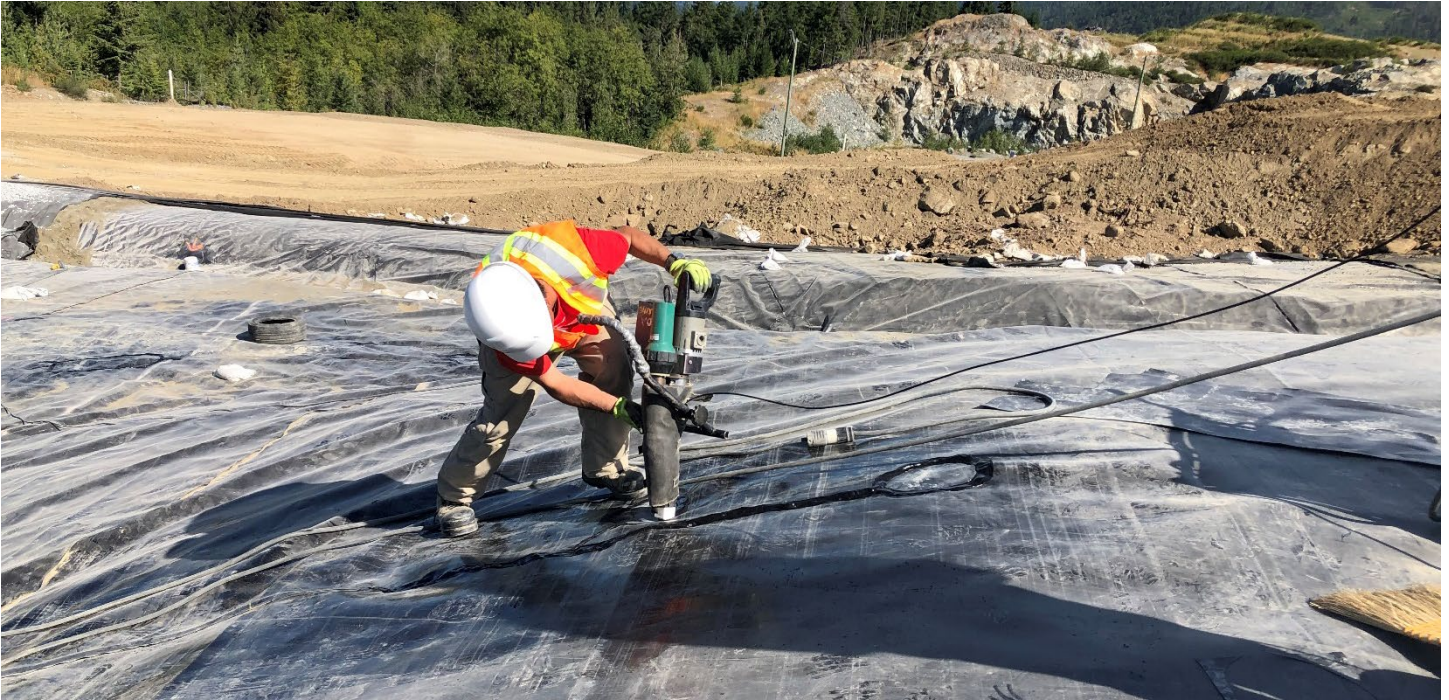
Picture # 6: WTL extrusion welding repair on geomembrane on crest of PEA.

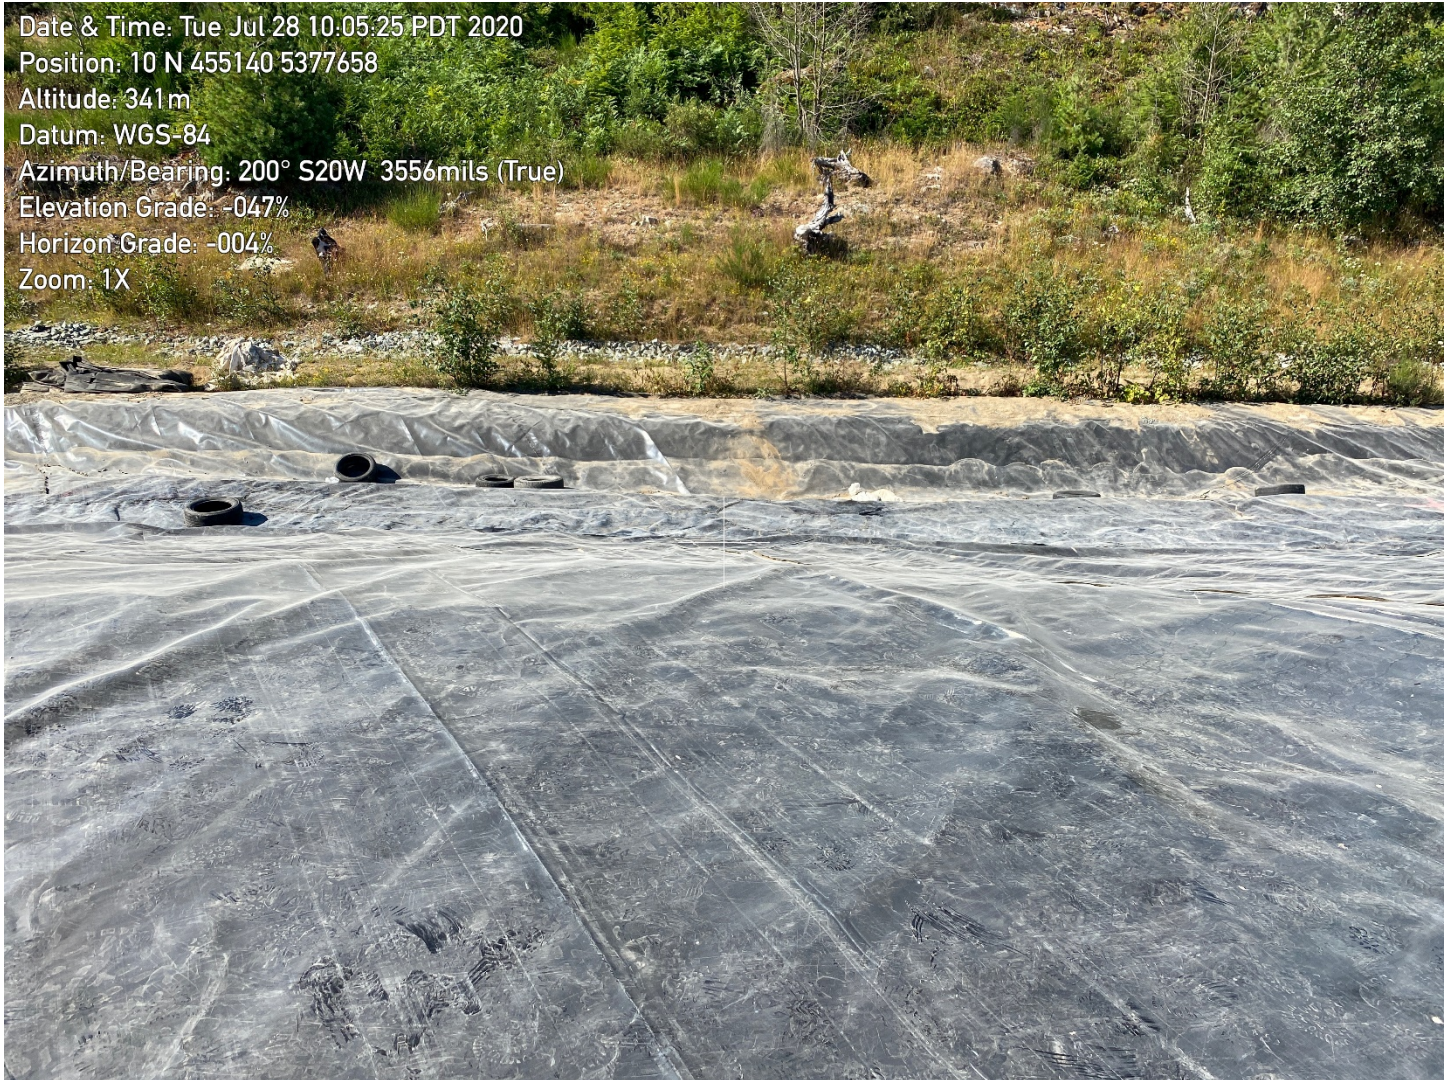
Picture # 10: Upon inspection of slope angles at the west and southwest sides of the crest of the PEA, it was found that the slopes are steeper than 3H:1V. SHA to discuss with Alterra design solution.
