BC Ministry of Transportation & Infrastructure
Old Spences Bridge No. 2411
Inspection Report

2009 December 21

Our Ref: 1884-RPT-SPE-001-0

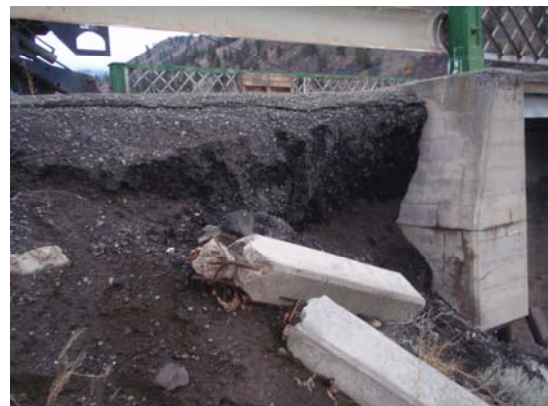
Figure 11: Sloughing Soil on West Side North Approach

It was observed that the soil on the east and west sides of the North Approach immediately behind the abutment was sloughing away. On the east side, the sloughing soil has undermined the roadway and the guardrail post. A tape measure was used to determine the extent of the undermined area and it was found that a void extended approximately 785 mm (31") under the roadway from the east side, refer to Figure 10. While a void was not identified on the west side, the ground was observed to have sloughed significantly resulting in a vertical face along the west edge, refer to Figure 11. It is recommended that the sides of the North Approach roadway immediately behind the abutment be reinforced and that the void under the roadway be filled (Maintenance Item M-1).

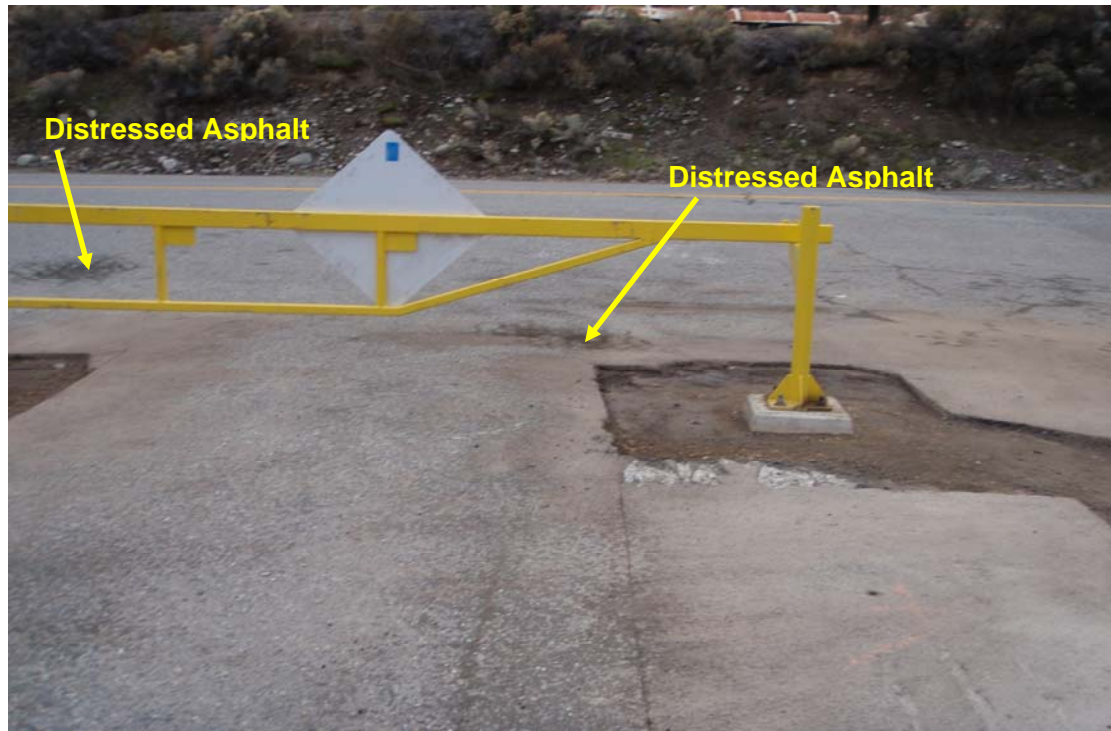
Figure 12: Areas of Distressed Asphalt on South Approach

Two areas of cracked and distressed asphalt were identified on the South Approach, refer to Figure 12. It is believed that these areas will eventually develop into potholes and it is recommended that these areas be repaired (Maintenance Item M-2).

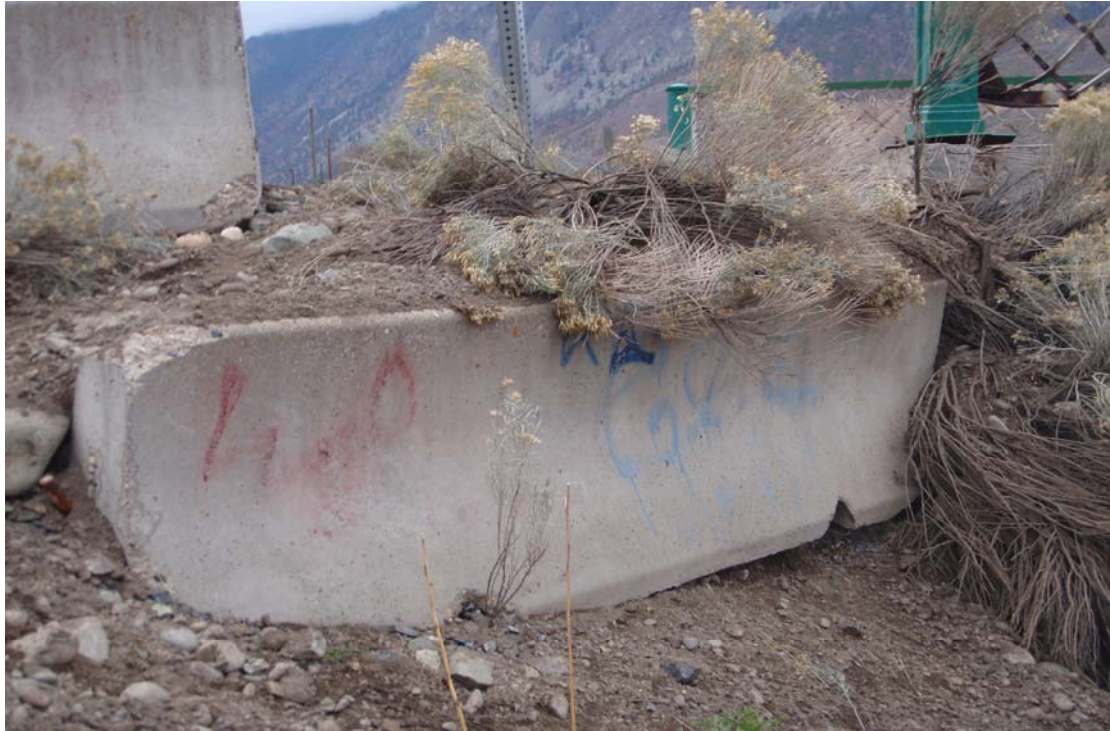
Figure 13: No-Post Barrier Supporting South Approach Fill

On the east side of the South Approach the slope appears to have been supported/reinforced using a no-post barrier, refer to Figure 13. It is recommended that the barrier be removed and a properly anchored support be installed to stabilize the approach fill (Maintenance Item M-3).

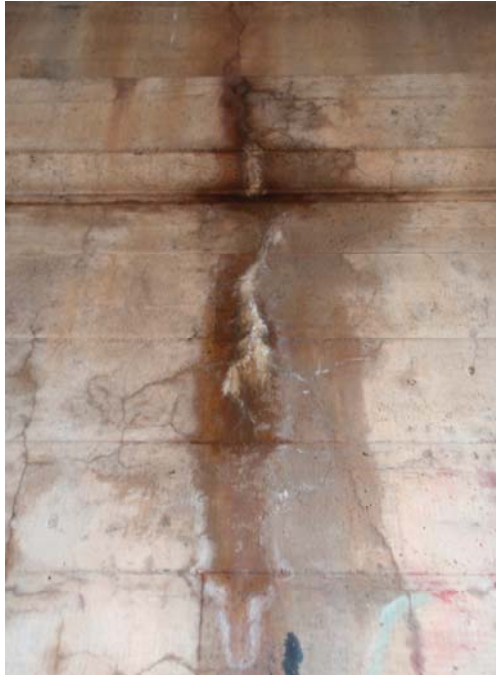
Figure 14: Crack with Efflorescence in North Abutment

Both the North and South Abutments were sounded using hammers in an effort to locate concrete delaminations. No delaminations were detected although a vertical crack was observed in the south face of the North Abutment wall, refer to Figure 14. The crack was located approximately along the bridge centreline and was observed to be accompanied by efflorescence. Cracks were also observed in the North Abutment wing wall on the east face. These cracks are not considered to be of concern at this time but it is recommended that the condition of the concrete around the cracks be monitored during future inspections (Inspection Item I-2).

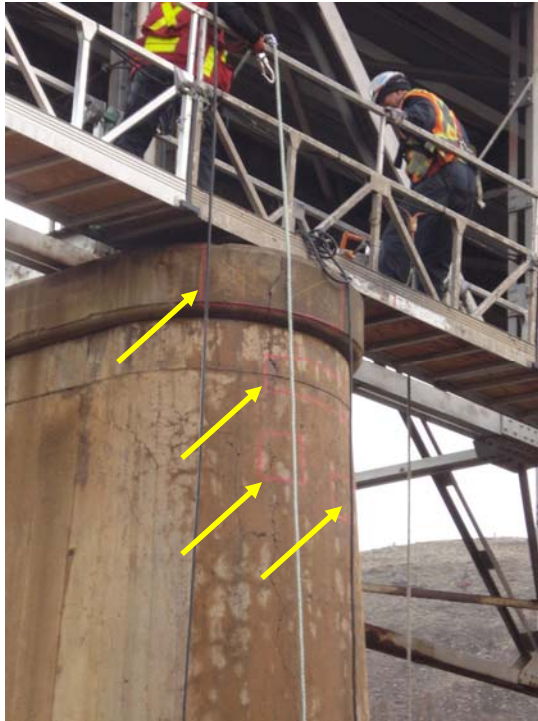
Figure 15: Degraded Concrete on East Face of Pier 1

Pier 1 was observed to have numerous cracks in all faces with widths ranging from hairline to a few millimetres. The most significant was a long vertical crack in the east face extending almost the full height of the pier with a maximum width of 6-7 mm near the pier cap. A horizontal construction joint near the top of the pier has also developed into a crack approximately 3 mm wide. The east and west faces of the pier were sounded with hammers using the swing stage access and a number of areas with degraded concrete were identified and marked using red paint; refer to Figure 15 and Figure 16. A large area of severe scaling was identified on the north face of Pier 1 extending approximately 1/3 of the height from the base. The condition of the concrete is not currently a concern but it is recommended that the condition of the concrete in Pier 1 be monitored in the future (Inspection Item I-3). For long-term durability of Pier 1, BC MoT may wish to consider injecting all cracks with epoxy - if and only if the bearings are rehabilitated to restore their original design condition.

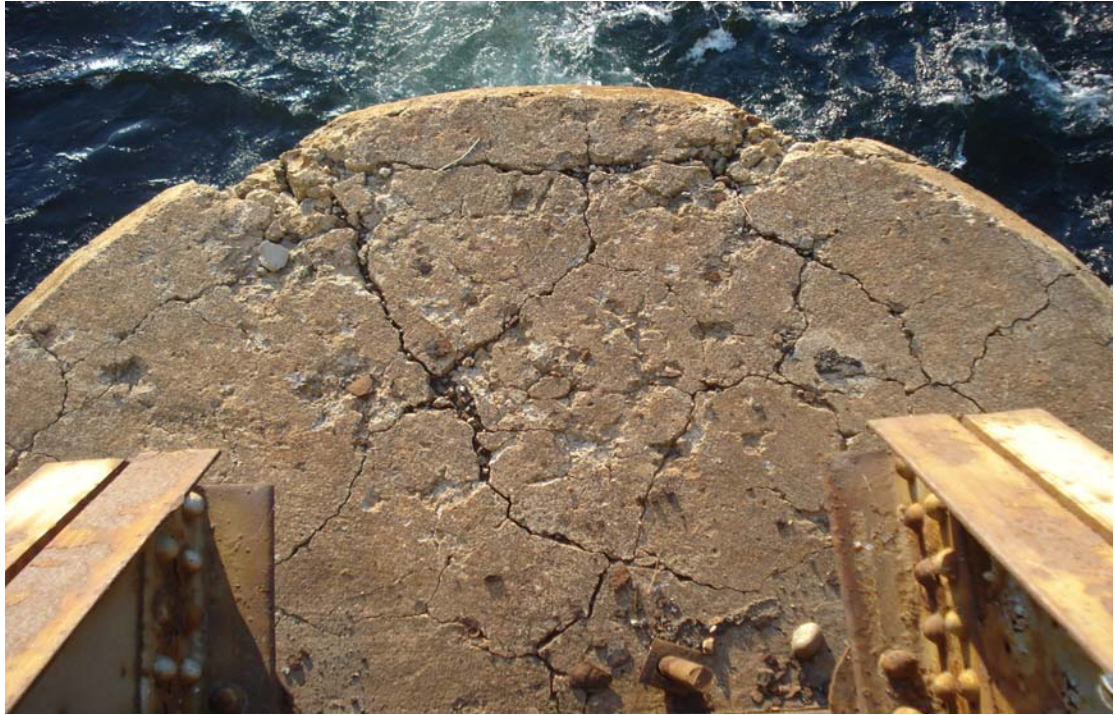
Figure 18: Cracks in Pier 3 Pier Cap at West End

Numerous cracks were identified in all faces of the pier as well as on the top surface and vertical surfaces of the pier cap, refer to Figure 18. These cracks ranged in width from 1 to 6 mm. Concrete delaminations were identified on the top of the pier cap adjacent to the west bearings, on the north and south sides and on the east and west ends of the pier. In some locations, efflorescence was also observed on the concrete surface at crack locations; refer to Figure 19 and Figure 20. The cracks are not currently a structural concern and no immediate repairs are recommended in the short term but it is recommended that the concrete be monitored during future inspections (Inspection Item I-5). However, for long-term durability of the Pier 3, BC MoT may wish to consider injecting all cracks with epoxy - if and only if the bearings are rehabilitated to restore their original design condition.

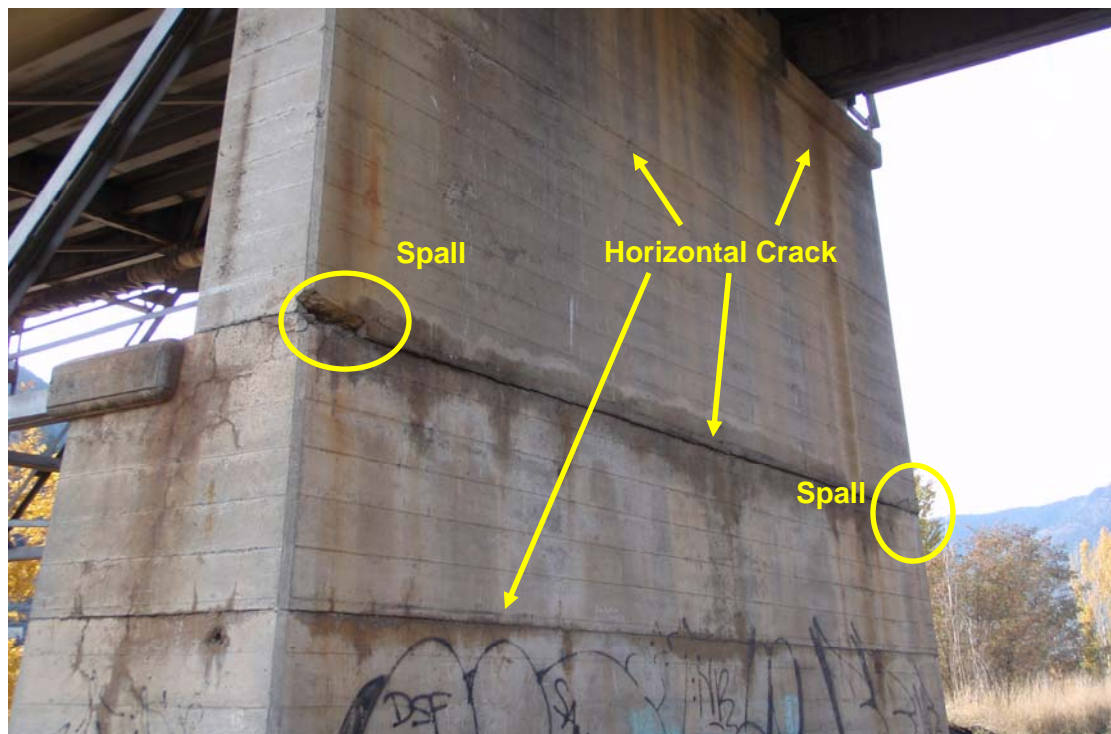
Figure 23: Four Horizontal Cracks and Two Spalls in North Side of Pier 5

Pier 5 was sounded on the north, east and west faces using the swing stage access. The north and south faces were also visually assessed from the ground and from the truss during the inspection of Span 5. Various hairline cracks were identified. Four horizontal cracks extending across the width of the pier were observed on the north side that were wider than hairline cracks, refer to Figure 23. It is believed that these locations correspond to construction joints during original construction. One of the horizontal cracks is located at the base of the bearing pedestal for the Span 5 bearings. At the northwest and northeast corners of the pier, this crack terminates at moderate (300 mm x 300 mm) sized spalls. It is recommended that these two spalls be repaired and the horizontal cracks be filled with a product similar to Sikaflex 2C NS (Maintenance Item M-5). In addition, for long-term durability Pier 5, BC MoT may wish to consider injecting all cracks with epoxy - if and only if the

bearings are rehabilitated to restore their original design condition. Additionally, graffiti was observed on the north and south faces of the pier and it is recommended that the graffiti be painted over (Maintenance Item M-6).

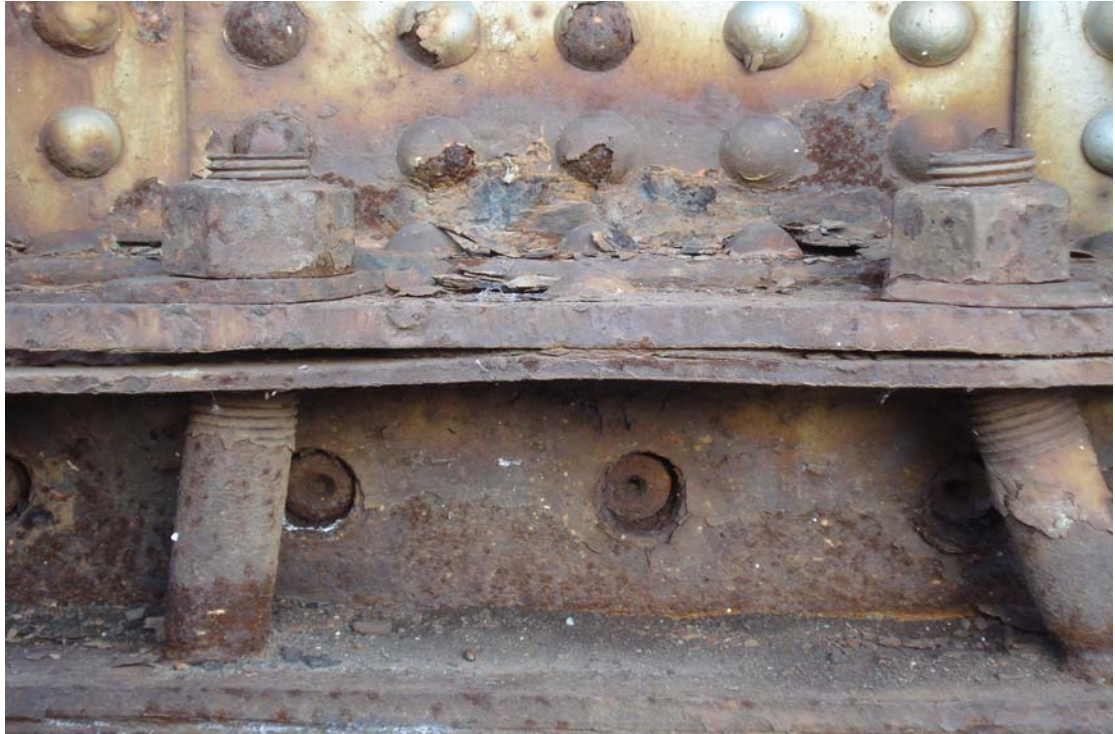
Figure 28: Inclined Anchor Bolts at Pier 3

Many of the anchor bolts were found to be out of plumb (i.e. they are no longer vertical), refer to Figure 28. At a given bearing, the anchor bolts did not appear to be bent in the same directions, which implies that misalignment during installation and forces transferred to the anchor bolt through seized bearings are likely what has resulted in the anchor bolts being inclined from the vertical. It is important to note that the top of the anchor bolt on the west side of the southeast bearing of Span 4 has sheared off and was found lying on the top of the pier cap, refer to Figure 29. Additionally, an area of reduced cross section was observed in the southwest anchor bolt at the northwest bearing of Span 3 and in the east anchor bolts at the southeast bearings of Span 4.

Since it is believed that the bearings are seized, then it is likely that Pier 3 is being subjected to loads for which it was not originally designed. It is recommended that Pier 3 be evaluated for the effects of the seized bearings (Evaluation Item E-1) and that rehabilitation options include repairing or replacing the sliding bearings at Pier 3 (Rehabilitation Item R-2).

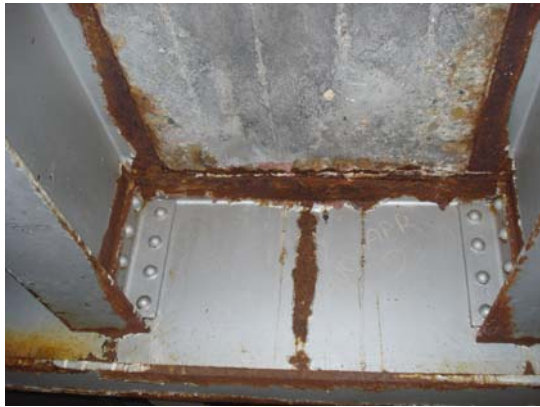
Figure 31: Typical Coating Failure near Centreline of Bridge at Deck Joint

Numerous areas of widespread and localized areas of coating failure were observed throughout the structure. The greatest concentration of these areas is on the structural steel in the vicinity of the deck joints. Specifically, the floorbeams, stringers, sway bracing, areas on the top chord lateral bracing and the top chord cover plates were found with the largest areas of coating failure. Figure 31 and Figure 32 show the typical failures of the protective coating near the centreline of the bridge for the deck joints and expansion joints respectively. The condition of the coating at the outer stringers is typically worse as shown in Figure 33 and Figure 34.

It is recommended that, in the short term, BC MoT consider tendering a contract to apply an easy to use, surface tolerant material, such as Termarust (or equivalent), to the corroding areas to drastically slow or stop additional corrosion (Rehabilitation Item R-3). In the longer term, it is recommended that BC MoT tender a contract to strip the bridge to bare metal and recoat the entire structure with a three coat zinc/epoxy/urethane system (or equivalent) (Rehabilitation Item R-4).

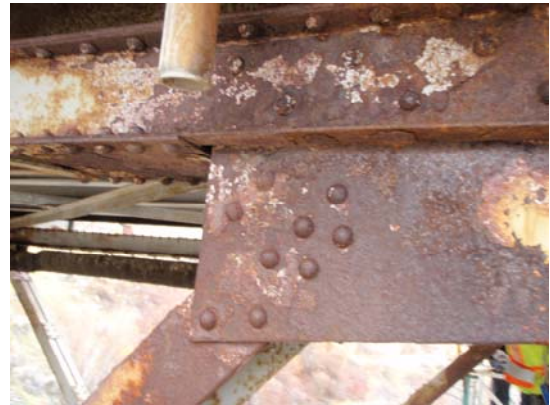
Figure 36: Widespread Coating Failure at Top Chord Connection below Drain

It was also noticed that coating failures typically occur on most members beneath the short deck drains that release deck run-off just below deck level. Degradation was observed to the face of the top chord at the deck drain and to the bottom chords. The smaller trusses have greater coating failure to the bottom chords since they are closer to the drains.

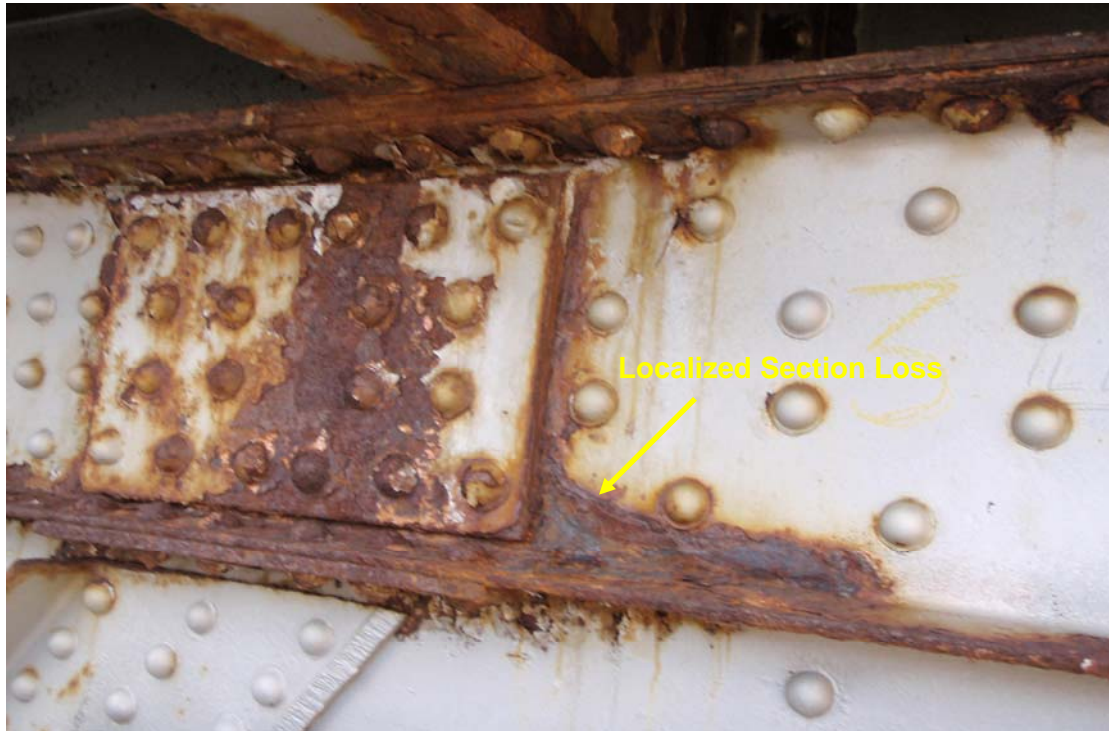
Figure 38: Localized Area of Section Loss in East Top Chord Web at Panel Point 3 – Span 4

A small number of isolated areas, typically at the east drain locations, were identified with coating failure and light to moderate surface corrosion. No significant section loss was found in the chord members themselves with the exception of one location in the web of the east top chord at Panel Point 3 in Span 4, refer to Figure 38. It is recommended that this localized area of section loss be evaluated to determine if repairs are required (Evaluation Item E-2). As stated in Section 3.5.1, it is also recommended that recoating the corroding areas on the top chords of the truss spans be included (Rehabilitation Item R-3).

The top chords of simply supported trusses, like the truss spans on the Old Spences Bridge, are compression members and batten plates are used to brace the chord members against local buckling by reducing their effective lengths; cover plates are used to add to the cross sectional area that resists the compressive forces. Because the locations of section loss are adjacent to the floorbeams, the localized areas of section loss are not a concern from a stability standpoint as the connection between the floorbeam and the top chord will also serve to provide lateral restraint against local buckling. However, it is recommended that the corrosion in these areas be slowed or stopped if possible. This can be accomplished by including these areas in Rehabilitation Item R-3.

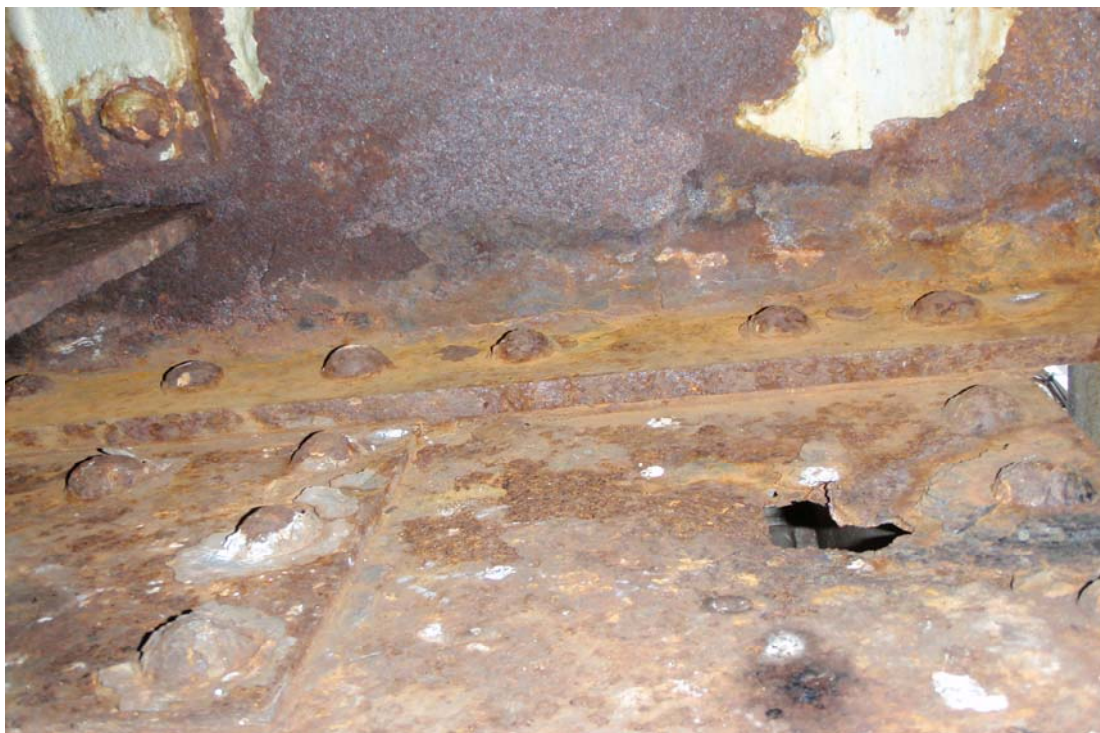
Figure 39: Hole in Cover Plate on Top Chord at Floorbeam 6 – Span 2

Due to significant localized corrosion, a hole has formed in the top chord cover plate adjacent to the east end of Floorbeam 6 in Span 2, refer to Figure 39. It is recommended that the effect of this hole in the top chord cover plate be evaluated (Evaluation Item E-3) and, unless the evaluation determines that the plate requires replacement, that the plate be included in Rehabilitation Item R-3.

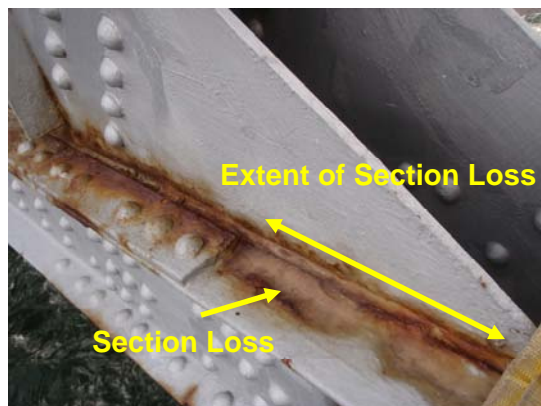
Figure 40: Section Loss in Top Flange of Bottom Chord Channel

Many of the batten plates along the bottom chord members were found to have corrosion, corrosion product build-up and section loss, ranging from areas of light to complete section loss. This is not a concern because the bottom chord members are tension members and do not rely on batten plates for strength or stability. However, there is a concern that corrosion in the batten plates could progress into the chord members themselves and it is recommended that the batten plates be cleaned and Ministry approved coating be applied (Rehabilitation Item R-5). At that time, BC MoT may elect to replace the batten plates exhibiting areas of complete section loss as they do assist in providing access to the bottom chord during bridge inspections. It is estimated that approximately 50% of the bottom chord batten plates in Spans 3 and 4 require cleaning and approximately 15% contain perforations due to corrosion.

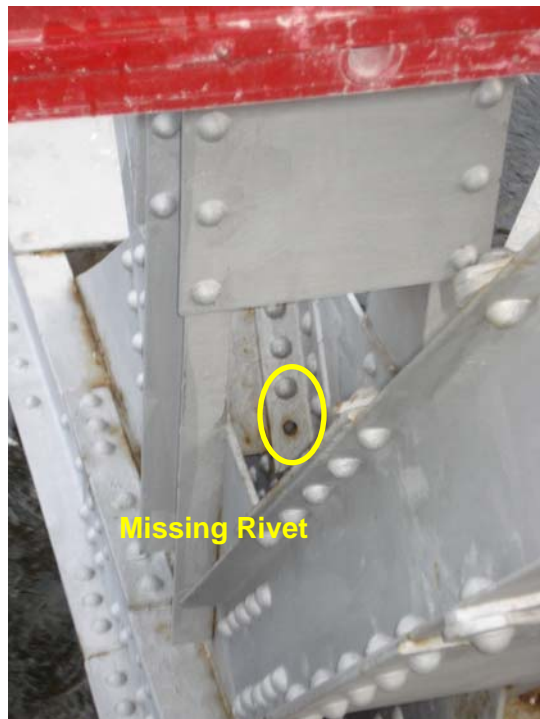
**Figure 45: Missing Rivet in Diagonal
L6-U7 – West Truss**

A rivet was missing in Span 4 in the connection between member L6-U7 and the bottom chord, refer to Figure 45. It is recommended that a fully tensioned bolt be installed in the empty rivet hole (Maintenance Item M-8).

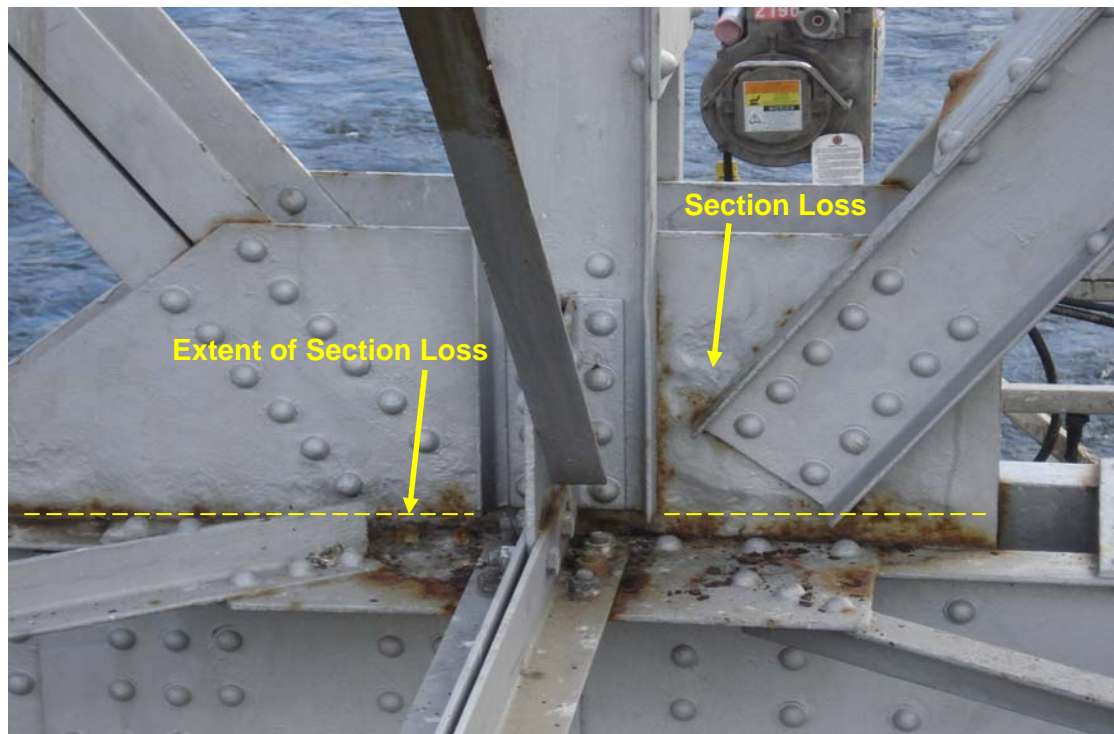
Figure 48: Section Loss along Gusset Plate

It is recommended that the gusset plates be evaluated in order to determine the impact of the observed corrosion and to determine possible rehabilitation options (Evaluation Item E-7).

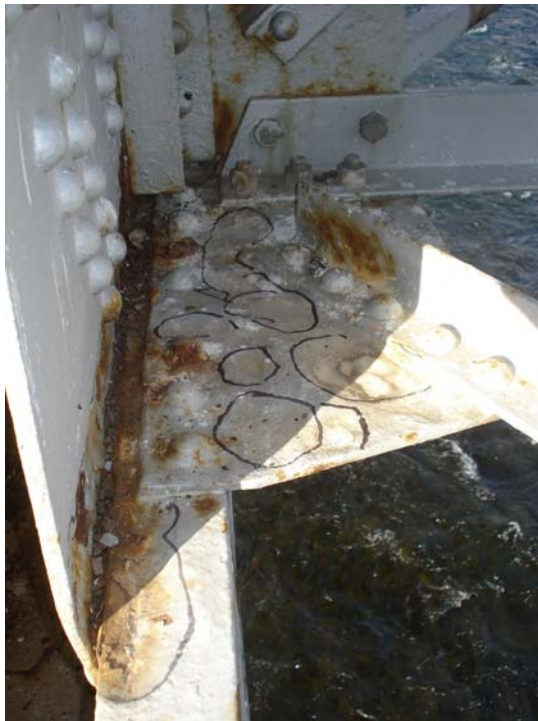
Figure 49: Areas of Section Loss in Gusset Plate

The bottom chord lateral bracing connections were found to be in worse condition than the top chord bracing connections due to their exposure to the elements. Numerous areas of section loss were identified on the bottom chord bracing connections and multiple holes were found, refer to Figure 49 and Figure 50. The bottom chord lateral bracing connections appear to be functioning adequately in their current condition and it is not believed that a widespread repair program is warranted at this time. It is recommended that the connections be cleaned, a Ministry approved coating applied and that they be monitored on an annual basis and replaced or repaired as necessary (Rehabilitation Item R-7 and Inspection Item I-9).

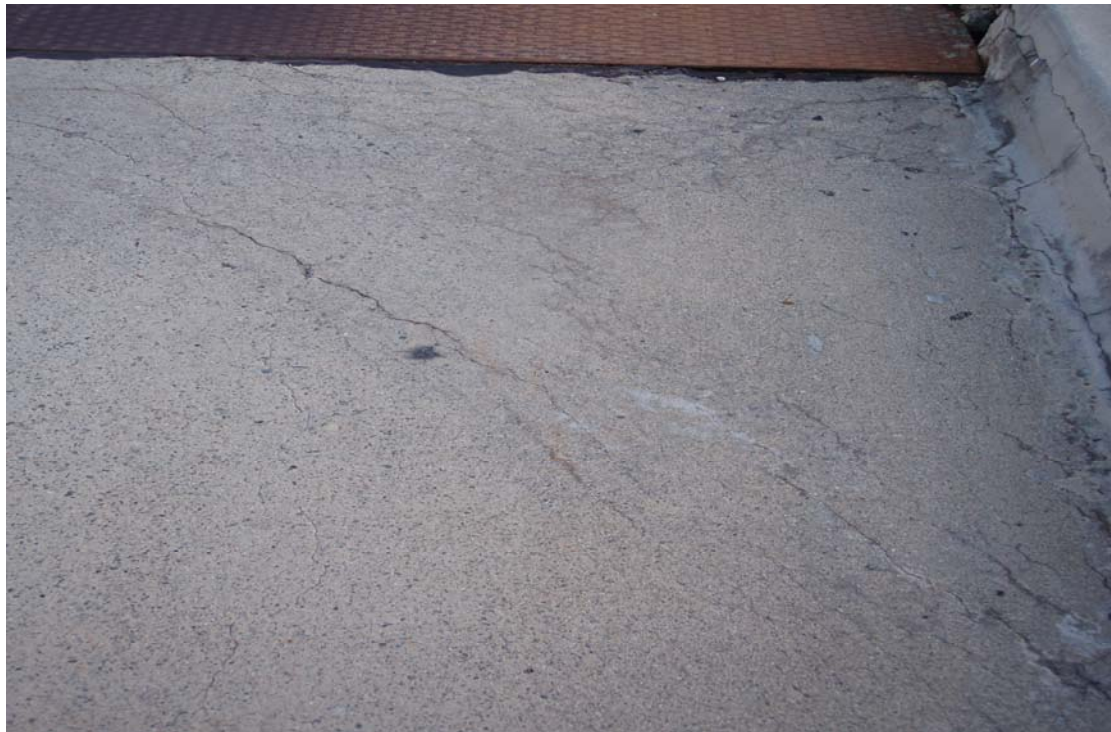
Figure 56: Crack Pattern at Corner of Deck Panel

No delaminations were detected while chain dragging the top surface of the roadway deck however a crack pattern similar to a spider web was observed at the four corners of each panel, refer to Figure 56. It is recommended that the deck be pressure washed and a silane sealer applied to the areas exhibiting cracks (Maintenance Item M-9).

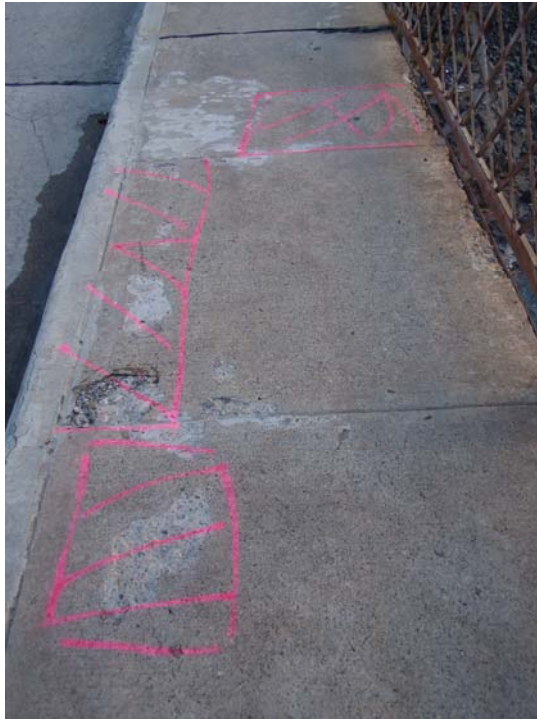
Figure 57: Voids and Spalls Noted in Sidewalk

In contrast to the roadway deck, numerous delaminations were detected while chain dragging the sidewalk. The areas with delaminations and the areas with spalls were marked with red paint and are concentrated towards the south end of the bridge deck, refer to Figure 57 and Figure 58.

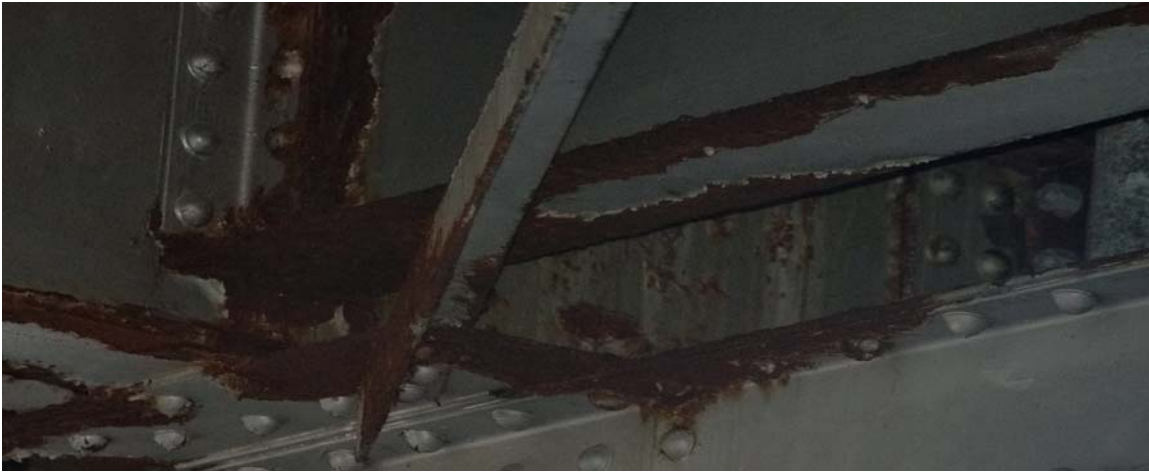
Figure 2 Span 1 First floor beam. Peeling and advanced corrosion.

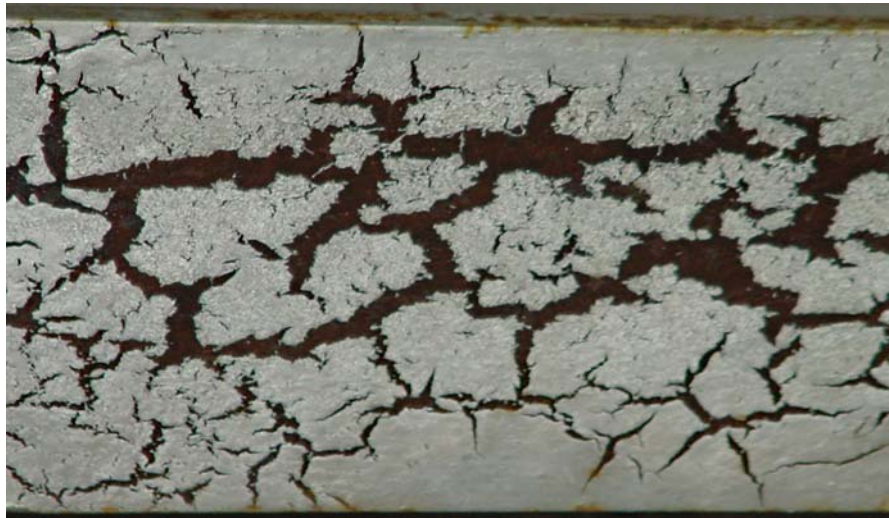
Figure 4 Alligator cracking was observed on the bottom of a deck stringer on Span 1. Some was also noted on the stringer webs in the protected area on Span 5. This appeared to be in fairly isolated areas, and was possibly an application error or insufficient cleaning before painting.

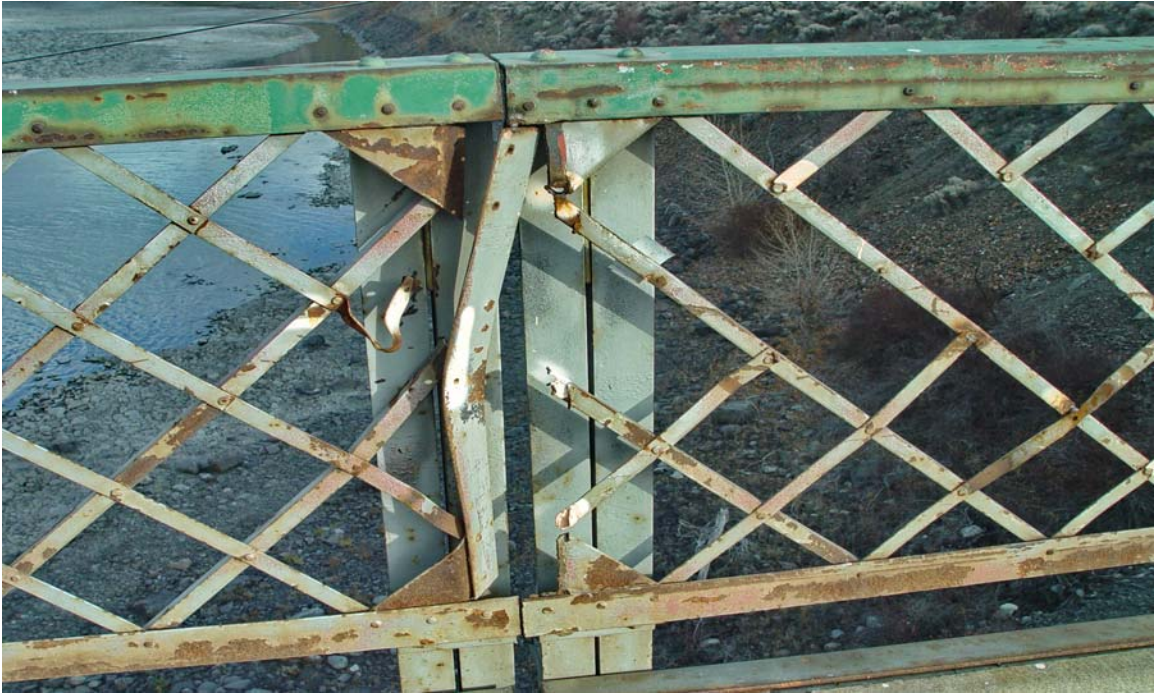
Figure 5 Section of the Handrail at the Span1, Span 2 Joint. The post and rail have experienced impact damage. Sections are missing and bent. Paint failure here is a little less than on the handrails as a whole. Many of the bottom gussets are corroded through.

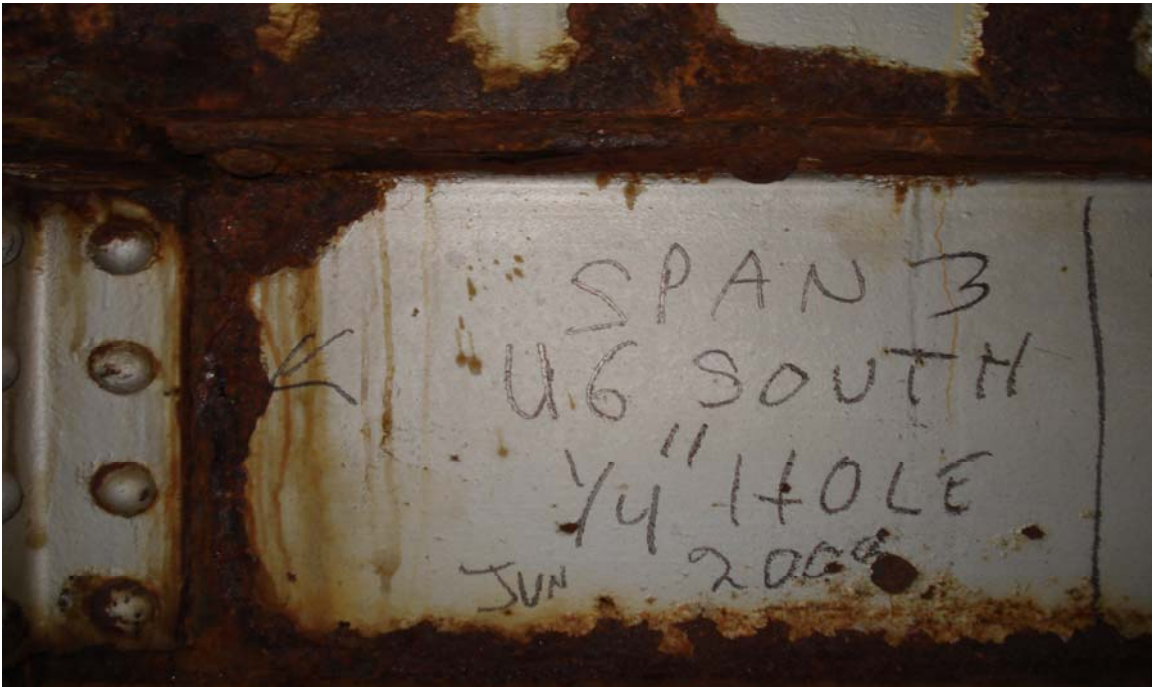
Figure 6 The protected area under Span 3. This is a little worse than average, but by no means unique. The steel is showing heavy corrosion including section loss and pack rusting. Photo courtesy of Buckland and Taylor Ltd.

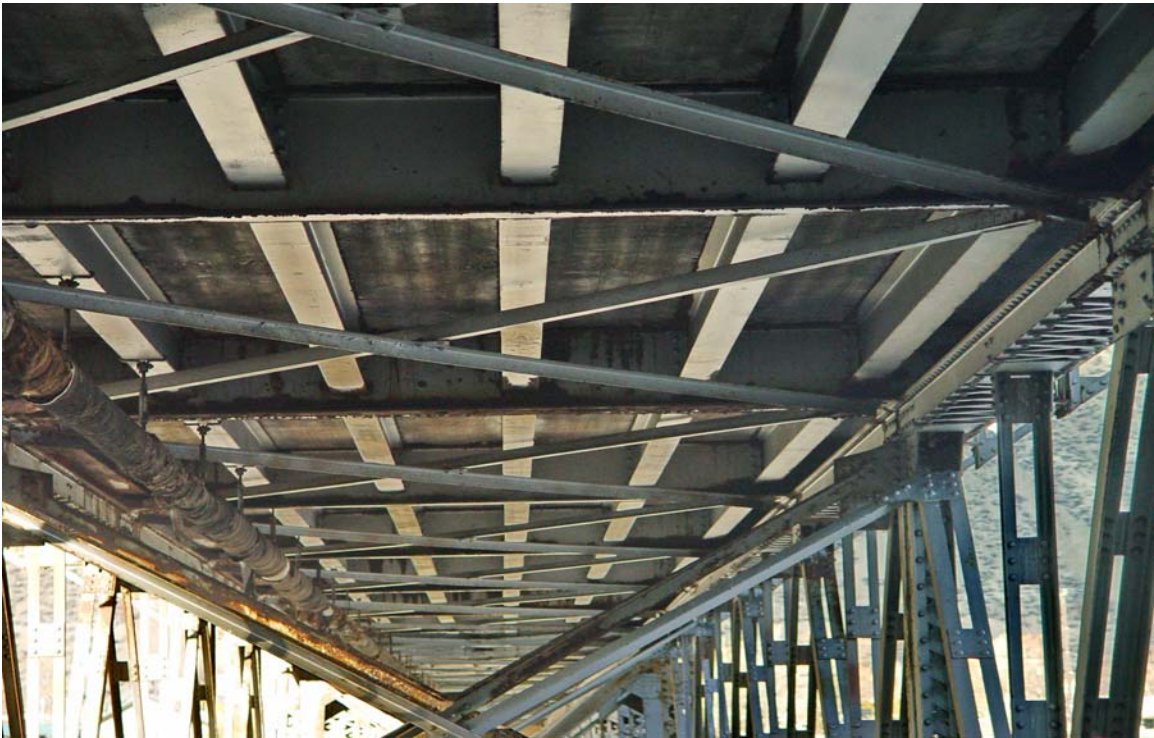
Figure 7 View of Span 1 Protected Area Looking North. This is fairly typical of the whole Bridge.

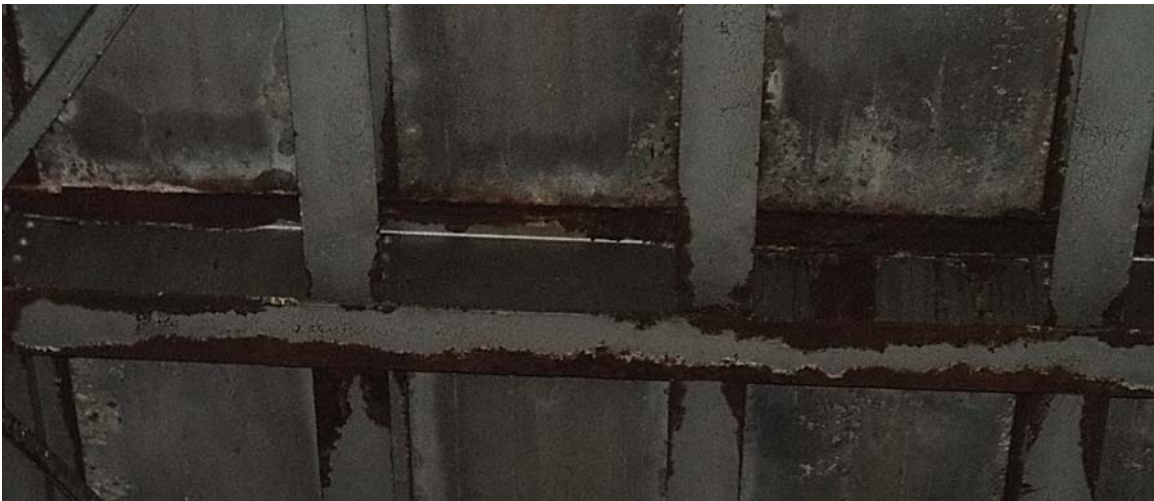
Figure 8 Span 5 Floor beam. This shows fairly heavy corrosion where the coating has failed. Note the checking pattern on the bottom of the stringer flanges. Although at first glance the paint appears reasonable, closer inspection reveals almost complete coating failure

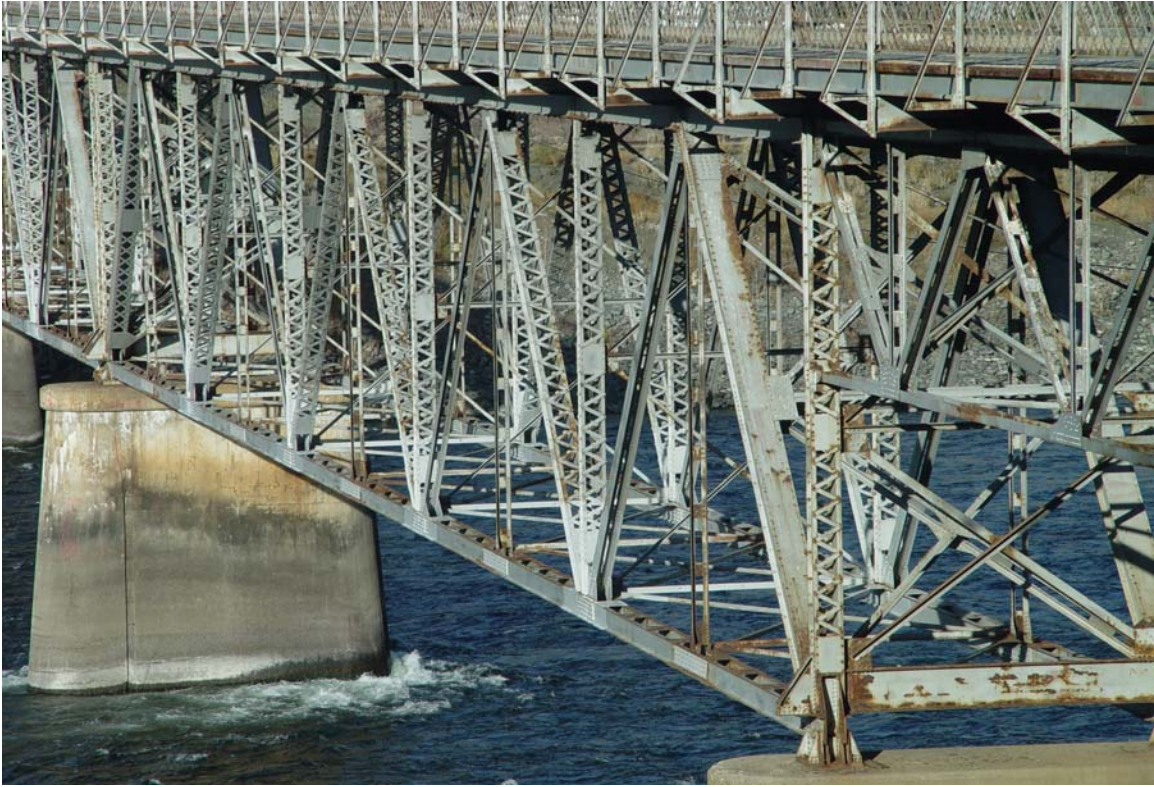
Figure 9 Span 2 West Side. Note coating failure and corrosion on the ends of the floor beams, on diagonals, and on the lower chord.

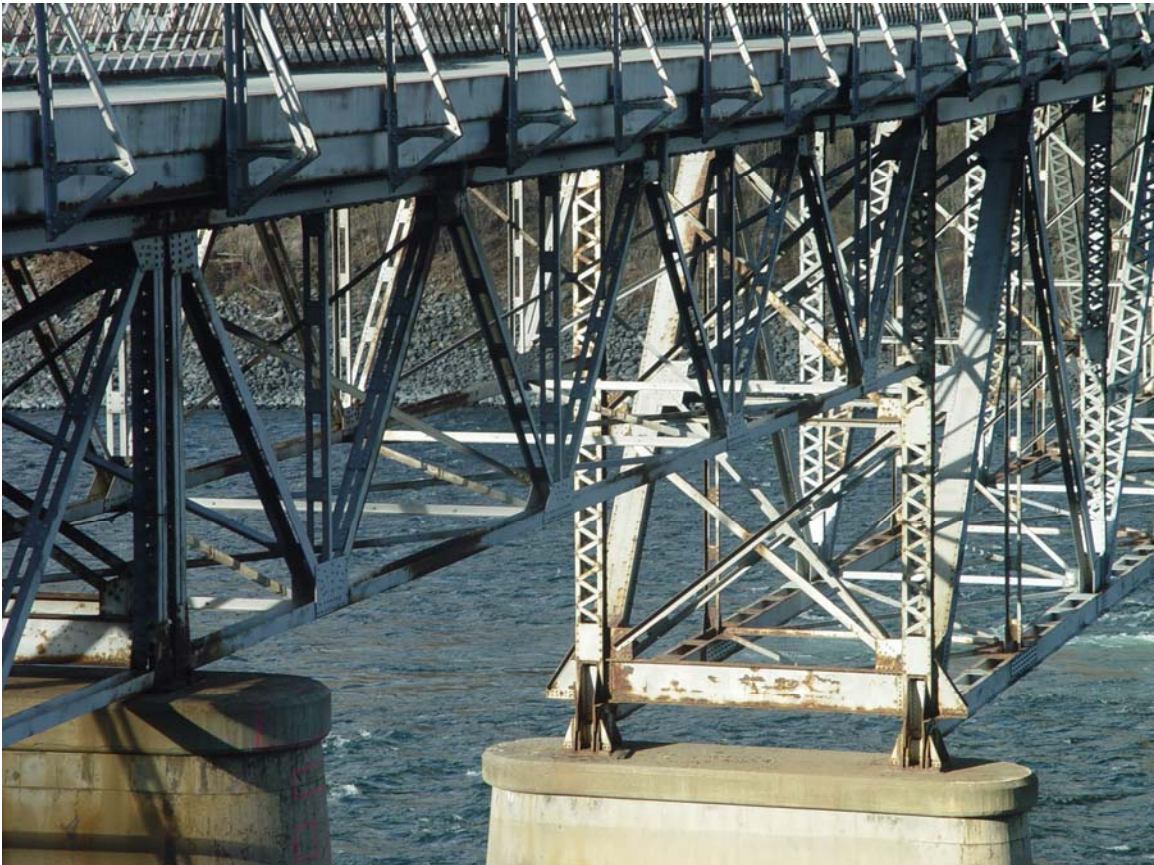
Figure 10 Span 2 East Side. Note the periodic nature of the failure on the bottom chords which correlates with the deck drains. Note also the deck joints where extra coating failure and corrosion have occurred.

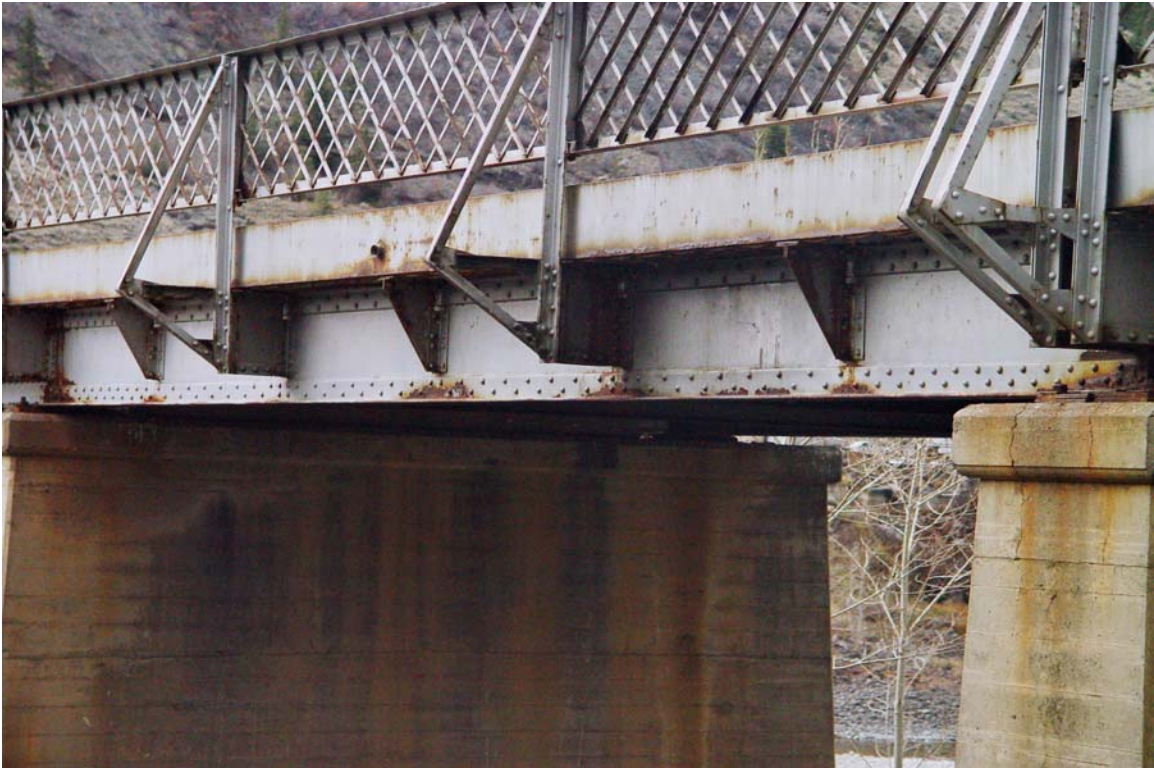
Figure 11 Span 6 East Fascia. This is typical of the two stringer spans. Most of the failure is on the bottom chord.

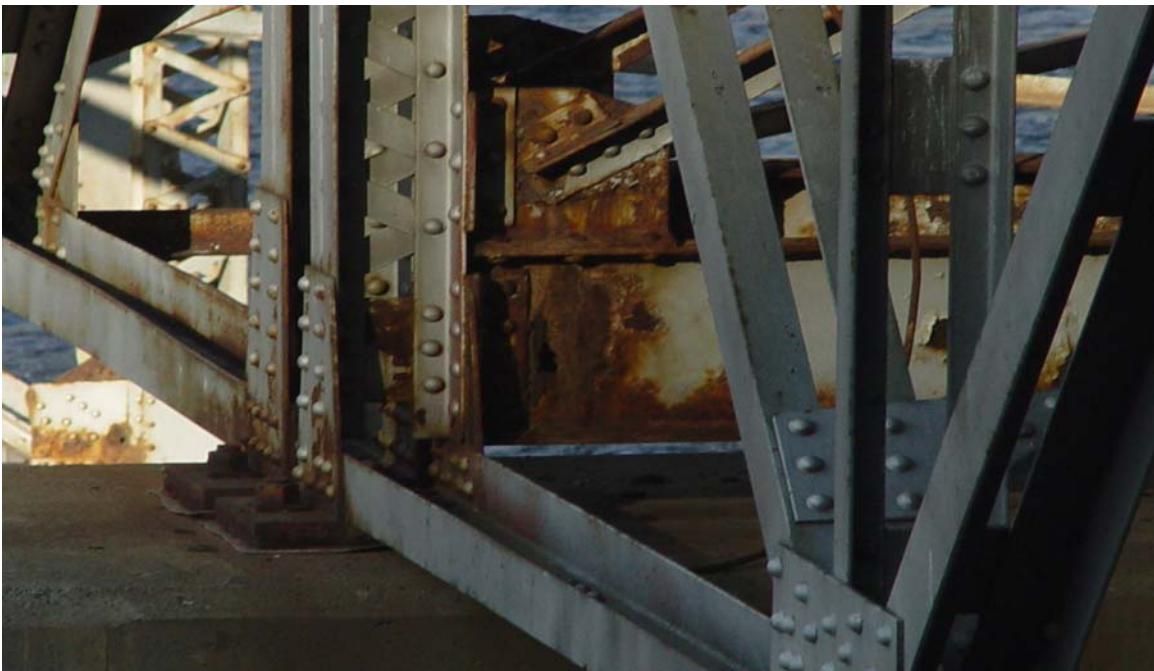
Figure 12 Span 1/2 Joint and Bearing. The corrosion here has perforated the lower transverse beam.

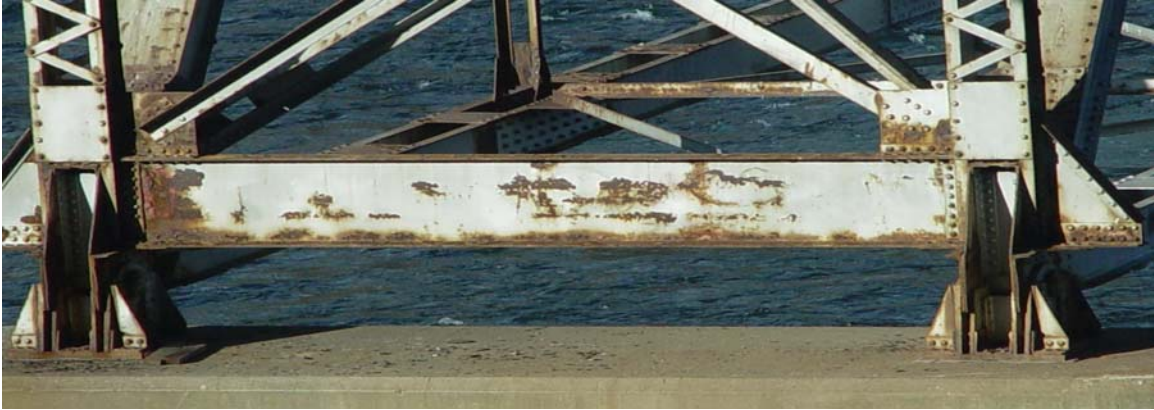
Figure 13 Span 2 North Bearings. This is fairly typical of the truss bearings.
