**PENDER ISLAND – CANAL ROAD DIP SLIDE  
GEOTECHNICAL DESIGN REPORT**

**BC Ministry of Transportation and Infrastructure**

Date: May 8, 2023  
File: 34450

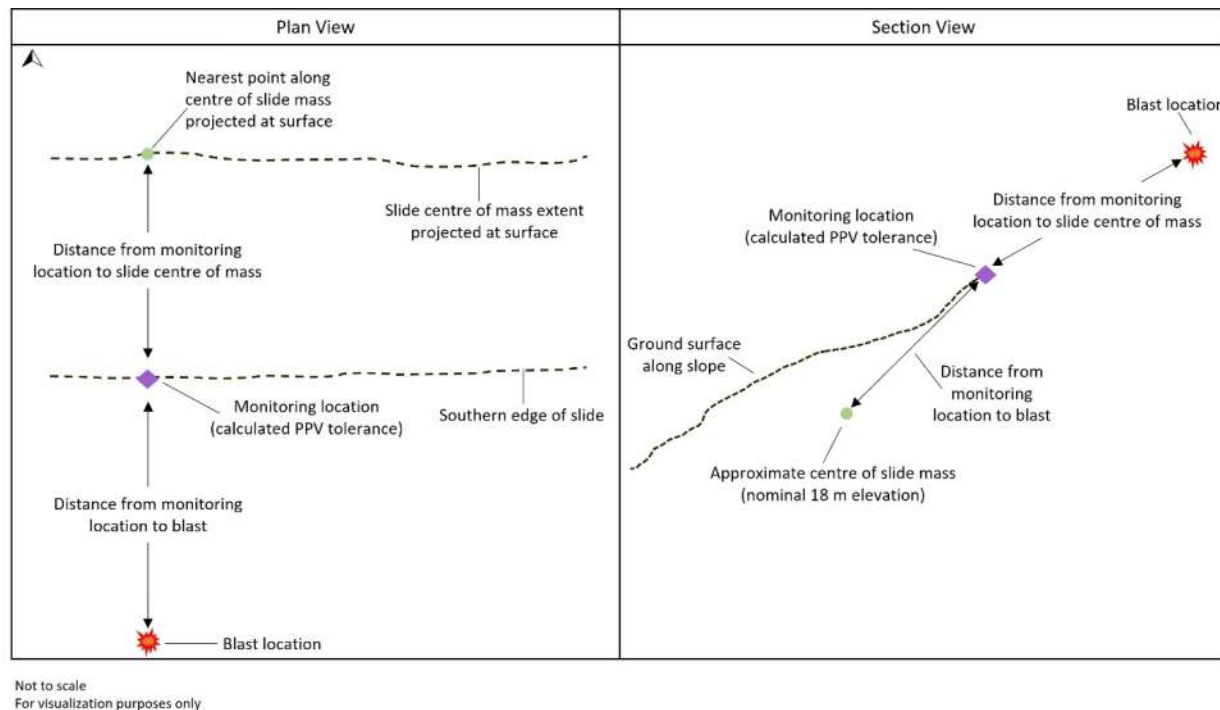
**Figure 8.1: Blast Monitoring Configuration**

For the purposes of setting guidelines at the outset of the project we believe it would be reasonable to limit the blast vibration at the centre of the slide to  $PPV \leq 3 \text{ mm/sec}$ . Measurement of the vibration at the centre of the slide may not be possible due to access constraints and may need to be measured at the edge of the slide. The tolerance for blast vibrations at the edge of slide will need to be calculated by the vibration specialist for each blast due to the square root distance attenuation relationship discussed above. An example of the configuration for blast monitoring is provided in Figure 8.1.

The centre of the slide in cross section is generally 15 m north of the downslope edge of pavement (north side of Canal Road). The slide is continuous between Sta. 100+145 to 100+315. The location of the centre of the slide mass is sketched on Figure A2 in Appendix A.

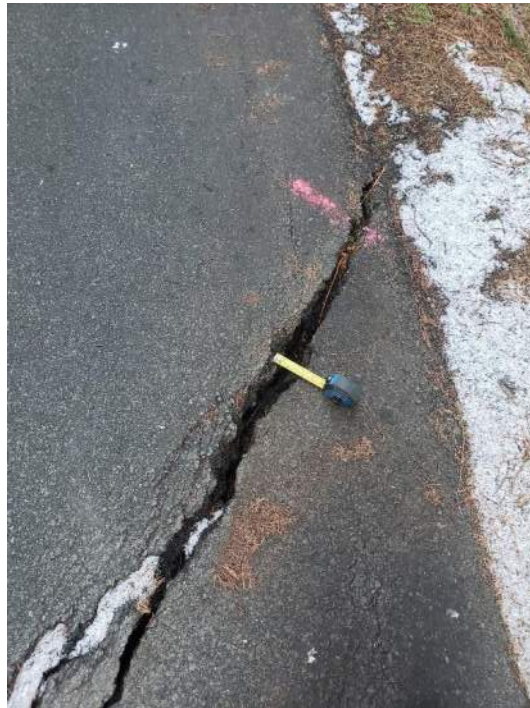
The tension cracks at the northwest end of the slide are significant and extend diagonally across the entire roadway. We understand that the maintenance contractor has been filling these cracks with cold patch asphalt at the recommendation of the MoTI geotechnical team to reduce water infiltration.

**PHOTO 15:** Example of cracking at the west end of site (24/2/2022) – Photo by Jill Usher

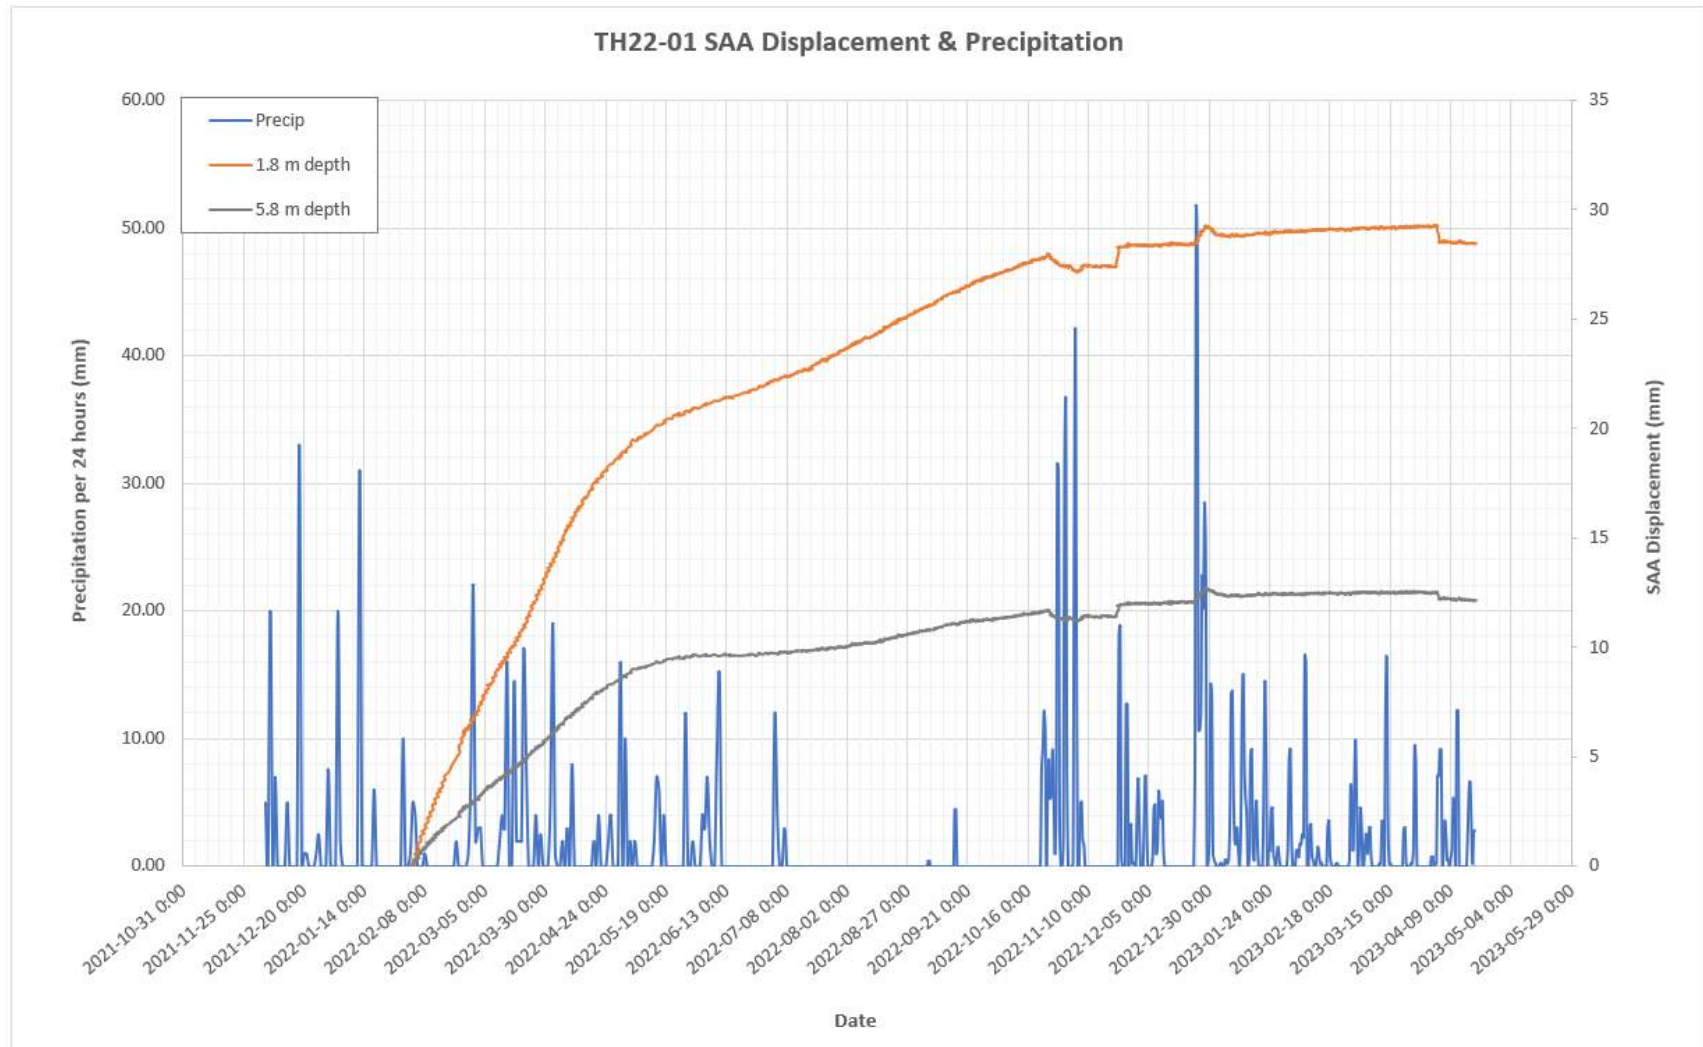
**FIGURE E.2 TH22-01 DEFORMATION AND PRECIPITATION PLOT**

The observed deformation in the test holes appears to be between depths of 7 m and 10 m below road grade near the transition from colluvial soils to dense glacial till in TH22-01 and within the glacial till in TH22-02. The nature of the movement appears to be tilting and/or sliding in the downslope (north) direction. The stratigraphy is discussed in more detail in Section 4.1 below. Plots of cumulative deflection and incremental deflection for TH22-01, TH22-02 and TH22-04 are attached in Appendix E. Rate plots of the total deformation in the downslope direction are also attached for TH22-01 and TH22-02. No significant deformation has been observed in TH22-04 and no rate plot has been prepared. Discussion of results is provided regularly in SAA Monitoring Memos.
