Province of British Columbia
MINISTRY OF ENERGY AND MINES
Report of Inspector of Mines
Reclamation
(Issued pursuant to Section 15 of the *Mines Act*)

Inspection No.: 59777
File: «FILE_NO»
Mine No.: 0100019
Permit No.: M-232
Emp/Cont: 1
Orders : 2
Stop Work:

Mine Name: Tulsequah Chief
Location: Atlin MD / 58.737, -133.600
Owner, Manager: Keith Boyle, Terry Zanger

Type of Mining: METAL MINE UNDERGROUND
Date of Inspection: 2015/10/15
Accompanying Inspectors: Mark Love (MOE), Neil Bailey (MOE)

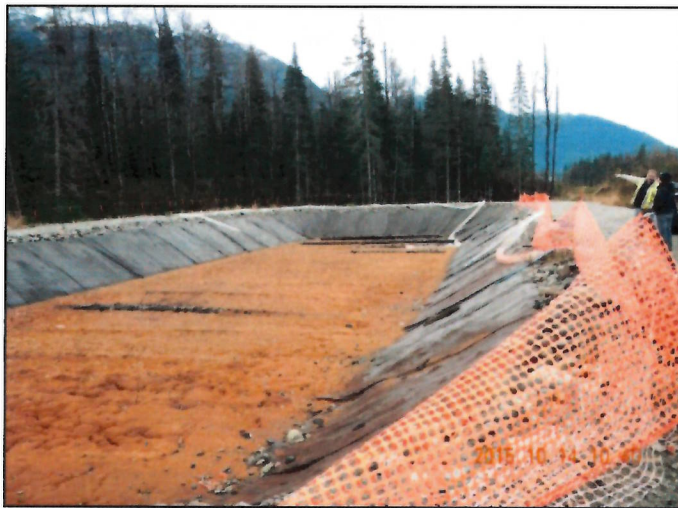
The temporary lime sludge storage pit, located just off the airstrip, contains approximate 35m³ of sludge generated from the WTP and is lined with a filter fabric to prevent migration of the sludge to the subsurface gravel. No deposition has occurred since the WTP shut down in June 2012. CMI maintains monitoring from 3 groundwater wells. CMI has committed, should mine operations not resume, to relocating the sludge to a secure location to the Rogers Creek area, which will be capped and re-vegetated.

Photo 1: Lime Sludge Pit Shaza AirStrip.

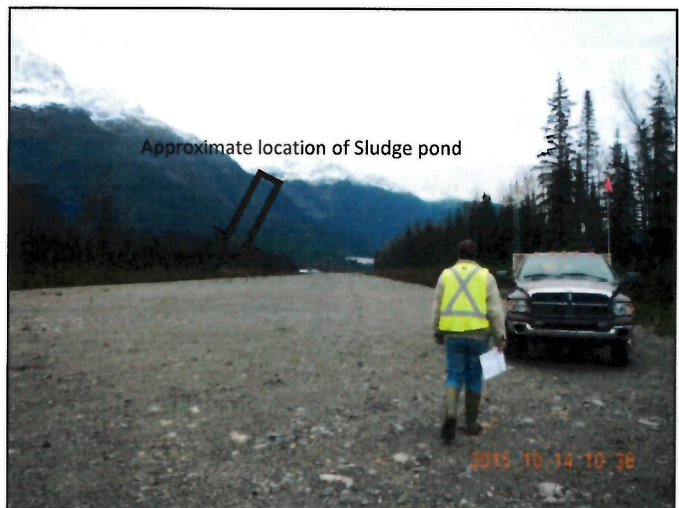
Photo 2: Shaza Airstrip location of Sludge Pit

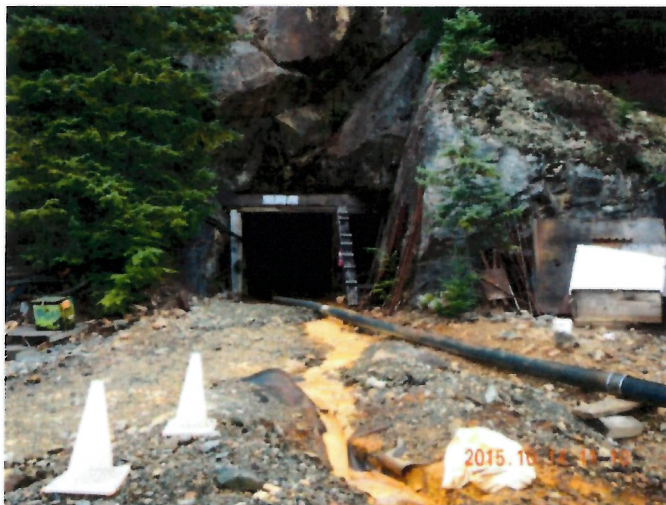
The acidic drainage seen exiting the mine as an orange flow (approx. 1L/s)(Photo 3) is captured in a pipe near the portal and is directly conveyed by a buried pipeline to the exfiltration pond located near the Tulsequah River. All drainage from the 5400 portal has been directed away from the historical waste thus limiting contaminated flows. (Photos 5 and 6)

Photo 3: The black pipe is diverting neutral drainage captured underground; The Fe stained drainage (acidic) is flowing freely from the portal and is captured in a pipe in the foreground.

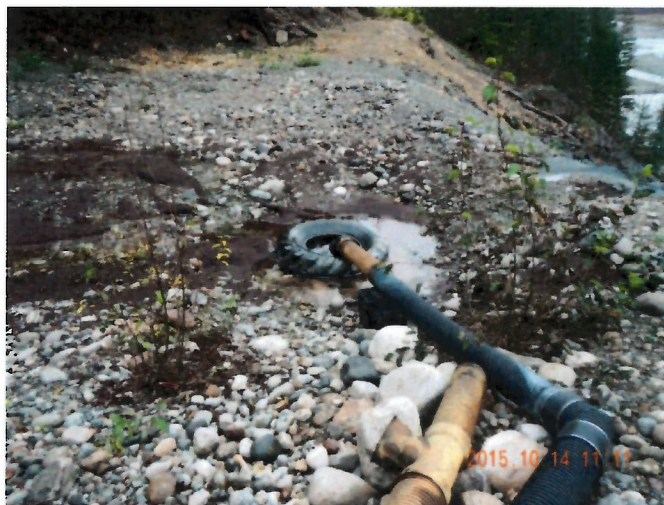
The 5400 portal, the upper most accessible portal, has been appropriately signed with "Danger No Entry" signage and is currently blocked by locked wooden doors. Limited work has been done at this portal site other than to remove the historic track from the underground and reconfigure the drainage exiting the portal. In 2011 CMI separated the acidic from non-acidic drainage inside the mine and today the non-acidic drainage (in black pipe Photo 3) is conveyed to Portal Creek where they are combined (photo 4) and directly discharged to the Tulsequah River via a buried (partial) 600mm HDPE pipeline.

Photo 4: The neutral drainage is combined with the Portal Creek drainage into a HDPE pipe and diverted away from historical waste rock to the Tulsequah River

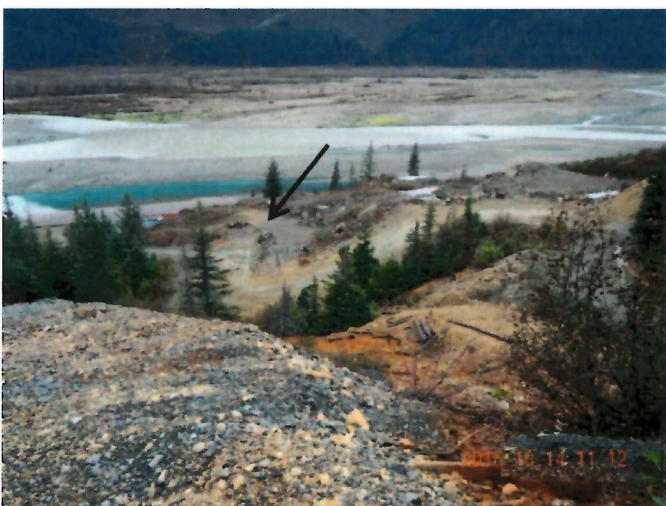
Photo 5: The black pipe (arrow) is the acidic discharge from the 5400 portal. Portal Creek and the combined non-acidic drainage discharge to the left of the picture in an underground HDPE pipe.

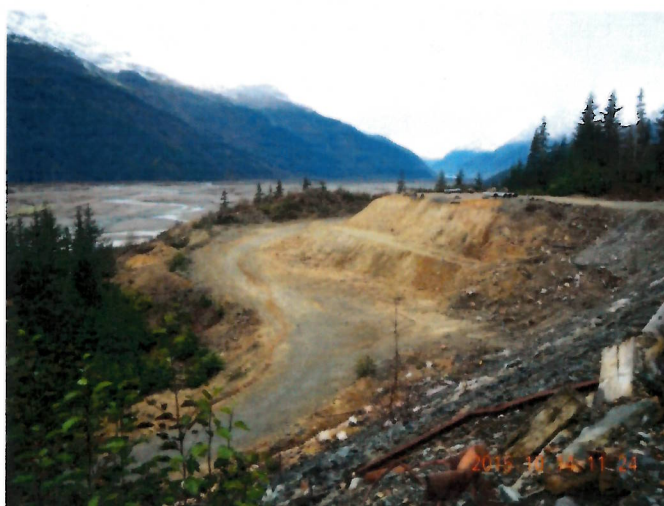
Photo 6: showing the historical PAG rock left from early mining. The ~80,000 tonnes of material to be relocated once mining restarts to the PAG dump on Rogers Creek.

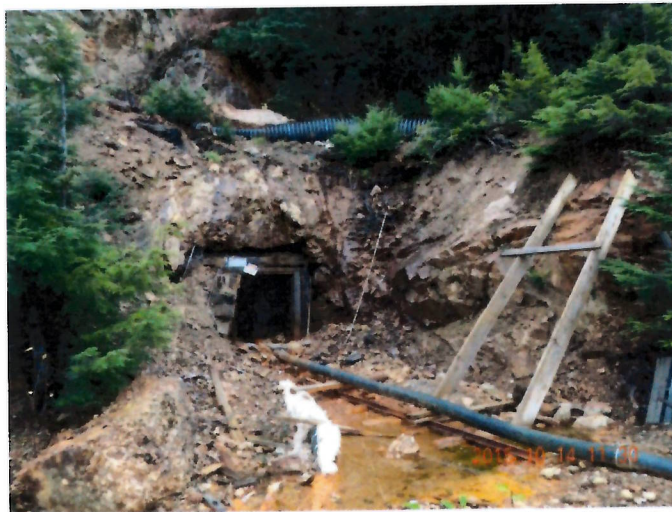
The 5200 portal, the lower most accessible portal is appropriately signed with "Danger No Entry" signs but the wood door is open to allow the passage of the discharge pipe seen in photo (Photo 7). Within 300 meters inside the entrance however, is a 1.8 m high dam used as part of an inactive passive water treatment system and the tunnel beyond is partially flooded. Acidic flow from this portal; which also includes partial flow from the 5400 and 5900 levels, averages ~ 7L/s.

Photo 7: 5200 Portal. Acidic discharge is in smaller pipe exiting mine. 5400 non acidic and Portal creek water is contained in the larger pipe located above the portal.

Notable in Photo 7 is the 600mm HDPE pipe over top of the 5200 Portal entrance which is conveying the Portal Creek and 5400 non-acidic drainage to the Tulsequah River. The pipe requires ongoing monitoring and maintenance because of rock falling onto the pipe and at times crushing the pipe causing leakage. From the photo it can be seen the pipe is currently leaking with water spilling down to pond in front of the Portal. This pond drains into the ex-filtration pond via ditching and a culvert under the road.

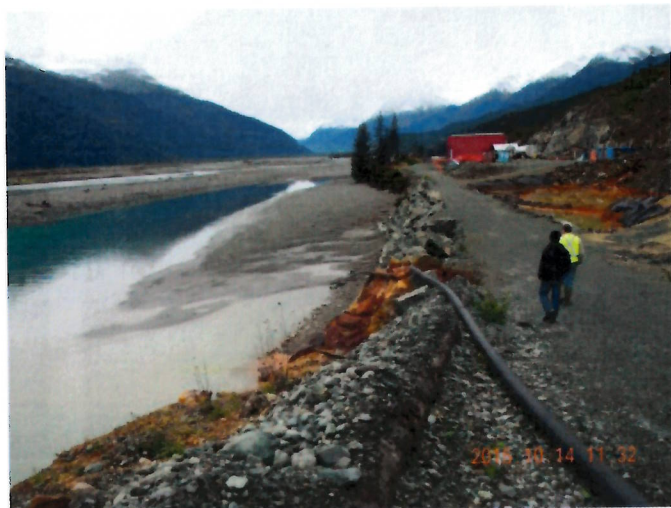
At the time of this inspection, the 5200 acidic discharge was being directly discharged to the Tulsequah River (Photo 8). MOE officials accompanying the author sampled at the end of pipe at this location. It is understood that the direct discharge to the Tulsequah River was also done last year during the high flow period in order to minimize sludge build up in the exfiltration pond thereby and reducing the hydraulic loading on the pond. (MEM understands this direct discharge has not approved by MOE and discussions are ongoing.)

Photo 8: 5200 acidic portal discharge to Tulsequah River

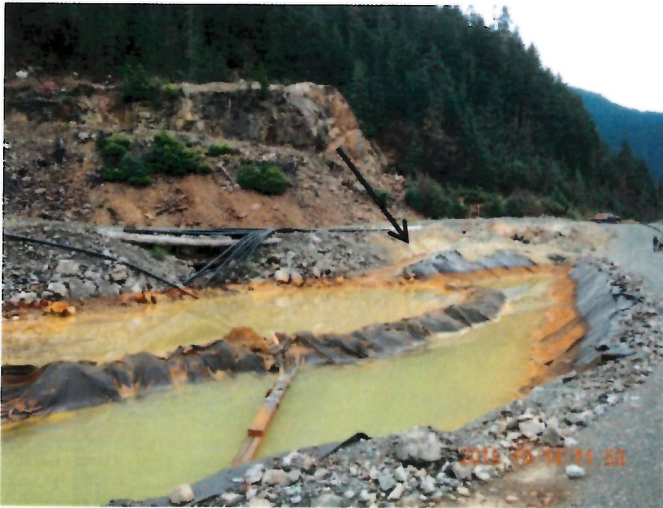
The observed ex-filtration pond was constructed in 2011 and was reportedly built to capture site drainage from the PAG waste dumps (Photos 9-11). Currently it is being used to capture all drainage, including the portal drainage, where the contaminated discharge is allowed to ex-filtrate through the road berm to the Tulsequah River (Photo 12). A filter fabric is used to prevent the migration of the Fe sludge into the dam rock void spaces would effectively block the diffuse flow. As noted in the 2014 ARR the sludge built up in 2013/14 nearly causing the pond to overflow requiring remediation to be taken by the company. (Note this incident was not reported to MEM)

A review of the applications submitted to MEM show the current ex filtration pond has not been built in accordance with the designs provided to the province. (Note MEM has not approved the design, construction or operation of this pond.)

A significant concern is the proper operation of the pond given there is no spillway observed and there is no continuous onsite presence.

Photo 9: Exfiltration pond receiving ditch water from the 5200 portal

1. Pursuant to HSRC 10.5.1 and 10.5.2, the company shall provide to the Chief Inspector by March 31, 2016, or earlier, an as-built report for the exfiltration pond signed by a qualified professional engineer.

2. Pursuant to HSRC 10.5.2, the company shall provide to the Chief Inspector by March 31, 2016, or earlier an Operation, Maintenance and Surveillance manual for the exfiltration pond operations to include all other water management structures, including diversion structures.

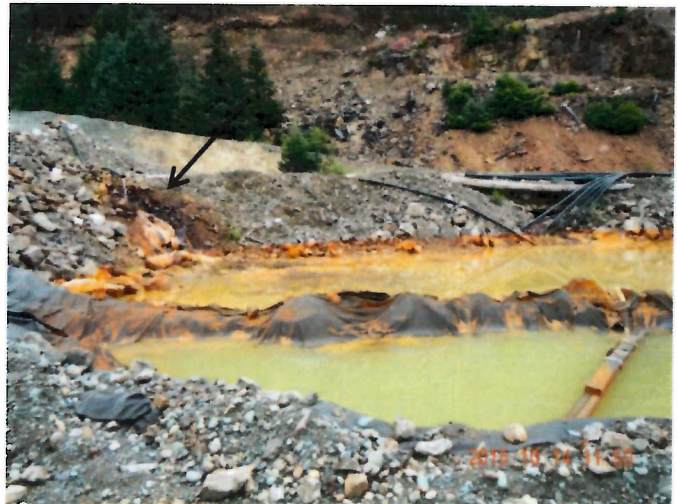
Photo 10: Exfiltration pond receiving acidic discharge from the 5400 portal

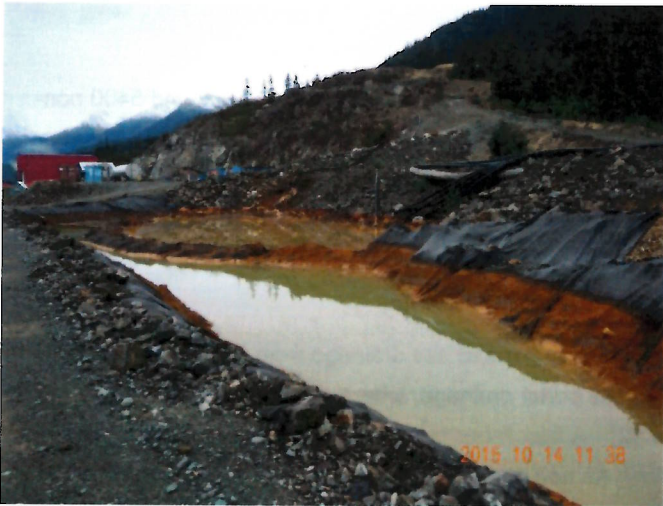
Photo 11 Exfiltration pond. Note high water level of sludge.

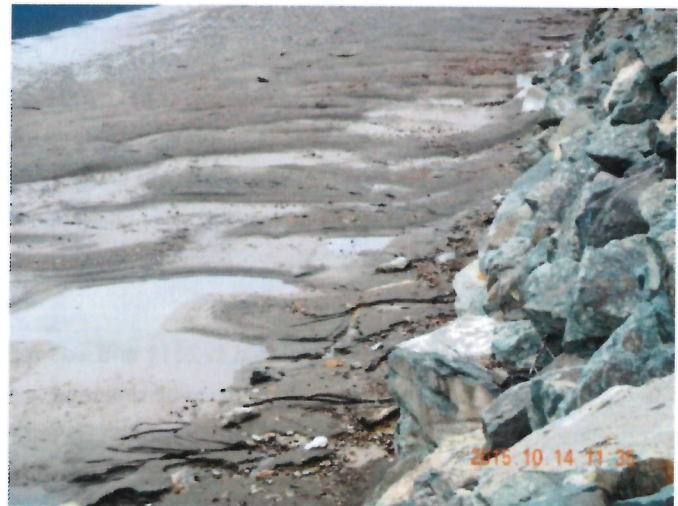
Photo 12: Diffuse discharge location through berm onto the Tulsequah river floodplain.

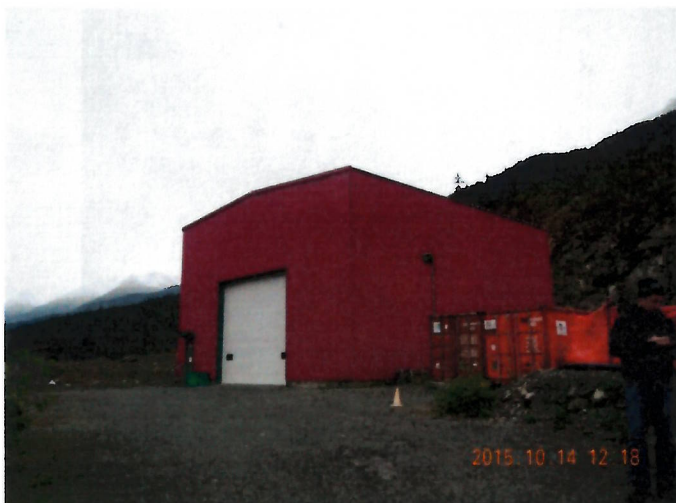
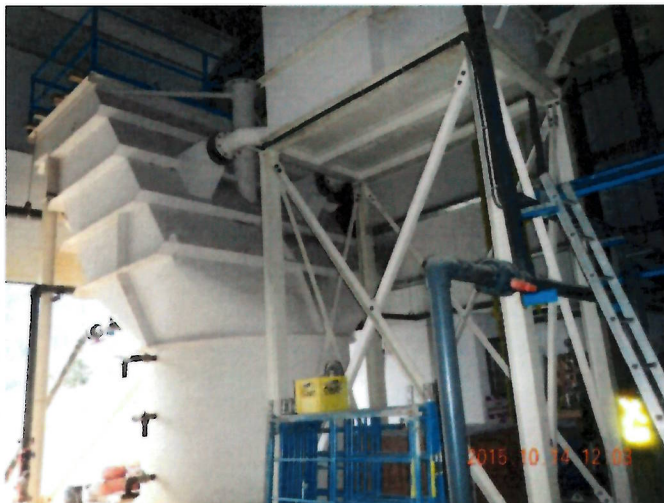
The WTP was constructed in its current location in 2011 after receiving approvals from the province to relocate and upgrade the previously proposed WTP (Photos 13, 14). The WTP is designed to treat acidic discharge on a temporary basis until the upper mine workings could be backfilled as per the mine design proposed in 2009. The plant ran from October 2011 till June 22, 2012 at which time operations were suspended due to operational issues. Since that time the company has sought guidance on process modification strategies to address the high operating costs. CMI has stated they are committed to re-commissioning the WTP at the earliest time upon completion of full project financing.

Photo 13: Acid Water Treatment Plant

Photo 14: Inside the AWTP

5. Prior to resuming operations of the WTP, CMI shall provide to the Chief Inspector final electrical line diagrams and building construction plans signed and sealed by a qualified professional.

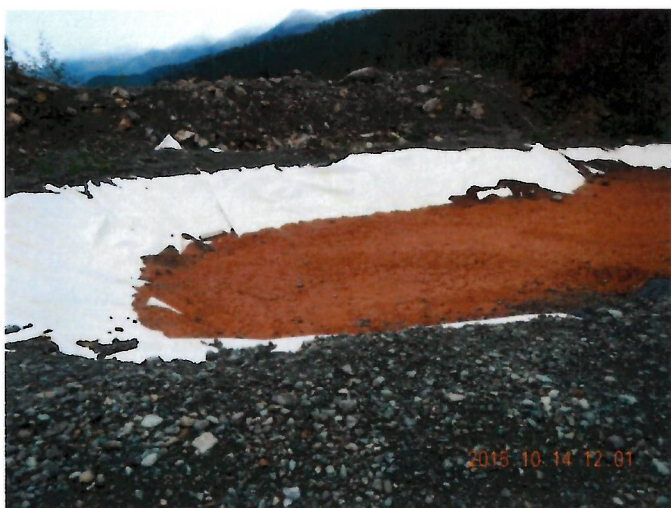
Noted during the inspection, beside the WTP, was another sludge pond which has not been approved by MEM (Photo 15)

Photo 15: Temporay Sludge pond beside AWTP

3. Prior to resuming operations of the sludge pond located beside the WTP, CMI shall provide to the Chief Inspector a final "as built" for the pond, and an operations, maintenance and surveillance manual. This may be combined with the OMS for the WTP once operations resume.

4. CMI shall provide in the next annual report or upon restart of operations, which ever comes sooner, a plan for the decommissioning of this pond

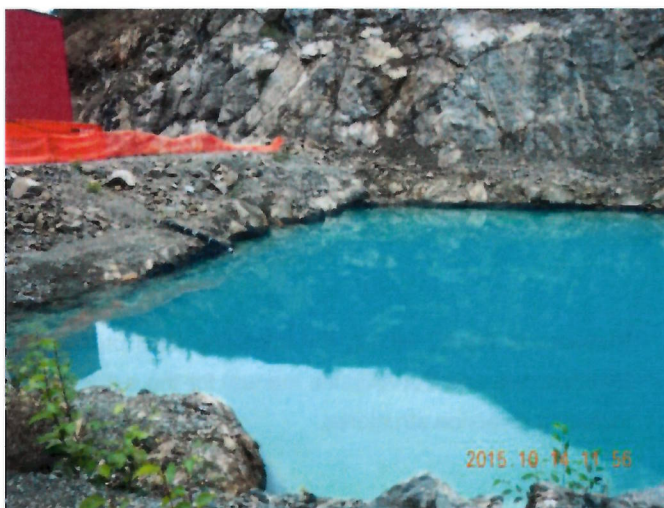
Photo 16: Site Collection Pond

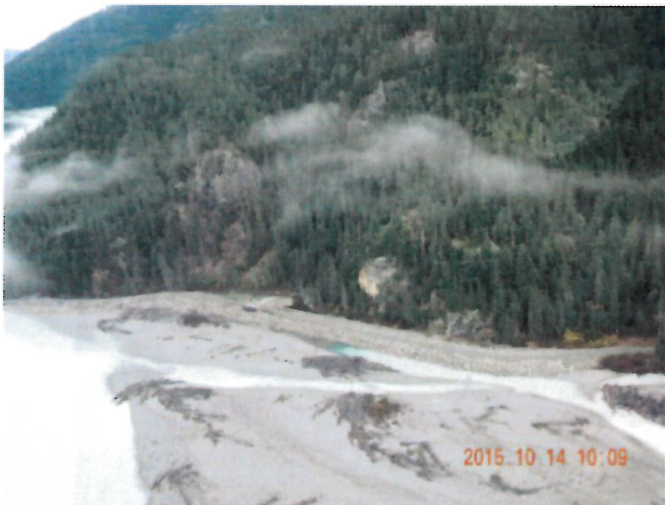
Other than clearing, and some minor construction of berms the areas reserved for PAG and NAG waste rock storage has been minimal (Photo 18). Access to these areas from the main mine site is good; the causeway remains in good condition (Photo 17).

Photo 17; Causeway between mine and Rogers Creek area.

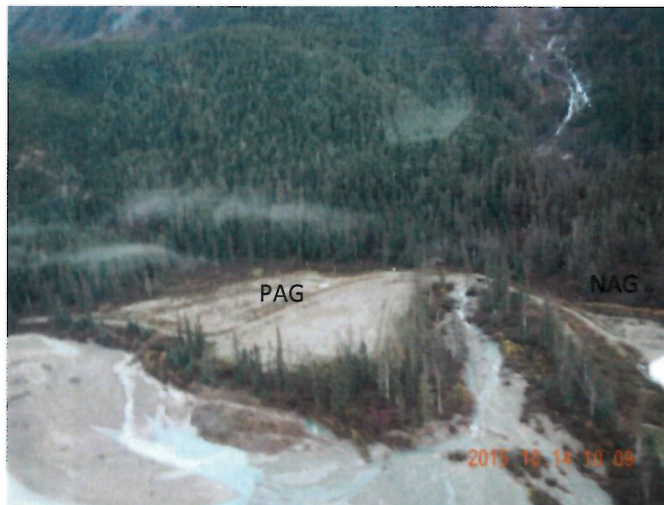
Photo 18: Clearing for the PAG and NAG waste rock areas.
