## **BI-WEEKLY STATUS REPORT**

### **Cobble Hill Landfill Closure**

<b>PROJECT # : PRJ18074</b>	<b>File #:</b> 18074- BWR-71
<b>REPORT #:</b> 71	<b>Date:</b> June 30, 2020
<b>SHA REPRESENTATIVES:</b> Dr. Tony Sperling, P.Eng. Scott Garthwaite Carly Wolfe, EIT	<b>Owner:</b> Cobble Hill Holdings Ltd.  <b>Contractor:</b> Allterra Construction Ltd.

# **SITE INSPECTION REPORT**

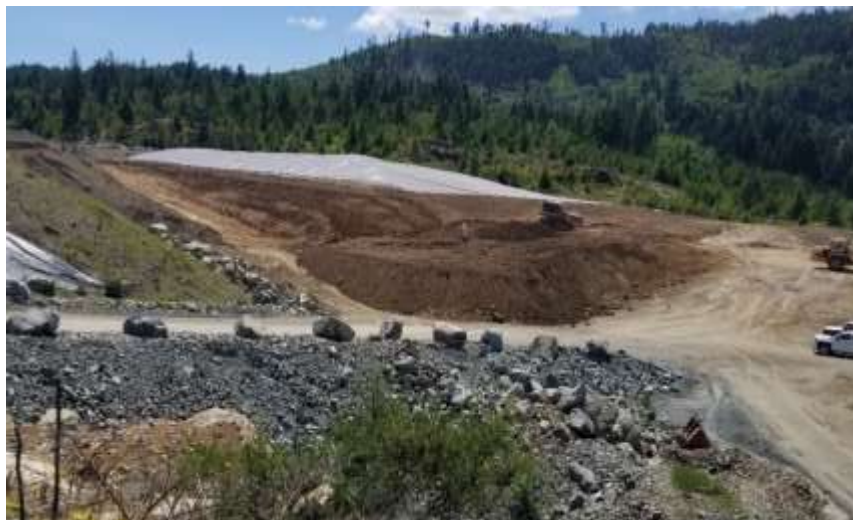
- Permanent Encapsulation Area (PEA): Liner appears to be in good condition. No noticeable changes since last reporting period.
- Soil Management Area (SMA): All works are in good condition, no noticeable changes since last reporting period.
- Cut-off ditch upland of PEA: All works are in good condition, ditch still performing well.
- Pictures detailing inspection results are shown at the end of this report.

**Picture #1: Looking southeast at PEA**

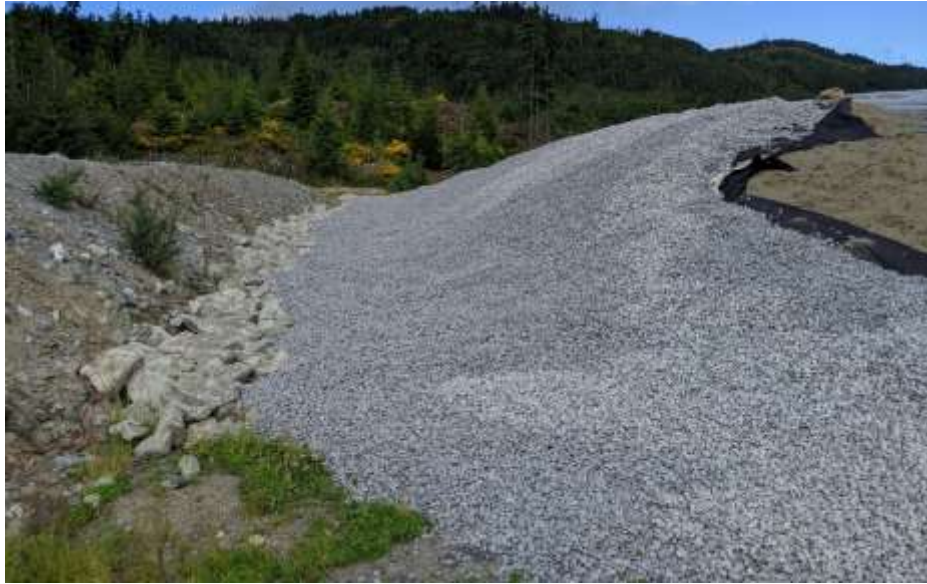
**Picture #2: Drain rock on south slope of PEA**

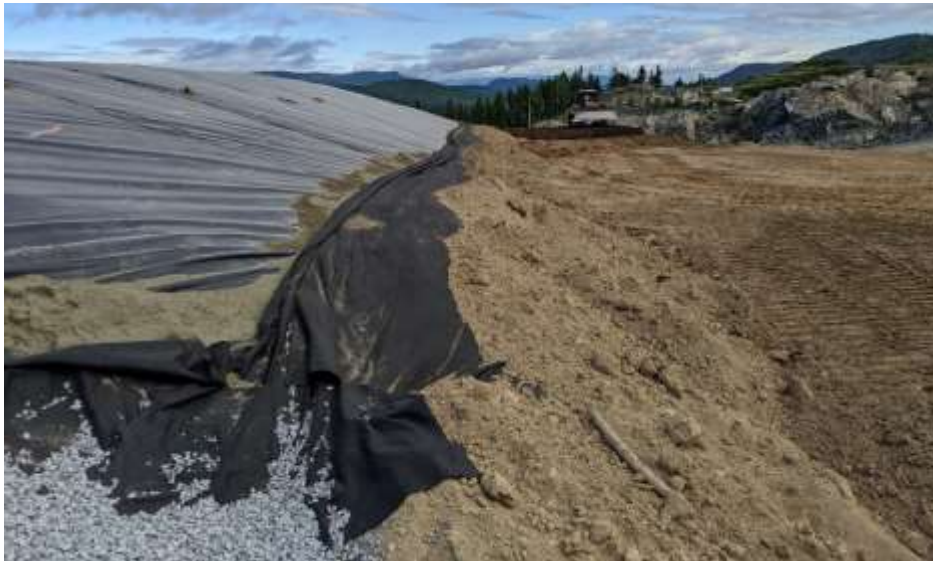
**Picture #3: Soil stabilizing wedge at east side of PEA**

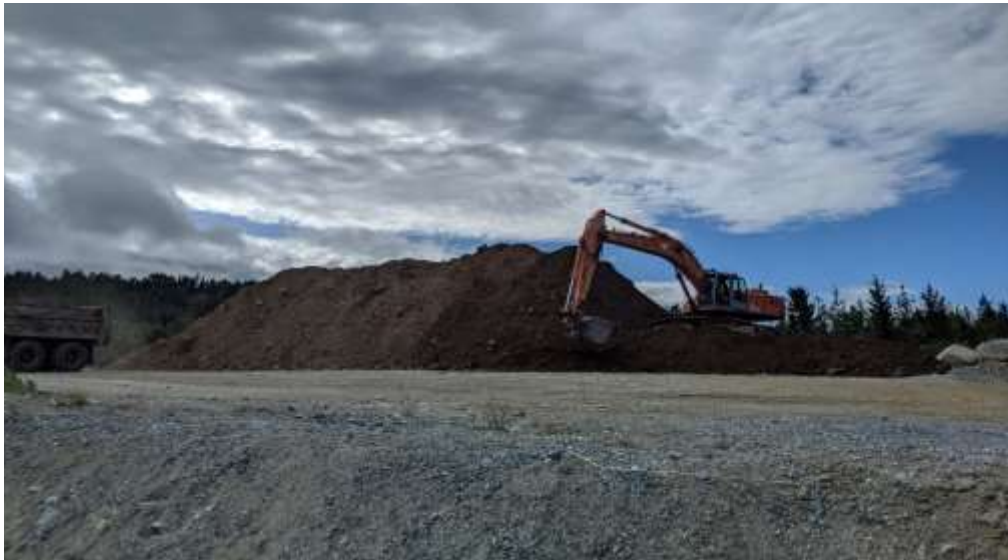
**Picture #4: Growing medium stockpile**

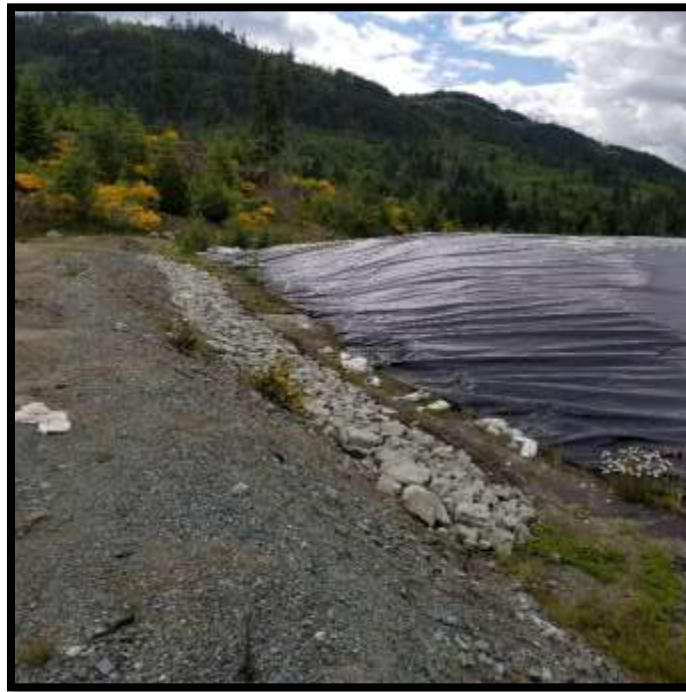
**Picture # 1:** Blast rock placed in East-West drainage ditch

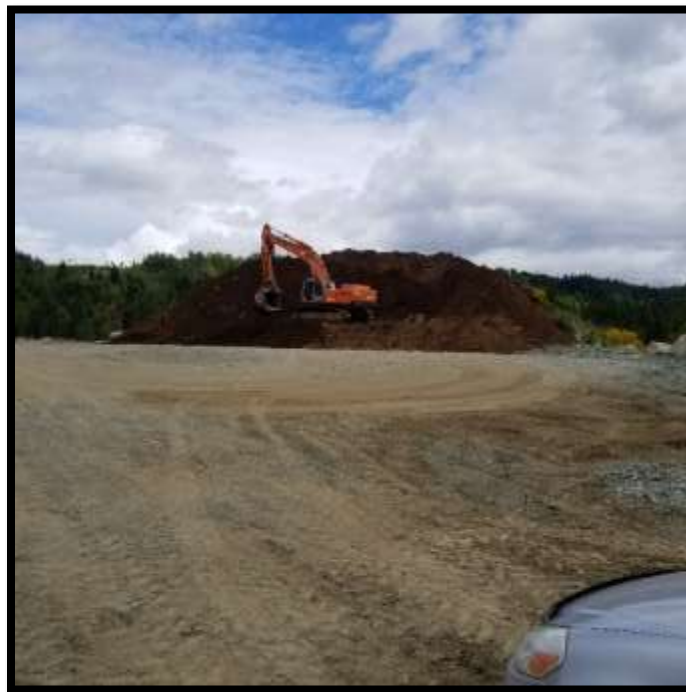
**Picture # 2:** Stockpile location – South Stockpile

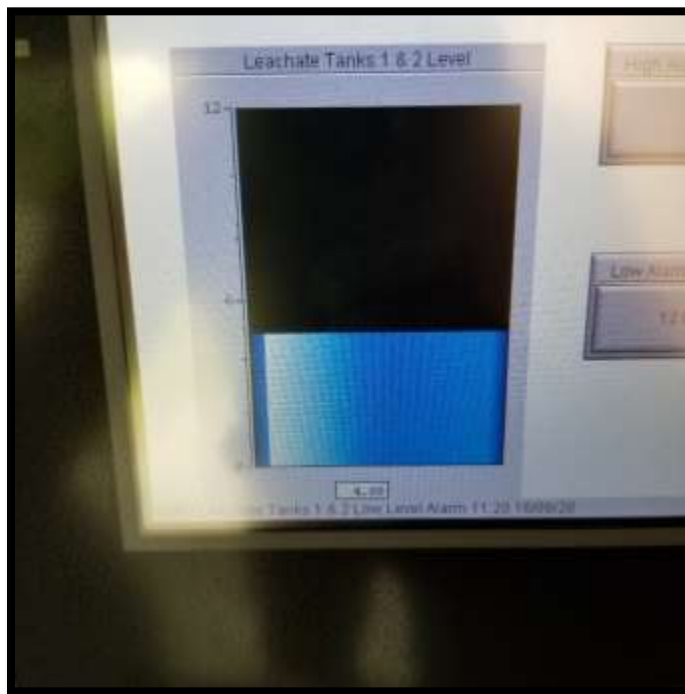
**Picture # 3:** Leachate Display – 4.88ft per tank

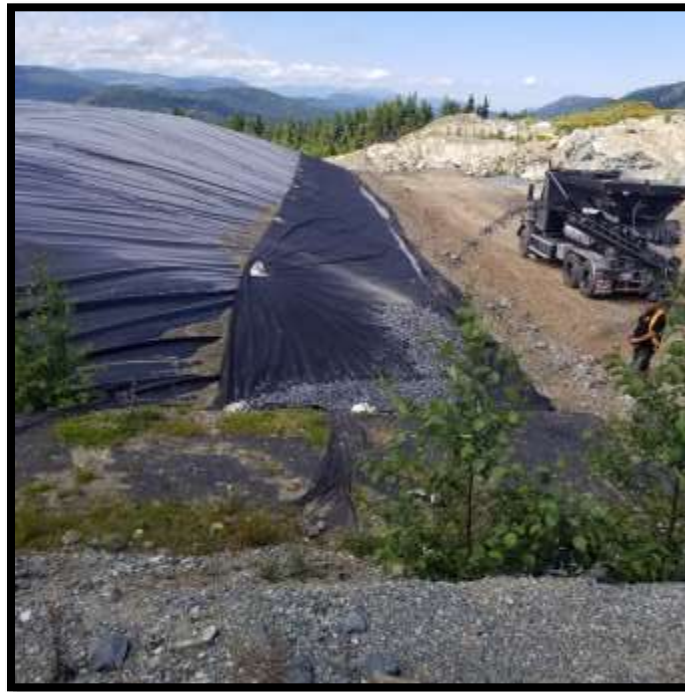
**Picture # 1:** New Lift – East face

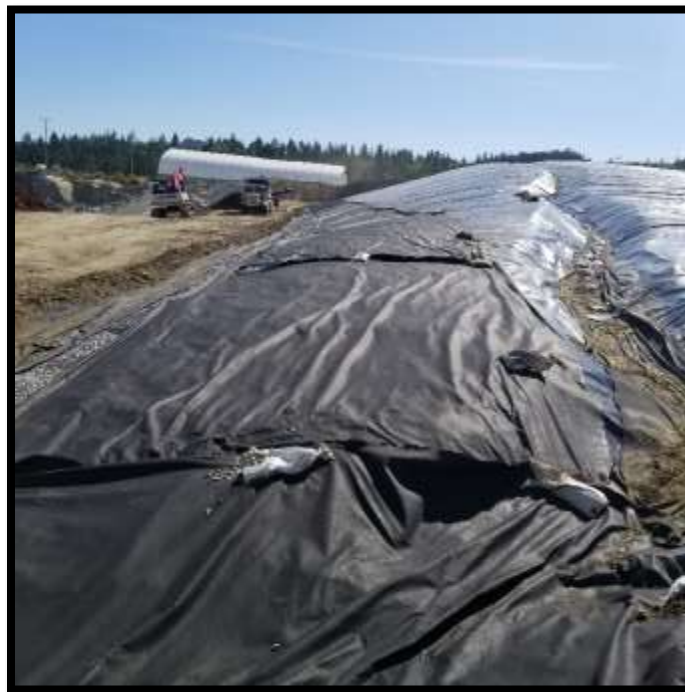
**Picture # 2:** New Lift – North Face

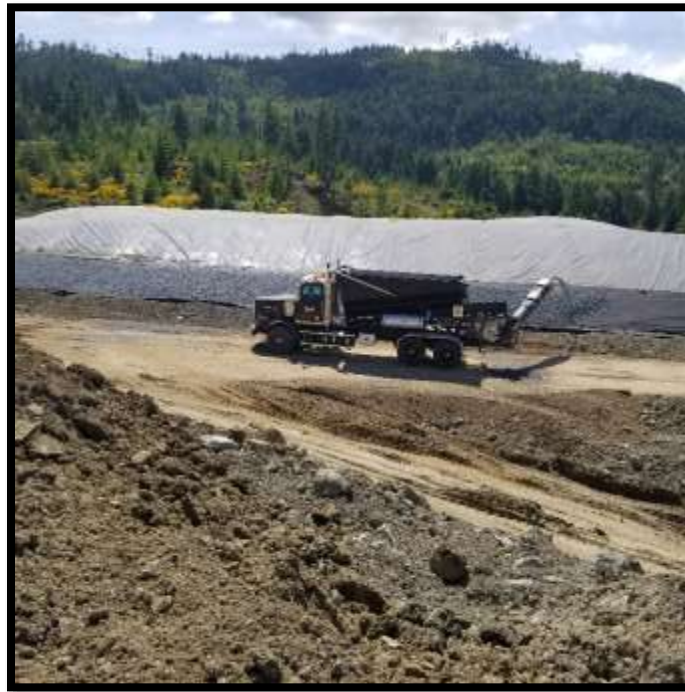
**Picture # 3:** Gravel Placement – East Face

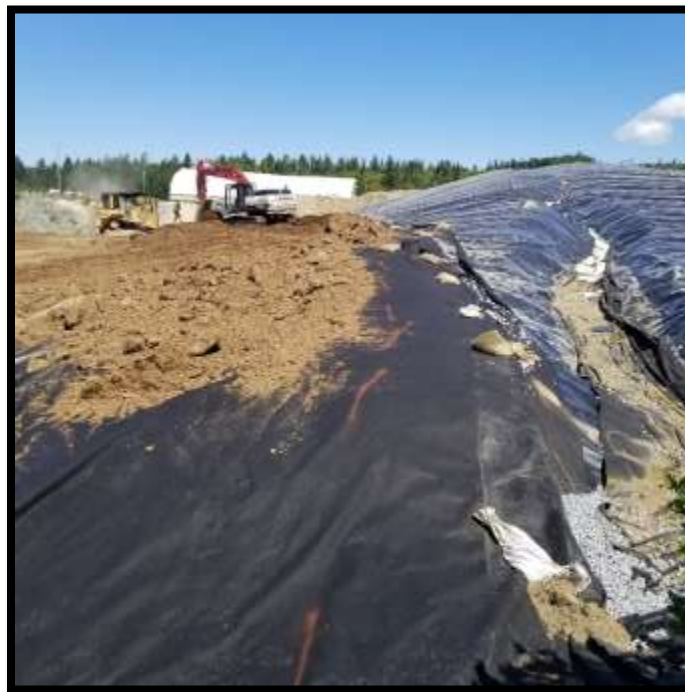
**Picture # 4:** Soil Placement on the North Face

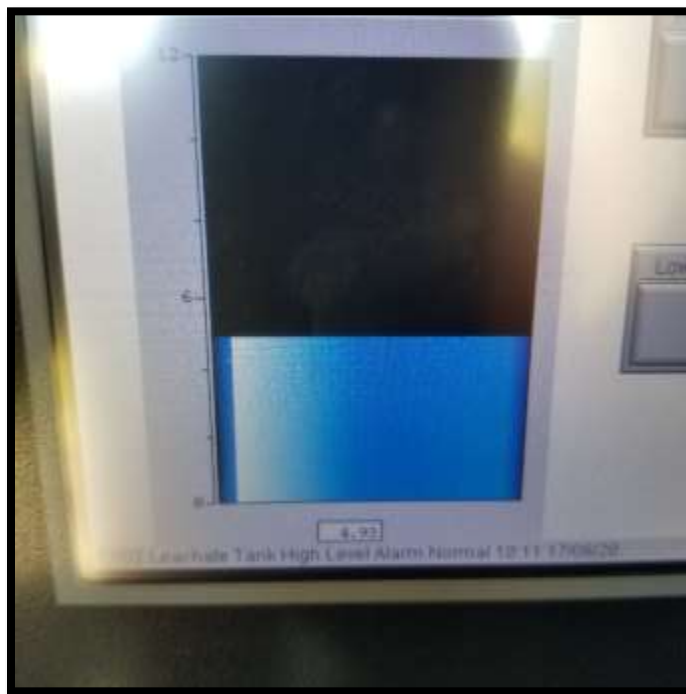
**Picture # 5:** Leachate Display – 4.93ft per tank

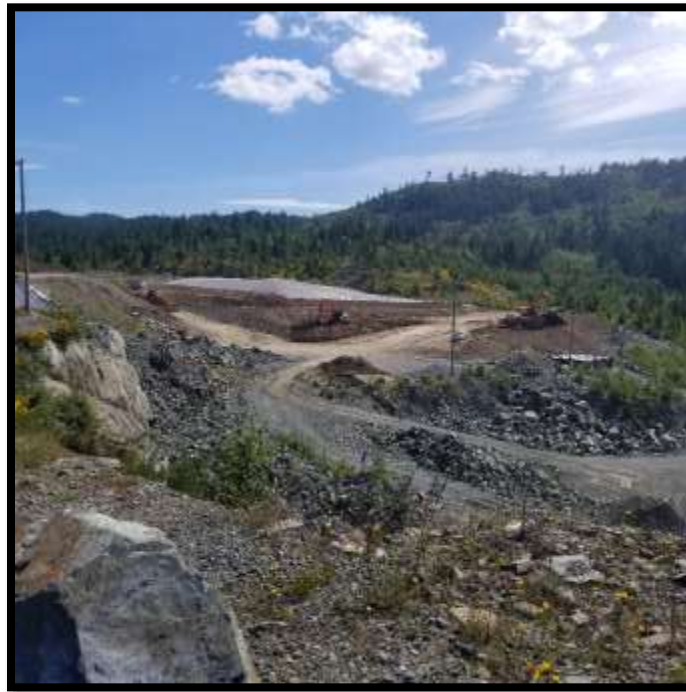
**Picture # 1:** Site – looking Southwest

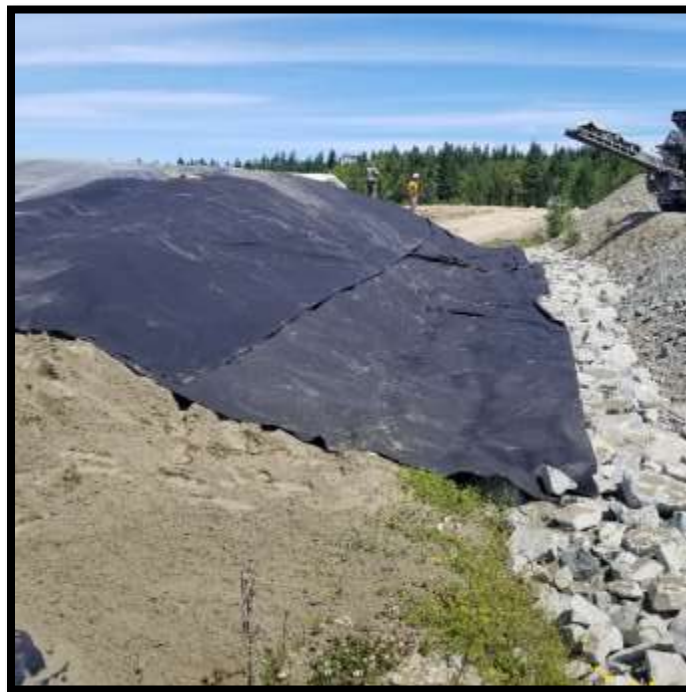
**Picture # 2:** South Face – Sand and Filter Cloth Placement

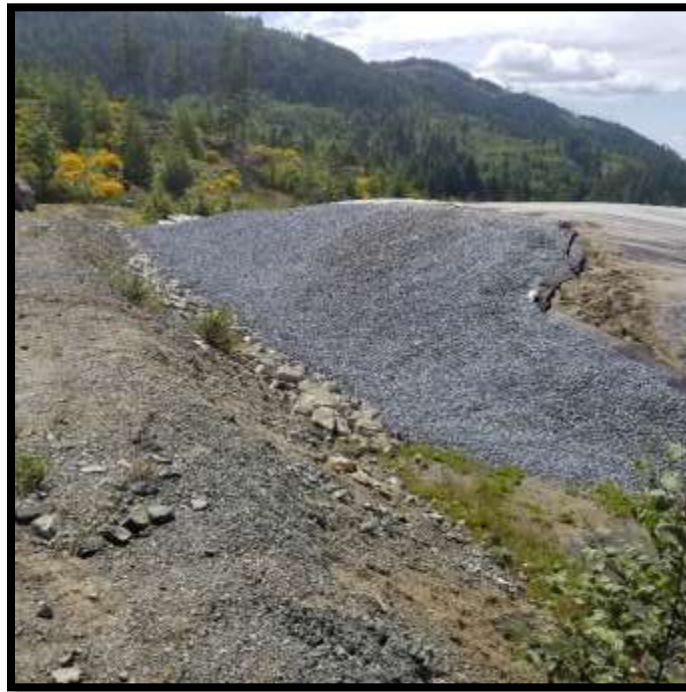
**Picture # 3:** South Face – Gravel Placement

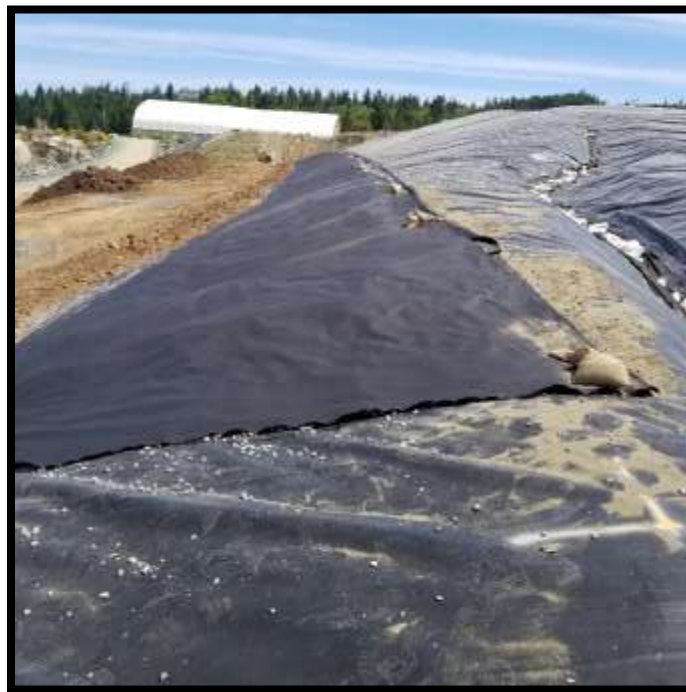
**Picture # 4:** North Face – Preparation for soil placement

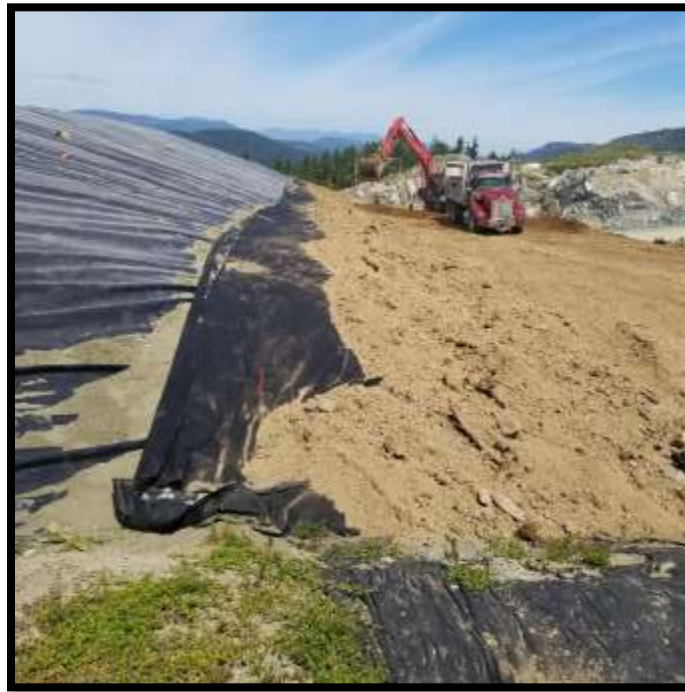
**Picture # 5:** East Face – Soil Placement

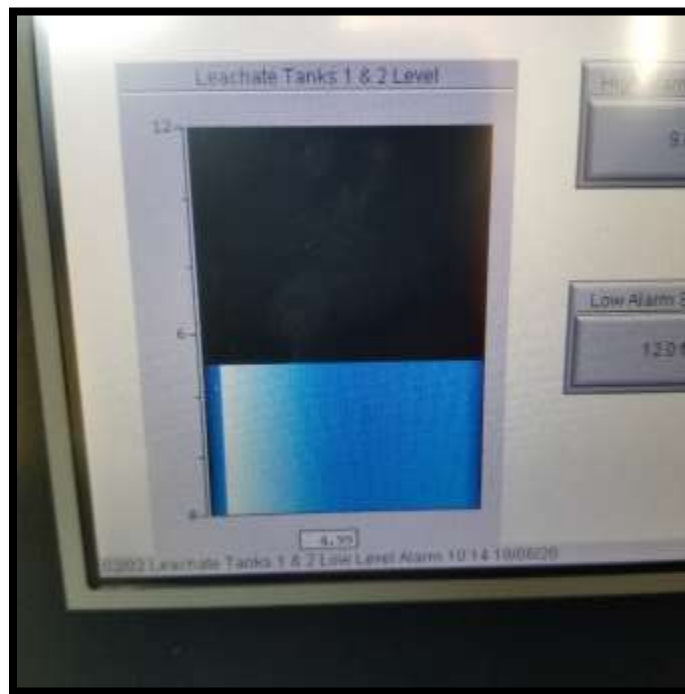
**Picture # 6:** Leachate Display – 4.99ft per tank

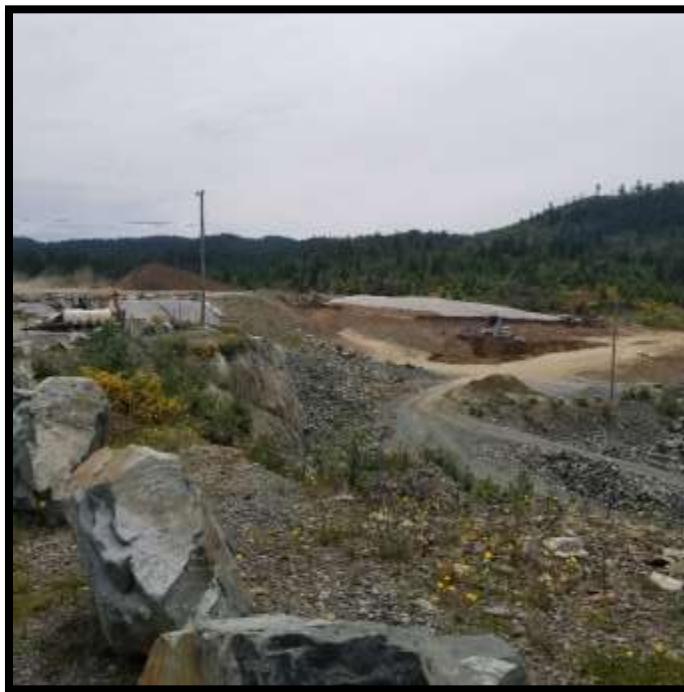
**Picture # 1:** Site – Looking Southwest – Soil Import to East Toe

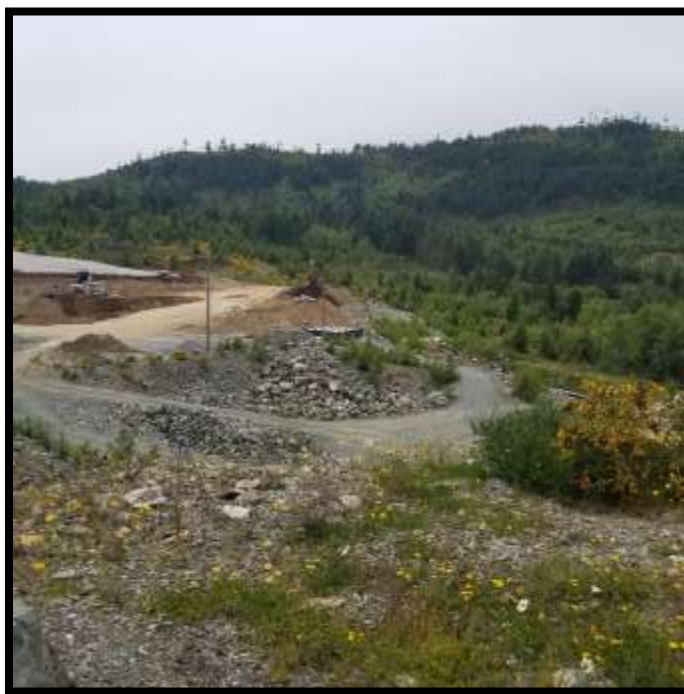
**Picture # 2:** Site – Looking West – Leachate Facility

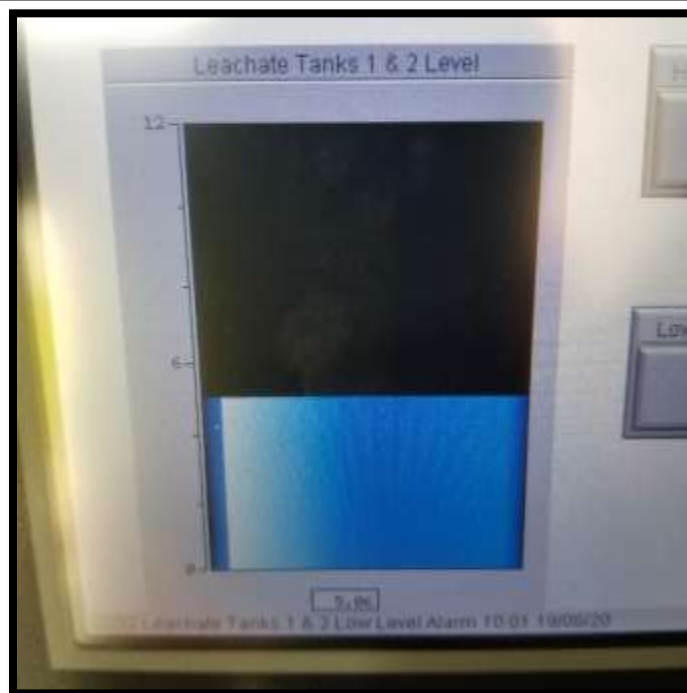
**Picture # 3:** Leachate Display – 5.06ft per tank

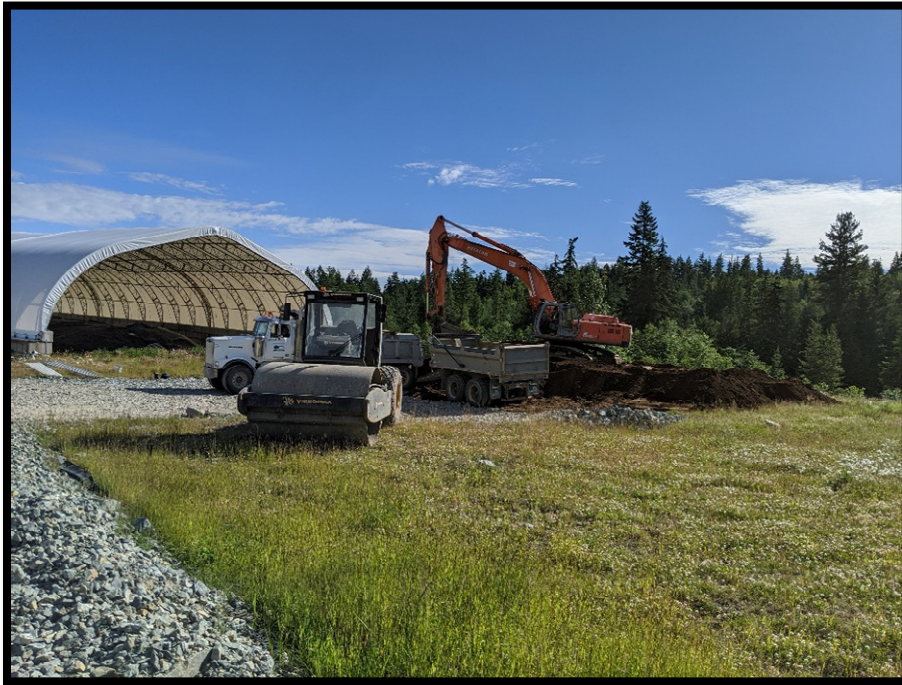
**Picture # 1:** Contractor stockpiling topsoil south of SMA.

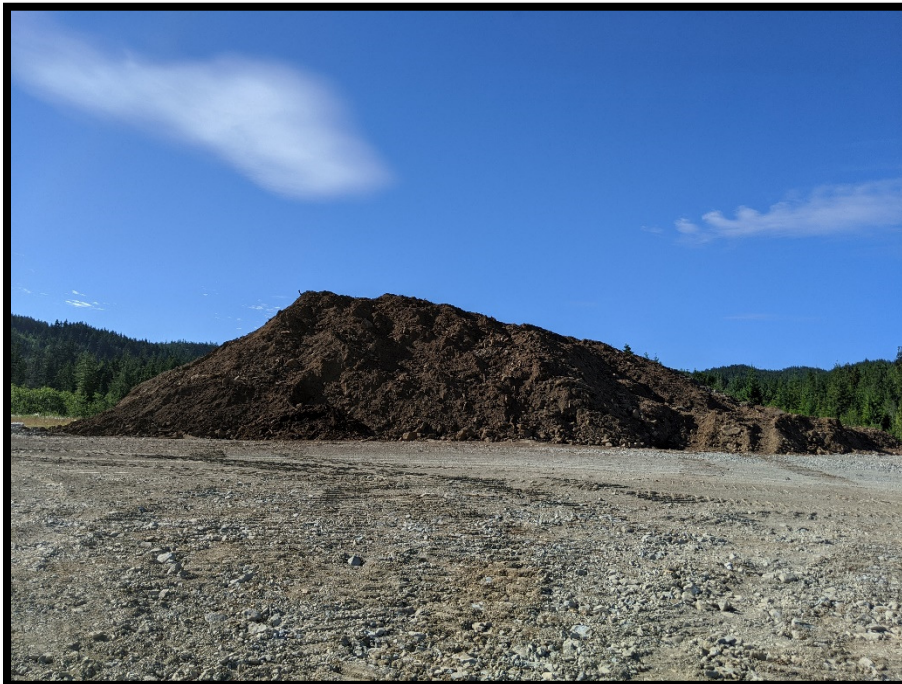
**Picture # 2:** Recently stockpile topsoils south of PEA.

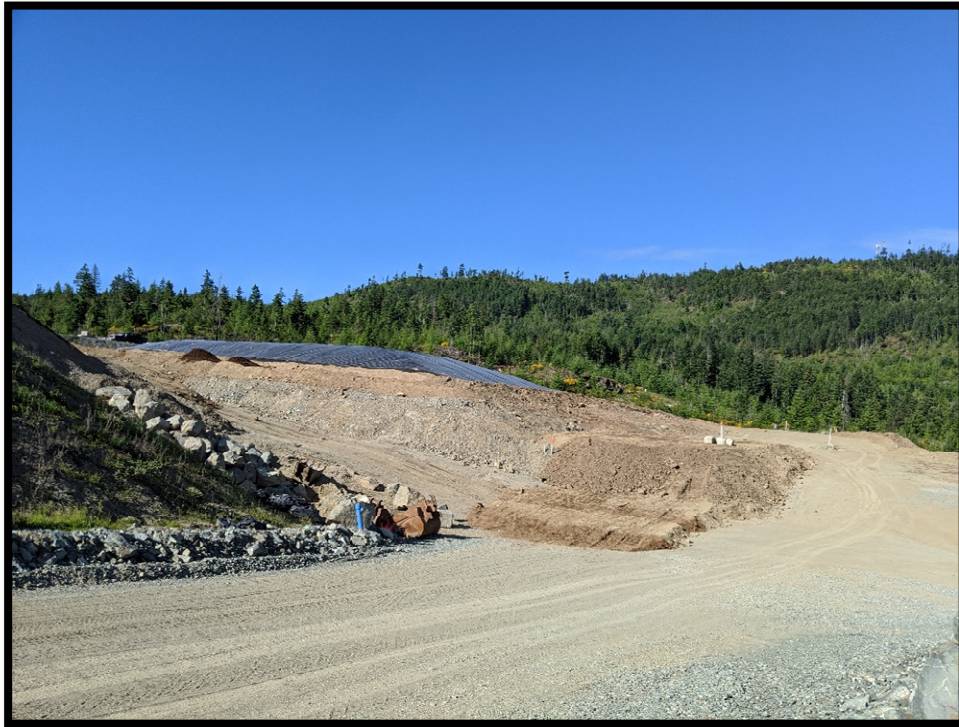
**Picture # 3:** Overview of PEA progress from quarry road.

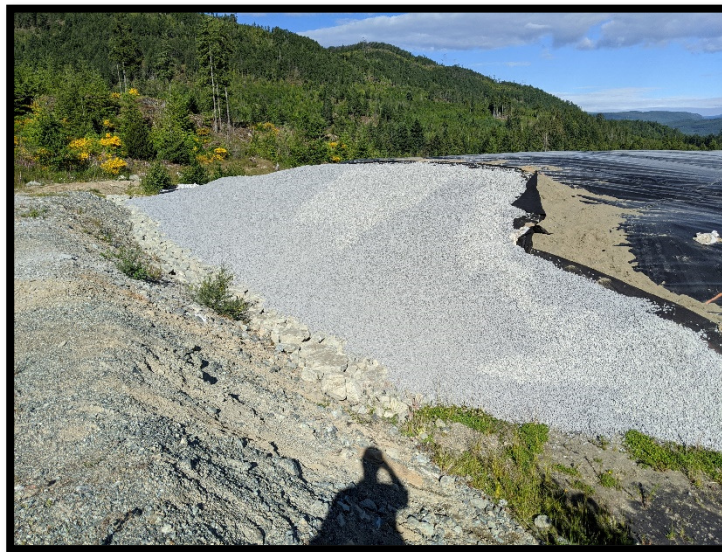
**Picture # 4:** Drain rock placed on south face of PEA.

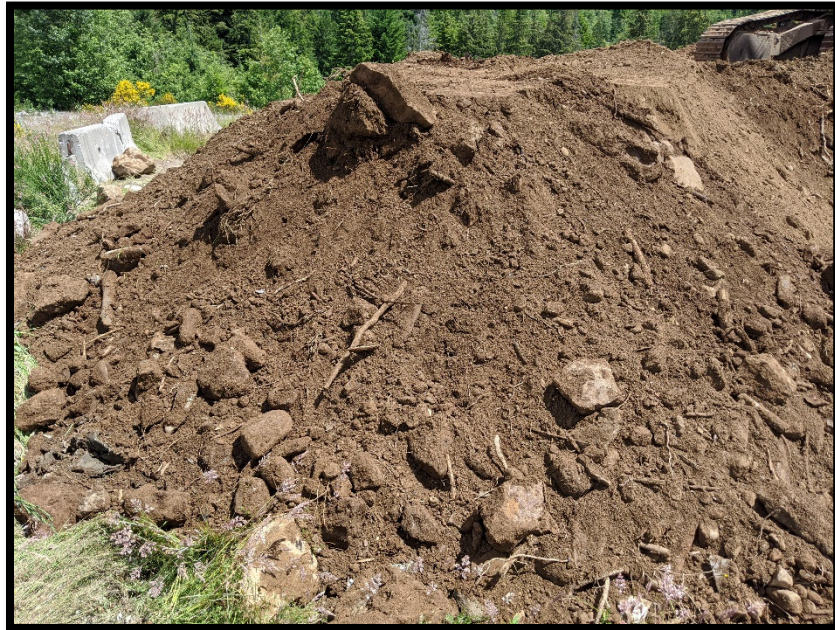
**Picture # 5:** Typical topsoil load from 2251 Bear Mountain Parkway.

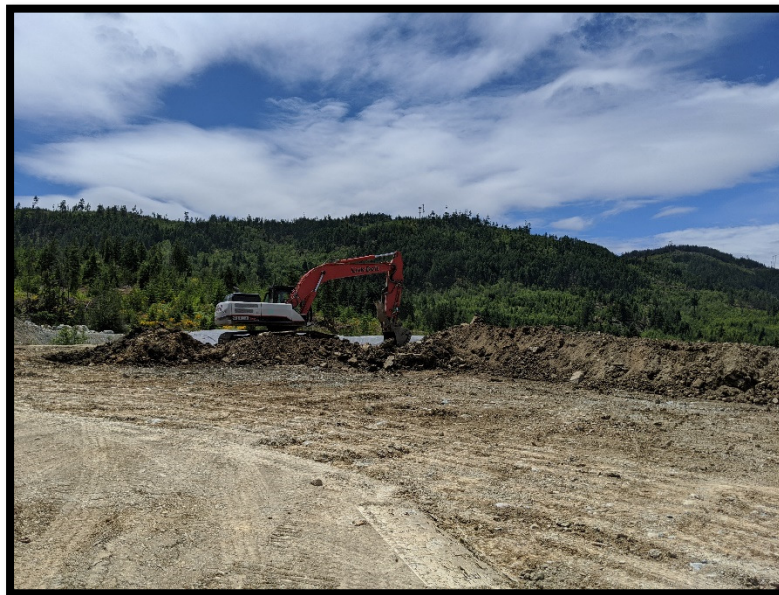
**Picture # 6:** Excavator preparing stockpiled soils for relocation at end of day.

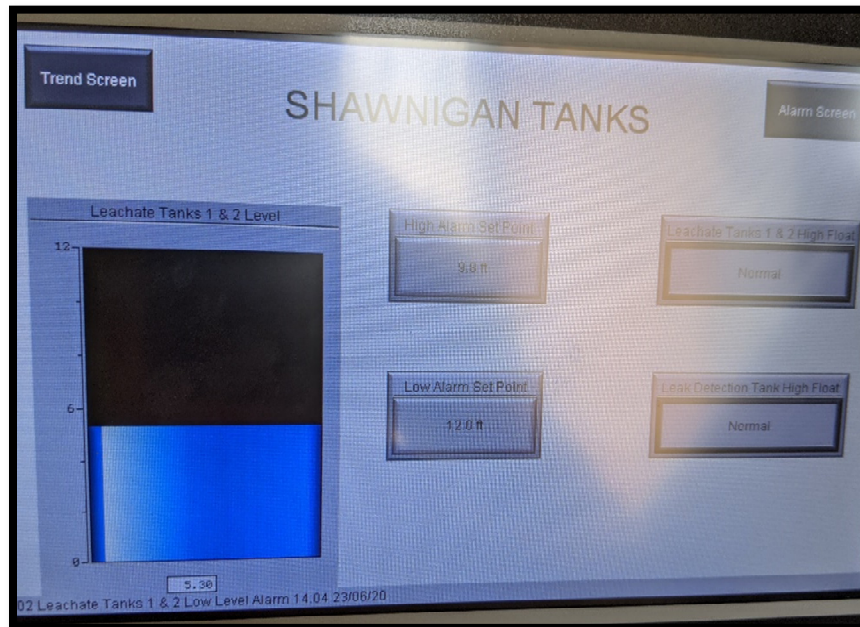
**Picture # 1:** Leachate level = 5.3 ft.

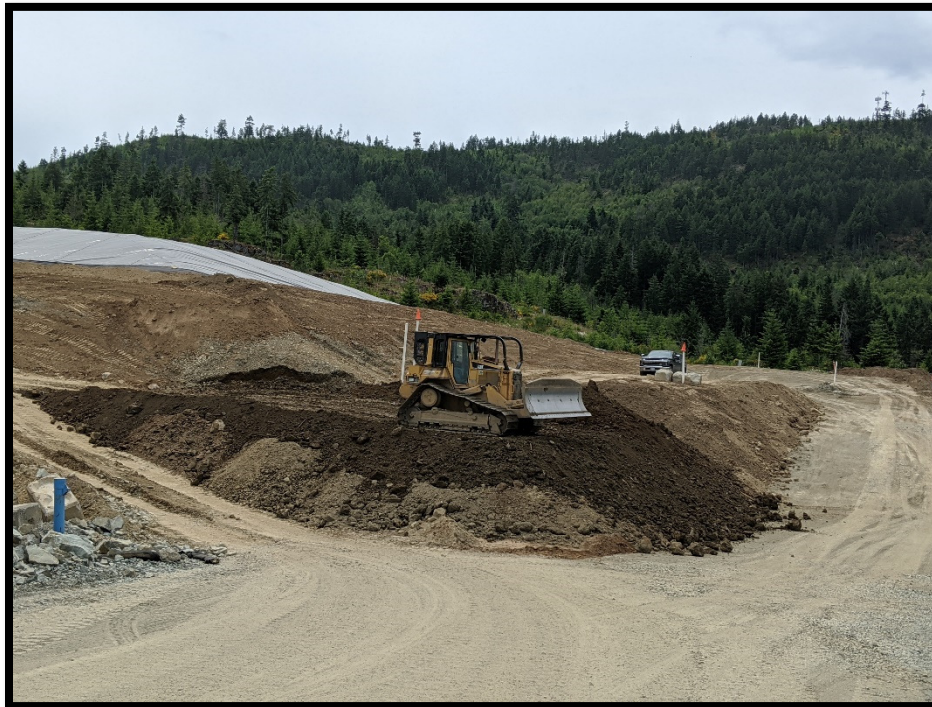
**Picture # 2:** D6 dozer track packing and distributing previously stockpiled soils.

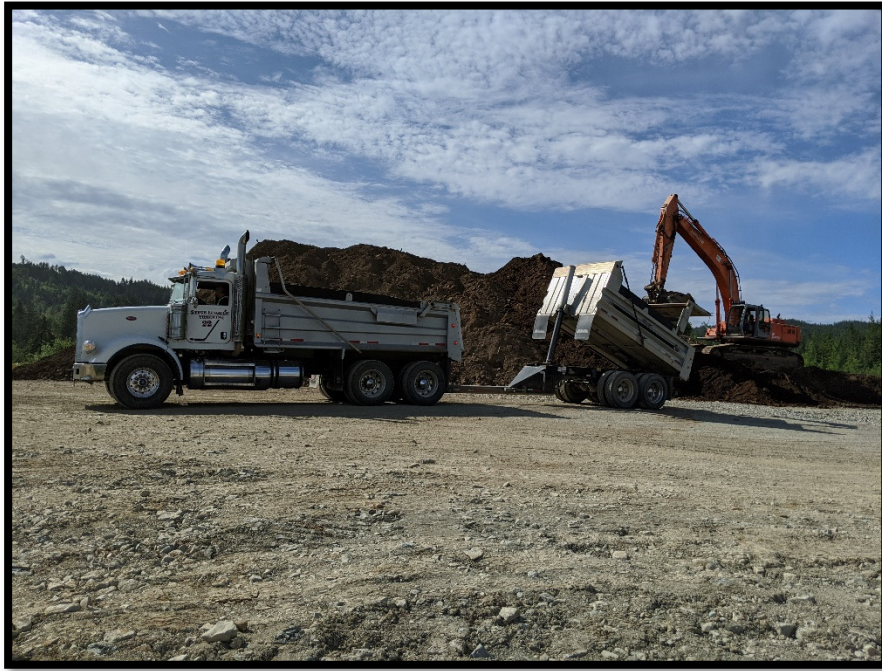
**Picture # 3:** Stockpiling of topsoils from 2251 Bear Mountain Parkway.

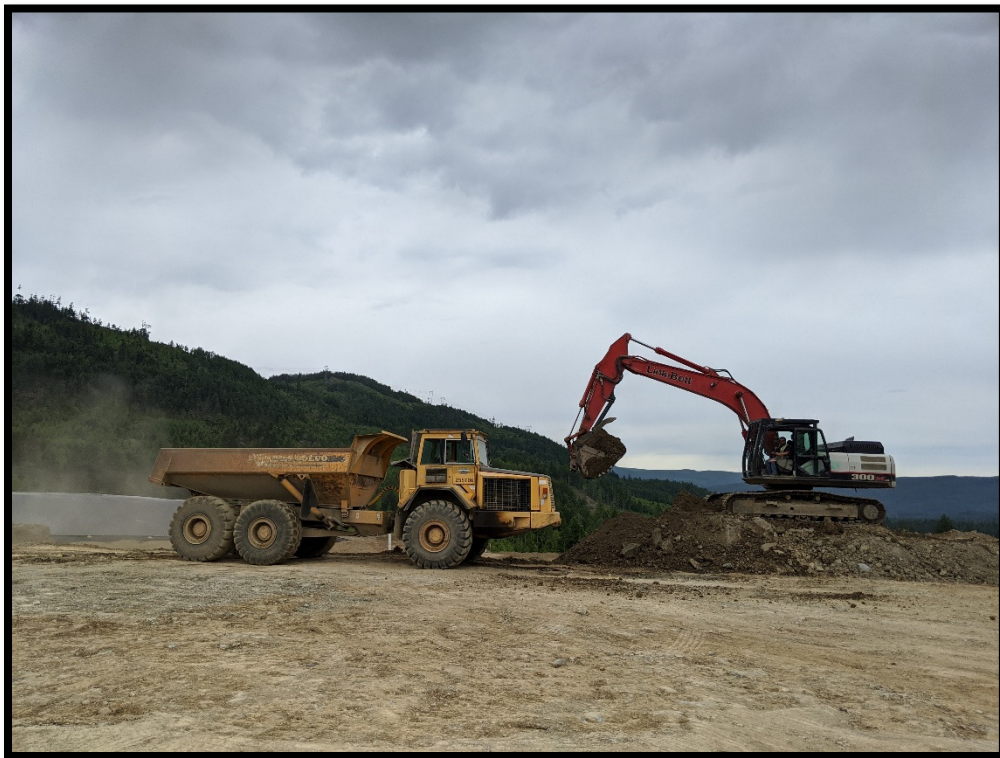
**Picture # 4:** Loading previously stockpiled soils from east of the PEA.

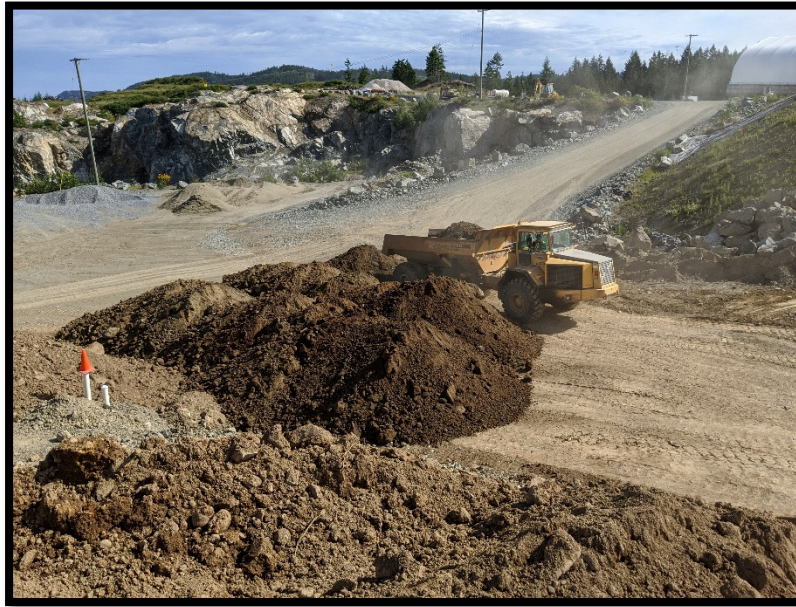
**Picture # 5:** Dumping of previously stockpiled soils at north east corner of PEA.

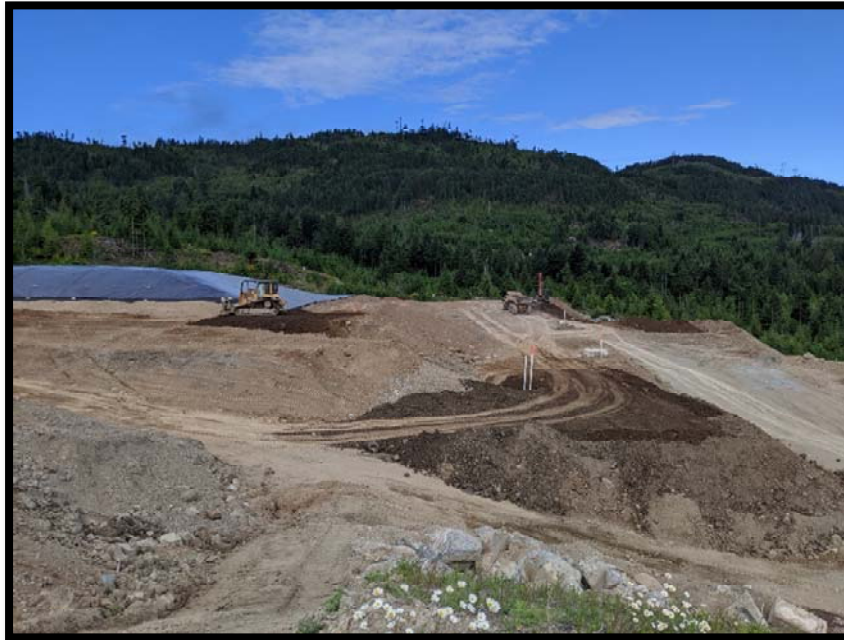
**Picture # 1:** Overview of construction progress, looking west. Previously stockpiled material on the north side of the PEA (excavator to right of the image) was hauled over to the east side of the PEA (bulldozer to the left of the image).

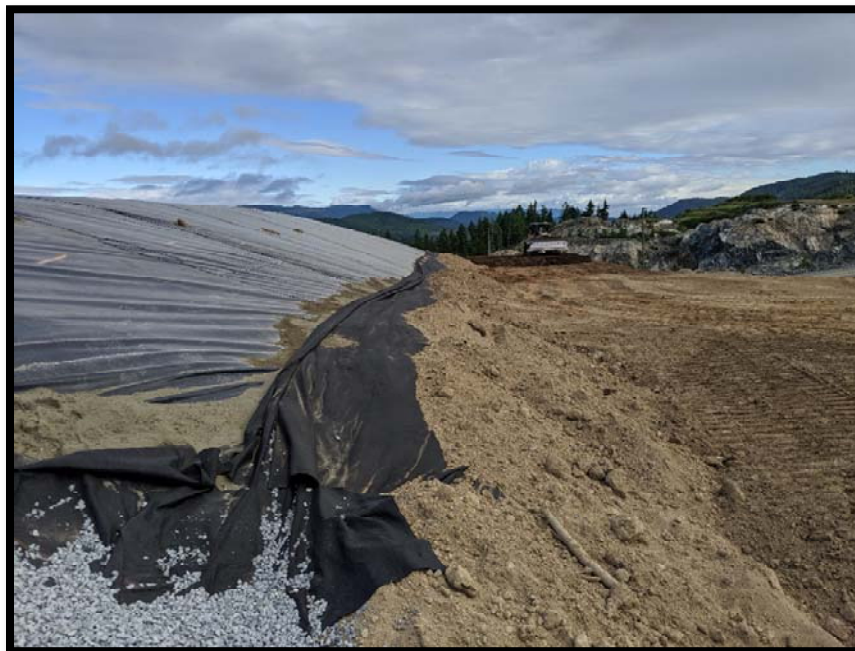
**Picture # 2:** Looking northwest along the east side of PEA towards the bulldozer pushing out material.

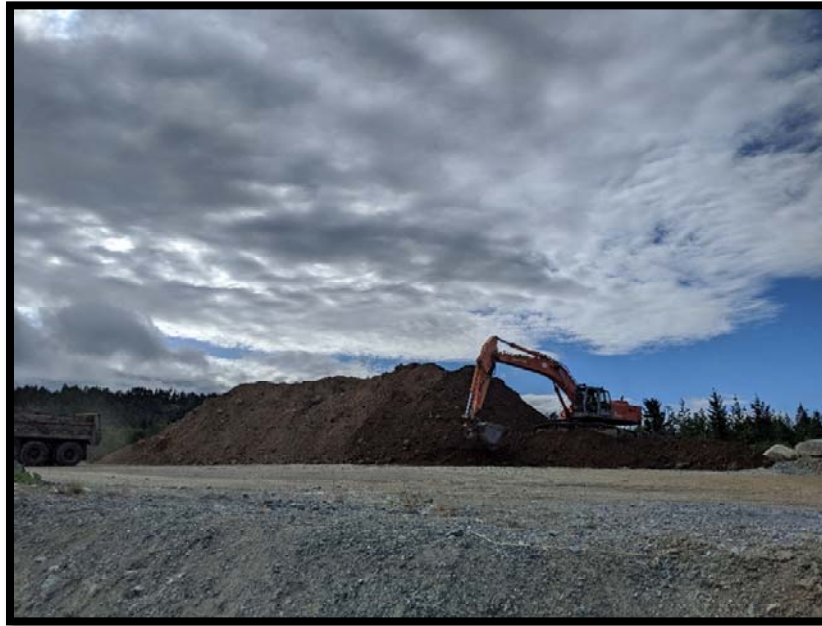
**Picture # 3:** Looking south from the south side of the PEA towards an excavator stockpiling imported capping material at the southeast corner of the site. Capping material was imported and stockpiled throughout the day.

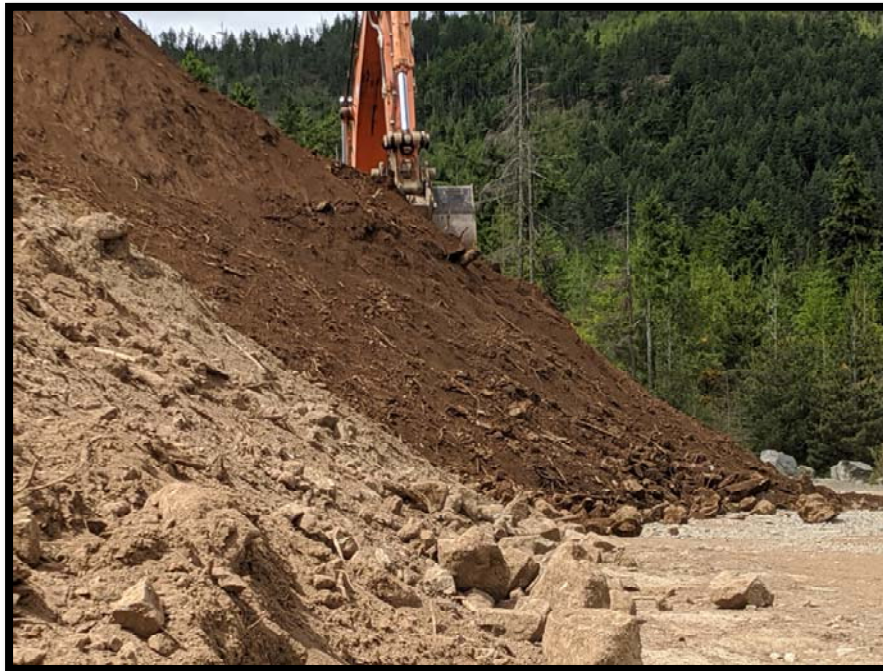
**Picture # 4:** View of the imported soil capping material. Some larger rocks and roots are present in the capping material. Contractor informed Islander (Joel Clarkston) that they will be removed prior to final placement.

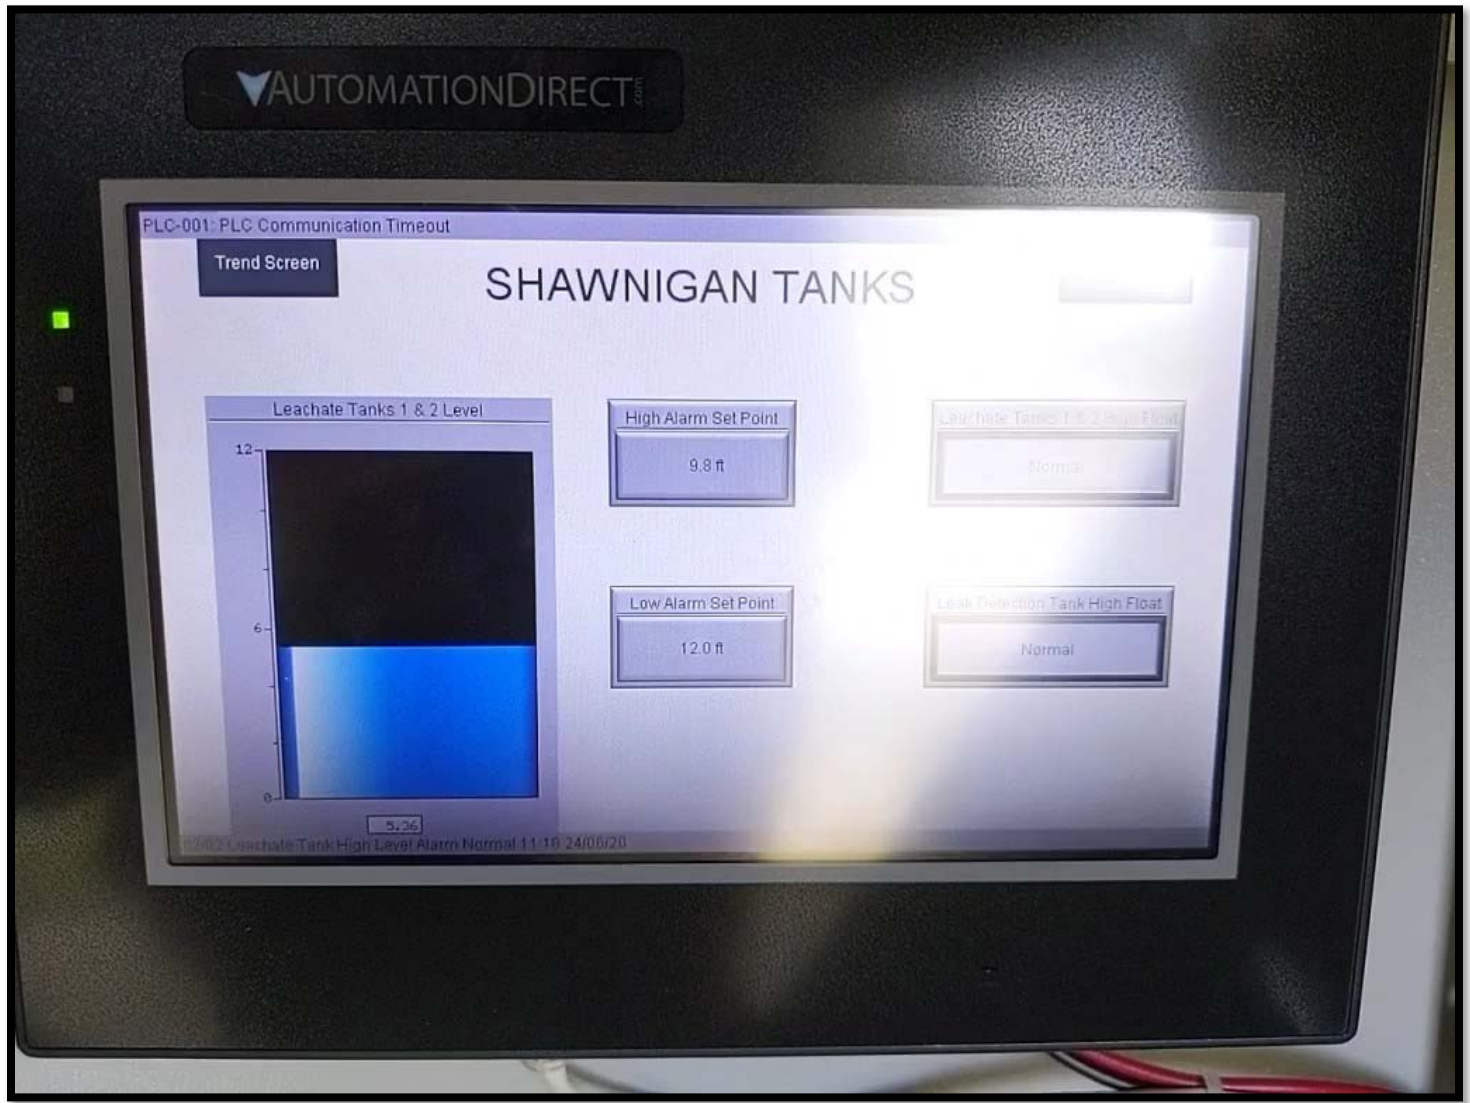
**Picture # 5:** Leachate display – 5.36 ft per tank.

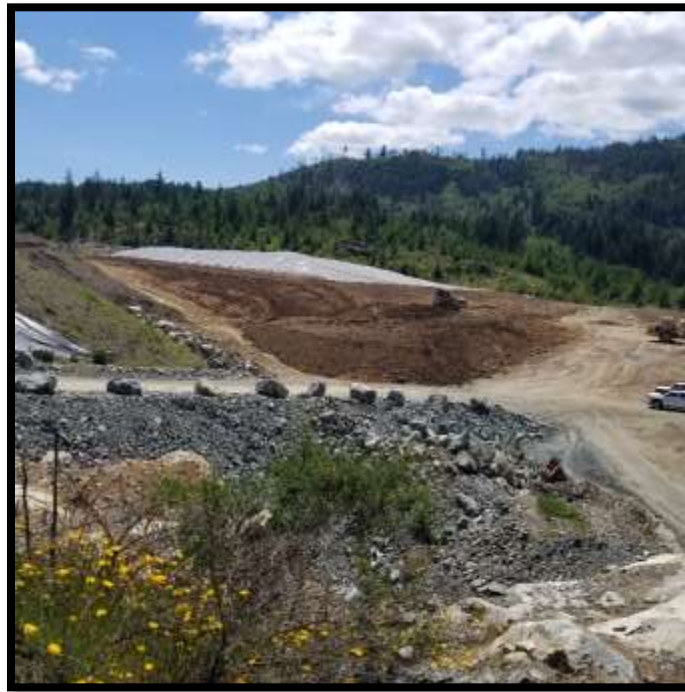
**Picture # 1:** Site – Looking Southwest – Site Soil Placement

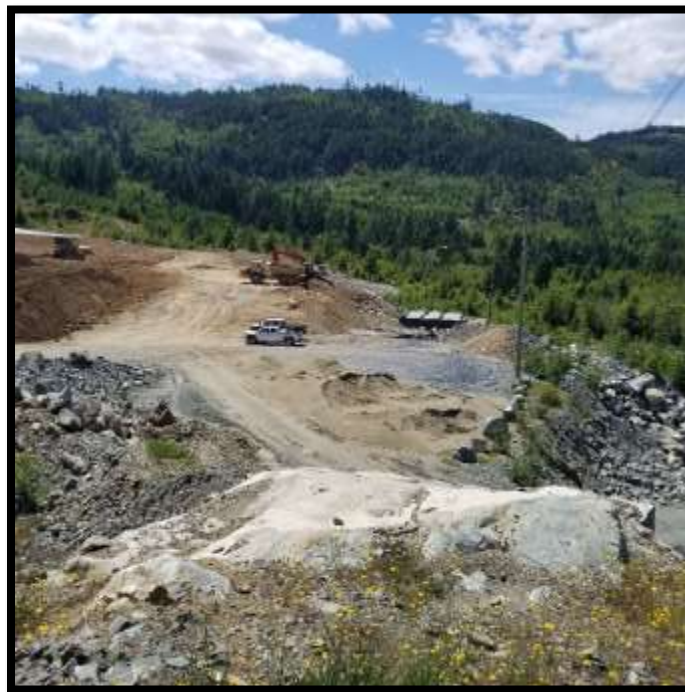
**Picture # 2:** Site – Looking West – Leachate Facility

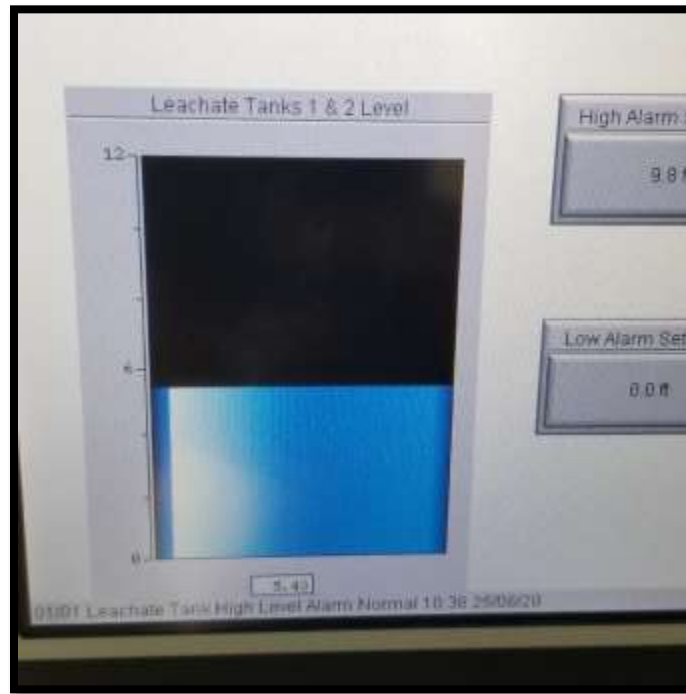
**Picture # 3:** Leachate Display – 5.43ft per tank
