From: spomo1701@outlook.com [<mailto:spomo1701@outlook.com>]
Sent: Tuesday, January 2, 2018 7:23 AM
To: Environmental Compliance ENV:EX; marty@chholdings.ca
Subject: SPO MO1701-Status Update December 30, 2017

| FIELD REVIEW REPORT | | DATE: Dec 26 2017 | | ISLANDER PROJECT No.: 2087 | |
| REPORT No: 11 | STAGE OF CONSTRUCTION: Landfill Closure | | WEATHER: Cloudy 1 deg | | PAGE: 1 of 3 |
| PROJECT: Cobble Hill Landfill 2017 Minor Construction Works | | | | | |

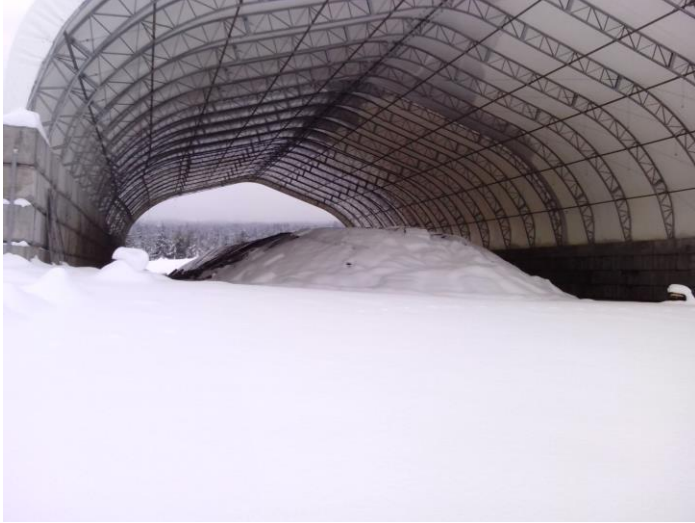
SMA - liner – looking south

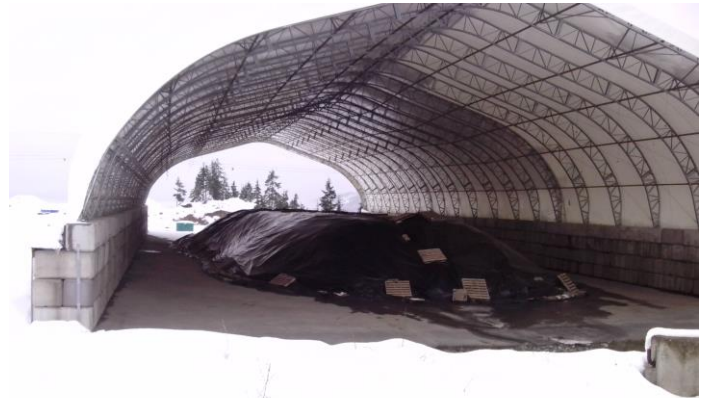
SMA – looking north

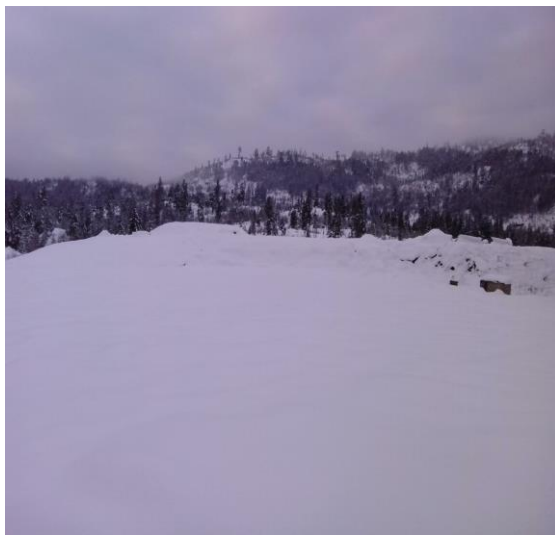
Contact water containment Pond

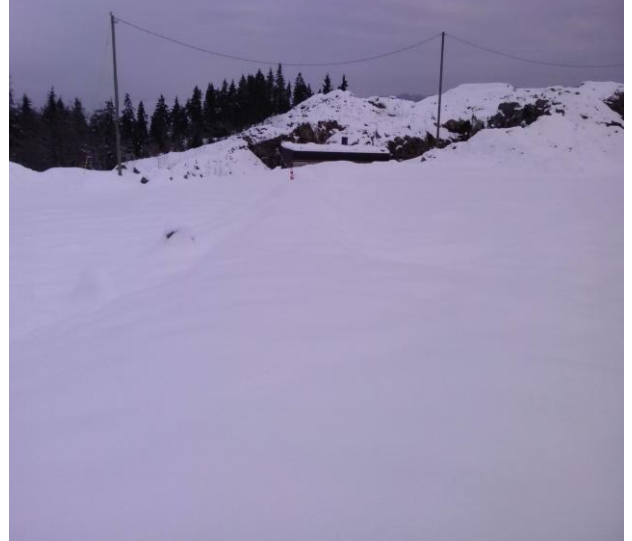
Pipe trenching and Leachate and Leak Detention facility

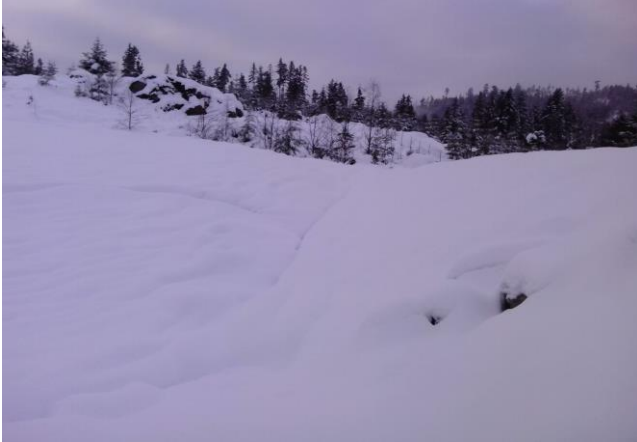
- **PEA**
 - *Liner appears to be in good condition. Snowy conditions did not allow a thorough review of PEA however based on historical inspections we do not expect to have any issues of concern.*
- **Leachate and Leak Detention facility**
 - To be reported on separate cover by others
- **Soil Management Area (SMA)**
 - All works are in good condition and no noticeable changes since the date of our last inspection
- **Contact Water Containment Pond**
 - All works are in good condition and no noticeable changes since the date of our last inspection
- **cut-off ditch upland of PEA**
 - This ditch is frozen and full of snow. Appears to be performing as intended

PEA – liner near NW corner

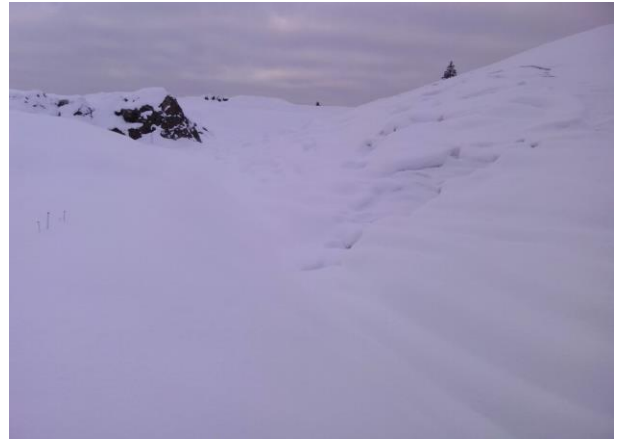
PEA– NE corner

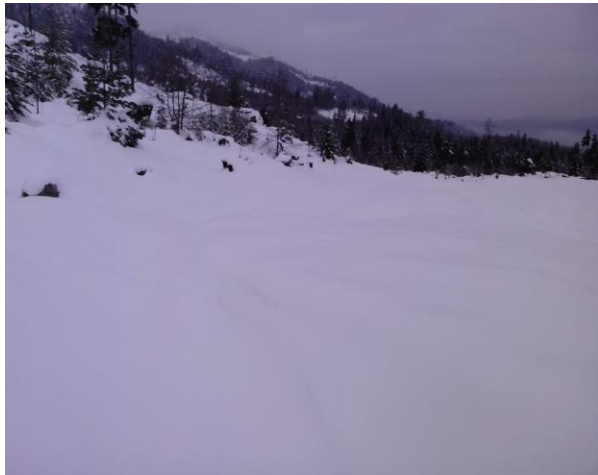
Cut-off ditch upland of PEA

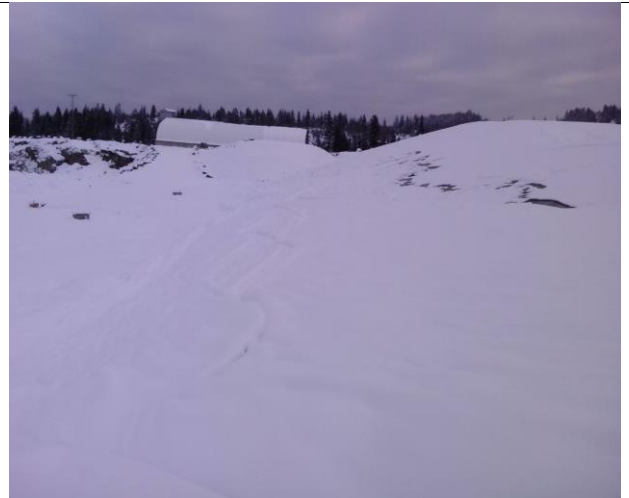
PEA north face
