TO: British Columbia Ministry of Transportation and Infrastructure
FROM: WSP Canada Group Ltd.
SUBJECT: Island Rail Corridor– Preliminary Rockfall Assessment Memo
DATE: December 5, 2019

SCOPE OF WORK

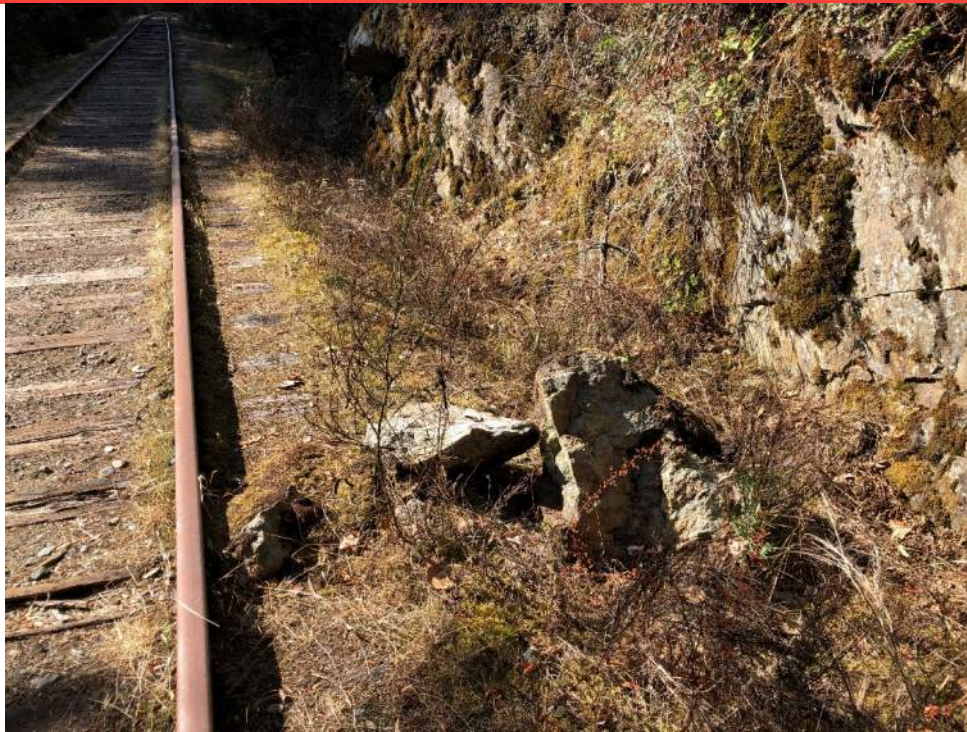
14.35 (Photo 3)	Cut rock face typically 4-6m high on west side of track. Irregular blasted sub-vertical face.
14.41	Cut rock face typically 7-9m high on west side of track. Irregular blasted sub-vertical face.

Photo 3:
Mile 14.35 rock in
ditch.

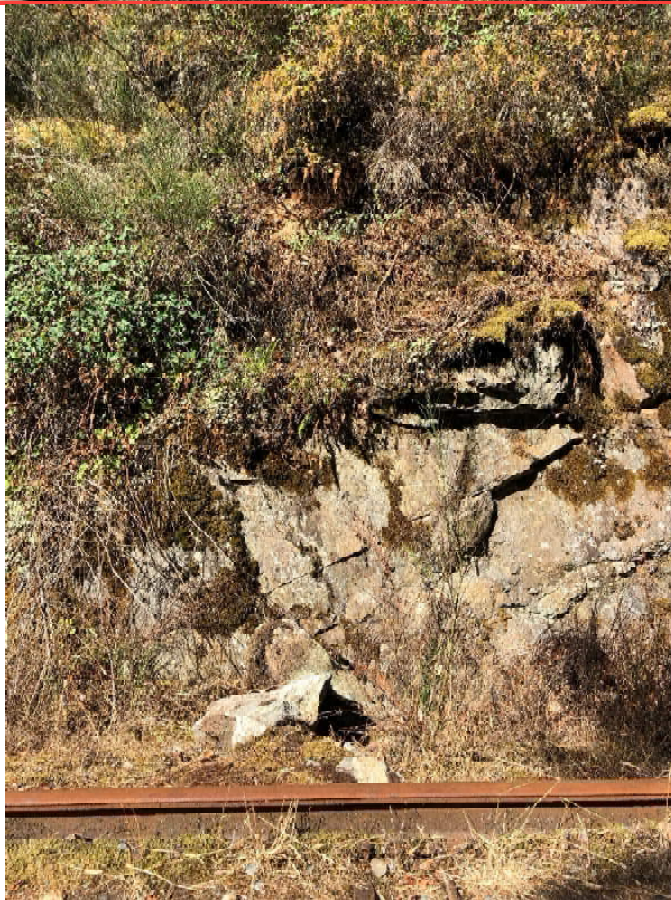
14.75	Cut rock face typically 8-10m high on west side of track. Irregular blasted sub-vertical face.
14.85 (north trestle) (Photo 4)	Cut rock face typically 4-6m high on west side of track. Irregular blasted sub-vertical face.
15 (Photo 5)	Cut rock face up to around 20m high on west side of track. Irregular blasted sub-vertical face. Some fallen rock observed at side of track.

Photo 4:
Mile 14.85 fallen
rock.

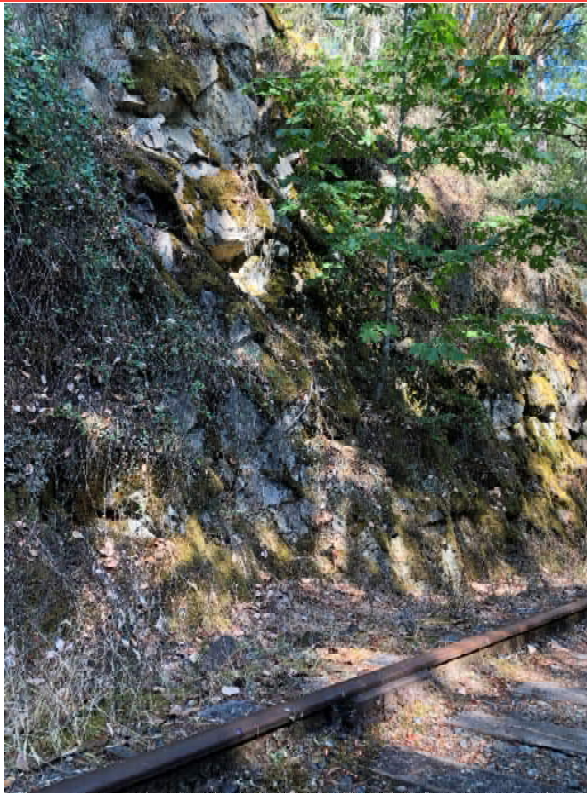
Photo 5:
Mile 15.

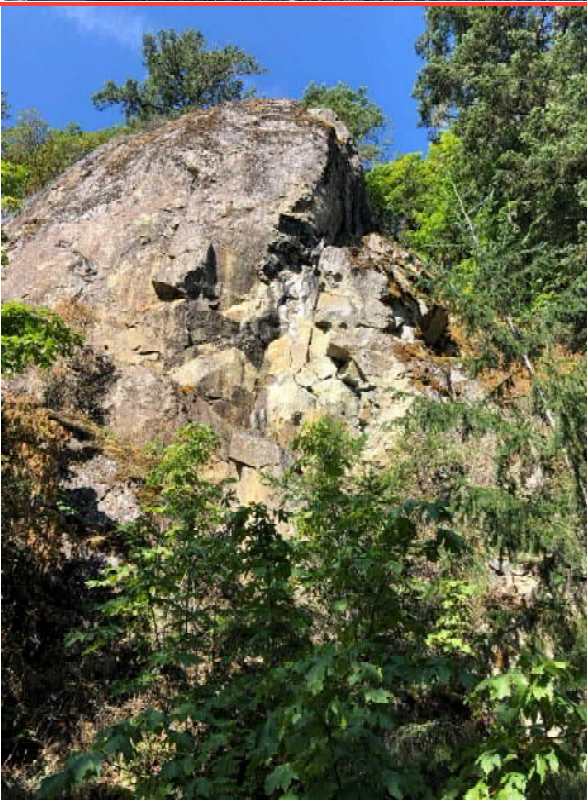
15.2 (Photo 6, 7, 8, 9)	Cut rock face up to around 20m high on west side of track. Irregular blasted sub-vertical face. Some existing mesh hanging on south side of exposure.

Photo 5:
Mile 15.2 (approx.
20 m high).

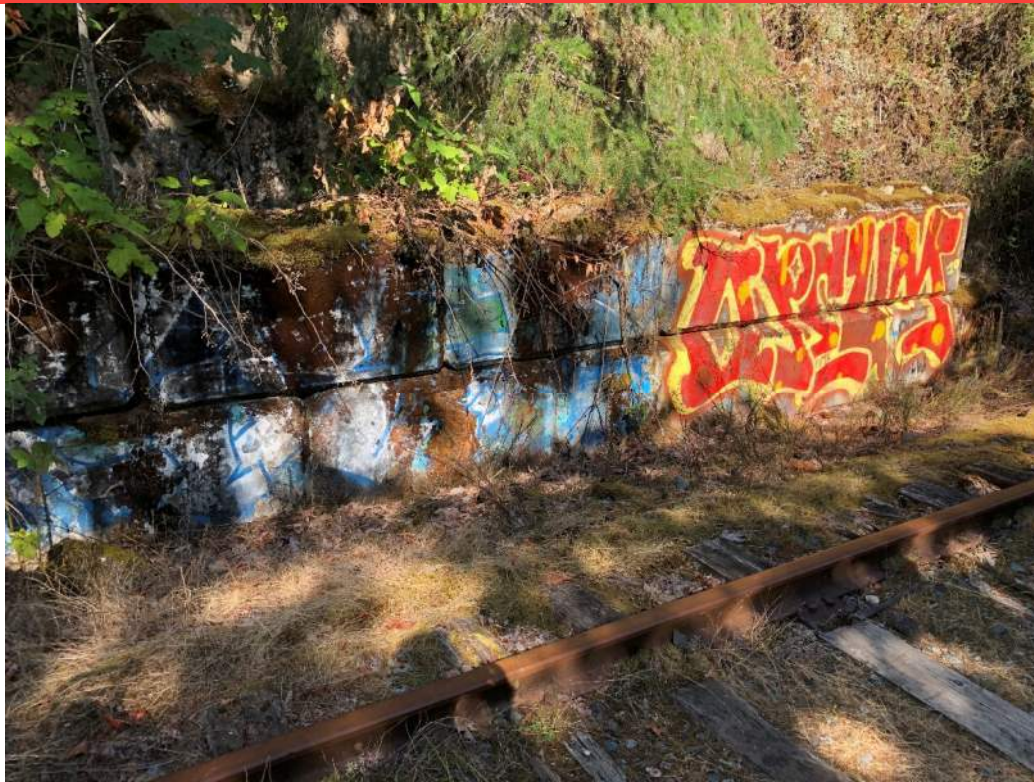
Mile/Photo No.	Rockfall Hazard Observation
	Large fracture noted on north side of exposure. Lock block wall noted at base along west side of track (probable historical rockfall mitigation) NOTE – potential hazard receptor downslope is Highway 1.

Photo 7:
Lock blocks at
mile 15.2.

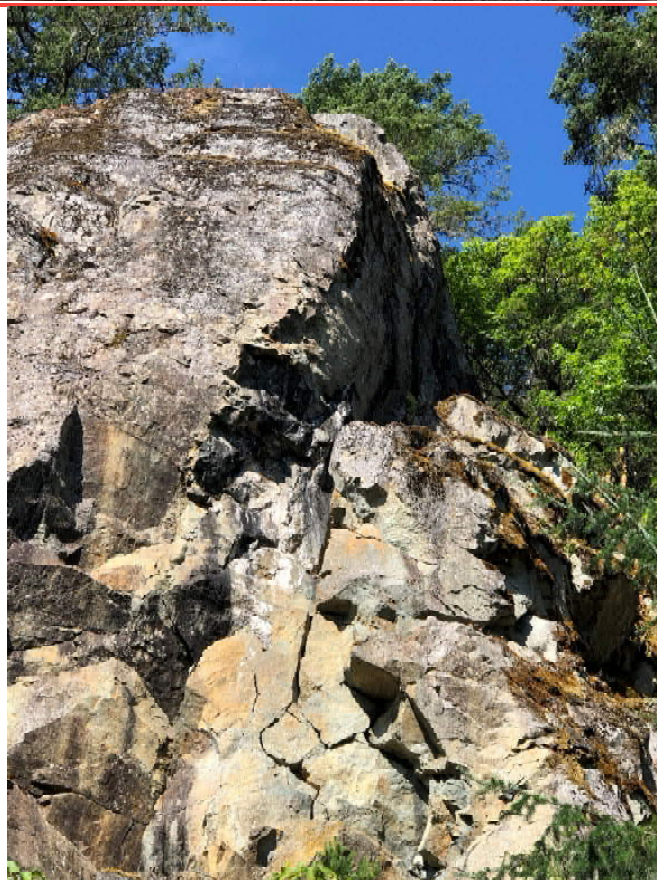
Photo 8:
Close up of rock
fracture at mile
15.2.

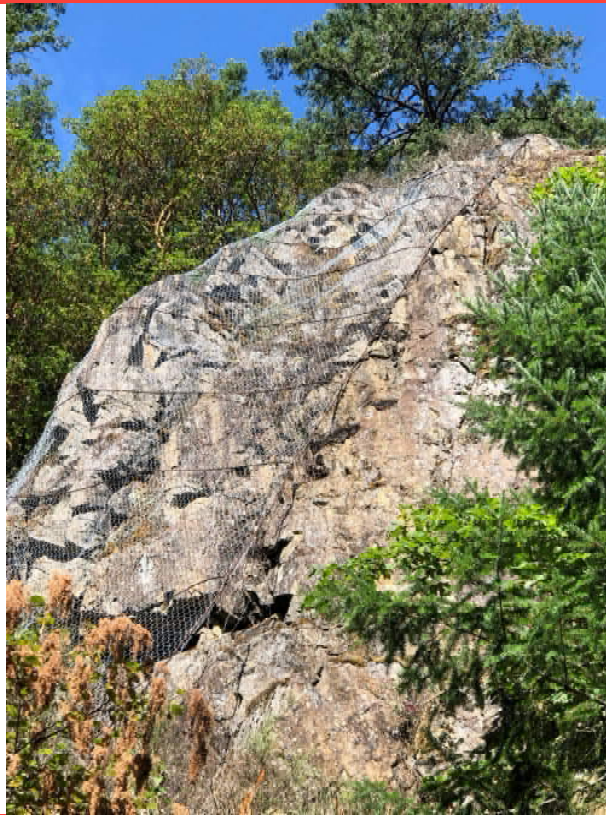
Photo 9:
Existing mesh
on South side of
rock face at mile
15.2.

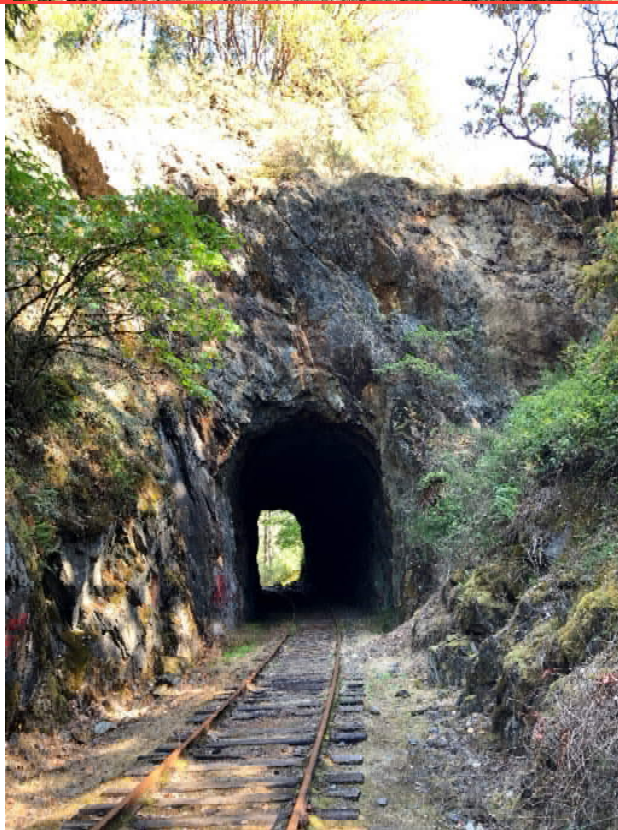
15.6 (tunnel south) (Photo 10, 11, 12, 13)	Entrance to tunnel – typically 15-20m high – steeper on west side. Cut rock face blasted, irregular, sub-vertical. Some fallen rock noted at side of track.
Tunnel Roof (Photo 14)	In general, the rock surface was irregular with significant staining and appeared in reasonable condition with localised areas where some scaling would be required. No significant cracks, joints or loose rock were observed.

Photo 10:
Tunnel entrance
South (looking
North).

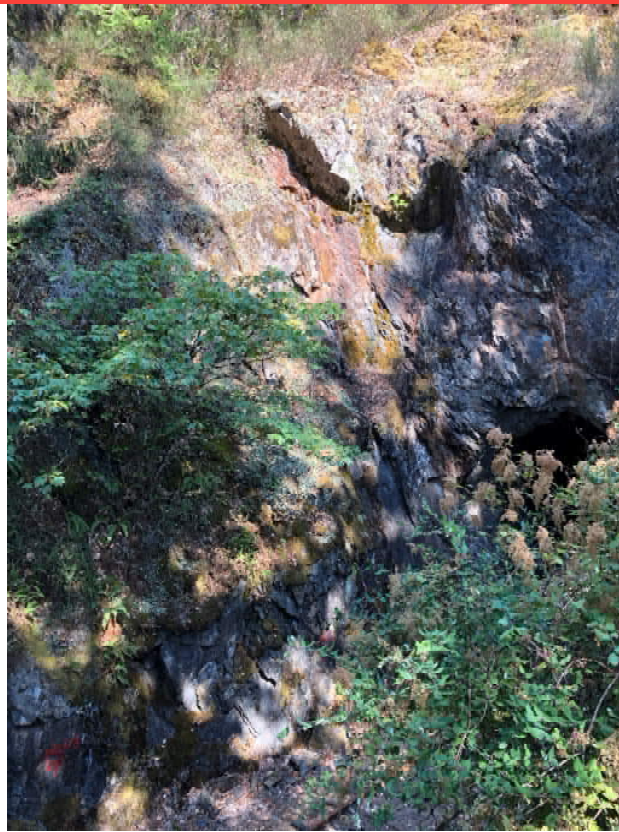
Photo 11:
Rock above
tunnel entrance
South.

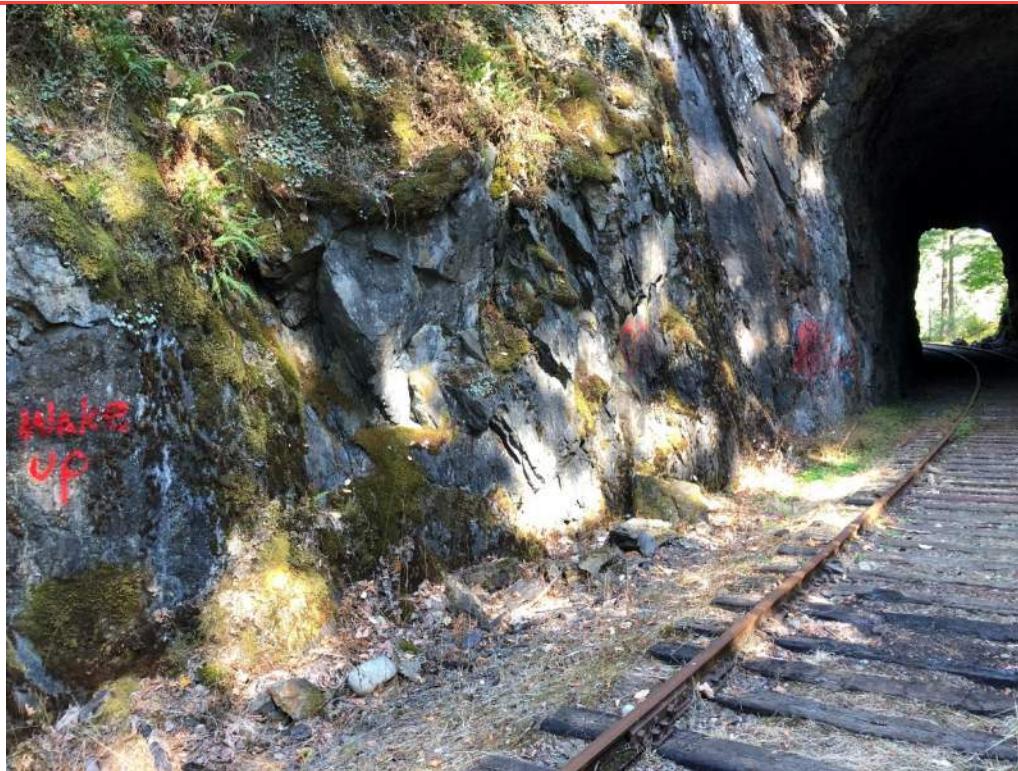
Photo 12:
Fallen rock
adjacent to
Tunnel entrance
South.

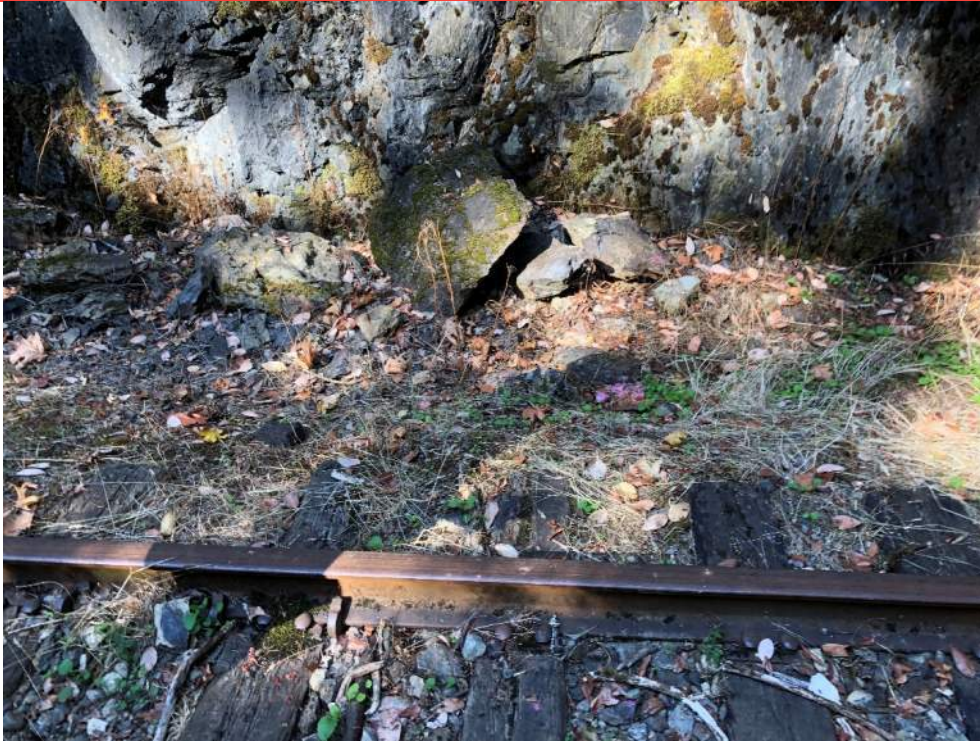
Photo 13:
Fallen rock at
tunnel entrance
South.

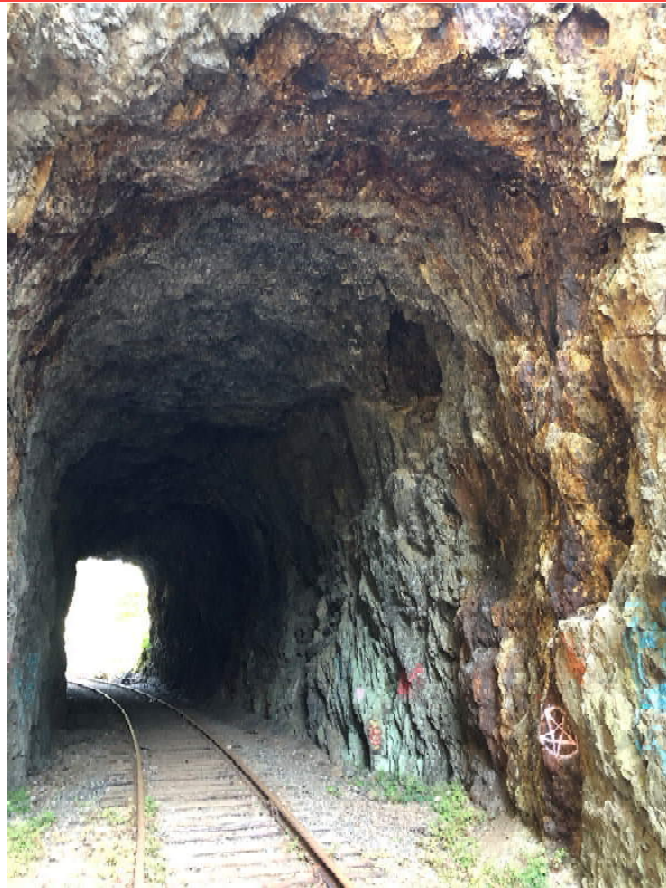
Photo 14:
Tunnel roof.

For the rock tunnel on the Malahat we have provided some general comments on our visual review, however a detailed assessment of the tunnel structure would be required prior to resuming operations.

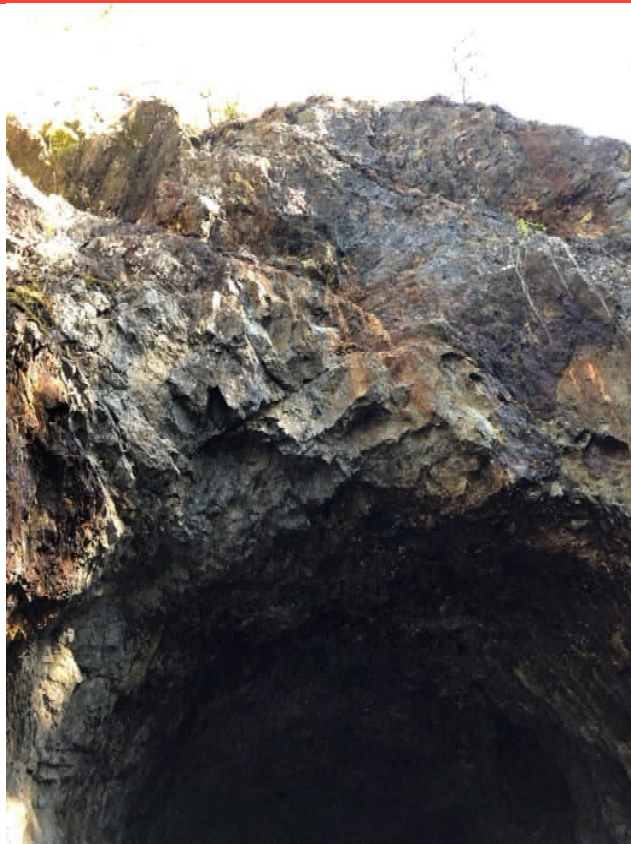
15.7 (tunnel north) (Photo 15,16,17,18)	Entrance to tunnel – typically 20-30m high with a slight bench noted above the tunnel entrance – steeper on west side. Cut rock face blasted, irregular, sub-vertical. Some fallen rock noted at side of track.

Photo 15:
Above tunnel
entrance North.

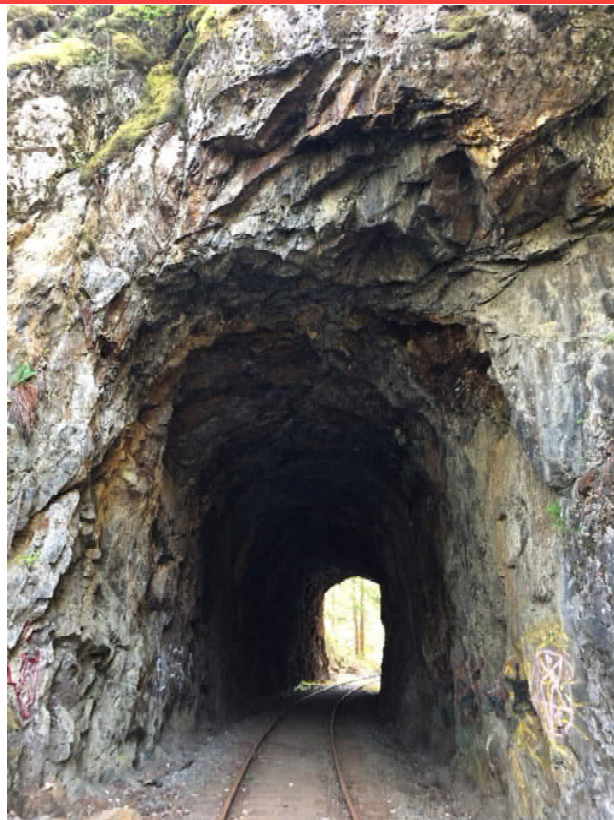
Photo 16:
Tunnel entrance
North (looking
South).

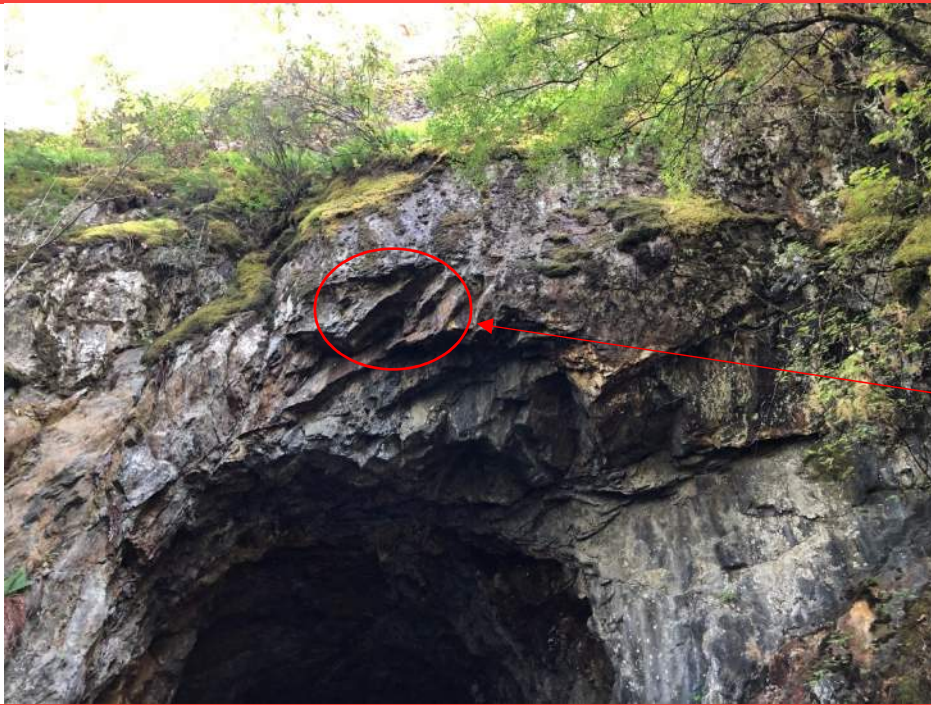
Photo 17:
Rock structure
above tunnel
entrance North
(note recent
wedge failure).

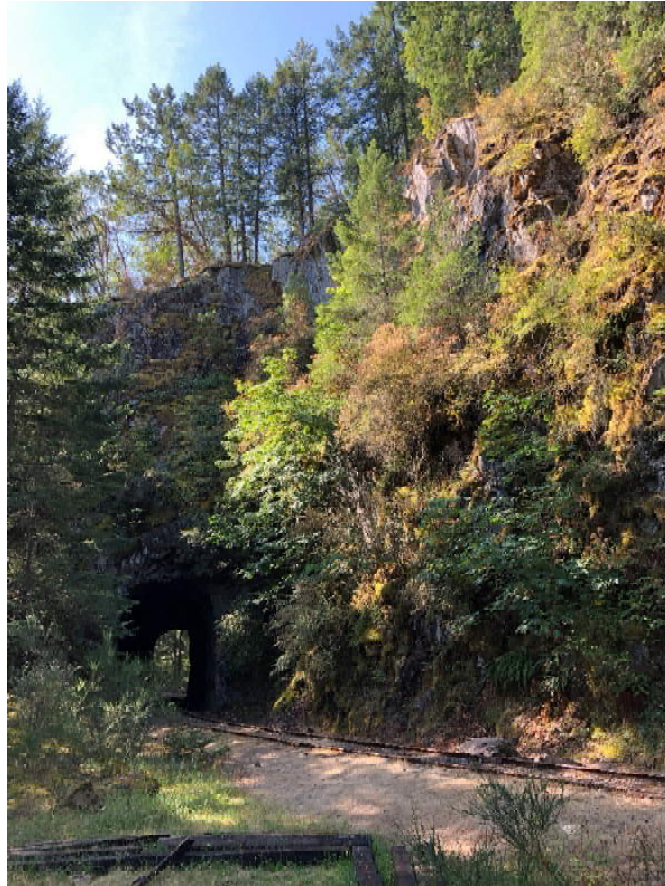
Photo 18:
General view
South of tunnel
entrance North
(approx. 30 m
high).

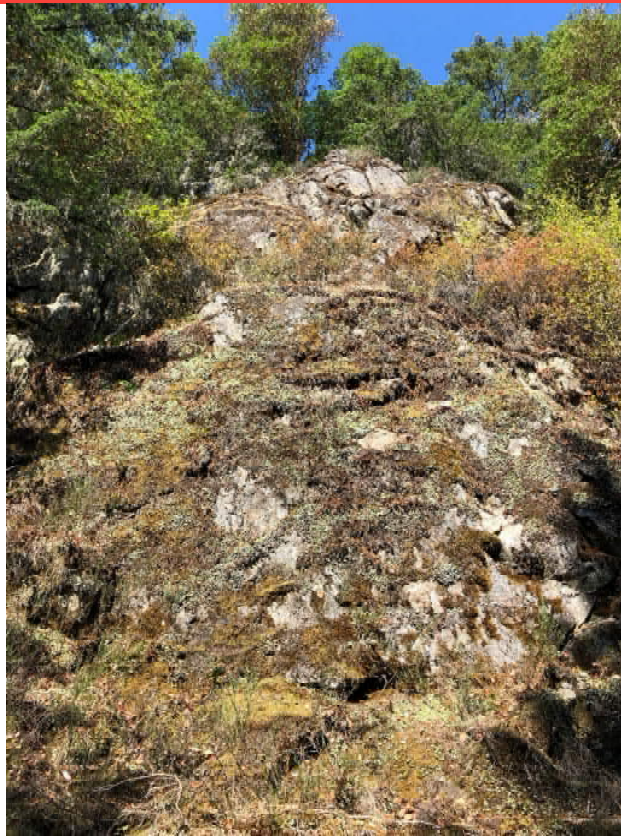
16.2 (Photo 19, 20, 21)	Cut rock face typically 15- 20m high on west side of track. Irregular blasted sub-vertical face. Some fallen rock observed at side of track.

Photo 19:
Rock face at
mile 16.2 approx.
20 m high.

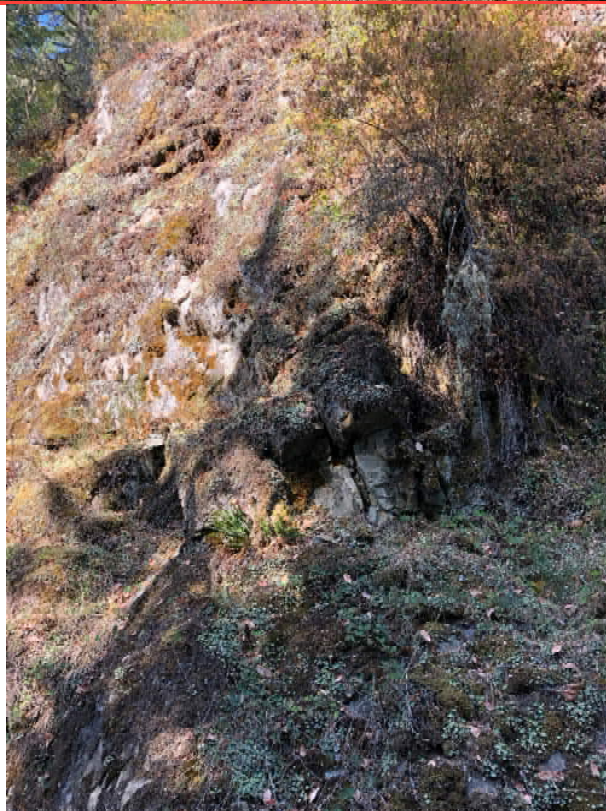
Photo 20:
Loose rock at
mile 16.2.

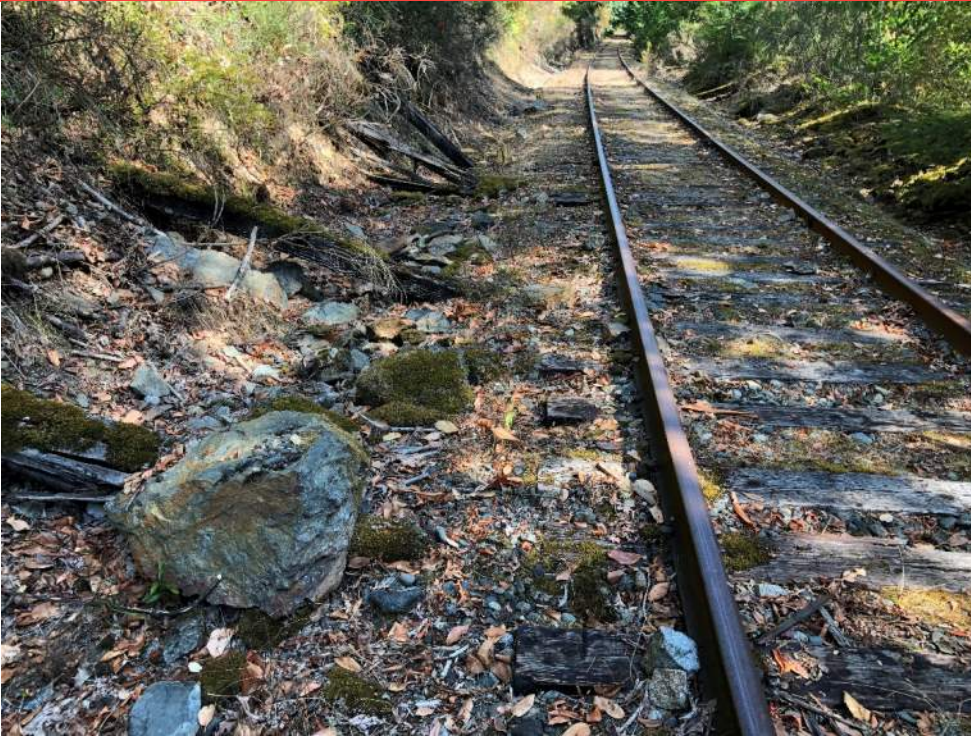
Photo 21:
Mile 16.2 fallen
rock.

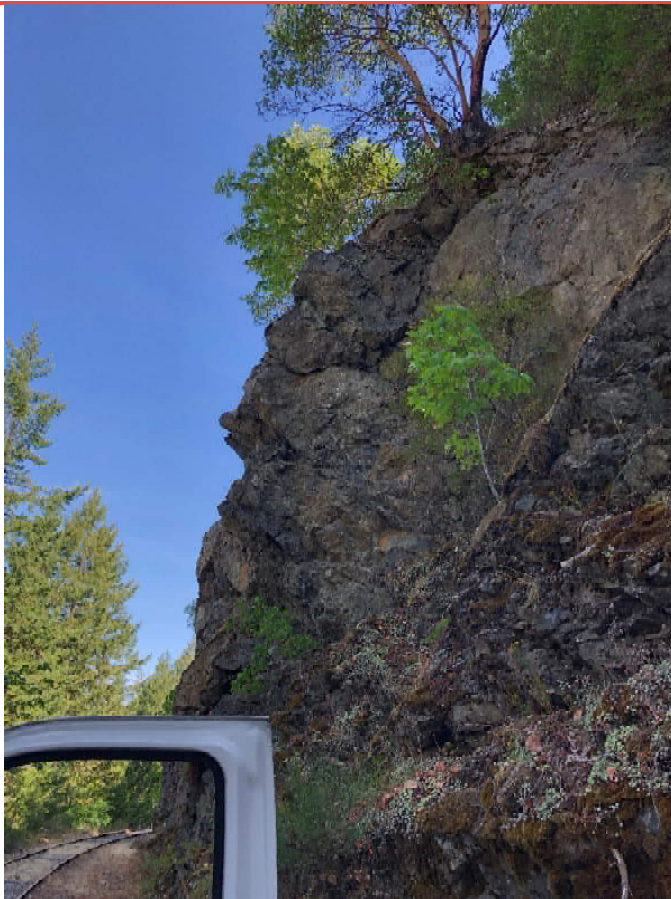
20.9	Approach to Shawnigan crossing – typically 6-8m high on east side of track. Irregular blasted sub-vertical cut face.
21.6 (Photo 22, 23)	North of Shawnigan crossing – typically 8-10m high on east side of track. Irregular blasted sub-vertical cut face. Occasional loose blocks and overhangs noted.

Photo 22:
Mile 21.6
fractural rock
and tree growth.

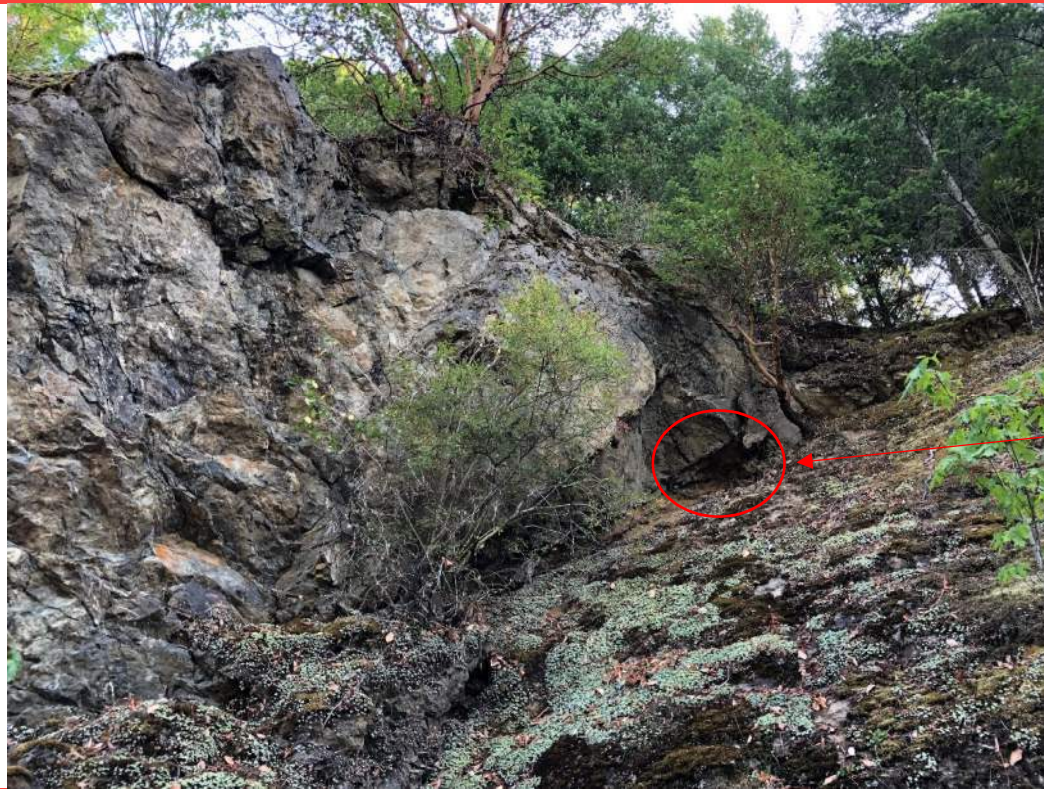
Photo 23:
Close up of rock
face at mile 21.6
(note recent
wedge failure).

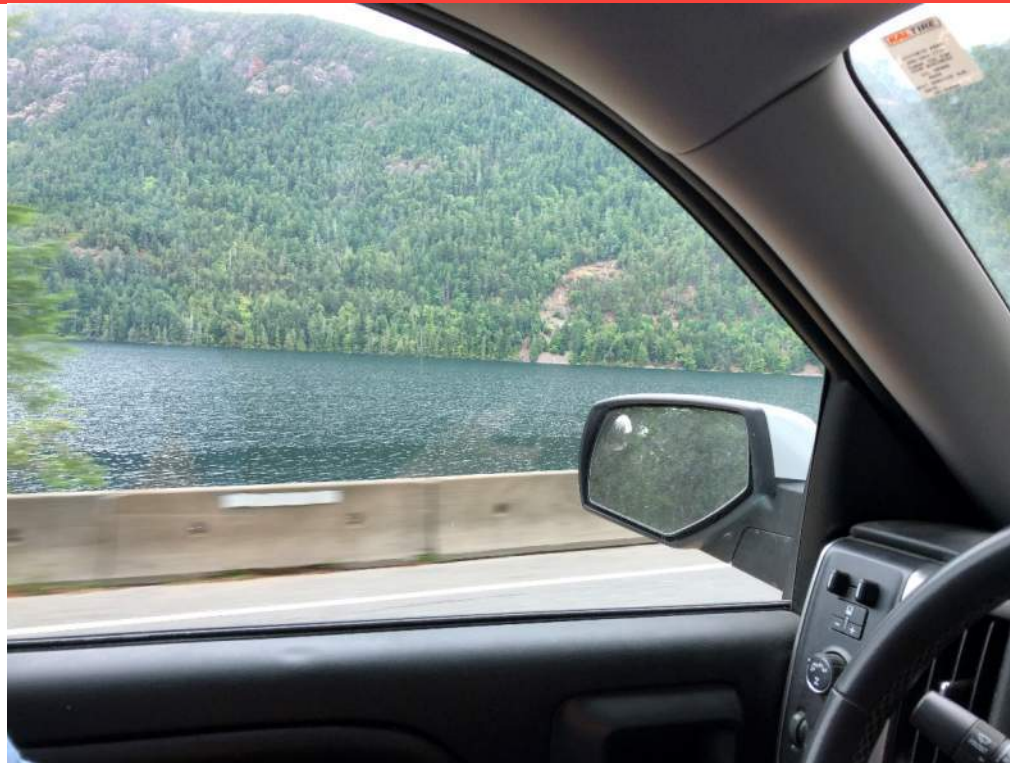
Photo 3:
Historic slide
area Approx.
co-ord.
49.296810 -
124.611607.

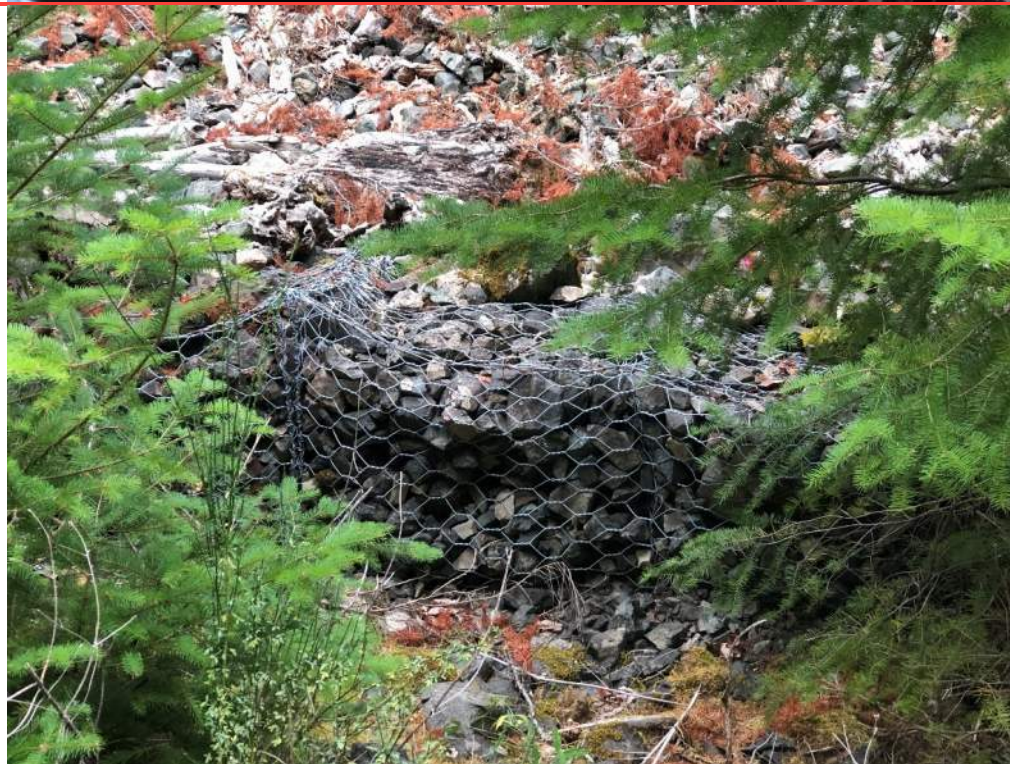
Photo 4:
Gabion baskets
at toe of slope
approx.
co-ord.
49.293110 -
124.589763.

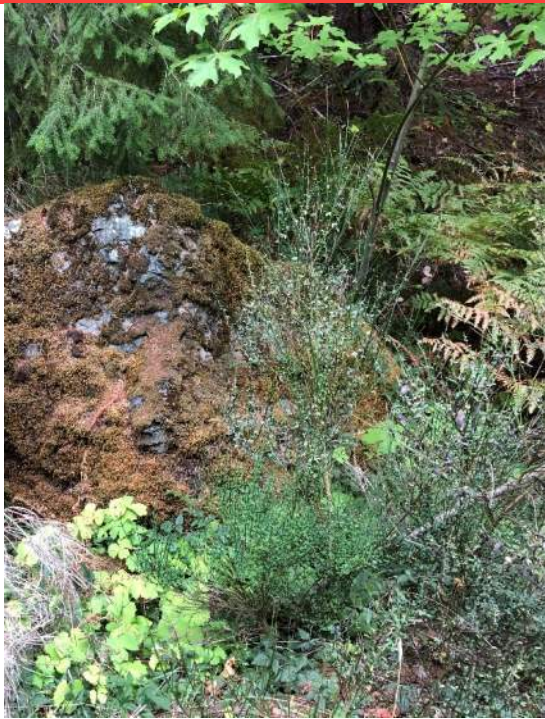
Photo 5:
Fallen boulder
beside track.

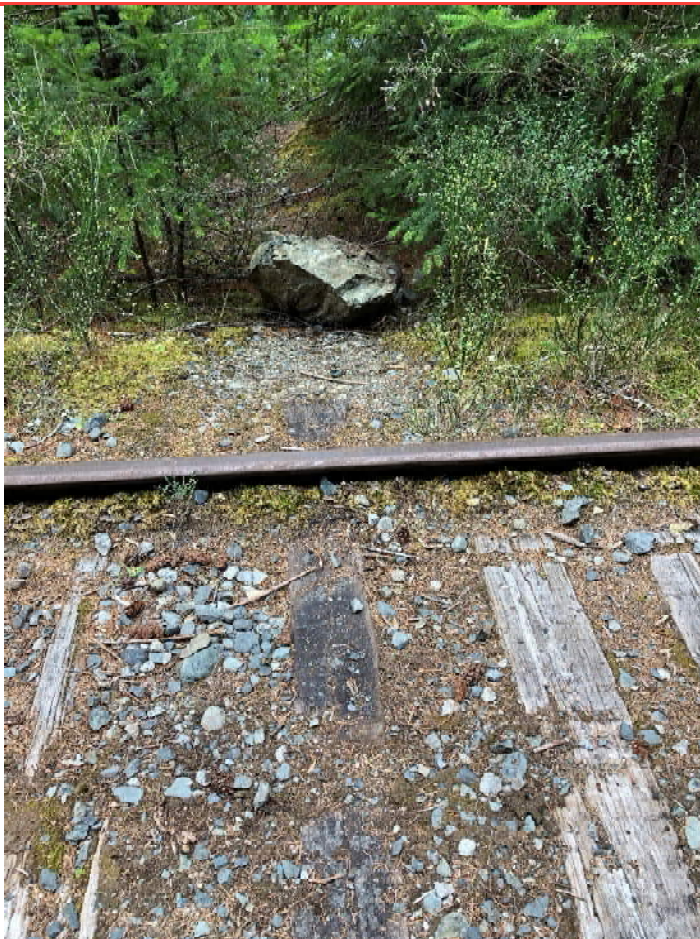
Photo 6:
Fallen boulder
beside track.

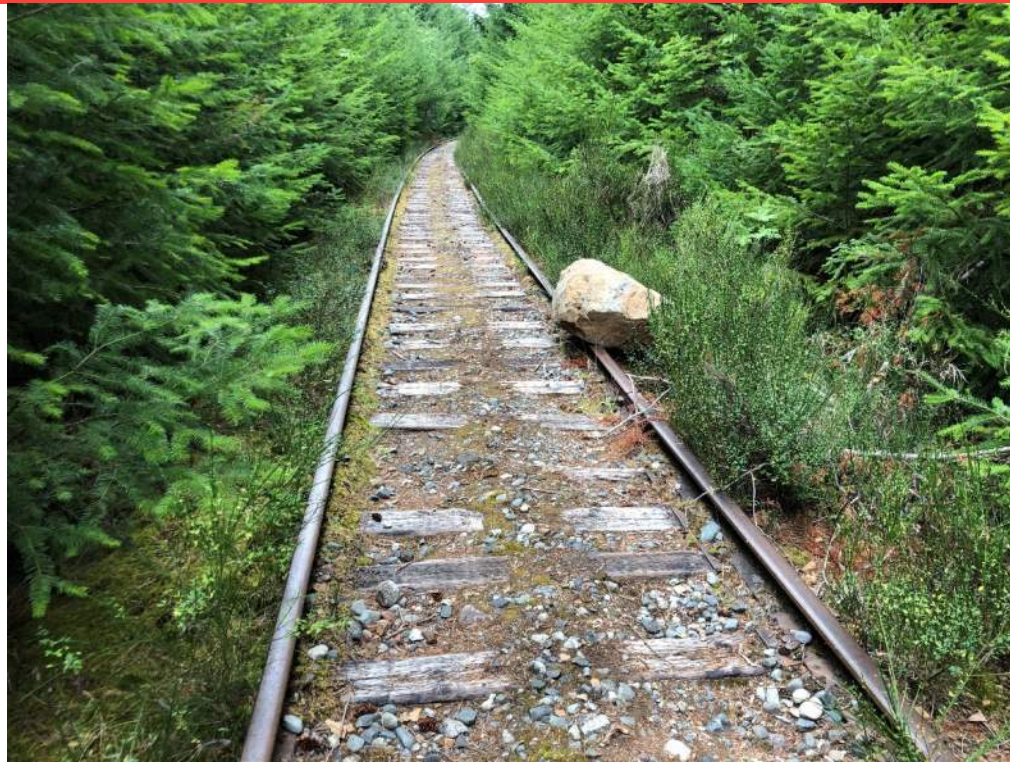
Photo 7:
Fallen rock on
track.

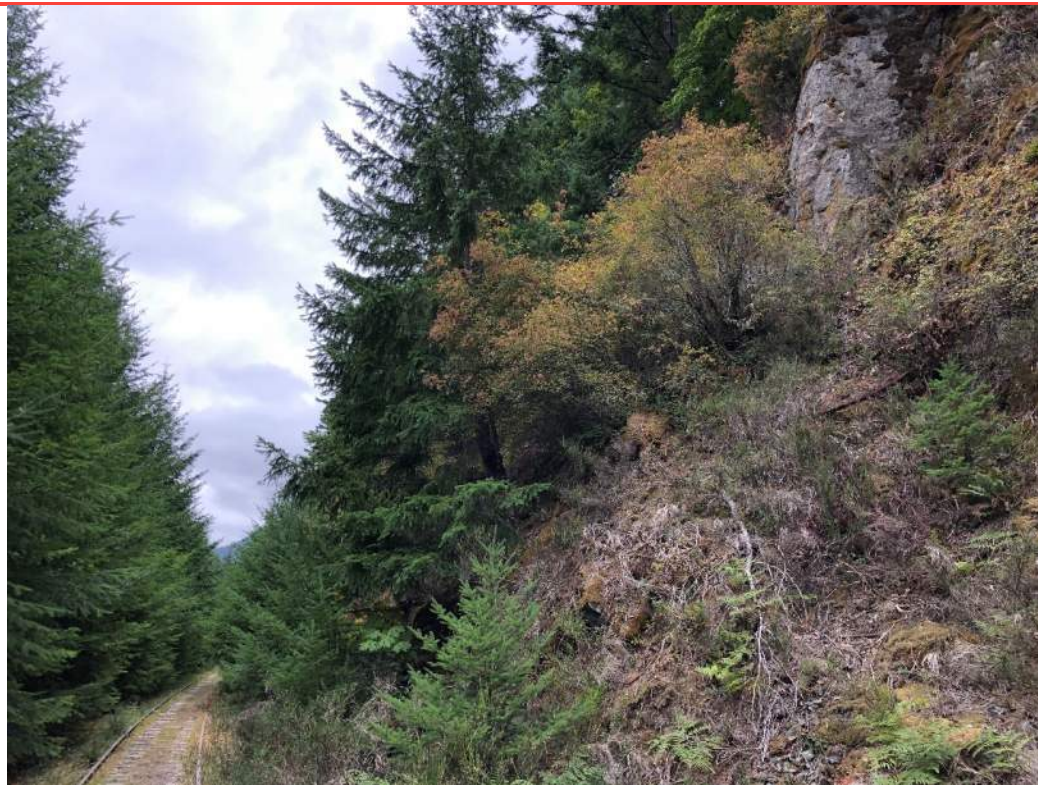
Photo 8:
Rock cut above
track.

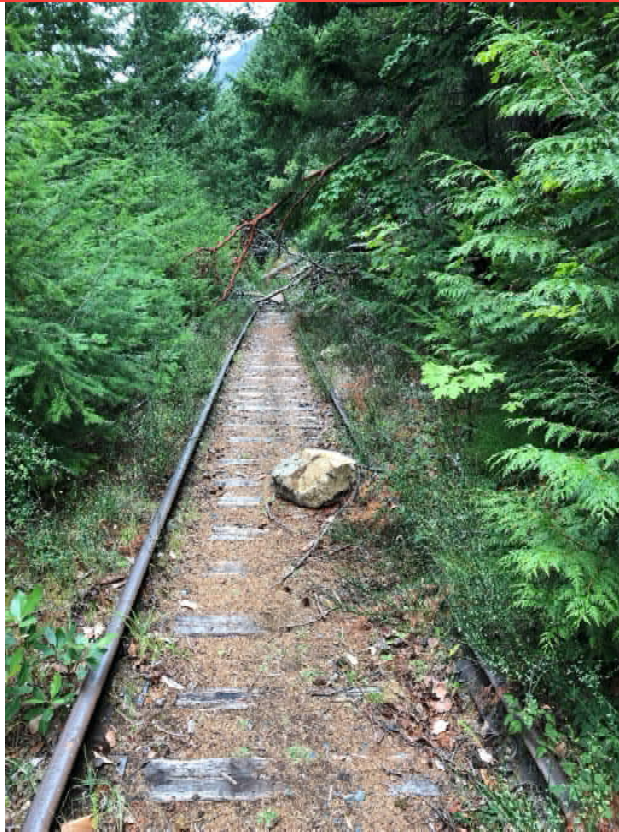
Photo 9:
Fallen rock on
track.

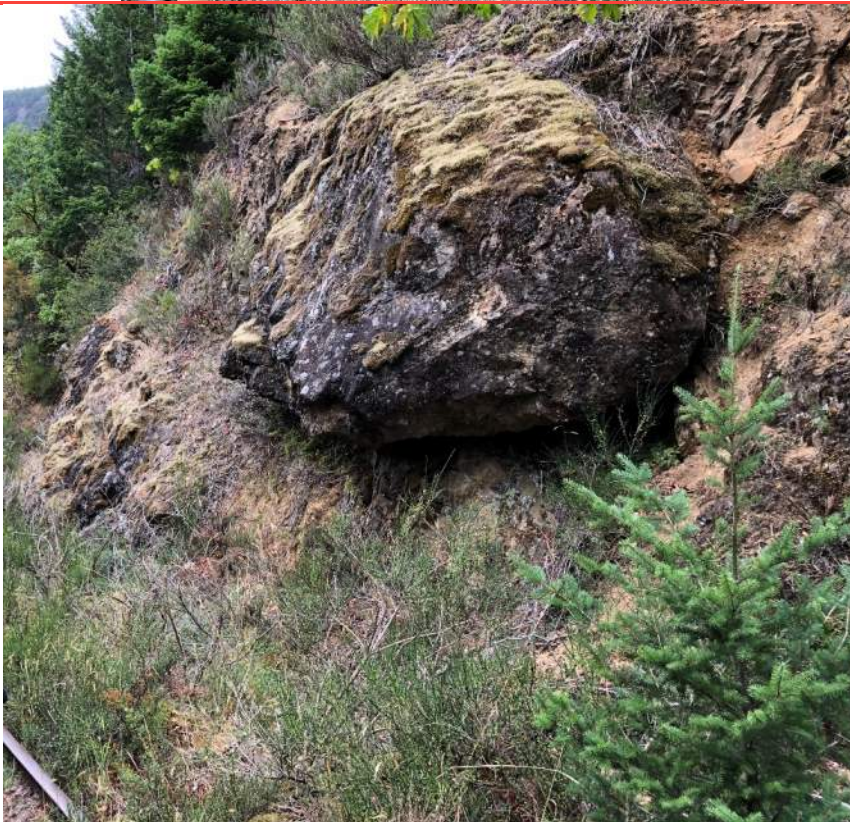
Photo 10:
Rock exposure
adjacent to
track.

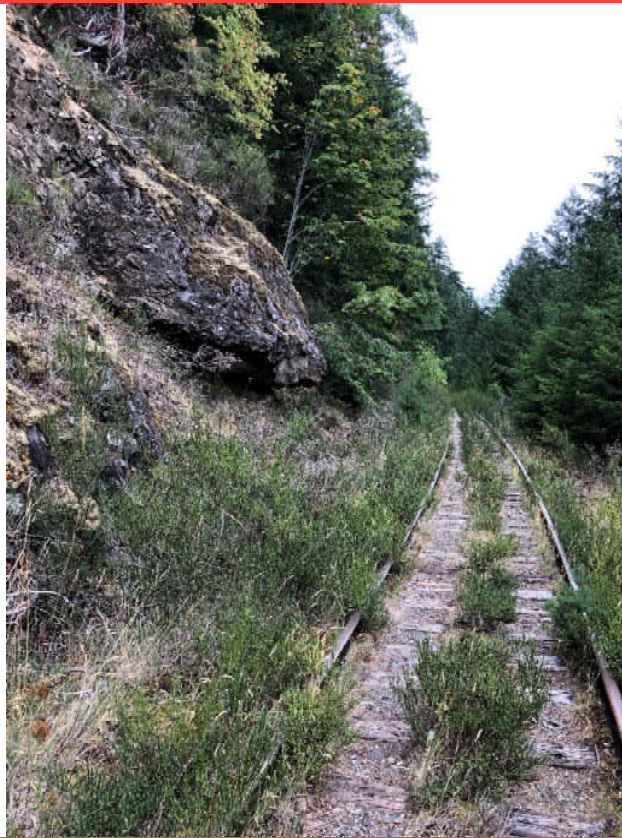
Photo 11:
Rock exposure
adjacent to
track.

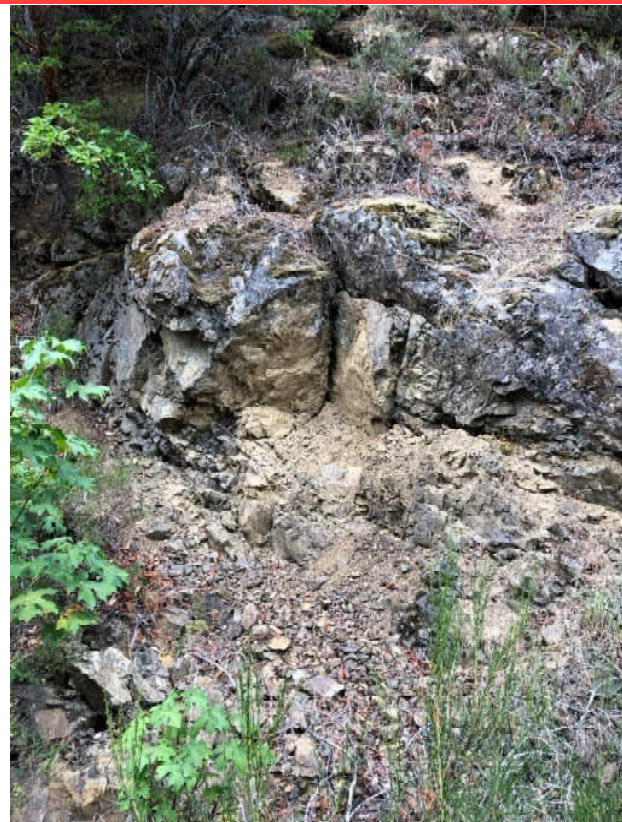
Photo 12:
Loose rock
above track.

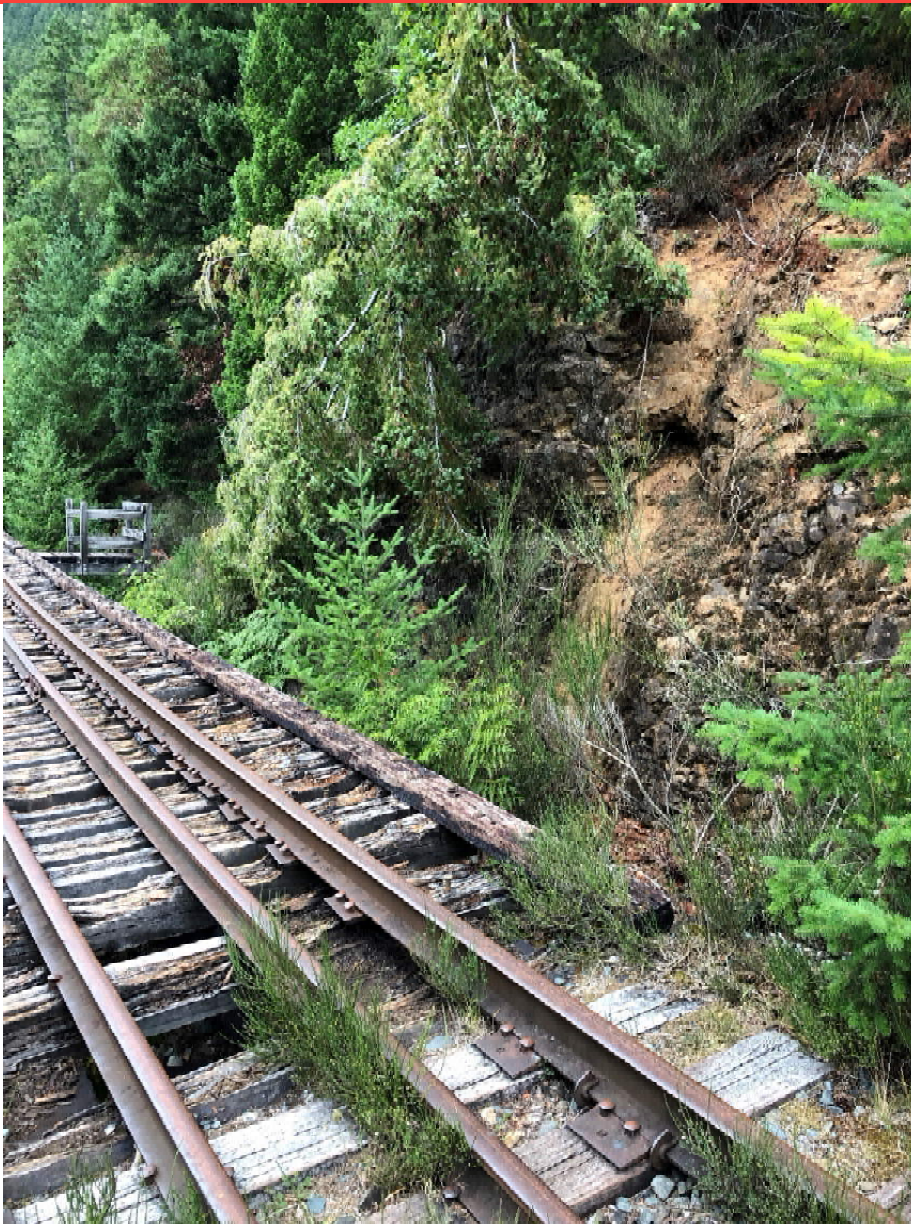
Photo 13:
Rock cut
adjacent to
east end of
trestle (first
trestle west of
the east end of
Cameron Lake).
