2016

Ministry of Forests, Lands
and Natural Resource
Operations

DETERMINATION OF UNIDENTIFIABLE BRIDGE COMPONENTS – K1629

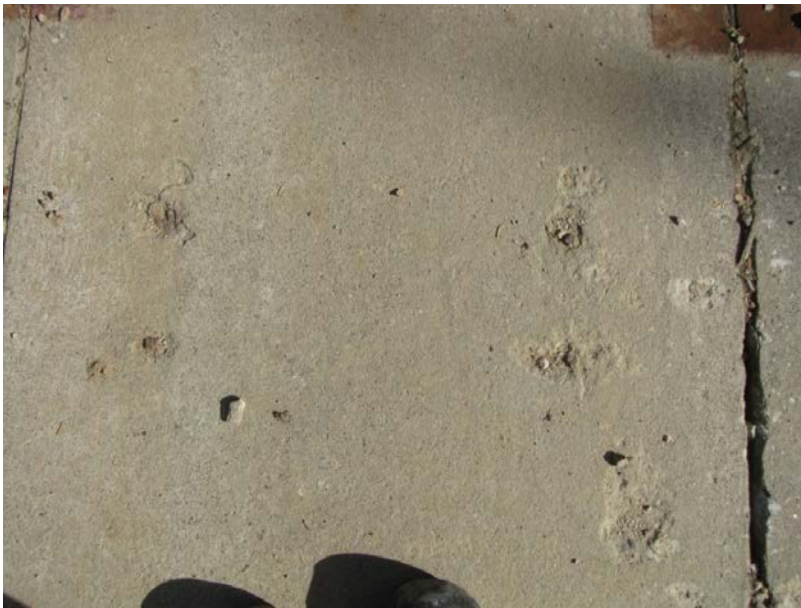
- Minor spall damage around formerly present lifting loops (Figure 2)
- Deck surface chipping damage likely from tracked equipment crossing(s) (Figures 3, 4)
- Significant leaning of left (woods) side abutment (Figures 5, 6)

Figure 2: Minor Spalling Around Pre-existent Loops

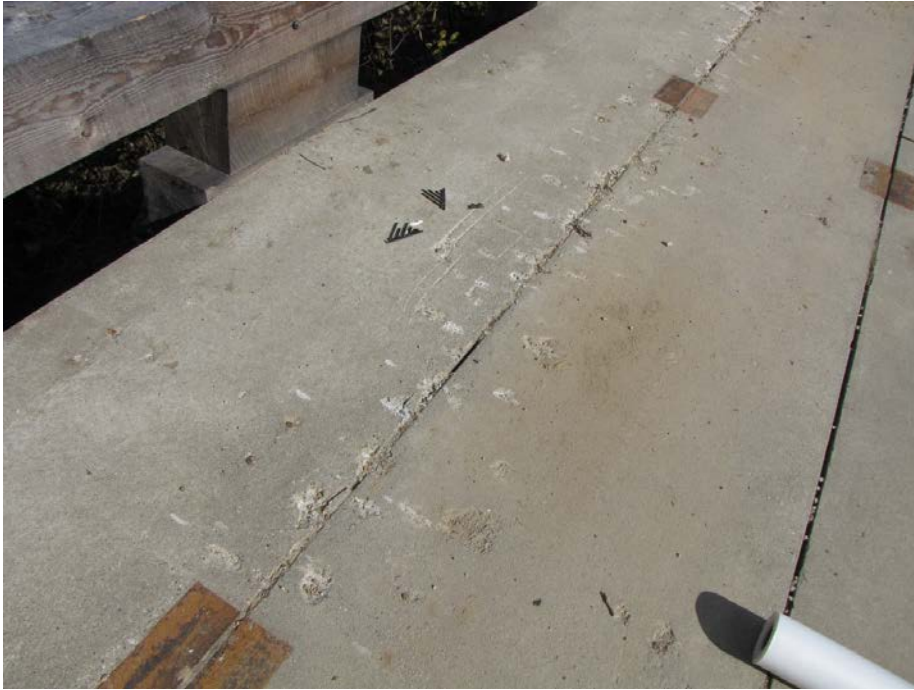
Figure 3: Chipping Damage from Track (Left Side)

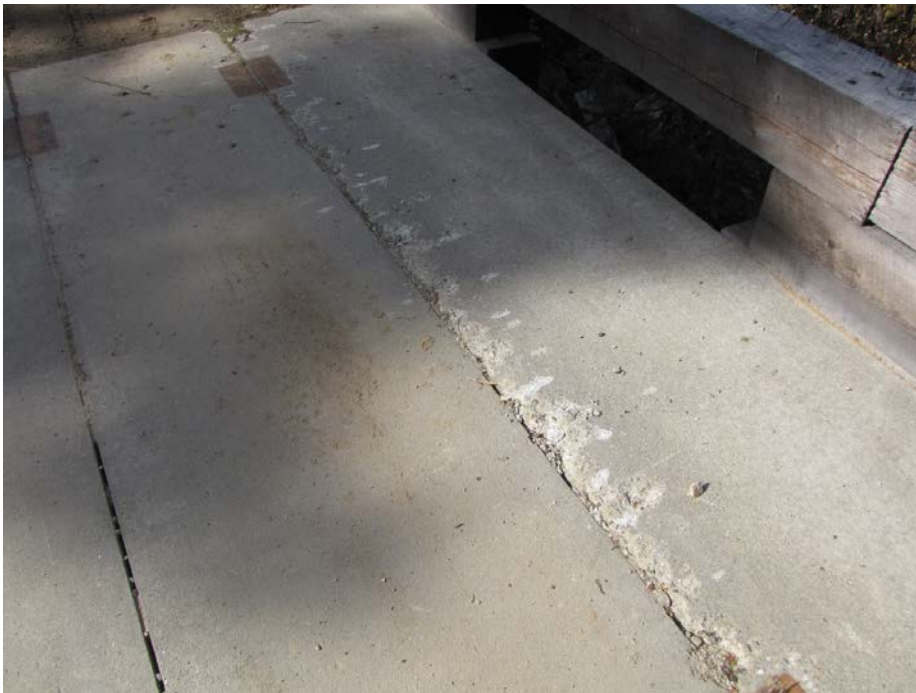
Figure 4: Chipping Damage from Track (Right Side)

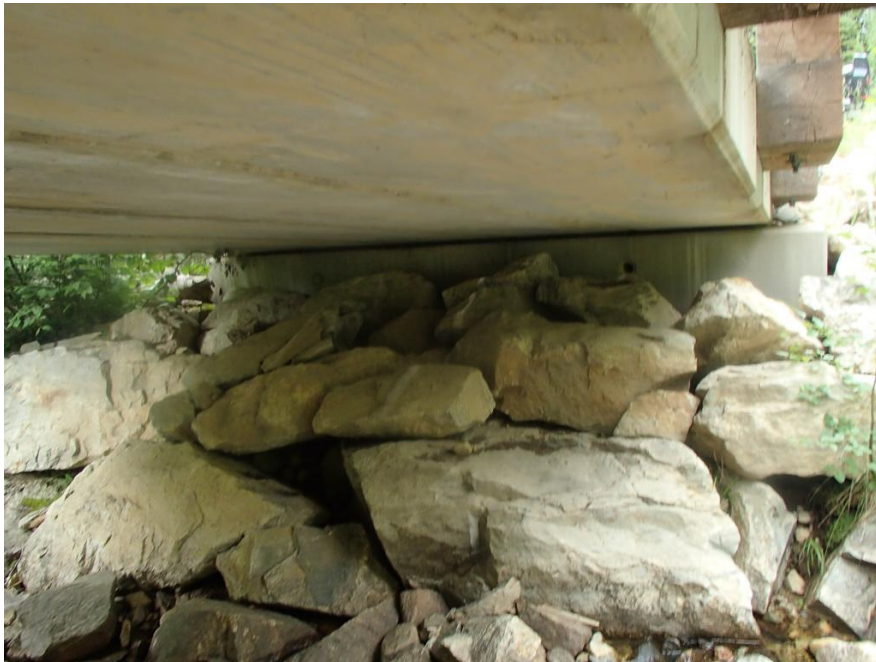
Figure 5: Rotated Left Abutment (observe gap between super- and substructure)

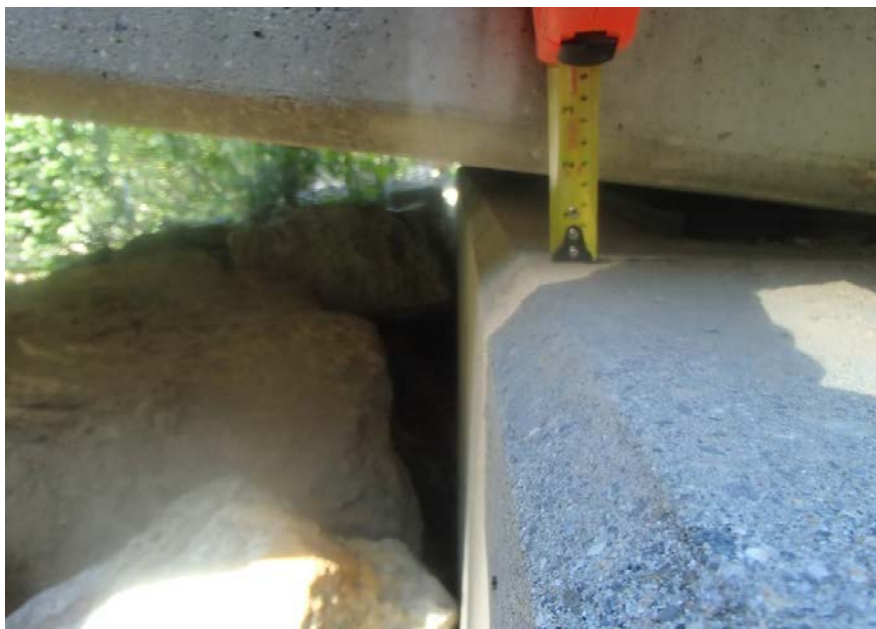
Figure 6: Measurement of Cap Beam Movement as a Result of Abutment Rotation

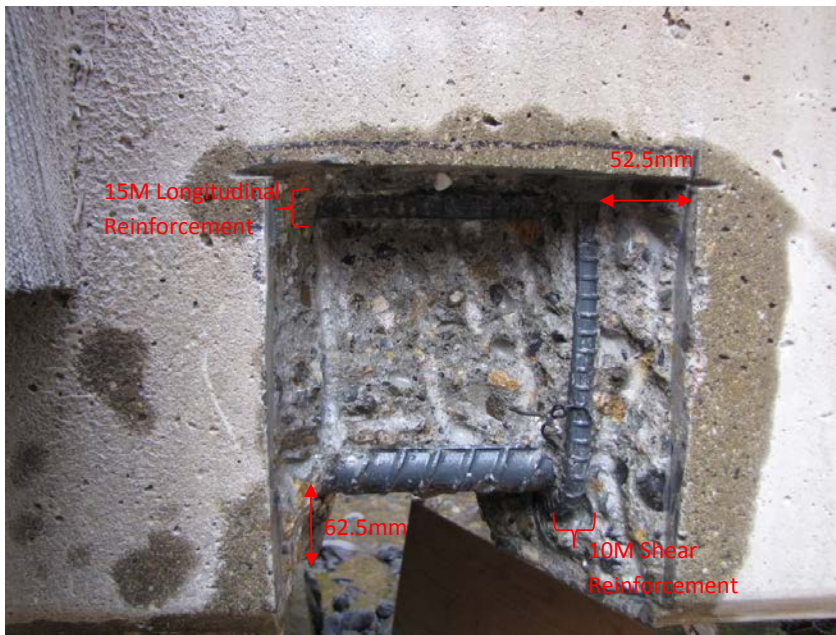
The total depth of removed concrete was approximately 62.5mm on the underside (50mm cover + 12.5mm reinforcement radius) and 52.5mm on the side face (45mm cover + 7.5mm reinforcement radius). The exposed reinforcement can be seen below in Figures 12 (side face) and 13 (underside).

Figure 12: Side Face Exposed Reinforcement

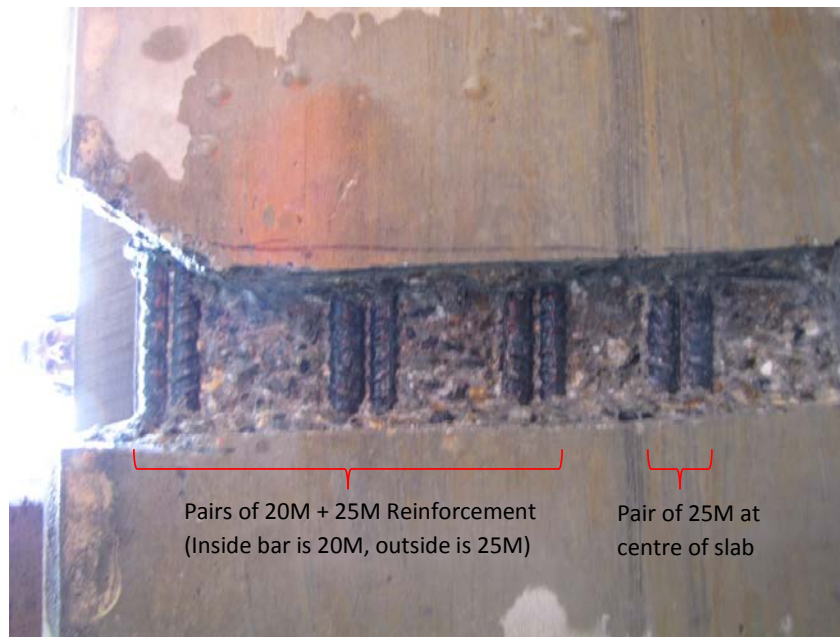
Figure 13: Underside Exposed Reinforcement

After chipping, it was observed that the underside reinforcement matrix is arranged as three pairs of 20M + 25M and one pair of 25M in the centre. Presuming that the slab is symmetrical about the longitudinal centreline, there would be three pairs of 20M + 25M on either side of the 25M pair. The shear reinforcement (side face) was found to be one 15M bar longitudinally accompanied by 10M stirrups. The top reinforcement and spacing between the stirrups was not observed.

No rust or corrosion was noted on the reinforcement.

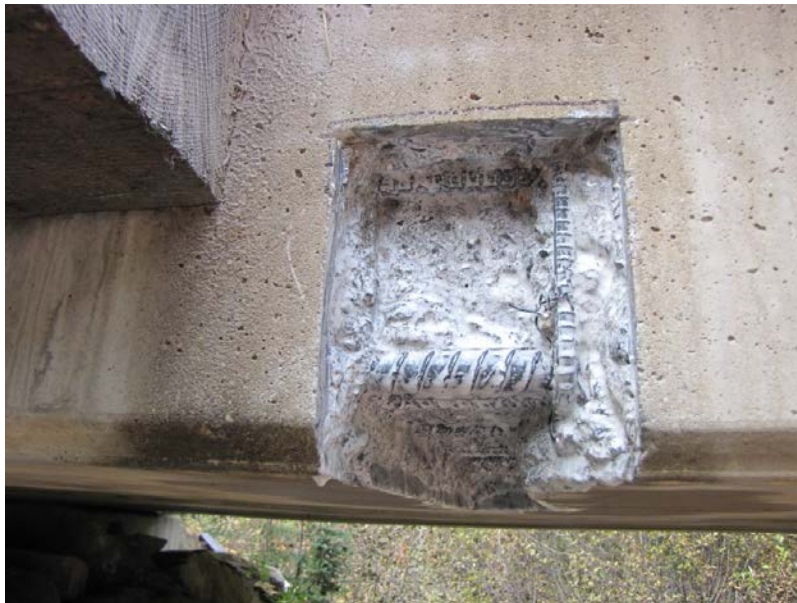
Figure 16: Exposed Rebar Section with Applied Weldbond Concrete Bonding Agent

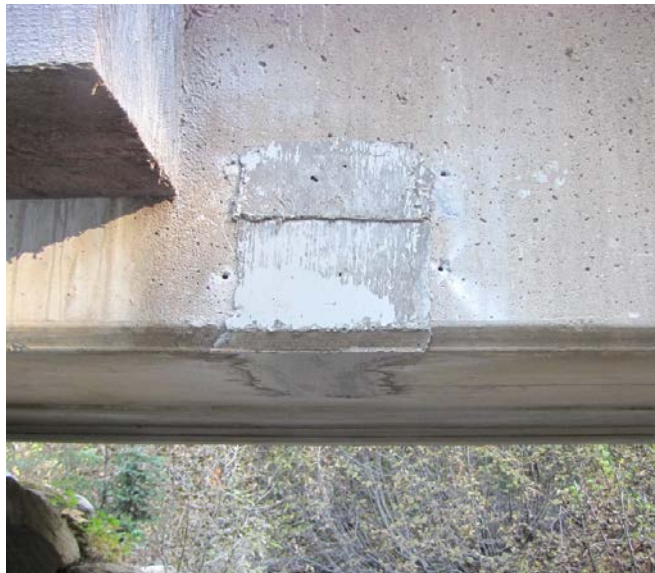
Figure 19: Concrete Repair Patch Following the Removal of Formwork

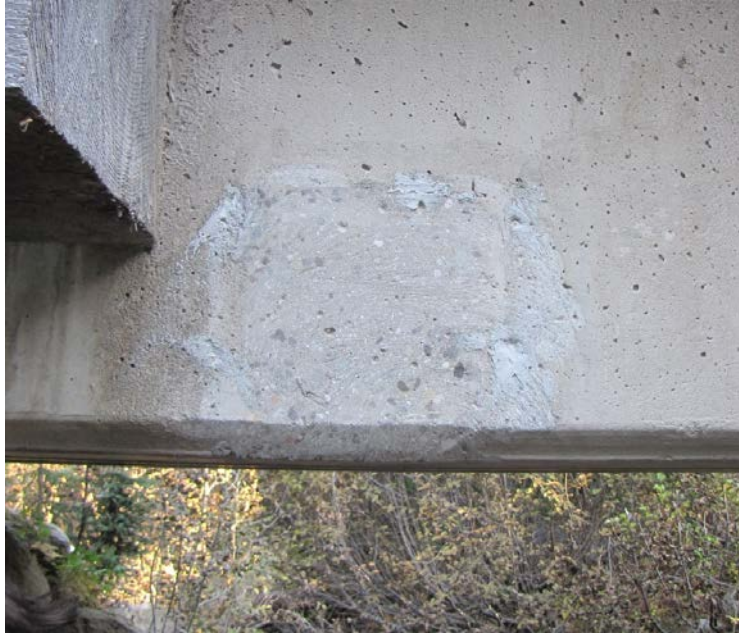
Figure 20: Side Face Repair Surface Following Grinding and Sealant Application

- Monitoring should continue on the grout repair patch to study the effectiveness of Target Traffic Patch and Weldbond products for overhead applications. The grout patch should be sounded during routine condition inspections to confirm its integrity.
- Explore non-destructive test methods to assess the compressive strength of the insitu precast concrete of precast bridge slabs
- Explore non-destructive testing alternatives to this method.
 - NDT tests could be performed to further confirm symmetry and other supplementary tasks, provided that trials are successful.

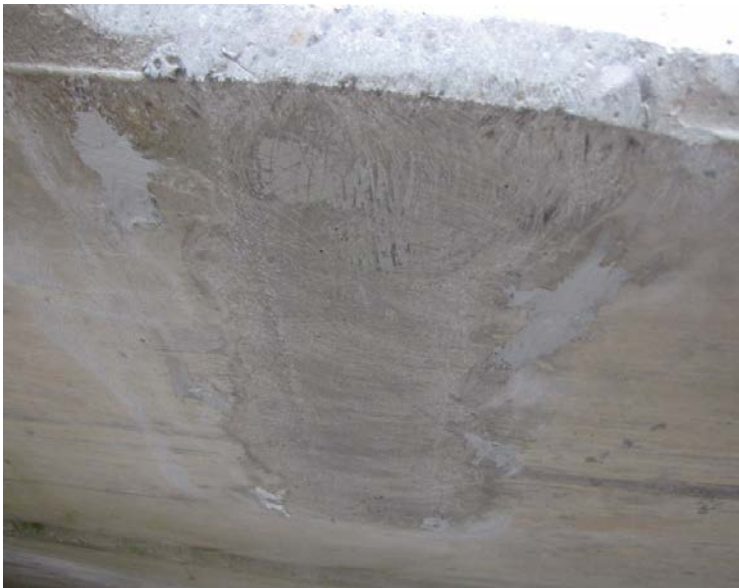
Figure 21: Underside Repair Surface Following Grinding and Sealant Application

9. The soundness of the concrete patch was tested by “sounding” with a hammer after 18 hours. No hollow sounds were noted over the full patch areas.
