**DATE** February 18, 2021

**PROJECT No.** 18-SS-1242

**SITE RECONNAISSANCE TO ASSESS POTENTIAL REINSTATEMENT OF TEMPORARY ROAD**  
20.3 KM SLIDE, QUESNEL HYDRAULIC ROAD, QUESNEL, BC

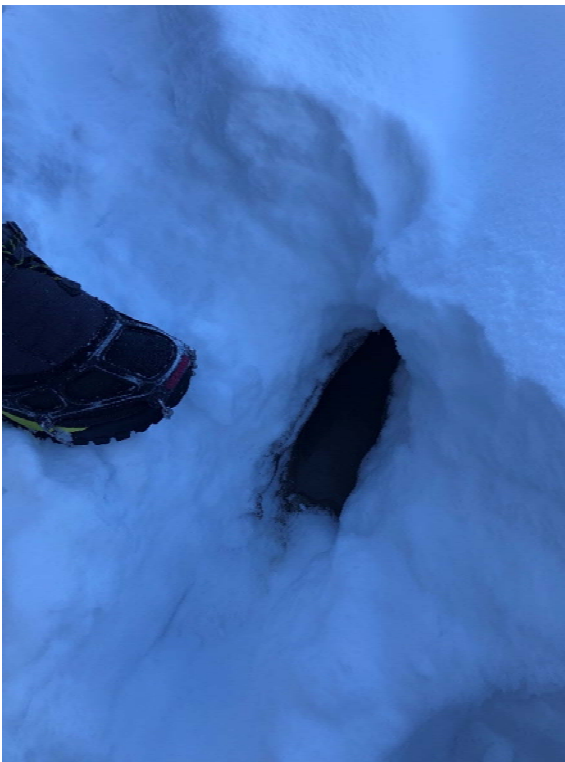
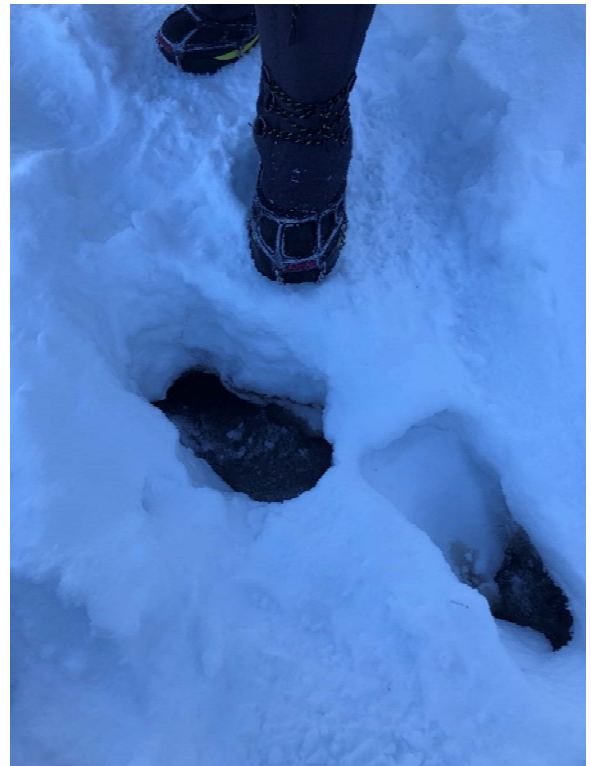
Field staff boots punched through the snow at Slide B in the vicinity of the previously observed surface water discharge to expose the flowing water observed during our previous site reconnaissance with Golder. See Photos 1 and 2 attached below. No flow was exposed under the snow at Slide E but seepage was assumed base on hearing trickling of water down the embankment. However, it was difficult to differentiate between surface water discharge noise and ice cracking.

Photos 1 & 2: Indication that water is discharging from the formation and flowing under the snow, over the road surface and down the embankment into the Quesnel River even in -25 degrees Celsius.

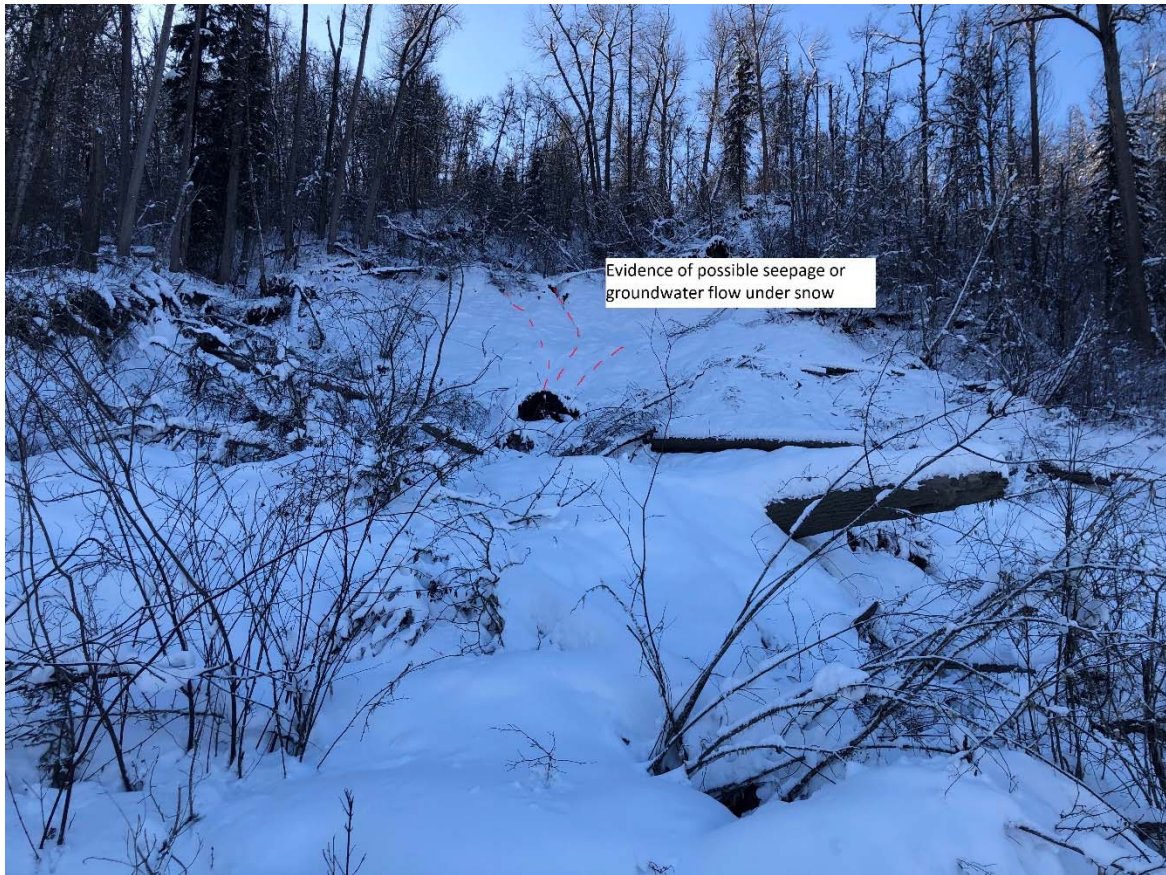
Observation of the upslope failure at Slide B indicates that the failure is still likely discharging water either from the formation or from surface water, despite the recent very cold weather. Photo 3 indicates where seepage was previously observed and appears to still be melting the snow cover compared to the surrounding snow cover.

Photo 3: Landslide mass above Quesnel Hydraulic Road at Slide B indicating possible surface groundwater or formation seepage discharge from the headscarp
