***City of Riverbend
Cost Recovery Plan
Engineer Assessment***

DFA Sample Report

PROJECT TITLE: Recovery Repair Works

NAME OF EVENT: Spring Freshet Flood 2020

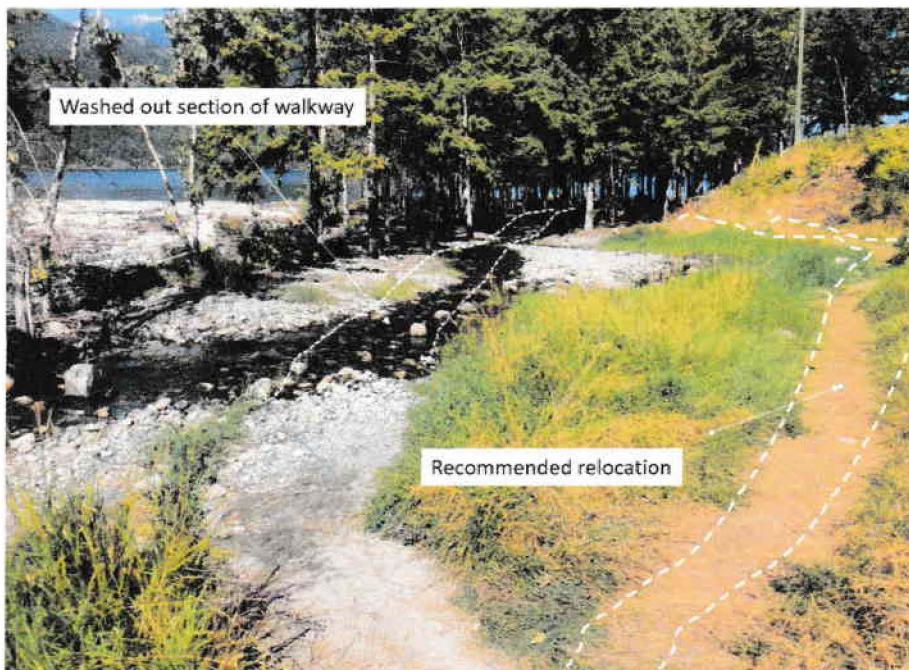
Site 1 - Walkway: A large volume of bed load was deposited and was shifting in the main channel of Carpenter Creek during the event resulting in an avulsion at the downstream right bank and subsequent flooding and erosion of a 55 m long section of 1 meter wide gravel walkway as shown in Figure 2. The City does not have pre-event photo. The trail was in good working order before the spring flooding occurred.

Figure 2: Site 1 – Walkway Flooding and Erosion August 25, 2020

The estimated cost to reconstruct the walkway is summarized in Table 1. The estimate is based on the relocation of the section of walkway approximately as shown in Figure 2. It is deemed impractical to reconstruct the washed out section of walkway in the location it existed prior to the flood. Firstly, it would require the excavation of the substrate of the main channel of Carpenter Creek to divert the water from the worksite. This work in and about a stream would require authorization from MFLNRORD increasing the project duration and cost substantially. It is questionable whether the ministry would authorize this work. Secondly, because of the elevated main creek bed adjacent to the entrance to the new channel that eroded the walkway and the continued deposition and shifting of gravel and accumulation of log jams there is a high probability that the area would flood again next freshet.

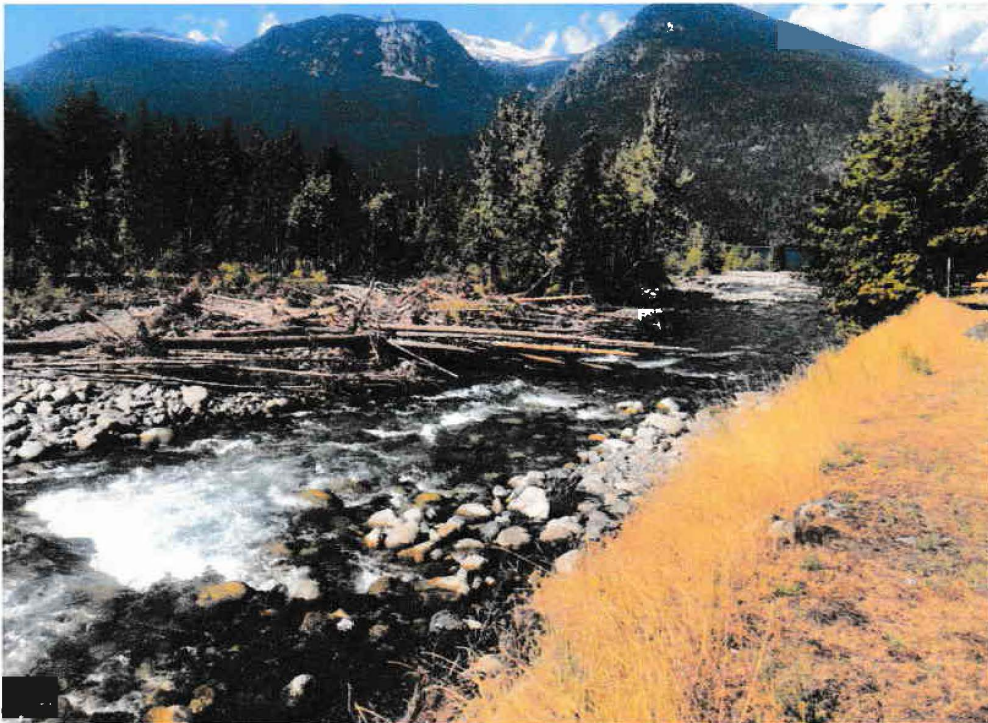
Site 2 – Log jam: The high creek flows resulted in development of several new log jams in the creek channel throughout the City. The City is concerned that the log jam shown in Figure 3 will increase the risk of erosion of the adjacent riprapped bank. The removal of the jam would reduce the likelihood of a bigger jam forming in subsequent freshet flows and would reduce the risk of damage to the adjacent riprap bank protection. However, there was no evidence of loss of riprap from the bank resulting from this event. The removal of the jam would require prior authorization from MFLNRORD. One alternative is to cut up and spread the logs in channel to reduce the likelihood of creek redirection.

Figure 3: Site 2 Log Jam August 25, 2020

NOT ELIGIBLE FOR DFA FUNDING

The removal of the tree debris is considered mitigative as no Infrastructure is impacted

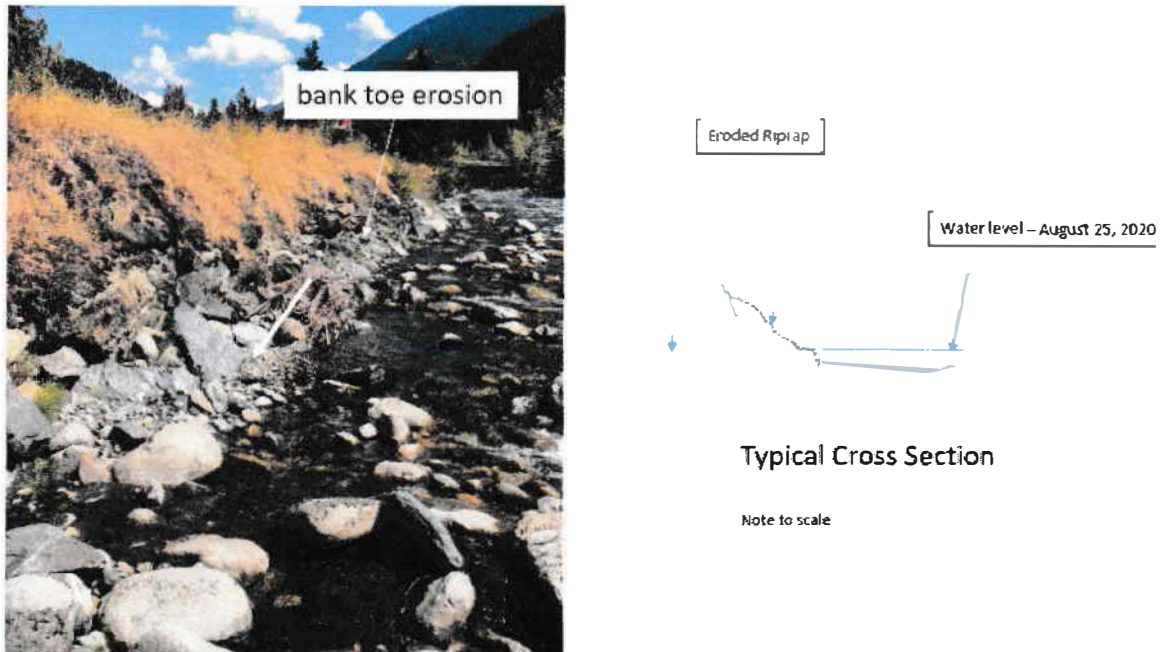
Site 3 Right Bank Erosion: A 15 m length of riprap bank protection, approximately 190 m downstream from the Highway 6 bridge (see Figure 1) was damaged as shown in Figure 4. Costs (Table 2) for riprap repairs to this site and Sites 4 and 5 are considered eligible.

Figure 4: Site 3 Riprap Toe Erosion August 25, 2020

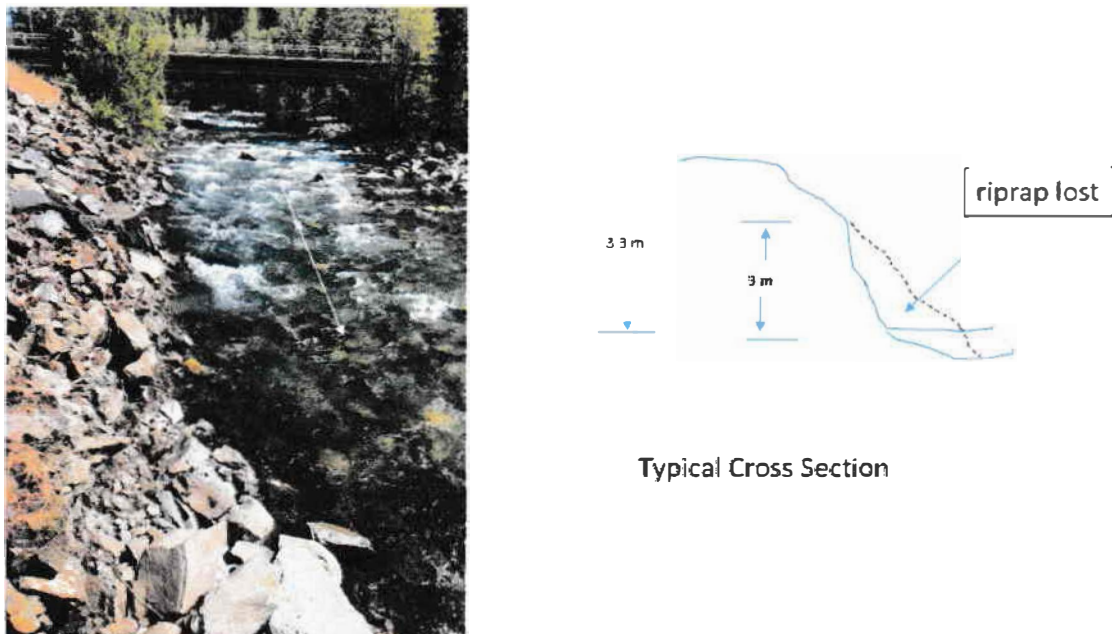
Site 4 -Riprap Replacement: Approximately 67 m of bank protection was damaged as shown in Figure 5.

Figure 5: Site 4 Riprap Lost August 25, 2020

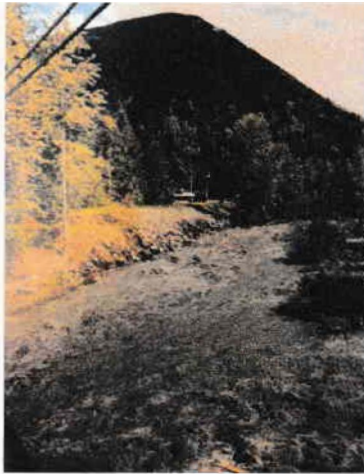
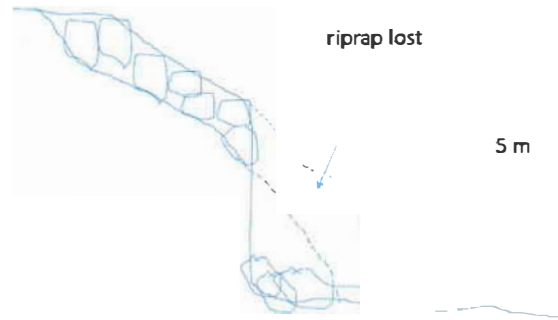
Site 5 Riprap Replacement: Riprap erosion protection on a 26 m section of dike upstream of the Highway 6 bridge was eroded as shown in Figures 6 to 8. A large gravel bar and trees in the

Figure 6: Site 5 Bank Erosion August 25, 2020

The estimated volume of riprap lost during the May 31/June 1 event is 143 m³. Simply reconstructing to the pre-event configuration is not recommended as there would be a high likelihood of a repeat failure. Conceptual review indicates that the maximum riprap slope angle should be 1.5H:1V (which is consistent with the 2013 riprap design) and should include a toe trench (also part of the 2013 design). The riprap placed on the lower slope in 2013 had a lower slope angle of 1H:1V compensated by larger riprap sizing. In addition, it is recommended that the gravel bar, log jam and trees shown in Figures 7 and 8 be removed from the channel to realign flow under the highway bridge and reduce pressure on the dike. Once the channel is cleared the accumulation of gravel and log jams should be monitored and actions taken to prevent the re-establishment of the channel constriction. This can be facilitated with coordination between the City, MFLNRORD (Dike Inspection and habitat concerns), DFO and MOTI by updating of the Vegetation Management Plan. During the May 31/June 1 event the highway bridge sustained damage in the form of lost riprap that provides pile cap protection (piles now exposed).

The cost of repairs summary (Table 1) for Site 5 is based on the plan to reconstruct the bank with a flatter slope angle and scour protection described above. The construction will involve instream work. Consequently, authorization will be required from MFLNRORD. Most likely MFLNRORD will require an environmental assessment and oversight during construction. This cost is included in Table 1.

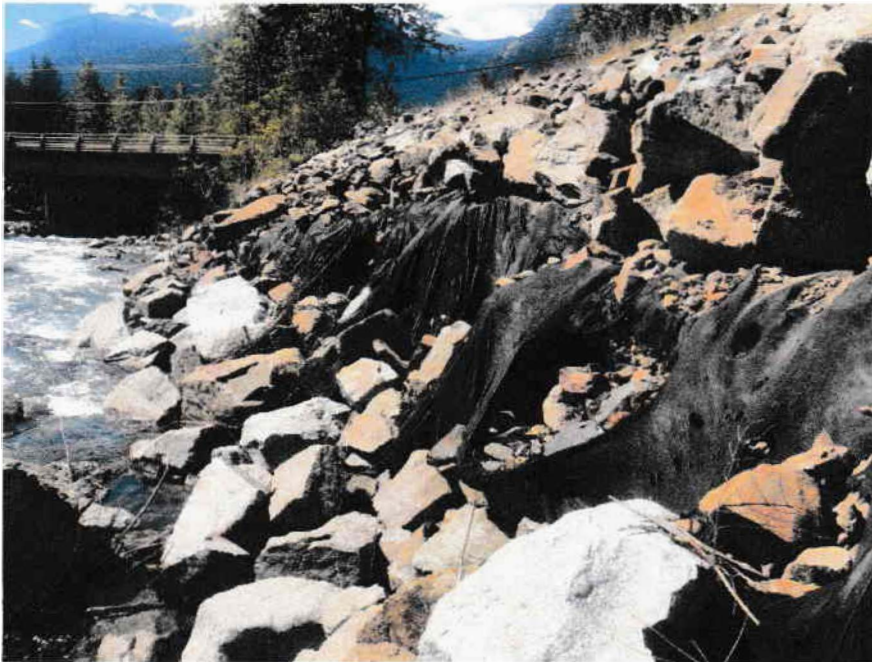
channel upstream of the bridge and adjacent to this site constricted the channel, caused log jams, and resulted in water being forced to impinge directly into the dike as shown in Figures 7 through 9.

Figure 7: Site 5 Dike Erosion August 25, 2020

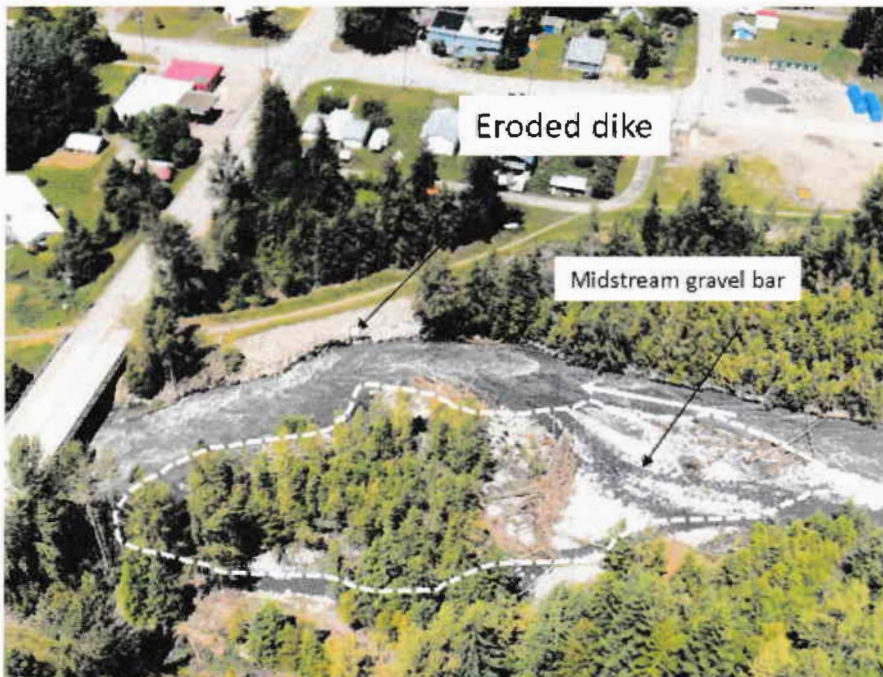
Figure 8a: Site 5 Gravel bar and trees mid stream upstream of Highway 6 bridge June 3, 2020

As noted above, Cedar Engineering recommends the removal and subsequent monitoring of the gravel bar build-up to reduce the risk of future damage to the dike and the highway bridge. This would include obtaining authorization from MFLNRORD and DFO to complete the initial gravel and

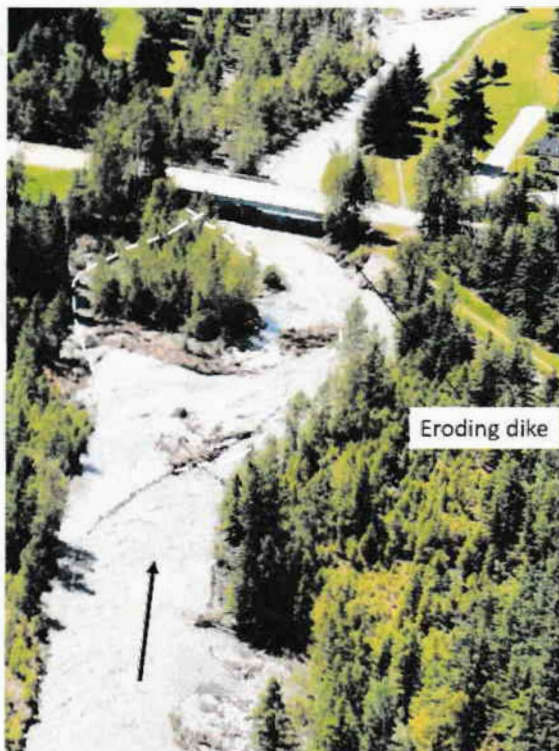
Figure 8b: View of midchannel bar and trees upstream of bridge June 3, 2020

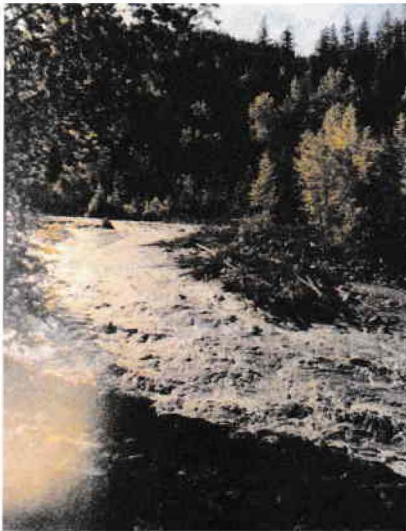
Figure 9: View of gravel bar and log jam forcing flood waters to impinge on dike May 31, 2020 (courtesy City of Riverbend)

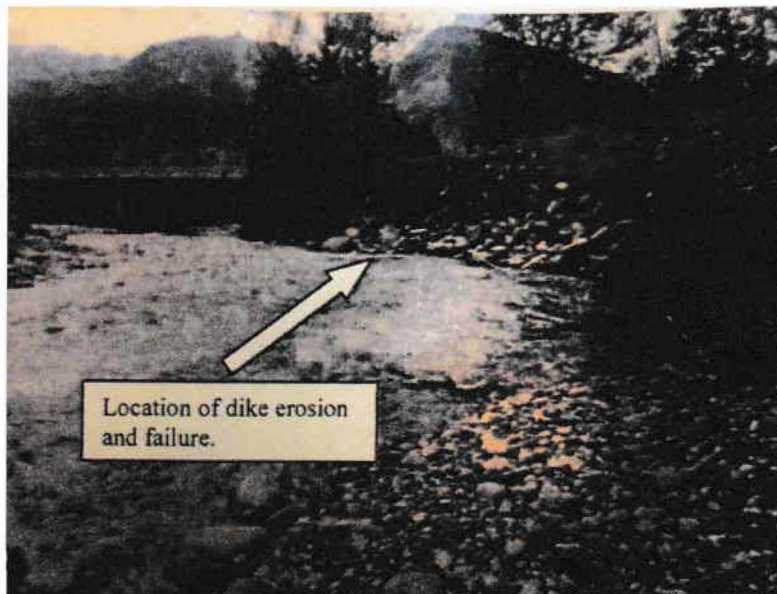
The dike was initially constructed in the 1970's and upgraded in the 1990's. During the 2013 freshet the dike was damaged at this same location with loss of erosion protection and some of the dike prism as shown in Figure 10. The photo in Figure 10 was taken from CGT Engineering letter report to the City dated September 11, 2013. In 2014 the dike slope was reconstructed and armoured with riprap, as shown in Figure 11, taken from CGT letter report to the City dated September 8, 2014. It is understood the repairs were funded partially by the Province.

Figure 10: View of Erosion Resulting from June 2013 Flood (CGT 2013)

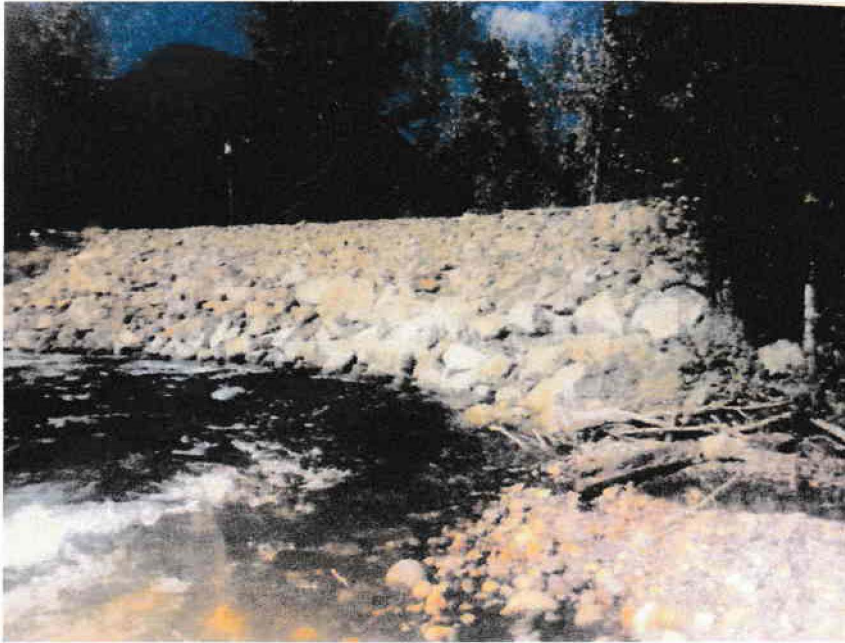
Figure 11: September 2014 photo of repaired dike (CGT 2014)
