## MEMORANDUM

**File:** 38000-25/CI Hullcar

**RE:** Memorandum regarding the April 11, 2017 site inspection in Hullcar, BC

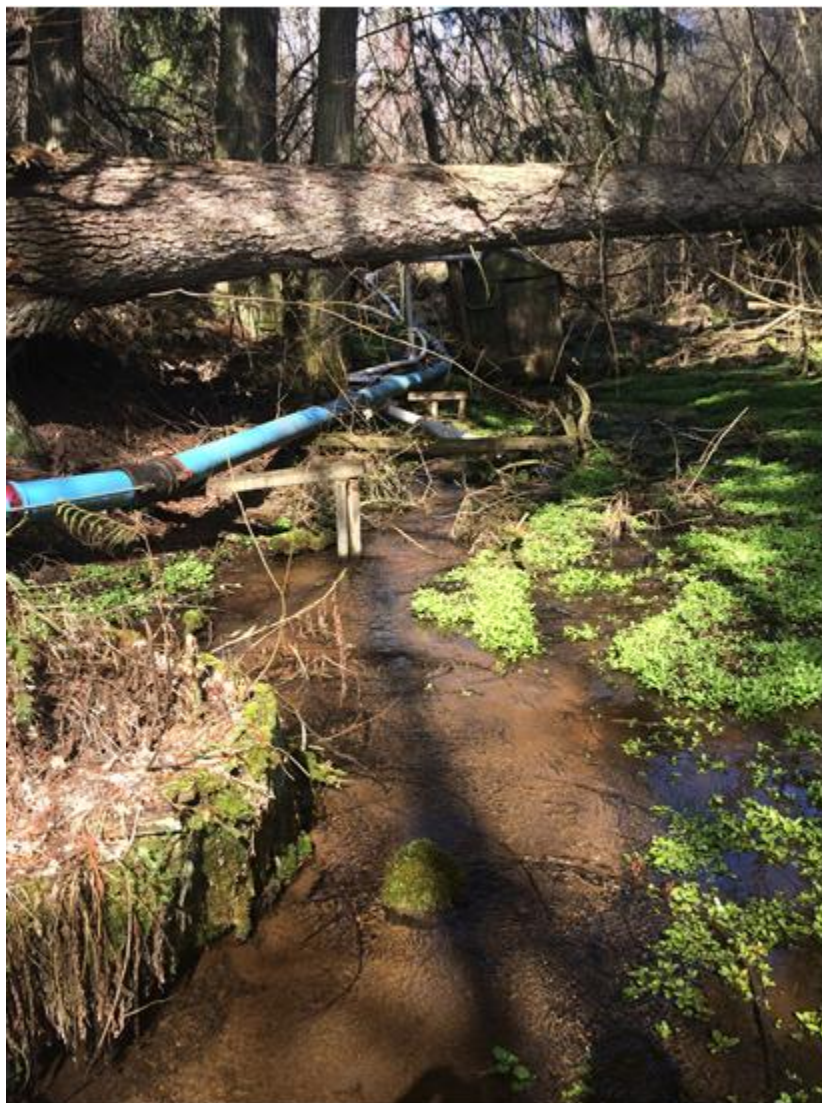
Figure 2: Supply line from the Steele Springs intake to the pump house. The photo direction is up the re-entrant (draw) to the North-West. Photo taken on April 11, 2017.

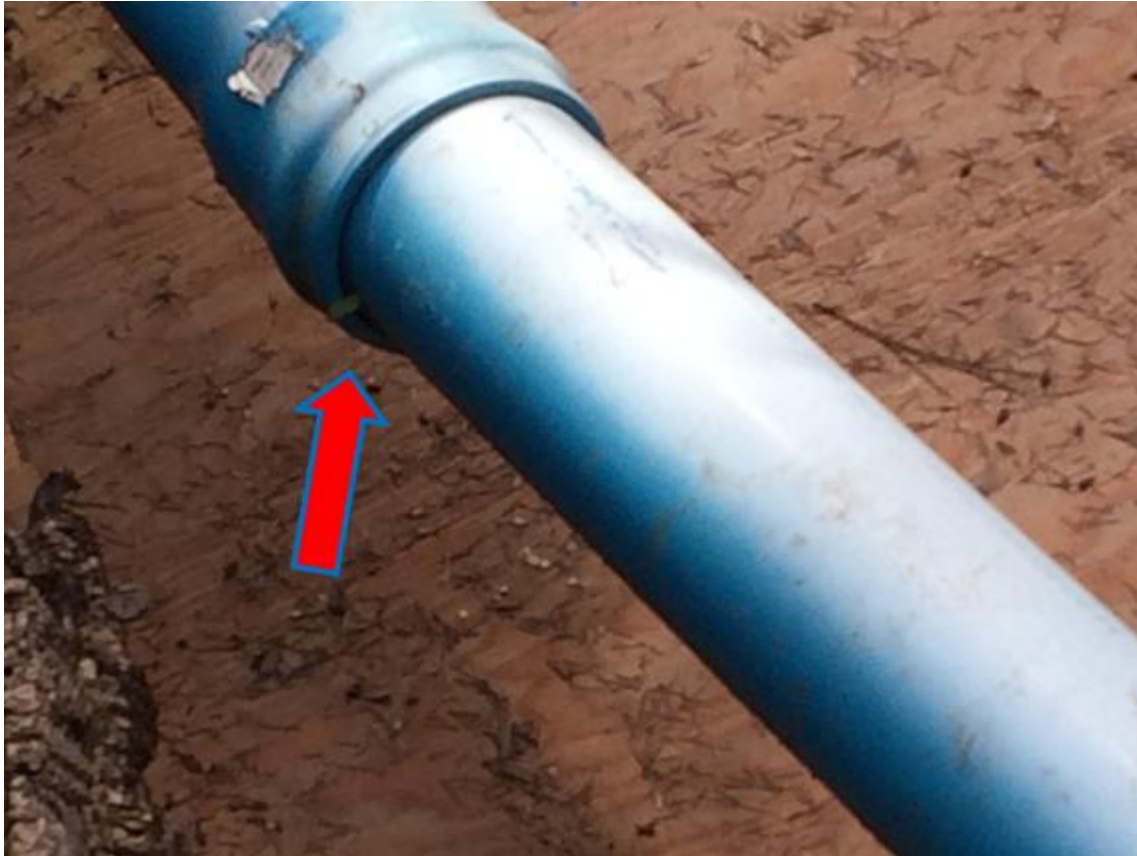
The Steele Springs intake itself is located in the bottom of a re-entrant (draw), reportedly drawing water from a depth of 1.5 m (five feet) below the ground surface. There is a potential for this intake to be receiving percolating surface water as well as water from the surficial aquifer. There are also locations along the supply line (e.g. open over-flows and pipe joints) that may allow surface contaminants to enter the system.

Figure 3: Supply line above the bed of the re-entrant (draw). Spaces in jointing may allow surface contaminants to enter the supply line in some circumstances. Photo taken on April 11, 2017.

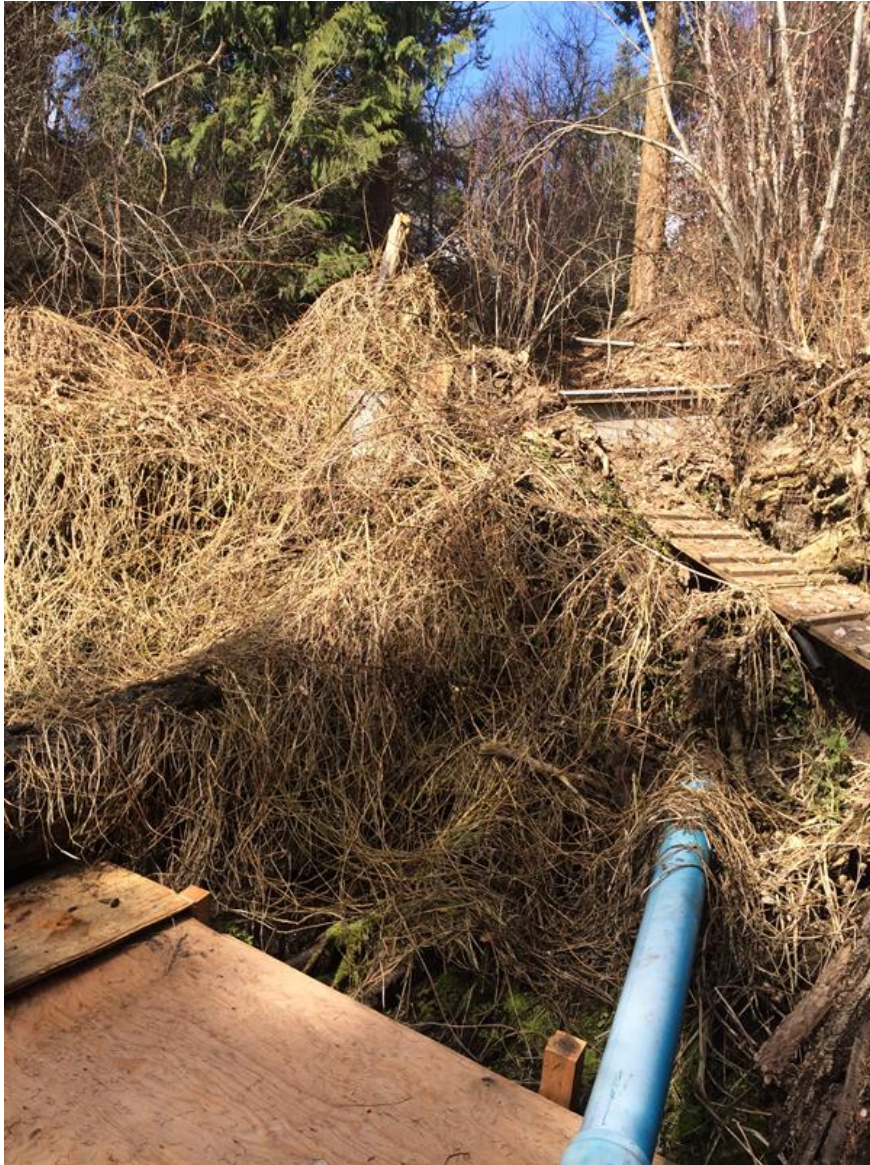
Figure 4: Jointed supply line positioned into the hillside on approach to the Steele Springs collection point. Photo taken on April 11, 2017.

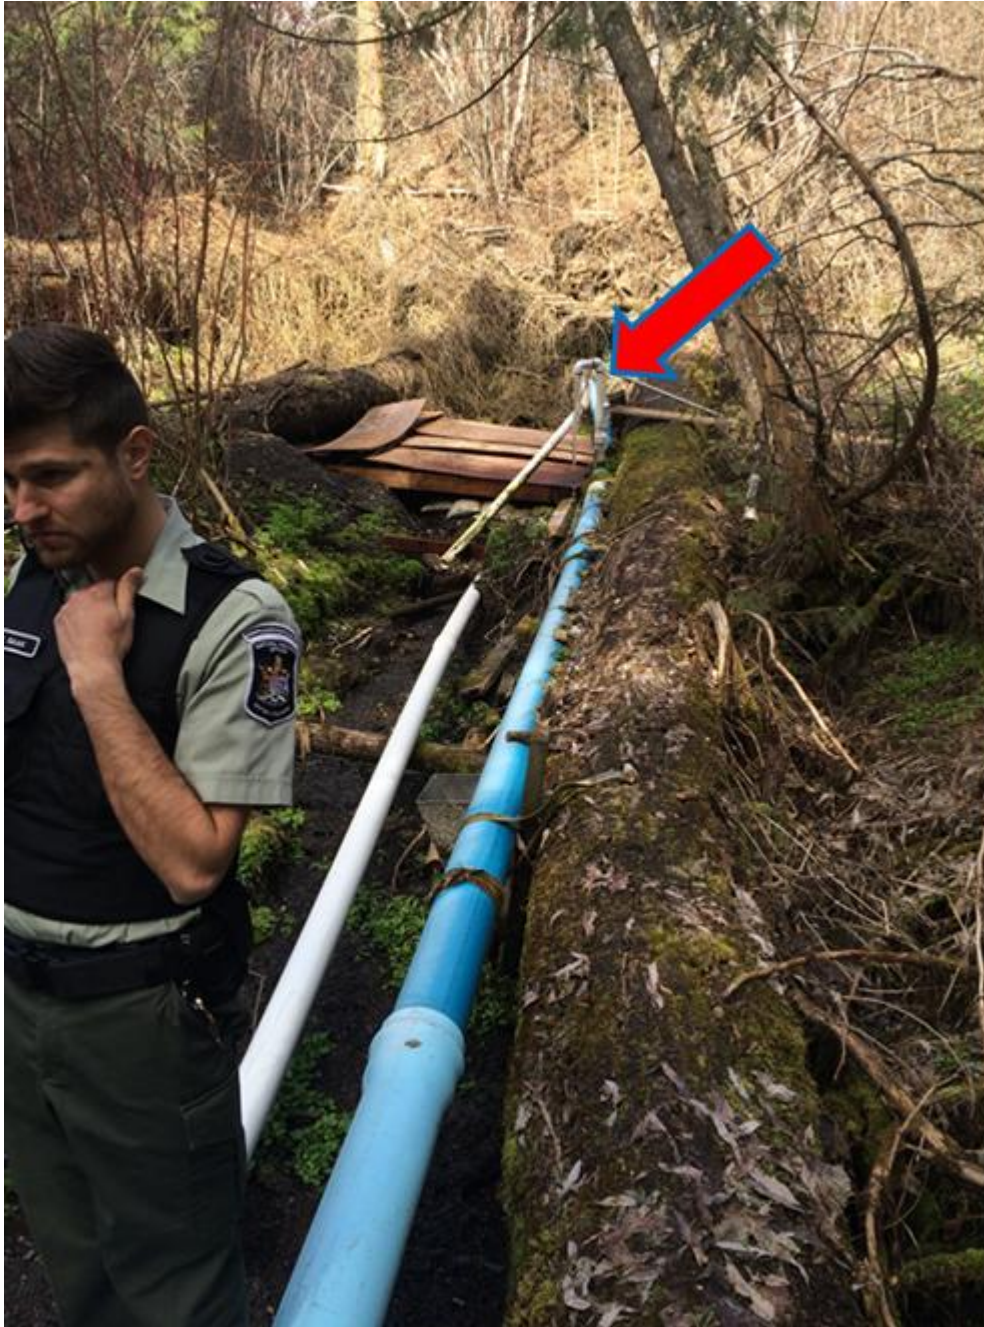
Figure 5: Supply line from the Steele Springs intake to the pump house (blue) and a secondary line (overflow?). The downgradient overflow port (open to air) installed into the supply line is indicated with an arrow. The photo direction is up the re-entrant (draw) to the North-West. Photo taken on April 11, 2017.

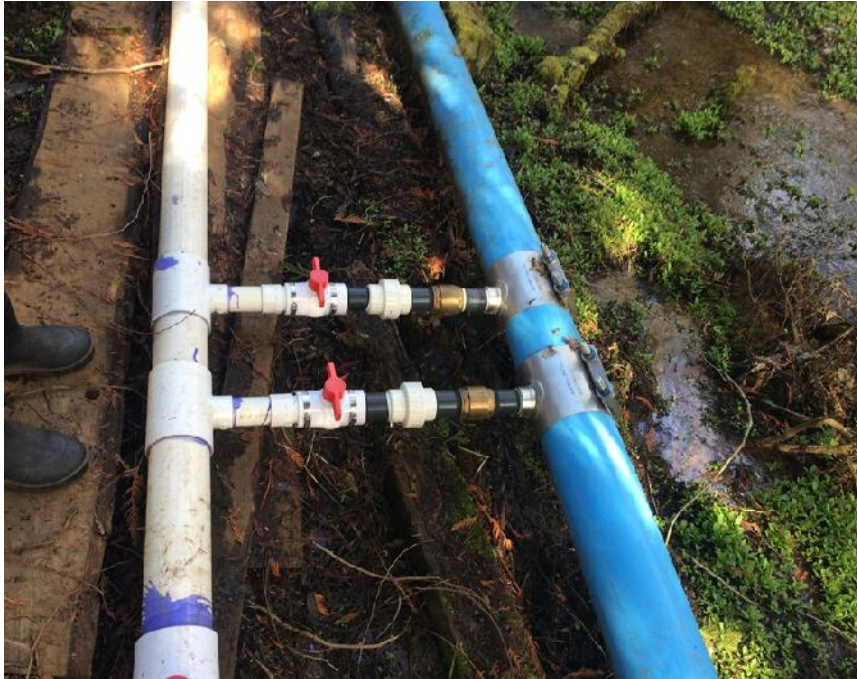
Steele Springs board members Brian Upper and Murray Todd received provincial government staff at the Steele Springs pump house along Schubert Road. D. Oldfield collected a water quality sample consistent with the previously employed sampling methodology for a standardized list of water parameters. N. Pyett and J. Pogson were guided by M. Todd from the pump house, upgradient along the supply line, to the point of collection. N. Pyett and J. Pogson inspected the supply line for any potential points of entry for contaminants (Figure 2). The supply line is comprised of segmented PVC piping, with friction fitted joints, placed along the bed of the re-entrant. The supply line was in direct contact with surface water and sediments in many areas. One joint appeared to have space for water entry as the friction fitting was cross-loaded to allow the pipe to fit the desired route up the re-entrant (Figure 3). Several joints were buried below the surface and were therefore not available for visual inspection (Figure 4). Approximately two thirds of the way up the re-entrant from the pump house to the intake point, provincial staff observed two overflow ports that were open to the air (Figure 5). Water was flowing rapidly from the downgradient port but was only dripping from the upgradient port. While these ports are open, it does not appear as though the water level has been high enough within the re-entrant to allow surface water to flow back into the supply line. Two intentional cross connections built into the system between the main supply line and secondary piping were observed to be closed at the time of inspection (Figure 6).

Figure 6: Connection between the supply line from the Steele Springs intake to the pump house (blue) and a secondary line (overflow?). The cross connection was shut at the time of the photo taken on April 11, 2017.

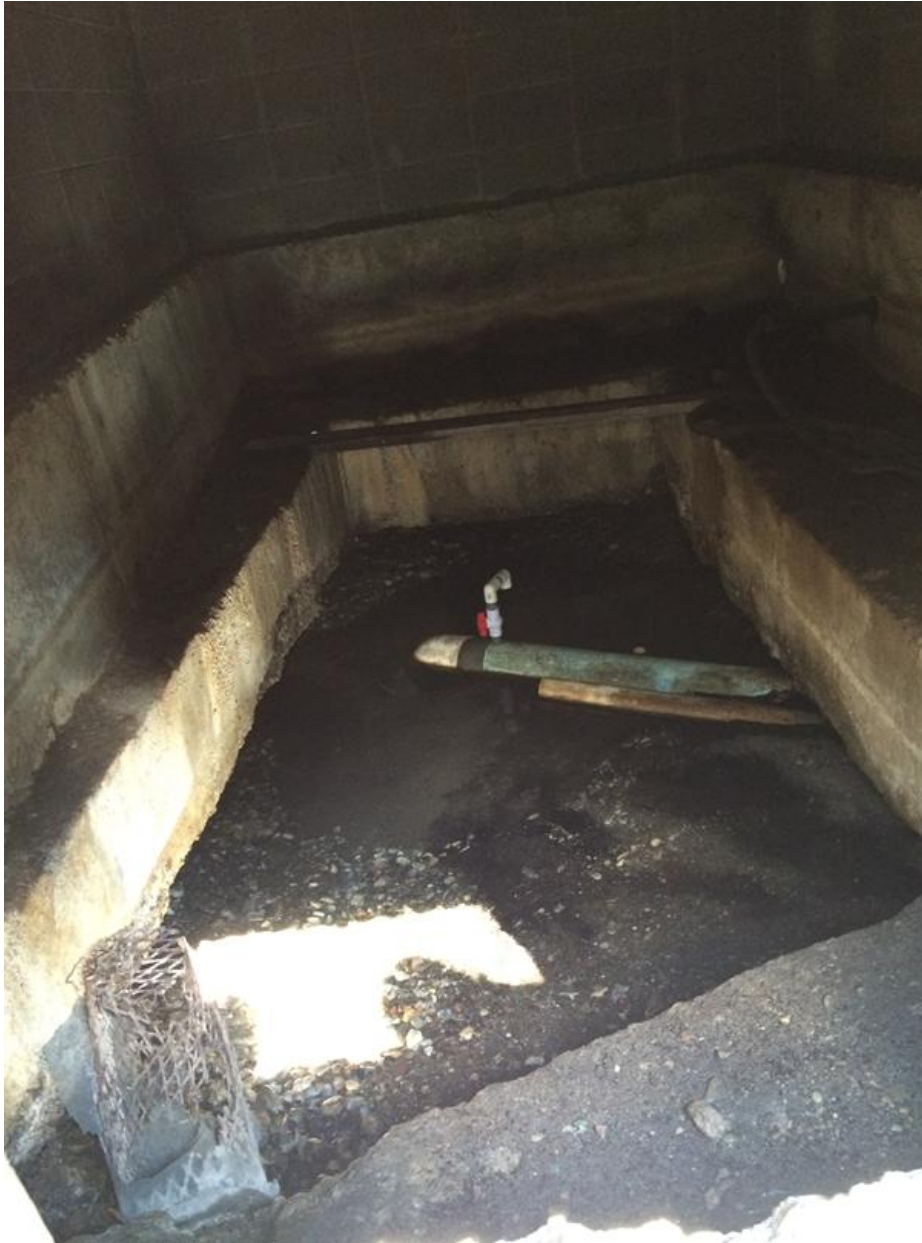
The system intake was described by B. Upper as a screened pipe buried into 1.5 m (5 feet) of sediment, consistently experiencing positive pressure flow conditions. The intake pipe is located within a shallow concrete building with footings approximately 0.6 m (2 feet) below the ground surface (Figure 7). The intake was observed to be located in the lowest point of the re-entrant allowing surface water to potentially pool against the protective building or the intake to receive upgradient shallow flow (Figure 8). Surface soils were wet upgradient of the intake, possibly from surface flows occurring during recent rains.

Figure 7: The Steele Springs collection point. Board member Brian Upper indicated the screen intake and the building footings are approximately five feet and two feet into the sediments, respectively. Photo taken on April 11, 2017.

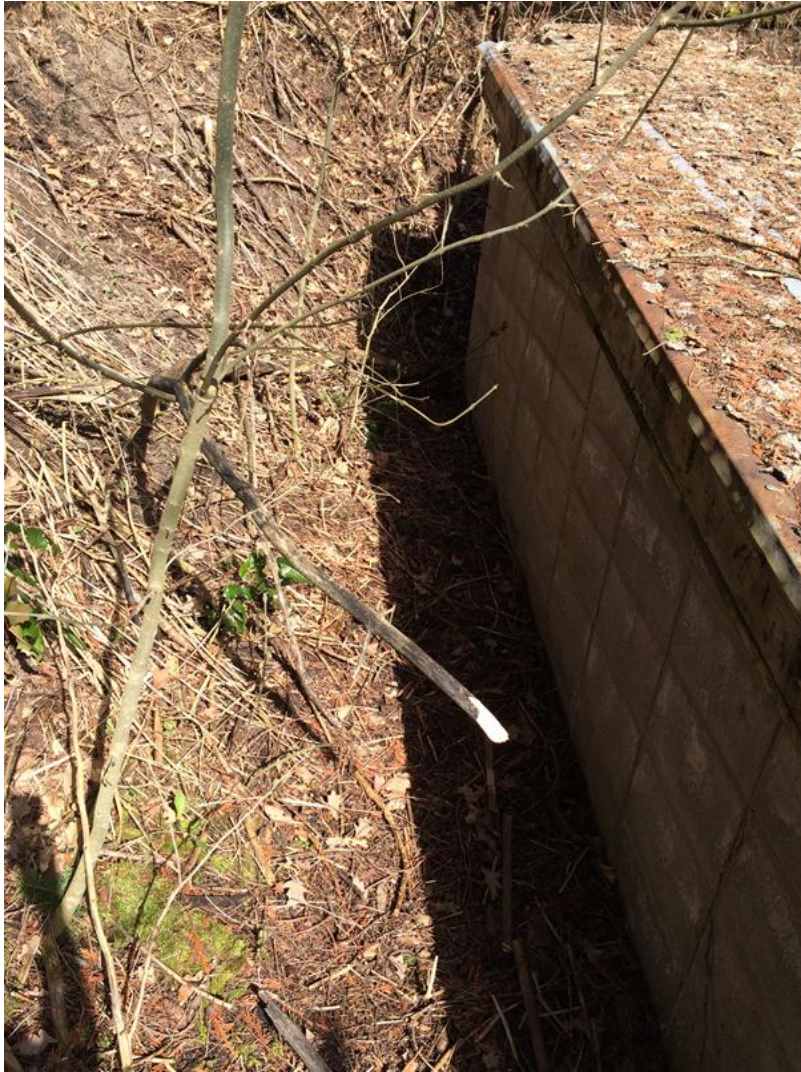
Figure 8: The upgradient side of the protective building over the intake point. The ground surface was observed to be damp during the April 11, 2017 site visit.

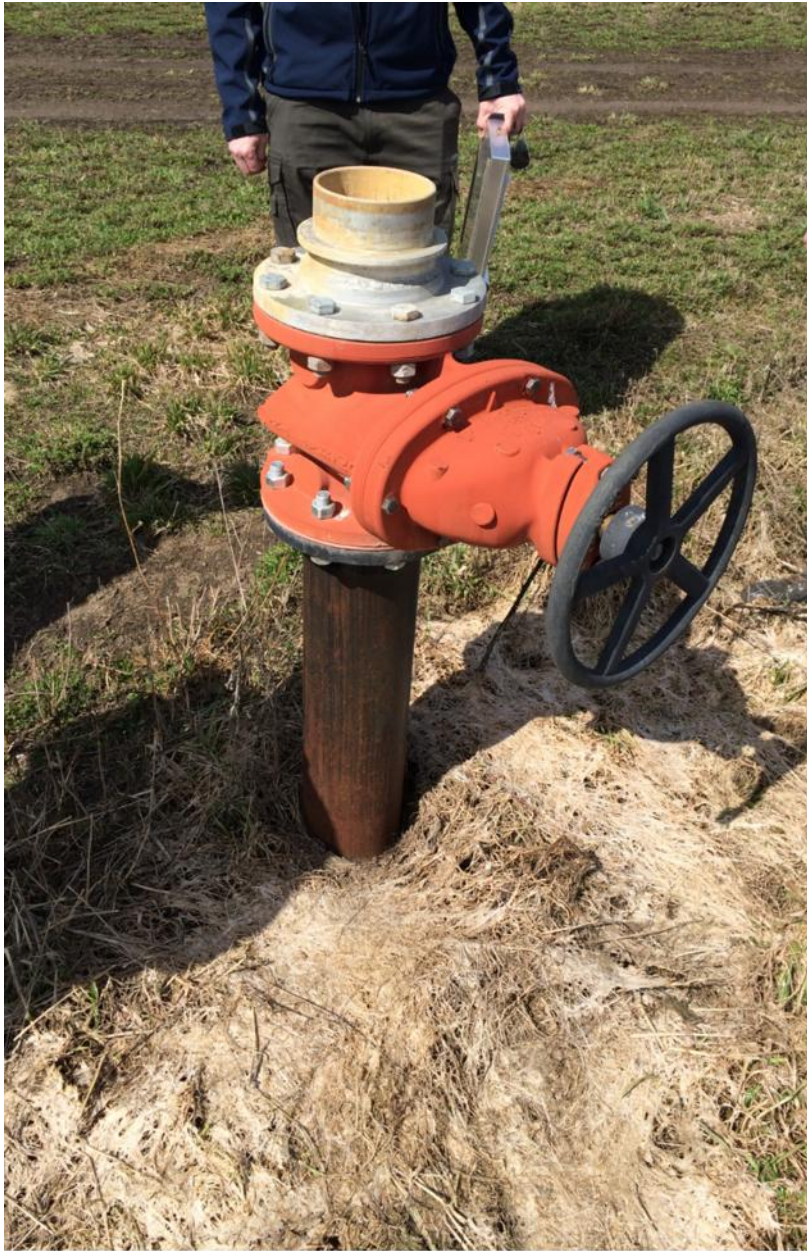
beyond the inspection radius at distances of approximately 0.5 – 1.0 km to the Steele Springs intake (Figure 9). They are likely part of an irrigation water distribution system and were not open to surface at the time of the site visit.

Figure 9: Irrigation system (?) infrastructure beyond area of interest. Photo taken on April 11, 2017.

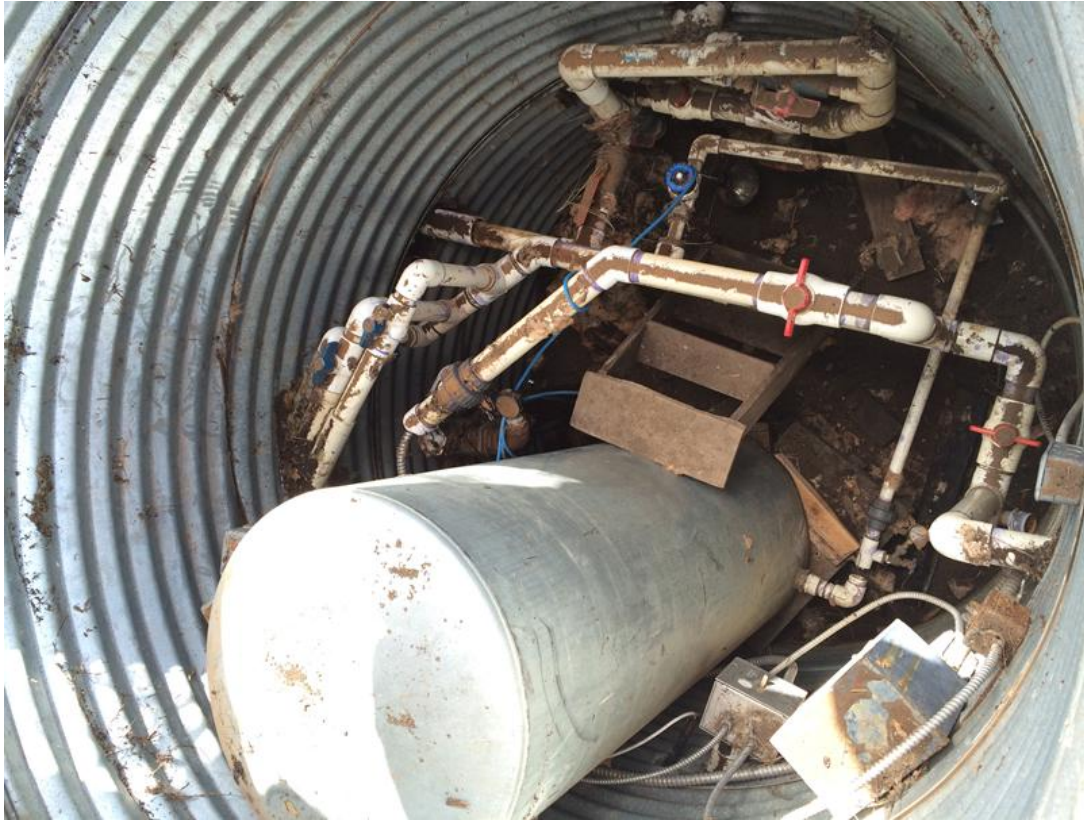
Figure 10: Well inspection 1. Photo taken on April 11, 2017.

The unregistered well (Well inspection 1 below) was found to be likely out of compliance with the Groundwater Protection Regulation but was deemed not likely a significant potential cause of surface contamination to the aquifer due to the nature of the construction of the well pit and the lack of pooling water around the wellhead.

No Well Tag Number or Well Identification Plate

- Approximately six inch well located in a well pit with a pressure tank and distribution line;
- Dripping observed from distribution line;
- Coarse sand floor with no standing water;
- Stick up on well pit preventing direct surface flows into well pit;
- No visible well plate; and,

- Unknown if the well is currently in use.

J. Pogson to contact well owner to establish well status and have well brought into compliance with Part 3, Division 3 of the WSA and the GWPR.

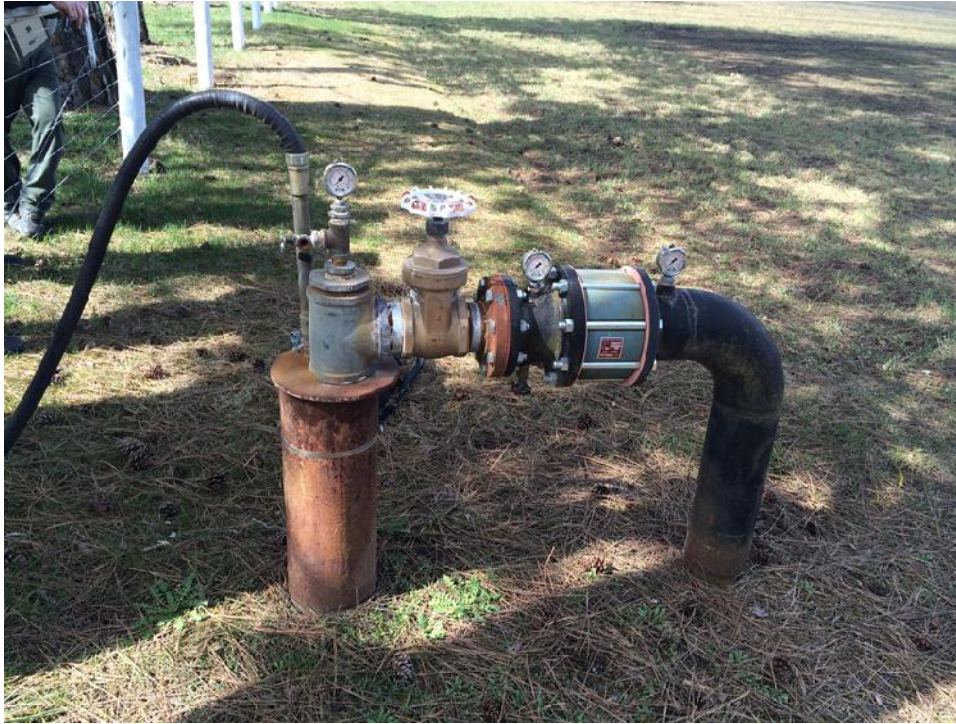
Figure 11: Well inspection 2. Photo taken on April 11, 2017.

Well I.D. Plate No. 25853

- Outside irrigation well;
- Appropriate grading around wellhead;
- Appears sanitary; and,
- Back check valve on distribution line.

J. Pogson to establish ownership and provide well inspection documentation to the well owner.

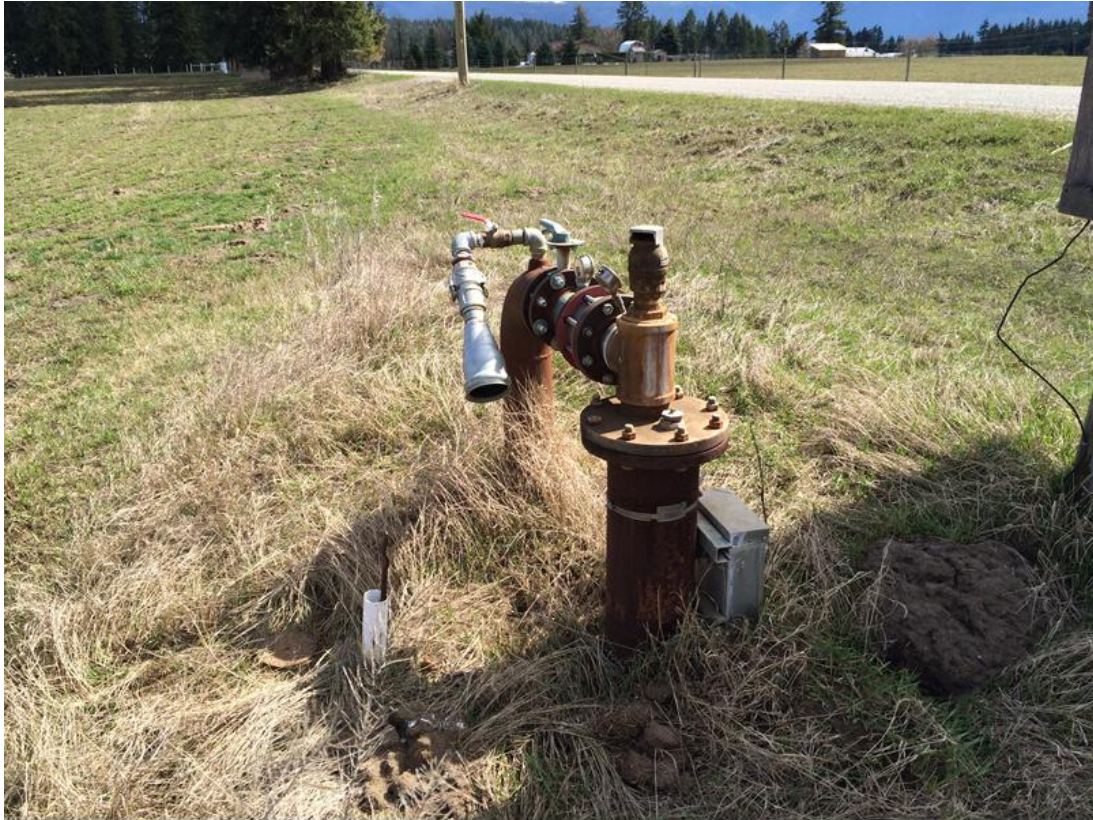
Figure 12: Well inspection 3. Photo taken on April 11, 2017.

Well I.D. Plate No. 25852

- Outside irrigation well;
- Appropriate grading around wellhead;
- Appears sanitary; and,
- Back check valve on distribution line.

J. Pogson to provide well inspection documentation to the well owner.

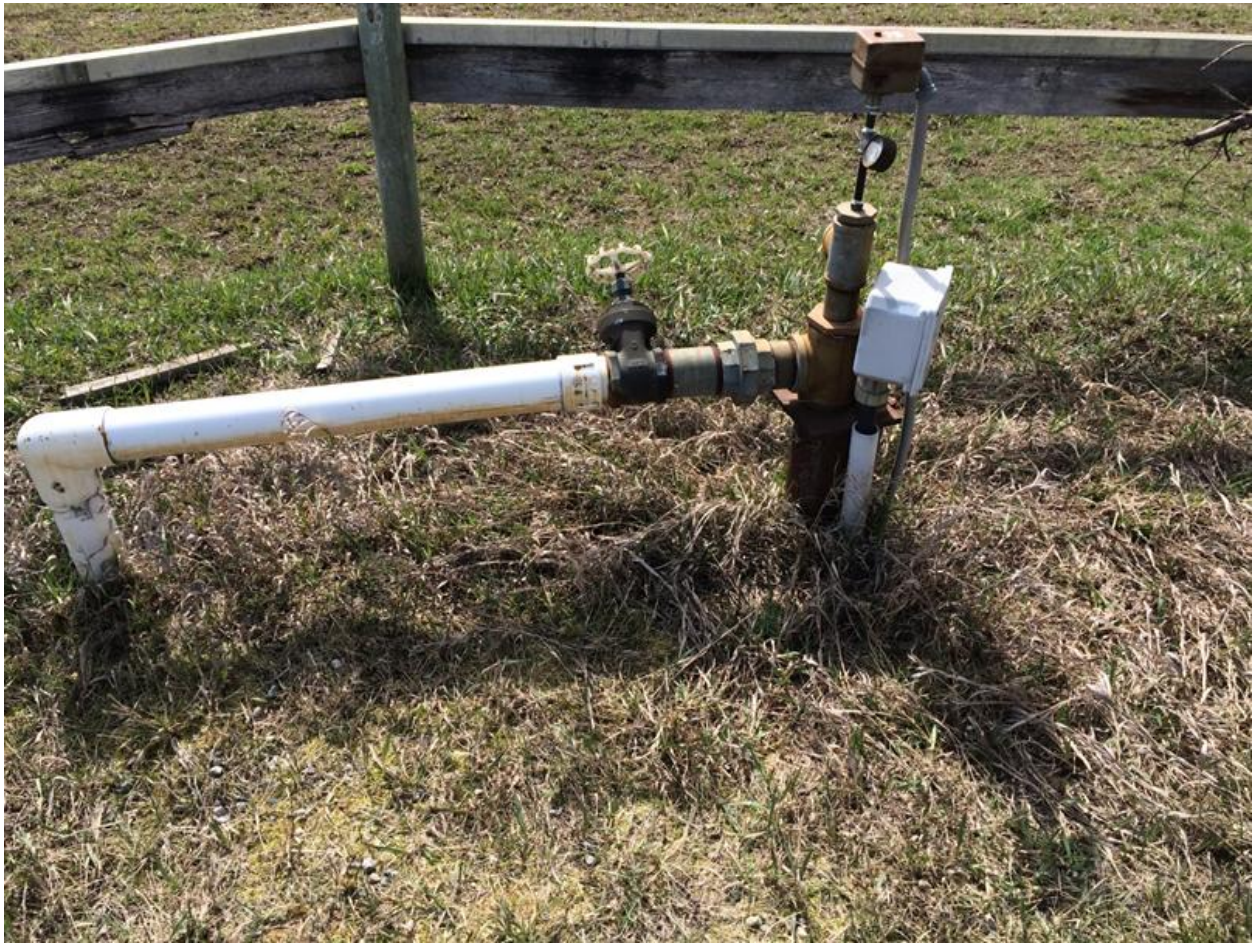
Figure 13: Well inspection 5. Photo taken on April 11, 2017.

No Well Identification Plate

- Outside irrigation well;
- Appropriate grading around wellhead;
- Appears sanitary; and,
- Pressure value on well read "0" at time of visit.

J. Pogson to provide a Well Identification Plate and well inspection documentation to the well owner.

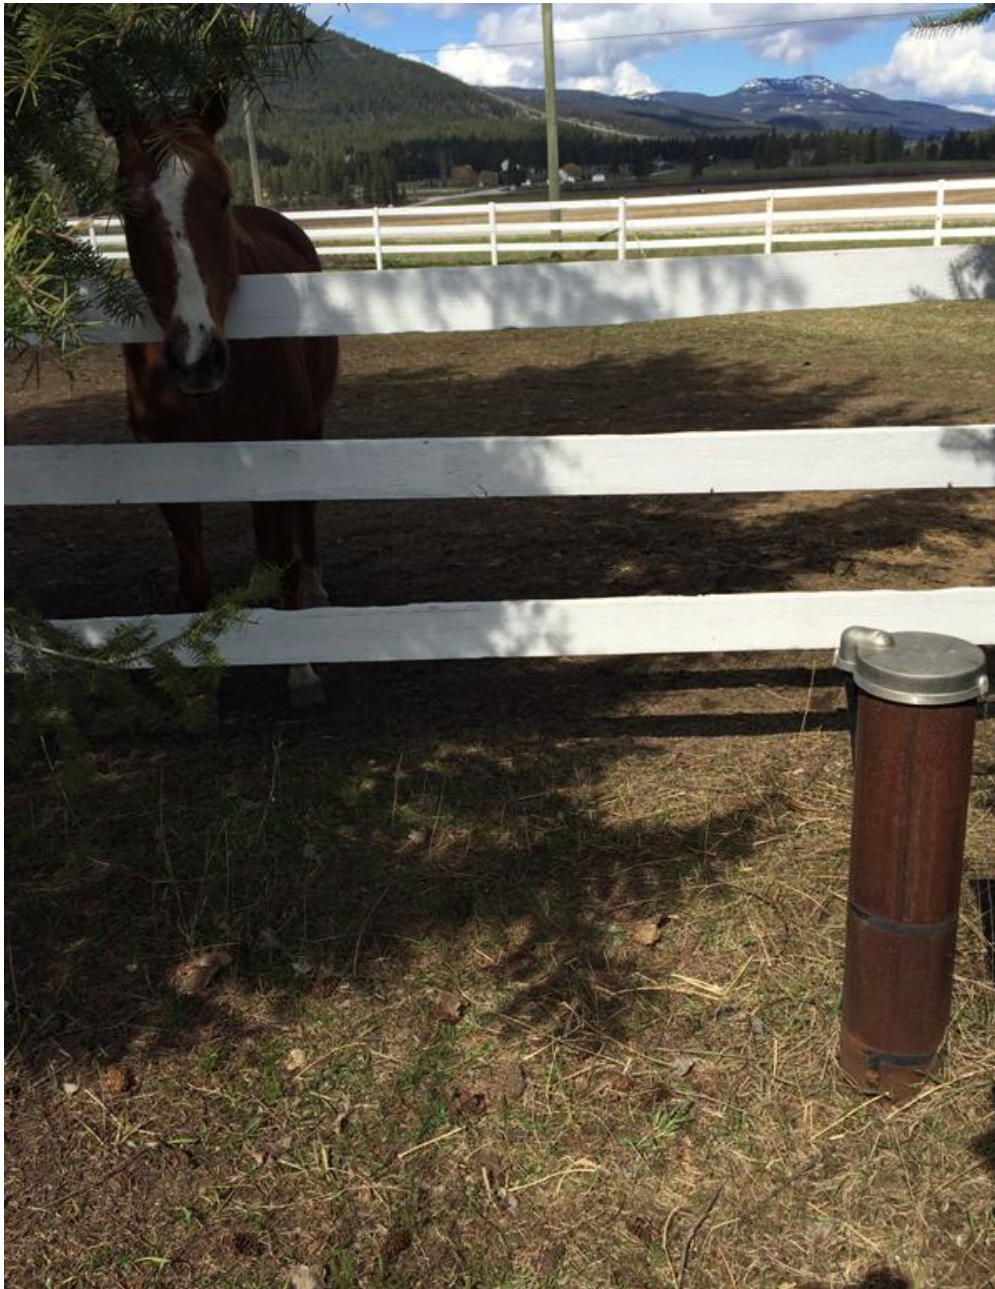
Figure 14: Well inspection 6. Photo taken on April 11, 2017.

The fifth registered well (Well inspection 6 below) was found to be constructed in a sanitary manner but was located in a close proximity to a horse enclosure. The well construction and grading around the wellhead indicates this well is not a significant potential hazard to surficial aquifer water quality.

Domestic well

No Well Identification Plate

- Outside with appropriate stickup and grading at ground surface;
- Within two metres of a fenced horse pen; and,
- No manure observed immediately adjacent to the well.

J. Pogson to provide a Well Identification Plate and well inspection documentation to the well owner as well as recommend further separation between the wellhead and the horse enclosure.
