MEMORANDUM

BC Ministry of Transportation and Infrastructure

PENDER ISLAND - CANAL ROAD DIP SLIDE ROCK DURABILITY TESTING MEMO (REVISION 1)

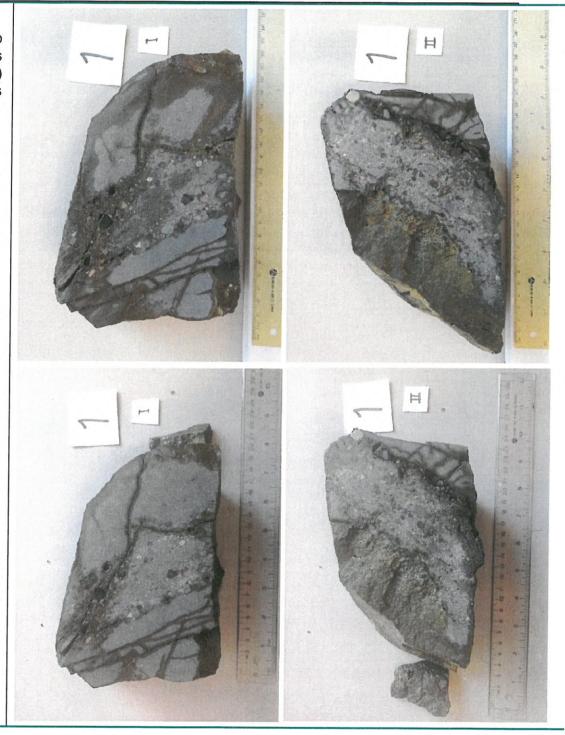
Photo 1.

Specimen ID	Initial Observation	Final Observation after 5 Cycles
1	Sample shows fractures and hairline fractures. Face I shows fractures and hairline fractures at random orientations. Face II shows fractures along the boundary between the fine sandstone and the gravelly sandstone.

The specimen remained intact and experience some material loss. The slab became more fragile with material loss upon slight touch. Fractures became wider and deeper. One cm-size chip detached form one edge.

Slab 1 prior to soundness cycles (upper photos) and after cycles (lower photos).

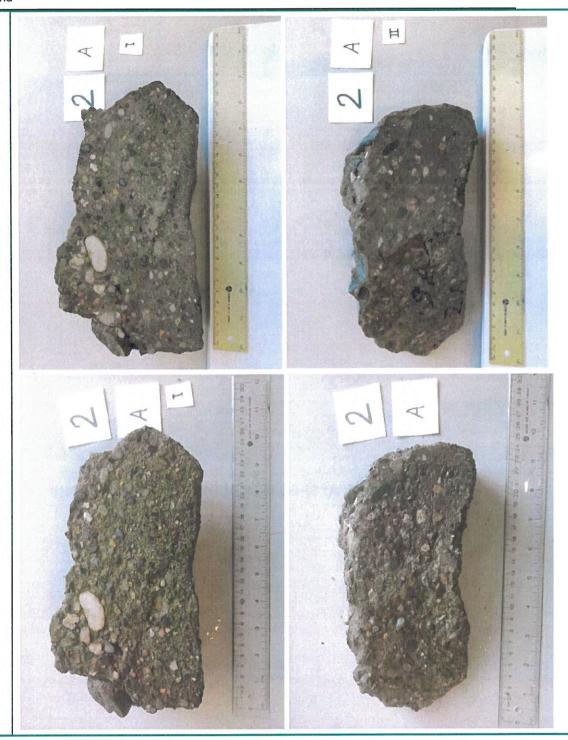
Photo 1.

Slab 2A: Light brownish grey, grey, beige, reddish orange, dark grey conglomerate. Reddish brown on the weathered surface. Pebble clasts are subrounded and have various shapes (some are subprismatic, some are oval, some are flattened). Grain size ranges from 2 mm to 4 cm. The sandy matrix is rust coloured, and the sand grains are angular to subangular. The lithological composition of the clasts includes volcanic, metamorphic, quartz, sandstone, siltstone, chert. Grains have a limonite-hematite coating. The sample can be scratched with a steel knife. Reaction to HCl is absent and no magnet response was observed. A few pits and vugs are visible under the microscope. The sample is fractured. Face I shows one fracture and one pit (a gravel clast that was removed during sample preparation), and one piece of slab is about to come off. Face II shows a few shallow pits.

Specimen ID	Initial Observation	Final Observation after 5 Cycles
2A	Few pits and vugs are visible under the microscope. Sample is fractured. Face I shows one fracture and one pit (a gravel clast came off during sample preparation), and one piece of slab is about to come off. Face II shows a few shallow pits.	Sample remained intact. The edges of the slab are more rounded. Minor material loss and some fine-grained material dislodges upon touch. Both faces became more porous and substantially rougher. Some gravel clasts came off.
2B	Sample is fractured and few pits and vugs are visible. Face I shows few pits and a couple of small fractures running around the gravel clasts. Face II shows three discontinuous fractures and a few pits, and one gravel clast about to detach.	Sample remained intact. Some gravel clasts came off, and the cracks around the pebbles became wider. Face II became more porous and rougher.

Slab 2A prior to soundness cycles (upper photos) and after cycles (lower photos).

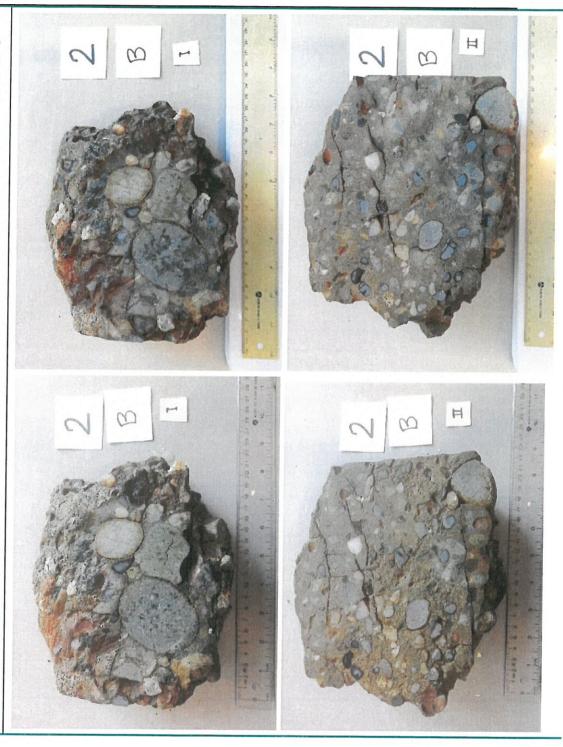
Photo 2.

Slab 2B: Light brownish grey, grey, beige, sand-supported conglomerate. Light rusty brown on weathered surface. Pebble clasts are subangular to subrounded and have various shapes (some are subprismatic, some are oval, some are flattened). Grain size ranges from a few mm to 5.5 cm, and average 1 cm. The sandy matrix is rust coloured, and the sand grains are angular to subangular. The lithological composition of the clasts includes volcanic, granitic, metamorphic, quartz, sandstone, siltstone, and chert. Grains have a limonite-hematite coating. The sample can be scratched with a steel knife. Reaction to HCl is absent and no magnet response was observed. The sample is fractured and a few pits and vugs are visible.

Face I shows a few pits and a couple of small fractures around the gravel clasts. Face II shows three discontinuous fractures and a few pits, and one gravel clast about to detach.

Slab 2B prior to soundness cycles (upper photos) and after cycles (lower photos).

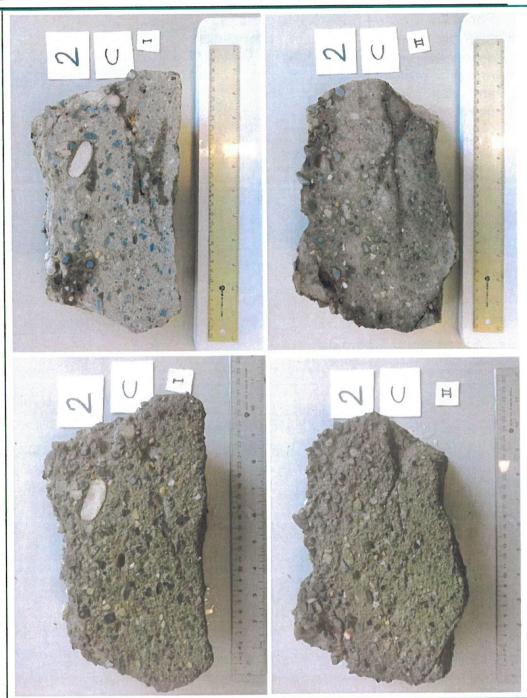
Photo 3.

Slab 2C: Light brownish grey, grey, beige, reddish orange, dark grey, sand-supported conglomerate. Reddish brown on weathered surfaces. Pebble clasts are subrounded and have various shapes (some are subprismatic, some are oval, some are flattened). Grain size ranges from 2 mm to 4 cm, and average 4-5 mm. The sandy matrix is rust coloured, and the sand grains are angular to subangular. The lithological composition of the clasts includes volcanic, metamorphic, quartz, sandstone, siltstone and chert. Grains have a limonite-hematite coating. The sample can be scratched with a steel knife. Reaction to HCl is absent and no magnet response was observed. A few pits and vugs are visible under the microscope. Sample is fractured. Face I shows few pits (a result of gravel clasts that came off during sample preparation). Face II shows few shallow pits and three fractures.

2C	Few pits and vugs are visible under the microscope. Sample is fractured. Face I shows few pits (as result of gravel clasts that came off during sample preparation). Face II shows few shallow pits and three fractures.	Sample remained intact. Some debris can be dislodged upon touch. The edges of the slab are rounded, and the overall porosity is much higher. The sample exhibits a more intense rusty color on the edges. Face I became more porous and rougher. The sandy matrix eroded, and the gravel clasts stand out. The fractures became wider and deeper. Face II one triangular piece came off from the right side. The surface is rougher and more porous. The gravel clasts stand out against the more eroded sandy matrix. Many gravel clasts came off.

Slab 2C prior to soundness cycles (upper photos) and after cycles (lower photos).

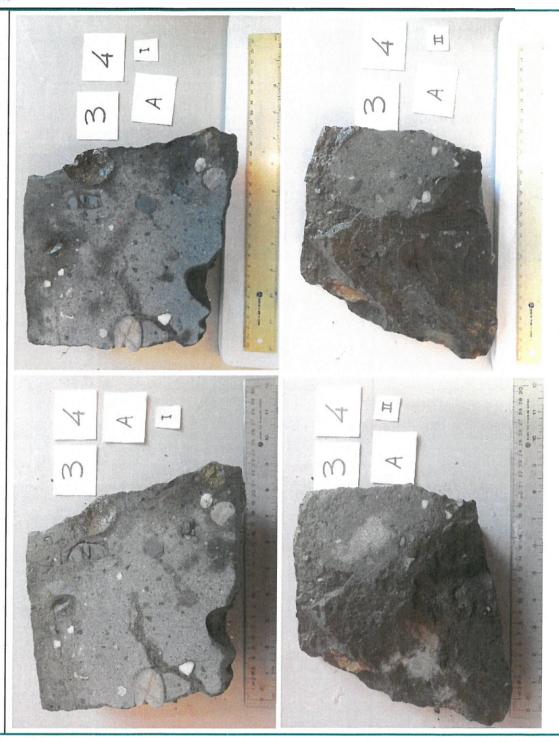
Slab 3/4A: Dark grey, grey, beige, and brownish grey, medium-grained pebbly sandstone. Rusty brown on weathered surface. The sand grains are angular to sub-angular and have variable shapes. The pebble clasts are subrounded to rounded. The lithological composition of the grains comprises chert, quartz, volcanic, minor carbonate grains and a trace of shale/schist. The sample can be scratched with steel knife with effort, locally with minor effort, locally cannot be scratched. Reaction to HCl is localized on the carbonate grains, and no response to magnet was observed, except for some rare gravel clasts where there was a very weak attraction. The sample is pitted from grains that came off during sample preparation and shows a few fractures. Face I shows a few pits and one curved hairline fracture.

Specimen ID	Initial Observation	Final Observation after 5 Cycles
3/4A	Sample is pitted (from grains that came off during sample preparation) and shows a few fractures. Face I shows a few pits and one curved hairline fracture.	Sample remained intact. Minimal loss of debris upon touch. Face I the top right corner became more porous and one new hairline fractured developed. Face II loss of material from the edges of the polished face, and the edges became rounded and more porous. Loss of some gravel clasts.
3/4B	Sample is pitted (from grains that came off during sample preparation) and shows a few fractures. Face I shows few pits, few hairline fractures, two small and one long fractures. Face II shows two small hairline fractures.	Sample remained intact. No change.
3/4C	Sample is pitted (from grains that came off during sample preparation) and shows a few fractures. Face I shows few pits. Face II shows the large rounded pebble clasts with microcracks.	Sample remained intact. No change.

Photo 1.
Slab 3/4A prior to soundness cycles (upper photos) and after cycles (lower photos).

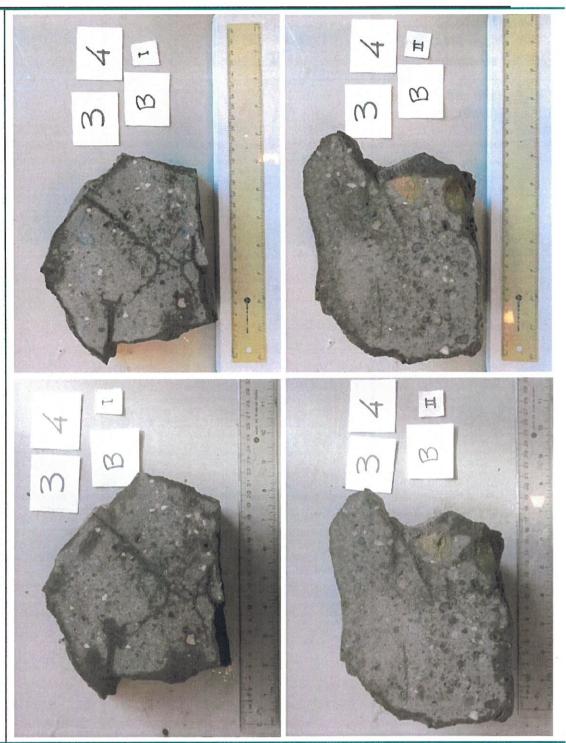
Slab 3/4B: Dark grey, grey, beige, and brownish grey, medium-grained pebbly sandstone. Rusty brown on weathered surface. The sand grains are angular to sub-angular and have varying shapes. The pebble clasts are subrounded to rounded. The lithological composition of the grains comprises chert, quartz, volcanic, minor carbonate grains and a trace of shale/schist. The sample can be scratched with steel knife with effort, locally with minor effort, locally cannot be scratched. Reaction to HCl is localized on the carbonate grains, and no response to magnet was observed, except for some rare gravel clasts where there was a very weak attraction. The sample is pitted as a result of grains that were removed during

sample preparation and shows a few fractures. Face I shows a few pits, a few hairline fractures, and two small and one long fractures. Face II shows two small hairline fractures.

Photo 2. Slab 3/4B prior to soundness cycles (upper photos) and after cycles (lower photos).

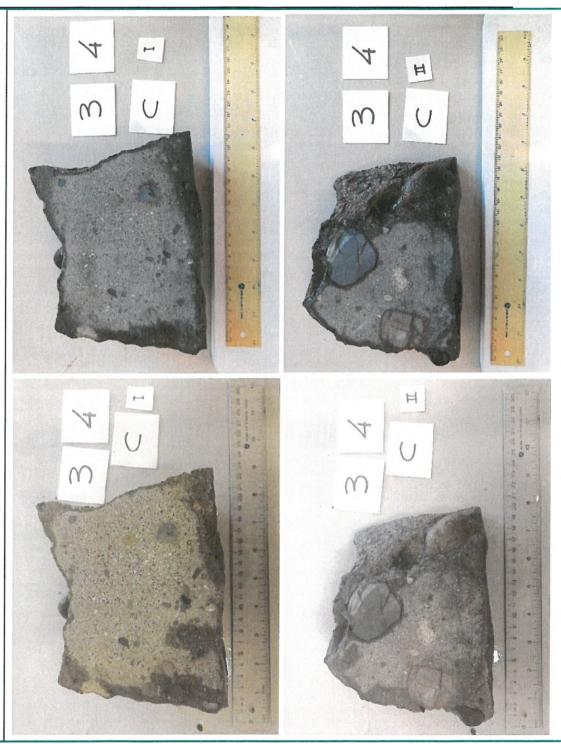
Photo 3.
Slab 3/4C prior to soundness cycles

Slab 3/4C: Dark grey, grey, beige, and brownish grey, medium-grained pebbly sandstone. Rusty brown on weathered surfaces. The sand grains are angular to sub-angular and have varying shapes. The pebble clasts are subrounded to rounded. The lithological composition of the grains comprises chert, quartz, volcanics, minor carbonate grains and a trace of shale/schist. The sample can be scratched with steel knife with effort, locally with minor effort, locally cannot be scratched. Reaction to HCl is localized on the carbonate grains, and no response to magnet was observed, except for some rare gravel clasts where there was a very weak attraction. The sample is pitted as a result of the removal of grains during sample preparation and shows a few fractures. Face I shows a few pits. Face II shows the large rounded pebble clasts with microcracks.

soundness cycles (upper photos) and after cycles (lower photos).

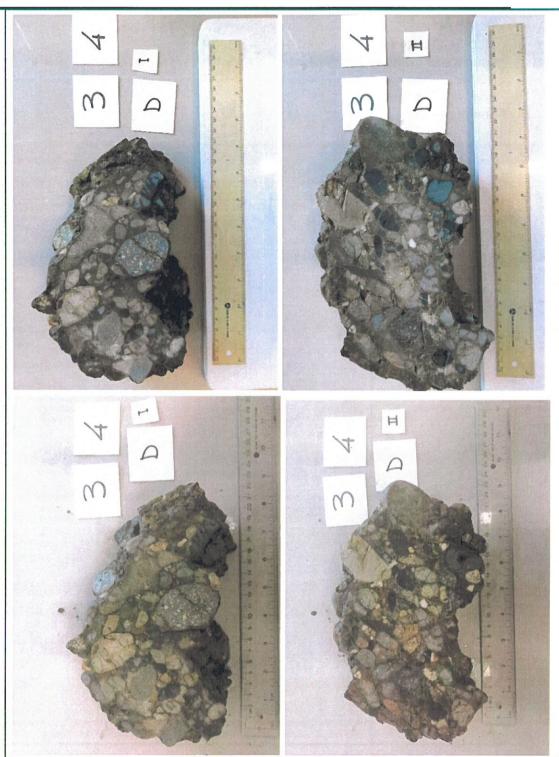
Photo 4.

Slab 3/4D: Grey, dark grey, light grey, greenish grey, brownish grey on weathered surface conglomerate. Matrix-supported. Clasts are subrounded to subangular and have various shapes and sizes up to 5 cm. The sand grains of the matrix are angular to subangular. The lithological composition of the clasts includes volcanic, siltstone, sandstone, chert, quartz, altered and weathered granitoids. The sample can be scratched with steel knife with variable effort. No response to the application of HCl was observed. Magnetis response was localized only on one volcanic clast of basaltic composition and was otherwise absent. The sample is pitted and fractured. Minor debris came off upon touch. Face I of the slab shows a few pits near the edges and hairline fractures, some around the harder clasts, some softer grains were fractured. Face II is pitted and shows abundant fractures, many going around the larger and harder clasts, and some fractured softer clasts.

3/4D	Sample is pitted and fractured. Minor debris came off upon touch. Face I of the slab shows a few pits near the edges and hairline fractures, some around the harder clasts, some softer grains were fractured. Face II is pitted and shows abundant fractures, many going around the larger and harder clasts, and some fractured softer clasts.	Sample remained intact. Some debris coming off upon touch. Both faces became slightly more porous, and some gravel clasts came off. The cracks around the larger pebbles became wider and deeper.

Slab 3/4D prior to soundness cycles (upper photos) and after cycles (lower photos).
