June 28, 2023 Project No.: 0272102

Re: Crazy Creek Bridge –Geotechnical Assessment of Scour and Erosion Mitigation Design

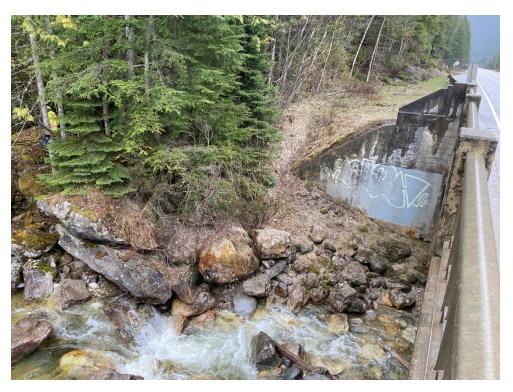
- East abutment area is shown in Photographs 1 to 4 and 10.
- BGC observed that there is no riprap amour against the foundation wall and at the downstream wingwall. Some cobbles and boulders were present at the upstream wingwall.

Photograph 2. View looking east at the upstream wingwall of the east abutment (Photograph by BGC taken on April 26, 2023).

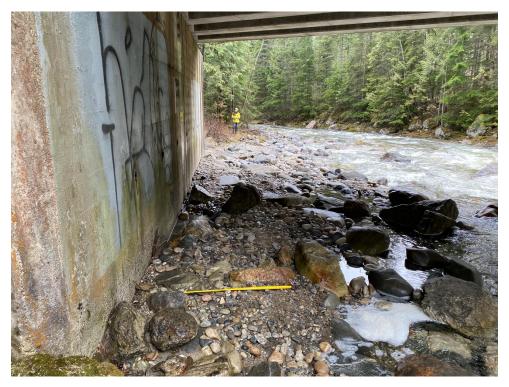
Photograph 3. View looking south (downstream) along the east abutment foundation wall. The measuring tape is extended to 1 m in the photo (Photograph by BGC taken on April 26, 2023).

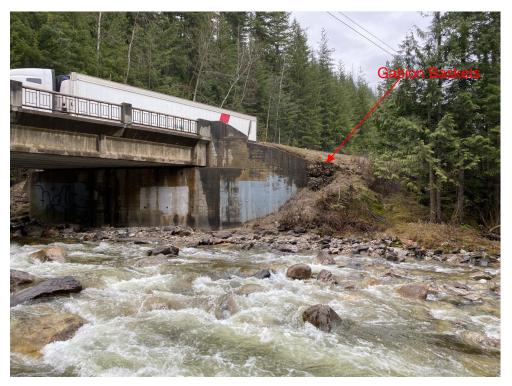
- Gabion baskets (total basket area about 1.9 m long by 1.8 m high) were observed extending downstream of the east abutment wingwall, shown in Photograph 4. BGC infers that the baskets were installed as a result of a loss of creek channel bed material and to maintain road embankment material. The baskets appear to have reached their service life with the basket infill bulging and some damaged/disconnects in the basket wires, shown in Photograph 11. The baskets are retaining soil behind the wingwall with no evidence of tension cracks behind the wall.

Photograph 4. View looking east (upstream) at the downstream wing wall of the east abutment. (Photograph by BGC taken on April 26, 2023).

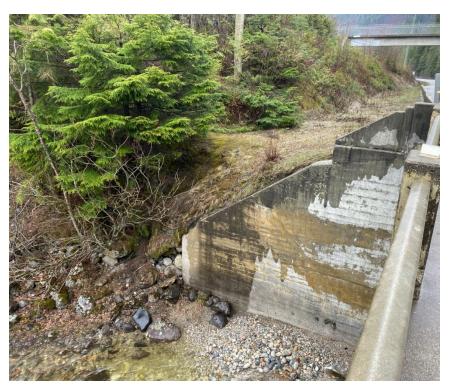
- West abutment area is shown in Photographs 5 to 9.
- BGC observed that there is no riprap amour against the foundation wall and at the downstream wingwall. Some cobbles and boulders were present at the upstream wingwall.
- Due to elevated creek flows, BGC was not able to walk under the bridge and observe the foundation wall and could only be observed from a distance.
- The downstream wingwall geometry is nearly perpendicular to Highway 1 alignment which is slightly different than the IFP drawings in Appendix B. The embankments slope immediately downstream of wingwall are very steep.

Photograph 5. View looking west at the downstream wing wall of the west abutment (Photograph by BGC taken on April 26, 2023).

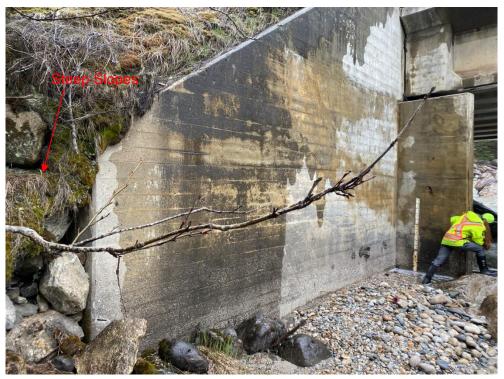
Photograph 6. View looking north (upstream) at the downstream wing wall of the west abutment (Photograph by BGC taken on April 26, 2023).

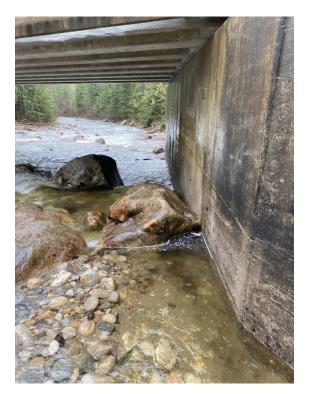
Photograph 7. View looking south (downstream) at the west abutment foundation wall (Photograph by BGC taken on April 26, 2023).

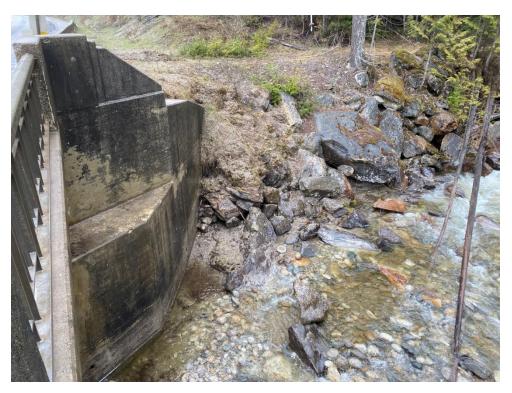
Photograph 8. View looking north (upstream) at the upstream wing wall of the west abutment (Photograph by BGC taken on April 26, 2023).

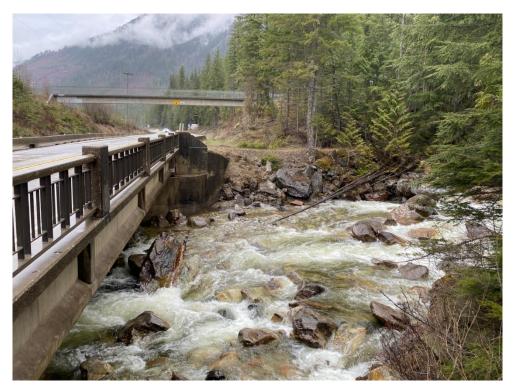
Photograph 9. View looking northwest at the upstream wing wall of the west abutment (Photograph by BGC taken on April 26, 2023).

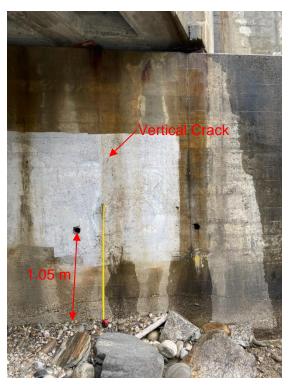
- A hairline crack was observed between the last two downstream drain holes on the abutment wall. The crack was vertical and extended from the top of the foundation wall to within 0.5 m of the gravel channel bed. A crack aperture of 1 mm or less was measured.

Photograph 10. View looking southeast at east abutment foundation wall. A vertical crack was observed extending from the top of wall to within 0.5 m of the gravel channel bed. A crack aperture of 1 mm was measured. The distance between the foundation wall drain hole to the current channel bed was measured to be 1.05 m (Photograph by BGC taken on April 26, 2023).

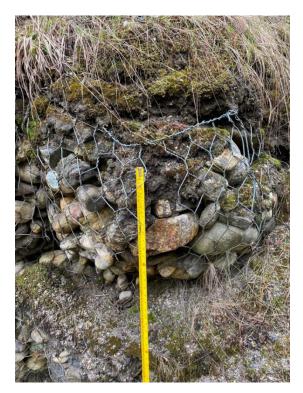
Photograph 11. View looking northwest damaged/disconnected wiring on the gabion basket (Photograph by BGC taken on April 26, 2023).

- 1. Where the wire facing on the gabion basket is damaged/disconnected (Photograph 11), it is recommended that additional wiring (of similar gauge) be stitched to close gaps in the basket.
- 2. At the downstream east abutment wingwall, the existing gabion wall can remain provided the riprap extends up to support the base of the gabion and prevent lateral movement. From a geotechnical perspective, it is recommended that there is no excavation of the soil down slope the gabion basket and only minimal stripping, 150 mm or less, occurs prior to the placement of riprap in this area. The placement of riprap should occur immediately following stripping activities. Visual monitoring and inspection shall occur (by a qualified person) during stripping, once the foundation soils are exposed and ongoing until riprap backfill is in place.
