# MOUNT POLLEY MINE TAILINGS STORAGE FACILITY BREACH

August 4, 2014

Investigation Report  
of the Chief Inspector of Mines

MOUNT POLLEY MINE  
MOUNT POLLEY MINING CORPORATION  
SUBSIDIARY OF  
IMPERIAL METALS CORPORATION

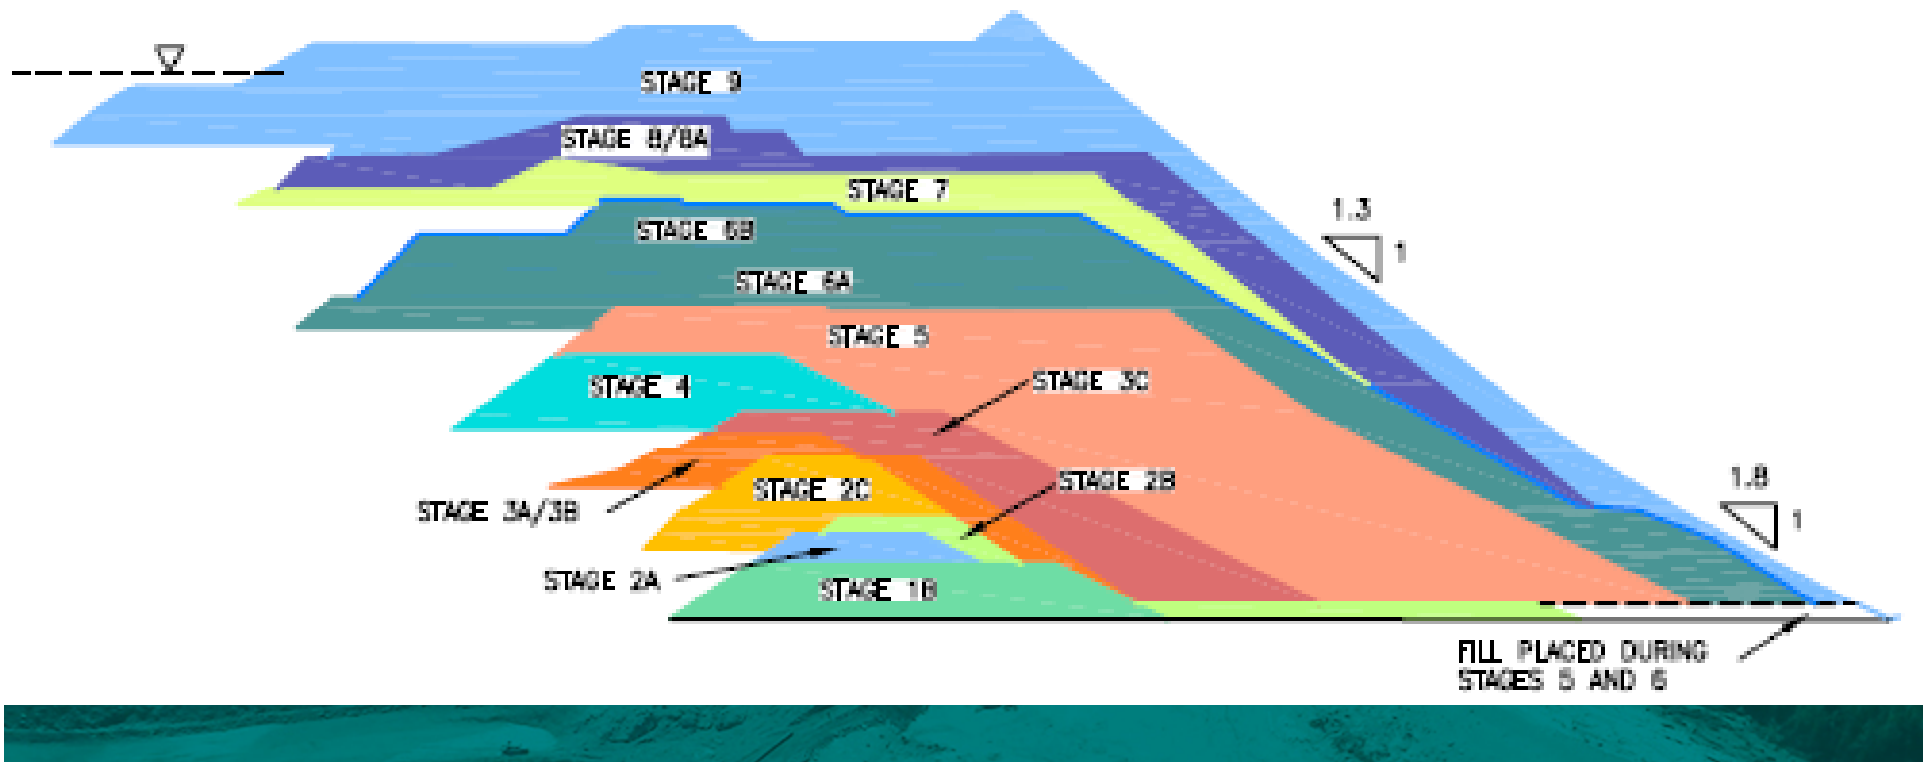
### Perimeter Embankment as-constructed condition

- Constructed in 9 stages (raises)
- Modified centerline dam with low permeability core zone, downstream rockfill with filters

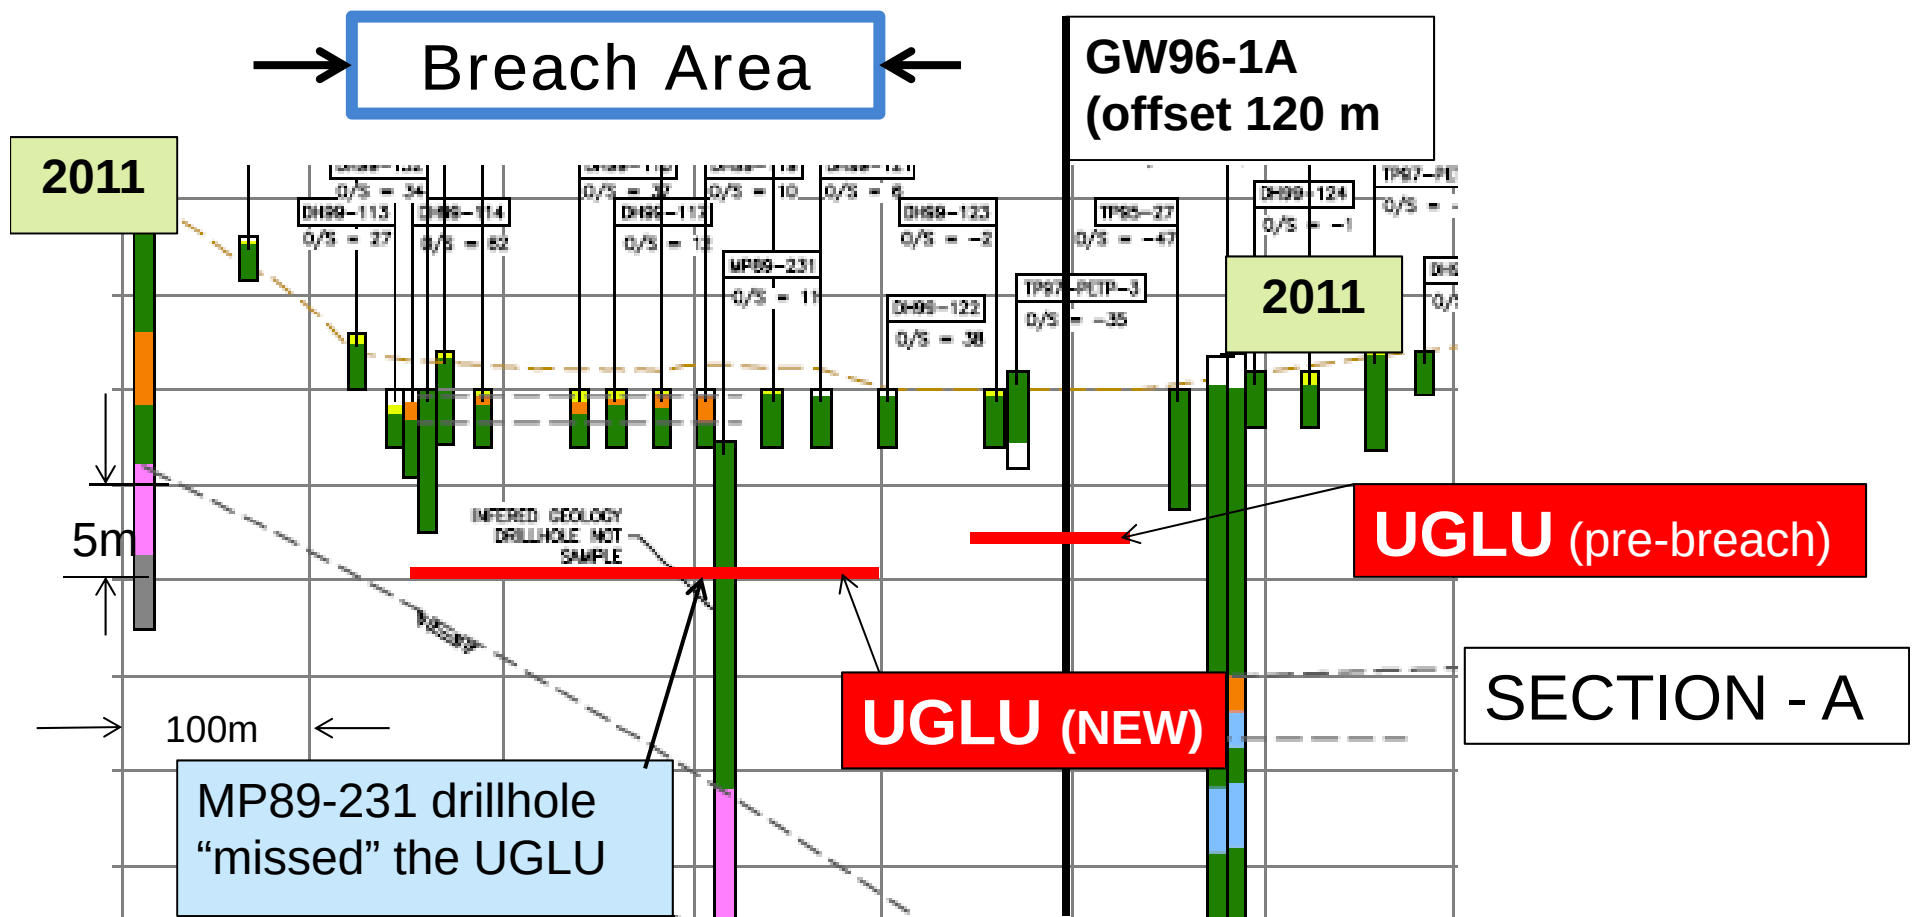
Limited deep soil investigations did not identify the weak clay layer (UGLU) - complex geologic history

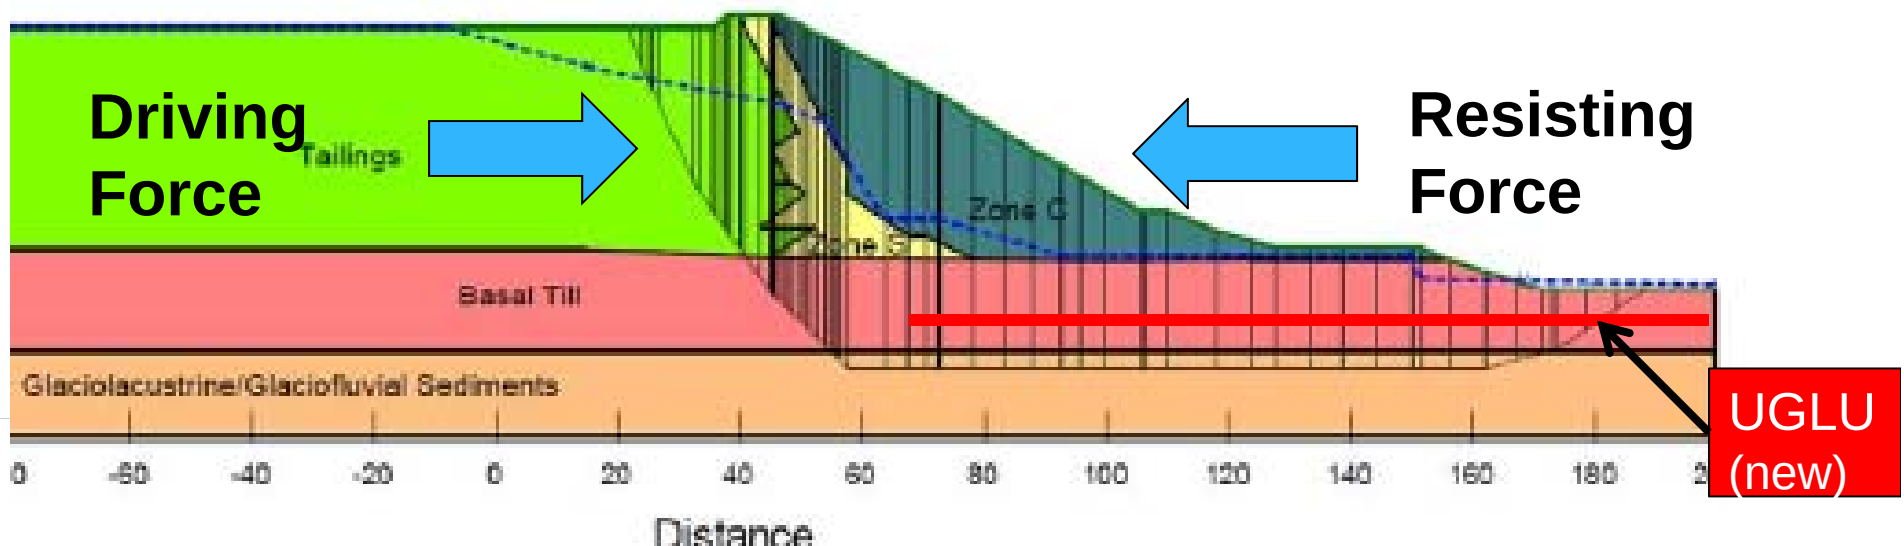
The soil foundation conditions did not include the UGLU.

- Purpose of stability analyses
- The expected Factor of Safety calculated for the stage 9 permit was 1.63
