Pilot of Procedure to Determine Unidentifiable Bridge Superstructure Components

K1629

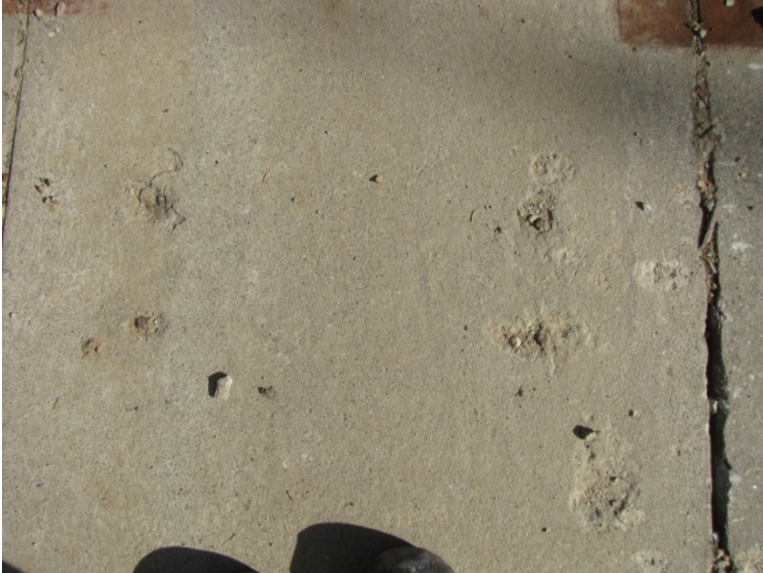
Minor spall damage around pre-existent lifting loops

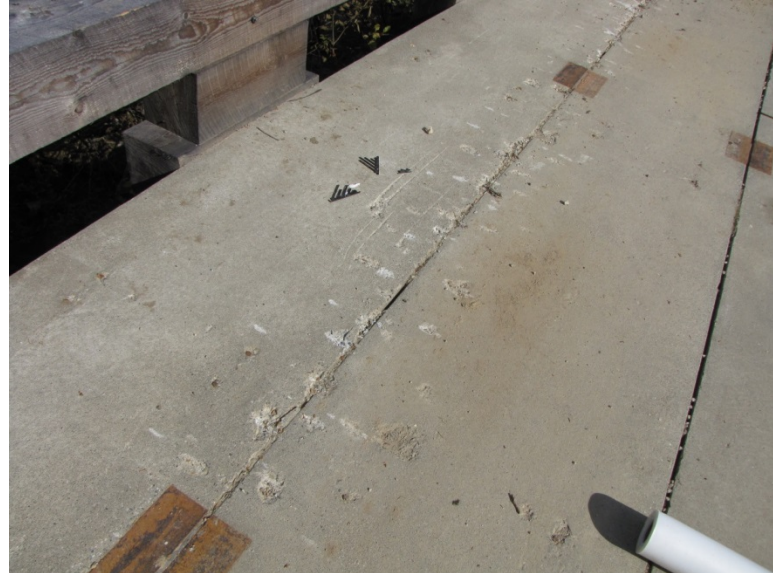
Chipping damage from track activity

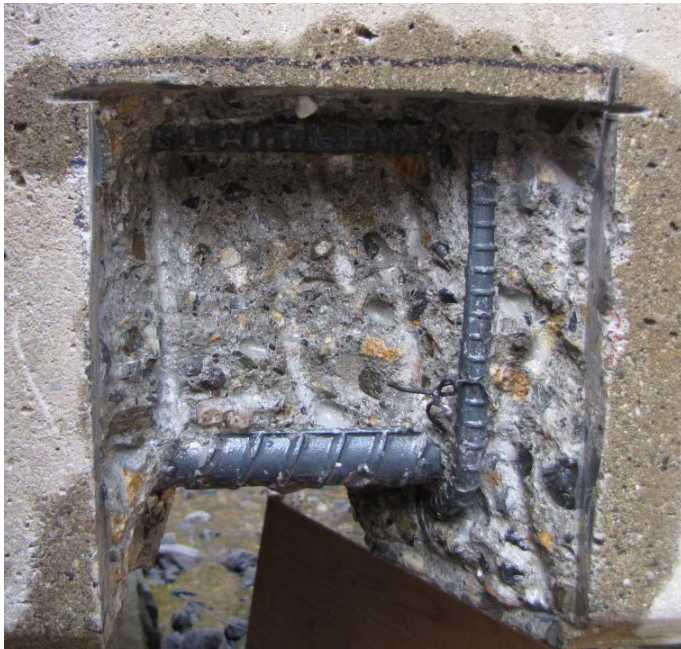
Side Face of Bridge Deck

- Concrete clear cover was 50mm on the underside and 45mm on the side face.
- Underside reinforcement matrix is arranged as three pairs of 20M + 25M and one pair of 25M in the centre
- Presuming that the slab is symmetrical about the longitudinal centreline, there would be three pairs of 20M + 25M on either side of the 25M pair.
- The shear reinforcement (side face) was found to be one 15M bar longitudinally accompanied by 10M stirrups.
- The top reinforcement and spacing between the stirrups was not observed.
- No rust or corrosion was noted on the reinforcement.
