Province of British Columbia
MINISTRY OF ENERGY AND MINES
Report of Inspector of Mines
Reclamation
(Issued pursuant to Section 15 of the *Mines Act*)

Mine Name: Tulsequah Chief Mine
Location: Atlin MD
Owner, Manager: (no manager has been assigned)

Type of Mining: METAL MINE UNDERGROUND
Date of Inspection: 2016/09/26
Accompanying Inspectors: Doug Flynn (MEM), Rory Cummings (MEM)

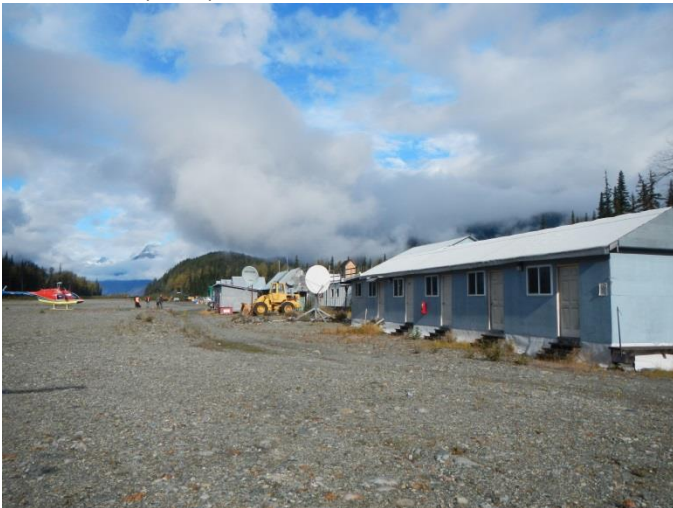
A general inspection of the airstrip camp was conducted looking at the overall condition of the facilities, security, signs of vandalism, or obvious signs of fuel spills. For the most part the camp is left unsecure except for the cook building and metal bunk trailer. Most other buildings were accessible with many of the buildings storing materials and equipment. Heavy equipment parked at the camp appeared to be secure and supplied with appropriate drip pans. Theft and vandalism is a potential concern given the site is relatively accessible and there is no caretaker on site.

Photo 1: Airstrip Camp

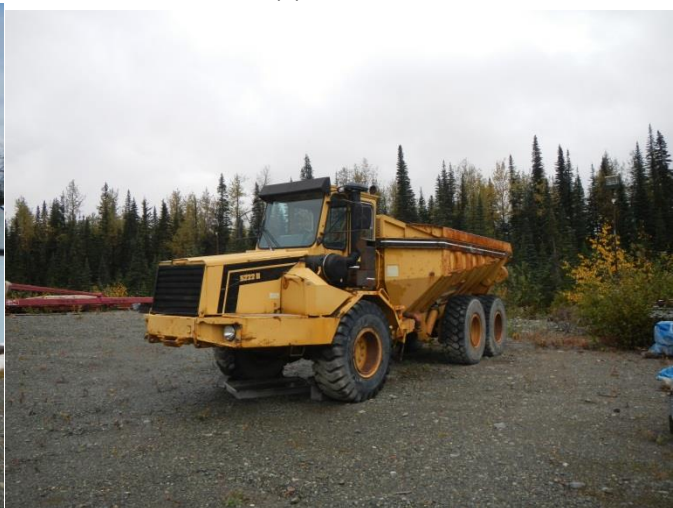
Photo 2: Rock truck with drip pan

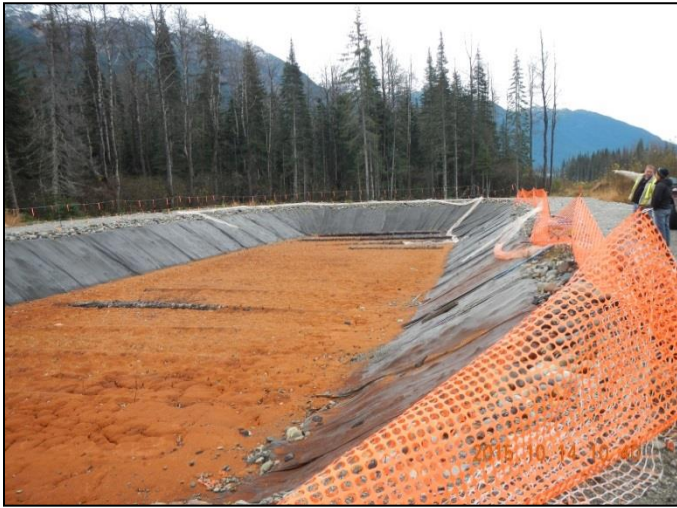
The lime sludge pit located adjacent to the airstrip remains inactive and in the same condition as was observed in 2015. CMI has maintained monitoring from 3 groundwater wells and until such time as the sludge is relocated, monitoring should continue.

Photo 3: Lime Sludge Pit at Shaza AirStrip. (2015 photo)

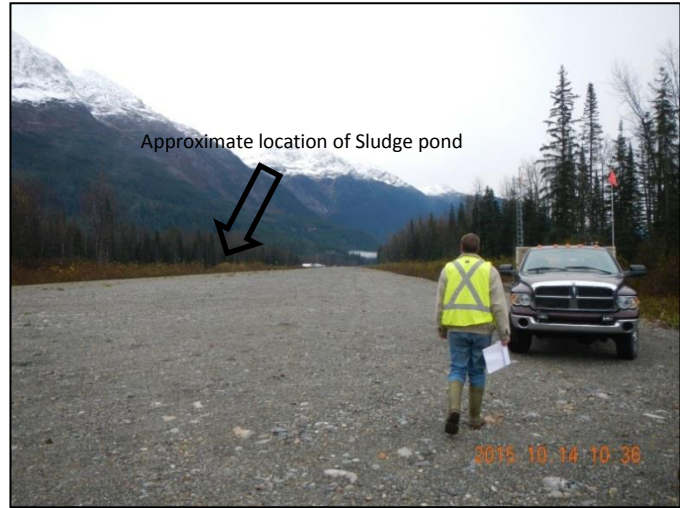
Photo 4: Shaza Airstrip, general location of Sludge Pit (2015 photo)

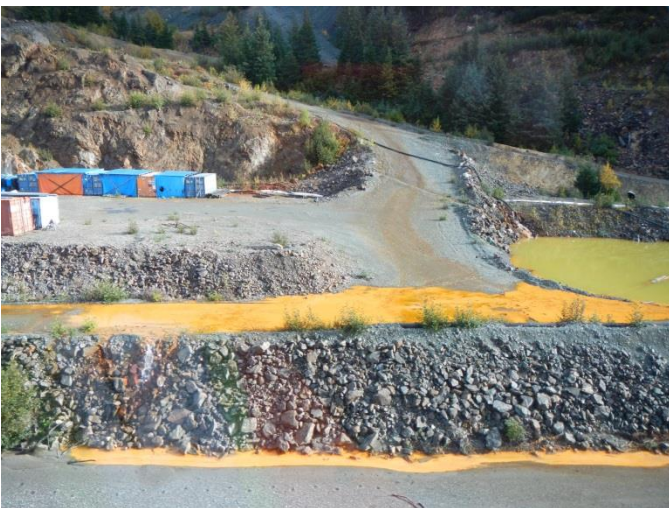
The exfiltration pond, is located adjacent to the 5200 portal and was built in 2011 as a settling pond for the mine portal drainage prior to being discharged to the Tulsequah River. There is no treatment of the portal waters other than the sludge being captured using filter cloth placed on the upstream side of the berm. In 2015 the company had to actively manage the pond by cleaning out the sludge to ensure maintenance of adequate capacity. At the time of this inspection, the exfiltration pond was no longer functioning as designed, likely the filter fabric is clogged from not being maintained, and the excess water is flowing over the rock berm and into the river.

As note in the 2015 inspection report, MEM had not approved the design, construction or operation of the exfiltration pond. As an order in the 2015 inspection, CMI was required to submit an as built and OMS manual for the operation of the pond. The manual was received by MEM, however given there is no continuous onsite presence, there is a significant concern that the pond is not being properly managed and may pose a risk if not immediately mitigated.

Photo 5 Exfiltration pond. Note overflow of mine portal water.

3. Pursuant to *Mines Act* 15.4.1, take remedial action. The Mine manager (in consideration of the EOR recommendations) shall immediately take action to alleviate the concerns observed at the Exfiltration Pond. A proposed plan and schedule for activities shall be submitted to the Chief Inspector by November 8, 2016.

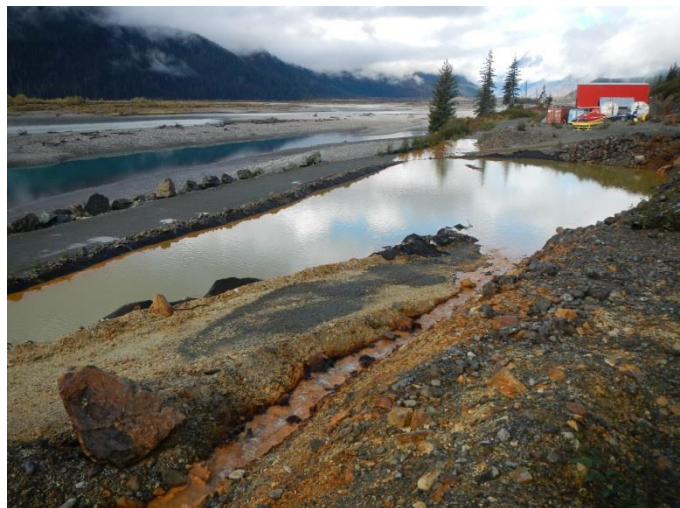
Photo 6: Exfiltration pond full of sludge mine portal water.

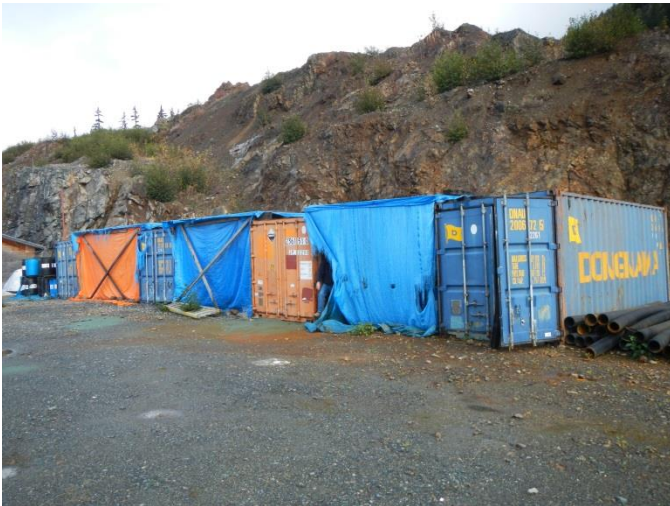
At the time of this inspection the AWTP building and generator building were locked and secure. Several sea-cans located adjacent to the AWTP and pad area still contain chemicals that are used in the WT process. Some of the storage locations remain secure in locked sea-cans (Photo 7), however there are materials exposed (Photo 8) and may pose a risk to water quality and/or wildlife that wander onto the site.

Photo 7: Stored WT chemicals, some in secured containers, others under tarps

4. Pursuant to *Mines Act* 15.4.1, take remedial action. The Mine manager shall take immediate action remove/secure all hazardous products from the mine site. A proposed plan and schedule for activities shall be submitted to the Chief Inspector by November 8, 2016.

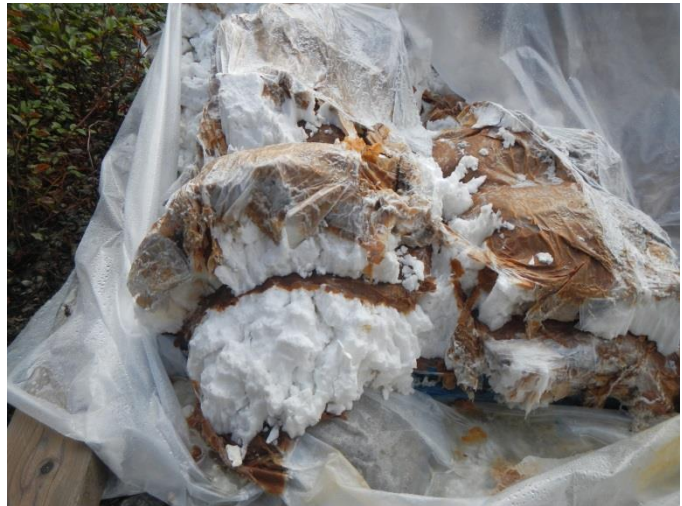
Photo 8 Exposed chemicals
