From: SPOMO1701@outlook.com
Sent: Tuesday, July 3, 2018 7:05 AM
To: Environmental Compliance ENV:EX; marty@chholdings.ca
Subject: SPO MO1701-Status Update June 30, 2018
Attachments: June 30, 2018 CHH Progress Report.pdf

FIELD REVIEW REPORT		DATE: June 30 2018	ISLANDER PROJECT No.: 2087
REPORT No: 23	STAGE OF CONSTRUCTION: Landfill Closure	WEATHER: Cloud cover, Sunny, 22 deg	1 of 3 PAGE:
PROJECT: Cobble Hill Landfill 2017 Minor Construction Works			
TO: CHH	ATTENTION: Marty Block		
CC:

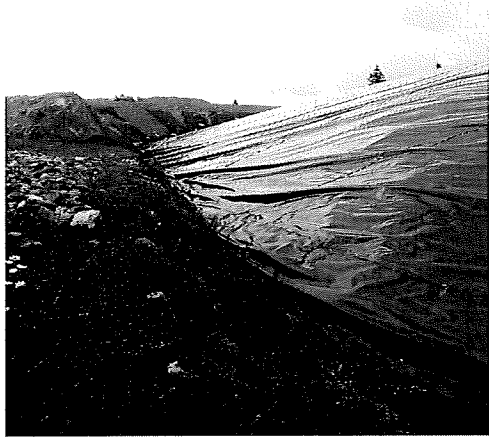
PEA – liner near NE corner

- **PEA**
 - Liner appears to be in good condition, and no noticeable changes since the date of our last inspection
- **Leachate and Leak Detention facility**
 - Total leachate collected: = **5.39 m³**
 - Total leachate stored = **37.60 m³**
 - Total leachate transported = **0 m³**
- **Soil Management Area (SMA)**
 - All works are in good condition and no noticeable changes since the date of our last inspection
- **Contact Water Containment Pond**
 - All works are in good condition and no noticeable changes since the date of our last inspection
- **cut-off ditch upland of PEA**
 - All works are in good condition, ditch still performing well.
