Testing of FLNR Standard Curb Systems

B. Robazza & S.F. Stiemer, Dept. of Civil Engineering, UBC August 2013

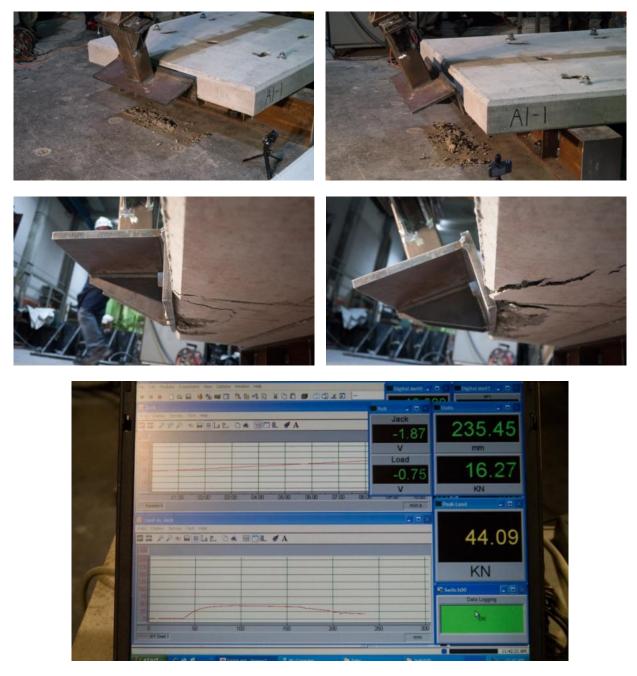
Figure 6: Images from A-1-1

Panels A, B and C all failed primarily due to crushing of the compression concrete beneath the anchors and up until the inset drip groove. There was very little surface cracking on the top of the panels as the relatively small compression zone of the bottom portion of the panel failed at load levels low enough that there was little strain on the anchors. The cracking was located only on the bottom side of the panel in the form of diagonal shear cracks extending to the drip groove from which they terminated. After the compression zone crushed and spalled away, the loads were transferred almost entirely through bending to the botts connecting the brackets to the panels. In one instance, bolt failure eventually occurred after significant bending stress and strains had been induced within the bolts.

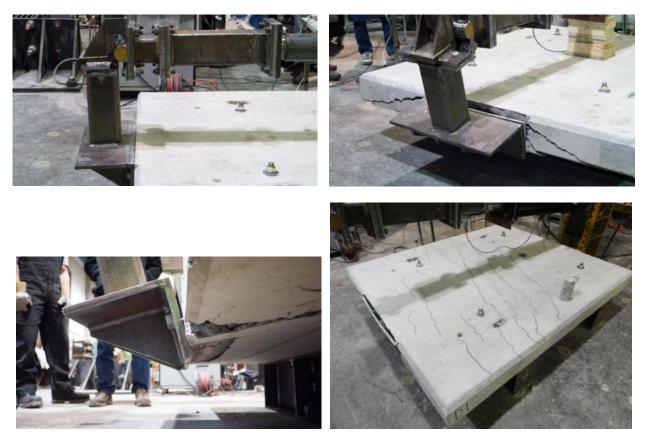
Figure 22: Concrete panel attachment detail failing

Panels D and E failed primarily due fractures of the exterior anchors with the most development length. After the majority of these four anchors had fractured, the interior four short anchors with insufficient development length would begin to pull out along their length. Interestingly, the most exterior, well developed anchor bars would fracture prior to the adjacent bars. This behaviour is not fully understood and may be due to varying workmanship during the welding. The cracking for these panels was extensive. On the top surface, the cracking consisted of flexural cracks extending over the breadth of the panels perpendicular to the loading. These cracks developed from roughly 300 mm from the bracket to the support holes on the opposite side of the panel. On the top surface near the bracket there were diagonal shear cracks forming a semicircular shape extending 250 mm along the length of the panel and 200 mm on either side of the bracket along the breadth of the panel. On the side face of the panel there were diagonal cracks formed at approximately 30° angles on either side of the bracket. On the bottom face of the panel, diagonal shear cracks extended from the bracket to the drip groove.

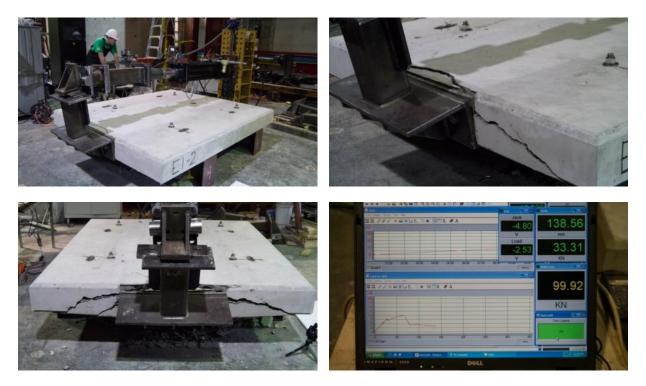
Figure 33: Images from E-1-2

Figure 32: Load/Deflection Curve of Top of Bracket, E-1-2 (Note initial slipping of support apparatus caused initial drops in load during the initial portion of the loading curve. There may have been an initial preload of roughly 50 kN which resulted in the low lateral load capacity of this specimen)

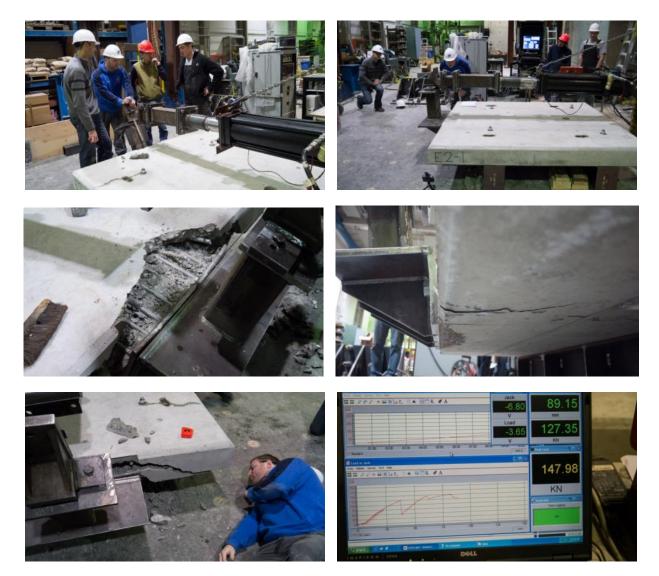
Figure 35: Images from E-2-1

Figure 34: Load/Deflection Curve of Top of Bracket, E-2-1 (Note drop in load of 83 kN at lateral displacement of 39 mm due to panel support apparatus shifting under load)

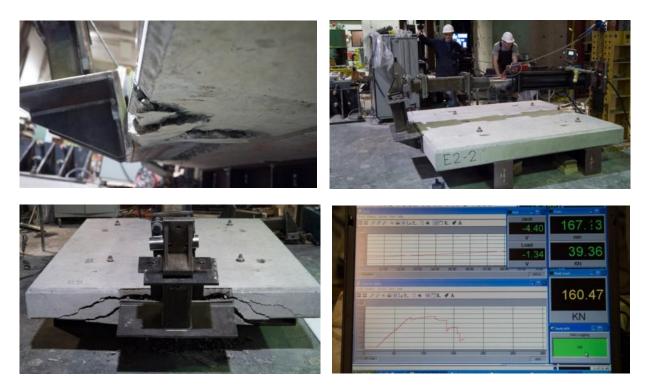
Figure 37: Images from E-2-2

Figure 36: Load/Deflection Curve of Top of Bracket, E-2-2 (Note that the major drops in load correspond to the capacity of an anchor bar as it fractured)

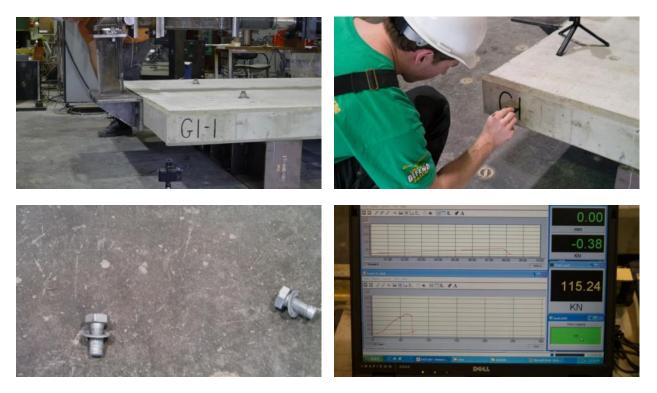
Figure 39: Images from G-1-1, loading to bolts stripping out of sockets

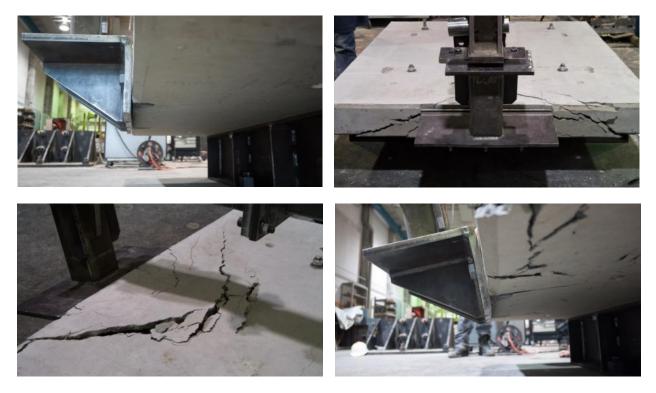
Figure 40: Images from G-1-1, new bolts, slightly longer (1/4")

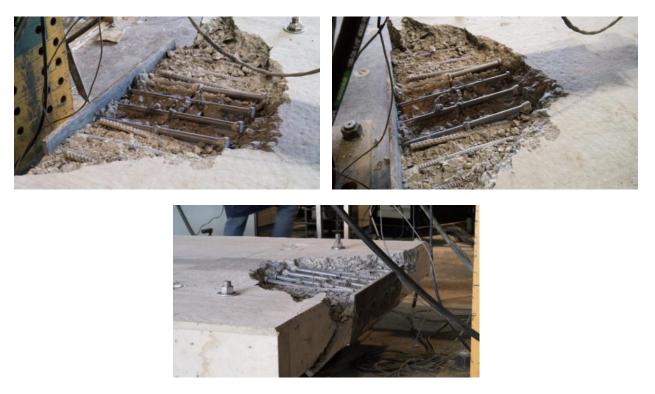
Figure 41: Images from G-1-1, failure inspection after top concrete removal

Panels G and H failed due to cover spalling on the top surface as the highly rigid Nelson studs experienced high levels of curvature. There were first flexural cracks extending over the length of the panel similar to what was observed for Panels D and E above. This was followed by shear cracks forming on the top surface at a distance corresponding to the length of the Nelson studs. At the peak load, the Nelson studs would spall off the cover concrete. At this point the load would remain nearly constant as the remaining anchors pulled out of the concrete. Similar to the D and E Panels, the cracking on the sides and bottom consisted of diagonal shear cracking to the bottom of the panels and the drip groove respectively.

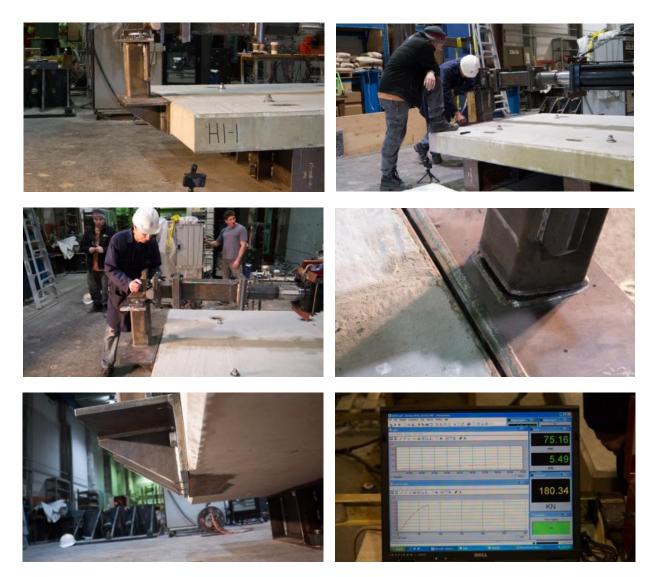
Figure 45: Images from H-1-1 to weld failure at post foot

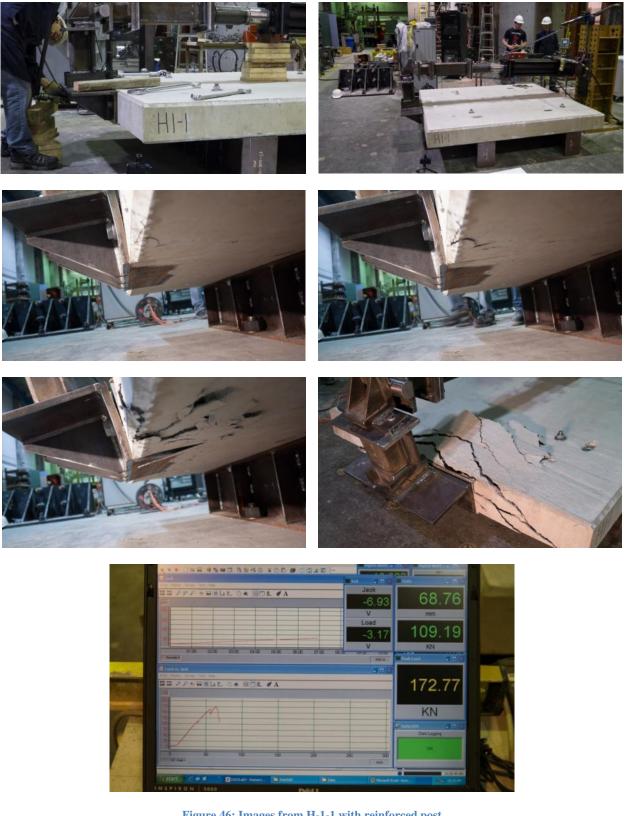
Figure 46: Images from H-1-1 with reinforced post

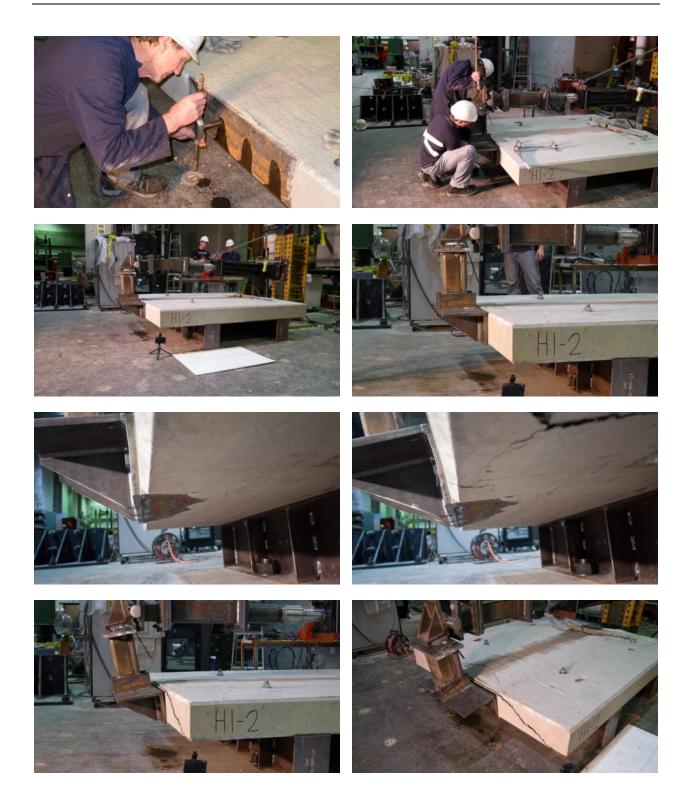
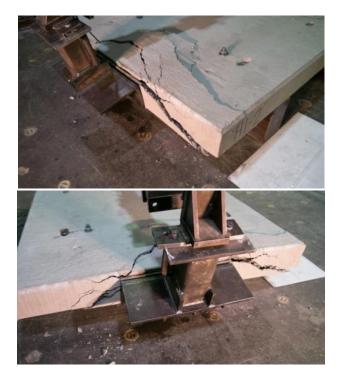
Figure 48: Images from H-1-2

Figure 47: Load/Deflection Curve of Top of Bracket, H-1-2 (Note the major drop in load at 97 mm lateral displacement was caused by the slippage of the support apparatus. Also note that the primary failure mechanism was characterized by the concrete cover above the Nelson studs breaking away as the rigid studs reached a critical curvature demand)

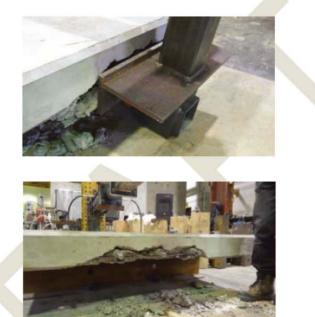
Figure 2 Typical Observed Failure of the Modified HSS Guide Retrofit Rail

Specimen ID ¹	Observed Peak Horizontal Load (kN)	Comments
4.3	154.8	Description: A307 bolts connecting barrier and concrete panel Failure Mode: Spalling of concrete in vicinity of inserts
4.4	124.1	Description: A307 bolts connecting barrier and concrete panel Failure Mode: Spalling of concrete in vicinity of inserts
4.5	164.4	Description: A307 bolts connecting barrier and concrete panel Failure Mode: Spalling of concrete in vicinity of inserts
