Ministry of Transportation & Infrastructure
Bridge Project
Holt Creek Trestle Bridge - Mile 59.7
Emergency Repair
Cowichan Valley Trail

DATE: 28 June 2000 CNR Cowichan Subdiv. + Holf Creek Trestle-Mile 59-7 MARTIN HOLDEN & ASSOCIATES, Consulting Engineers, 2000/27-0/ PH6-2277 OAK BAY AVENUE, VICTORIA, B.C., V8R 1G6. Proposed New Deck Details

FIGURE 3	Province of British Columbia - L.U. C.O.
A COUNTY OF THE PARTY OF THE PA	SCALE: 25 5 60 W 1 APPROVED BY DRAWN BY MARKET BOTTOM PER . REVISED
MARTIN HOLDEN & ASSOCIATES, Consulting Engineers PH6-2277 OAK BAY AVENUE, VICTORIA, B.C., V8R 1G6. TEL: (250) 592 3639; FAX: (250) 592 3641.	CNR Cowichan Subdiv Holf Creek Trestle - Mile 59.7
	Proposed Repairs and Additions 2000/27-02

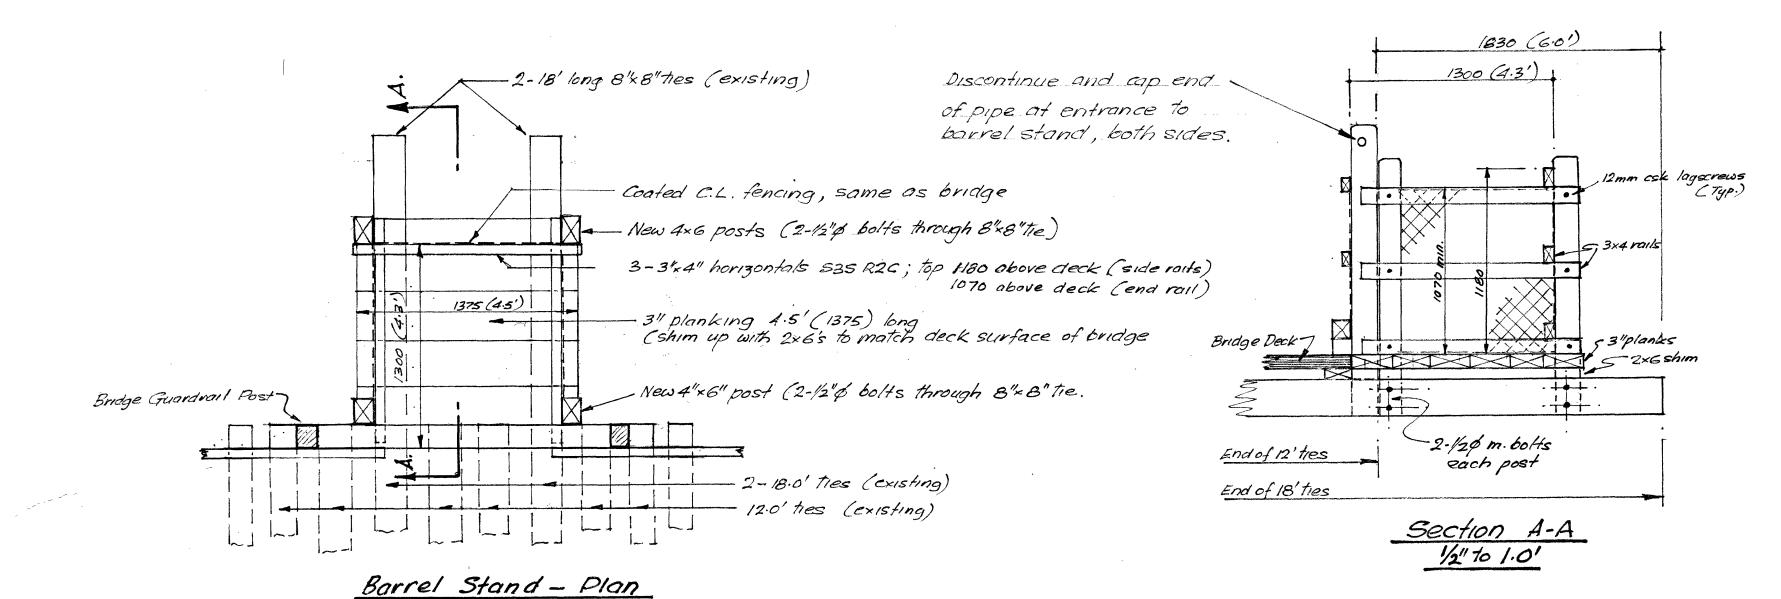
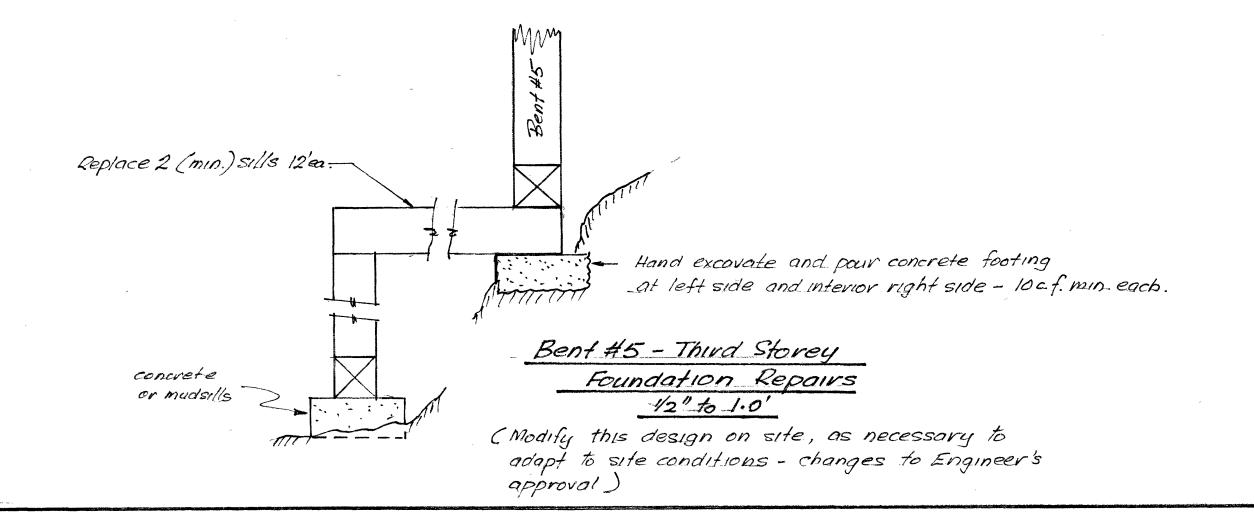
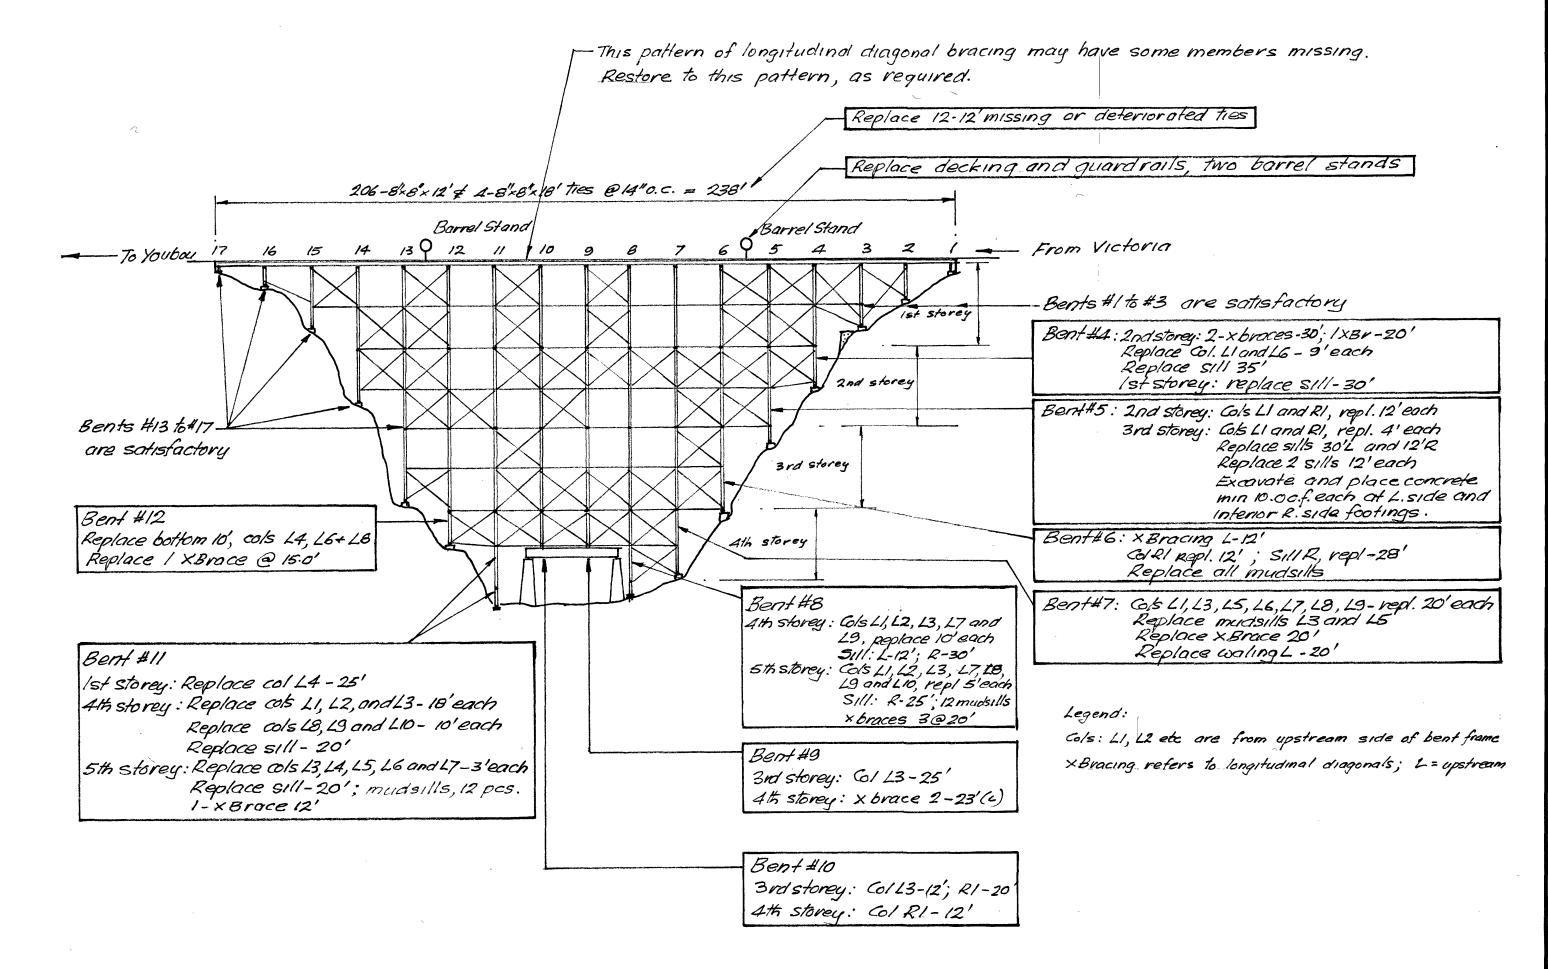
- 1. Bent #8 has a 5th storey ± 5.0' high; Bent #11 has a 5th storey ± 3.0' high.
- 2. The actual pattern of existing longitudinal x Bracing may be different from above diagram. Restore to above pattern.
- 3. Member sizes for replacements (nom.):- Columns 12"x12"; sills 12"x12"; walers 2-3"x10"; x braces 3"x10"; struts 6"x10"; long. diags 3"x10"; ties 8"x8"x12" x4'
- 4. See Sheet OI (Drawing No 2000/27-01) for specifications, and details of new deck and guardrails.
- 5. Construct approach guardrails to suit site; use design shown here as a guide (not in contract).
- 6. Work in river flood plain (Bents 7, 8 and 11) to be done with special care for environmental requirements
- 7. Secure chainlink fence material to each longitudinal guardrail timber by at least three staple nails,
- 8. Cap ends of guardrail top pipe.

- 3. Repair and replace missing and deteriorated timbers in bent caps, posts, sills, and cross braces as shown on Sheet 02
- 4 Replace missing or deteriorated longitudinal diagonals, struts, and girts, as shown on Sheet 02 (Drawing No 2000/27-02).
- 5 Replace deteriorated mudsills, as noted on Sheet 02; approx. quantity: 30 pcs. 12"x 12" x 4.0'
- .6. Reconstruct bent support and foundation, Bent # 5, as detailed on this sheet and Sheet 02.
- 7. Add new levelling strips (6"x6"x 12.0') on top of end bulkheads; reconstruct decking and guardrails two barrel stands.
- 8. New approach guardvails required at each end, both sides.
- 9. Clear and grub right of way for 3.0 m beyond the feet of bent towers, both sides. Approved disposal of debris.
- 10. Do other repairs, discovered as work proceeds, as called for by the Engineer (extra work item).
