LIONS GATE BRIDGE NORTH VIADUCT 2021 ORTHOTROPIC STEEL PLATE DECK INSPECTION REPORT

A234840

A234840-Lions-Gate-North-Viaduct-OSPD-Inspection-Report

2023 Mar 24

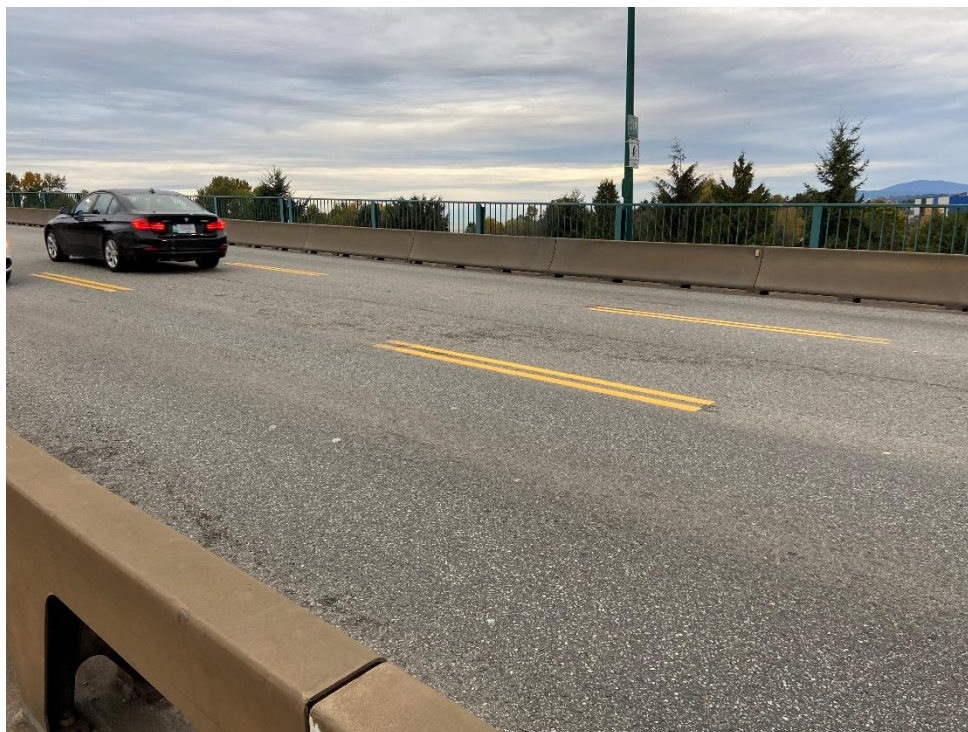
The typical wearing surface (not at the link plates) was observed from the sidewalk and no signs of unexpected movement of the deck plate were noted. For further detail on the condition of the wearing surface, refer to the Surface Condition Assessment Report [1].

Figure 5: Typical Wearing Surface Typical Condition.

No structural concerns were observed in the typical wearing surface or waterproofing, and therefore no associated actions are recommended. While some longitudinal cracking has been previously noted, COWI understands this occurred shortly after installation and is expected to increase in severity over time.

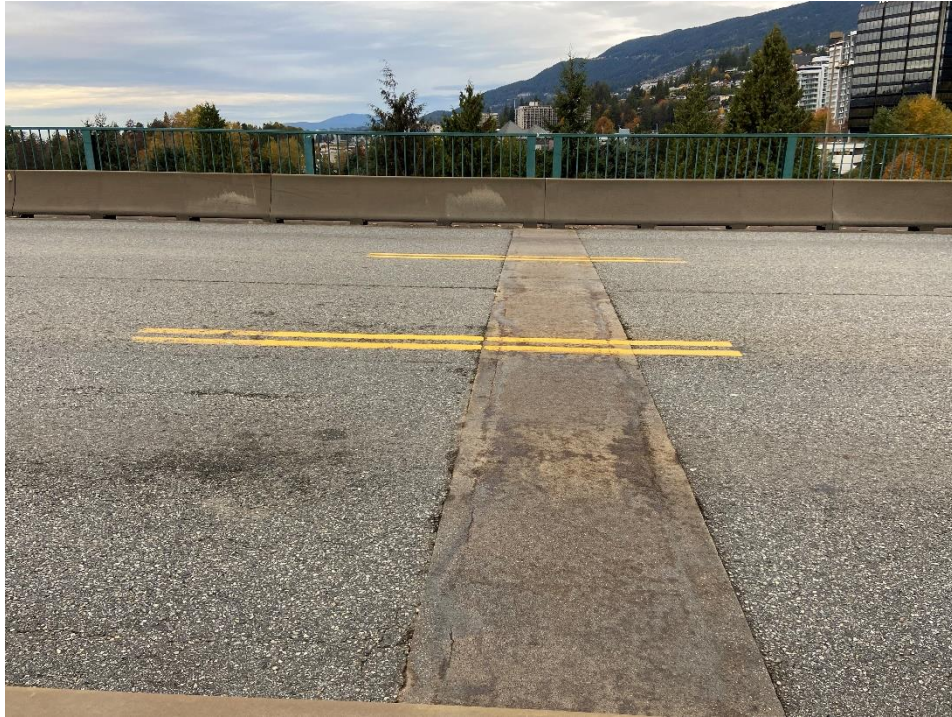
Similar to the typical wearing surface, the PPC wearing surface above the link plates was observed from the sidewalks. In general, the PPC wearing surface was observed to be in fair condition, with cracking observed in the transverse direction of the deck, as shown in Figure 6. This cracking is occurring along the edge of the link plates shown in Figure 4 that were installed in 2014.

Figure 6: Typical Cracking in Wearing Surface at Link Plates.

Some locations of PPC were observed to be exhibiting spalls and cracks. COWI recommends that these locations be investigated to determine if measures should be implemented before the full paving replacement is completed, possibly in conjunction with the mitigation measures associated with the link plates as outlined in Section 3.5 below.

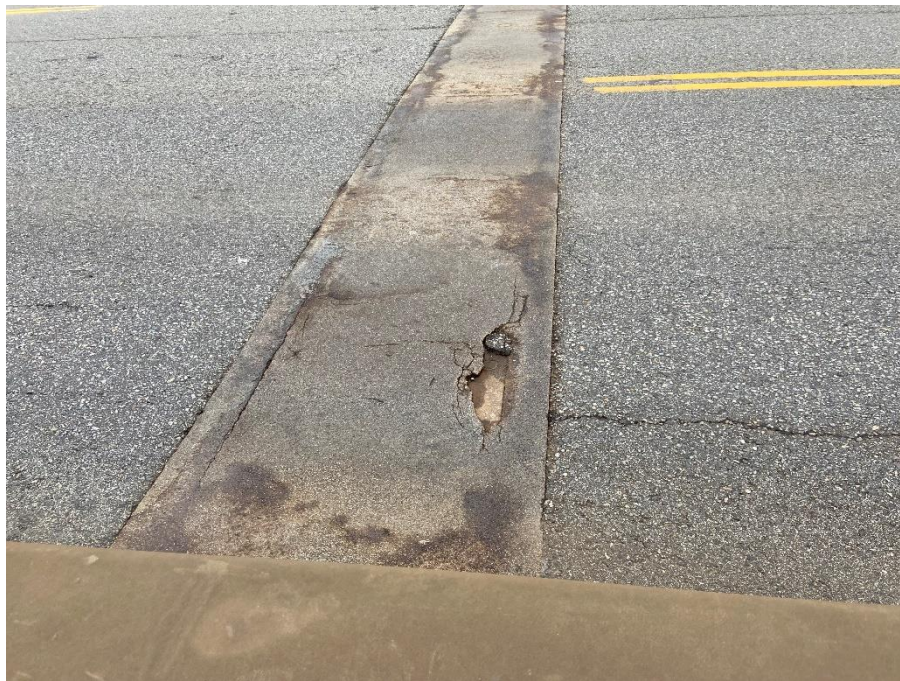
At some link plates, localized areas of spalling were observed, exposing the link plate underneath, as shown in Figure 7.

Figure 7: Localized Spalling in Wearing Surface at Link Plates.

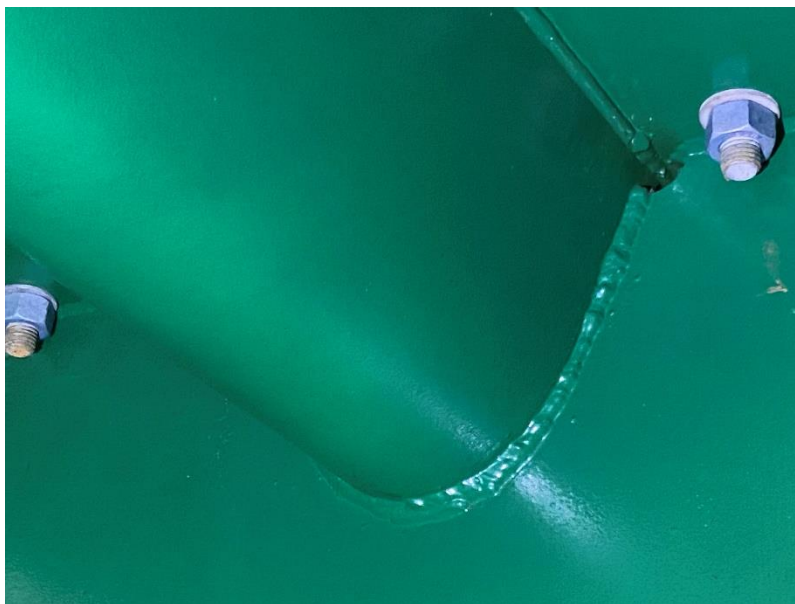
The OSPD trough welds connecting the trough to the deck plate (longitudinal) and to the floorbeams (vertical) were observed from the catwalks and the boom lift; these were found to be in good condition. At most of the locations inspected, the welds the paint system was found to be intact and there was no indication of cracking occurring. The typical condition of the welds is shown in Figure 8 below. The bolts shown in Figure 8 are those associated with the installation of a link plate.

Figure 8: Typical Trough Weld Condition.

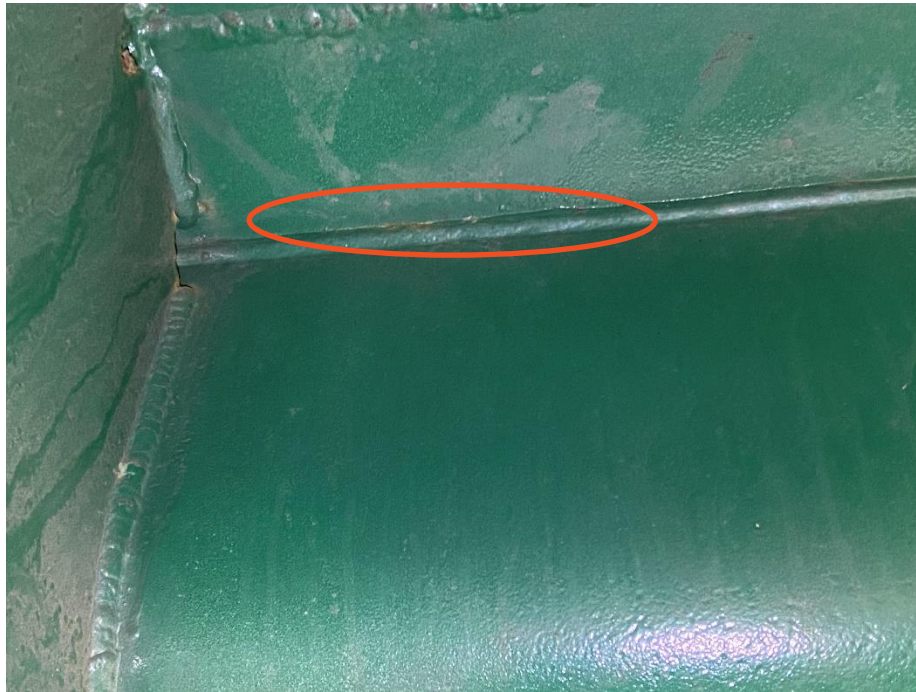
Figure 9: Minor Rusting on Longitudinal Weld on East Side of Trough 3 at 3rd Floorbeam from Bent 1 in the Direction of Bent 2.

The inspection did not note any significant defects or crack indications within the trough to top plate welds. However, as this is the susceptible region for fatigue cracking, particularly adjacent to floorbeams, COWI recommends that MPI testing be performed at the locations identified in Section 2.3 to confirm that no cracks are present in the welds. These locations were selected to represent the worst condition of the paint system observed to enable testing to capture the highest risk locations. COWI recommends that this be done prior to the paving program such that if cracks are found, they can be dealt with ahead of the paving closures where possible.

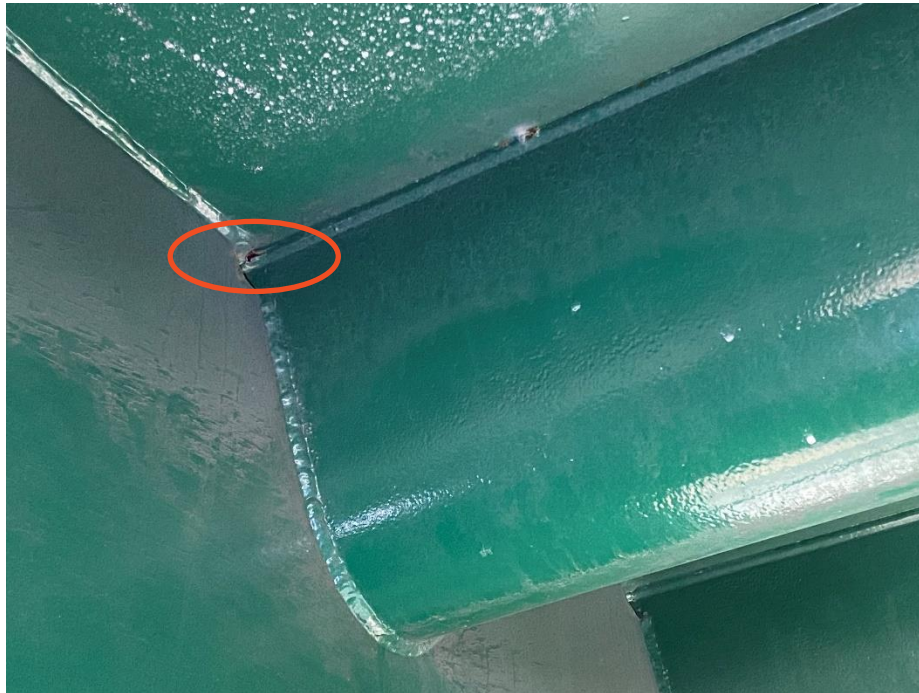
Figure 10: Localized Paint Failure at Termination of Longitudinal Weld on West Side of Trough 6 at 3rd Floorbeam from Bent 4 in the Direction of Bent 5.

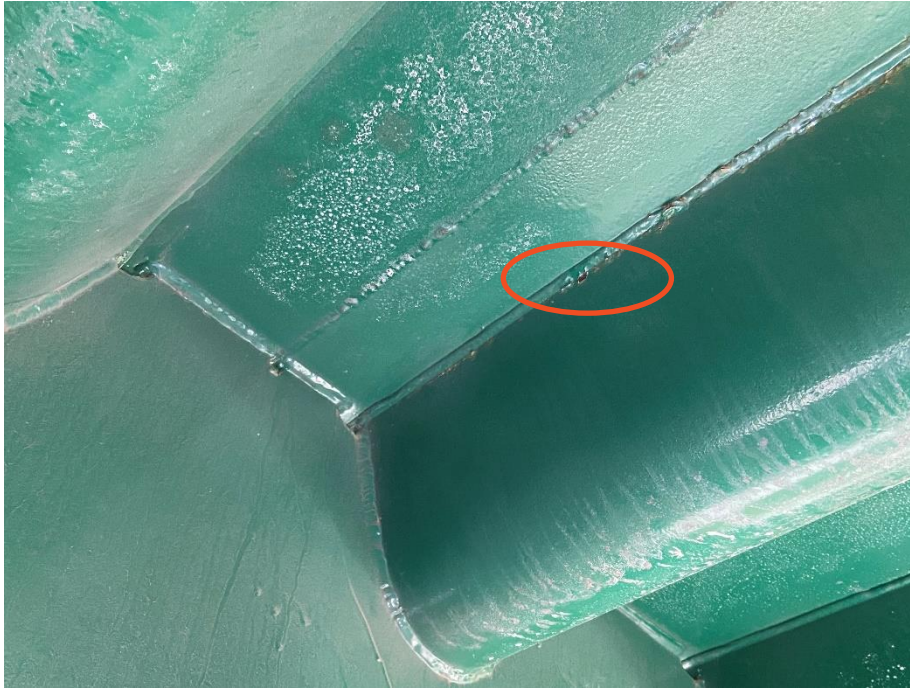
Figure 11: Localized Paint Failure on Longitudinal Weld on East Side of Trough 3 at 2nd Floorbeam from Bent 8 in the Direction of Bent 7.

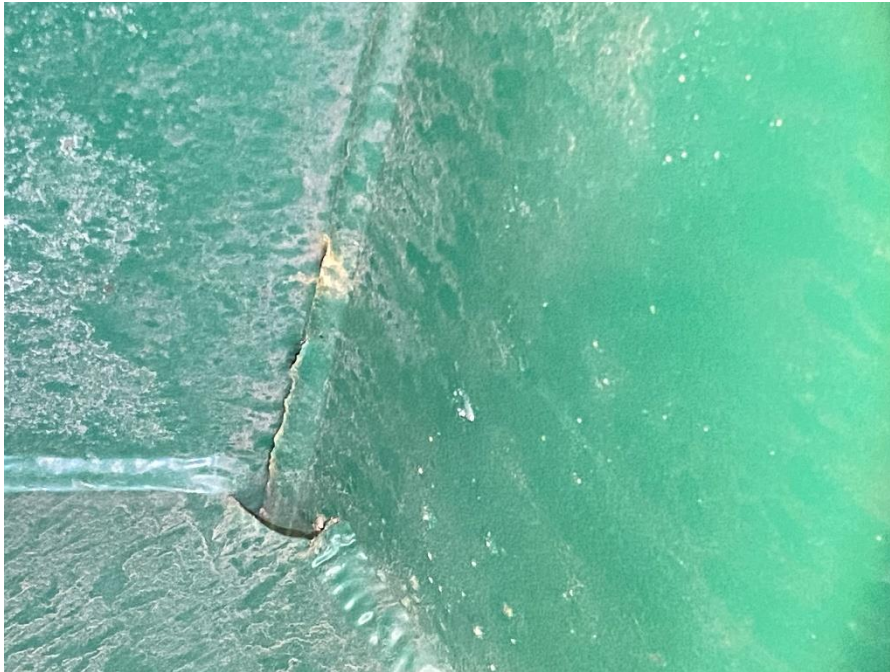
Figure 12: Paint Deterioration at Termination of Longitudinal Weld on West Side of Trough 4 at 4th Floorbeam from Bent 10 in Direction of Bent 9.

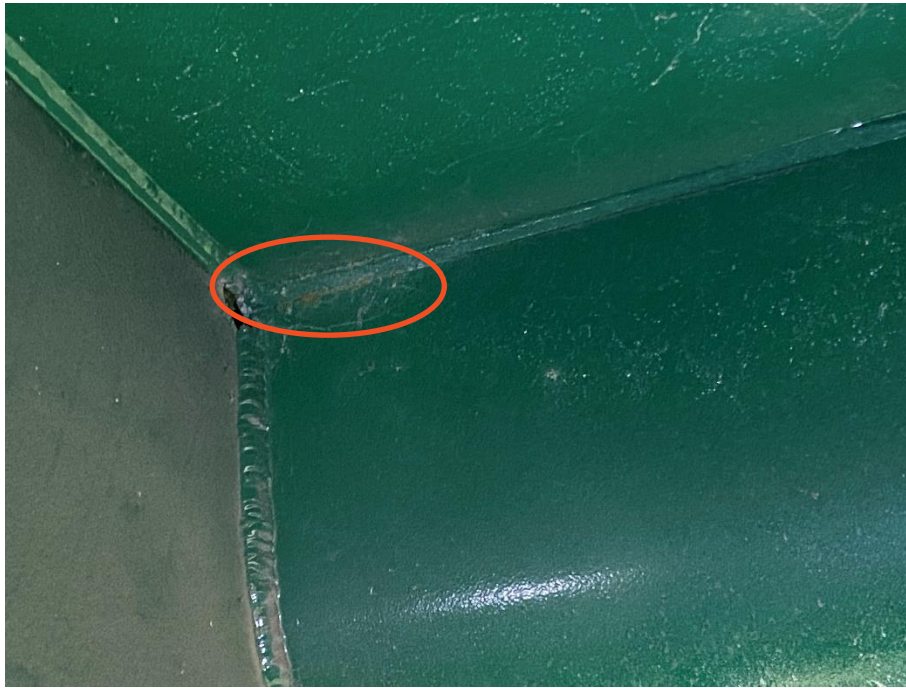
Figure 13: Minor Rusting near Termination of Longitudinal Weld on West Side of Trough 5 at 3rd Floorbeam from Bent 13 in the Direction of Bent 12.

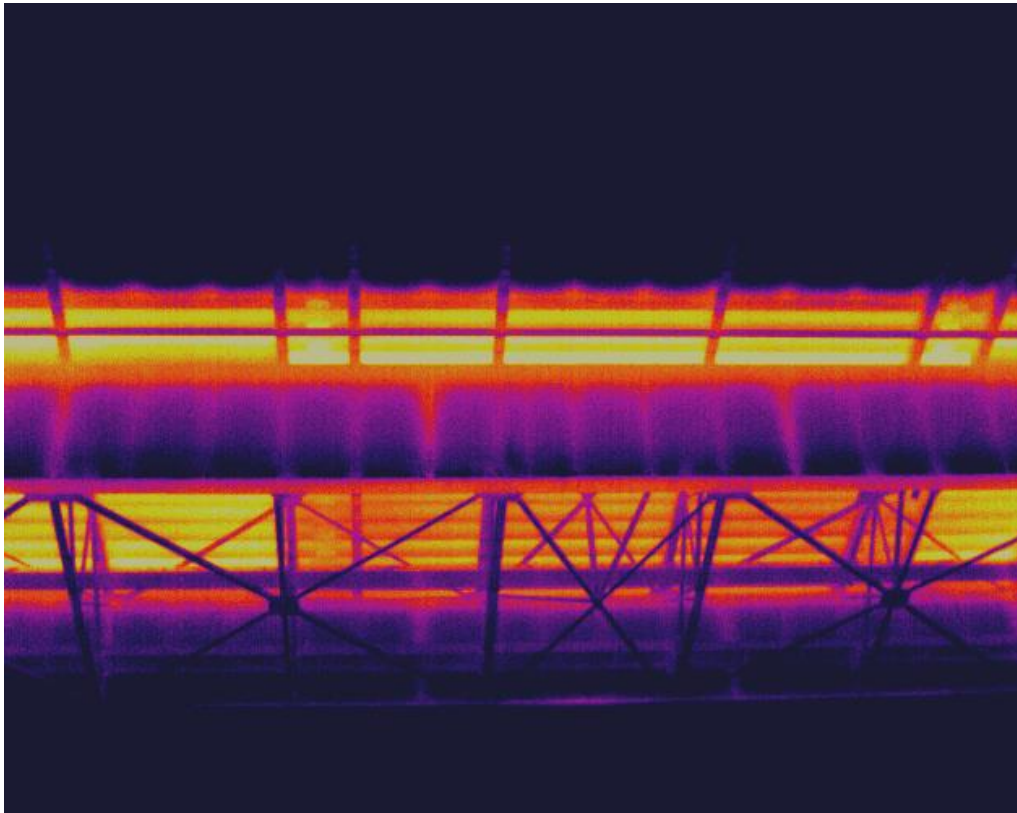
Following a detailed examination of the radiometric images, nothing was observed that suggested the collection of water in the troughs. It was noted in several locations that one of the panels was cooler than the ones on either side, as shown in Figure 14. However, this is unlikely to be due to fatigue cracking as a wide area showed consistently cooler temperatures within and between the troughs, and it would be highly unlikely for a fatigue crack to cross more than one trough. Instead, this temperature differential may be due to other factors such as thicker paving or moisture in the asphalt.

Figure 14: Typical Panel Showing Cooling Temperatures than Adjacent Panels. Span Between Bent 2 and 3 Shown.

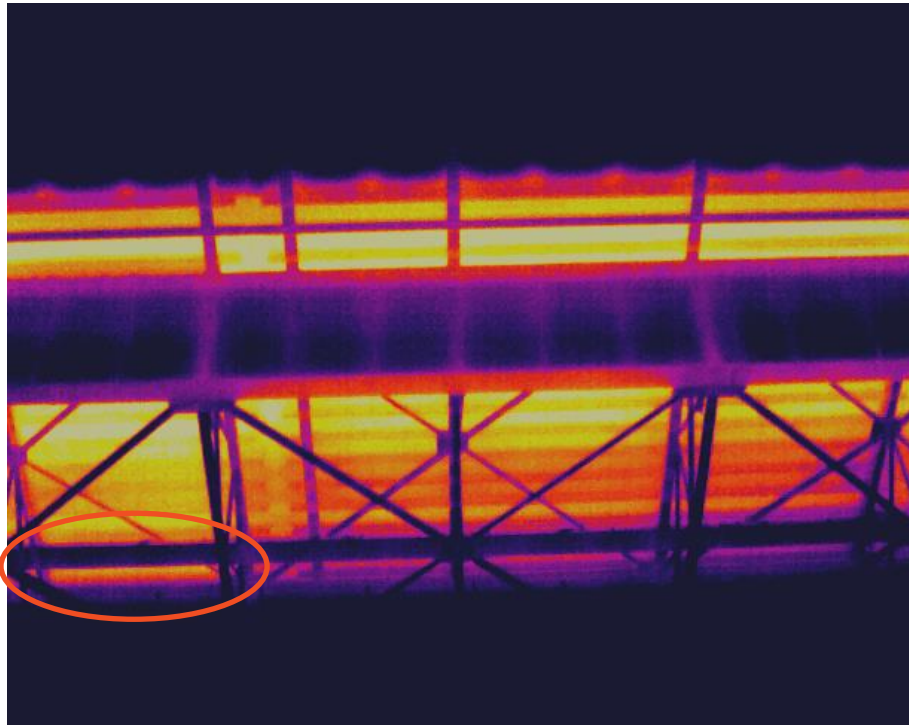
Additionally, between the first and second floorbeams north of Bent 5, it was noted that the trough indicated in Figure 15 appeared to be warmer than the surrounding troughs. However, this was noted to be the location of a trough diaphragm (vertical plate extending from trough down to the girder below), and therefore not an area of concern.

Figure 15: Slightly Brighter (Warmer) Trough Between First and Second Floorbeam North of Bent 5.

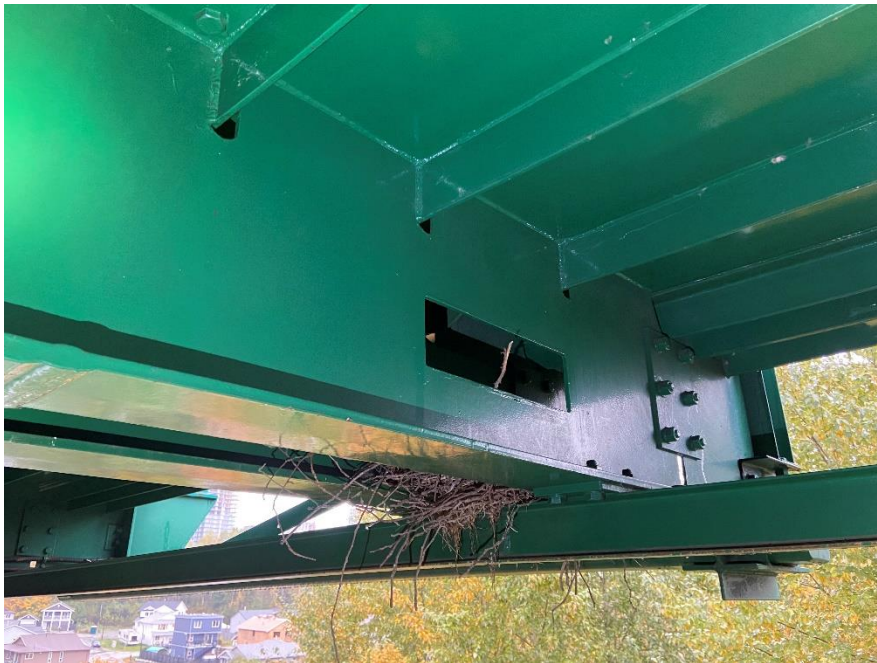
The welds connecting the sidewalk panel to the vertical plates, as shown in Figure 16, were found to be in good condition, with no indication of paint failure or indications of cracking noted.

Figure 16: Typical Condition of Sidewalk Panel Plate Welds.

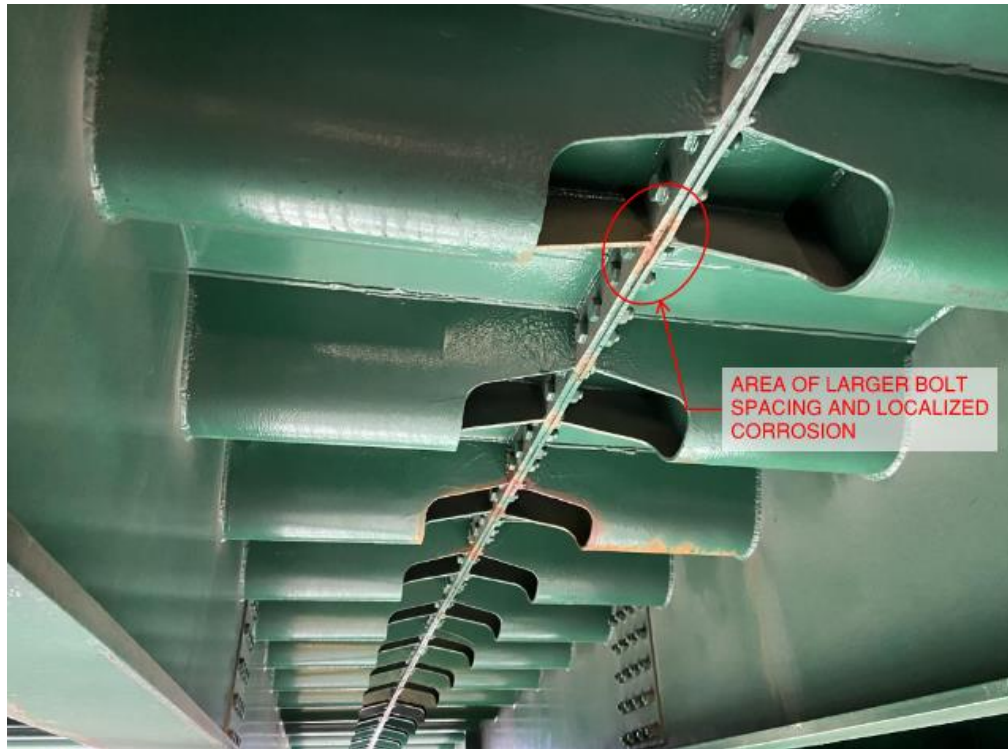
The OSPD bolted splices were typically observed to be in fair condition. Localized areas of corrosion were noted along the length of most splices. As shown in Figure 17, these areas correspond to the locations where the trough walls are welded to the end flange of the OSPD segment. Therefore, it is likely that this corrosion is a result of the bolt spacing that is larger at these points than in the rest of the splice to accommodate the trough walls.

Figure 17: Typical OSPD Splice Condition (Splice 18A Shown).

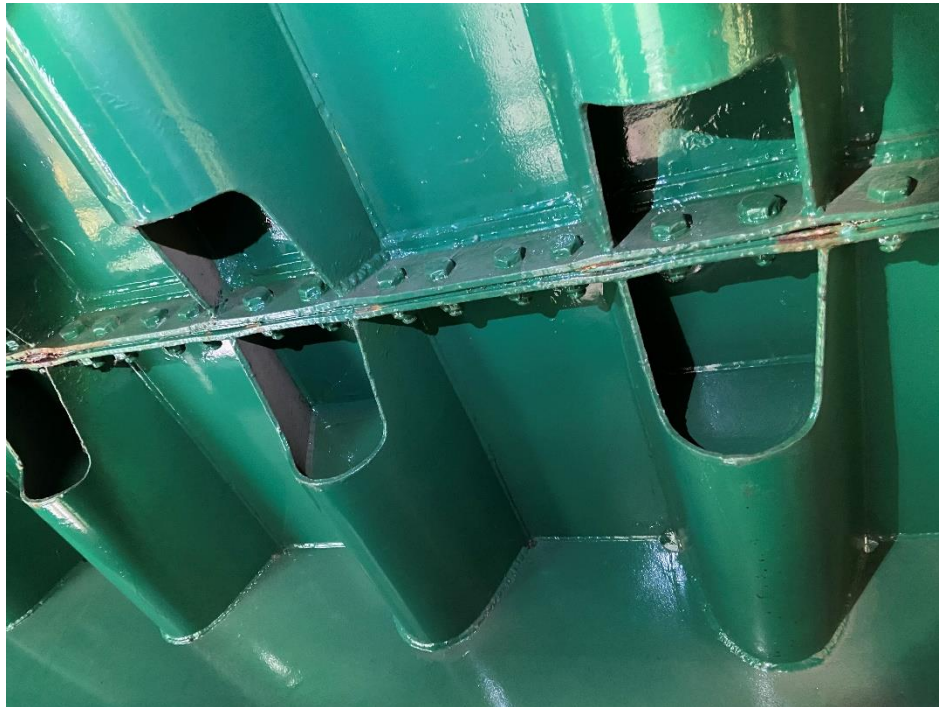
While corrosion at most locations was found to be minor, more significant rust jacking was observed in the splice located between Bent 19 and 20, as shown in Figure 18.

Figure 18: Rust Jacking at Splice Between Bent 19 and 20.

The rust jacking and moisture observed suggest that the crevice corrosion will continue to advance and may begin to occur at locations that currently appear to be in good condition. If the prying of

the plates extends up to the deck plate, the corrosion may be exacerbated as the jacking of the plates will allow more moisture in, leading to more corrosion.

To appropriately plan mitigations to address the crevice corrosion observed at the OSPD bolted splices, COWI recommends that the pavement at the splices between Bents 4 and 5, and Bents 19 and 20 be removed and the condition of the splice be observed from above. If the corrosion extends up to the top of the plate, it is recommended that the corrosion be ground out and a weld seal applied (care must be taken in the details of the weld). If the corrosion does not appear to extend to the top of the plate, it is recommended that the bolts near the rust jacking be removed, the corrosion be ground out, the bolts replaced, and the paint coating reapplied.

COWI recommends that this work be performed well in advance of the paving closures, since the results of these two test locations may result in recommendations to do similar mitigation above all the OSPD bolted splices.

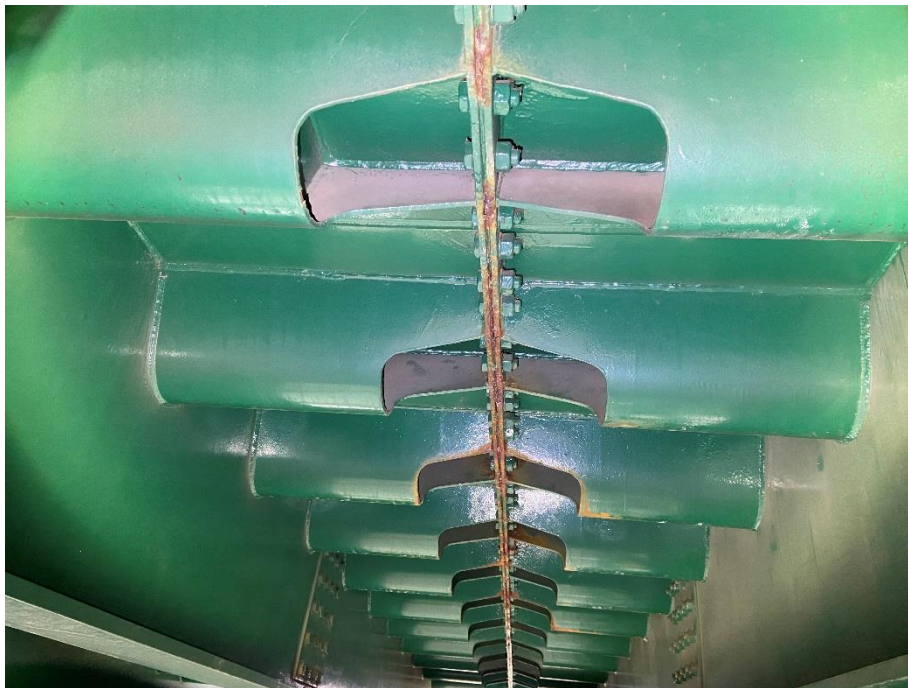
Additionally, it appeared that more moisture than typical was seeping through the splice between Bent 4 and 5, where the steel deterioration was more widespread, as shown below in Figure 19.

Figure 19: Splice Between Bent 4 and 5 Showing More Moisture Than Typical.

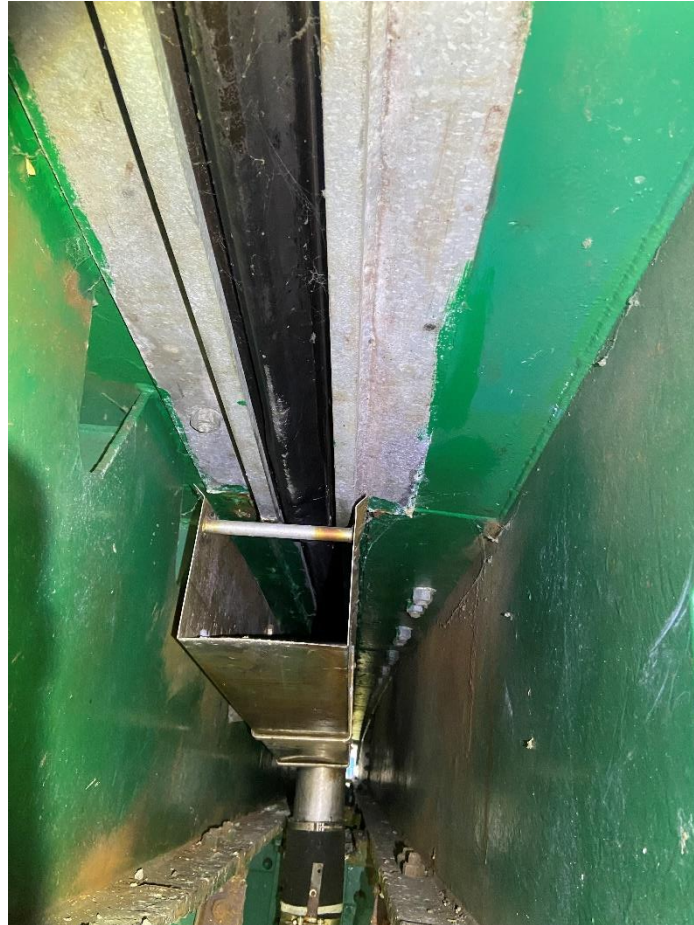
The expansion joints were generally found to be in fair condition, with no deterioration observed in the paint, steel, or joint seal, as shown in Figure 20.

Figure 20: Typical Expansion Joint (Joint at Bent 19 Shown).

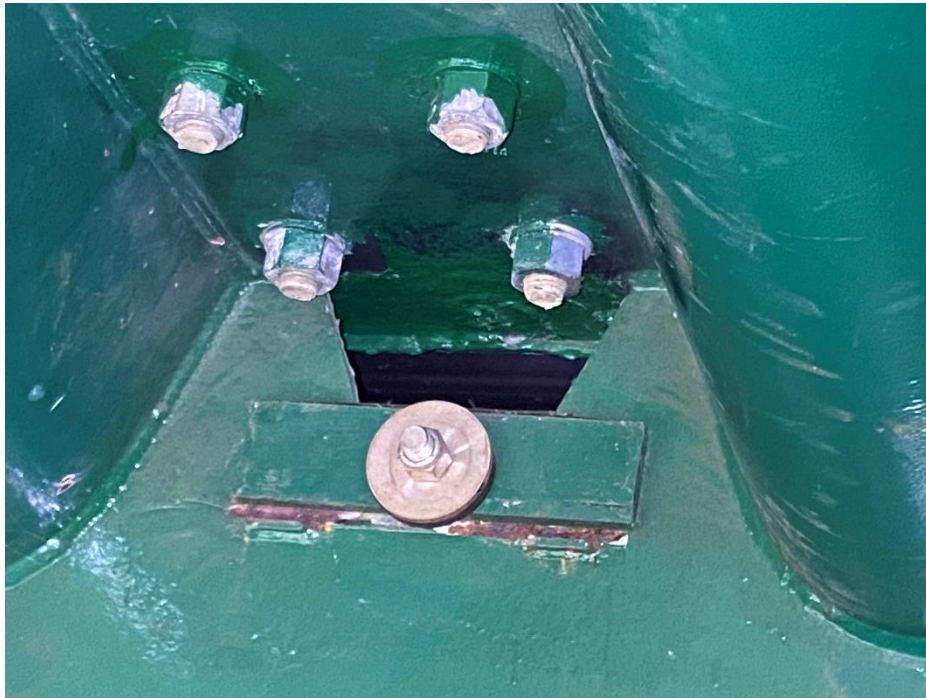
At Bent 9, the drainage trough appeared to have shifted since the last application of paint, as bare steel was visible at one the connections, shown below in Figure 21.

Figure 21: Evidence of Movement of Drainage Trough at Expansion Joint at Bent 9.

No deterioration was observed in the expansion joints and therefore no actions are recommended at this time. However, COWI recommends that the exposed steel at the drainage trough connection at Bent 9 be cleaned and repainted to reduce the risk of corrosion.

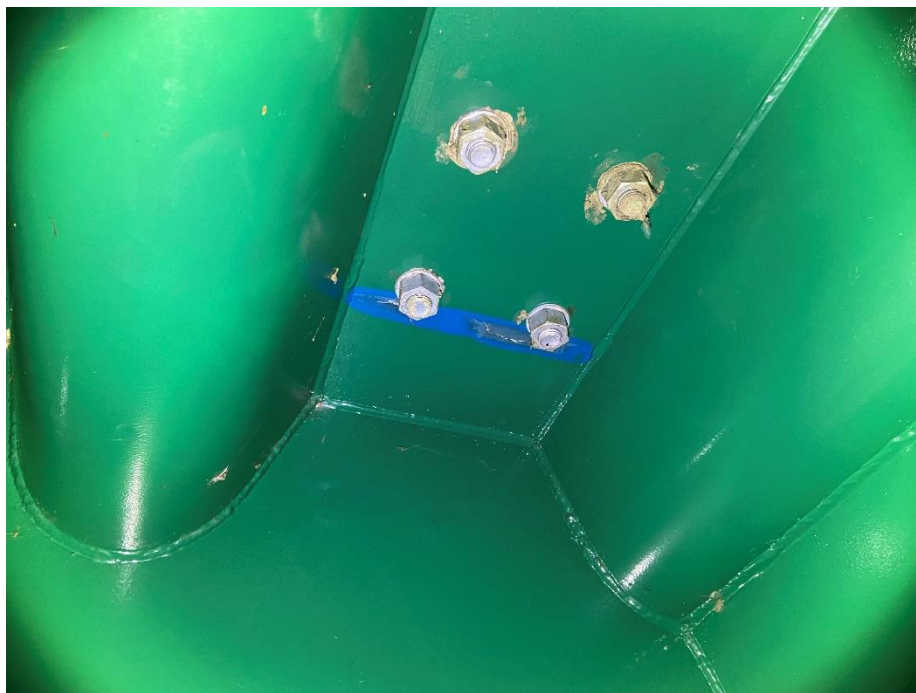
At the expansion joint at Bent 19, some cracking of the paint near the bolts was highlighted by a previous Inspector (Figure 22). As shown in Figure 23, closer inspection of the steel did not result in any cracking indications observed.

Figure 22: Cracked Paint at Expansion Joint at Bent 19 Identified Previous to this Inspection.

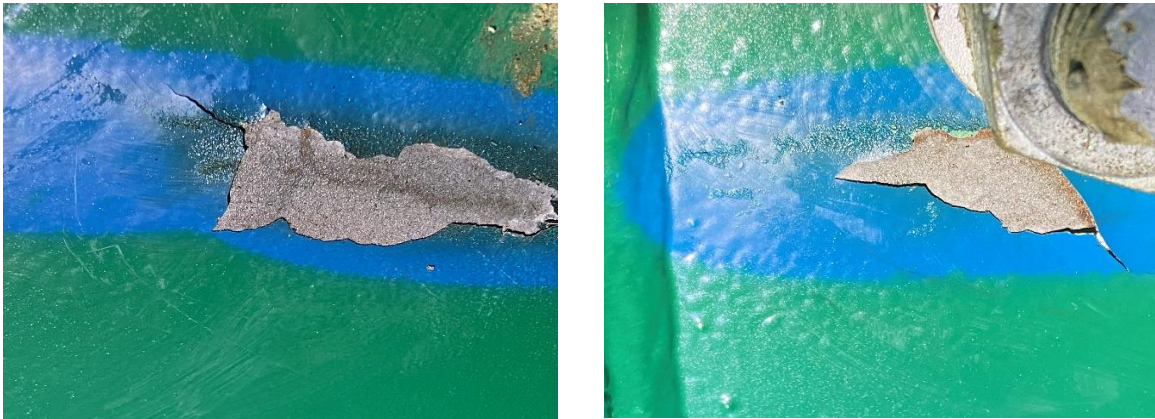
Figure 23: Close-Up of Plate Under Cracked Paint at Expansion Joint at Bent 19.

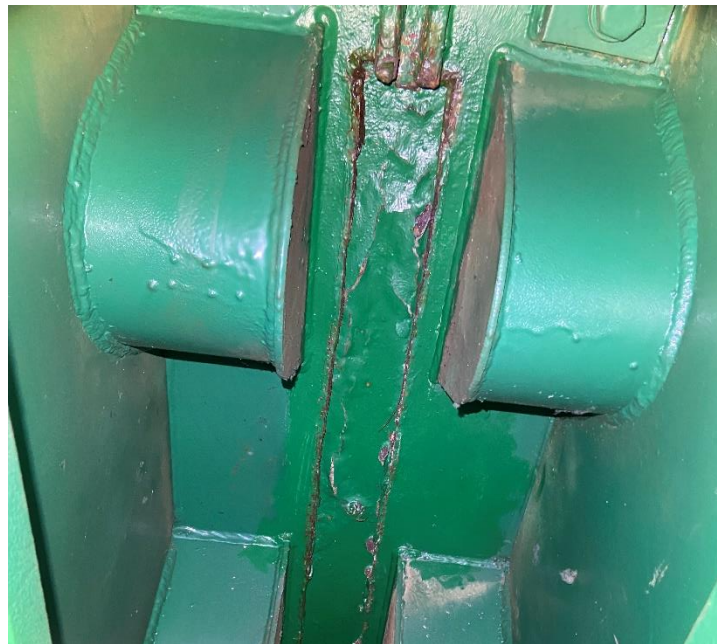
In general, these link plates were observed to be in fair to poor condition. At all locations observed, it appeared that the cut edges of the OSPD plate were not ground smooth. As a result, the paint coating is failing and rust was noted to be forming on the exposed steel, as shown in Figure 24.

Figure 24: Typical Link Plate; Plate at West Side of Bent 20 Shown

Based on COWI's observations of the underside of the link plates, significant corrosion exists after only seven years, and significant further paint failure and corrosion of the OSPD top plate is anticipated if the details are left as is. This deterioration is particularly of concern for the portions of OSPD top plate that are above the troughs, since even pinhole corrosion that occurs could lead to the ingress and collection of water in the troughs. These areas of the plate are very difficult to inspect since the sealed ends of the troughs prevent observation from below the deck, and inspection from above the deck would require removal of paving and the link plate.

Due to the probable and significant negative impact on the lifespan of both the OSPD and the wearing surface if the observed deterioration continues, as well as the inspection challenges, COWI recommends that an alternate detail that ideally removes the link plates be explored. However, it is not immediately obvious if a solution can be developed for this as there are fatigue issues of the OSPD that must be avoided, and significant sophisticated analysis will be required to understand the global and local behaviour of the area. COWI further recommends that any retrofit in this area be performed prior to the repaving work, if possible.

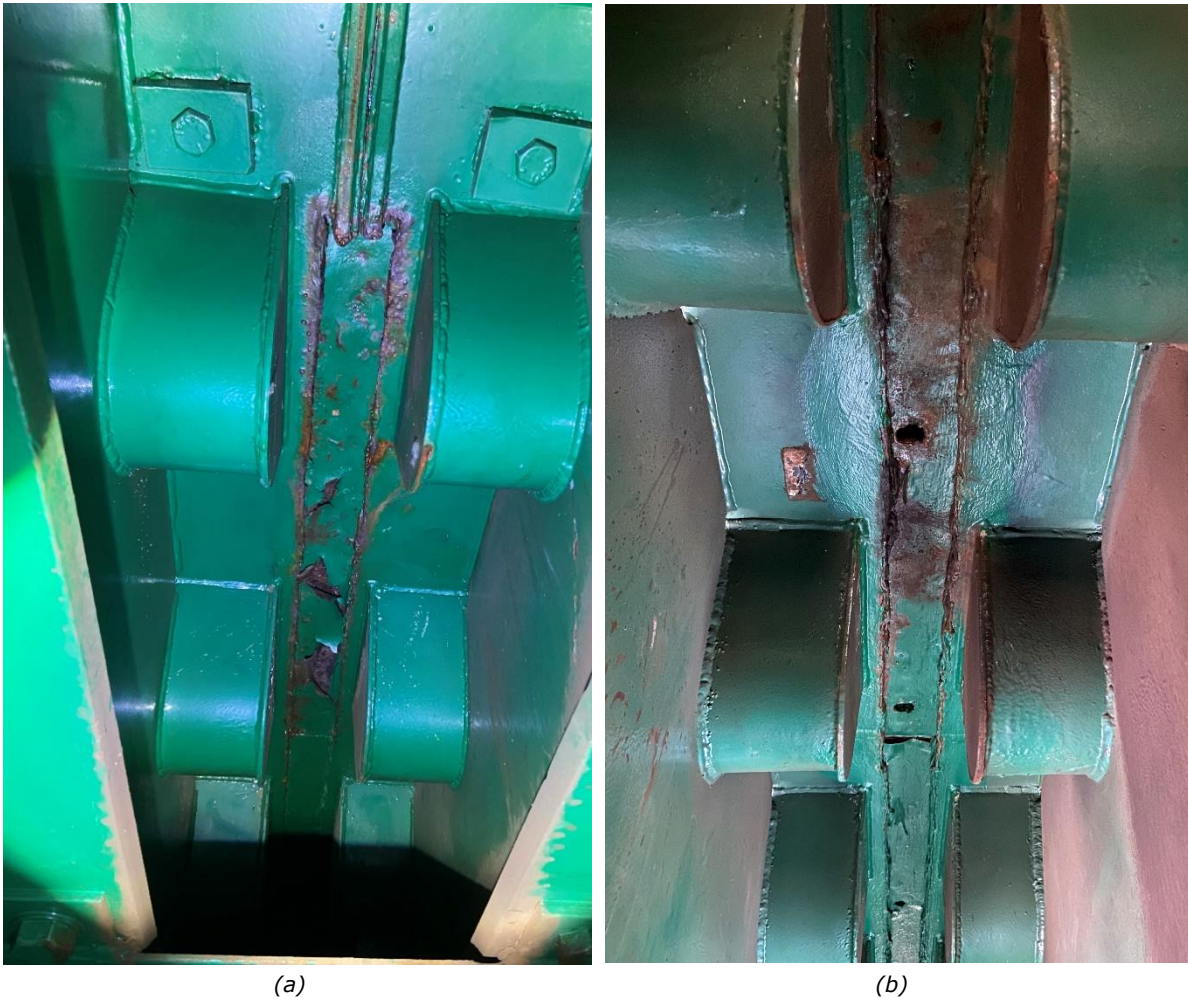
At some locations, as shown in Figure 25, water was noted to be leaking from above, leading to more significant corrosion.

Figure 25: Poor Condition Link Plates at (a) West Side of Bent 21 and (b) Bent 3
