15 December 2014

AMEC Project No.: VA06726.800.03

RE: Asphalt Asbestos and Lead Paint Testing
001481V Lions Gate North Approach Viaduct

Enclosed are the analytical results for the asphalt and primer samples collected from the North Approach Viaduct of the Lions Gate Bridge.

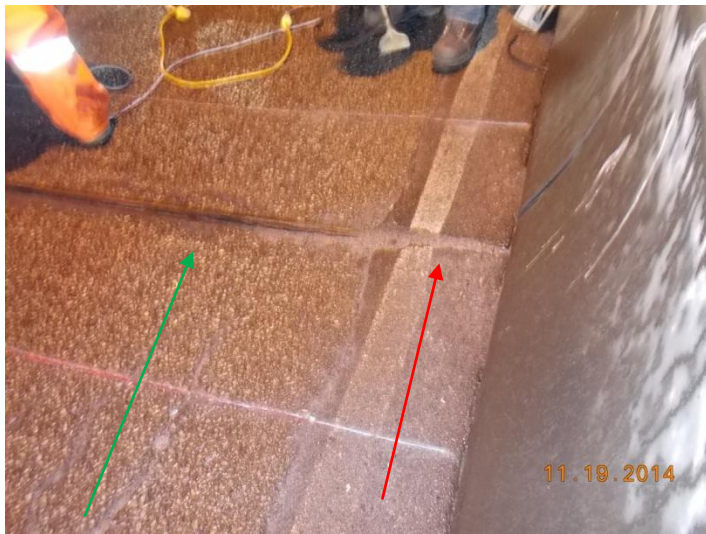
Photo 1:

Description: Joint 12 Prior to Demolition

Lions Gate Bridge North Approach Viaduct – facing Southward. West parapet shown on right hand side of photo. 1970s Epoxy asphalt shown with red arrow and newer asphalt (inner field) shown with green arrow.

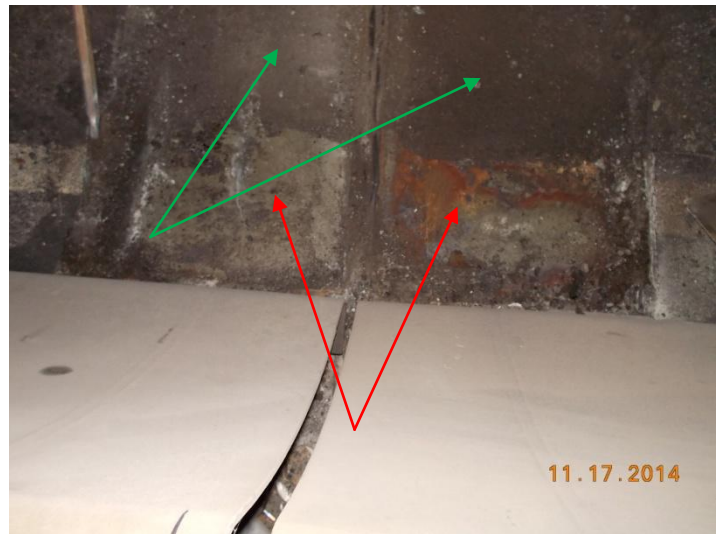
Photo 2:

Description: Joint 14 During Demolition

Lions Gate Bridge North Approach Viaduct. East parapet shown at bottom of photo. 1970s Epoxy asphalt removed and substrate now visible (steel deck and primer), shown with red arrow. Newer asphalt (inner field) removed, but membrane bottom layer still present (shown with green arrow). This membrane layer was included in the majority of the “Inner Field Asphalt” samples analyzed for asbestos content.

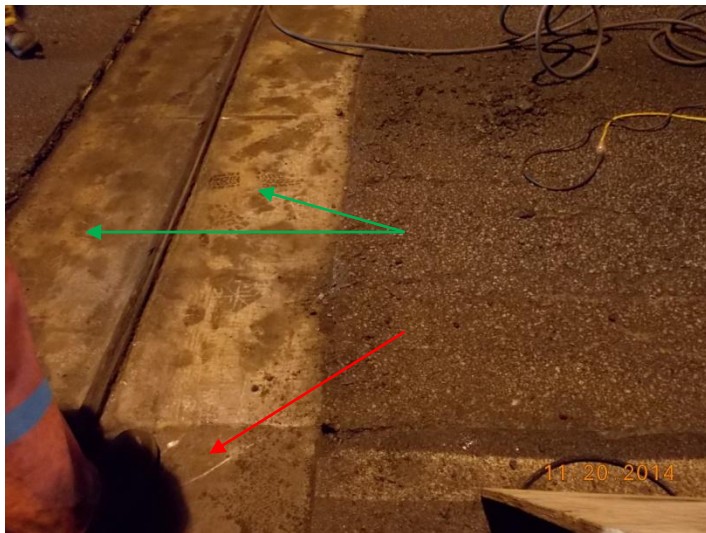
Photo 3:

Notes: ¹The reference point for the coordinates of each sample is the parapet referenced for the east/west direction and the joint referenced for the north/south direction.
²Sample was collected following minimal jack-hammering. An approximate 36 square inch piece of asphalt was cut and then removed via jack-hammer prior to primer sampling (refer to Photo.4 of Appendix C). This may have led to less disturbance of the substrate than during collection of all other samples, which were collected following "demolition of the majority of asphalt (and associated membrane, when applicable) from the area surrounding the joints (refer to Photo 3 of Appendix C).

Description: Joint 14 Post Demolition

Lions Gate Bridge North Approach Viaduct (West lane). All asphalt and membrane has been removed, therefore exposing the steel deck and primer applied to the substrate. Substrate from below the 1970s Epoxy asphalt (outer edge) is shown with red arrow, and the inner field substrate is shown with green arrows.

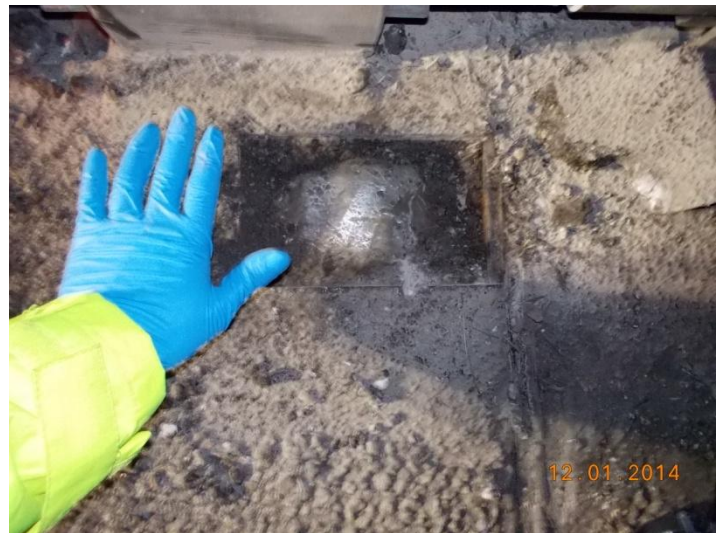
Photo 4:

Description: Joint 8 During Primer Sampling

Lions Gate Bridge North Approach Viaduct (West lane). Due to delays associated with the scheduled demolition work, the usual process of jack-hammering the entire area surrounding the joint (as shown in Photo.3) prior to primer collection was not performed. Instead a small square of asphalt was cut and jack-hammered out. This process required minimal jack-hammering, relative to the “normal” procedure which occurred prior to primer sample collection at all other joints.

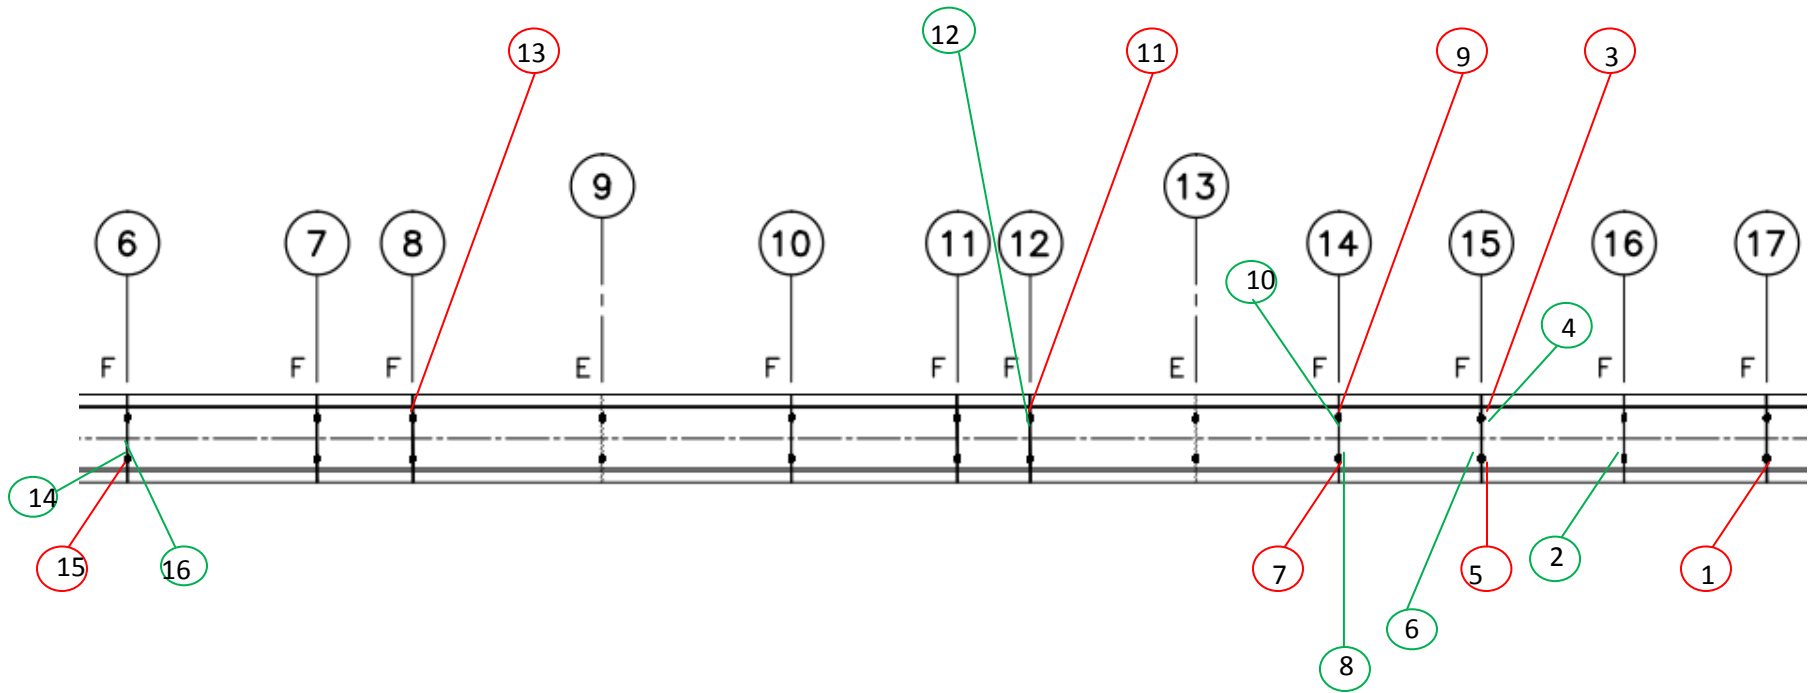
Asphalt Sample Locations

- Asphalt sample from outer edges / beside parapets (1970s Epoxy Asphalt)
- Asphalt sample from the inner field

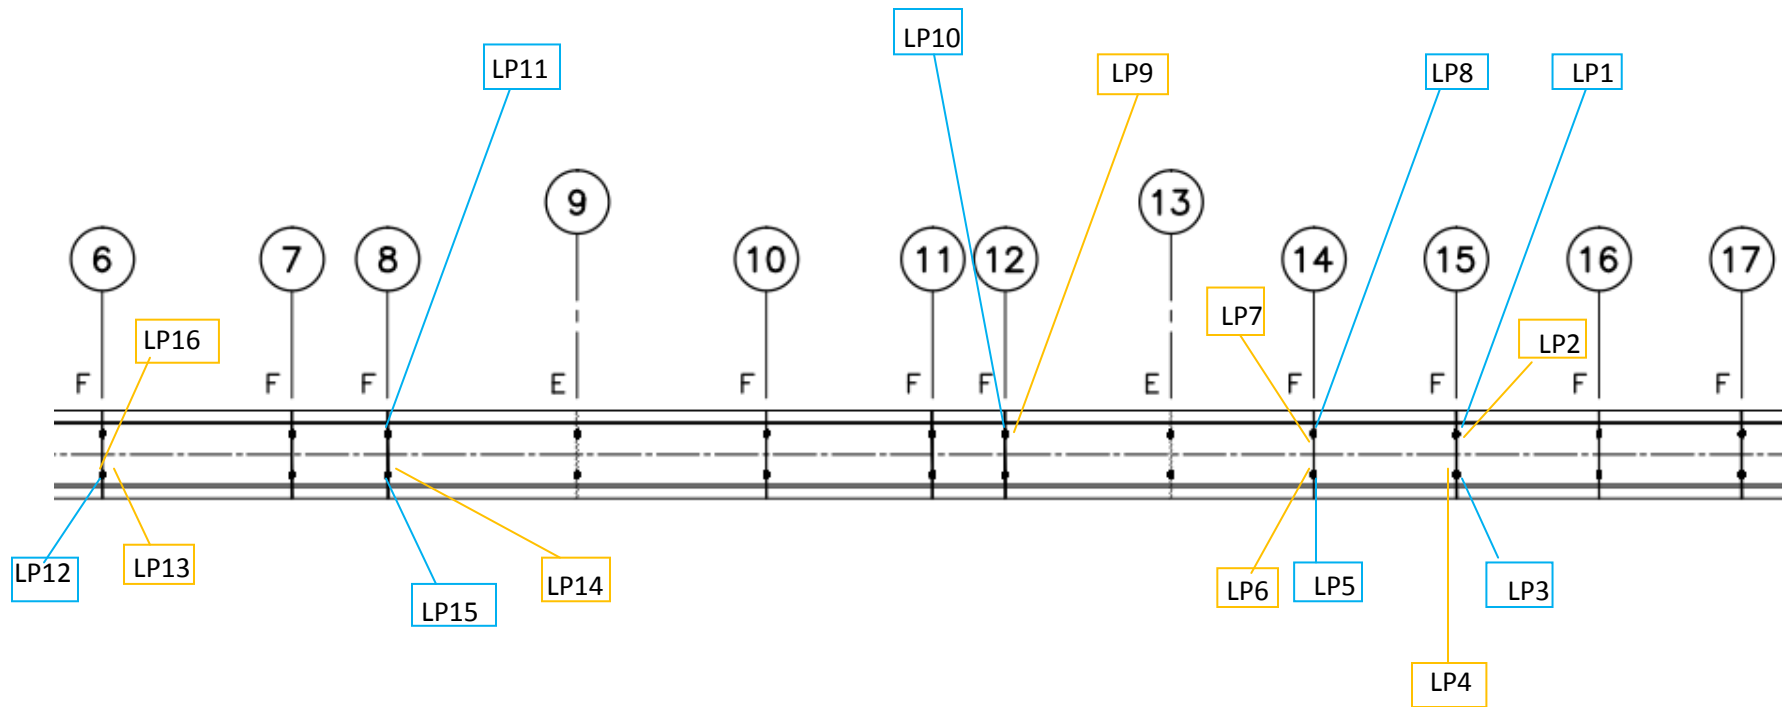
Primer Sample Locations

- Primer sample from outer edges / beside parapets (Substrate of 1970s Epoxy Asphalt)
- Primer sample from the inner field (Substrate of newer asphalt)
