Photo: Horseshoe Bay Underpass

Upper Levels Highway Underpasses - Seismic Retrofit Project

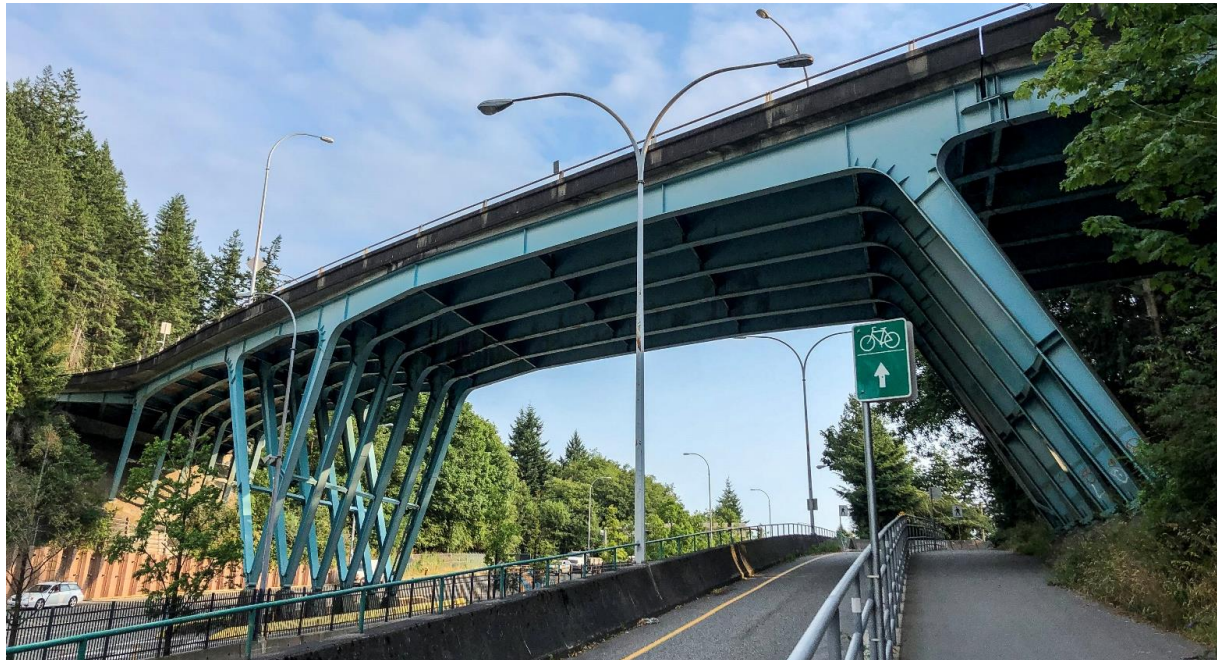
Exhibit 2.1-1: Horseshoe Bay U/P Looking South

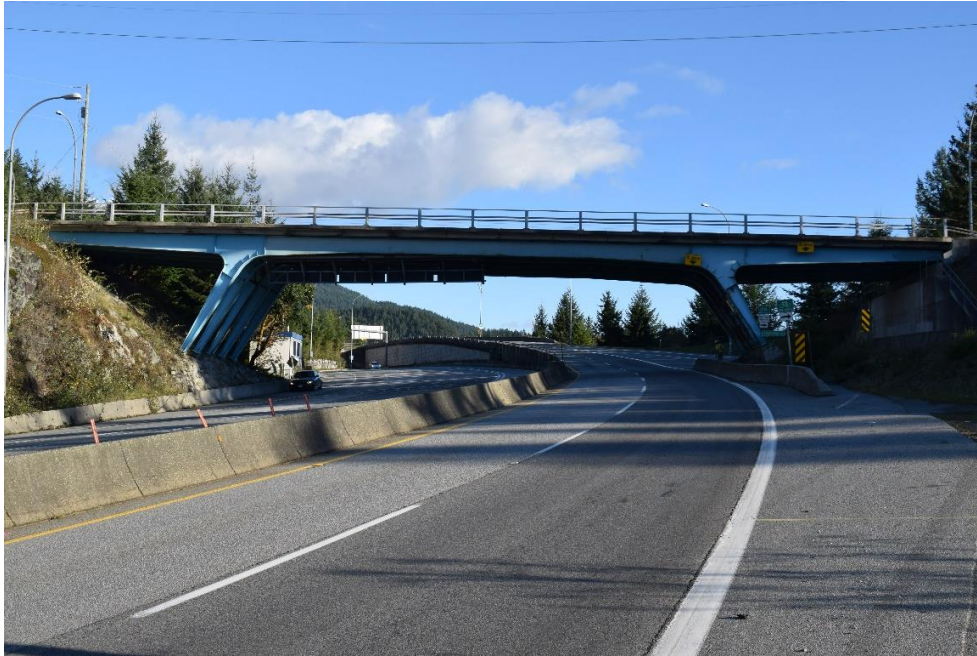
Exhibit 2.2-1: Eagleridge U/P Looking East

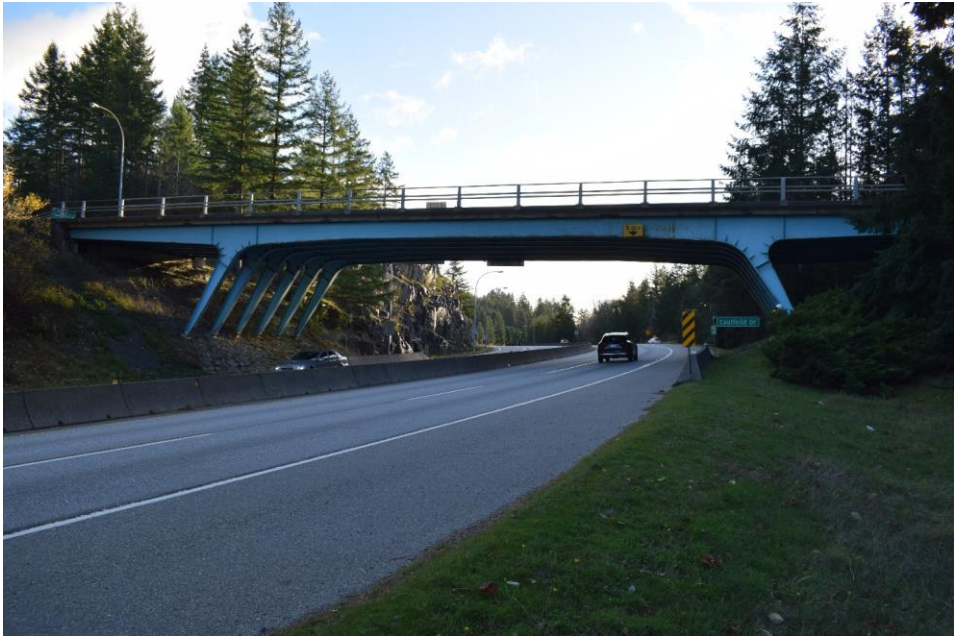
Exhibit 2.3-1: Caulfield U/P Looking East

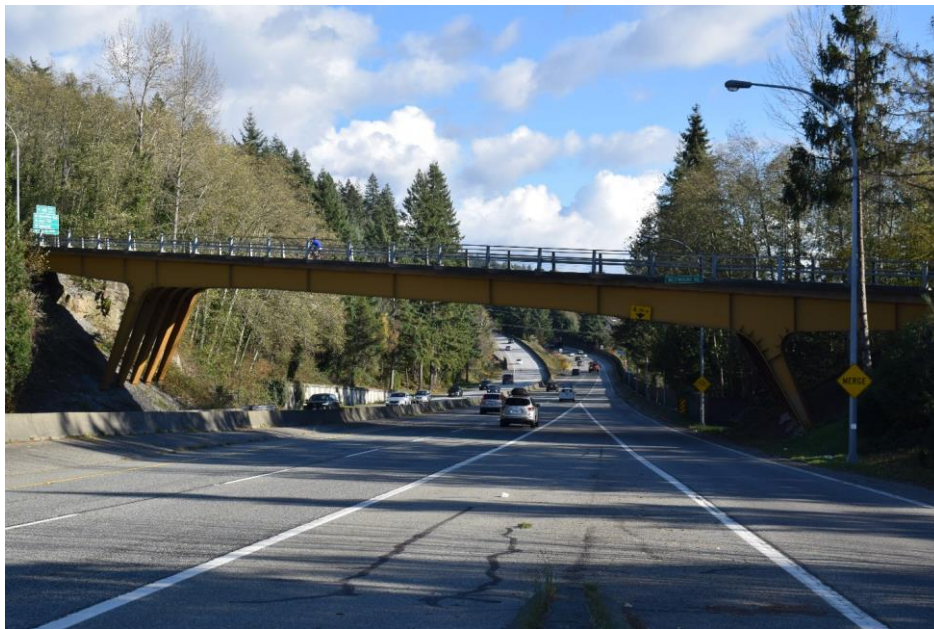
Exhibit 2.4-1: Westmount U/P Looking East

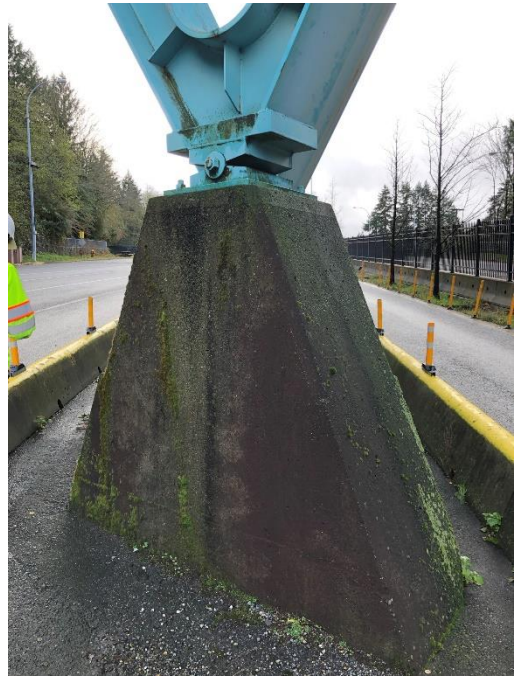
Exhibit 3.1-1: Central Pier Bearing Plinth 6, Typical Condition

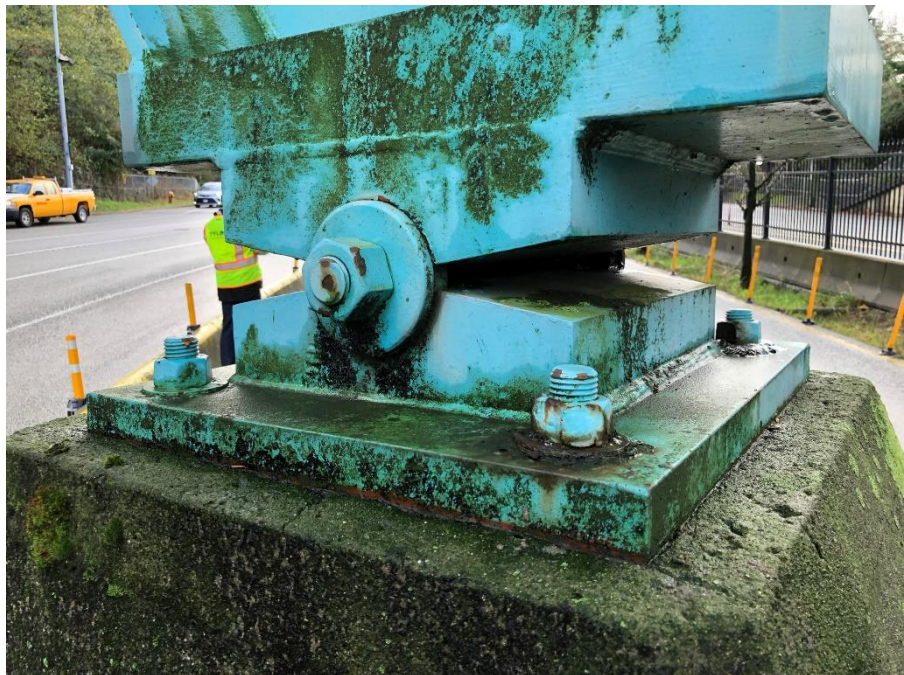
Exhibit 3.1-2: Central Pier Bearing 6, Typical Condition

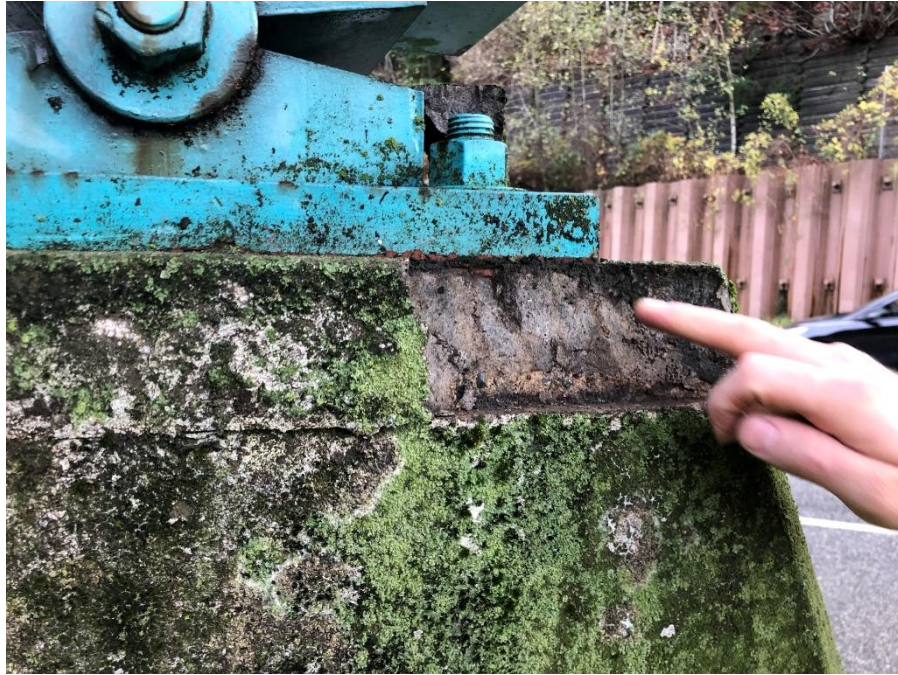
Exhibit 3.1-3: Debonded Grout at Delta Pier 4 Plinth

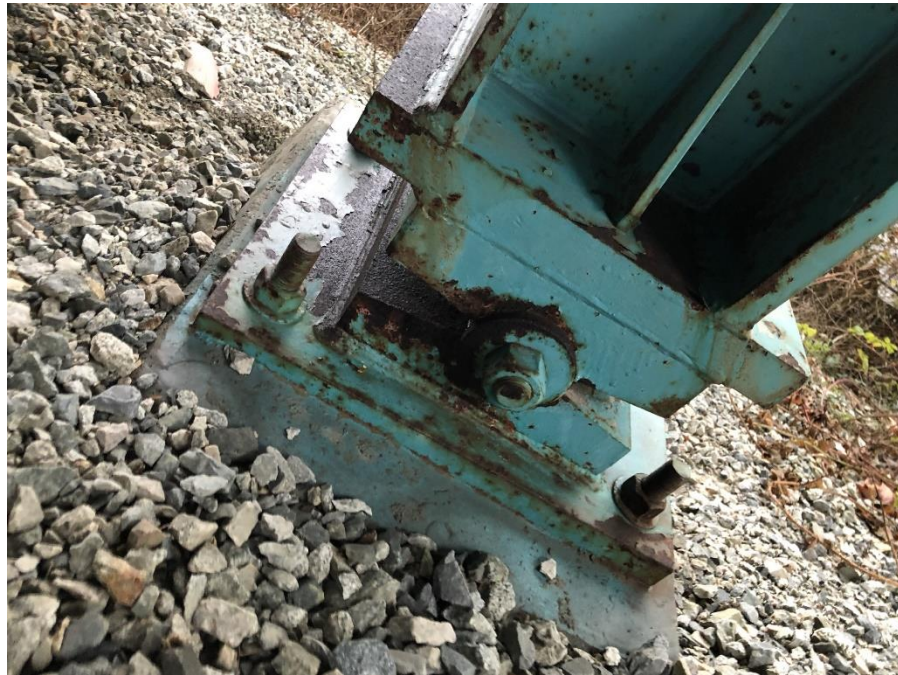
Exhibit 3.1-4: Rocker Plate/Washer Corrosion, Inclined Pier Bearing E4

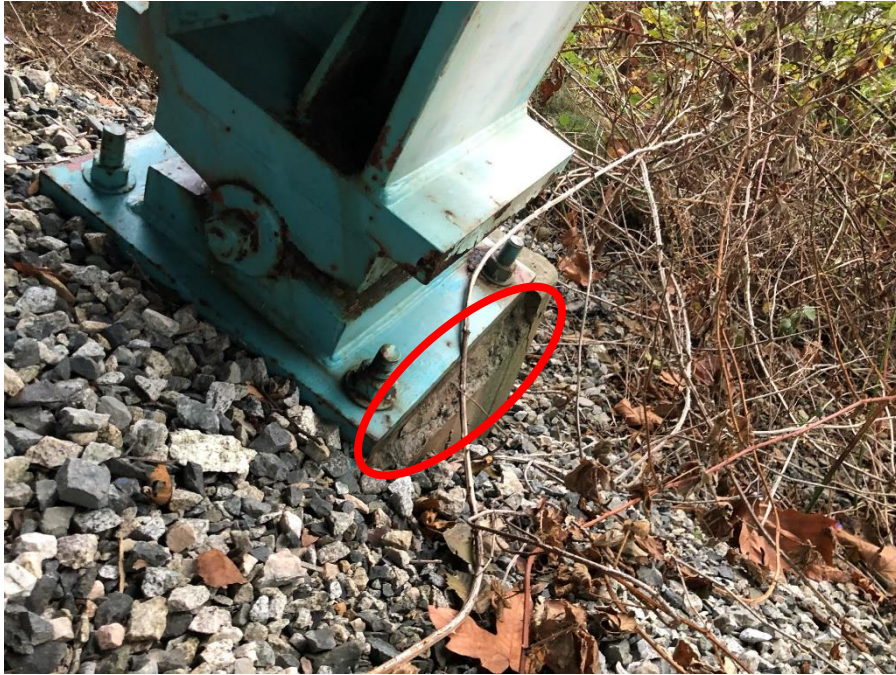
Exhibit 3.1-5: Inclined Pier Bearing E1, Superficial Delamination in Grout Pad

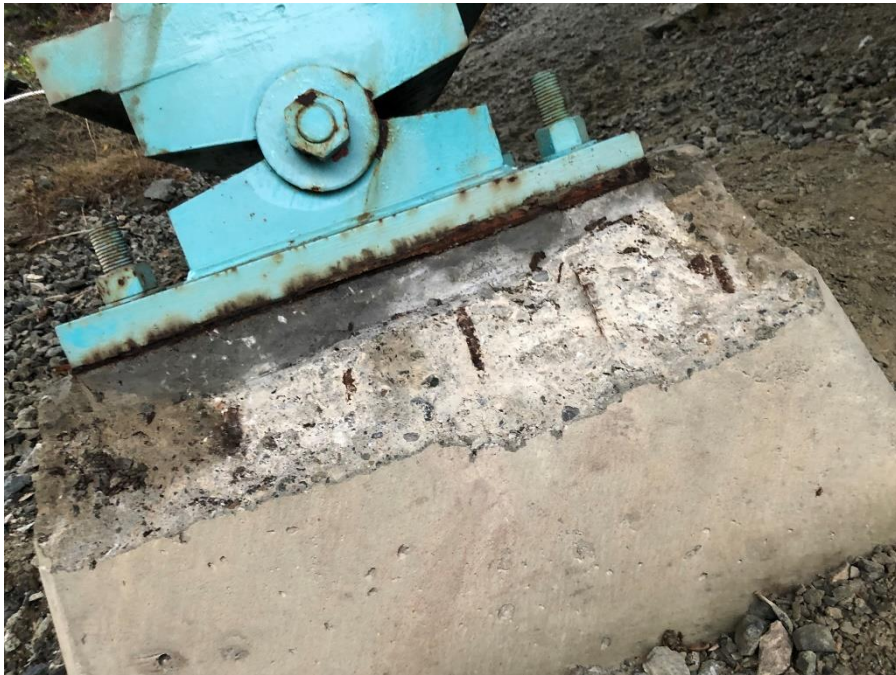
Exhibit 3.1-6: Inclined Pier Bearing E5, Exposed Rebar After Removal of Delaminated Concrete

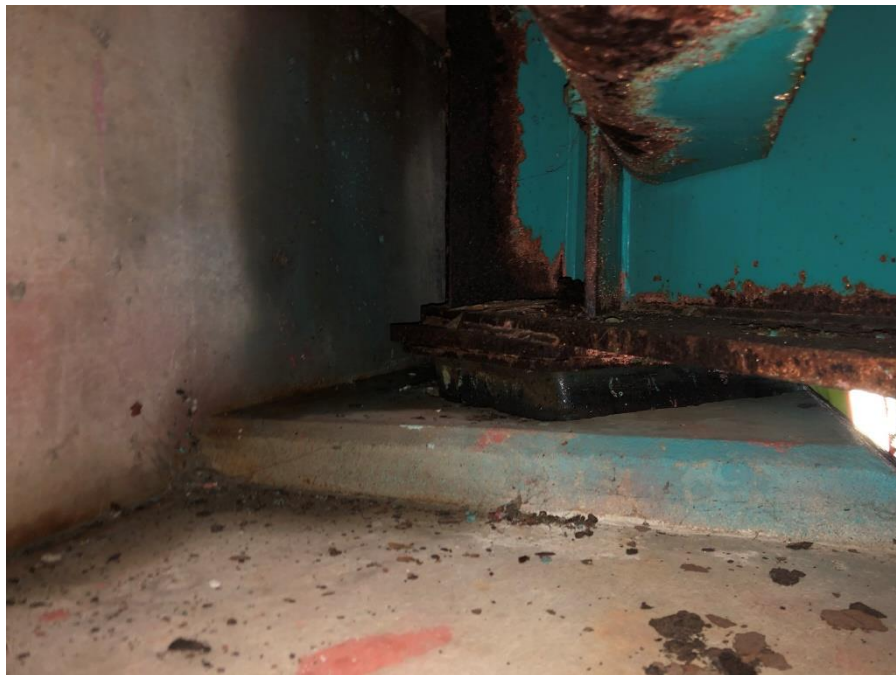
Exhibit 3.1-7: Abutment Bearing E7, Moderate Corrosion of Base Plate and Sole Plate. Typical East Abutment Bearing Condition.

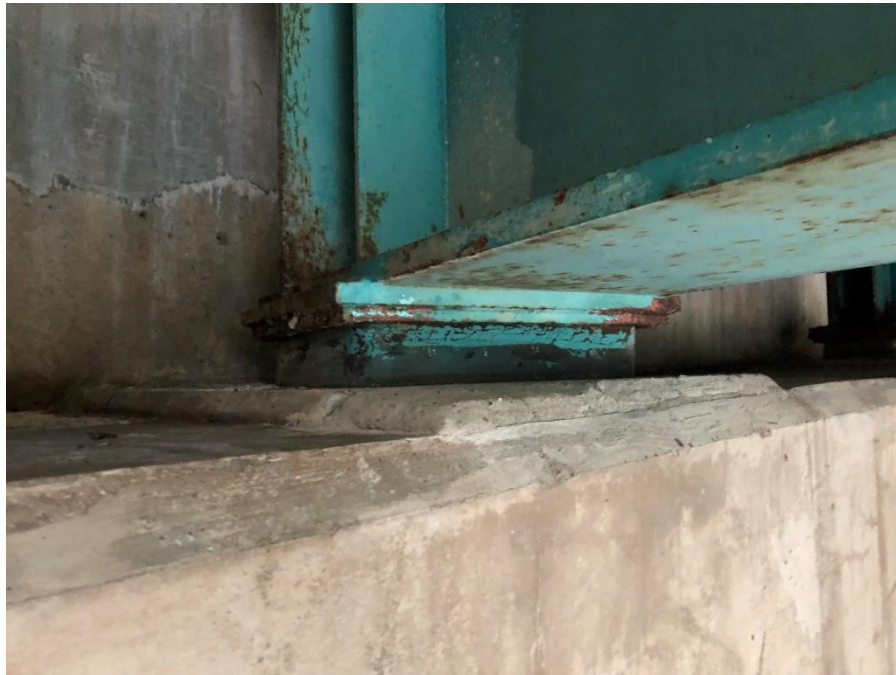
Exhibit 3.1-8: Abutment Bearing W6, Typical West Abutment Bearing Condition.

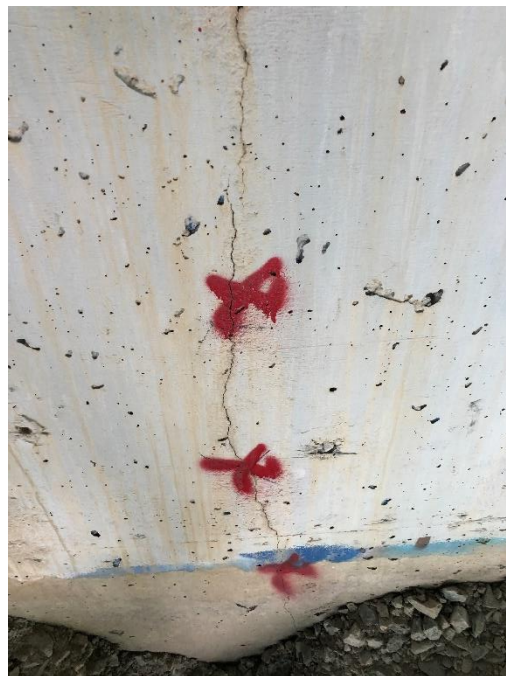
Exhibit 3.1-9: Vertical Crack Just North of Abutment Bearing E4

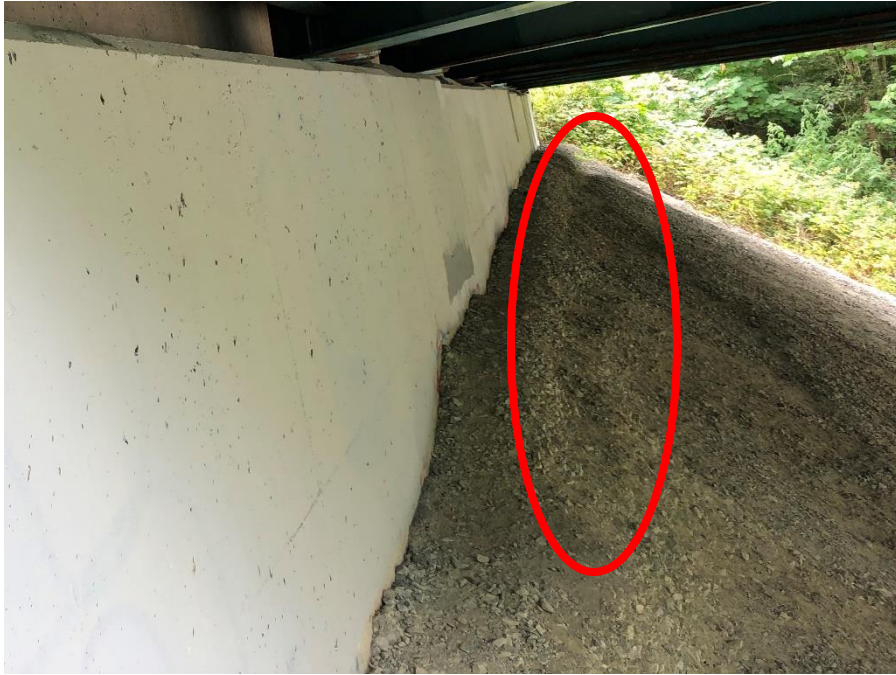
Exhibit 3.1-10: Erosion of East Abutment Slope.

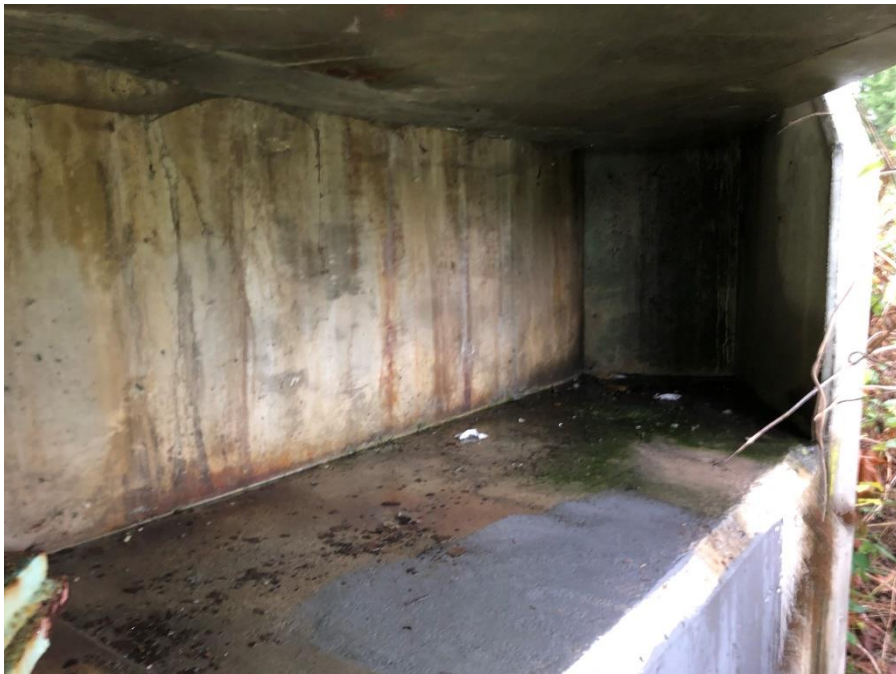
Exhibit 3.1-11: Water on South End of East Abutment Bearing Shelf

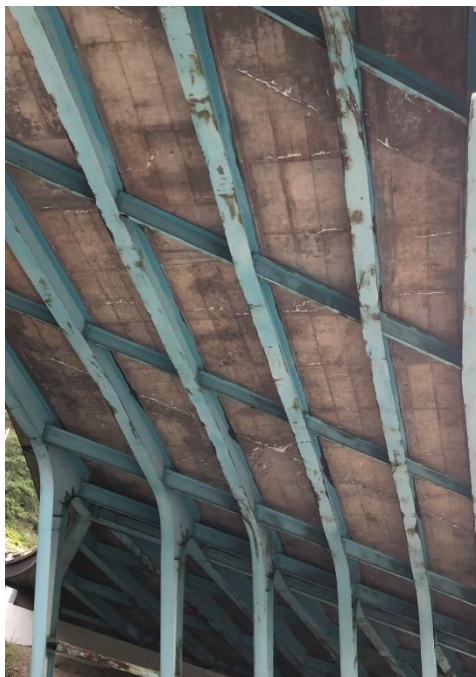
Exhibit 3.1-12: View of Steel Condition and Efflorescence on Soffit Looking East

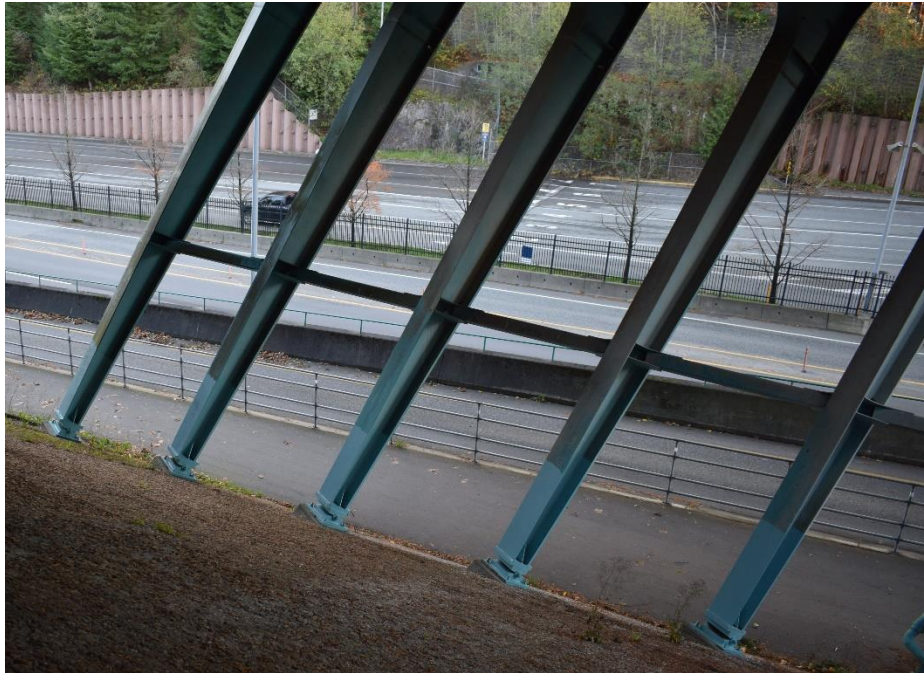
Exhibit 3.1-13: West Inclined Pier Legs Observed in Good Condition

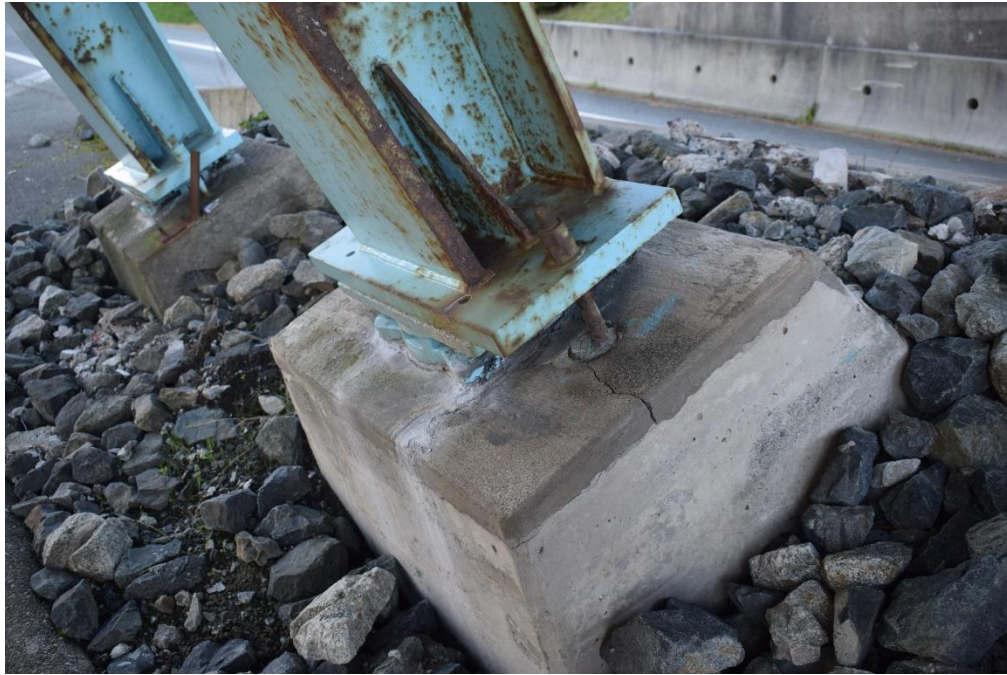
Exhibit 3.2-1: Pier S4 Bearing, Minor Corrosion on Base Plate. Crack in the Debonded Layer.

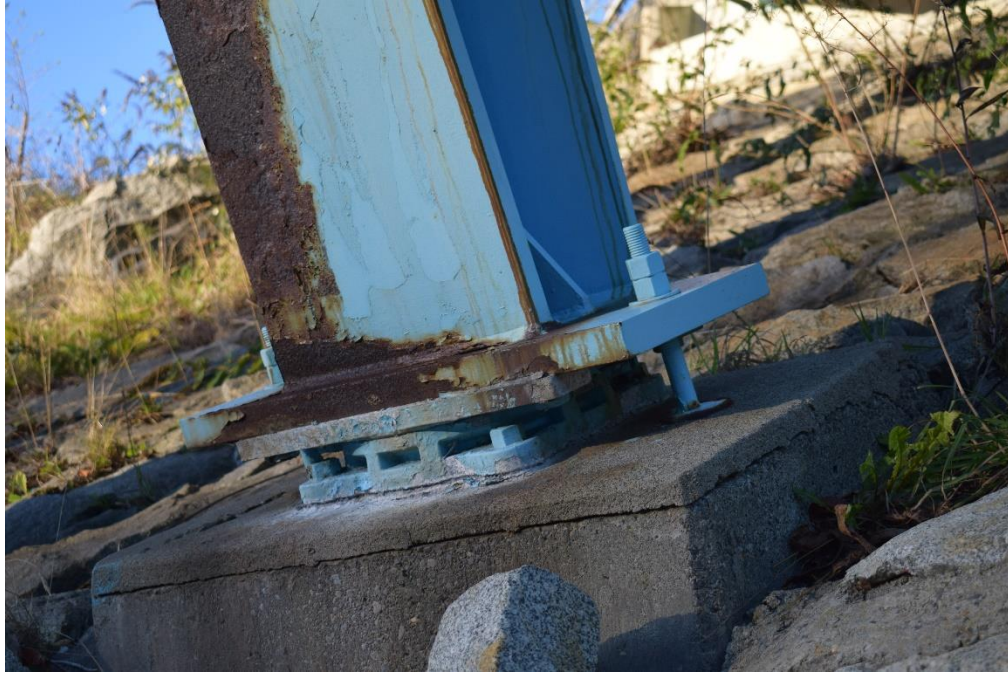
Exhibit 3.2-2: Pier N3 Bearing, Corrosion on Base Plate

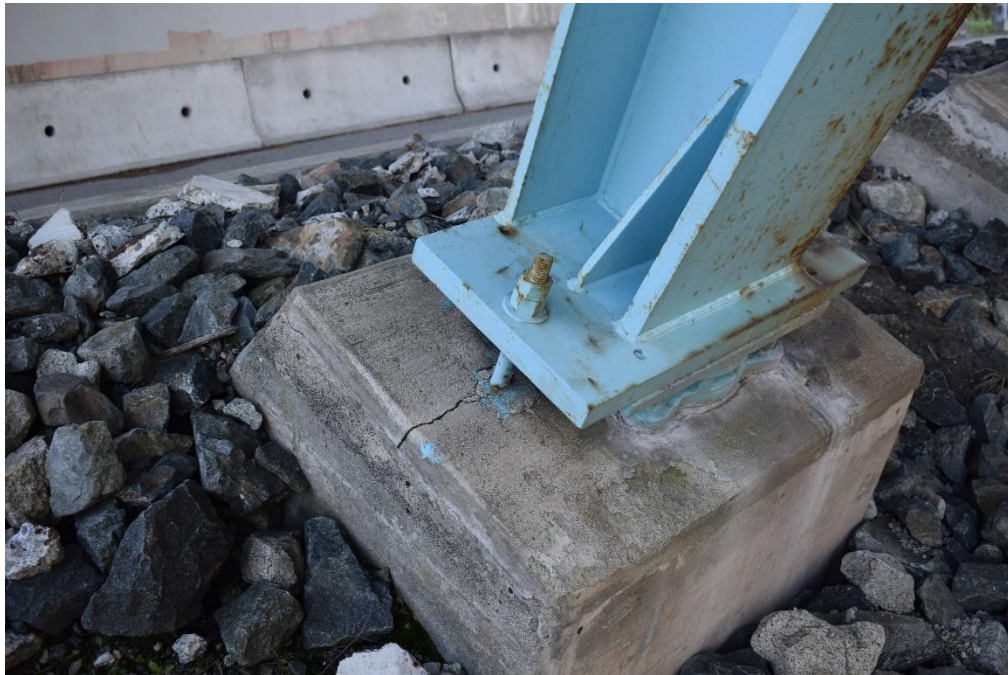
Exhibit 3.2-3: Pier S4 Bearing, Debonding of Grout Pad. Crack in the Debonded Layer.

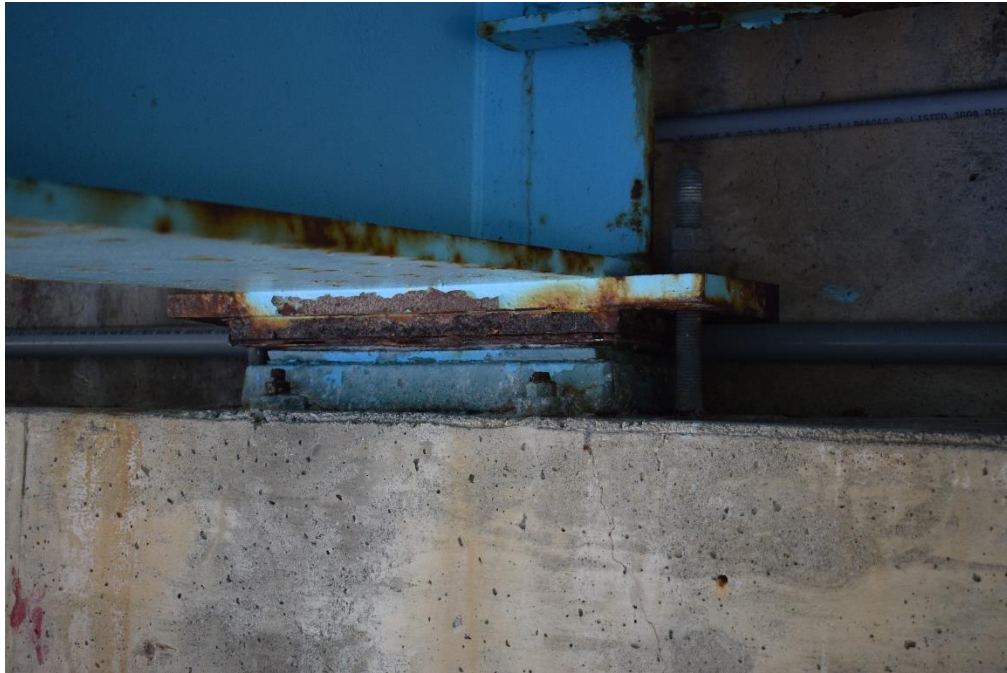
Exhibit 3.2-4: Abutment Bearing N4, Moderate Corrosion

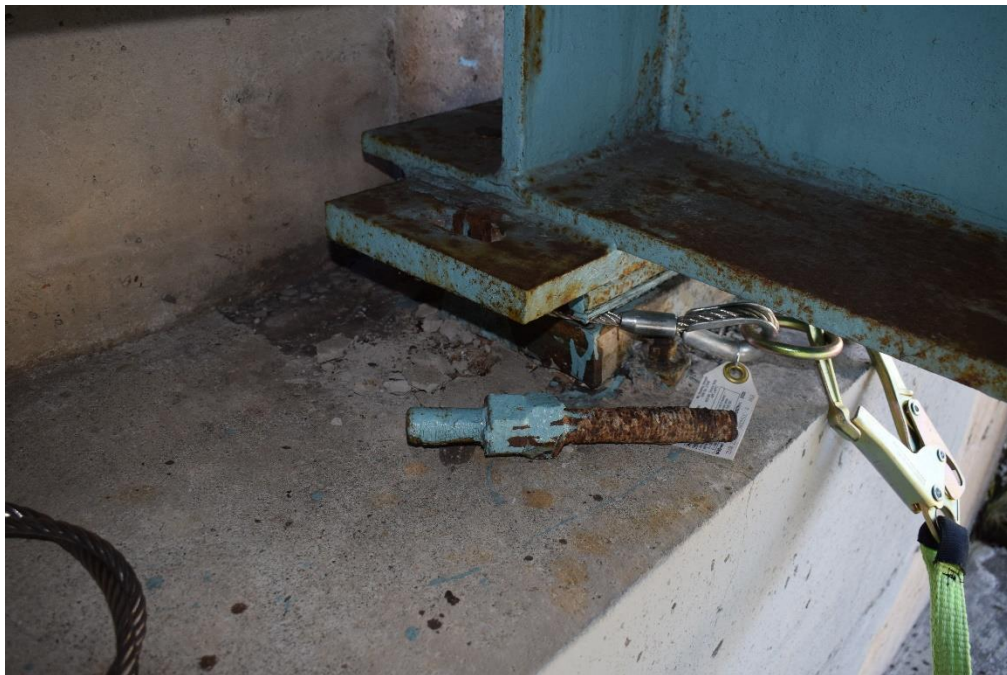
Exhibit 3.2-5: Abutment Bearing S1, Failed Anchor Bolt

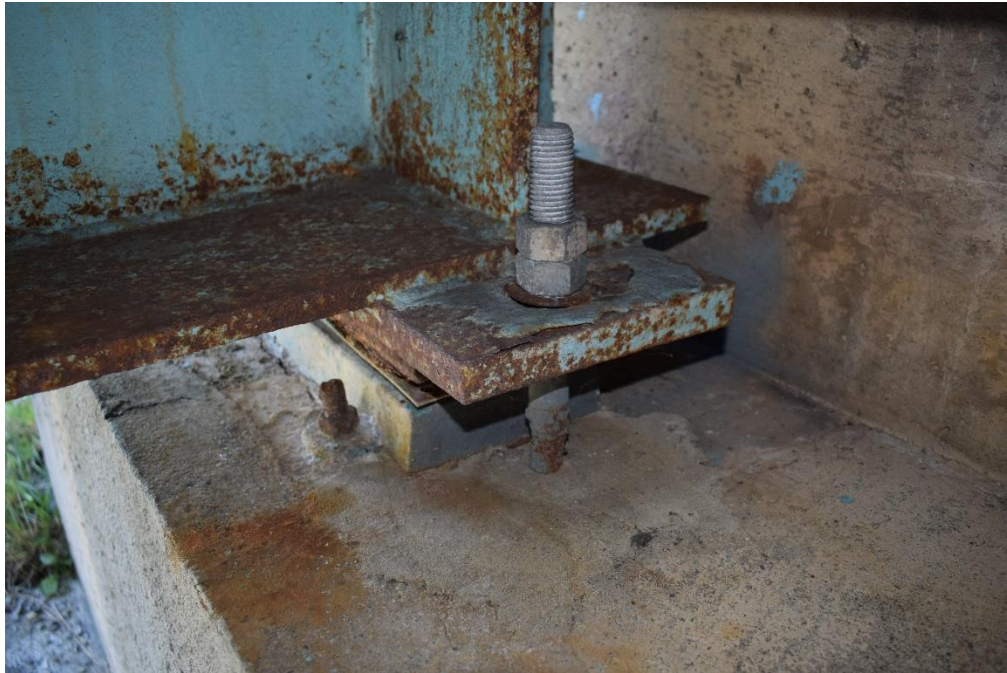
Exhibit 3.2-6: Abutment Bearing S5, Severe Necking at Base of Anchor Bolt.

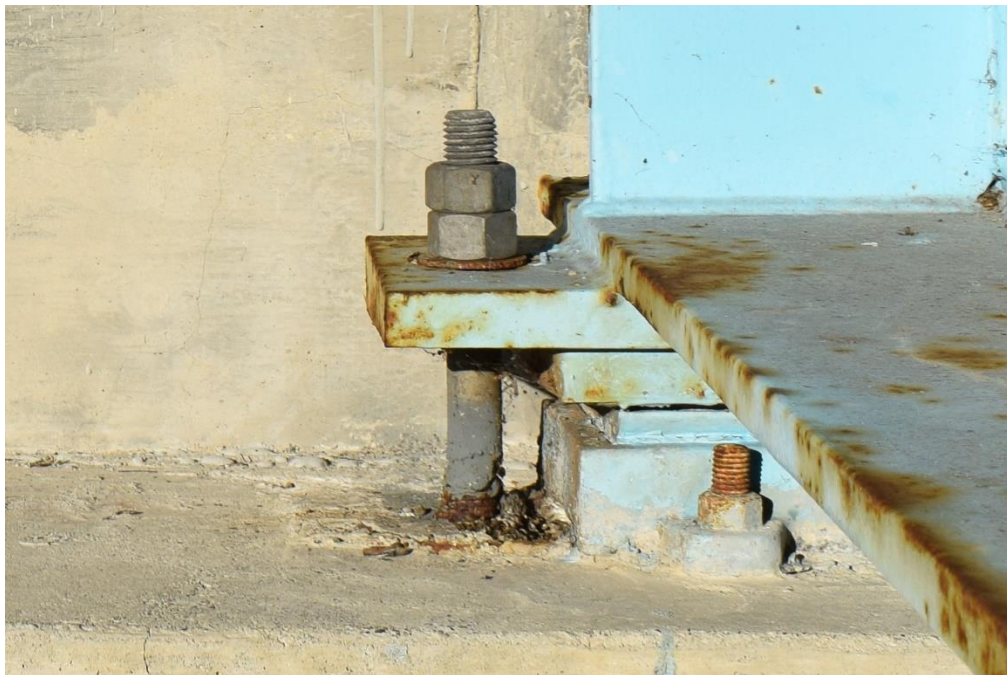
Exhibit 3.2-7: Abutment Bearing N1, New Threaded Rod Welded to Existing Anchor Bolt

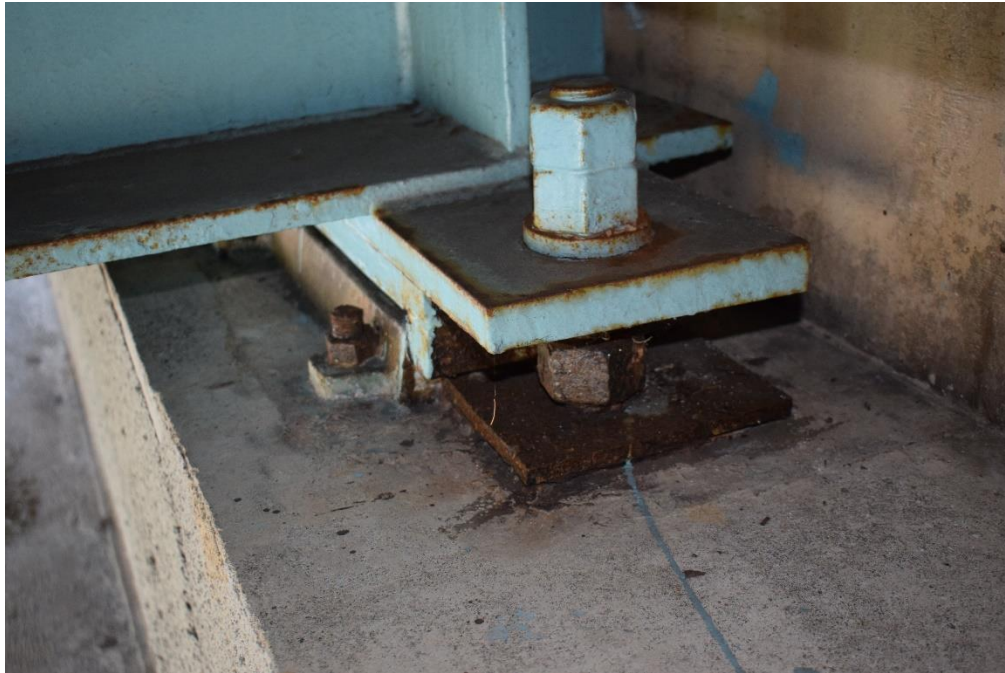
Exhibit 3.2-8: Bearing S3, Corroded Keeper Plate

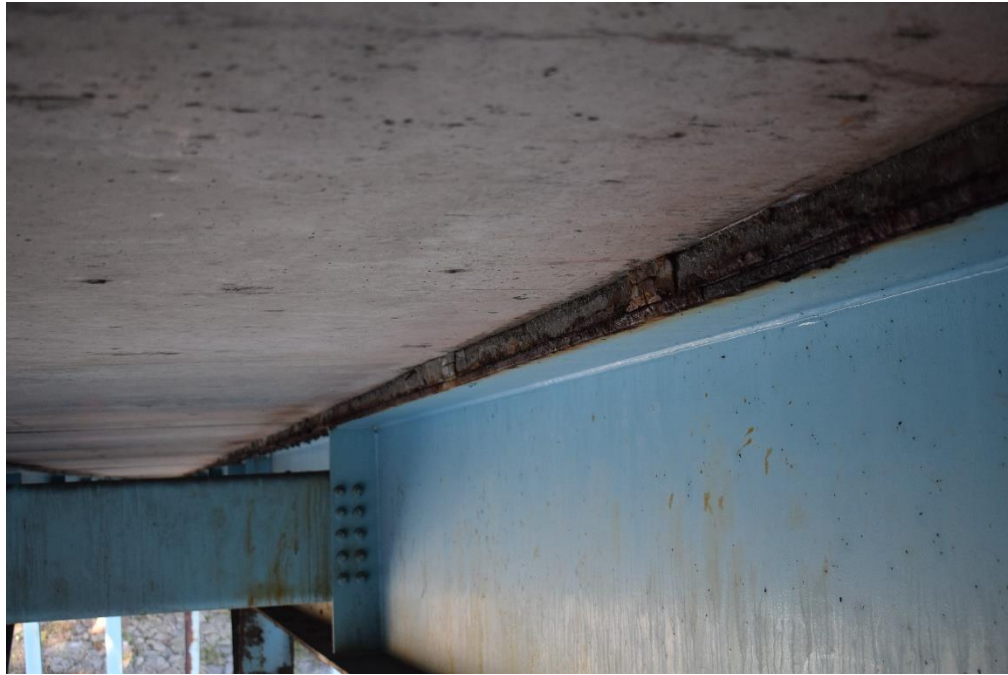
Exhibit 3.2-9: Girder 3 Looking North, Coating Loss and Corrosion Along Top Flange

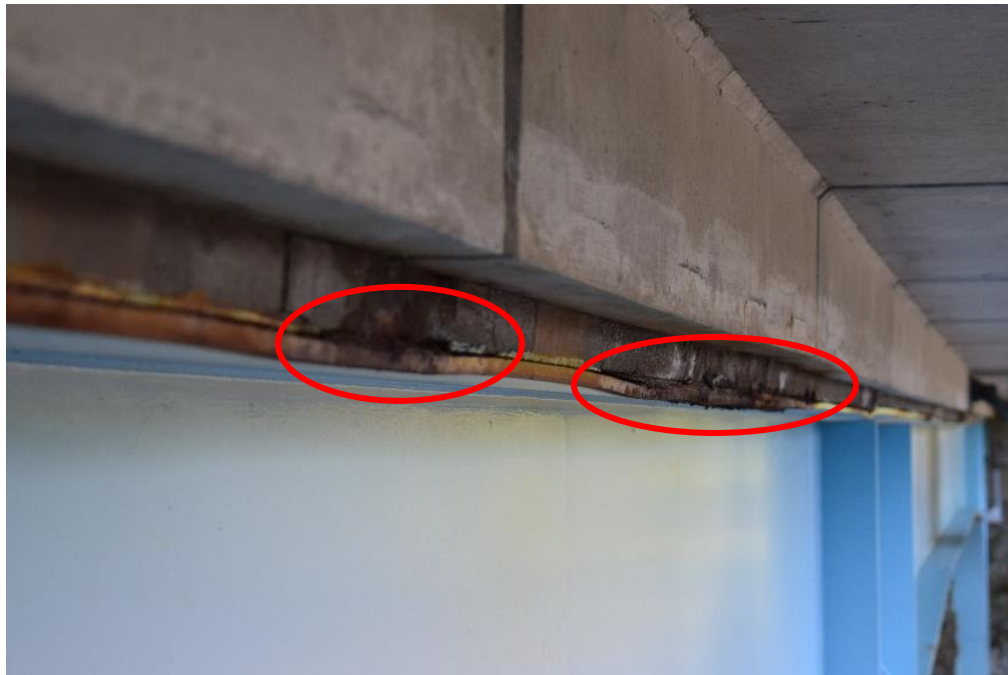
Exhibit 3.2-10: Girder 5 Looking North, Undulating Top Flange Due to Pack Rust

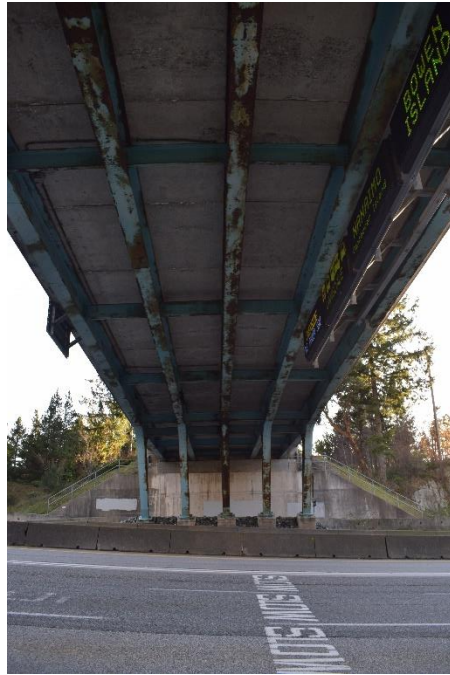
Exhibit 3.2-11: Looking South, Girder Bottom Flange Corrosion

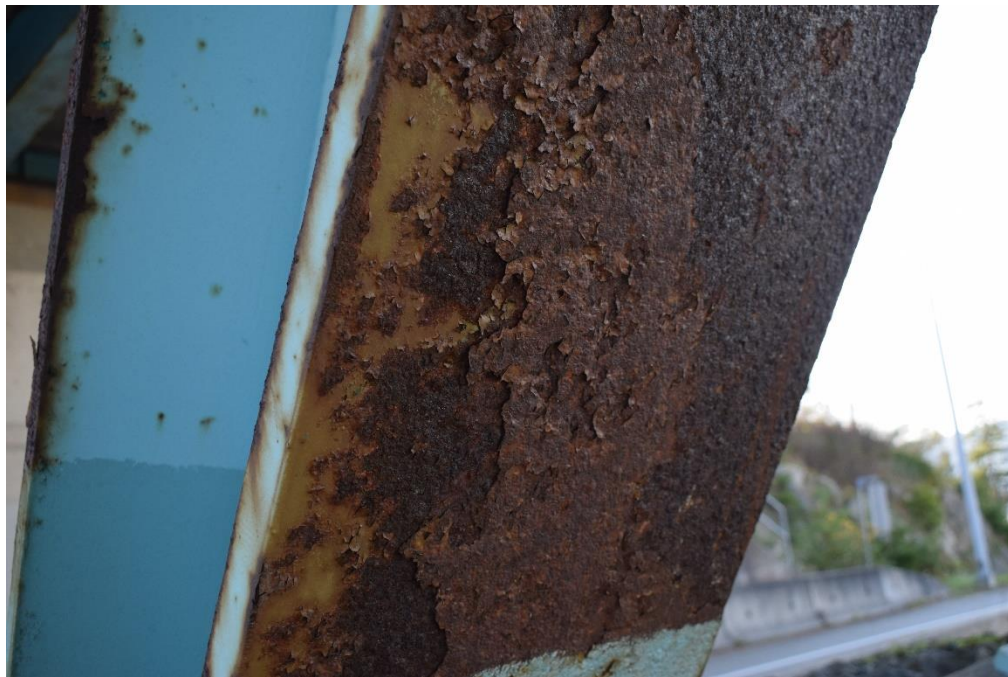
Exhibit 3.2-12: Pier Leg S3 Bottom Flange Corrosion

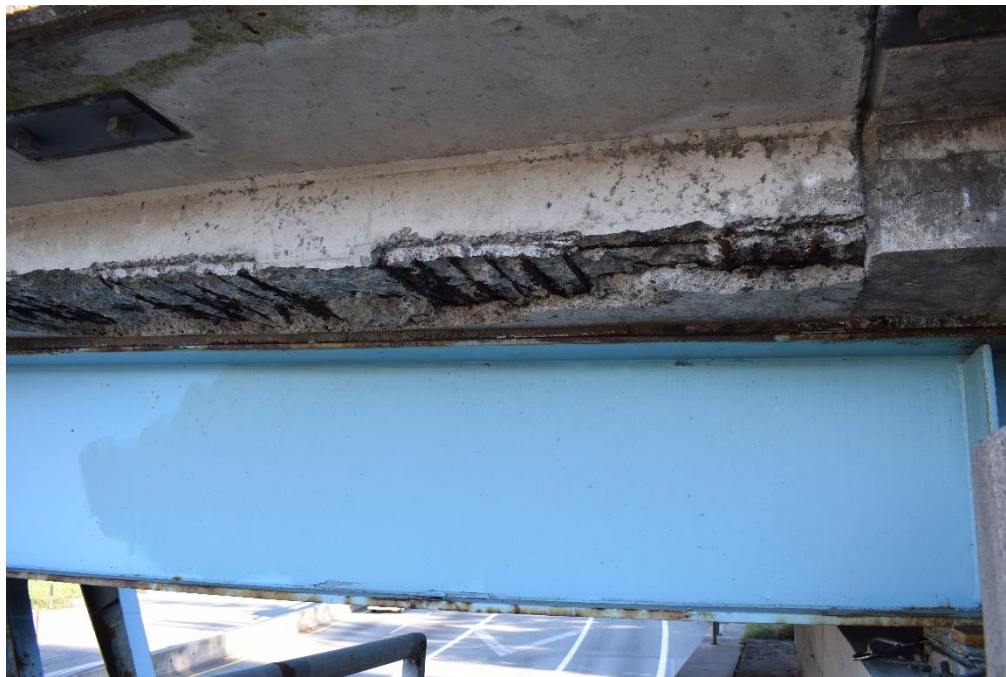
Exhibit 3.2-13: West Deck Fascia at South End of Bridge, Spalling and Exposed PT

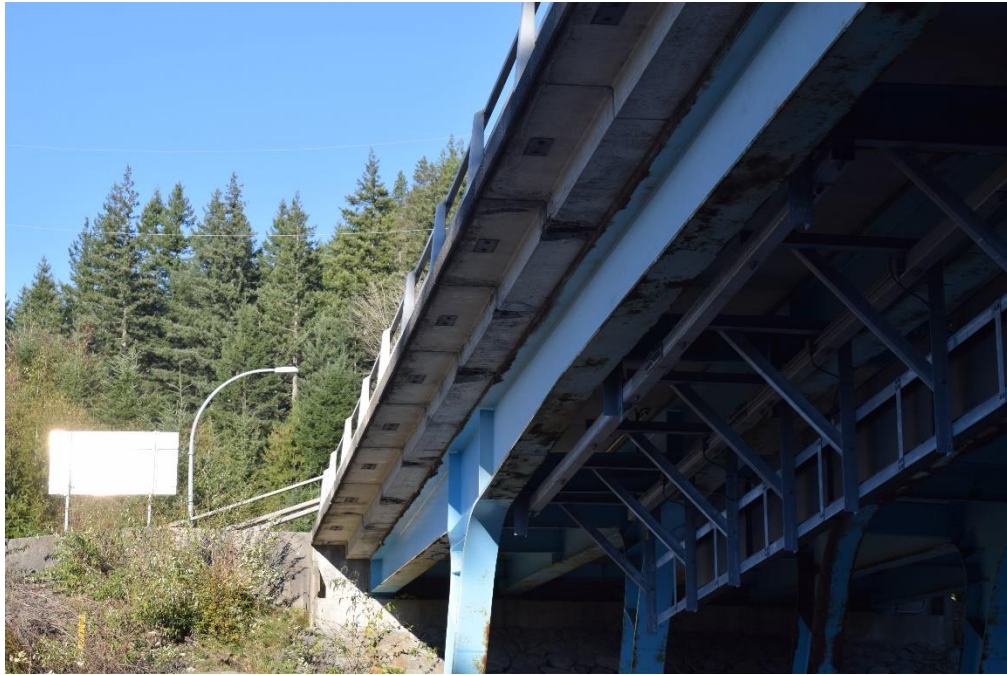
Exhibit 3.2-14: West Deck Fascia, Spalling and Exposed Prestressing Strands

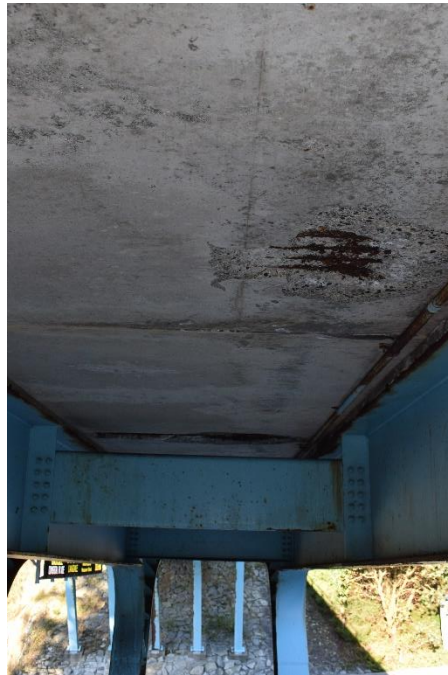
Exhibit 3.2-15: Concrete Spall and Exposed Strand Deck Soffit Between Girders 4 and 5, Looking North

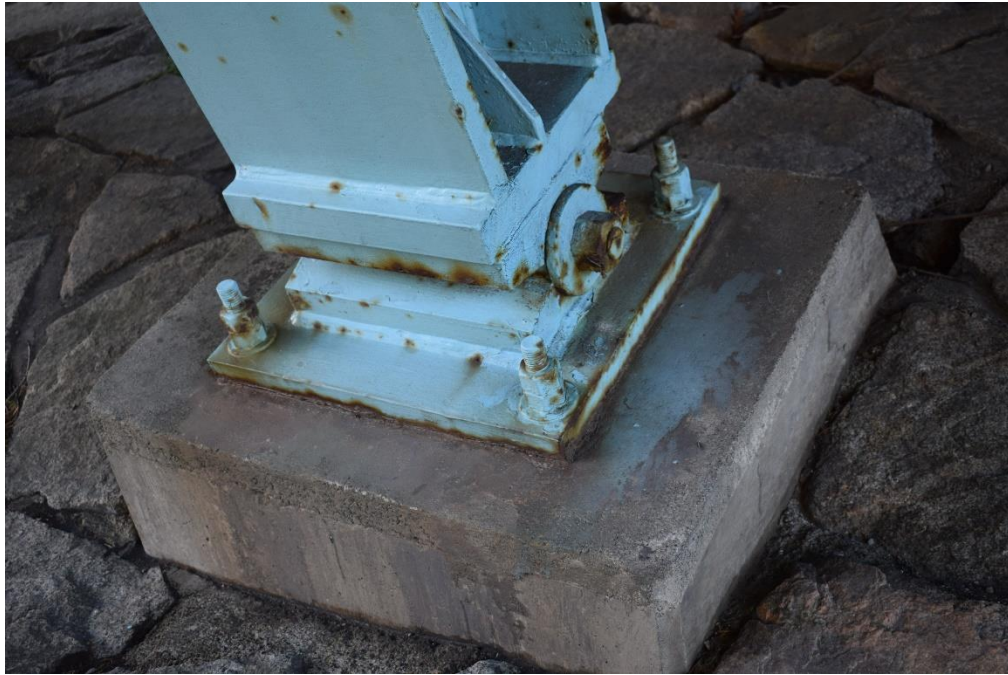
Exhibit 3.3-1: Inclined Pier Bearing S4, Typical Inclined Pier Bearing Condition

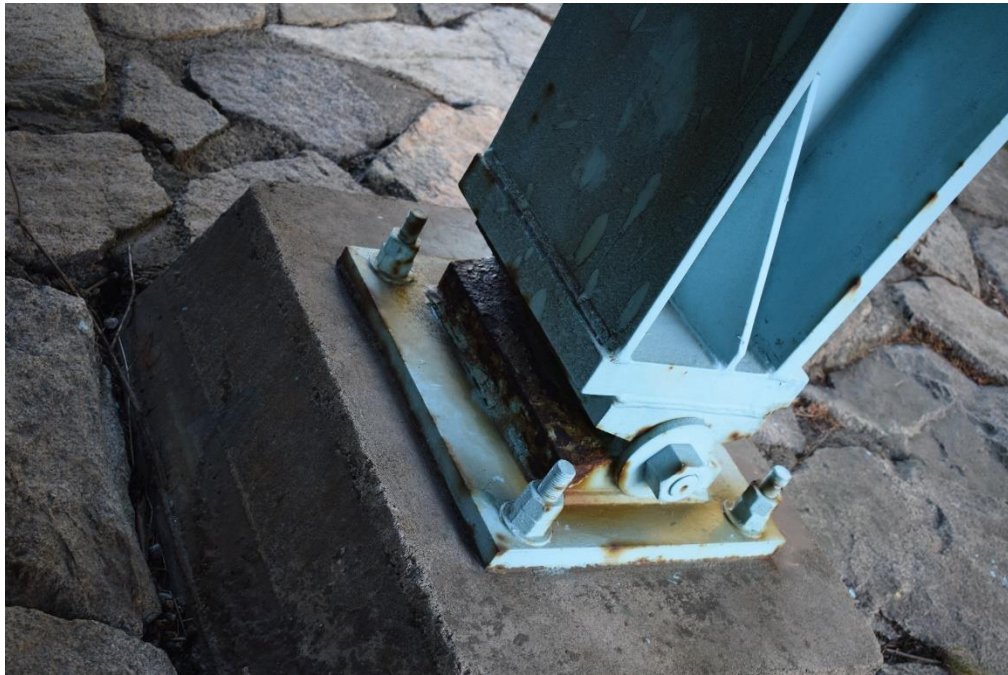
Exhibit 3.3-2: Inclined Pier Bearing S4, Corrosion on Lower Rocker Plate

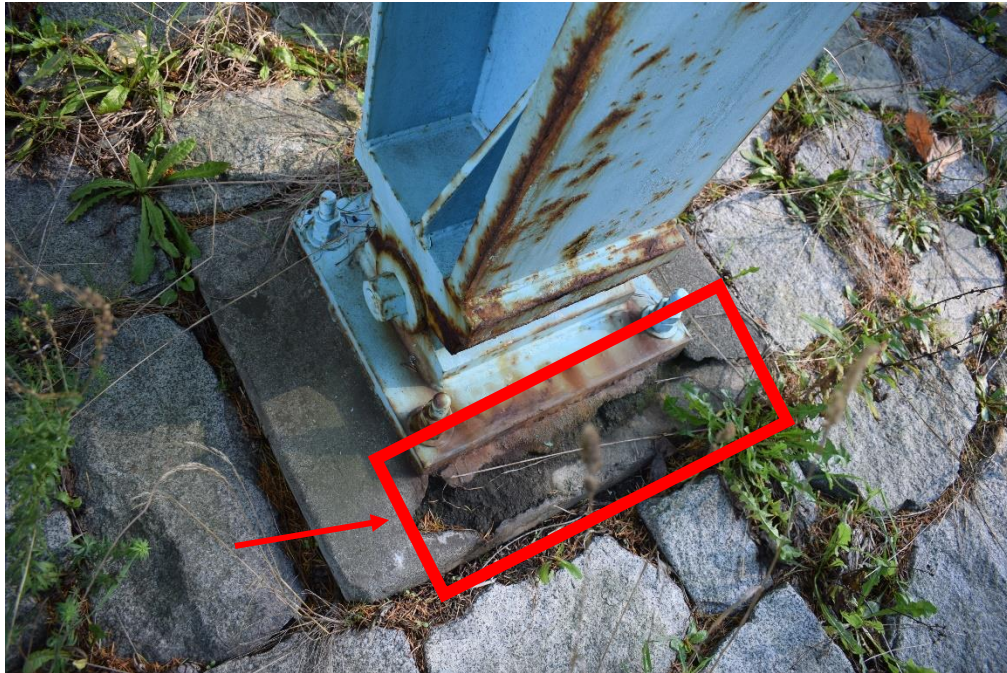
Exhibit 3.3-3: Inclined Pier Bearing N5, Debonded Grout Pad

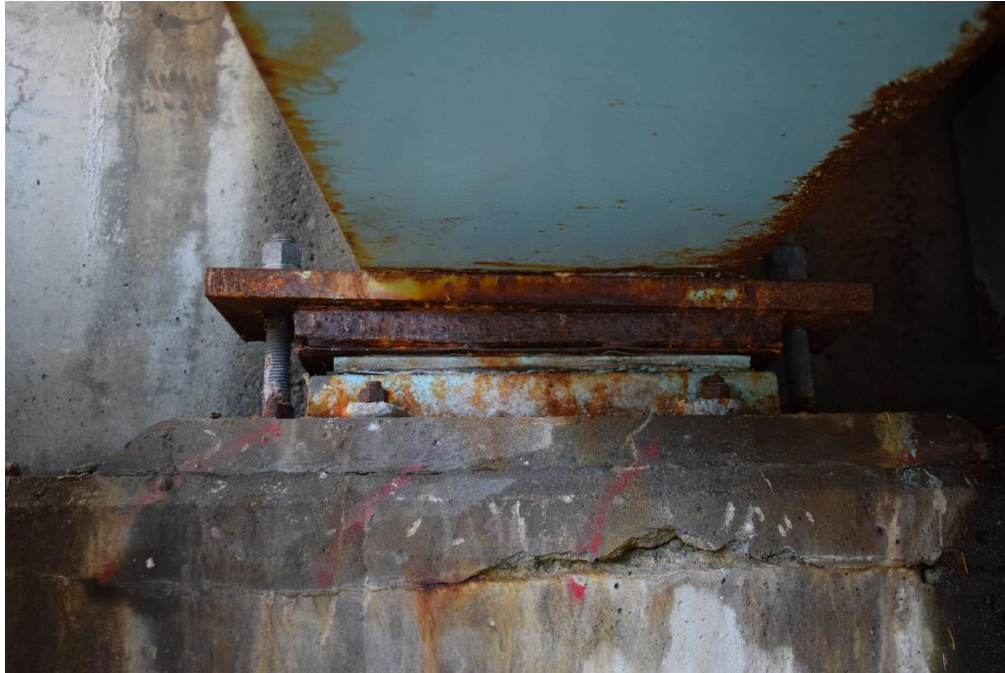
Exhibit 3.3-4: Abutment Bearing N1, Heavily Corroded

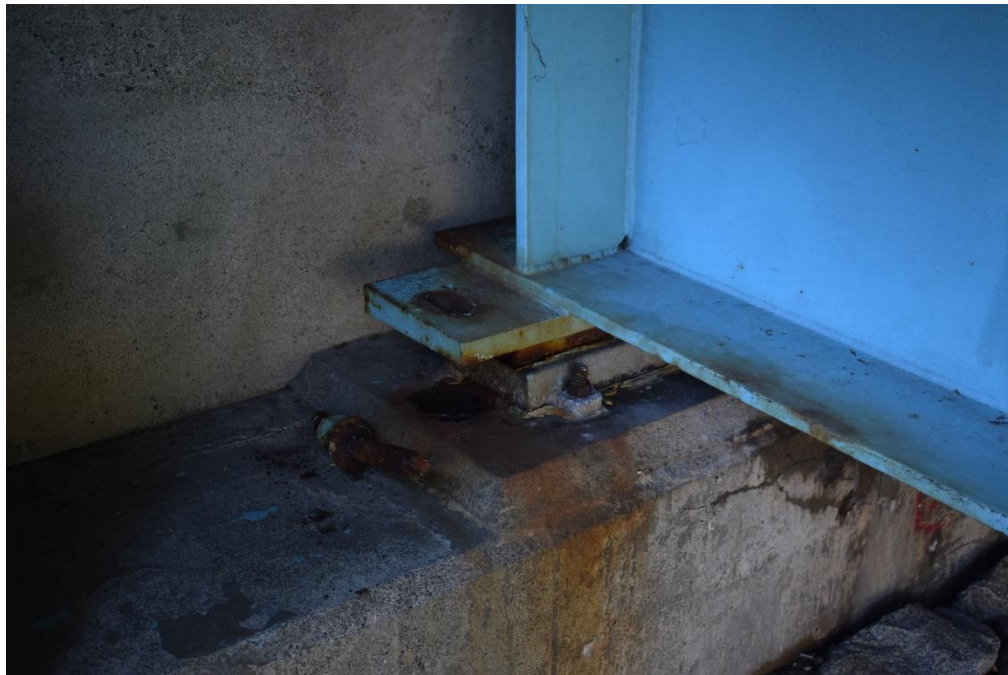
Exhibit 3.3-5: Abutment Bearing S6, Anchor Bolt Failure
