Photo: Horseshoe Bay Underpass

Upper Levels Highway Underpasses - Seismic Retrofit Project

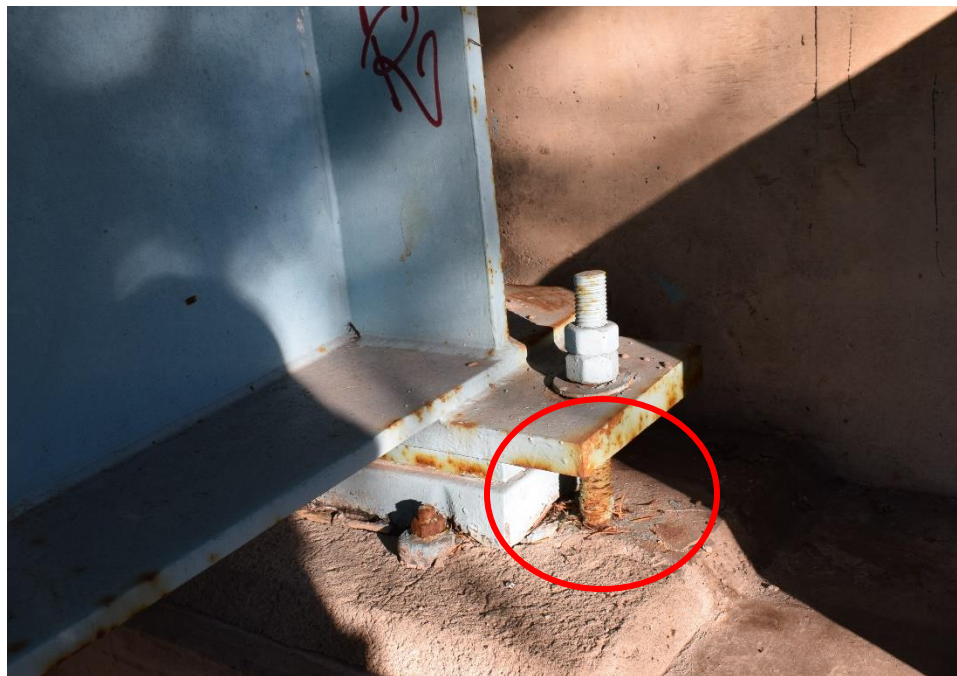
Exhibit 3.3-6: Abutment Bearing N6, Necking of Bolt Entering Bearing Shelf

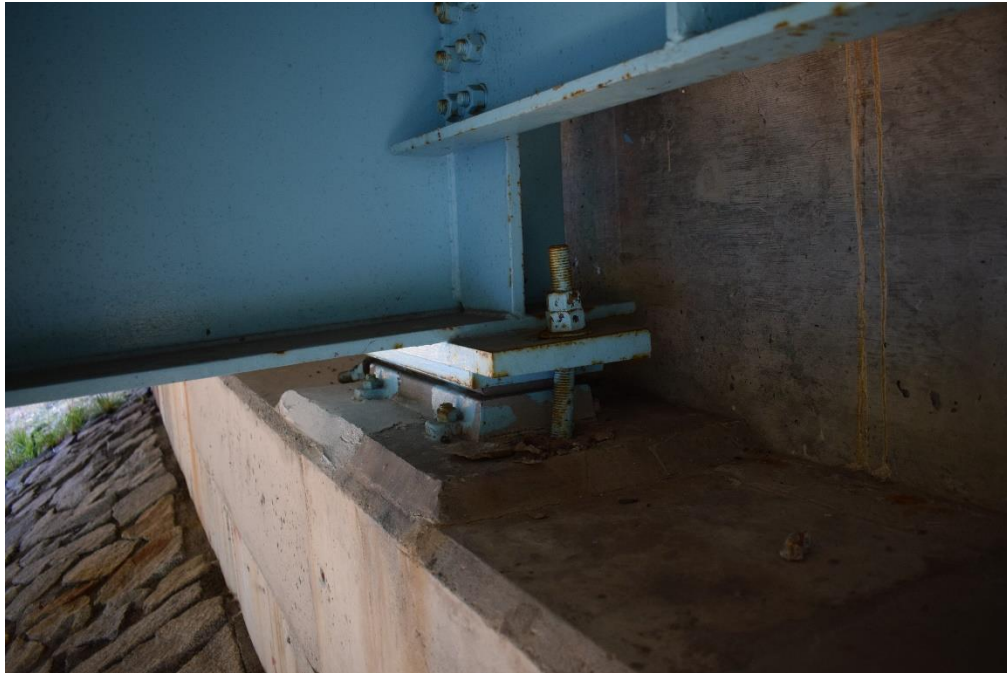
Exhibit 3.3-7: Abutment Bearing N4, Bolt Bent Towards the North

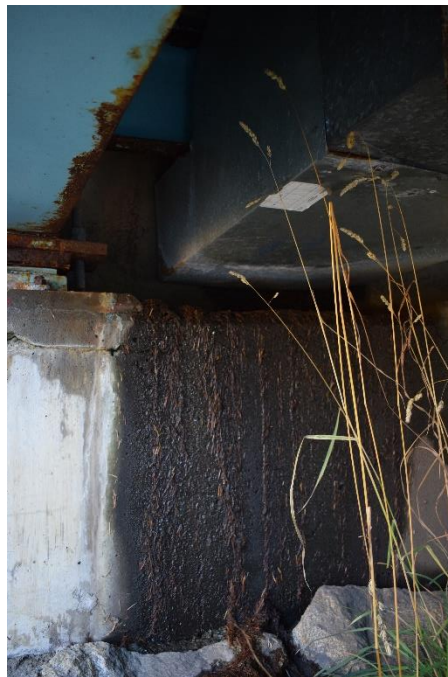
Exhibit 3.3-8: Water Ingress Through Joint at North Abutment Beneath Utilities

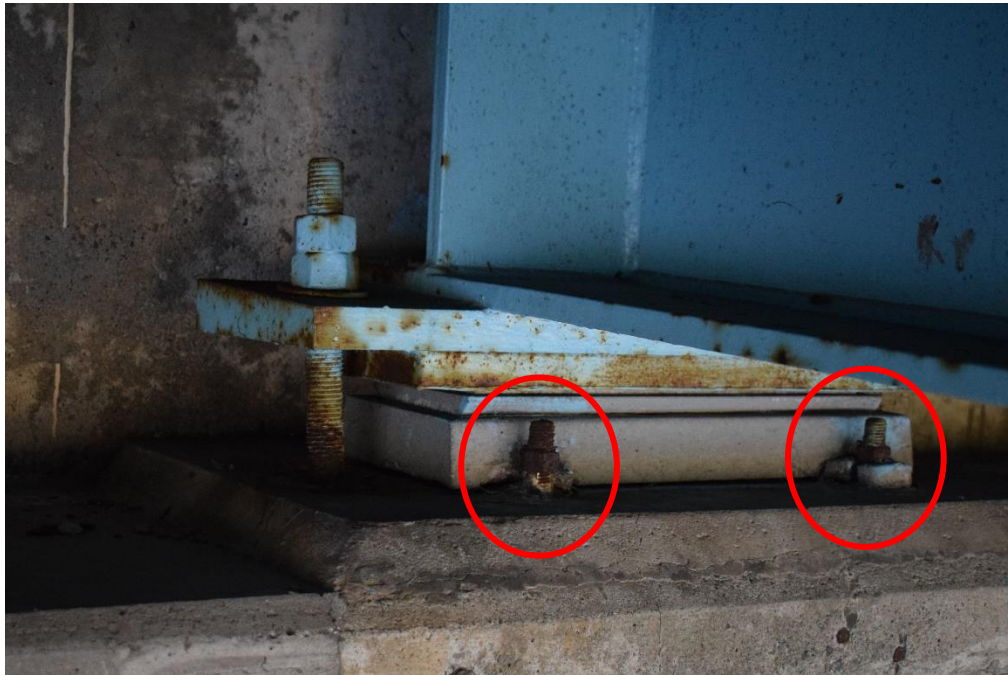
Exhibit 3.3-9: Abutment Bearing S2, Fractured Tabs on Base Plate

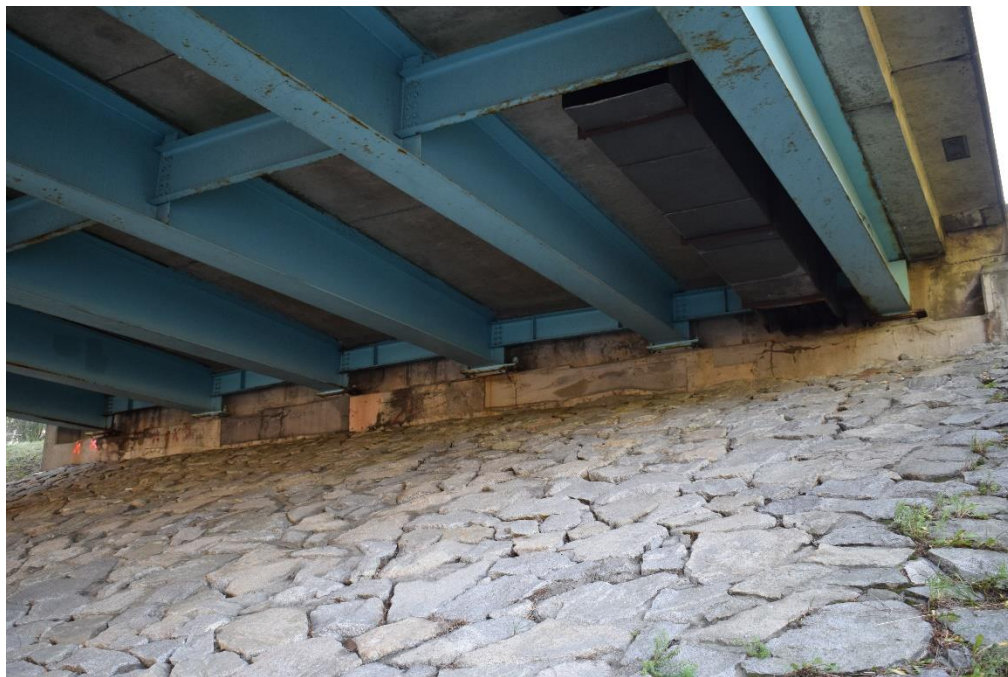
Exhibit 3.3-10: South Bearing Shelf, Cracking, Delaminations and Past Repairs Visible

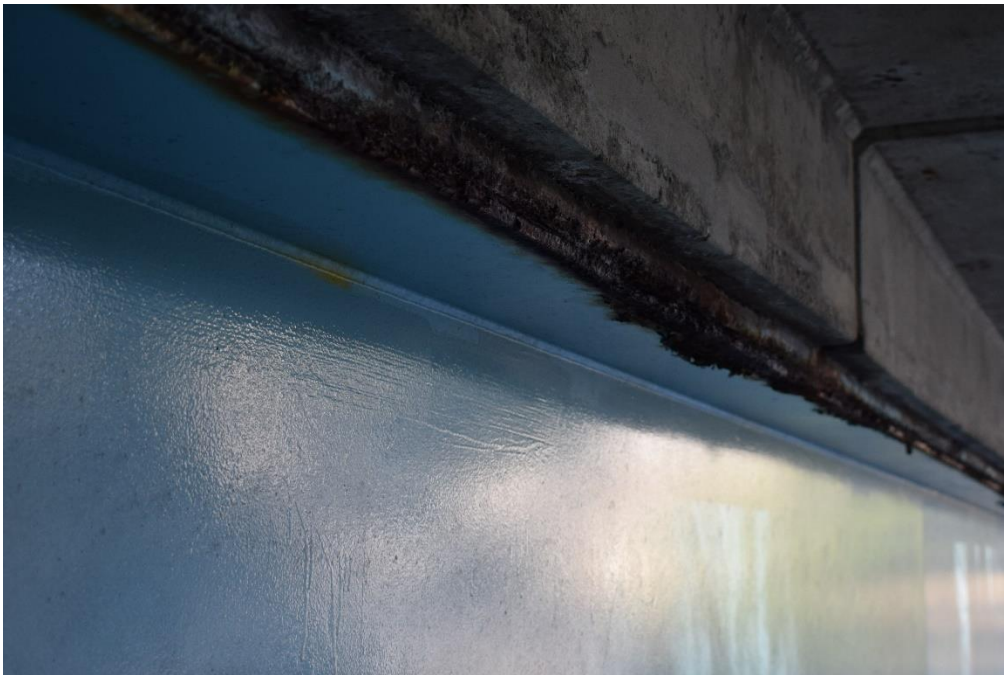
Exhibit 3.3-11: Girder 6 Top Flange Corrosion, Looking North

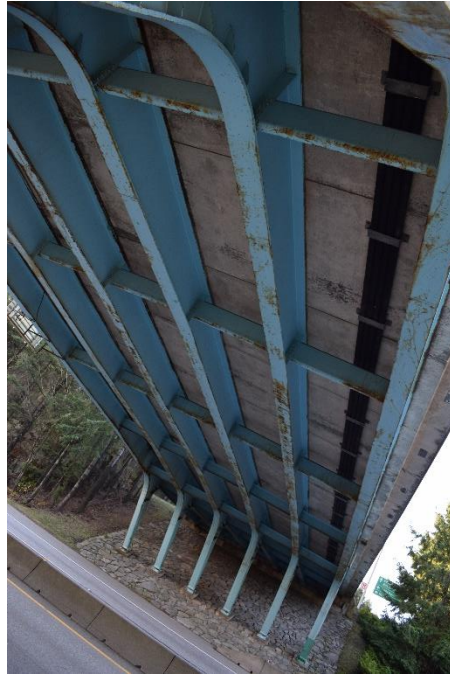
Exhibit 3.3-12: Bottom Flange Corrosion/Coating Loss

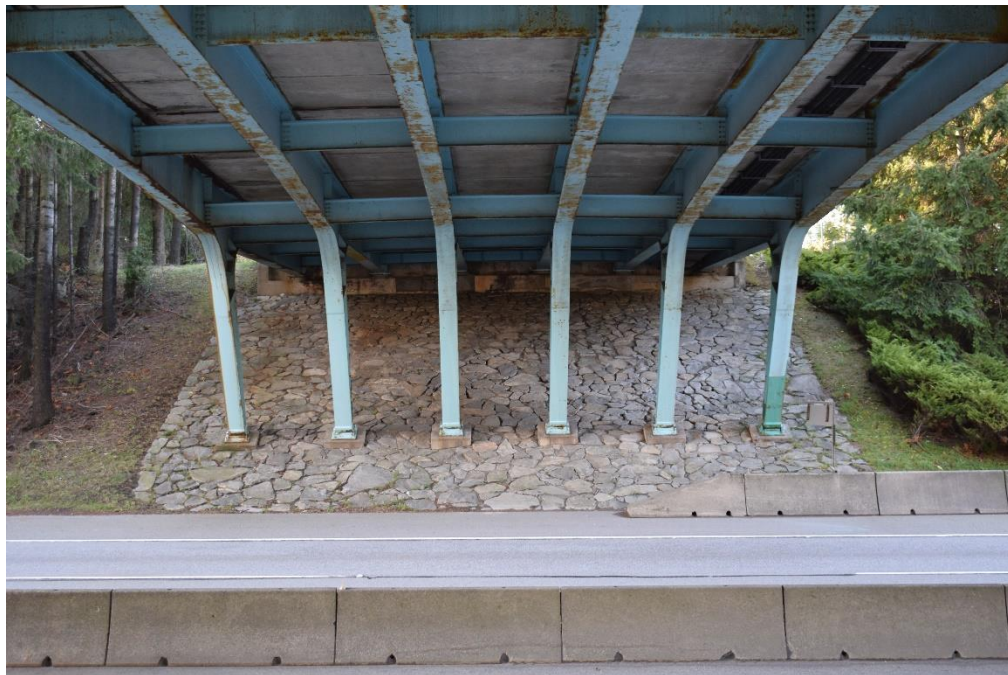
Exhibit 3.3-13: South Pier Legs

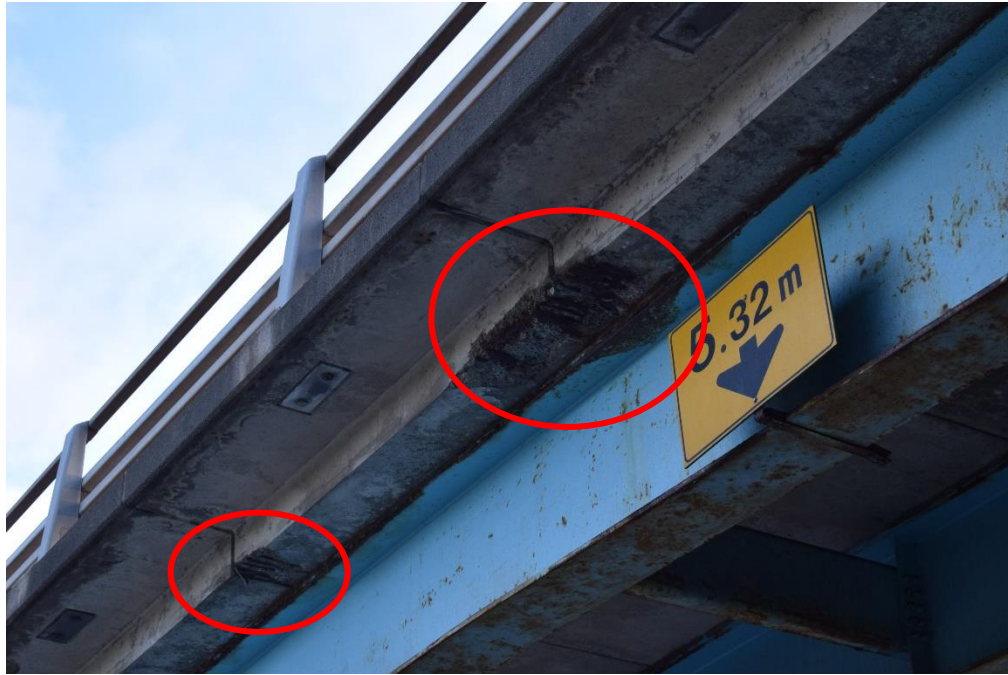
Exhibit 3.3-14: West Deck Fascia, Corroded Tendons Exposed at Concrete Spalls

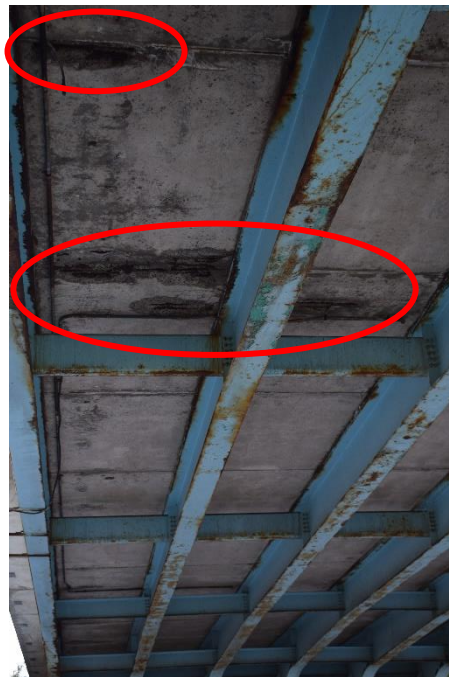
Exhibit 3.3-15: Soffit of Deck with Spalls between Girder 4/5/6, Looking South

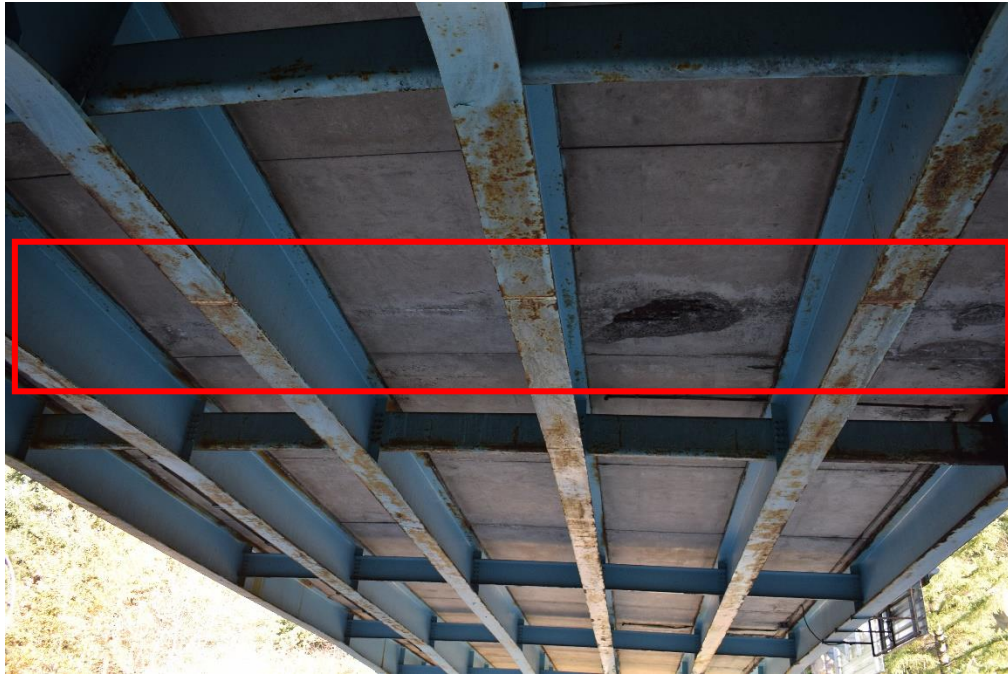
Exhibit 3.3-16: Transverse Strip of Discolouration Along Soffit of Deck, South End of Bridge

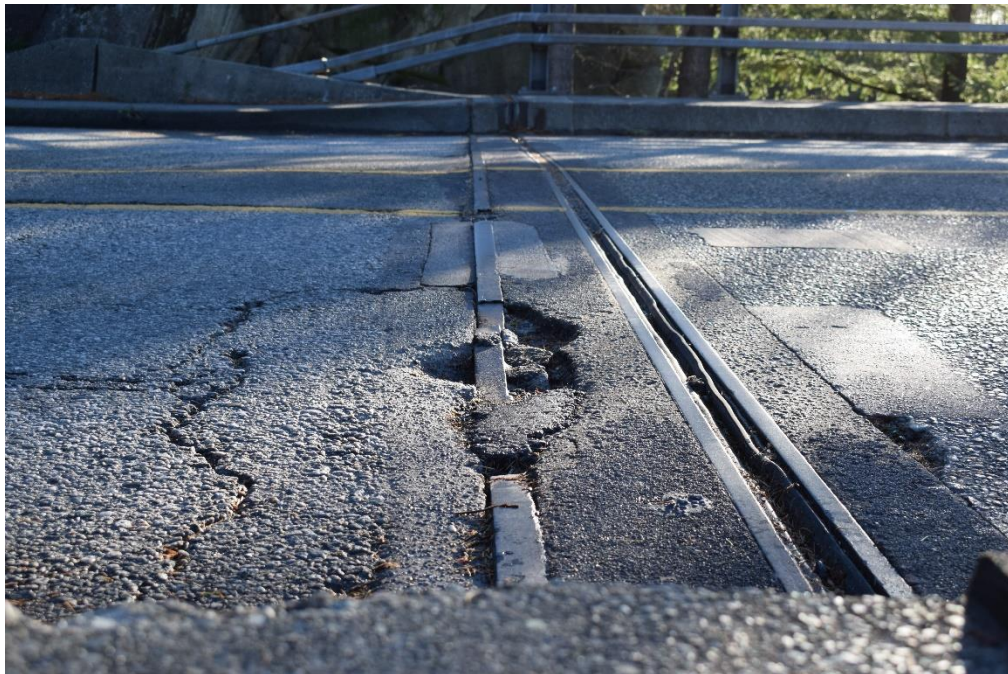
Exhibit 3.3-17: Asphalt Damage and Fractured Armoring near North Joint

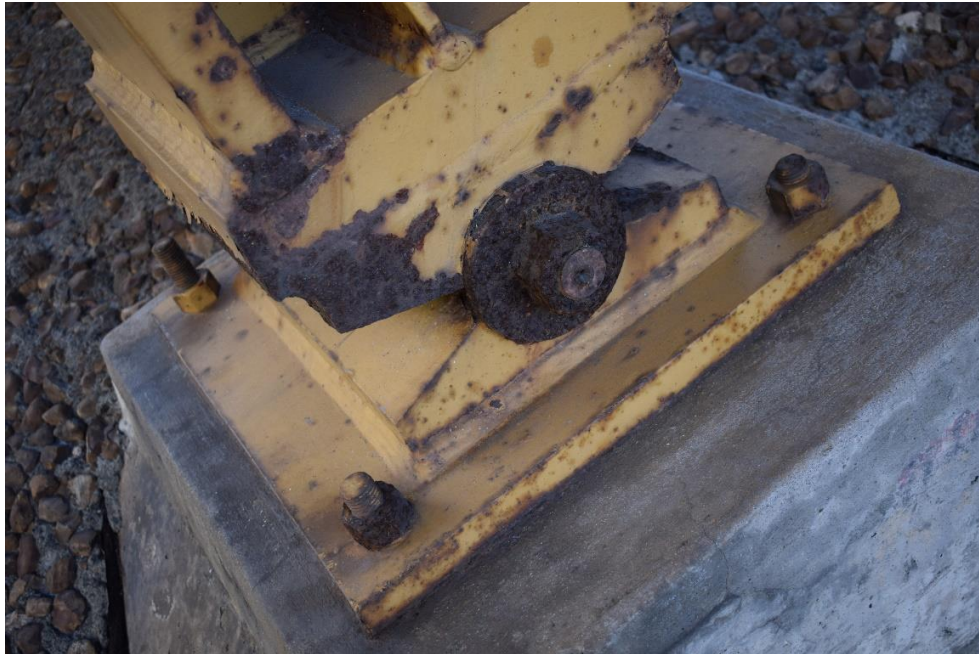
Exhibit 3.4-1: Pier N3 Bearing, Corrosion on Pin Washer and Rocker Plates

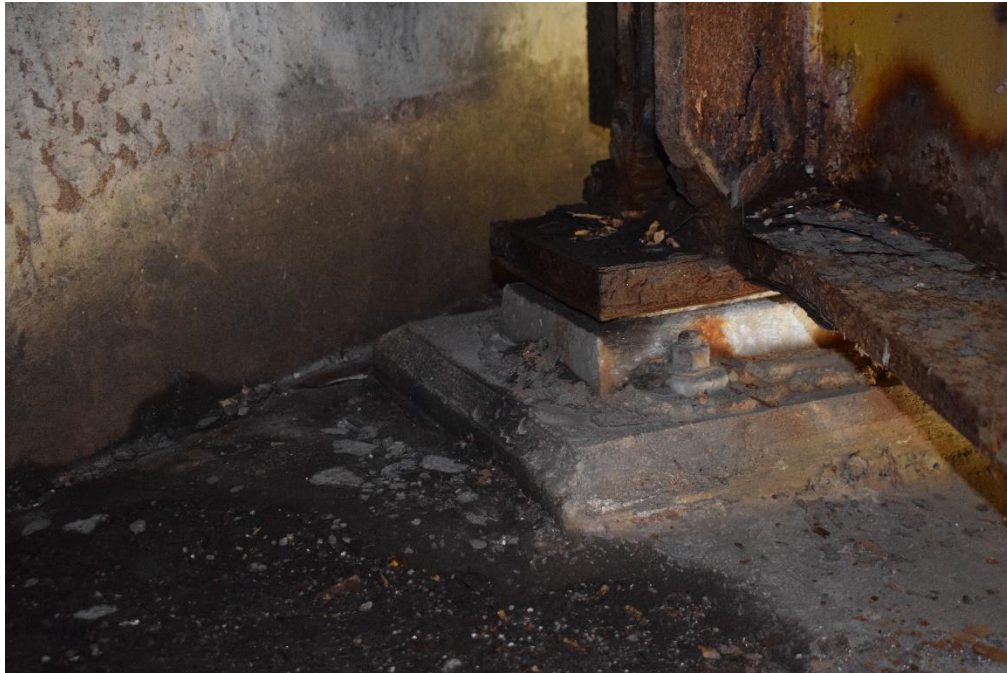
Exhibit 3.4-2: Abutment Bearing N4, Corrosion of Bearing and Girder Flange

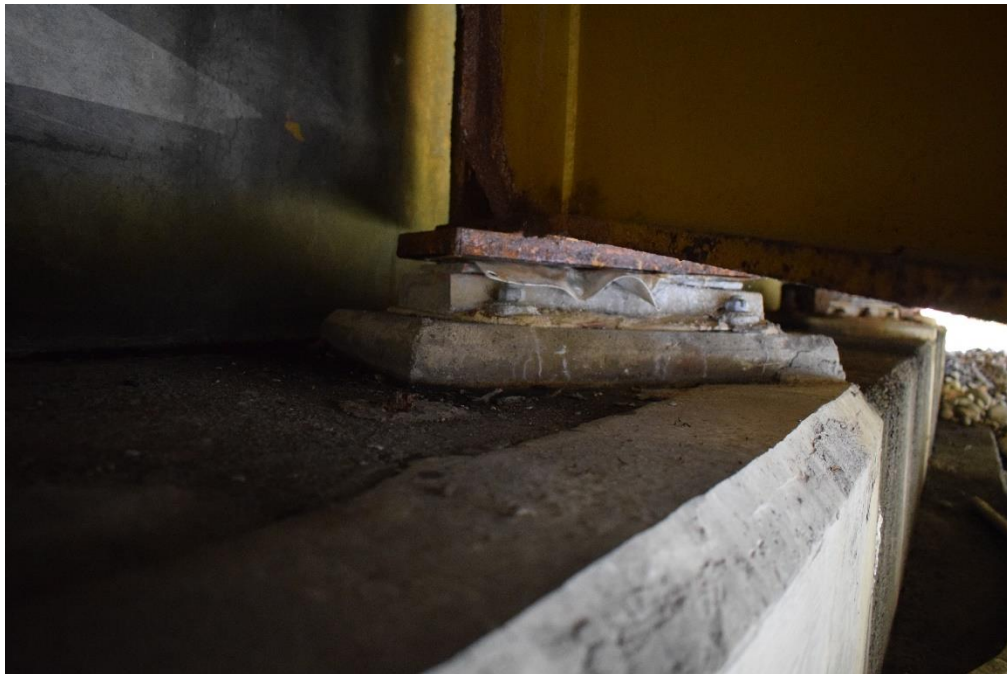
Exhibit 3.4-3: Abutment Bearing N2, Failed Polymer Sheet

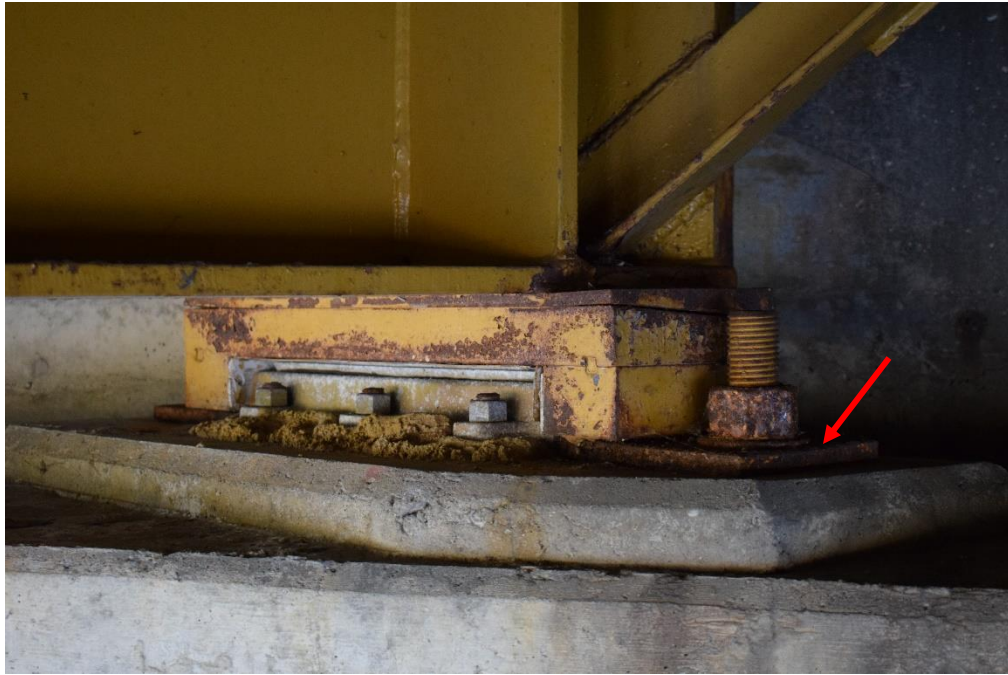
Exhibit 3.4-4: Abutment Bearing S3, Corrosion on Keeper Plate

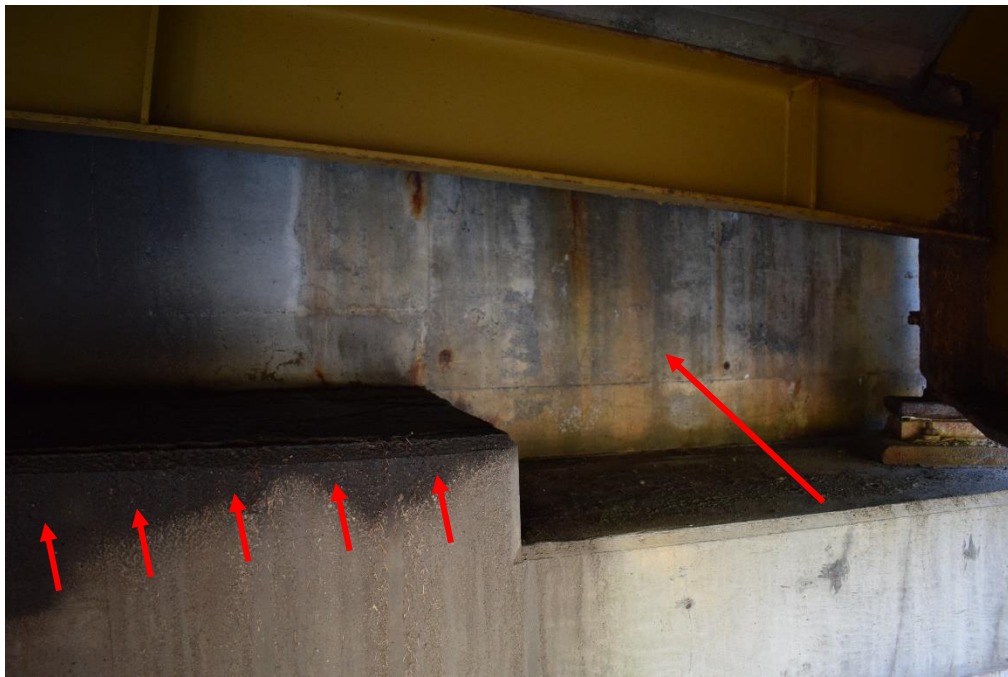
Exhibit 3.4-5: Water Stain Between Abutment Bearings S1 and S2

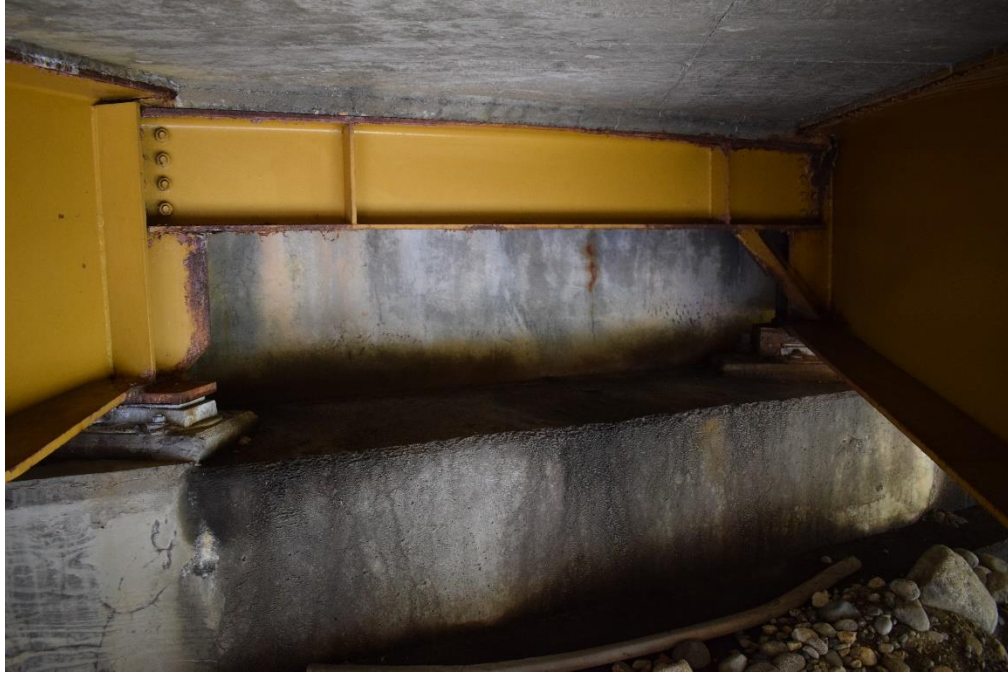
Exhibit 3.4-6: Water Stain Between Abutment Bearings N2 and N3

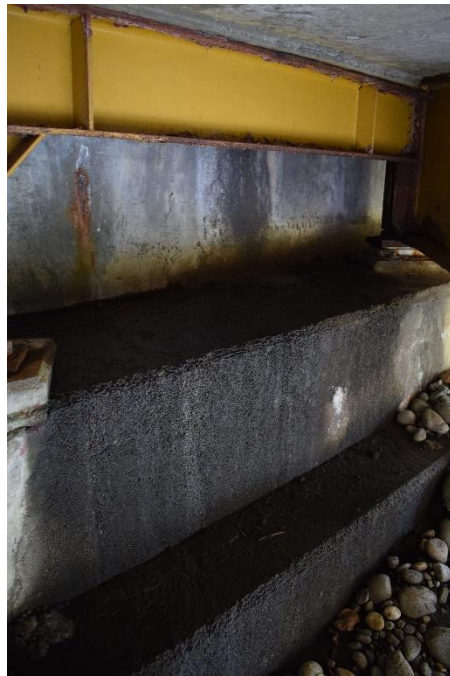
Exhibit 3.4-7: Water Stain Between Abutment Bearings N3 and N4

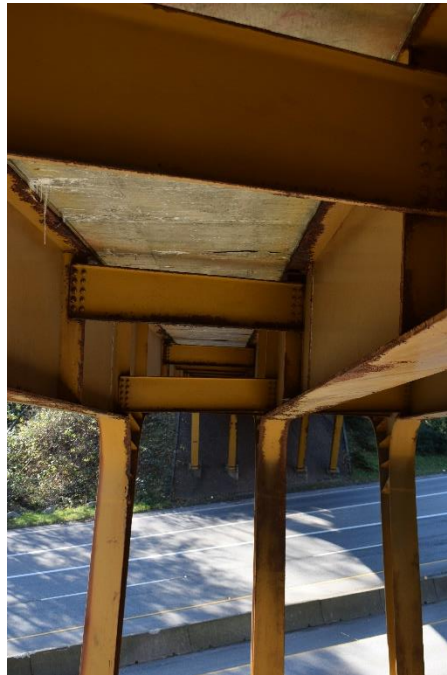
Exhibit 3.4-8: Between Girders 4 and 5 Looking South, Coating Loss Along Top Flange

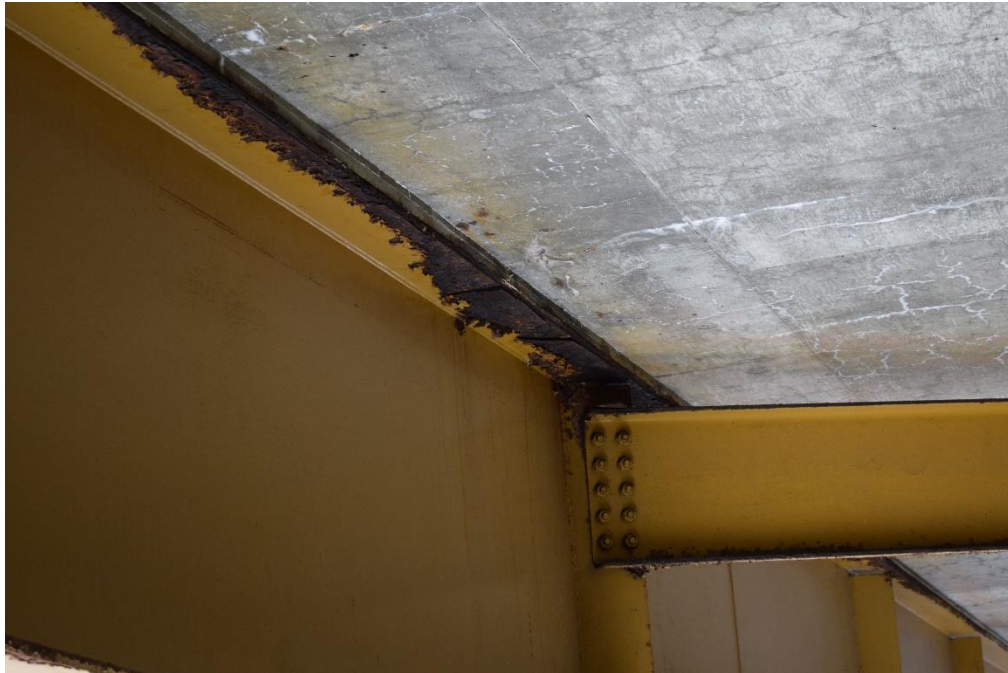
Exhibit 3.4-9: Girder 4 Top Flange from North Abutment, Localized Flaking/Section Loss

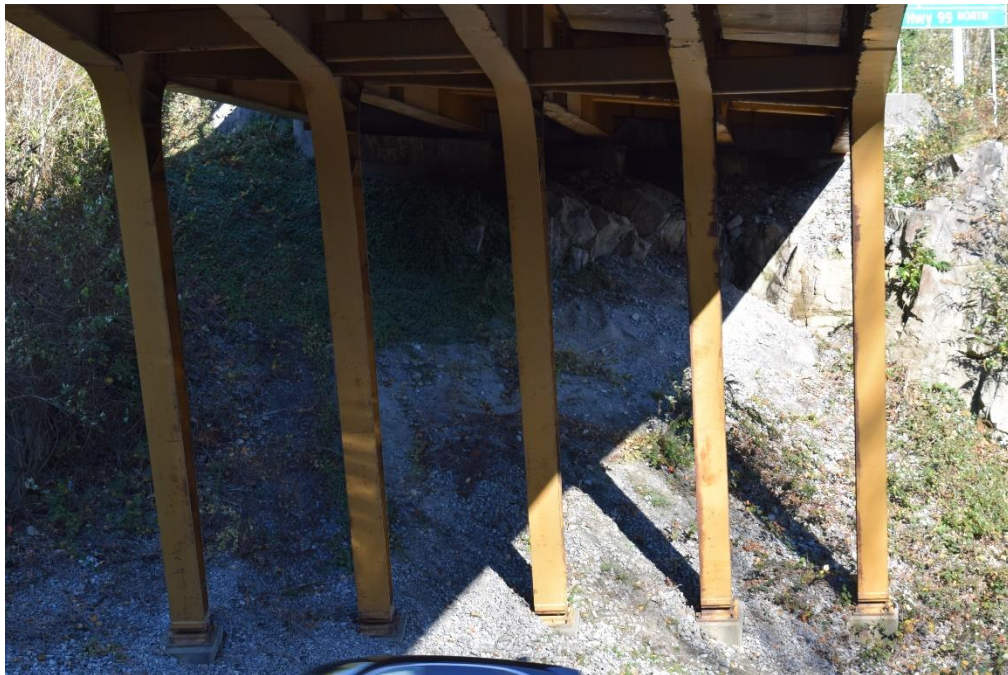
Exhibit 3.4-10: North Abutment Pier Legs, Fair to Good Condition

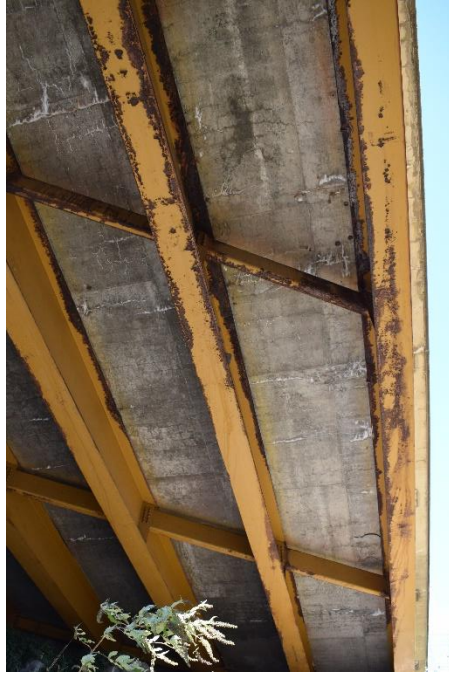
Exhibit 3.4-11: Efflorescence on Deck Soffit

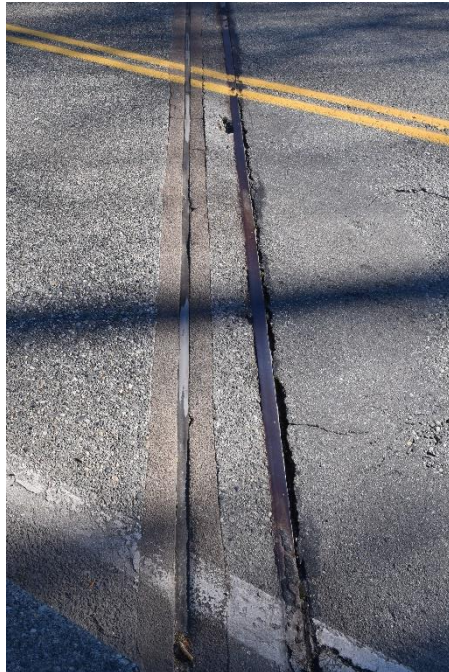
Exhibit 3.4-12: Asphalt Deterioration at South Abutment Joint

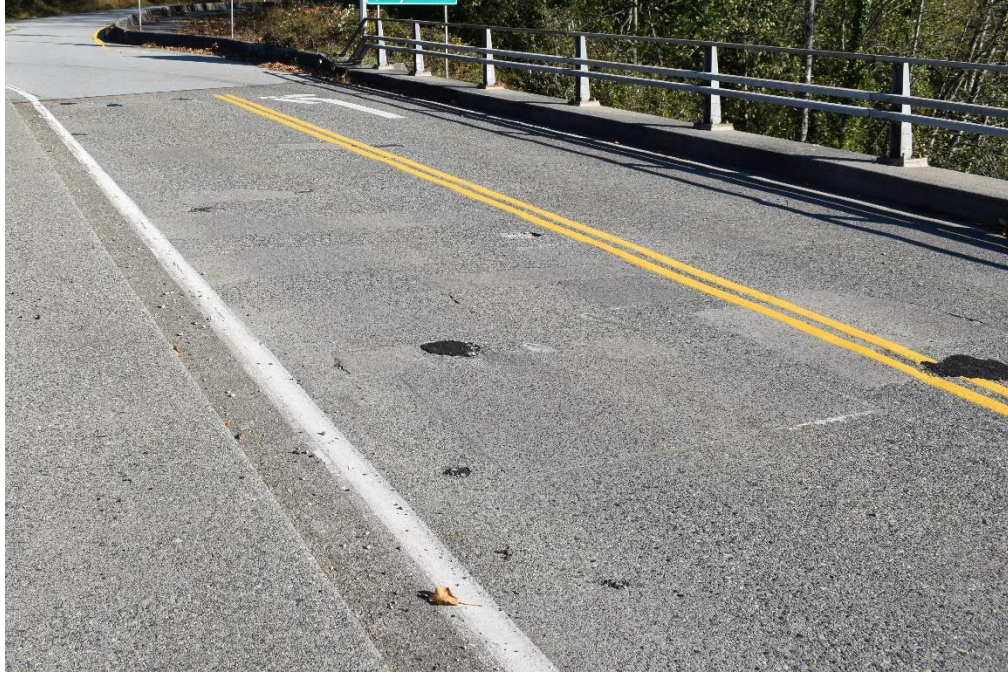
Exhibit 3.4-13: North End of Deck Surface with Repairs Visible
