**THURBER ENGINEERING LTD.**

# **H7/H11 Truck Re-Routing Intersection Improvements Supplemental Geotechnical Report**

**Client Name:** Urban Systems Ltd.

**Date:** October 13, 2023

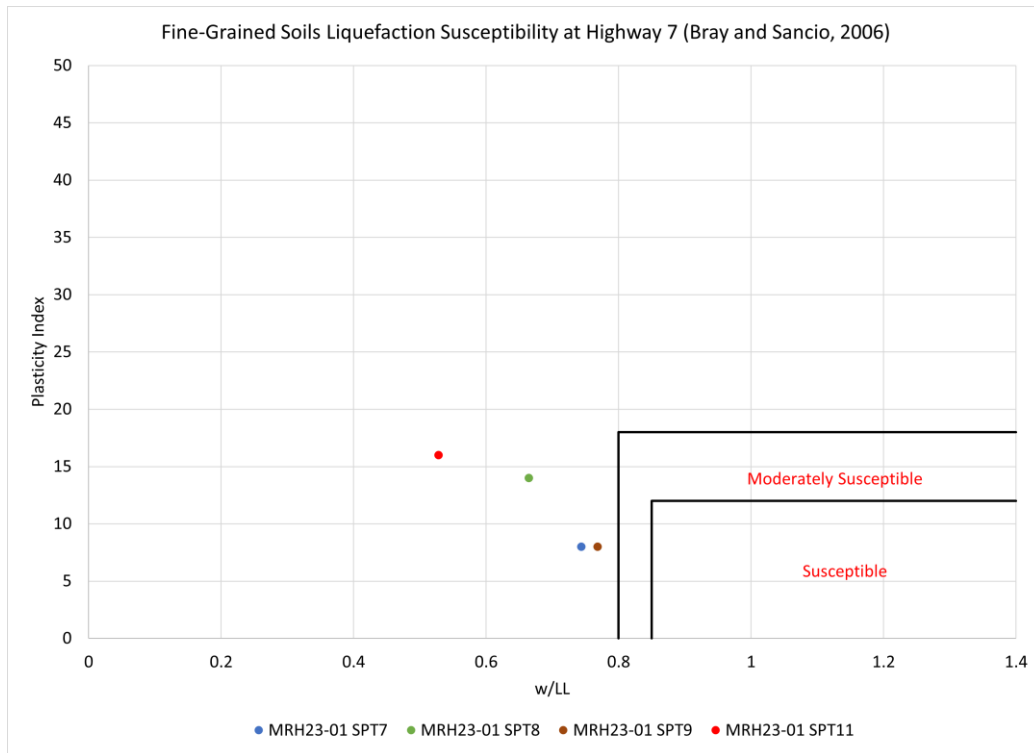
**Figure 8.1 Fine-Grained Soil Liquefaction Susceptibility at Highway 7**

The liquefaction potential of the very stiff to hard silt and silty clay encountered was assessed using published correlations related to Atterberg limits and water content (Bray and Sancio, 2006). The results were plotted on Figure 8.1 which indicate that the silt and silty clay at MRH23-01 is not likely susceptible to liquefaction.

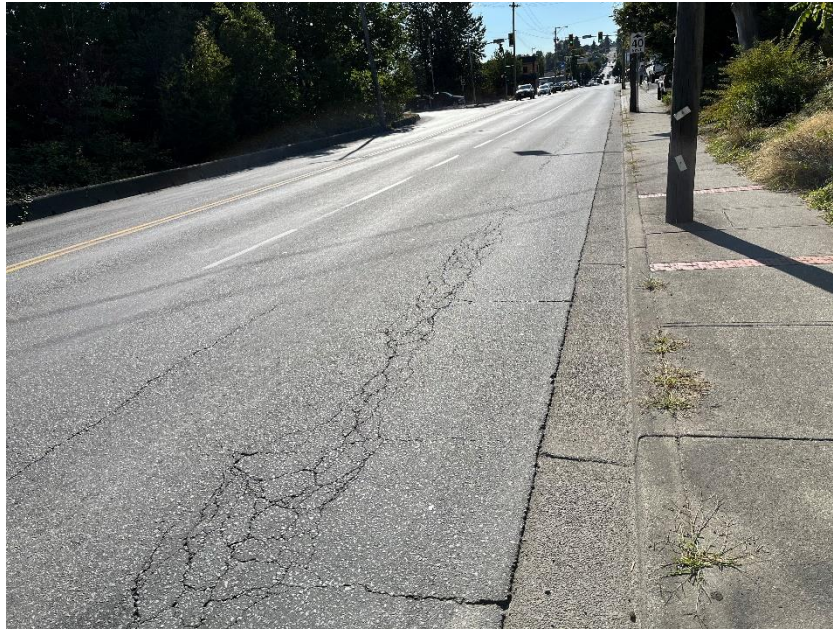
- Sta. 101+30 to 102+90 (westbound lane): moderate to high severity longitudinal wheel path cracking, nearly continuous;
- Sta. 102+10 (westbound lane): moderate severity alligator cracking, about 6 m<sup>2</sup> and a severe pothole;

The observed longitudinal wheel path cracking, alligator cracking and rutting are likely indicators of inadequate pavement structure and poor pavement drainage. This is consistent with the findings of the Falling Weight Deflectometer (FWD) testing completed for the initial Geotechnical Report. The transverse cracking may be caused by, among other things, frost action on the pavement soils or reflection cracking from underlying asphalt layers.

***Photo 1: High Severity Longitudinal Wheel Path Cracking Near Sta. 101+50 (Westbound)***

Considering our site observations described in Section 3.3, in combination with the subsurface soil conditions and FWD measurements at the site, full-depth pavement reconstruction per our initial Geotechnical Report is recommended to achieve a 20-year design life pavement structure. This includes repairs to the existing “dip” in the Highway 7 asphalt around Catherwood Street.

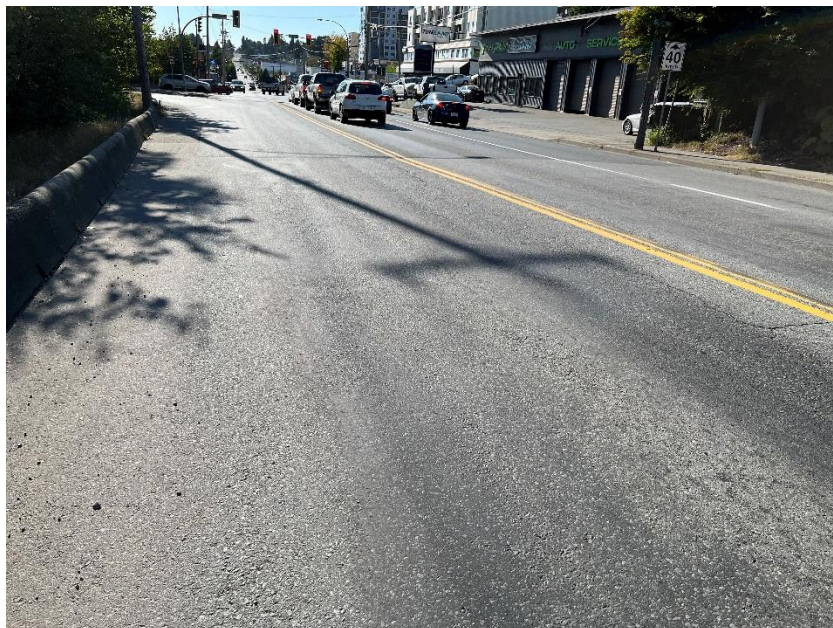
- Sta. 101+30 to 101+40 (eastbound lane): moderate severity longitudinal wheel path cracking;
- Sta. 101+30 to 101+65 (eastbound lane): moderate to high severity rutting;

***Photo 2: Moderate Severity Rutting Near Sta. 101+50 (Eastbound)***

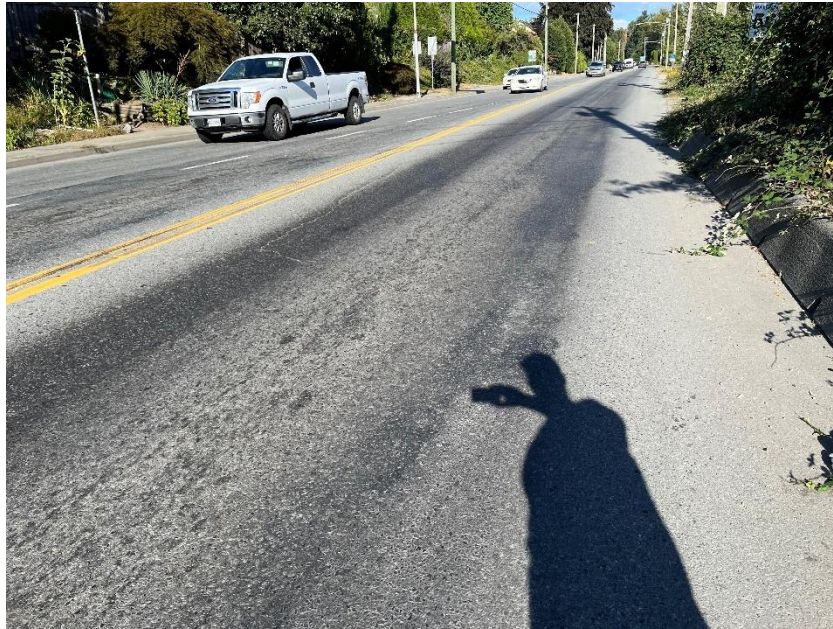
- Sta. 103+70 (westbound lane): moderate severity alligator cracking, about 6 m<sup>2</sup>;
- Sta. 100+95 to 103+60 (eastbound lane): moderate severity bleeding;

***Photo 3: Moderate Severity Bleeding Near Sta. 101+50 (Eastbound)***

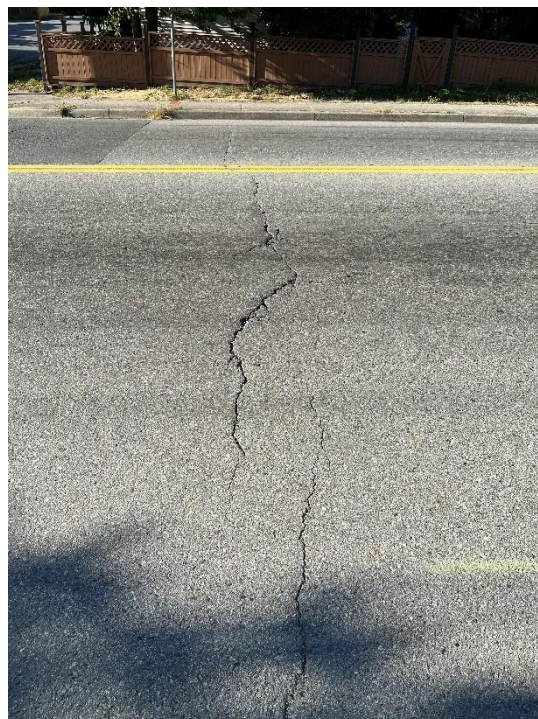
- Sta. 103+25 to 103+55 (eastbound lane): moderate to high severity longitudinal wheel path cracking; and
- Sta. 103+20 to 103+75 (eastbound lane): moderate to high severity transverse cracking (localized)

***Photo 4: Moderate to High Severity Transverse Cracking Near Sta. 103+70 (Eastbound)***

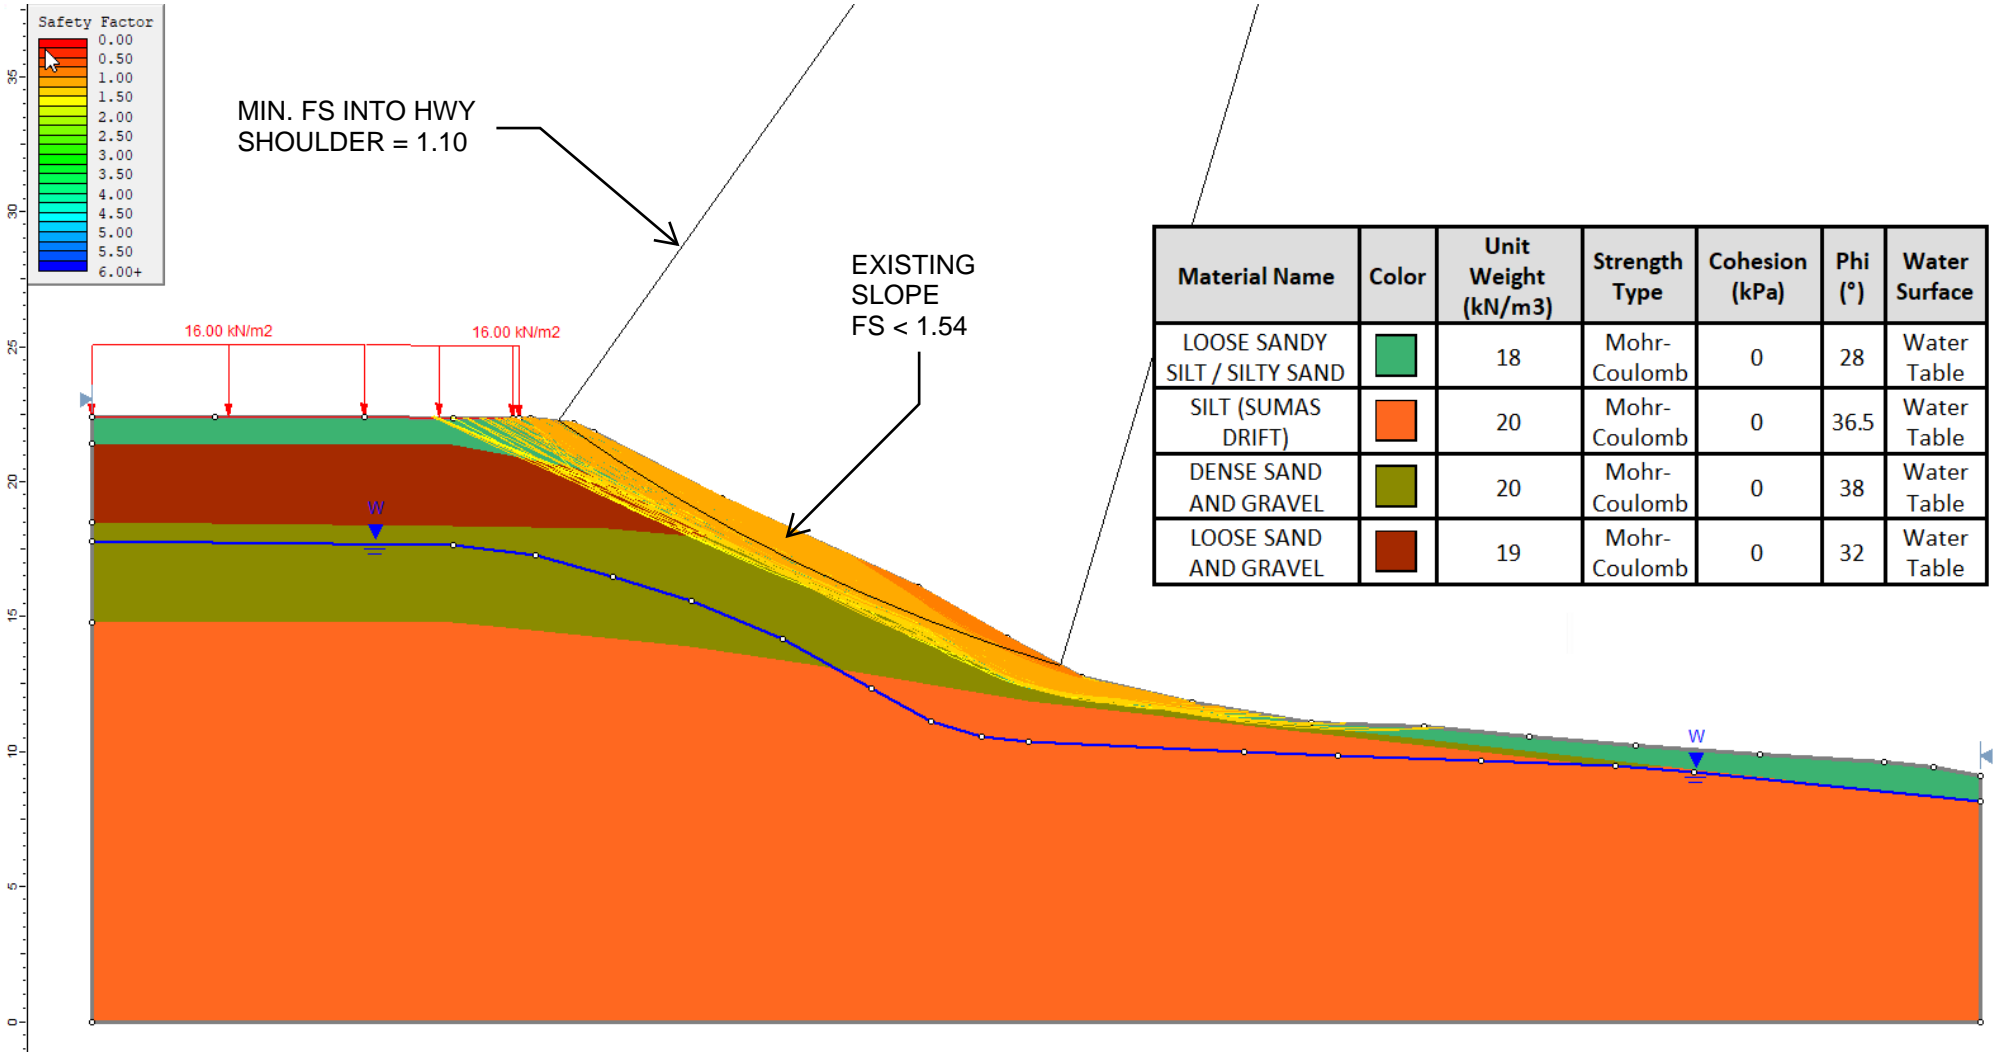
conditions for permanent slopes is 1.54. Consideration was also given in our stability analyses to raising the interpreted groundwater elevation by 1 m over measured levels to account for potential future increases.

EXISTING SLOPE FS < 1.54

The Highway 7 embankment at the BCTFA property should be constructed in accordance with the Ministry's Standard Specifications. We recommend that the Highway 7 embankment be cleared and grubbed and subgrade at the face and toe of the embankment should be free from deleterious, loose/soft or otherwise unsuitable soils. The subgrade at the toe of the embankment should be horizontal and compacted with a large steel drum vibratory roller where possible. The subgrade should be reviewed prior to fill placement and any sub-excavation operations completed, if required. Following subgrade approval, imported fill should be used to reconstruct the entire embankment slope at 2.25H:1V or flatter to meet the geotechnical design criteria.

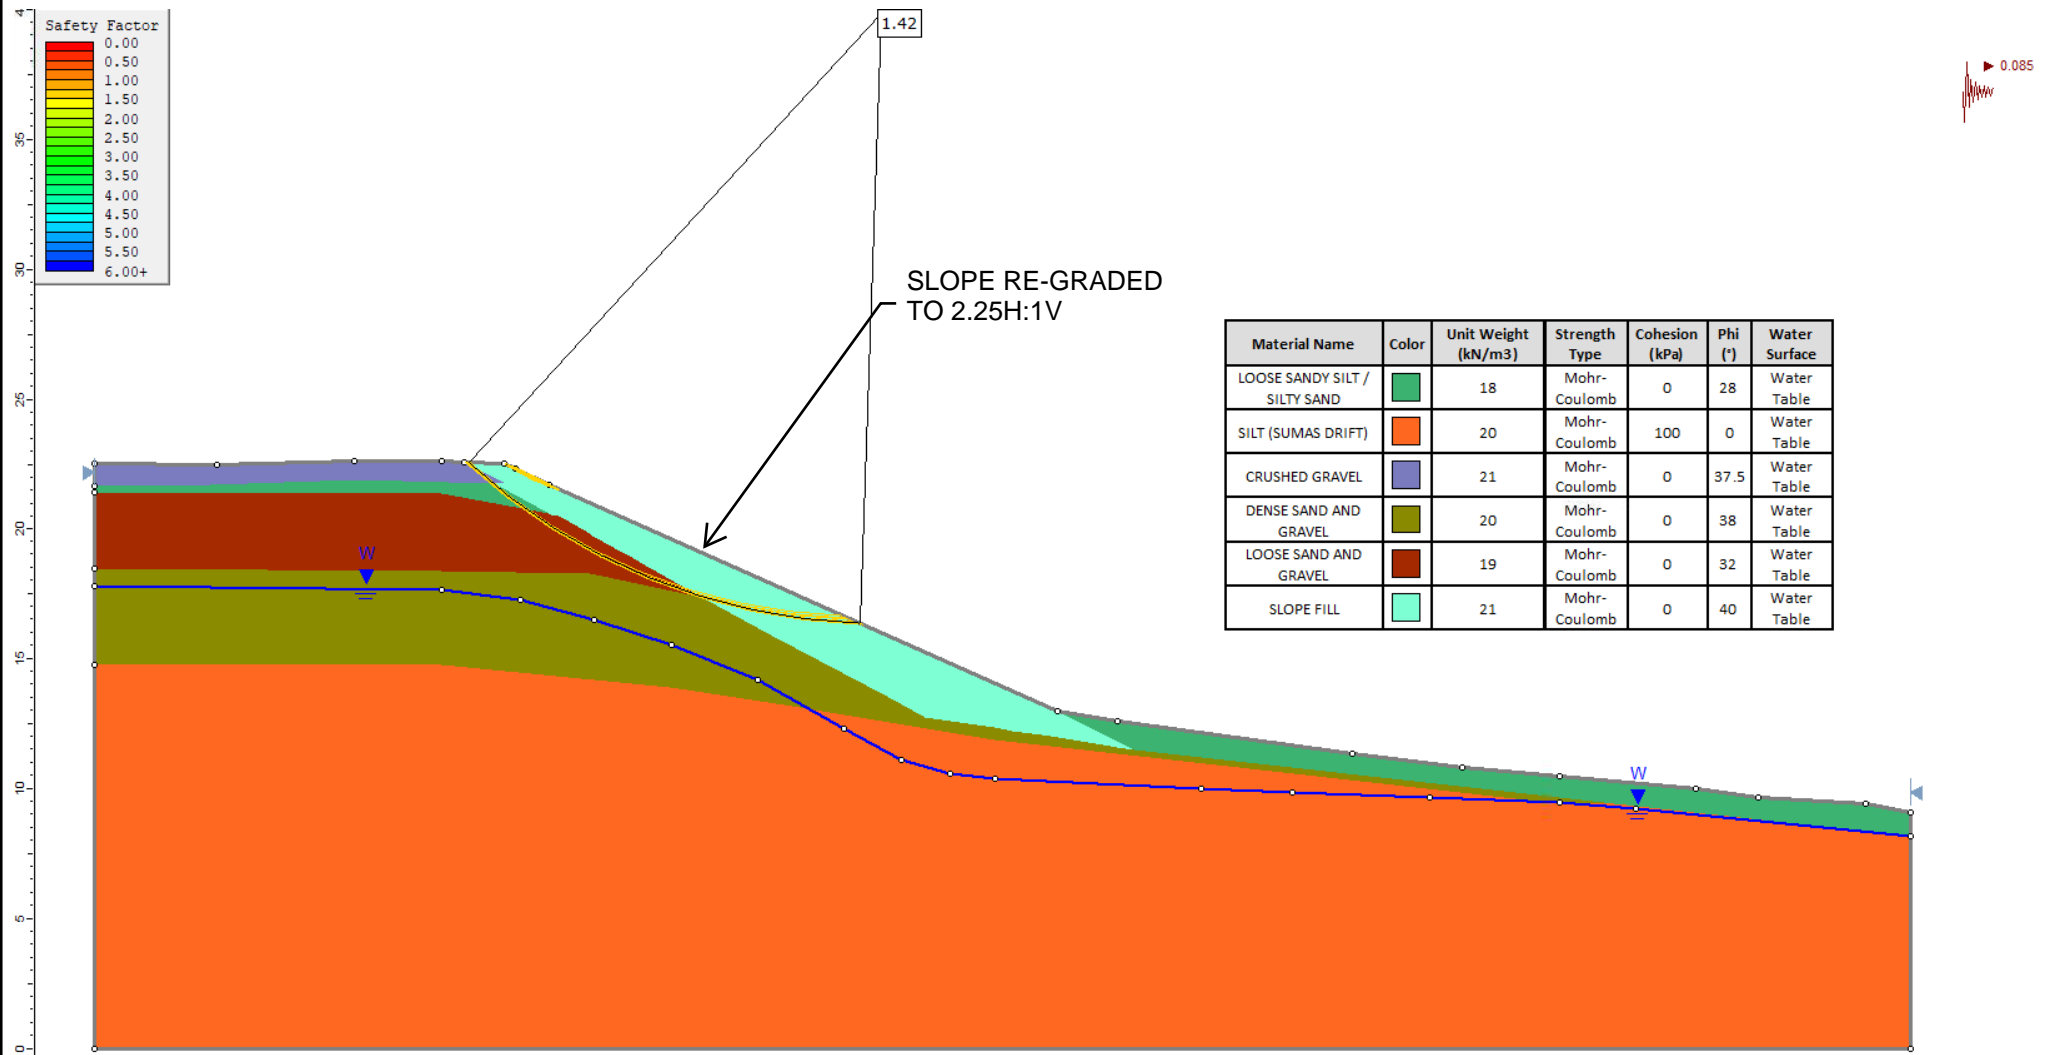
Pseudo-static limit equilibrium analyses were carried out using 50% of the Site Class D, 1 in 475-year return period peak ground acceleration. Slip surfaces for the embankment slope reconstructed in accordance with Section 9.5 were found to have a FS > 1.3.

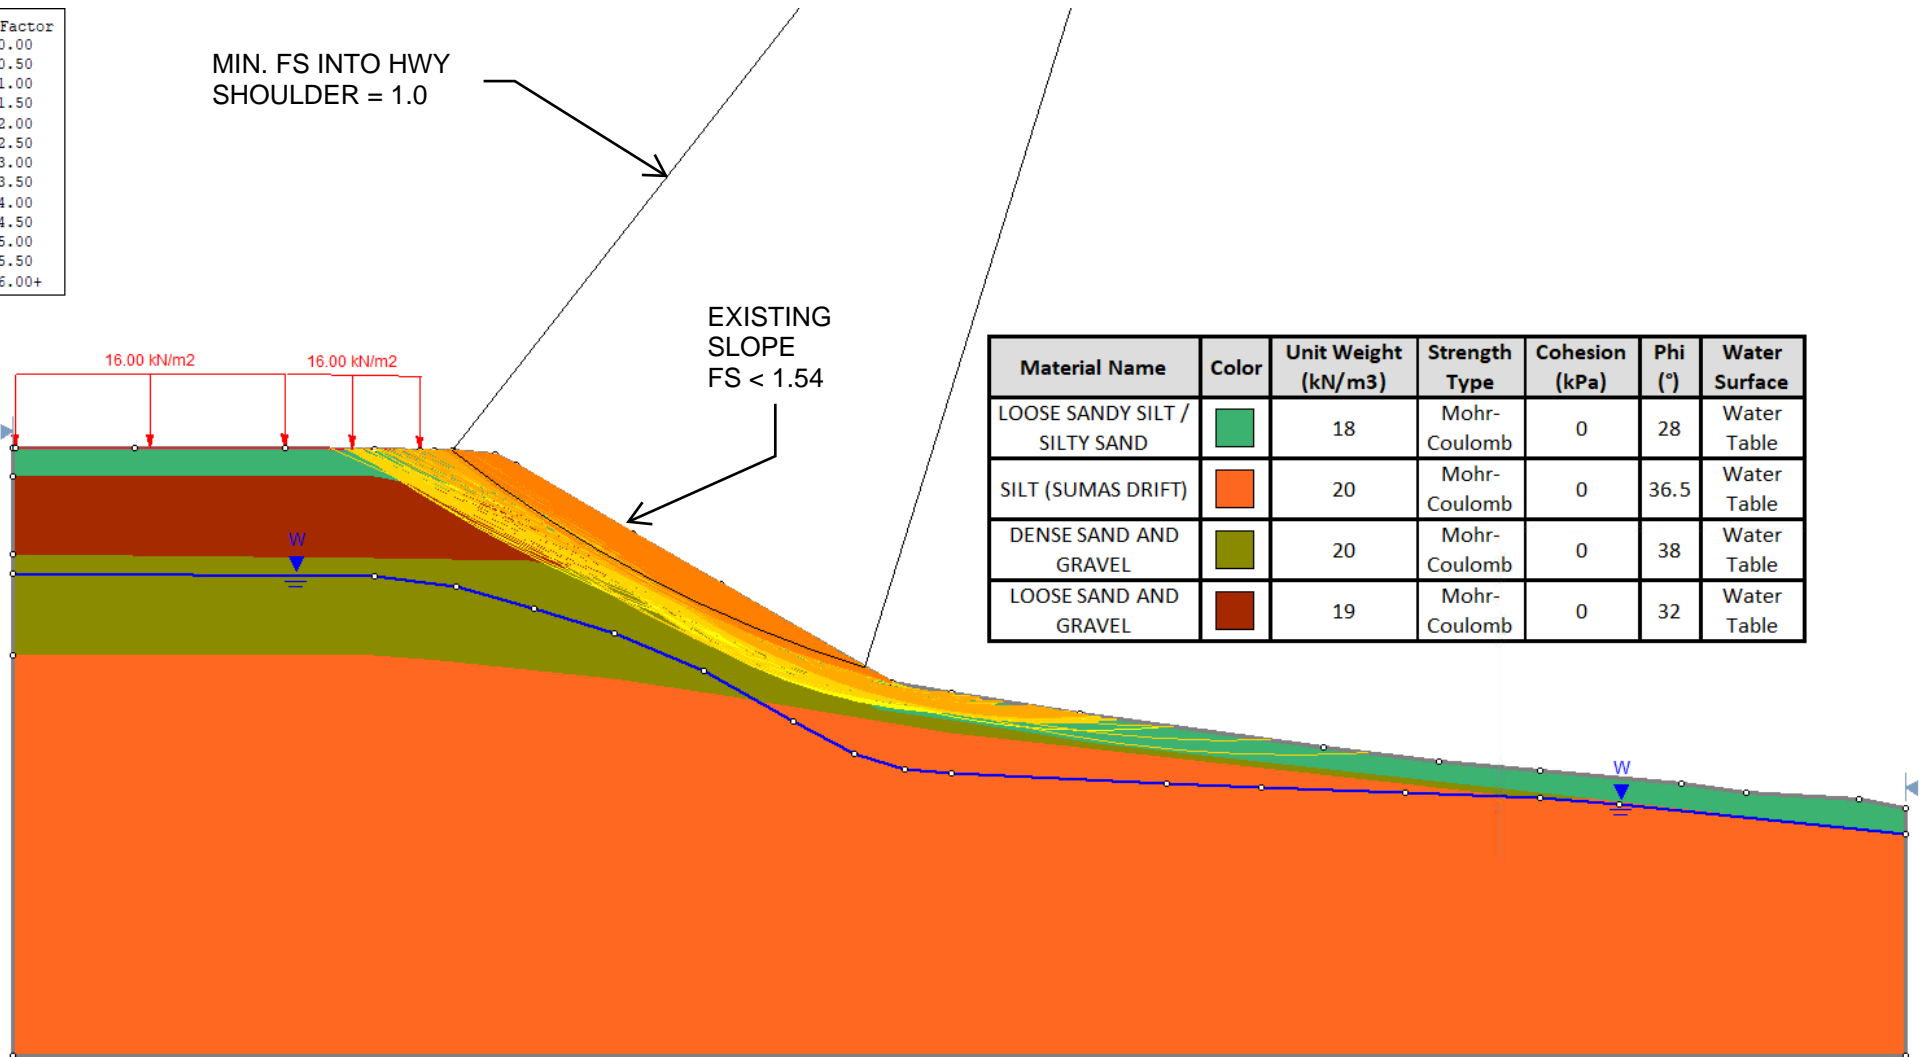
EXISTING SLOPE FS < 1.54
