**BC Ministry of Transportation and Infrastructure
South Coast Region**

**PAVEMENT STRENGTH TESTING AND EVALUATION
HIGHWAY 7 & 7B - LKI SEGMENTS 2730 AND 2715
PITT MEADOWS / PORT COQUITLAM, BC**

V13101493.002

February 2010

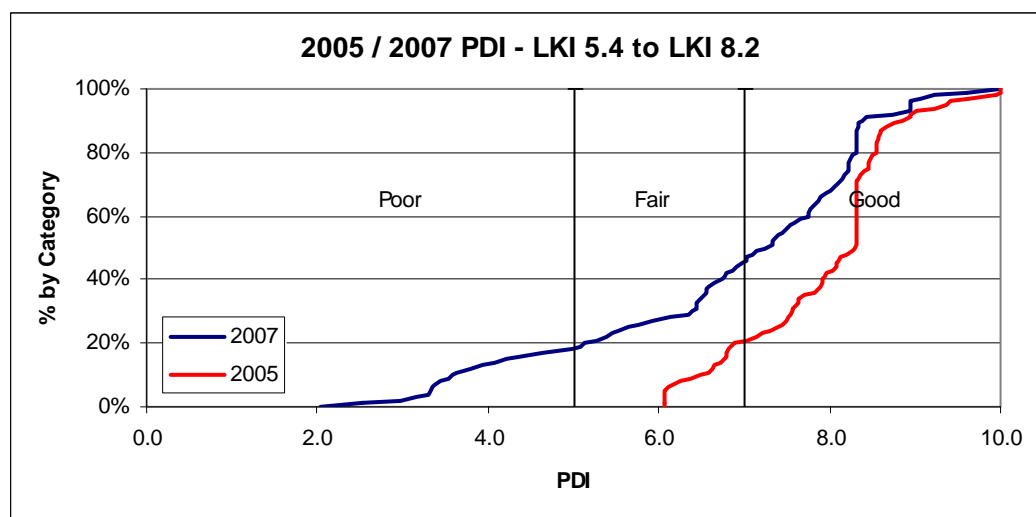
In general, differences in 2005 and 2007 RPMS data are representative of reasonable rate of deterioration for this section of roadway. There is however, there is indication of a increased rate in pavement distress values, and indicated by comparing 2005 and 2007 PDI values, between LKI 5.4 to LKI 8.2. Within this area, the overall percentage of poor pavement condition increased from 0% to 19% between 2005 and 2007. In addition, the percentage of fair pavement condition increased from 20% to 45% between 2005 and 2007. A statistical comparison showing the percentage of PDI severity by category (poor, fair, or good condition) of the 2005 and 2007 RPMS data can be seen below.

This increase in roadway PDI may be indicative of a weakening pavement structure. The rate of deterioration suggests that rehabilitation of this area may be required. 2005 and 2007 RPMS data for Highway 7B has also been plotted, and can be found in Figure 3.

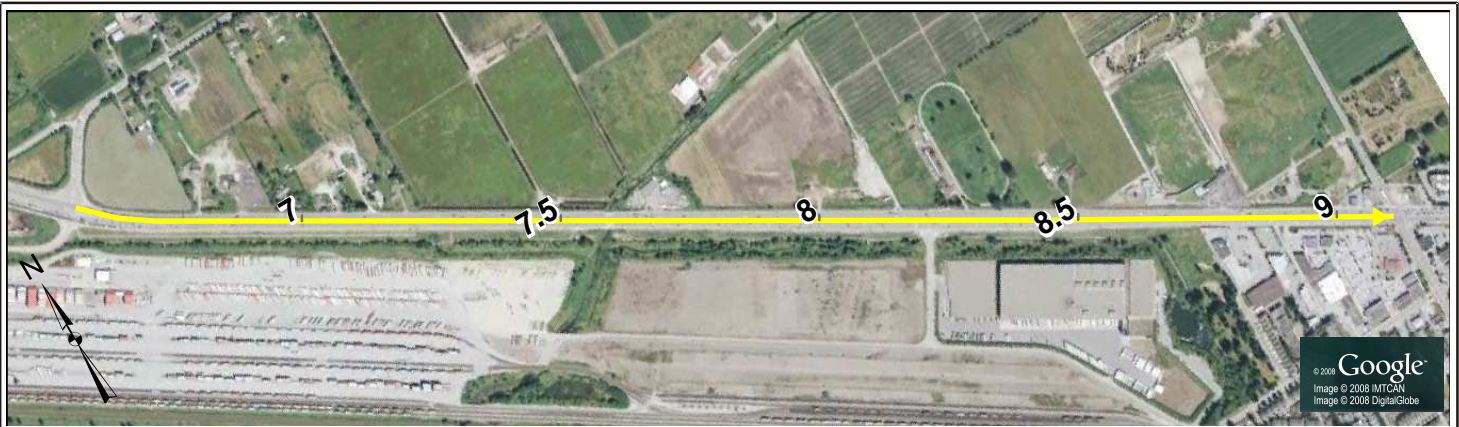
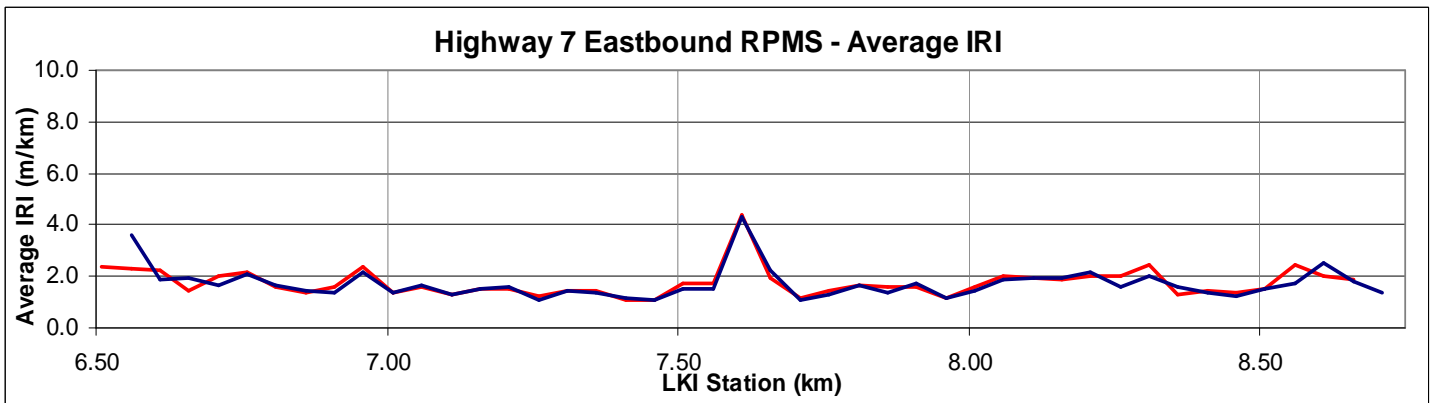
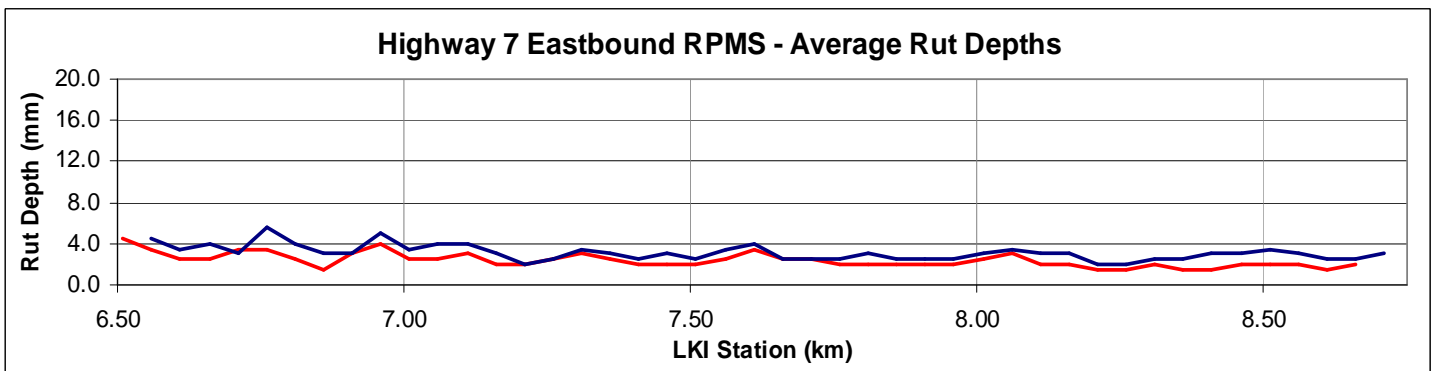
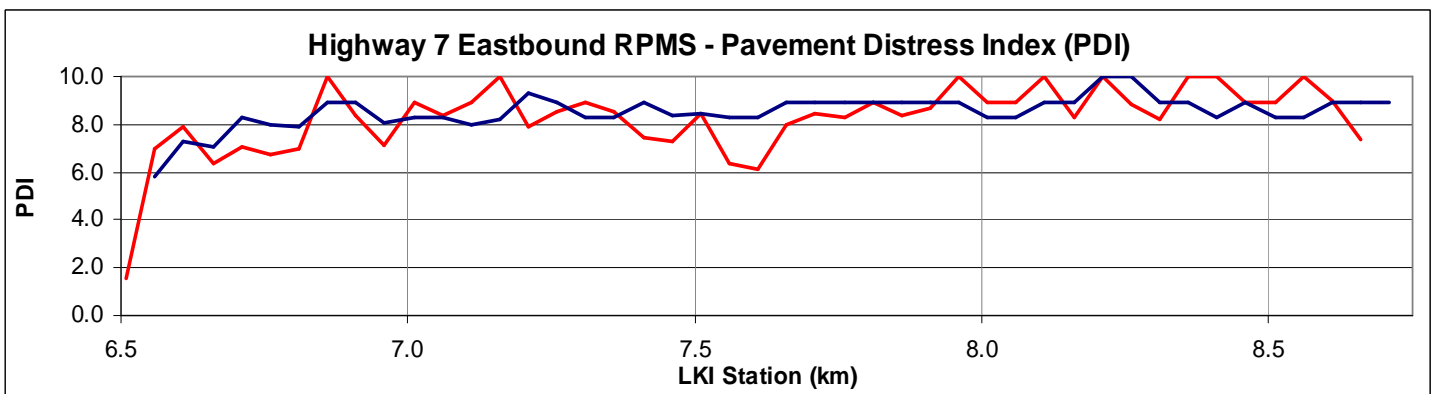
Figure 2

In general, differences in 2005 and 2007 RPMS data are representative of reasonable rate of deterioration for this section of roadway. 2005 and 2007 RPMS data for Highway 7 has also been plotted, and can be found in Figure 2.

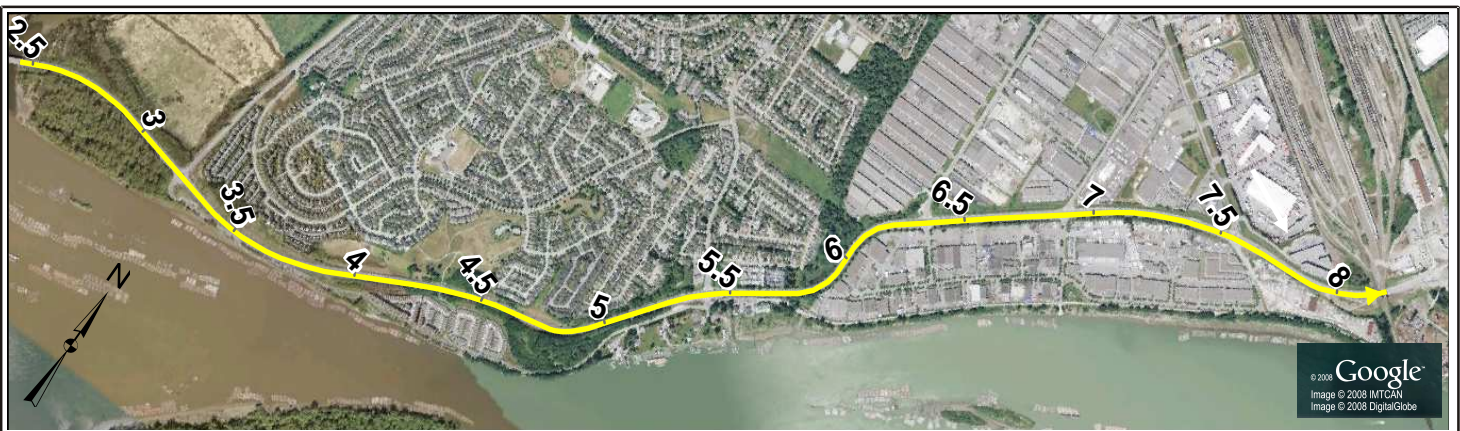
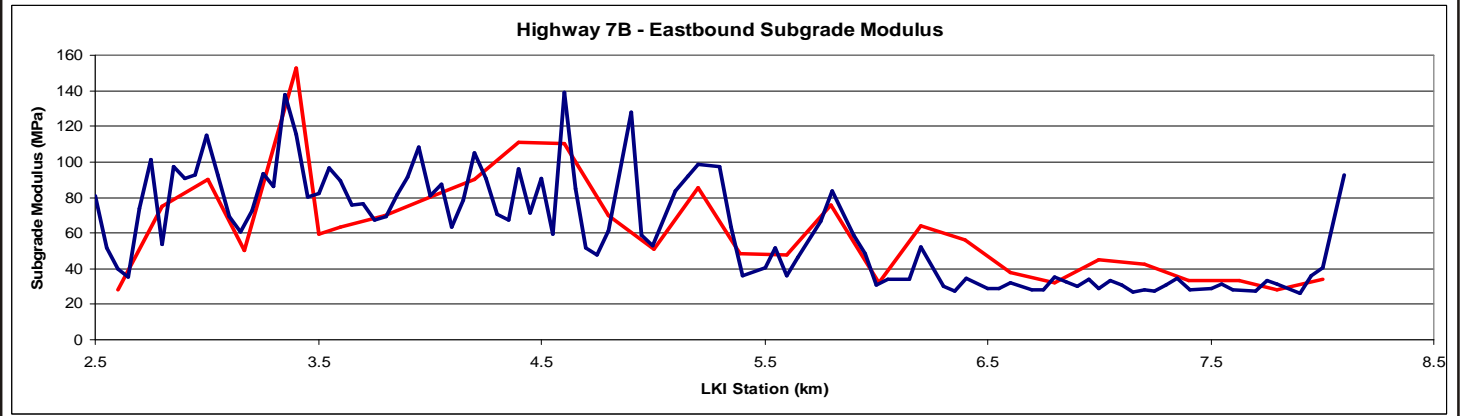
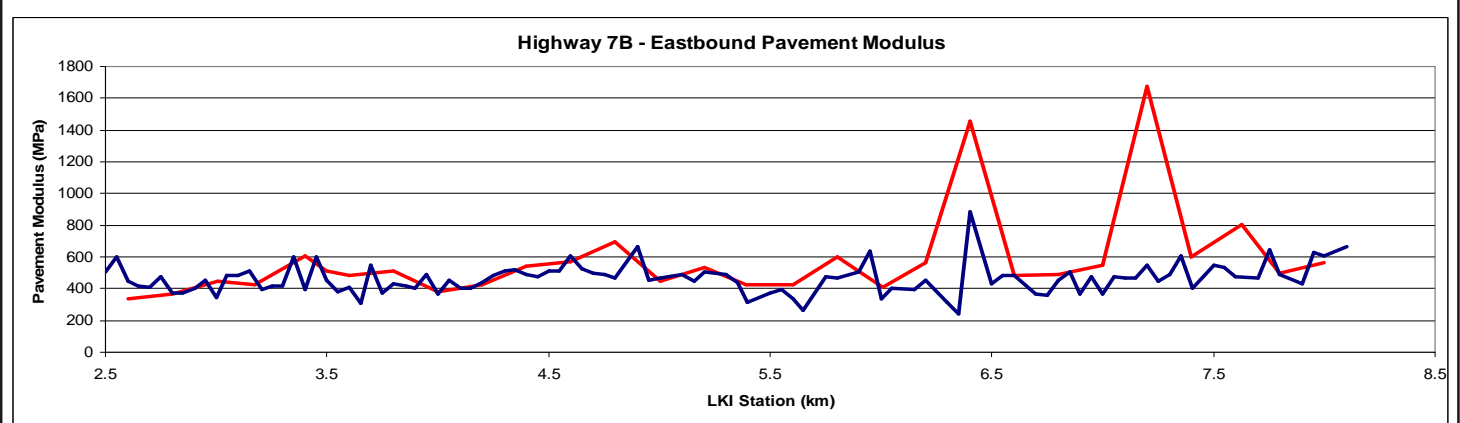
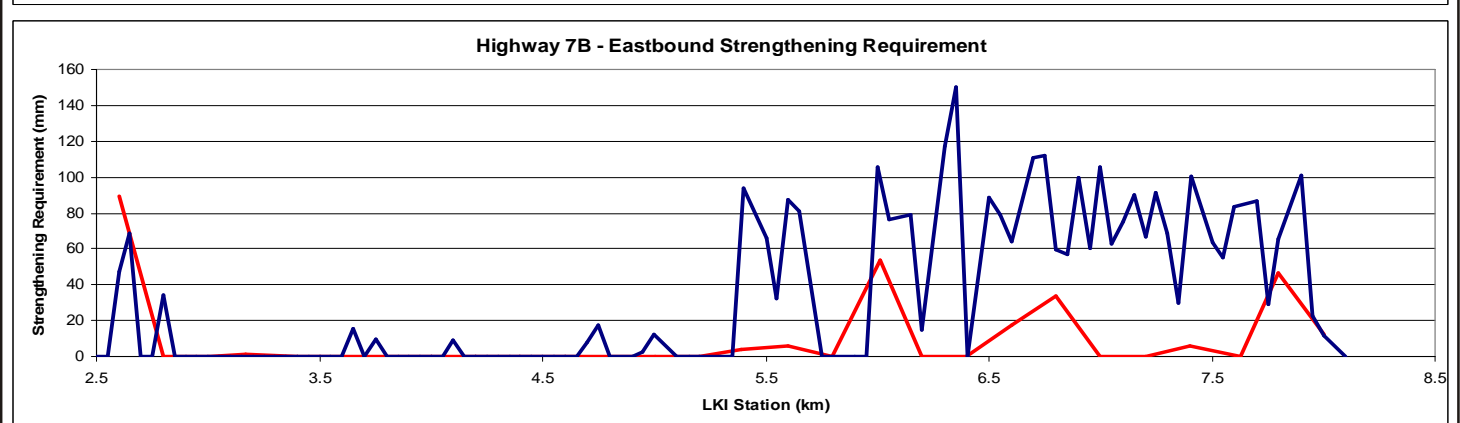
**HIGHWAY 7B EASTBOUND
 STRENGTHENING REQUIREMENT**

requirements; however, areas of structural deficiency do exist between LKI 5.60 and LKI 8.10. Pavement strengthening requirements (20-year design ESALs) for Highway 7B are summarized in Table 10.
