# HIGHWAY 7 & HIGHWAY 11 INTERSECTION IMPROVEMENTS PROJECT

**100% GEOTECHNICAL DESIGN REPORT**

Client Name: ISL Engineering and Land Services Ltd. Date: March 11, 2024 MoTI File: 13252 Thurber File: 15723

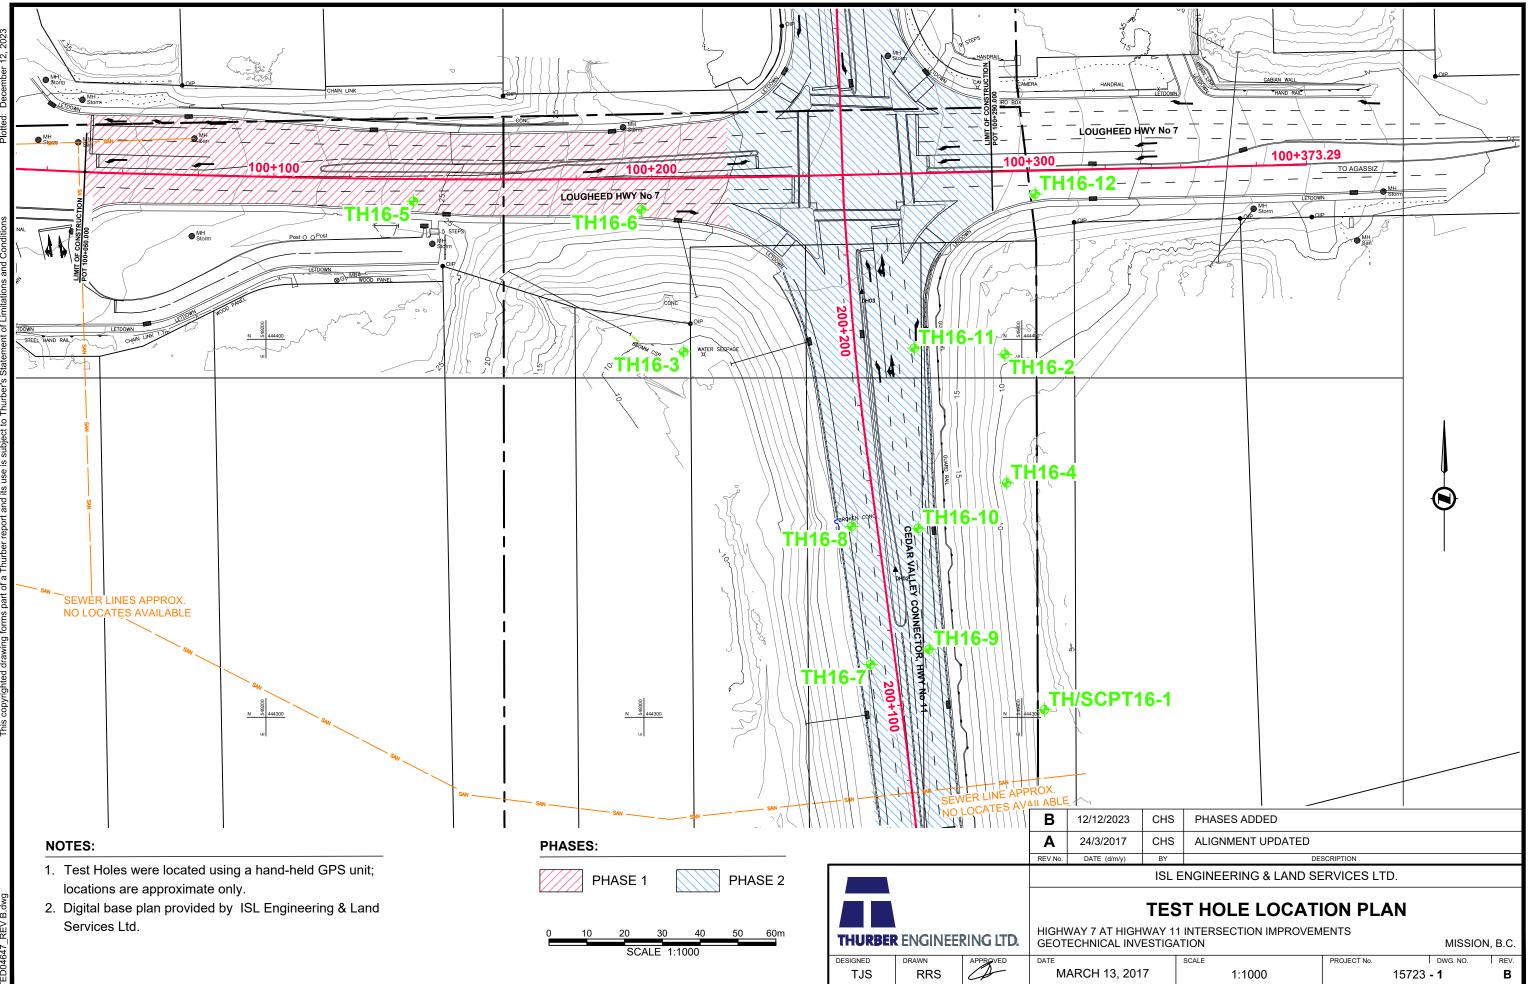
Southwest of the intersection, the groundwater table was generally near-surface at TH16-3 and upward seepage was observed at the toe of the embankment, as noted on Dwg. 15723-1. The groundwater seepage was observed to contribute to flow in the surface water ditch adjacent the west toe of the Highway 11 embankment.
