To: **ISL Engineering and Land Services** Date: **January 31, 2024**
Attention: **Amanda Pellam, P.Eng.** Project No.: **33580**
Cc: **Steve Clark, P. Eng.; Octaviano Salgado Perez, P.Eng., PMP; Alana Getty Somers, P.Eng.; Cory Clark, P.Eng., David Neufeld, R.P.Bio, B.Sc.**
Reference: **Highway 7 and 11 Upgrades –Environmental Assessment**
From: **Larissa Darc, M.Sc., B.I.T**

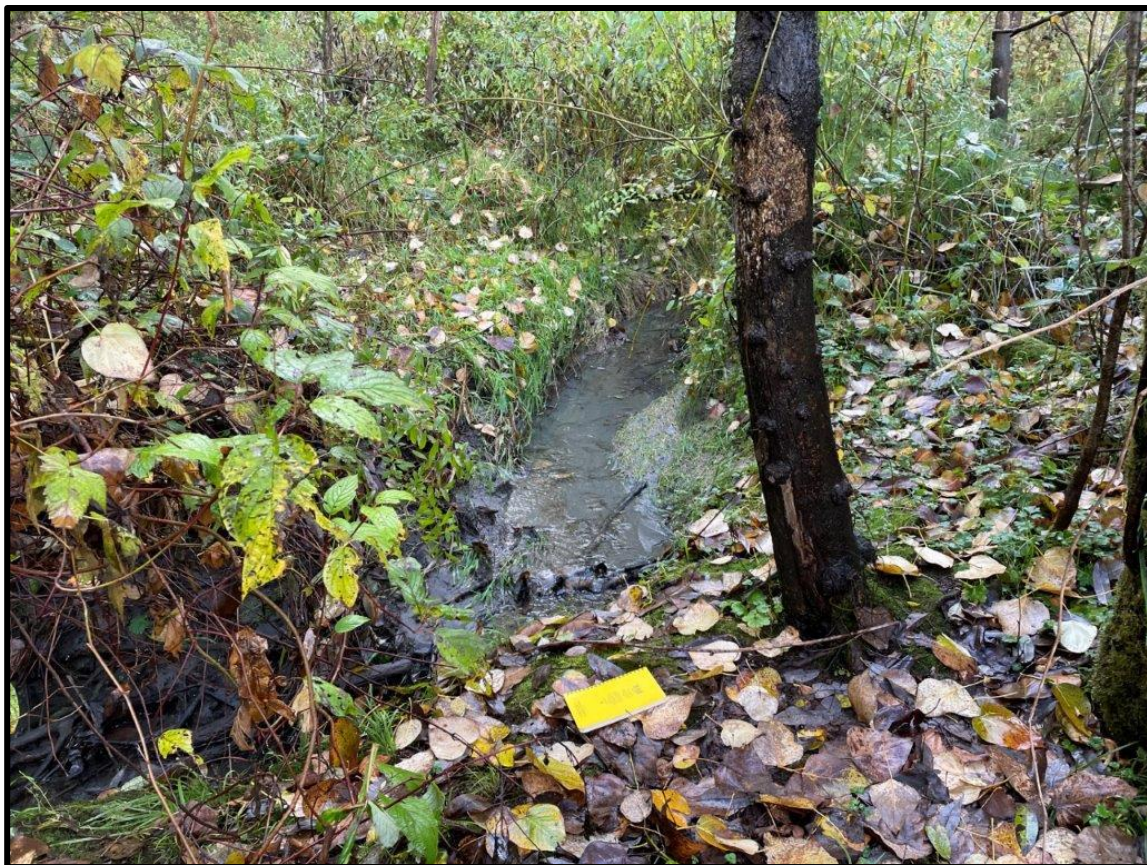
Watercourse A is unconfined in its headwaters and appears to be sourced by a spring located near the southwest corner of the intersection (see Figure 3). There is also a tributary to Watercourse A in the form of a stormwater outfall from under Highway 7 (ISL, 2016). The channel becomes more confined 35 m downstream from the spring. Watercourse A has an average bankfull width of 1.2 m and a substrate of 100% mineral fines, which had a sandy texture (Figure 2).

Figure 2. Representative instream conditions at Watercourse A. Photograph facing upstream (north).

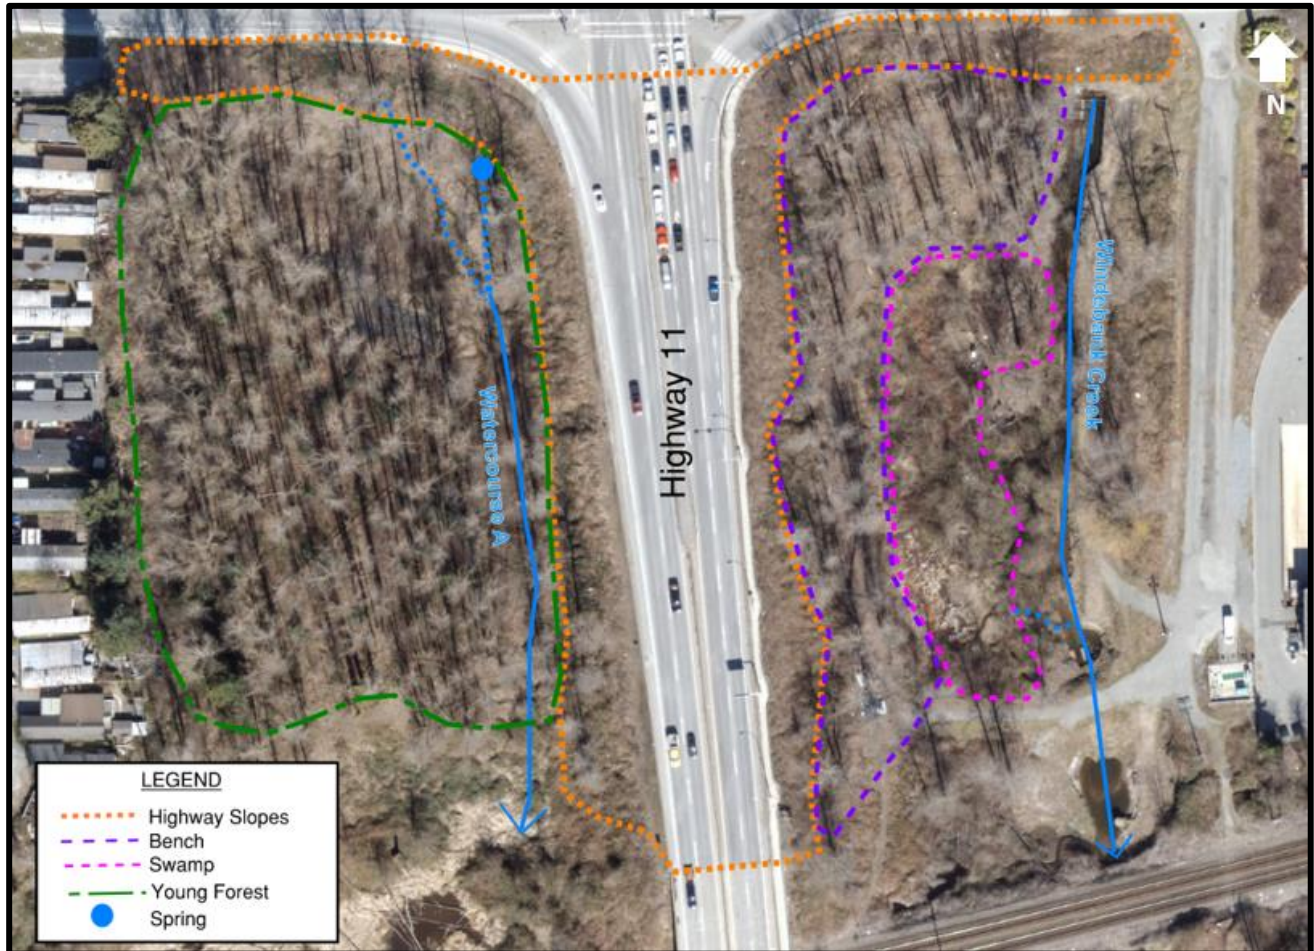
Four polygons were delineated across the project site, based on canopy type and age (Figure 3).

Figure 3. Polygons and drainages within the project location (imagery source: Mission WebMap, 2023).

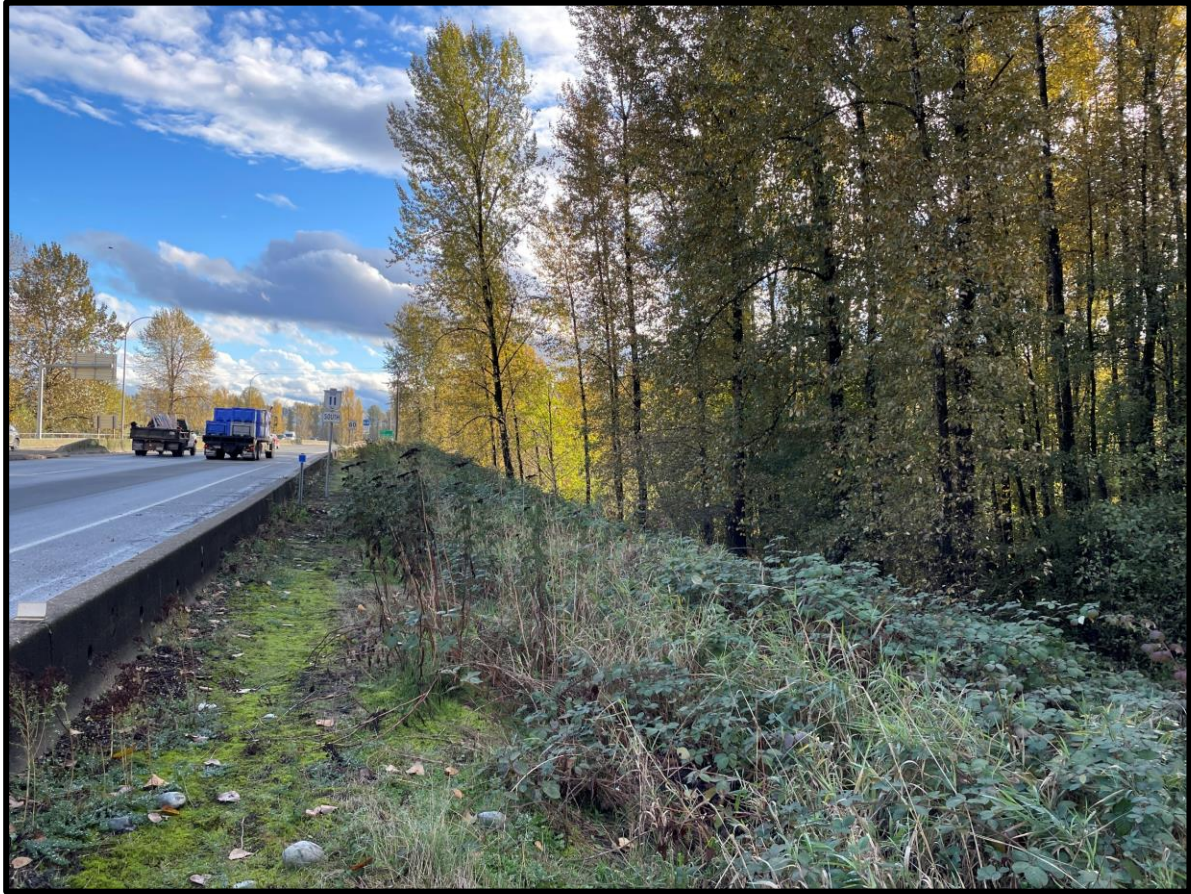
Slopes with a 40-60% gradient slope are present immediately west and east of Highway 11. These areas have been historically cleared of trees, but trees which have become re-established are near the toe of slope. The canopy cover on the slope was < 5%. All trees were < 30 years of age. Tree species present included black cottonwood (*Populus trichocarpa*), willows (*Salix* spp) and red alder (*Alnus rubra*). The shrub layer on the slopes consisted solely of non-native Himalayan blackberry (100% cover). No herbaceous layer was observed. Invasive plant species and weeds were observed upslope adjacent to the highway road edge and included: Canada goldenrod (*Solidago canadensis*), scotch broom (*Cytisus scoparius*), yarrow (*Achillea millefolium*), reed canary grass (*Phalaris arundinacea*), and Himalayan blackberry (*Rubus armeniacus*) (Figure 4).

Figure 4. Invasive plant species present upslope adjacent to the highway. Photograph facing south.

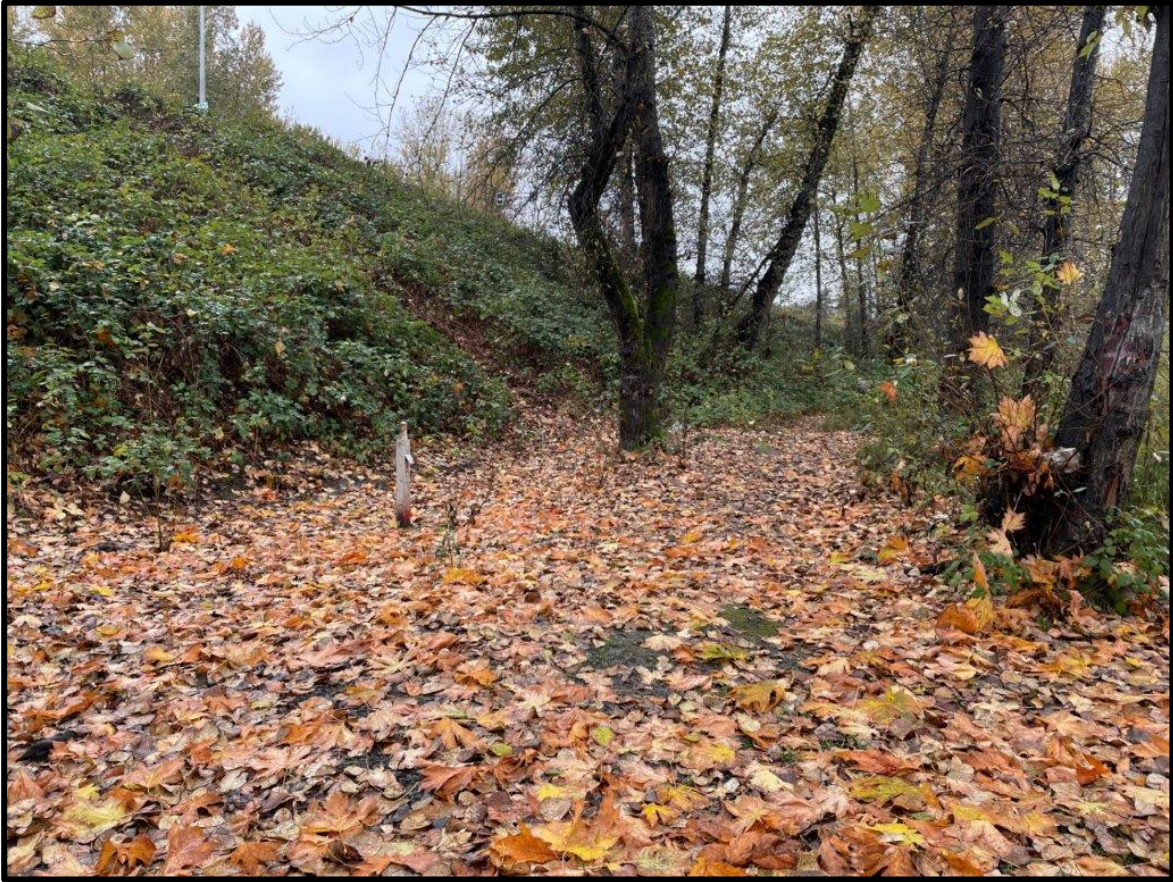
The bench had multiple areas of human encampment, with trash and other objects throughout the riparian zone. Multiple trees have been vandalized by people, with damage including hacked off bark, metal objects stuck into trees, axe marks, and spray paint. A hydrogeological monitoring well was also observed in this area.

Figure 5. Representative conditions of the slope east of Highway 11 and the bench. Photograph facing north.

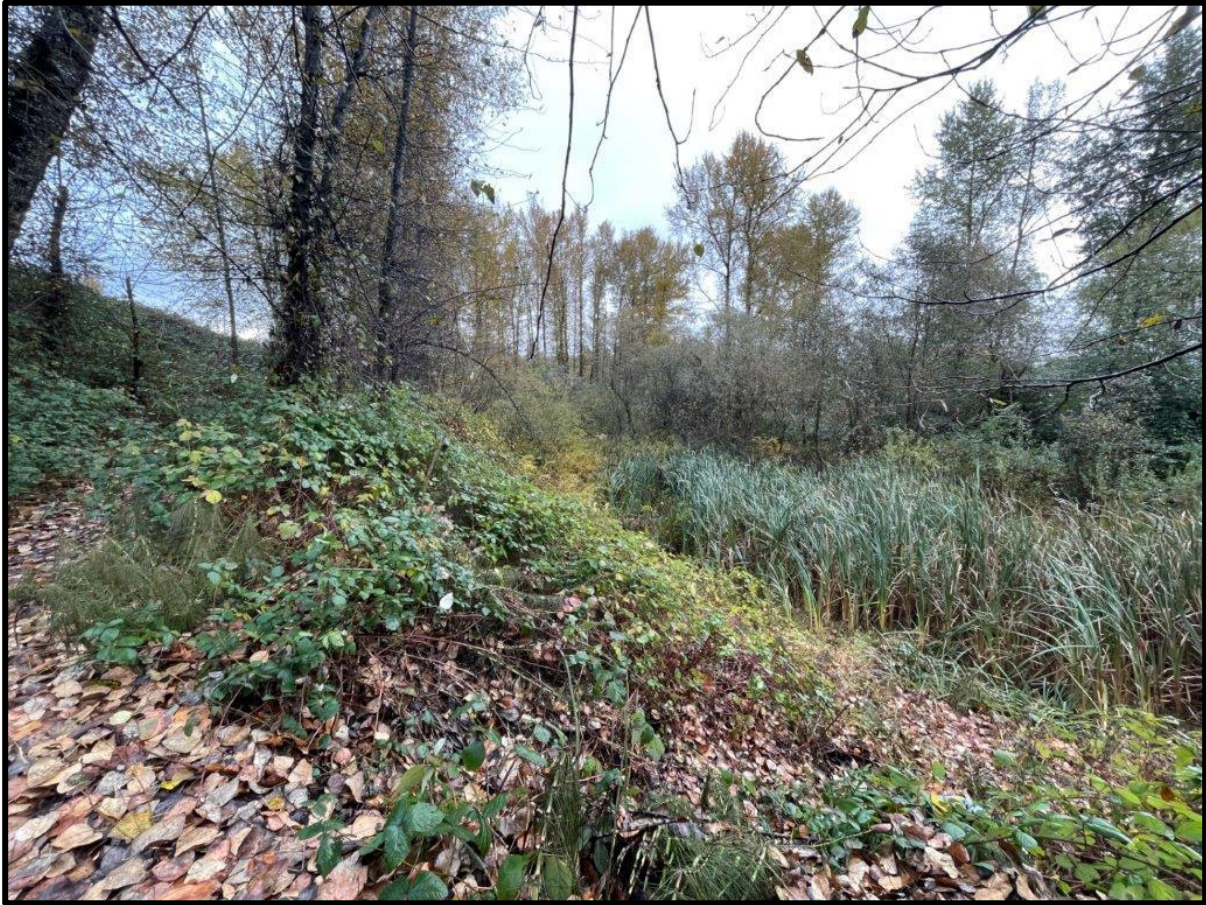
Immediately below the bench (approximately 35 m from Highway 11) we observed a low-lying area with pooling water and shrub vegetation consistent with a swamp, consisting of cattails (*Typha latifolia*), hardhack (*Spiraea douglasii*), and willows (**Figure 6**). Water pooling in this area was orange-brown in colour with iron precipitate buildup and a top layer of organic sheen, that we attribute to the breakdown of organic compounds within the swamp. This swamp was observed to discharge to the east into Windebank Creek.

Figure 6. View of the area of pooling water present downslope from the bench.

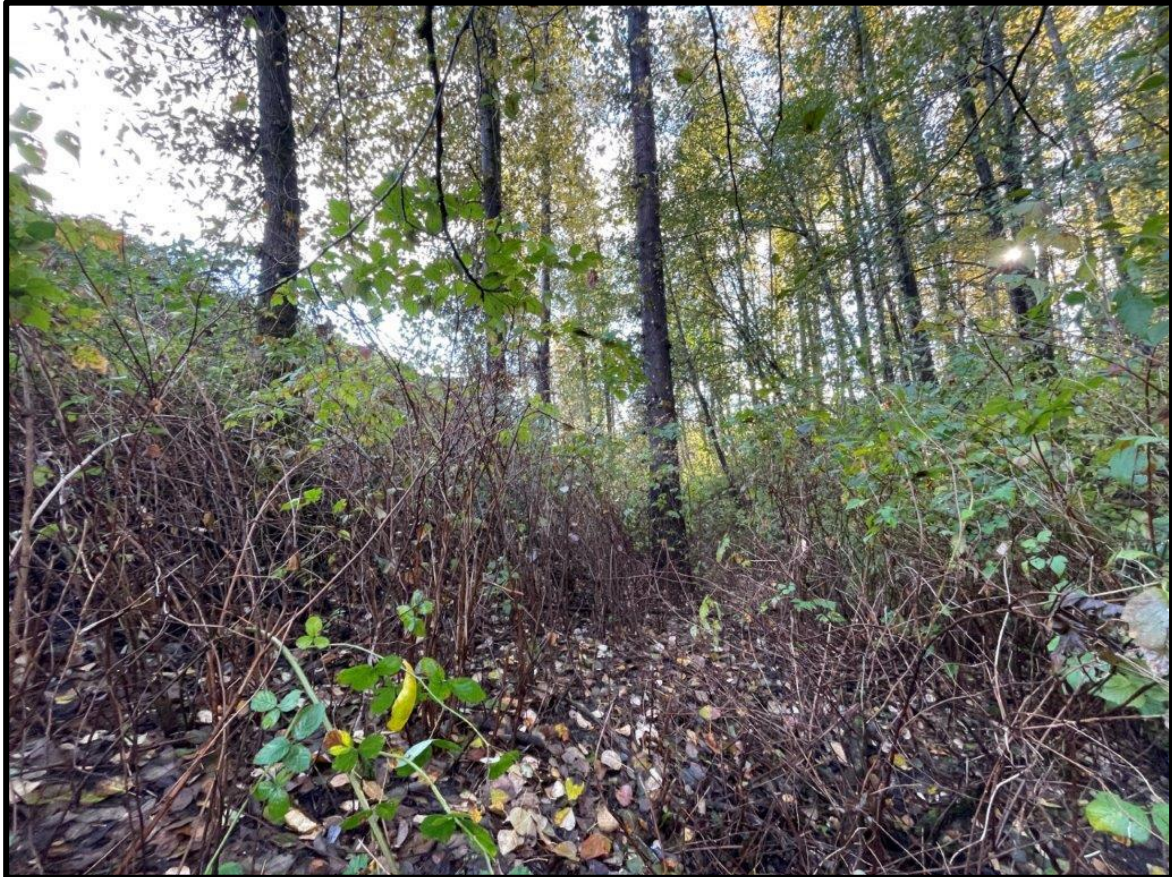
Watercourse A is located within the Young Forest at the base of the slope, approximately 26 m from the edge of the highway median. The tree canopy surrounding Watercourse A was denser at the base of the slope (20% canopy cover) and was dominated by black cottonwood, with a subdominant component of willow and trace amounts of red alder. The shrub layer was more diverse and began at the base of Highway Slope 2. Tall shrubs consisted of salmonberry (*Rubus spectabilis*, 30%), red elderberry (*Sambucus racemose*; 5%), and Indian plum (*Oemleria cerasiformis*; 5%) (**Figure 7**). The short shrub layer was also dominated by salmonberry (50%), but had elements of willow (5%), Indian plum (5%), elderberry (5%), hardhack (5%), and Nootka rose (*Rosa nutkana*; 5%). Herbaceous species present consisted of horsetails, bracken fern (*Pteridium aquilinum*), swordfern (*Polystichum munitum*), and grasses.

Figure 7. Representative conditions of the shrub layer in the Young Forest polygon. Photograph facing south.
